A Different View of Stone Monuments, Memorials and Buildings of Washington, D.C.

Field Trip Guidebook T235

IGC FIELD TRIP T235:
A DIFFERENT VIEW OF STONE MONUMENTS, MEMORIALS, AND BUILDINGS OF
WASHINGTON, DISTRICT OF COLUMBIA

Bruce R. Doe
U. S. Geological Survey, Reston, Virginia

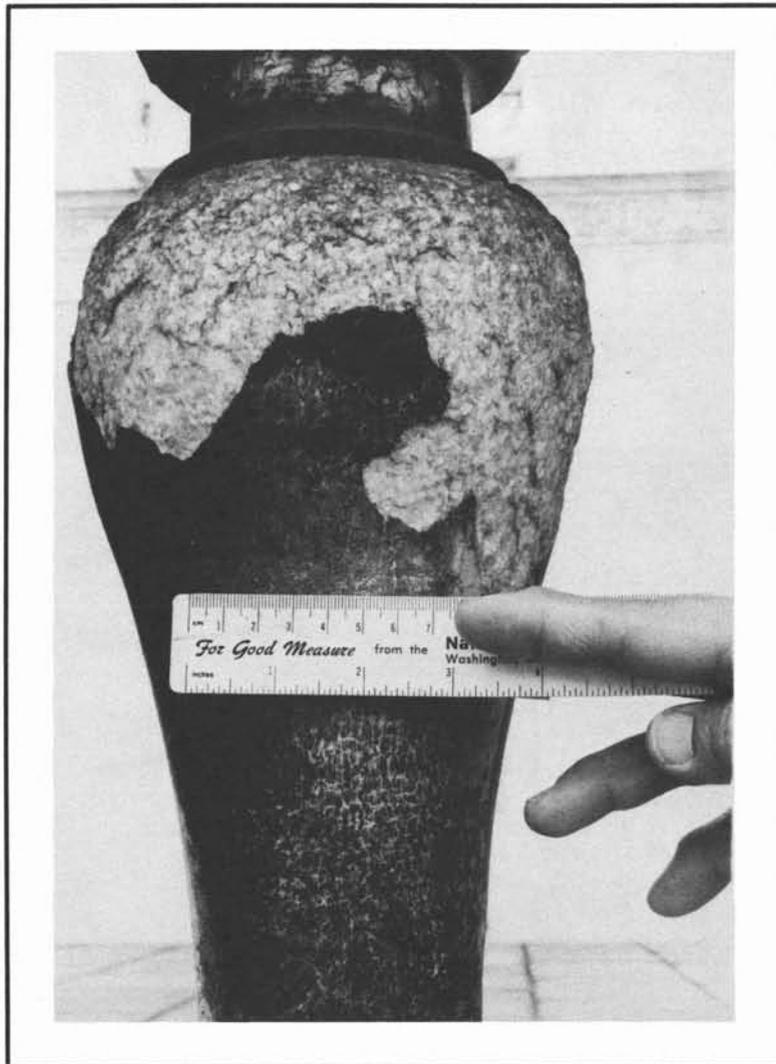
COVER Marble baluster in balustrade of the west patio, Pan American Union Building (completed 1910), Washington, District of Columbia. The black coating contains fine-grained gypsum and is scaling off. Photograph by Deborah Dwornik, U.S. Geological Survey, 1984.

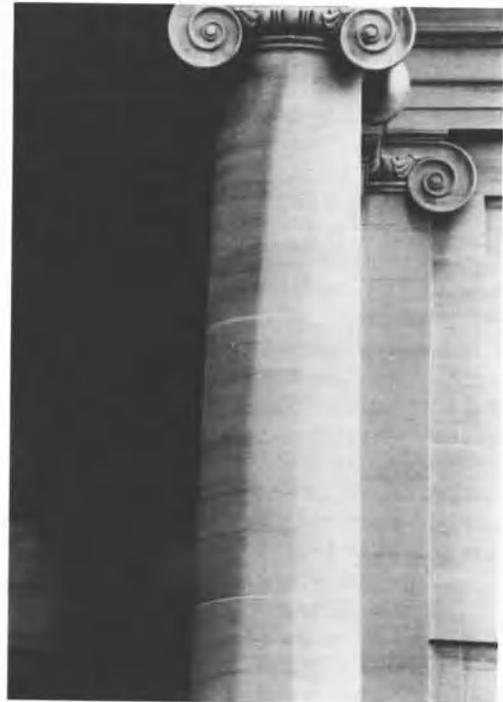
A walk along C Street towards 18th Street enables an examination of Constitution Hall of the DAR. This building was constructed when Memorial Continental Hall was condemned and was completed in 1929. It is constructed of limestone from Alabama (Unfluted columns on the east and north sides of Memorial Continental Hall also appear to be of this stone.). In general the stone is in remarkably good shape; however, some restoration of the limestone on the south (and north) podia, steps and landing was made in the spring of 1985 to correct damage possibly related to salting of the steps and landing in the winter. Some limestone has been replaced in the steps on 18th Street also. The area of a sill will be examined to see how even minor overhangs protect stone from precipitation runoff damage. Columns along 18th Street show a predominant precipitation direction from the south as evidenced by clean-looking and roughened surfaces to the south and smoother but polluted surfaces on the north (Fig. 2).

FIGURE 2 Acid rain effect on column of Constitution Hall. Southward facing surface is abrasive feeling and clean looking. Northward facing surface is smoother feeling with accumulation of pollution.

This condition is well observed by crossing 18th street and looking east, back at Constitution Hall. The relationship is common, and I have observed it on a variety of construction materials in diverse locations of the world, e. g. sandstone (City Police Station near the Rat Haus Bruche, Switzerland) and concrete (Powell Building, Reston, Virginia).

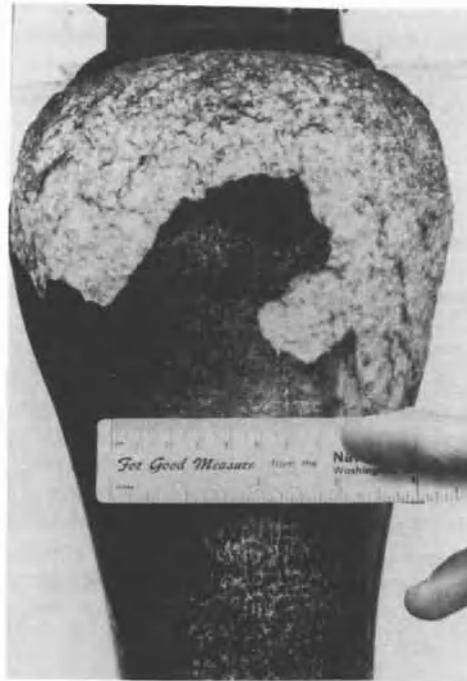
Some cracking of rails around the garden appears to go all the way through. Surfaces of the rails are extremely rough with some mineral accumulations--probably magnesian calcite or dolomite as in the Corcoran Gallery -- standing in positive relief. Accumulations of white material under the broad rails contain

FIGURE 3 Gypsum alteration and spalling at the Pan American Union Building.

gypsum. In 1985, it could be seen that vines had been recently removed from the east-facing podium of the garden and the south side of the adjacent building. The Aztec Garden is the most vegetated location studied with numerous trees nearby so that organic acids from the

trees or other exudates perhaps contributed to the accelerated decay of this stone.

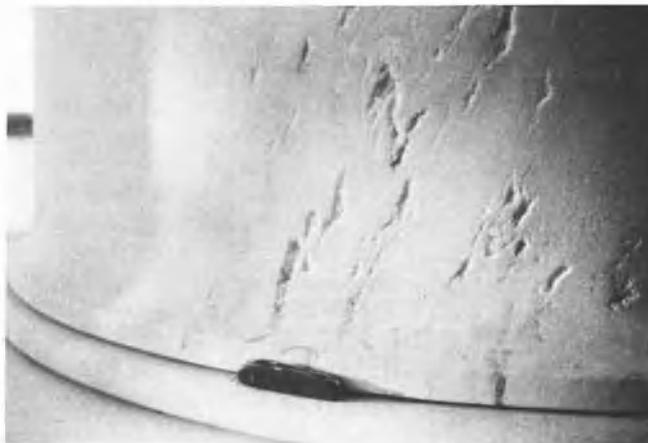
FIGURE 4 Grooving of column at the Jefferson Memorial.

alteration rind seems to be continuously removed furnishing surfaces for further reaction. Once the grooves begin, excellent locations for freeze-thaw action are formed to create spalling.

The unusual amount of damage may be related in some fashion to its location near the bottom of the area known as "foggy bottom", brackish water nearby, its proximity to a coal fired power plant in the days before the Clean Air Act, hydraulic cleaning, and/or its location on the flight path to National Airport. Grooving is observed near the tops of the columns that would seem to be well above the horizon of normal hydraulic cleaning. Perhaps the lower mean annual temperature somehow accounts for the significant damage observed in short-lived marble structures of the Washington, D. C. area relative to centuries older structures in Rome or Greece; however, Skoulikidis [1982] has estimated from studies of photographs and molds that damage to the Acropolis accelerated 20-25 years before his report along with the development of industrialization in Greece where fuels high in sulfur content were used.
