Failure Analysis of Engineering Structures

Methodology and Case Histories

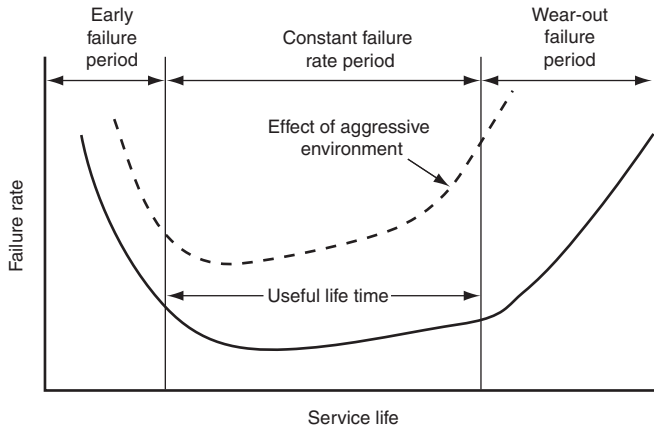
Fig. 1.1 Failure rate during the service life of a system. Source: Ref 1

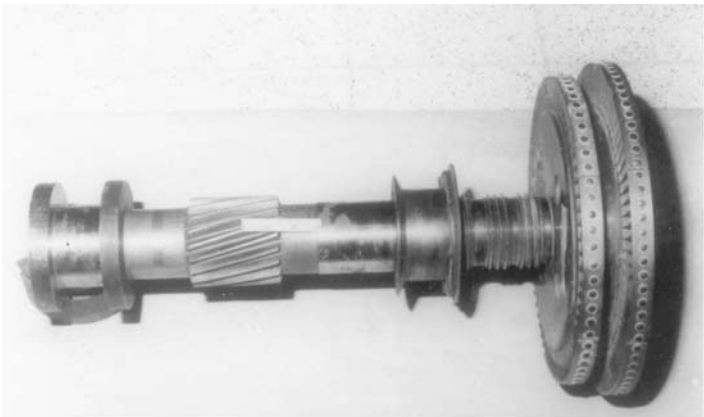
Figure 2.1 shows the two-stage turbine disk and the shaft. The locking nut fitted at the end of the shaft with its two locking pins intact is shown in Fig. 2.2. The locking mechanism is shown in Fig. 2.3. The locking nut with left-handed threads was tightened by rotation in a direction opposite to the rotation of the disk. To retain the nut in this position after tightening, two holes were drilled in situ through the nut and the disk and two pins were inserted.

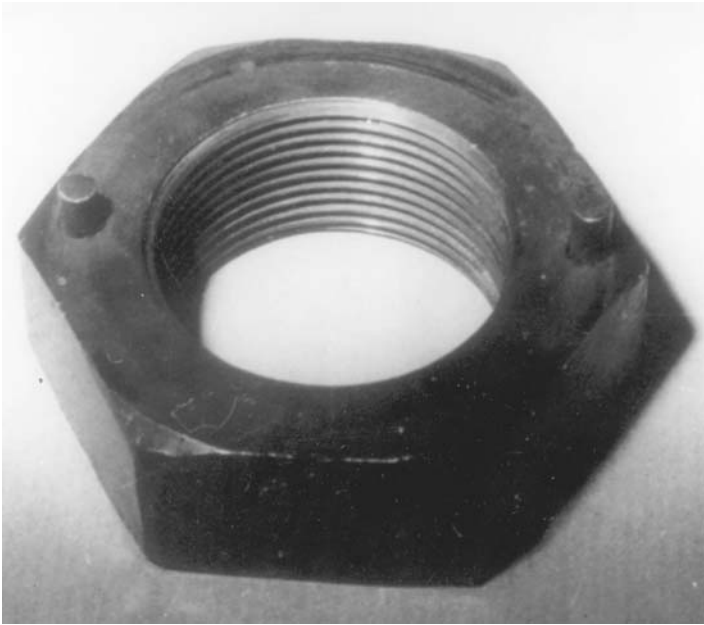
Fig. 2.2 Locking nut with the two pins intact. Source: Ref 3

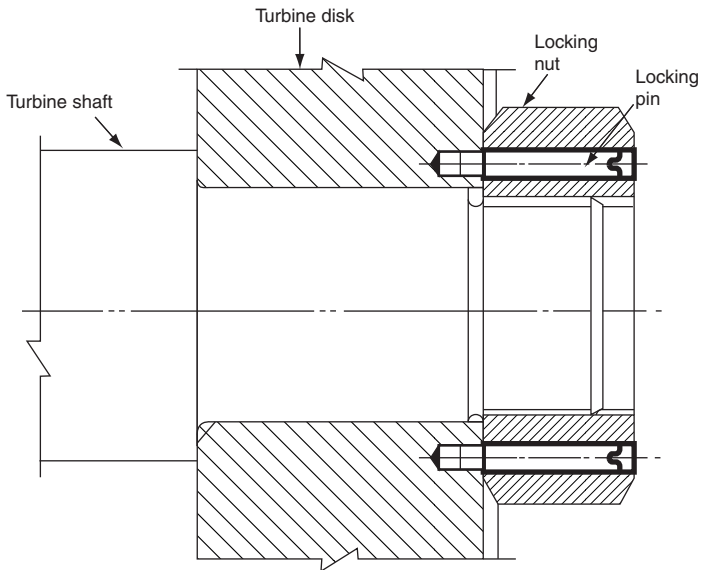
Fig. 2.3 Disk locking arrangement. Source: Ref 3

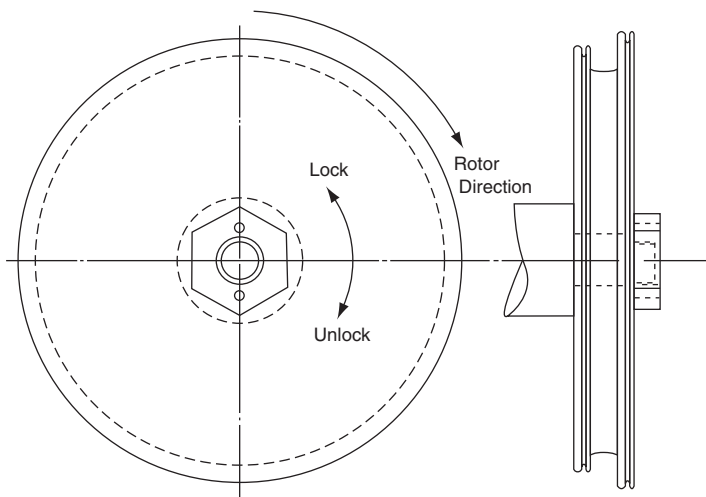
Fig. 2.4 Diagram showing the directions of rotation of the turbine disk and the locking nut. Source: Ref 3

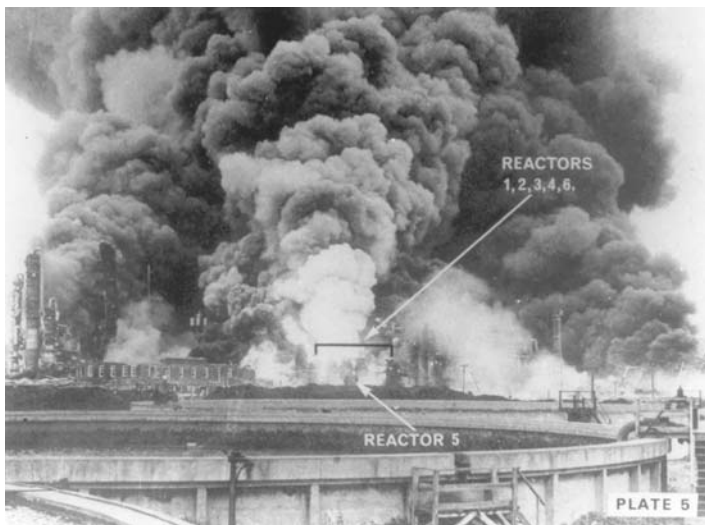
Fig. 2.5 The conflagration. Source: Ref 4. With kind permission of Her Majesty's Stationery Office

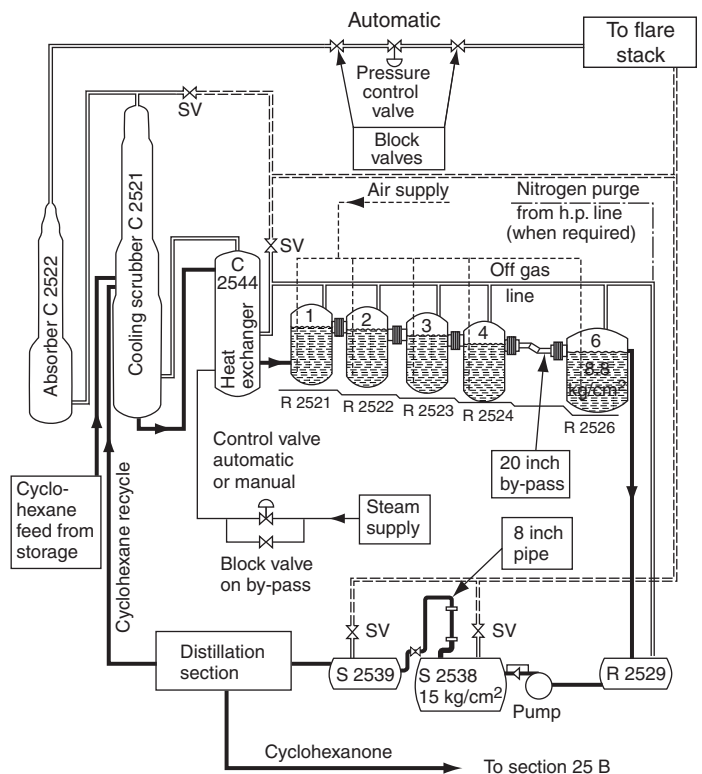
Fig. 2.6 Schematic sketch of the modification in the cyclohexane oxidation plant. Source: Ref 4. With kind permission of Her Majesty's Stationery Office

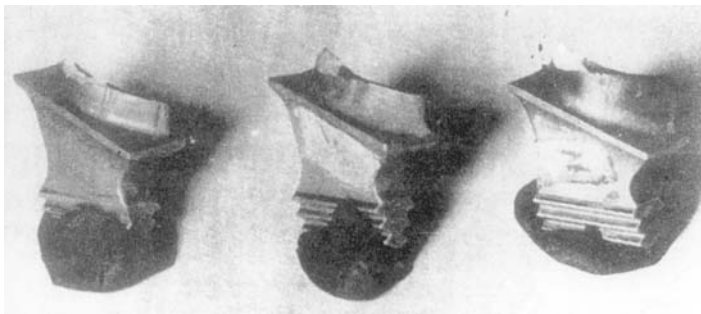
Fig. 2.7 Turbine blades failed near the root. Source: Ref 7

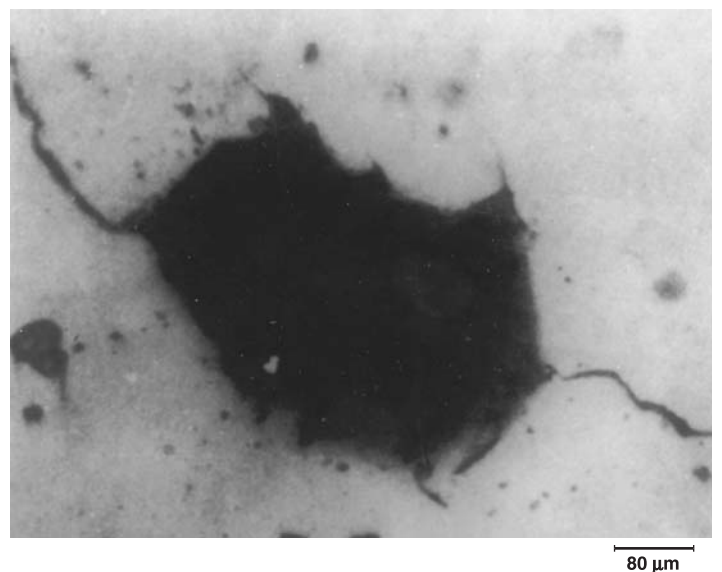
Fig. 2.8 Crack associated with an inclusion. Source: Ref 7

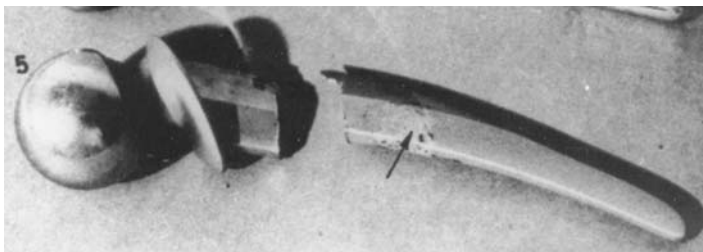
Fig. 2.9 Hip prosthesis failed in the microweld region. Source: Ref 8. With kind permission of Chapman and Hall Limited

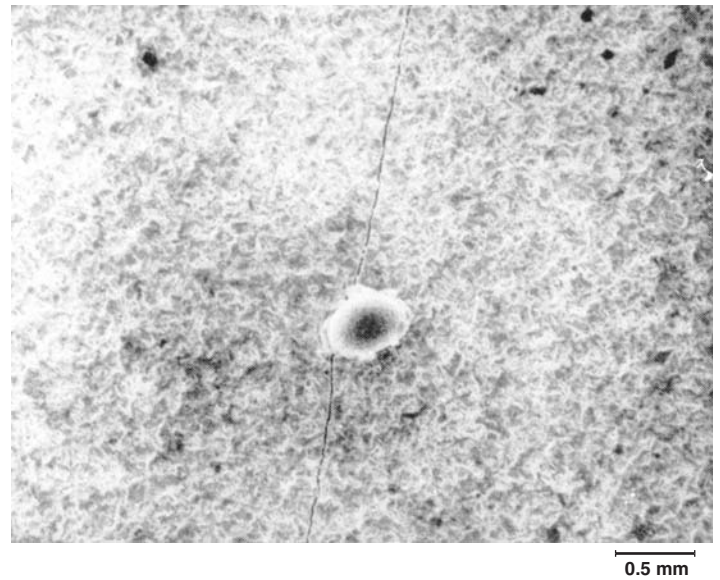
Fig. 2.10 Fractograph showing a metallic bead at the fracture origin. Source: Ref 9

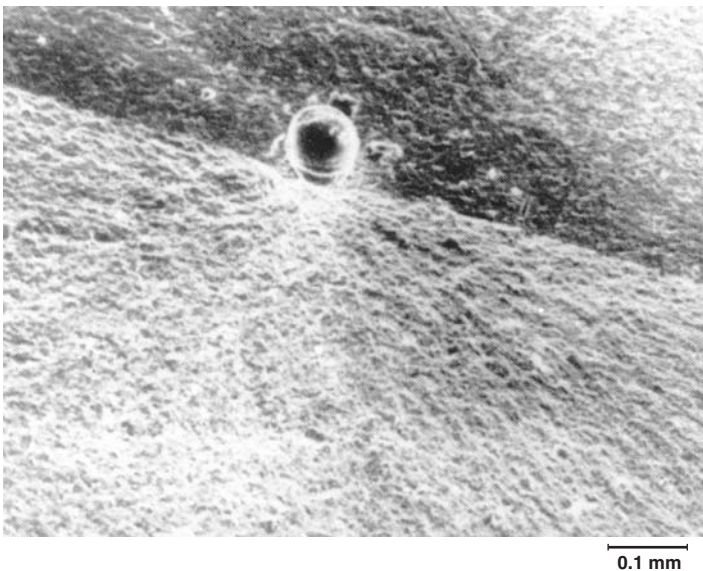
Fig. 2.11 Fatigue crack associated with a bead on the blade surface. Source: Ref 9

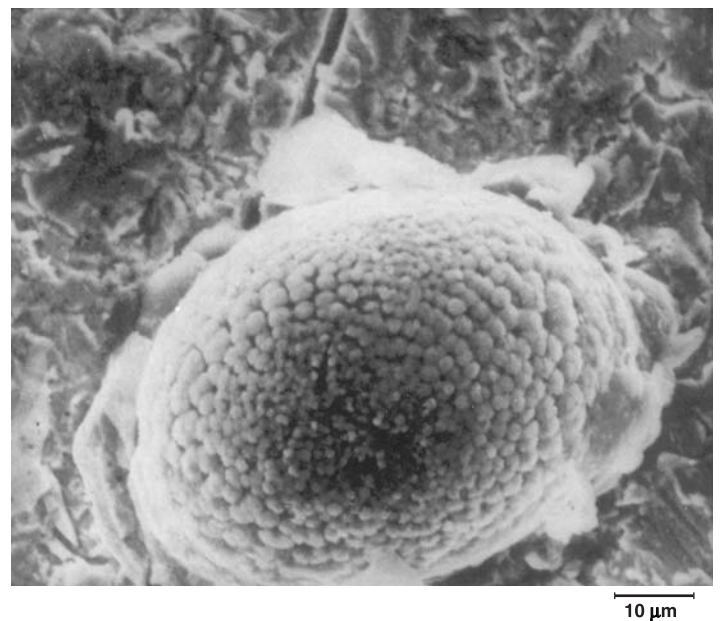
Fig. 2.12 SEM photograph showing the fatigue crack and the dendritic structure of the bead. Source: Ref 9

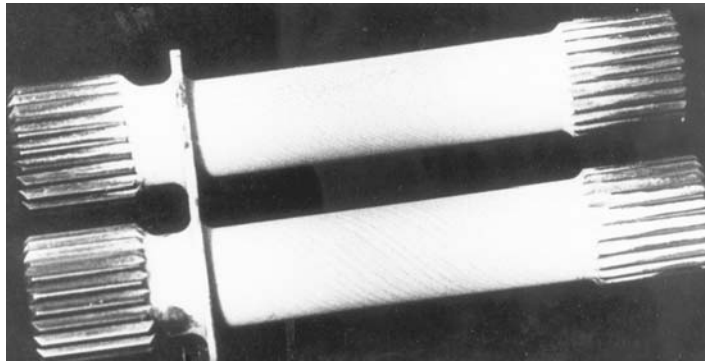
Example: Hydrogen Embrittlement: Failure of a Rocket Suspension Lug. Hydrogen embrittlement is a phenomenon com-

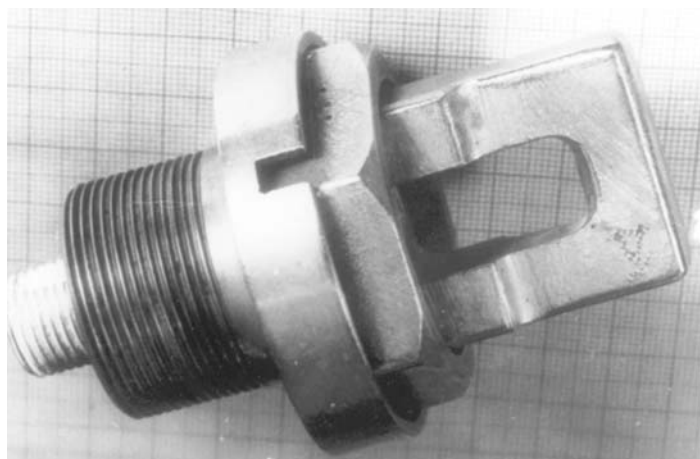
Fig. 2.14 Rocket suspension lug

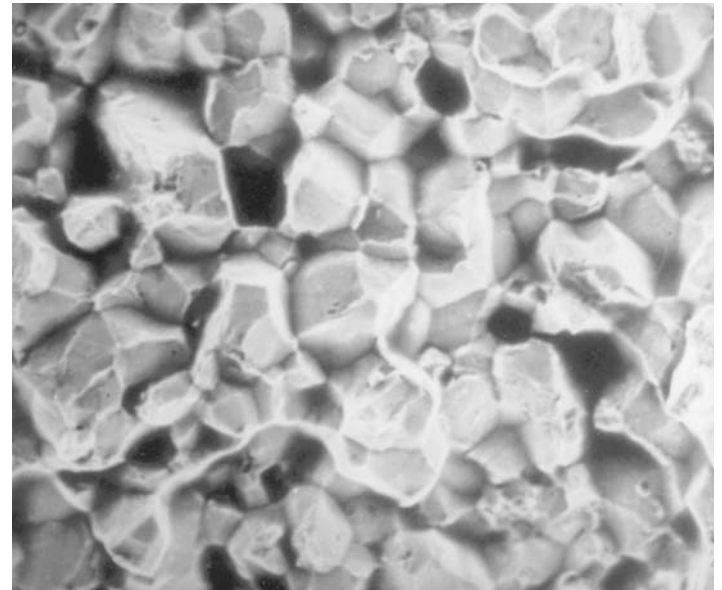
monly found in high-strength steels after they are exposed to environments in which hydrogen is produced. Cadmium plating is a common surface protection treatment for high-strength steels to guard against corrosion. If proper precautions are not taken, the

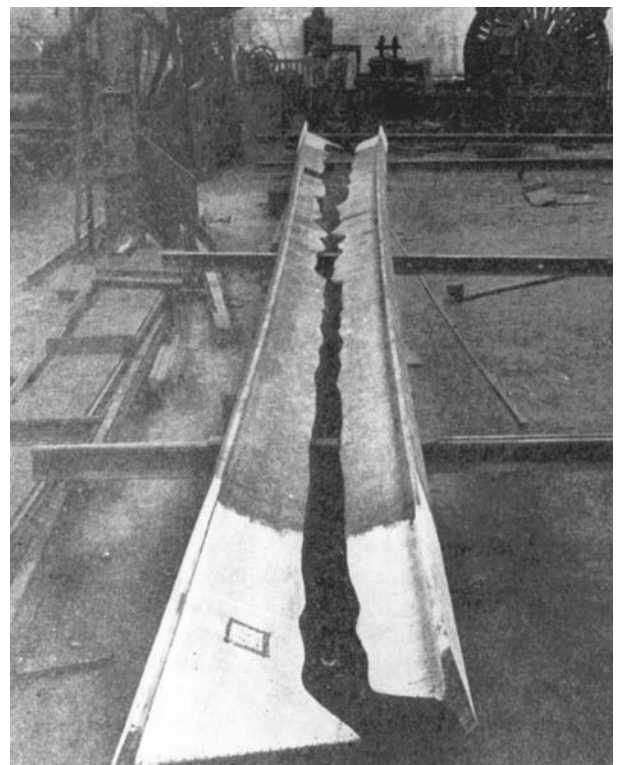
Fig. 2.16 12 m long I-beam split along the web. Source: Ref 10. With kind permission of Reinhold Publishing Company

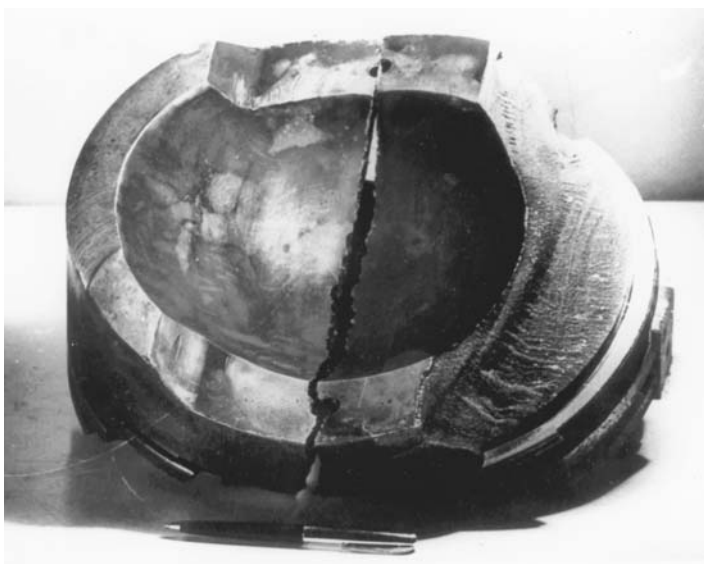
Fig. 2.17 Broken piston head showing primary failure by fatigue and a secondary crack through two bolt holes

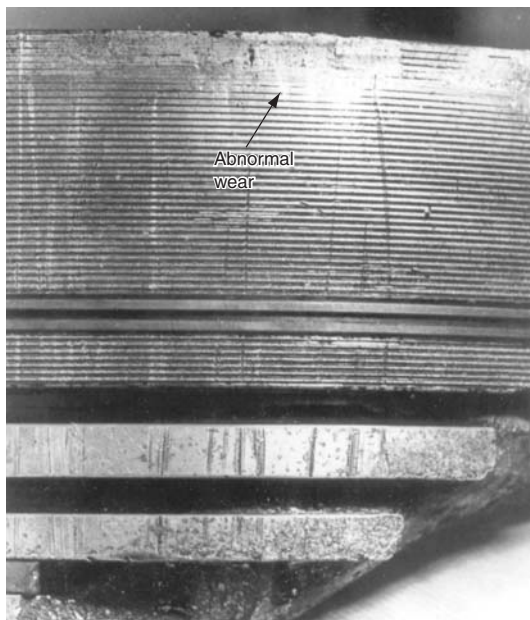
Fig. 2.19 Abnormal wear on one side of the piston head

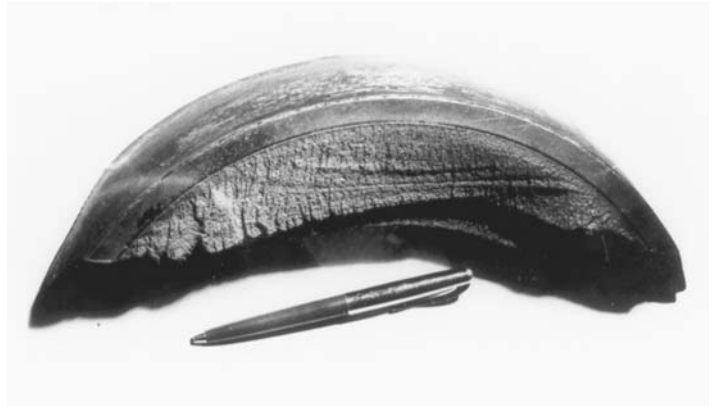
Fig. 2.18 Fracture surface of the primary failure, showing beach marks

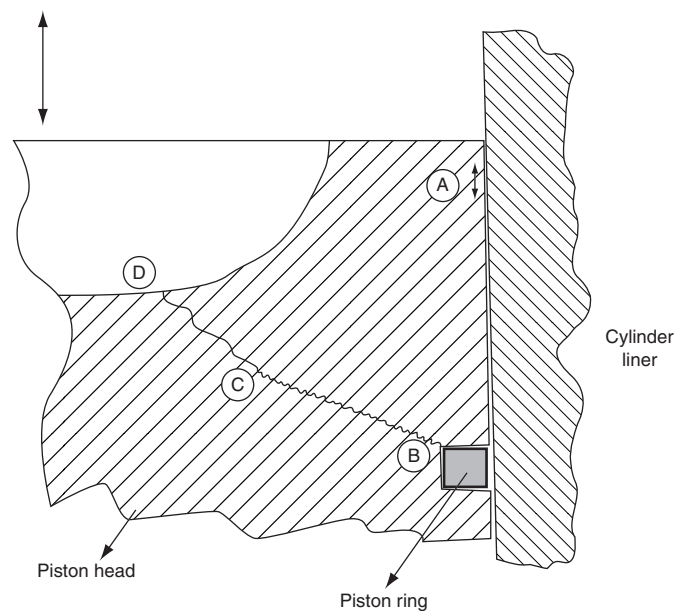
Fig. 2.20 Sketch illustrating piston head misalignment, fatigue crack initiation, and propagation. A, region of misalignment; B, sharp corner of piston ring groove; B-C, fatigue crack; and C-D, sudden overload failure

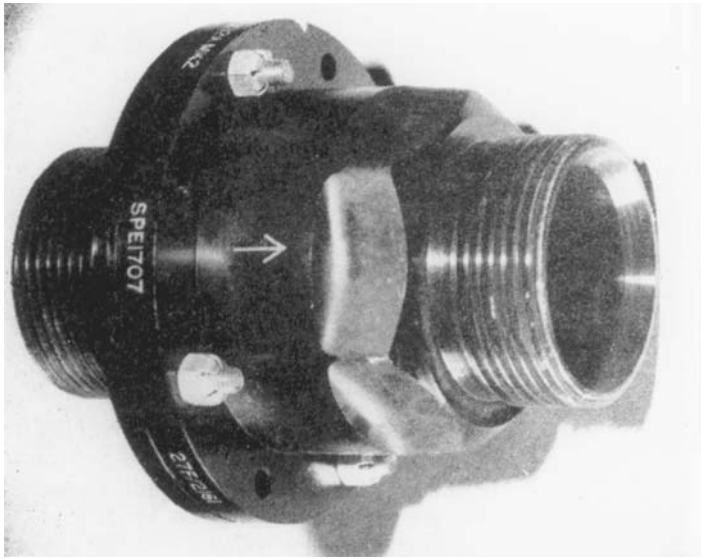
Fig. 2.21 A non-return valve that can be fitted incorrectly because of its design. Source: Ref 12. With kind permission of Royal Aeronautical Society

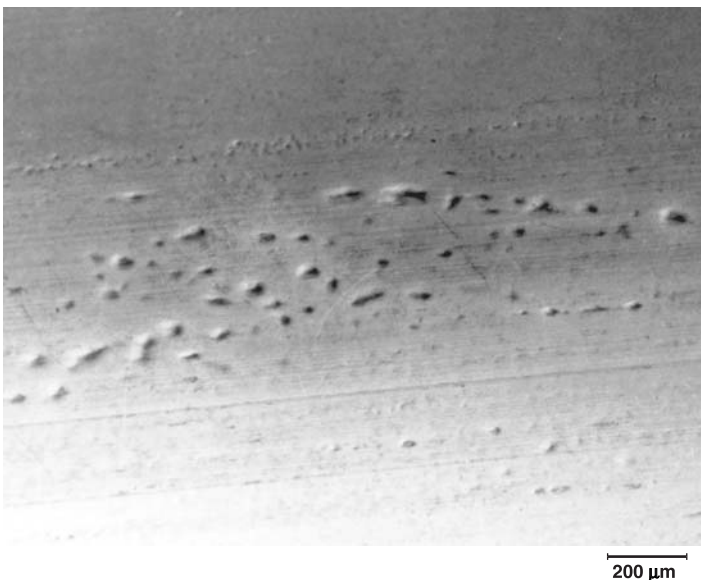
Fig. 2.22 Blisters in aluminum alloy extrusions

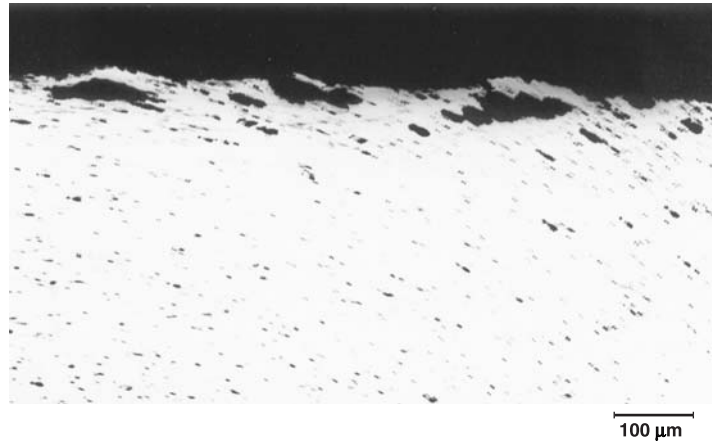
Fig. 2.23 Transverse section of the blistered extrusions, showing cavities near the surface, about to open up

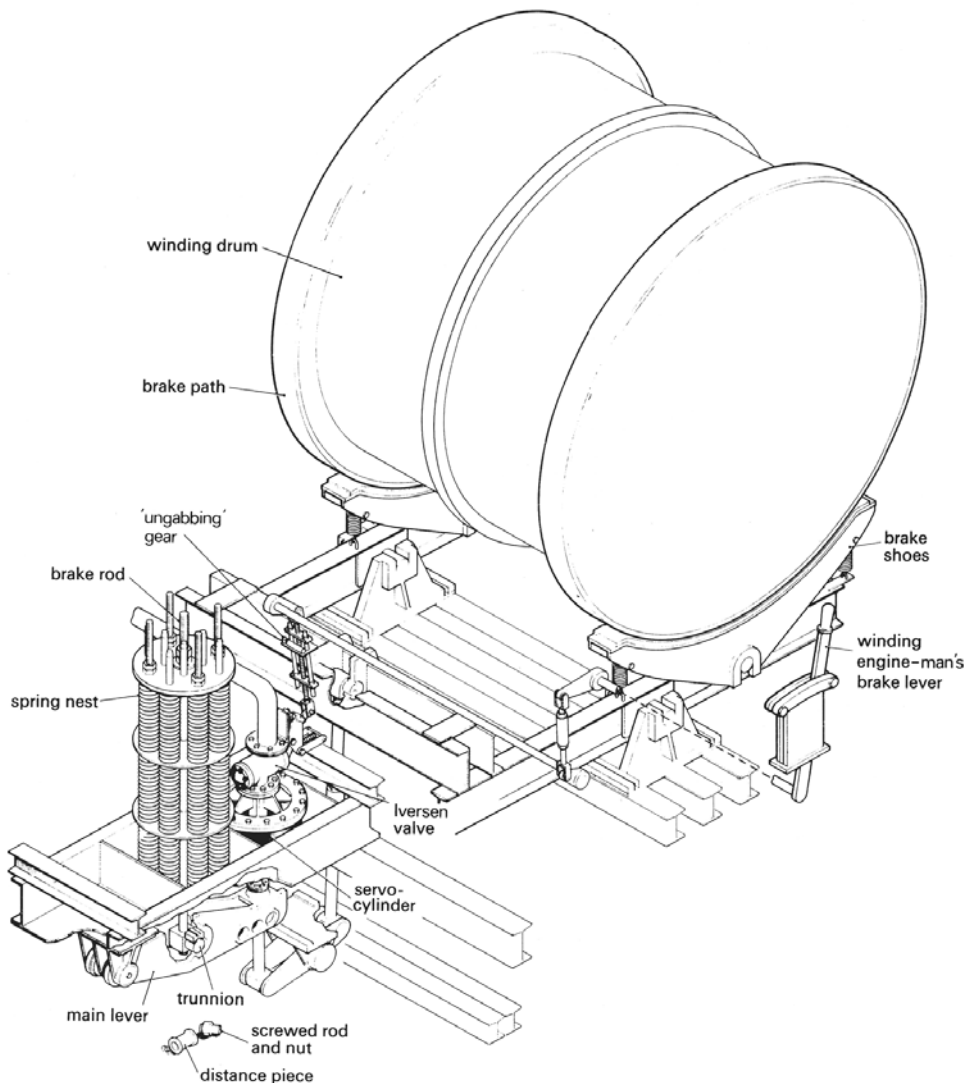
Fig. 2.25 Shaft winding engine and brake system. Source: Ref 13. With kind permission of Her Majesty's Stationery Office

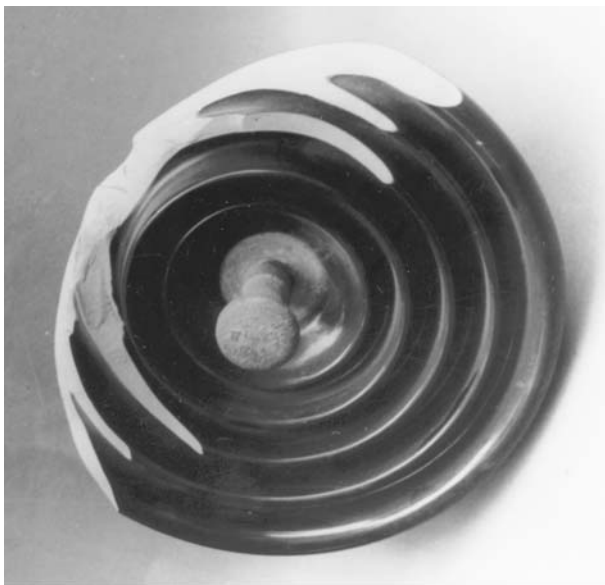
Example: Infrequent Inspection: A Mine Accident. In the Markham coal mine in North Derbyshire, England, there was a fatal accident in which 18 miners died and 11 sustained serious injuries on July 30, 1973. The cage in which they were traveling in a shaft crashed into the pit bottom with tremendous force, the speed of impact estimated to be 43 km per hour (Ref 13). When these miners were being lowered into the shaft, the brake system failed to work. The brake system consisted of a pair of brake shoes applied by the action of a compressed nest of springs operating through a system of levers. The force from the spring nest was transmitted to the main lever of the brake system by a steel rod, 50 mm in diameter and 2.7 m long, located in the center of the

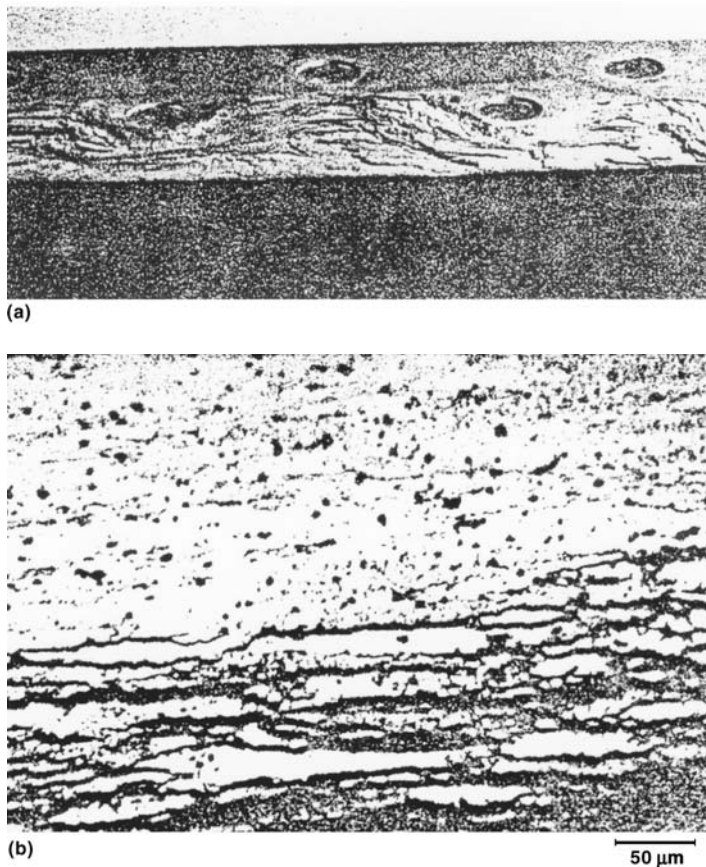
Fig. 2.28 Exfoliation corrosion on a structural member of an aircraft. (a) Cracking in the direction parallel to the rolled surface. (b) Cracks along the boundaries of elongated grains

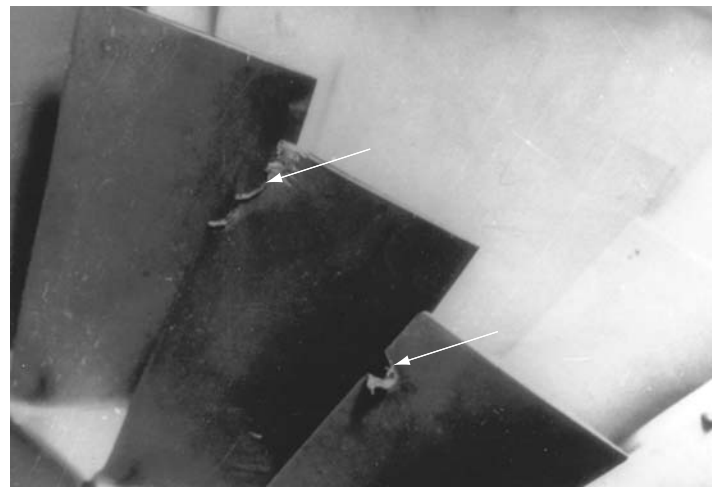
Fig. 2.29 Damage to fan blades of an aircraft engine by a foreign object

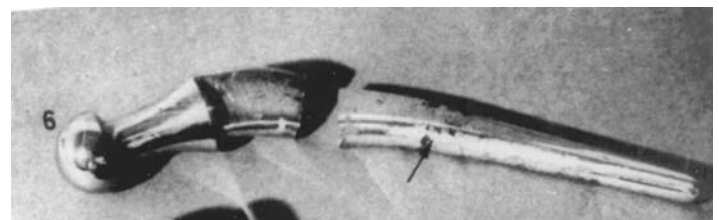
Fig. 2.30 Hip prosthesis failed by fatigue following fretting. Source: Ref 8. With kind permission of Chapman and Hall Limited

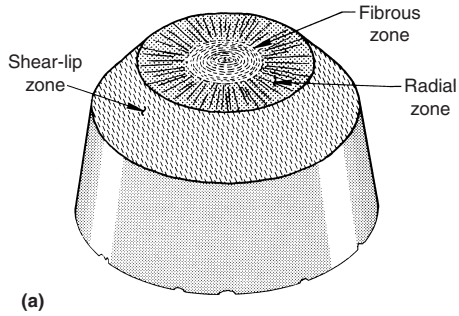
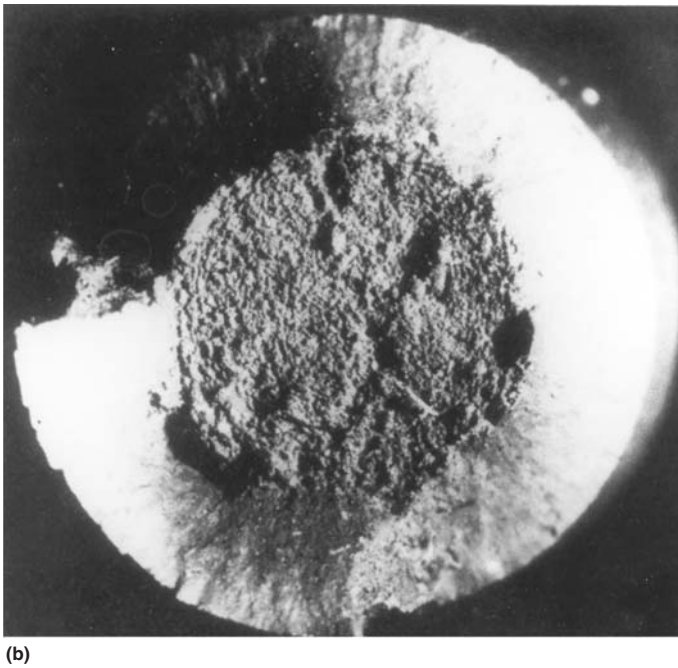
Fig. 4.1 The three distinct zones on the fracture surface of a ductile material failed under tensile load. Source: Ref 3

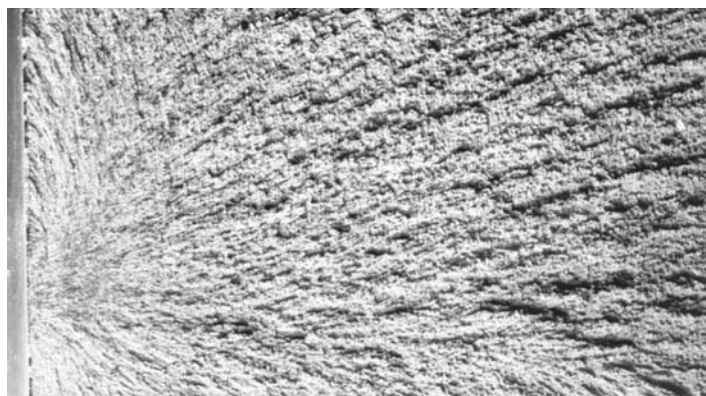
Fig. 4.2 Chevron marks indicating fast fracture

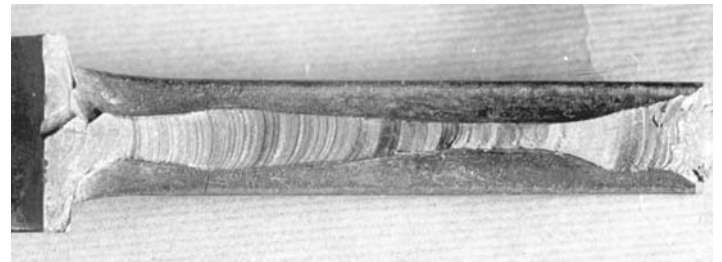
Fig. 4.3 Beach marks characteristic of fatigue fracture. Source: Ref 3

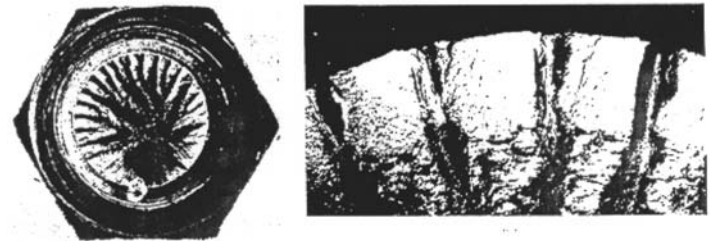
Fig. 4.4 Ratchet marks around the perimeter of a shaft that failed in fatigue indicate multiple origins of fracture.

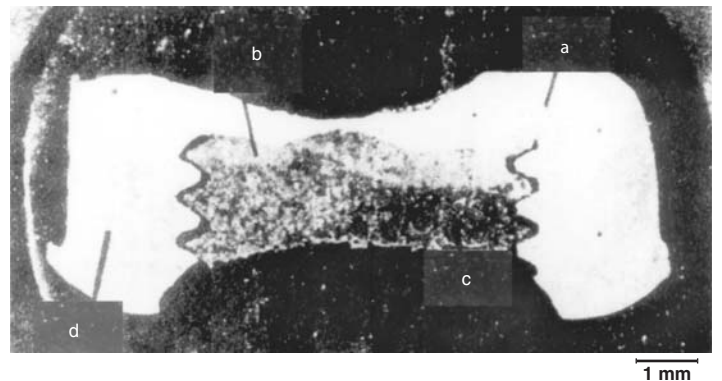
Fig. 4.5 Polished and etched longitudinal section of a bolt-nut assembly. The bolt and nut are held together by very few threads.

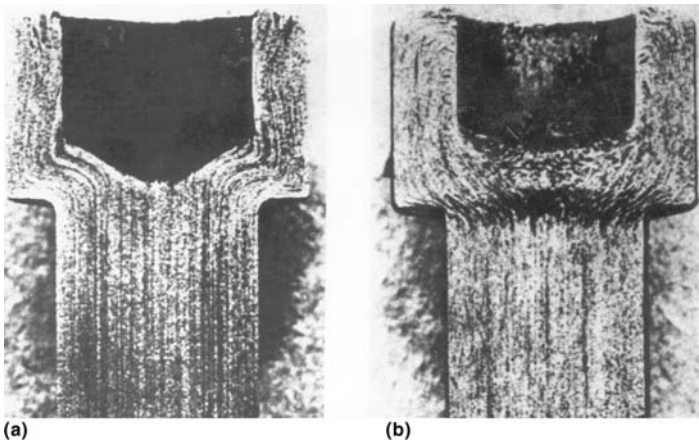
Fig. 4.6 Comparison of (a) desirable and (b) undesirable flow lines in forged components. Source: Ref 4. With kind permission of Elsevier Publishing Company

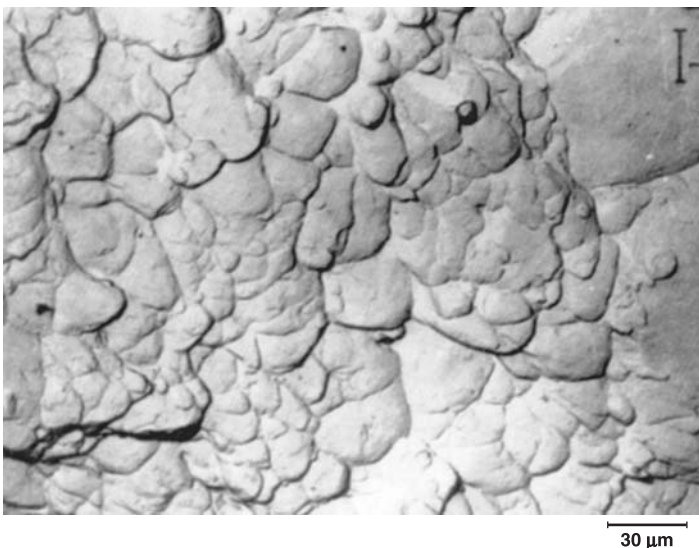
Fig. 4.7 TEM fractograph showing equiaxed dimples caused by tensile overload. Source: Ref 5. With kind permission of Metals and Ceramics Information Center

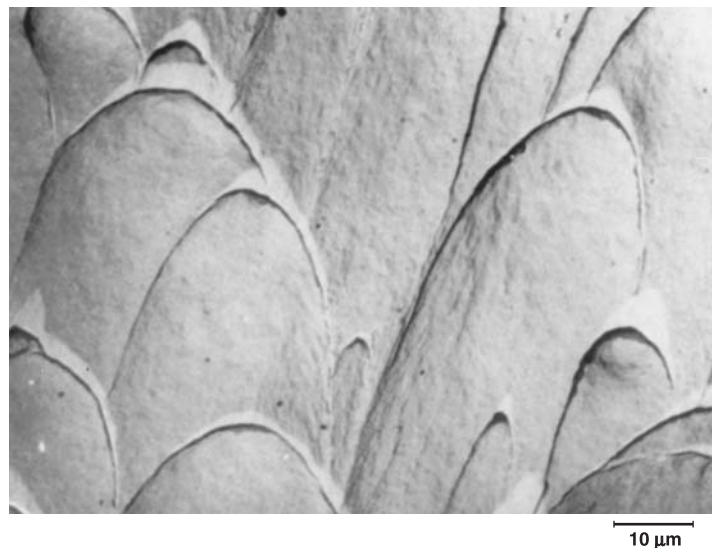
Fig. 4.8 TEM fractograph of a shear fracture, characterized by open-ended dimples. Source: Ref 5. With kind permission of Metals and Ceramics Information Center

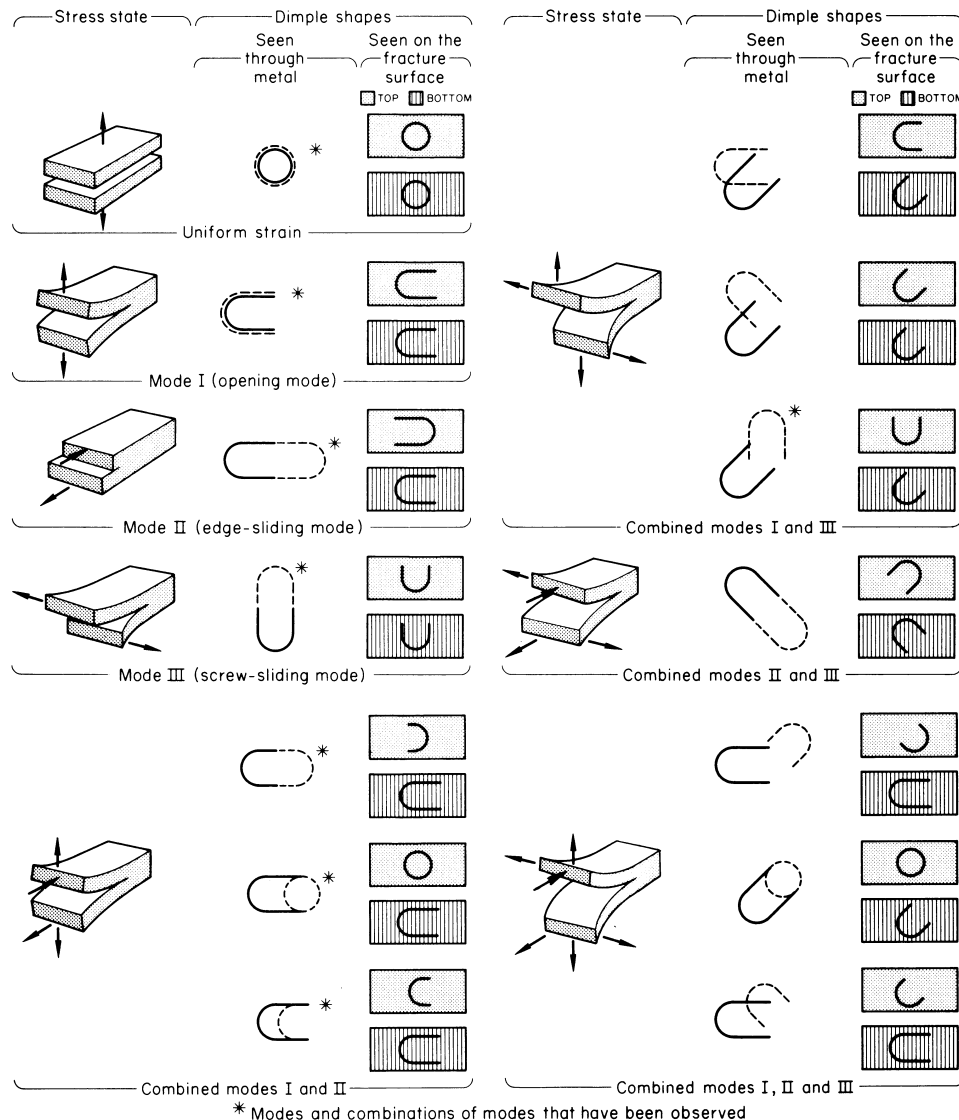
Fig. 4.9 Possible combinations of mating dimple shapes resulting from different stress states, which cause the crack tip to deform by various modes. Source: Ref 3

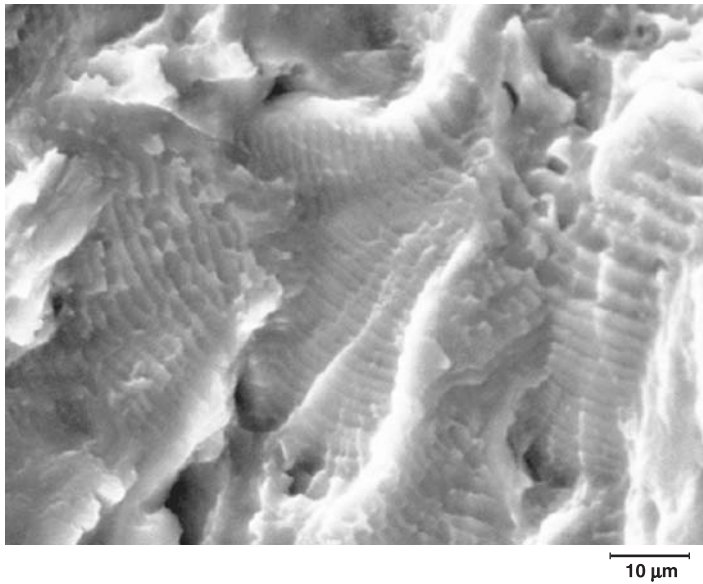
Fig. 4.10 SEM fractograph showing fatigue striations

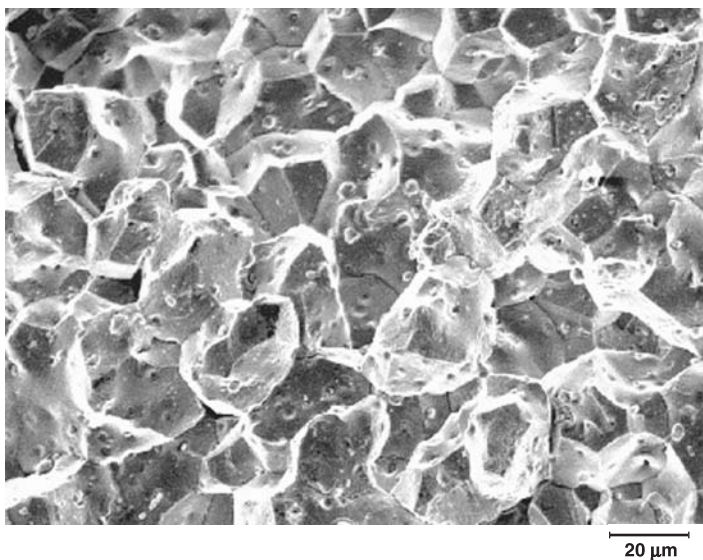
Fig. 4.11 SEM fractograph of an intergranular fracture caused by hydrogen embrittlement in a high-strength steel component

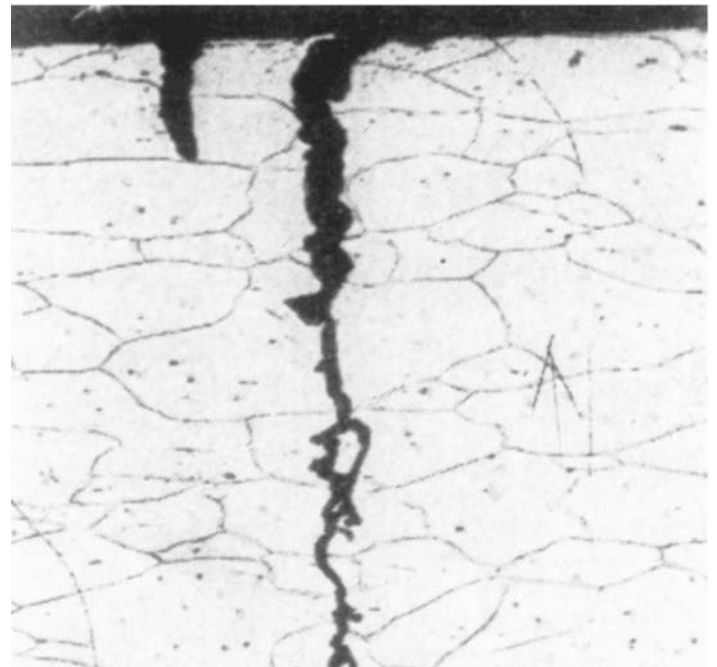
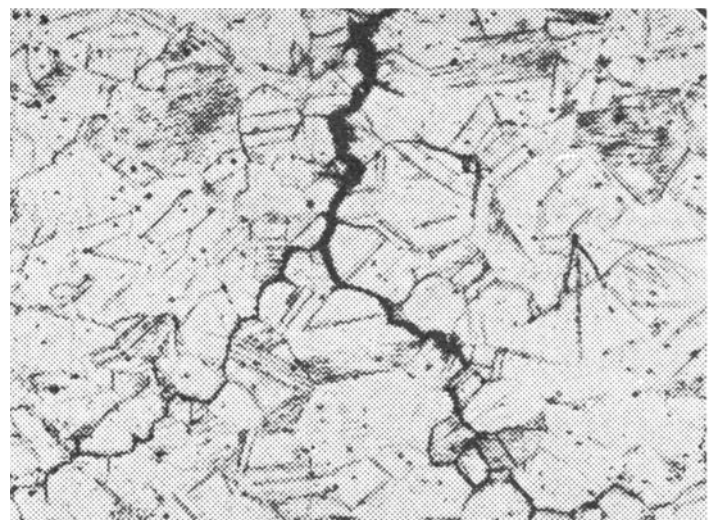
Fig. 4.12 Optical microstructure showing (a) transgranular and (b) intergranular crack propagation. Source: Ref 4. With kind permission of Elsevier Publishing Company

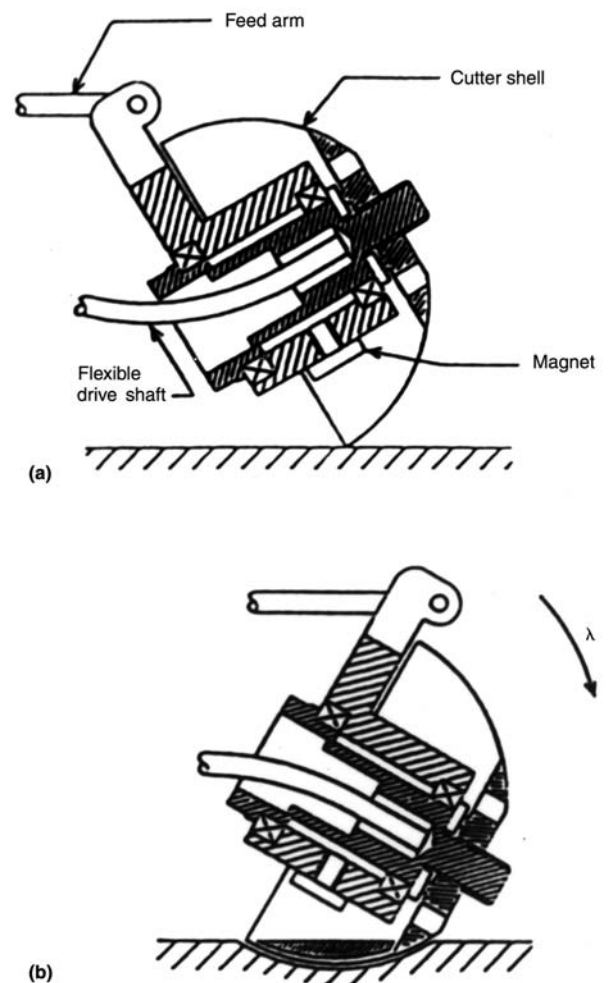
Fig. 5.1 SSam surface sampling system: schematic of cutting process. Source: Ref 2. With kind permission of Exponent Failure Analysis Associates

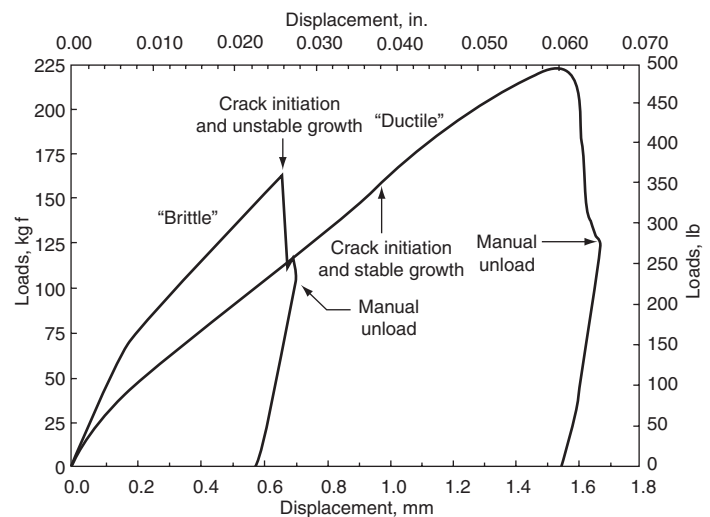
Fig. 5.2 Typical load-displacement curves in small punch tests for ductile and brittle behavior. Small punch energy is measured as the area under the curve up to the peak load. Source: Ref 3. With kind permission of Springer Science and Business Media

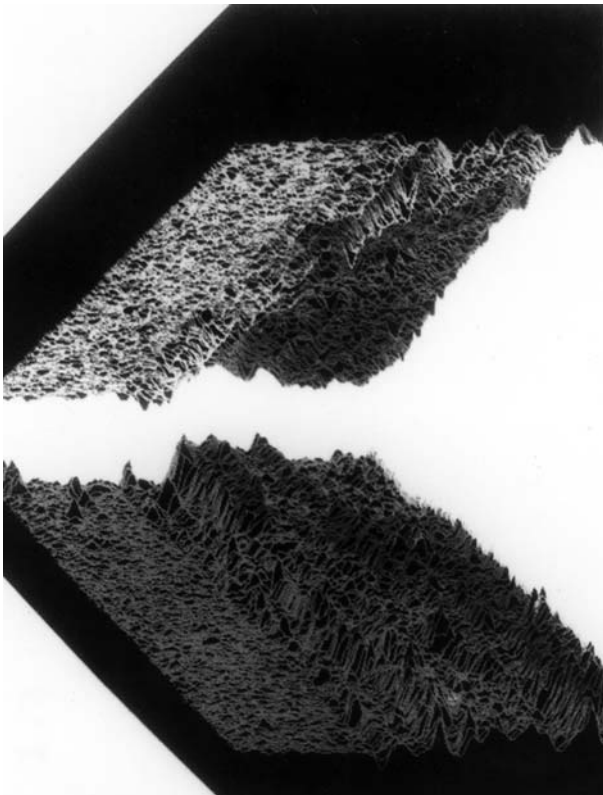
Fig. 5.3 Perspective view of conjugate fracture surfaces. Source: Ref 11

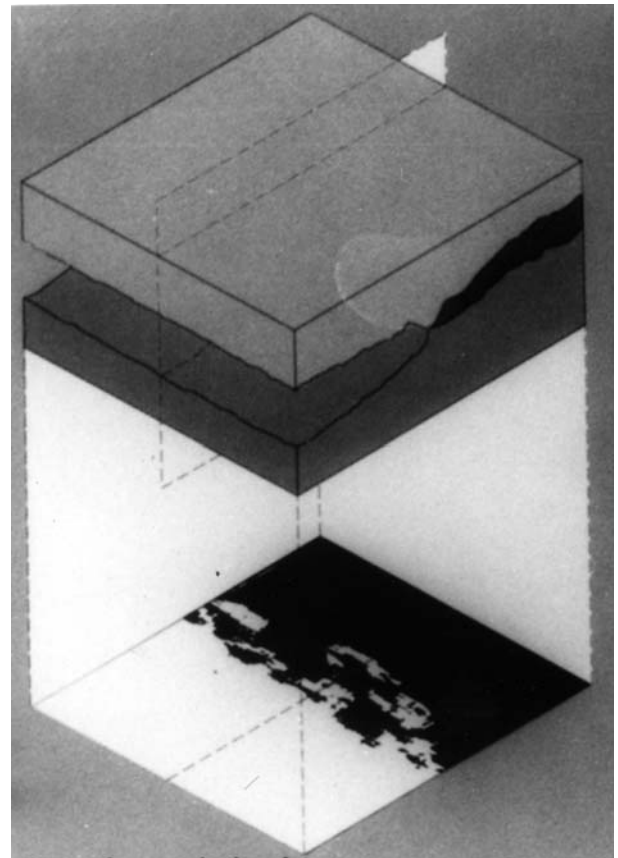
Fig. 5.4 Fractured-area-projection plot. Source: Ref 11

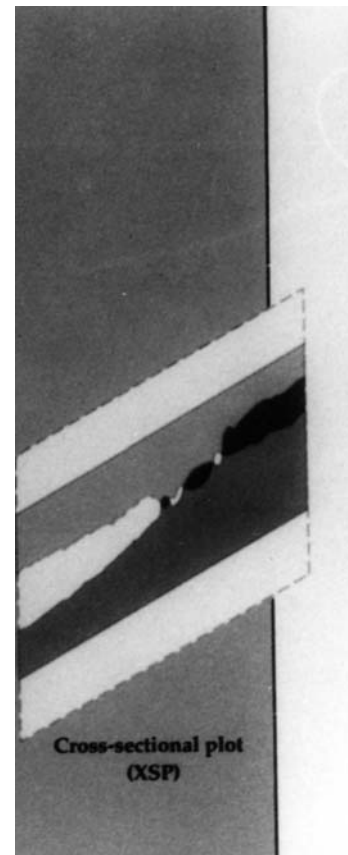
Fig. 5.5 Cross-sectional plot. Source: Ref 11

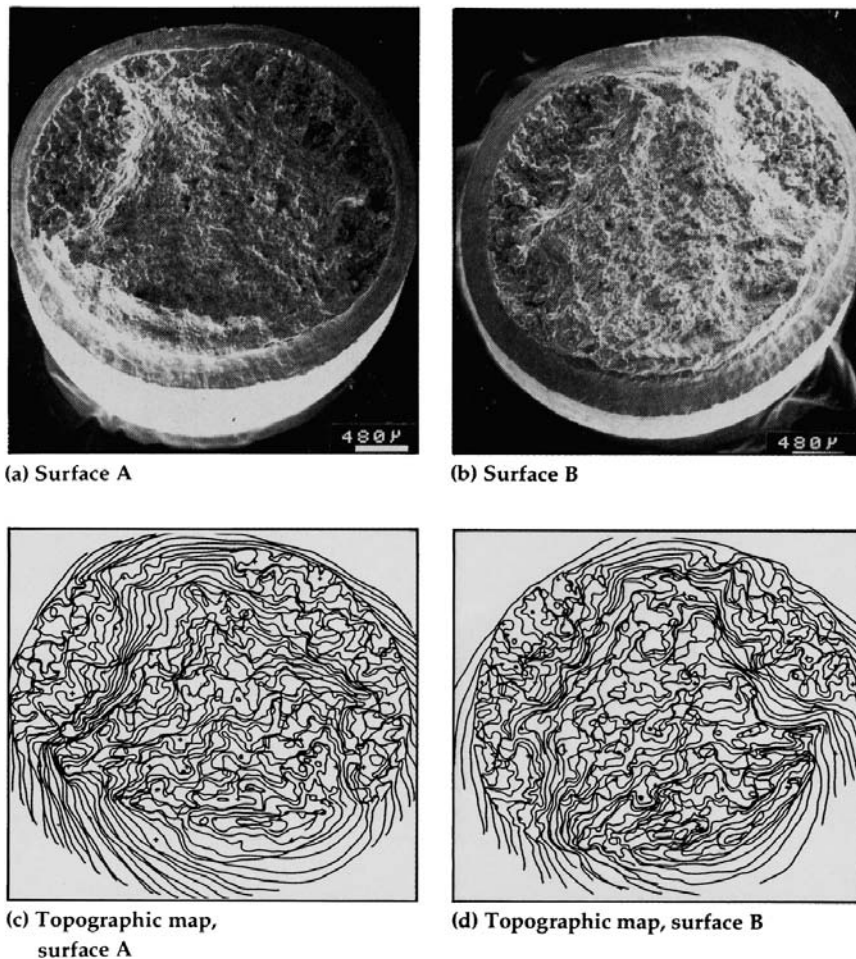
Fig. 5.6 Scanning electron fractographs and corresponding topographs of conjugate fracture surfaces of sensitized 304 stainless steel tested in clean water. Source: Ref 11, 13

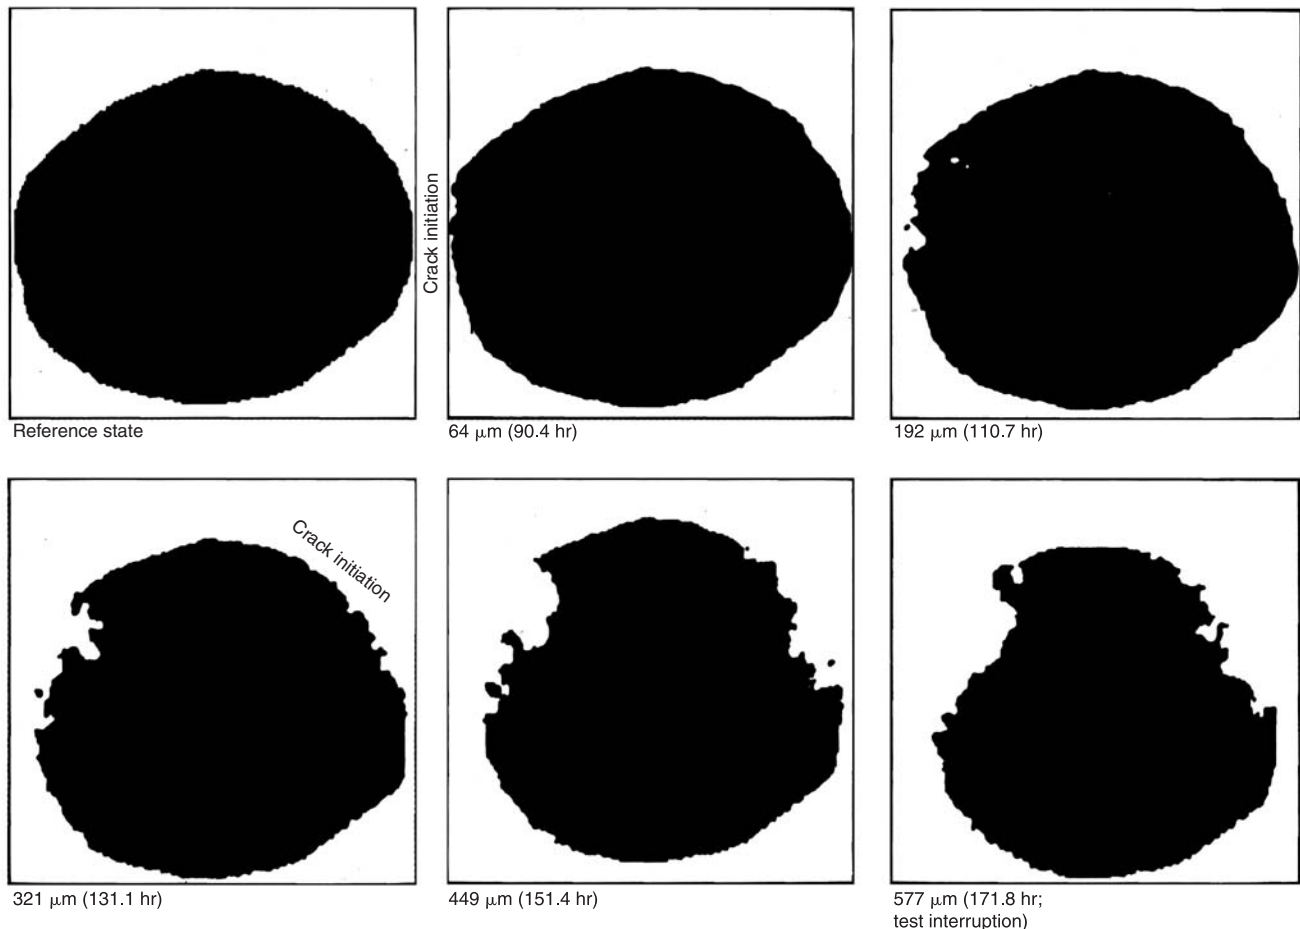
Fig. 5.7 FAPPs for the stainless steel specimen referred to in Fig. 5.6. White areas indicate cracks. Source: Ref 11, 13

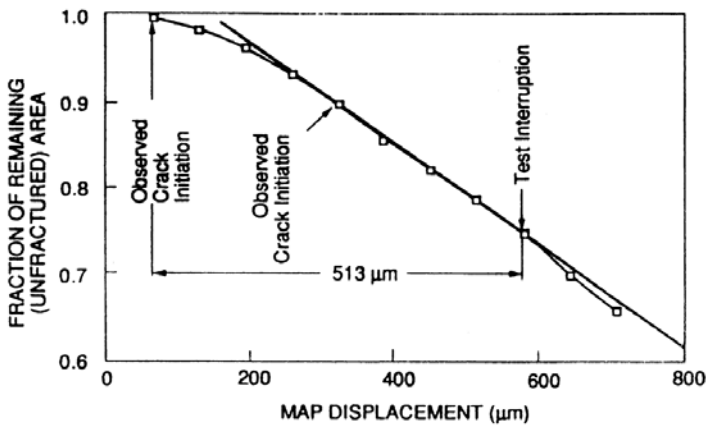
Fig. 5.8 Relationship between unfractured area (black areas in the FAPPs) and topographical map displacement for the specimen referred to in Fig. 5.6. Source: Ref 11, 13
