Failure Analysis of Engineering Structures

Methodology and Case Histories

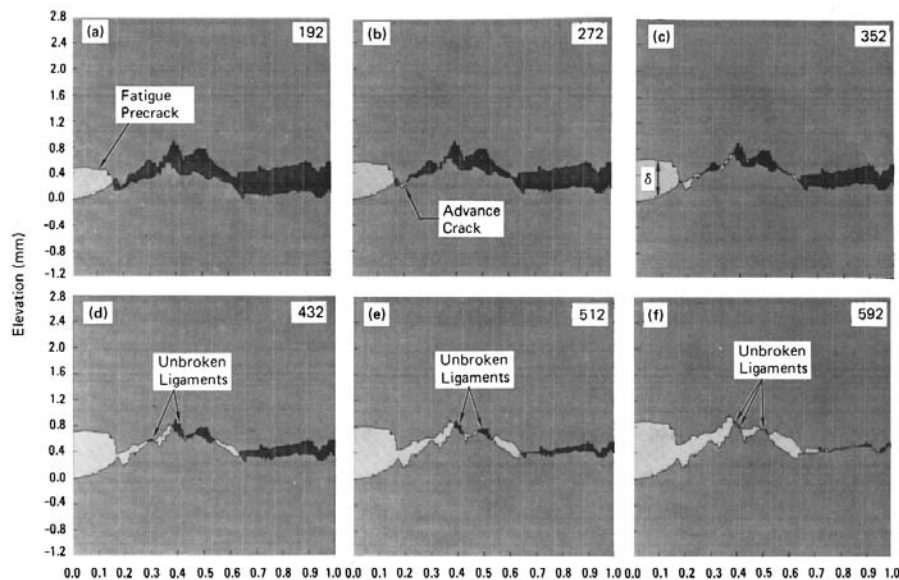
Fig. 5.9 XSP of crack tip showing successive stages of crack propagation in a thermally embrittled stainless steel. Source: Ref 14, 15

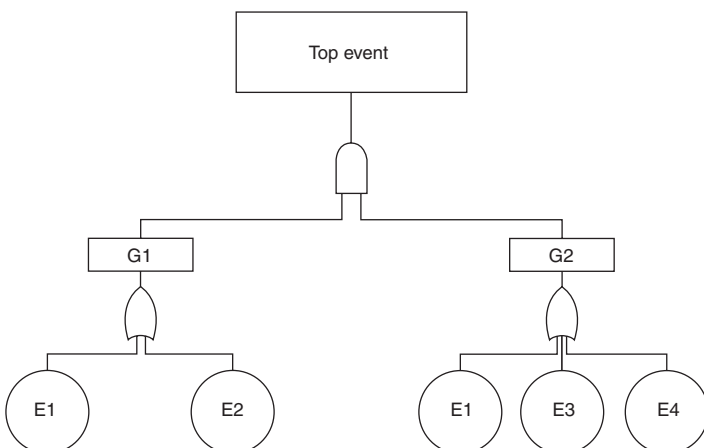
Fig. 5.10 Schematic of a simple fault tree. Source: Ref 26

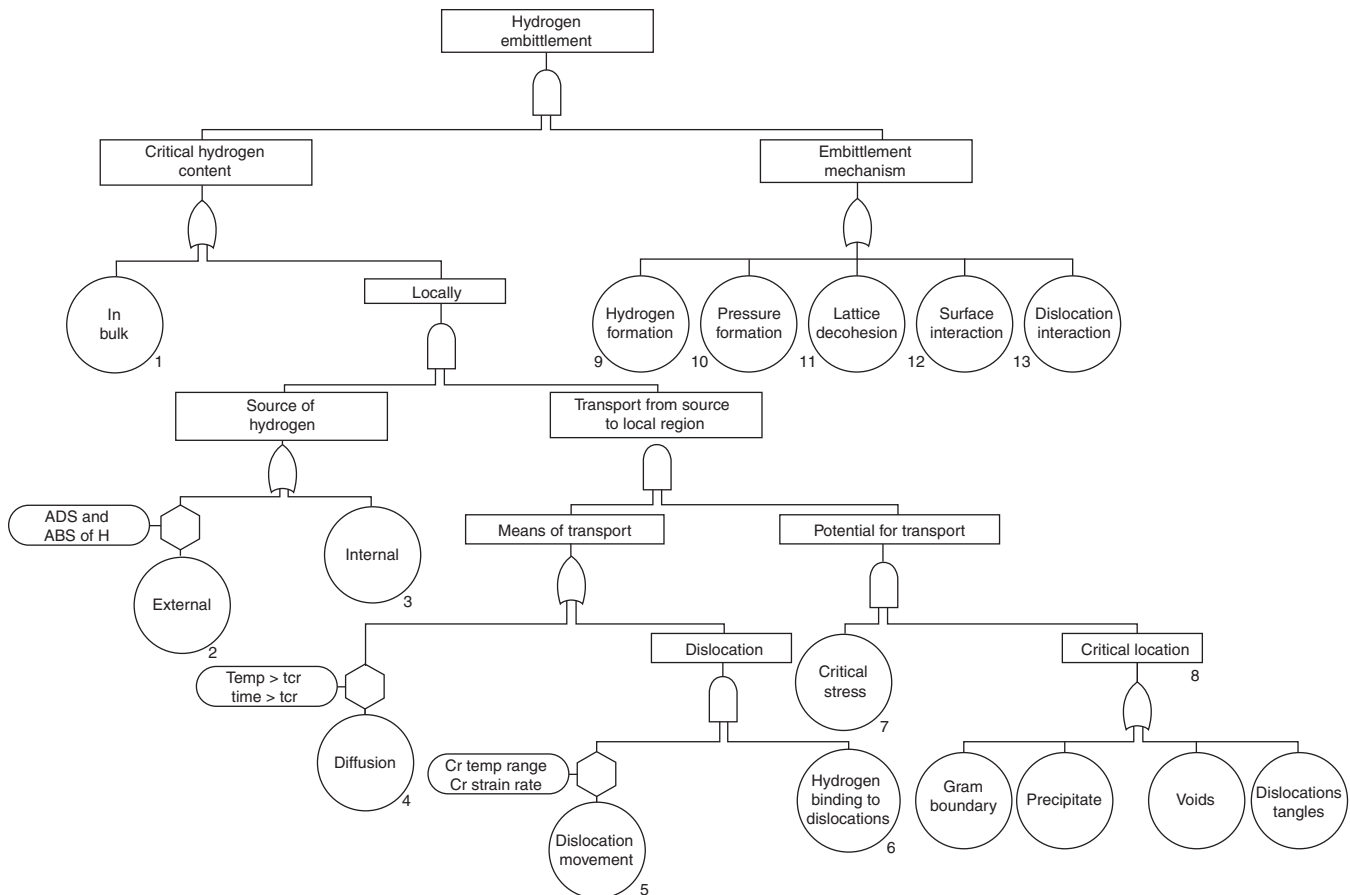
Fig. 5.11 Fault tree for hydrogen embrittlement. Source: Ref 28

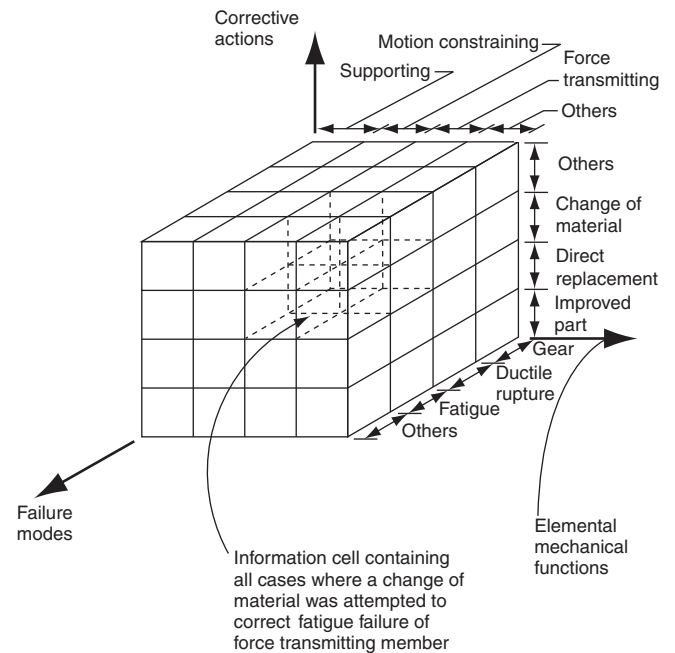
Fig. 5.12 A portion of the failure-experience matrix for documenting failures of helicopter components. Source: Ref 32. With kind permission of American Society of Mechanical Engineers

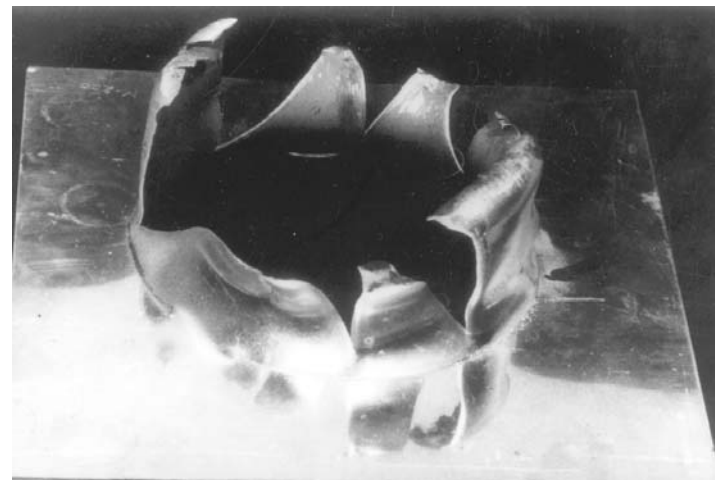
Fig. 6.1 Petaling and curling on the reverse side of a sheet subjected to explosive fracture

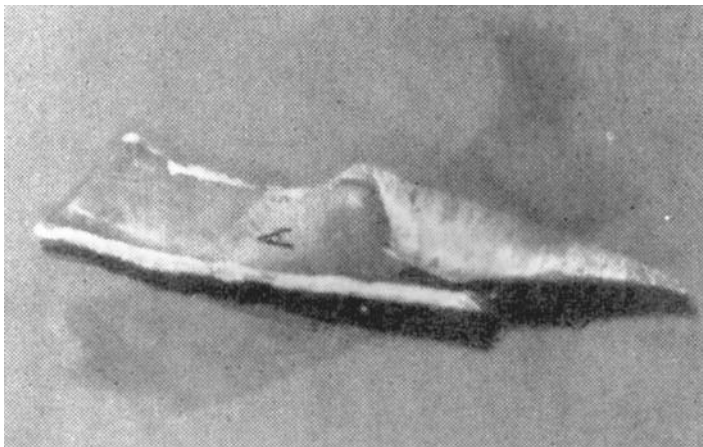
Fig. 6.3 A curved fragment

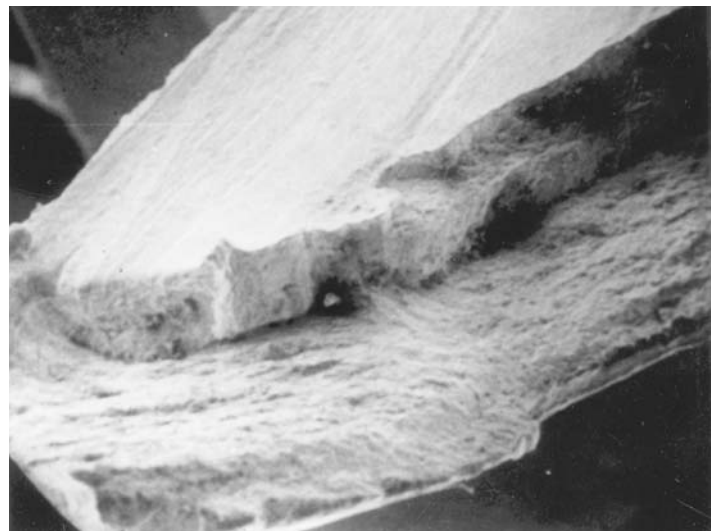
Fig. 6.4 A spalled fragment. Note the fracture on a plane parallel to the sheet surface.

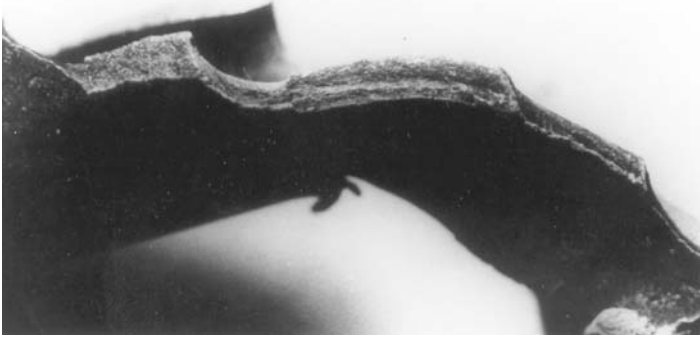
Fig. 6.5 Reverse slant fracture

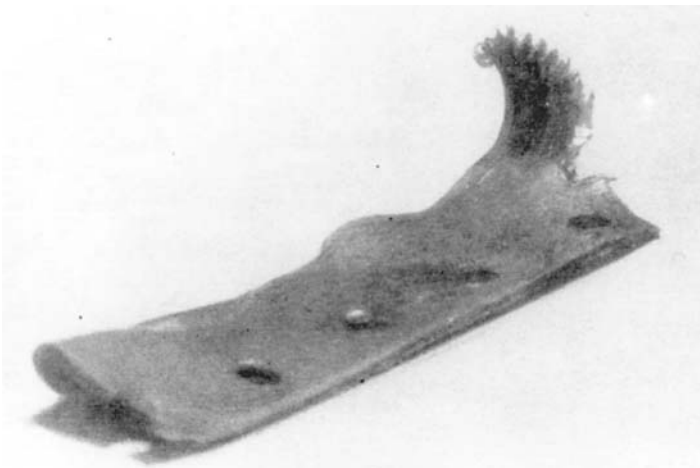
Fig. 6.6 Spikes on the fracture edge of a fragment

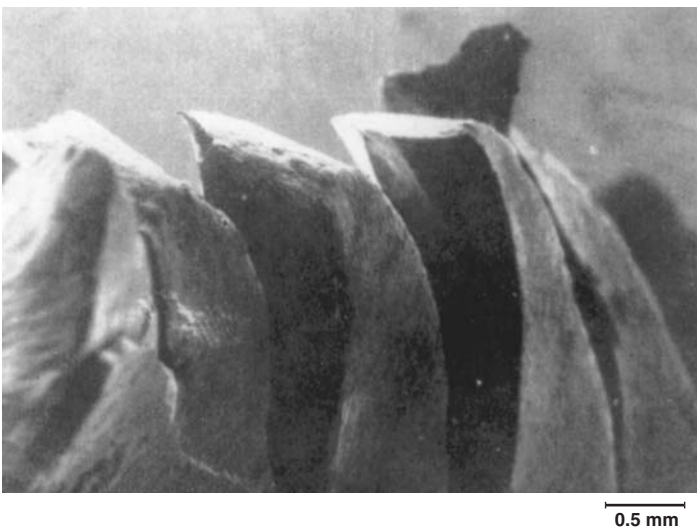
Fig. 6.7 SEM photograph of the spikes

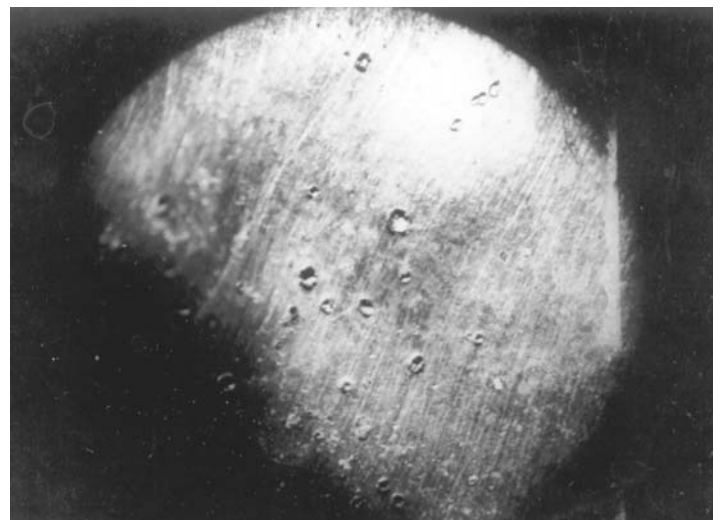
Fig. 6.8 Typical explosion craters in a fragment

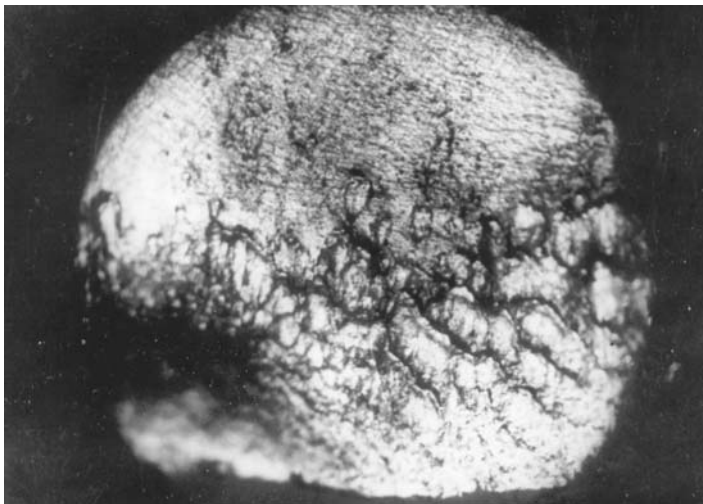
Fig. 6.9 A fragment showing a rippled surface

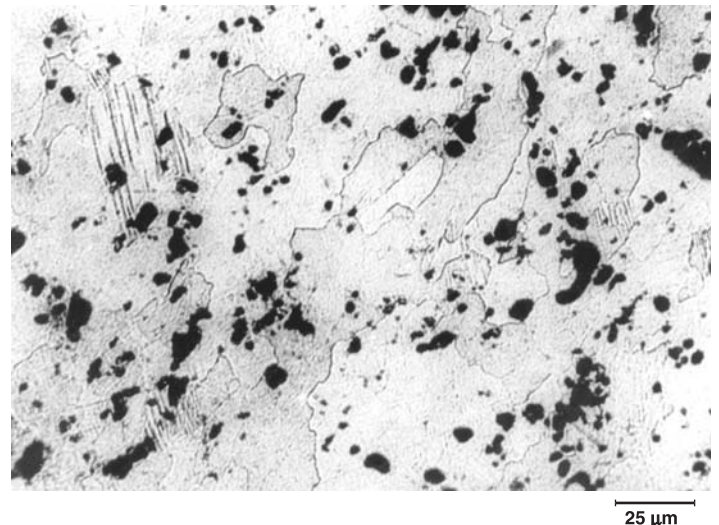
Fig. 6.10 Microstructure of a 2024 aluminum alloy fragment showing twins

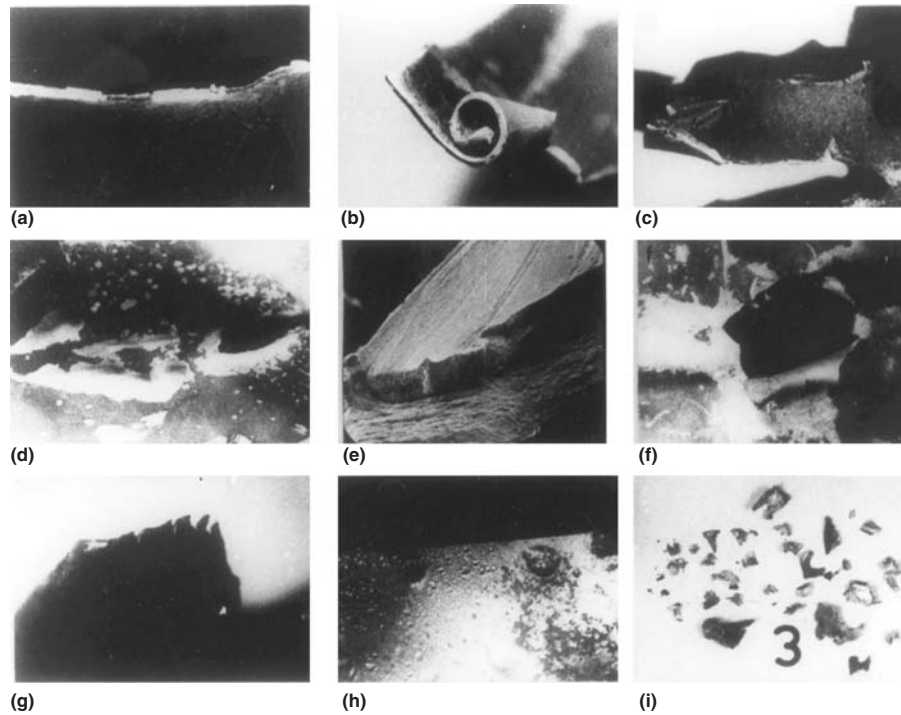
Fig. 6.11 Signatures of explosive deformation and fracture on fragments retrieved from the wreckage. (a) Reverse slant. (b) Curled fragment. (c) Curved fragment. (d) Dent. (e) Spalled fragment. (f) Petaling and curling. (g) Spikes along fracture edge. (h) Craters on sheet metal surface. (i) Nondescript fragments

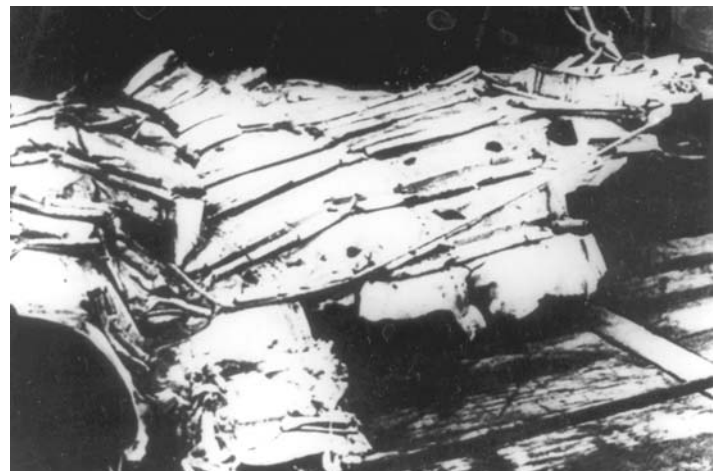
Fig. 6.12 Bottom skin of the front cargo hold of the Boeing 747 aircraft, retrieved from the ocean. Source: Ref 11

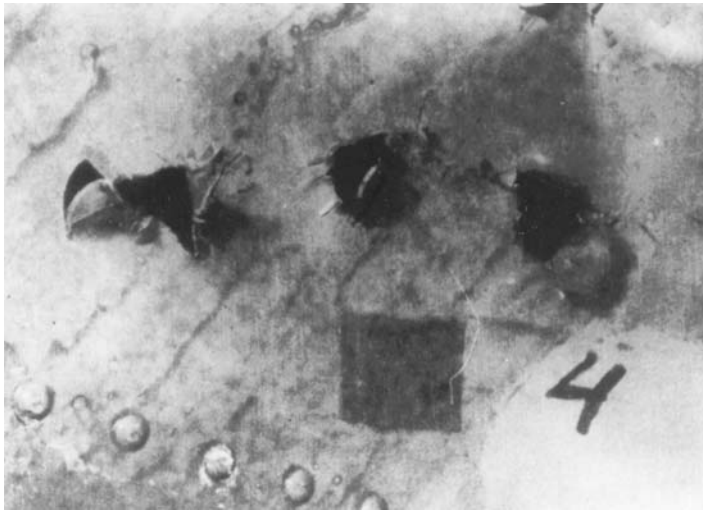
Fig. 6.13 Petaling around holes in the bottom skin of the front cargo hold. Source: Ref 11

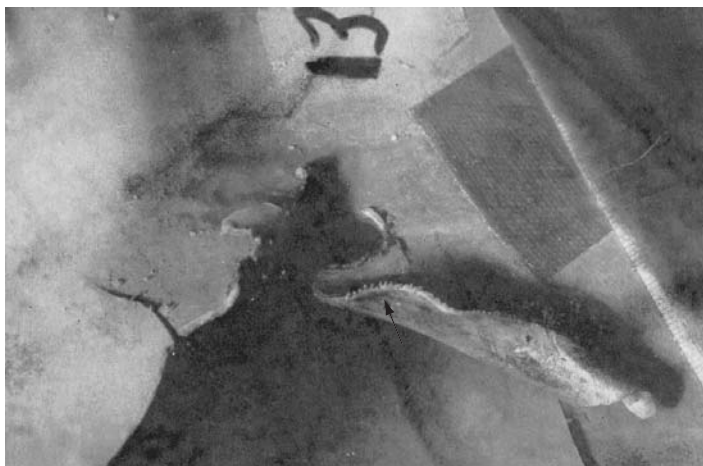
Fig. 6.15 Spikes along fracture edge. Source: Ref 11

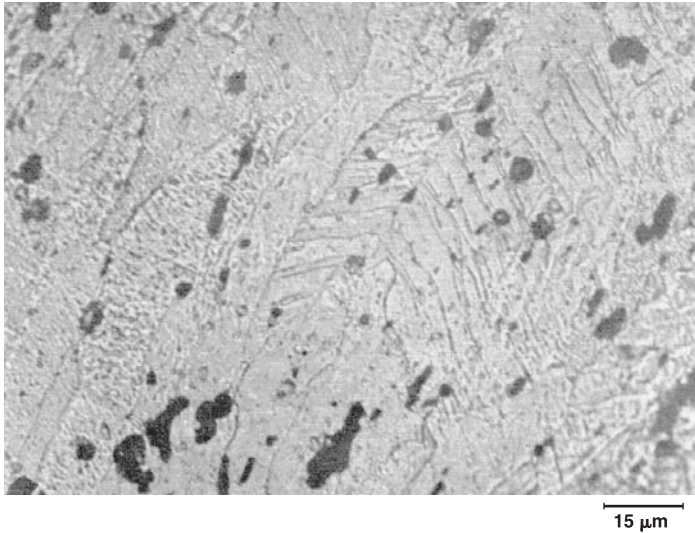
Fig. 6.17 Microstructure of a fragment from the front cargo compartment showing twins. Source: Ref 11

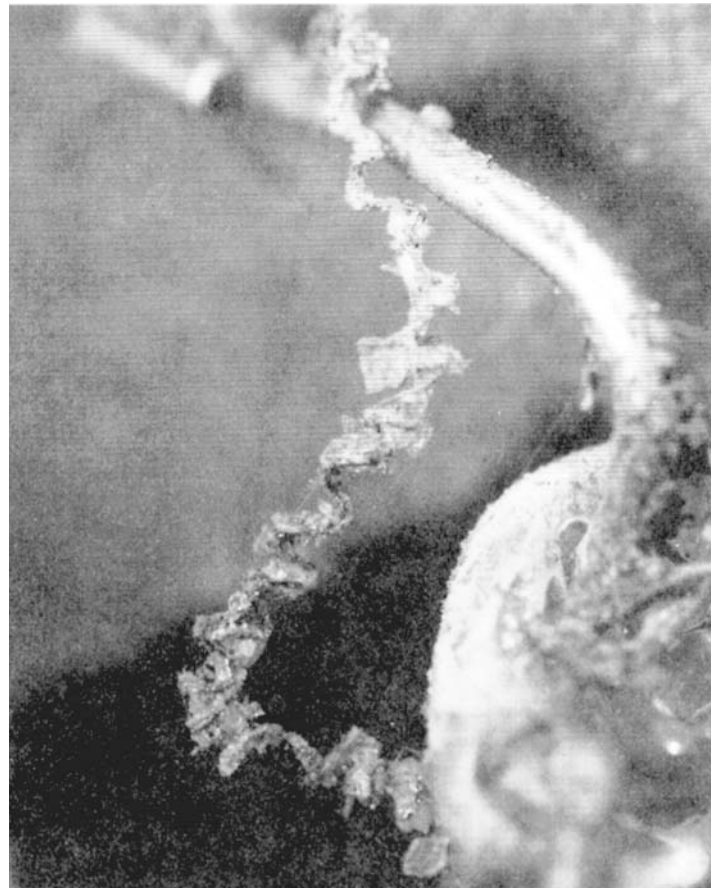
Fig. 7.1 Glass particles fused to a filament. Source: Ref 2. With kind permission of Elsevier Publishing Company

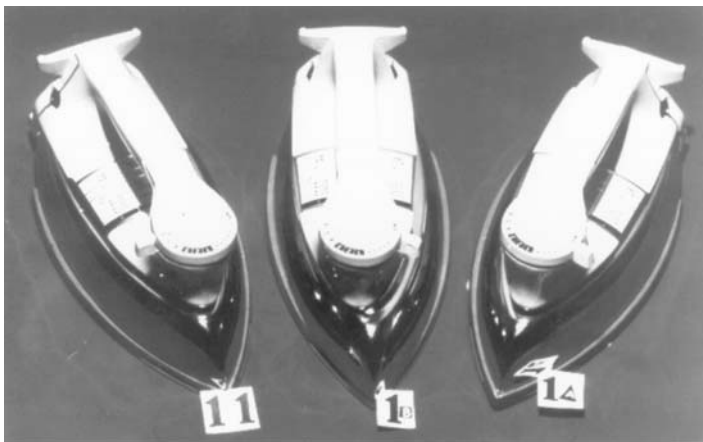
Telegraphic Wires. Another common crime is theft of telegraphic wires for their expensive copper content. Such cases are resolved in courts by a combination of tests. When a piece of stolen telegraphic wire is recovered from a suspect, it is compared with the original wire through metallography; tool mark comparison at the cut edge surfaces; measurement of conductivity and hardness; and analysis for trace elements, which are sometimes deliberately added in the original wire.

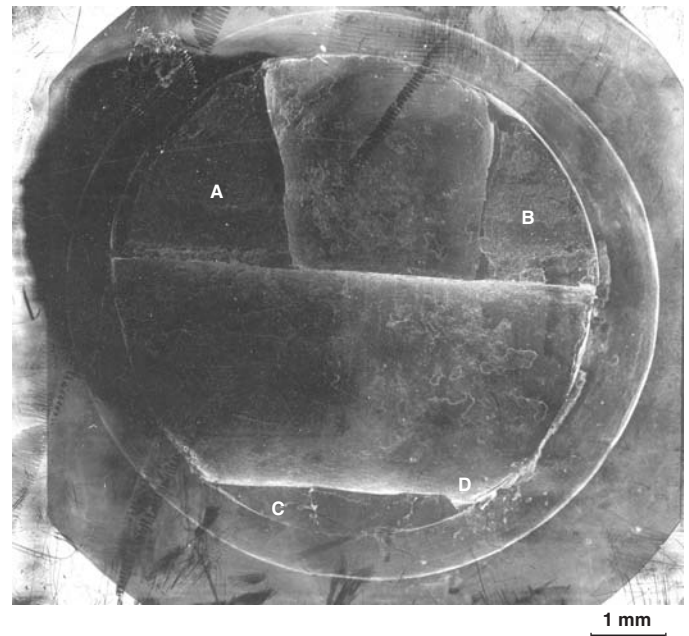
Fig. CH1.1 Fracture surface on one-half of the stud showing the rivet holes. Note the taper of one of the holes and noncentering of the other.

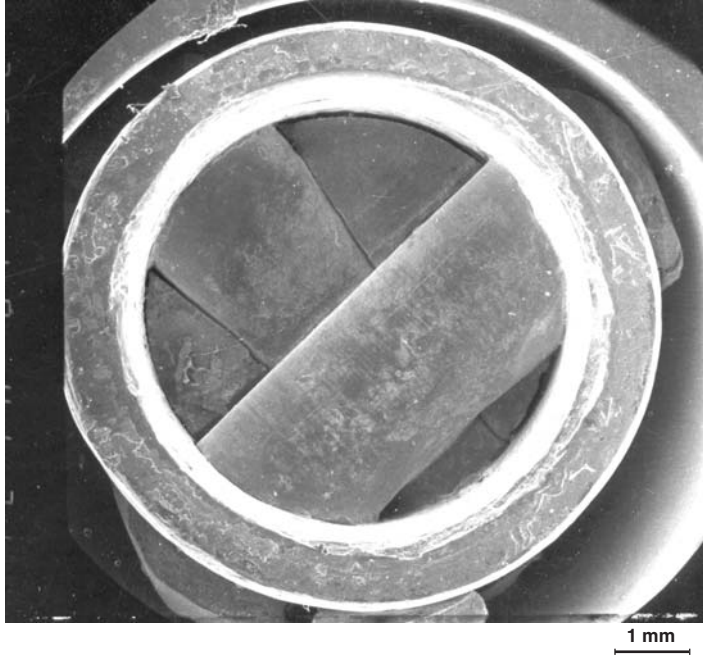
Fig. CH1.2 Fracture surface of the mating half of the stud, from inside the tube with rivets still in position

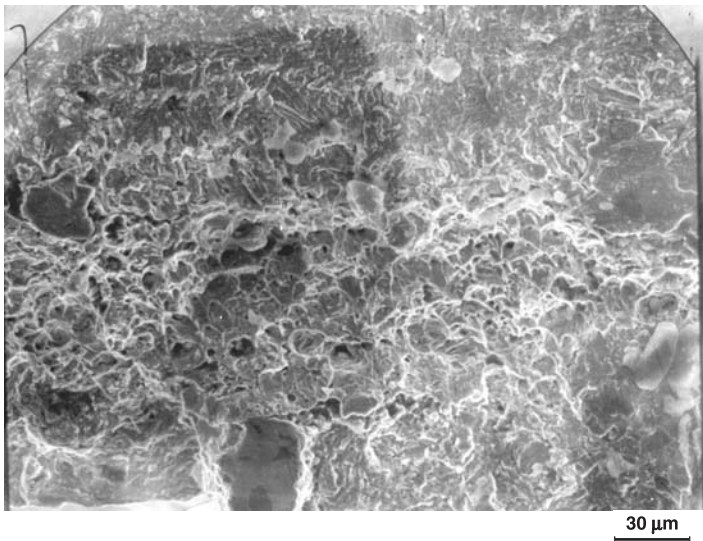
Fig. CH1.3 SEM fractograph of region A of Fig. CH1.1, close to the rivet hole, showing tearing mode of fracture

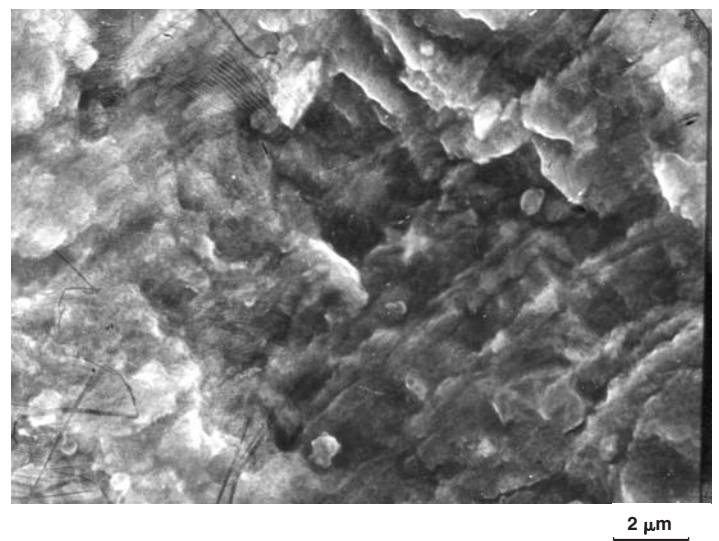
Fig. CH1.4 SEM fractograph of region A of Fig. CH1.1, showing fatigue striations

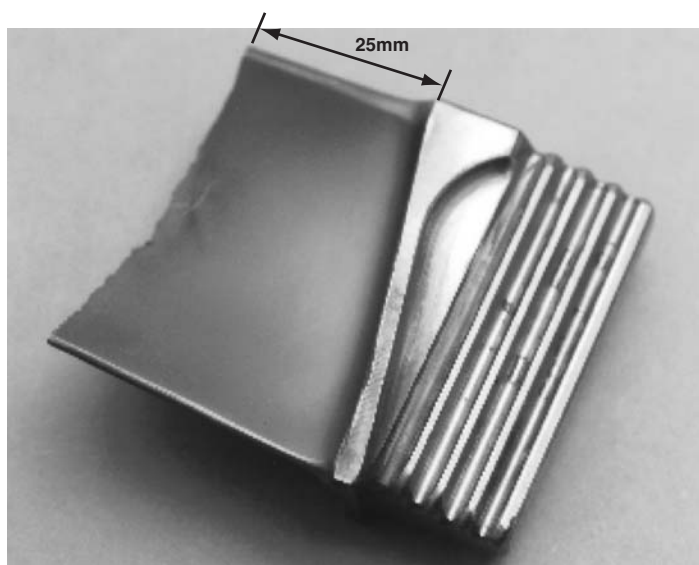
Fig. CH2.1 Photograph of the failed LPTR blade

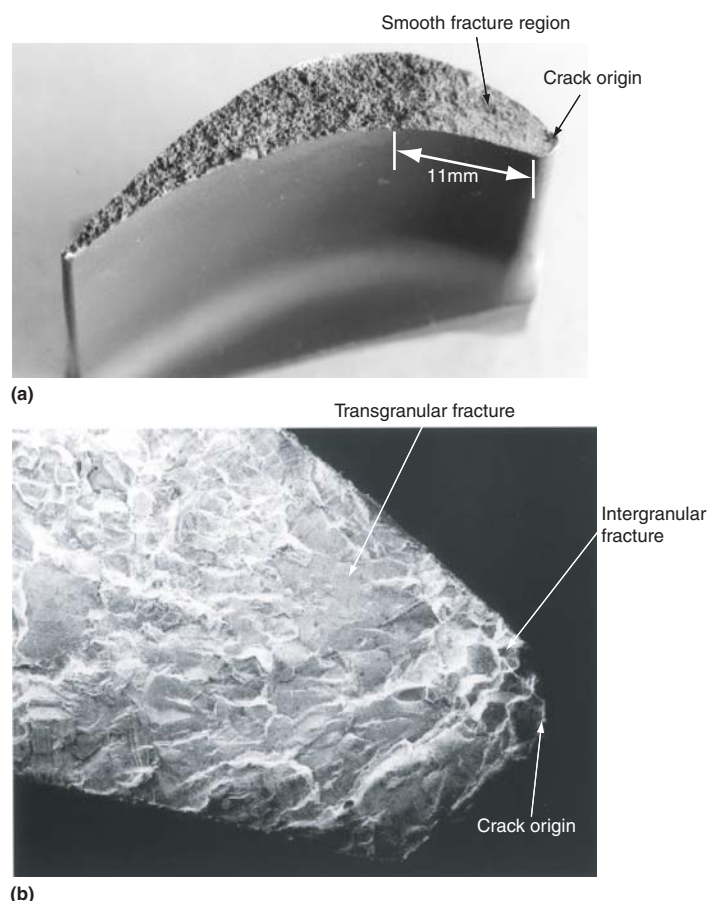
Fig. CH2.2 Photograph of the LPTR blade showing (a) entire fracture surface and (b) intergranular fracture features at the crack origin

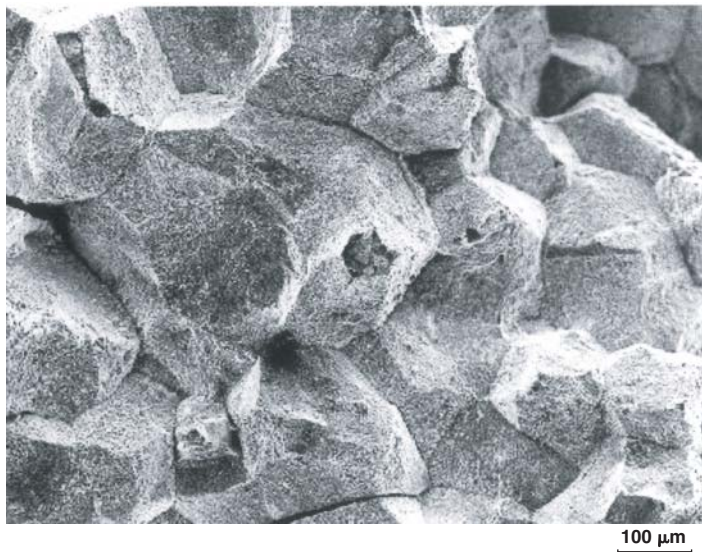
Fig. CH2.3 SEM fractograph showing intergranular fracture at the leading edge of the LPTR blade

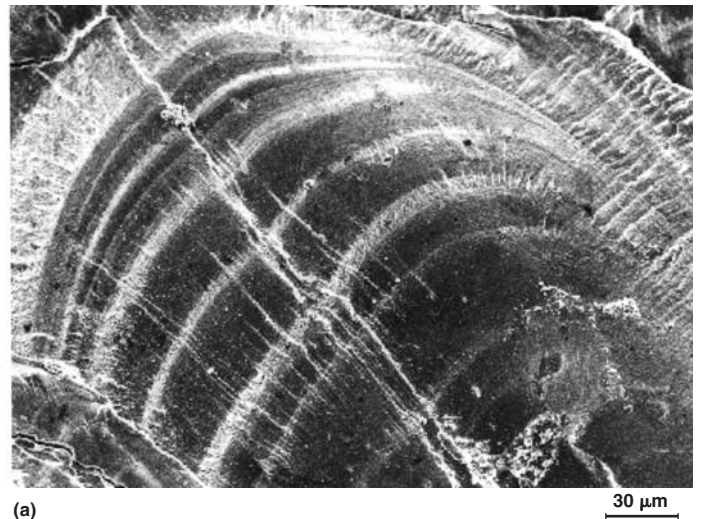
Fractographic study revealed that the fracture surface of the LPTR blade consisted of three distinctive fracture zones. The blade at the leading edge fractured in intergranular mode. Such fracture features were confined to about 1 mm from the leading edge. Intergranular initiation and propagation of cracks are the principal mode of fracture in high-temperature creep/stress rupture. Void formation and cracking occur principally along the grain boundaries normal to the major stress axis of the blade. The progress of

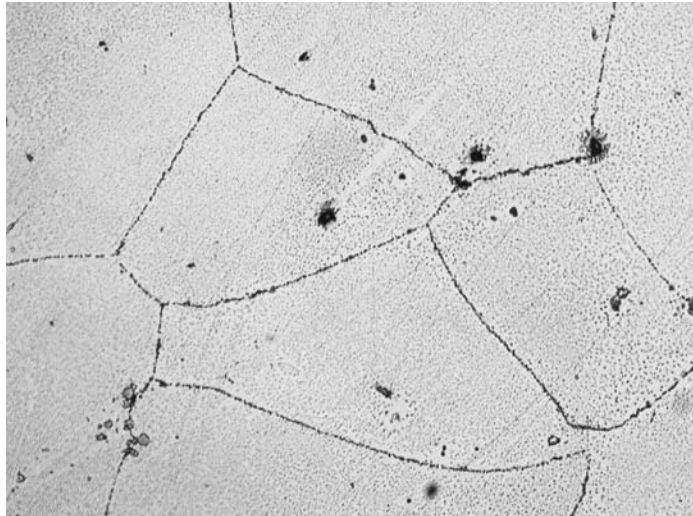
Fig. CH2.4 SEM fractographs showing (a) beach marks and (b) striations in the fatigue failed region

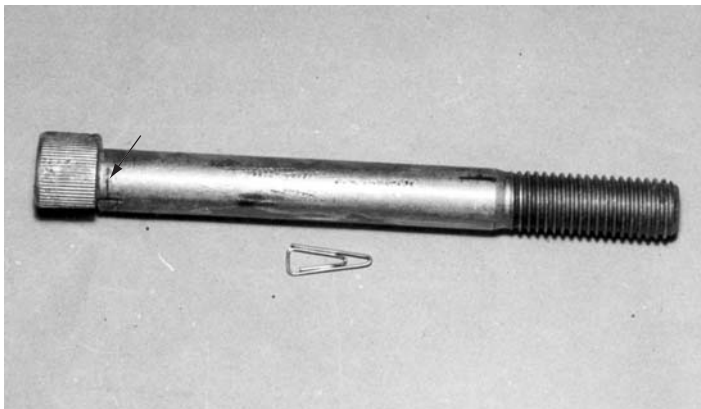
Fig. CH3.1 A bolt in the as-received condition

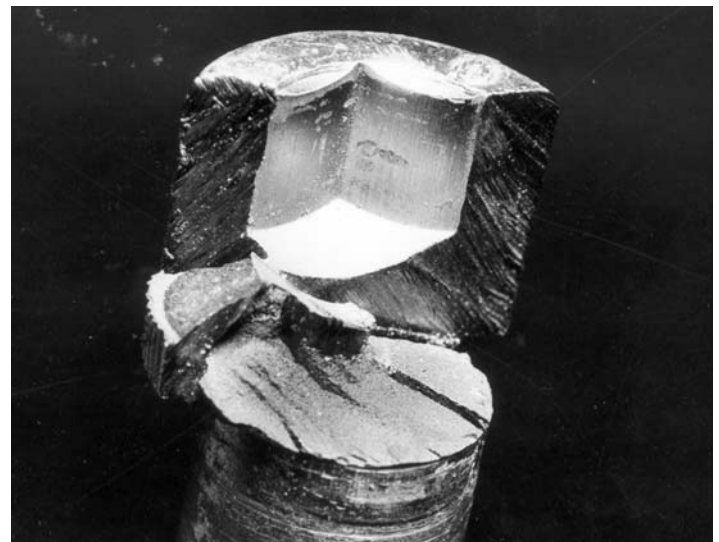
Fig. CH3.2 Bolt head after sectioning

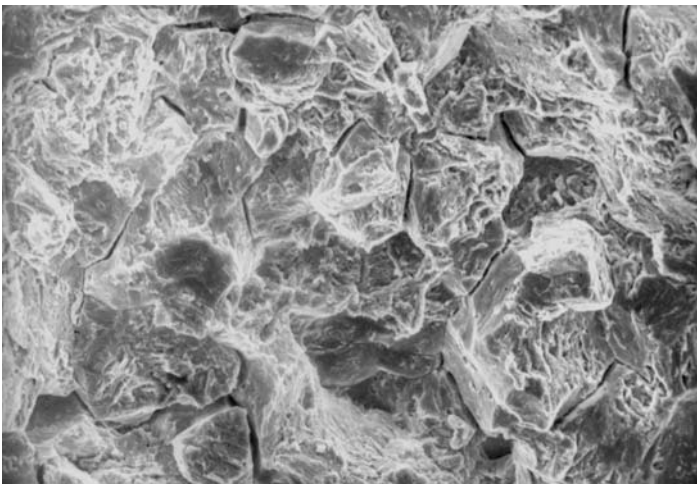
Fig. CH3.3 SEM fractograph showing intergranular fracture

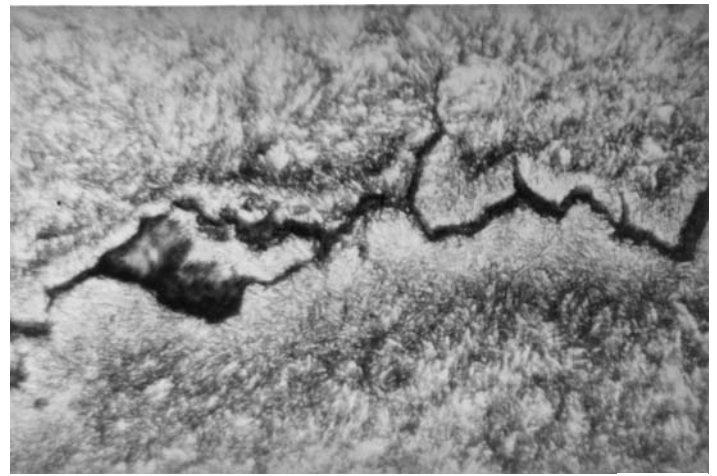
Fig. CH3.4 Intergranular path of the crack

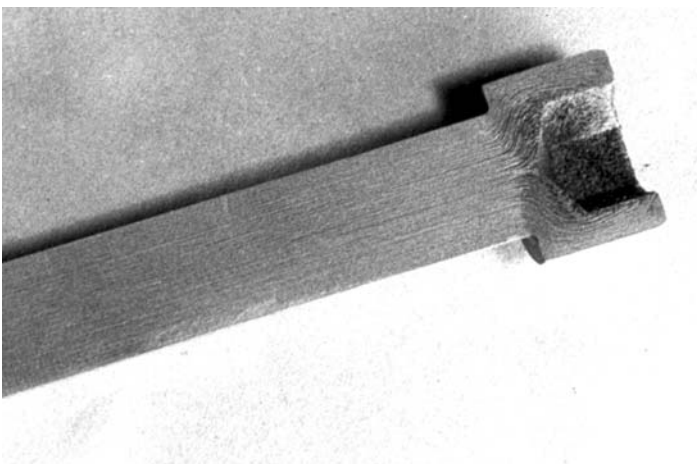
Fig. CH3.5 Flow lines on a longitudinal section of the bolt

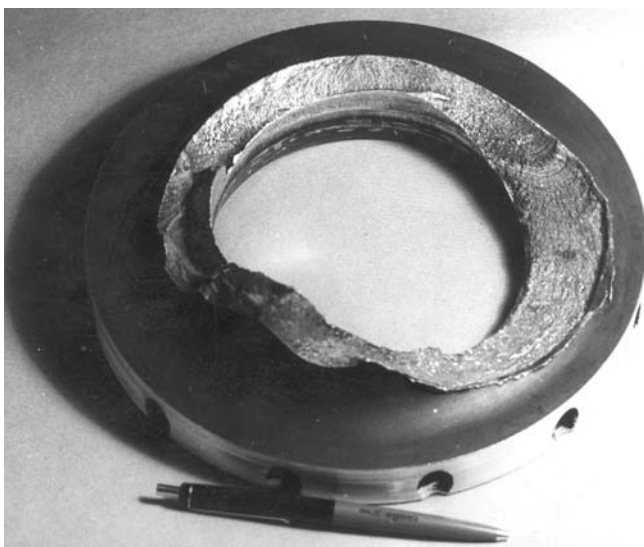
Fig. CH4.1 Portion of the broken hub in the as-received condition

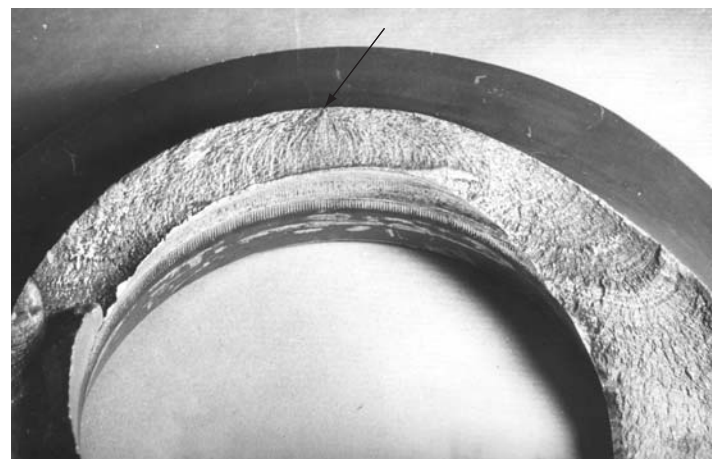
Fig. CH4.2 Close-up view of the fracture showing the beach marks typical of fatigue. Arrow indicates the origin.

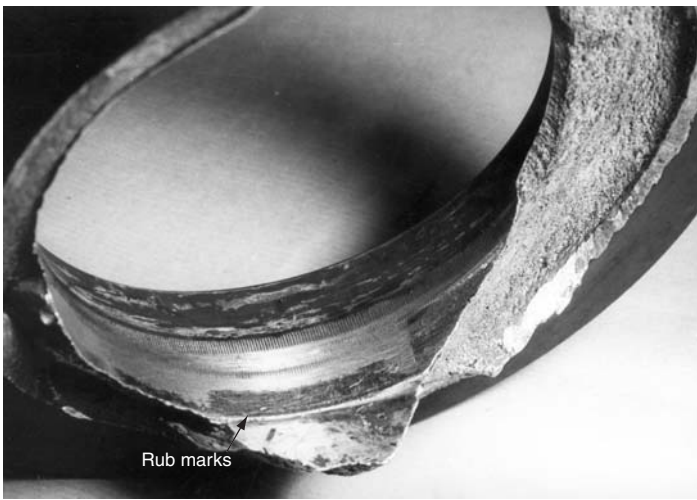
Fig. CH4.3 The arrow indicates the area having rubbing and metal flow.

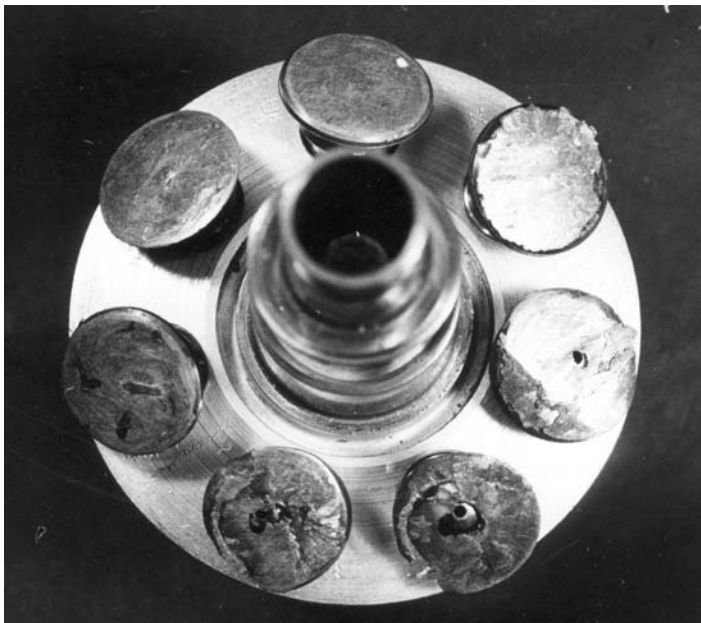
Parts of the damaged fuel pump are shown in Fig. CH5.1 and CH5.2. All seven slipper pads in the rotor assembly of the pump had been damaged, some of them severely. These pads were made of copper-beryllium alloy. The orifice of some of the pads got completely covered by smeared copper. The pads had rubbed heavily against the surface of the cam plate. The original silver plating on the pads was completely missing. The copper layer from

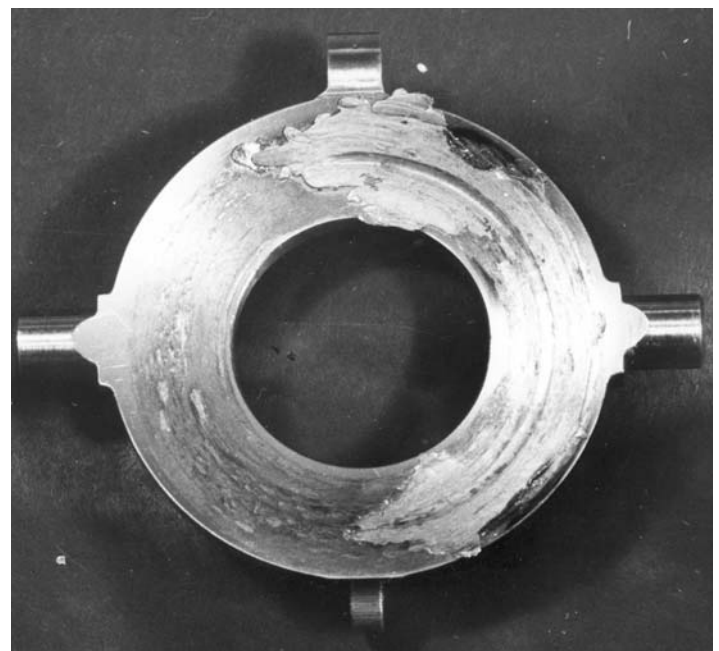
Fig. CH5.2 Cam plate showing adhesion of copper from the slipper pads

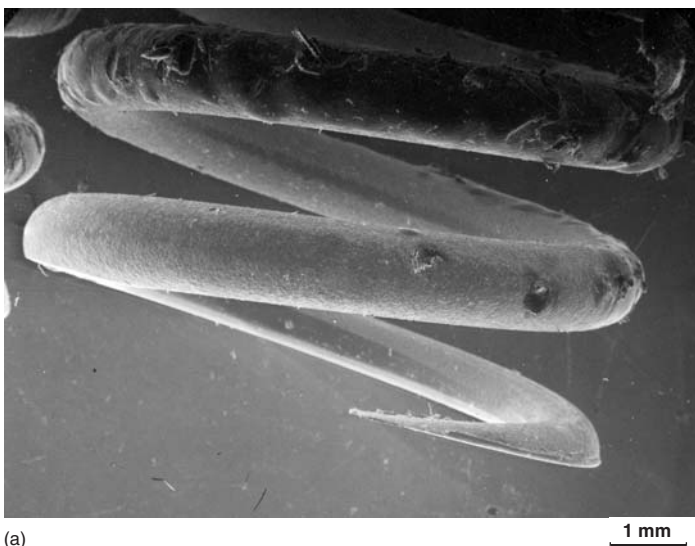
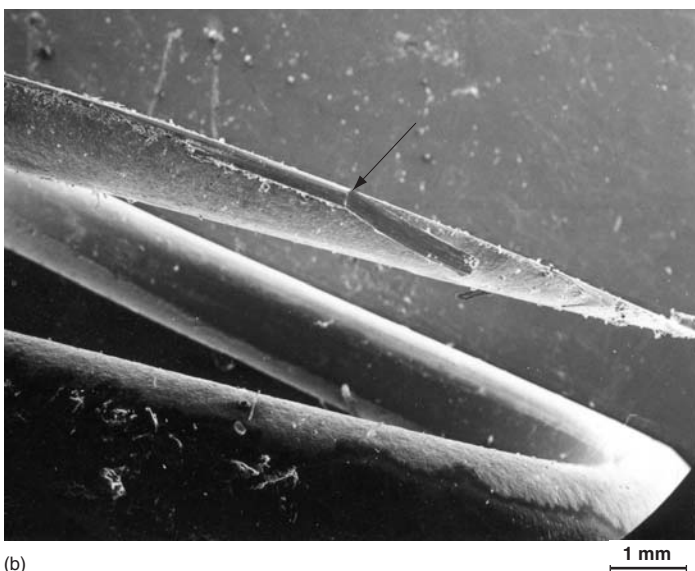
Fig. CH5.3 (a) and (b) Wear on spring No. 2. Arrow indicates a sliver.

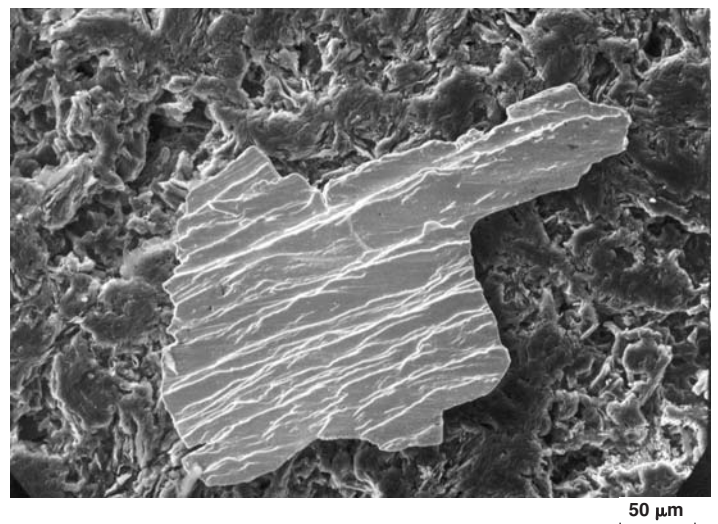
Fig. CH5.4 SEM photograph of a copper flake

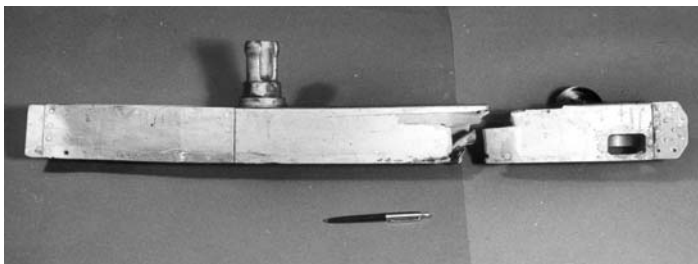
The fracture surfaces indicated by arrows in Fig. CH6.2 and CH6.3 were examined in a SEM. Figures CH6.4 and CH6.5 are

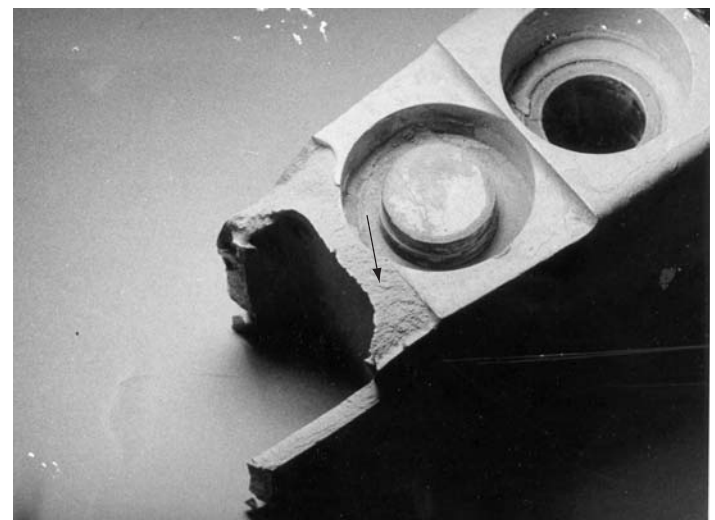
Fig. CH6.2 Close-up view of the fracture surface in the adaptor

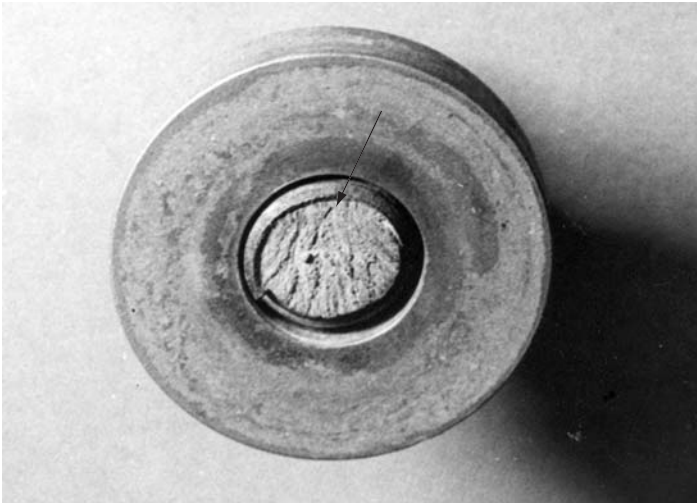
the SEM fractographs of the two regions. The fractographs indicate dimples characteristic of failure by overload. There are no indications of progressive failure.

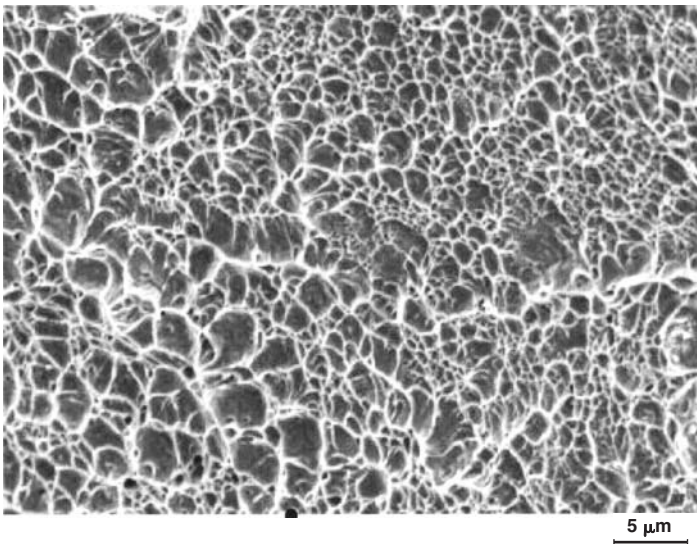
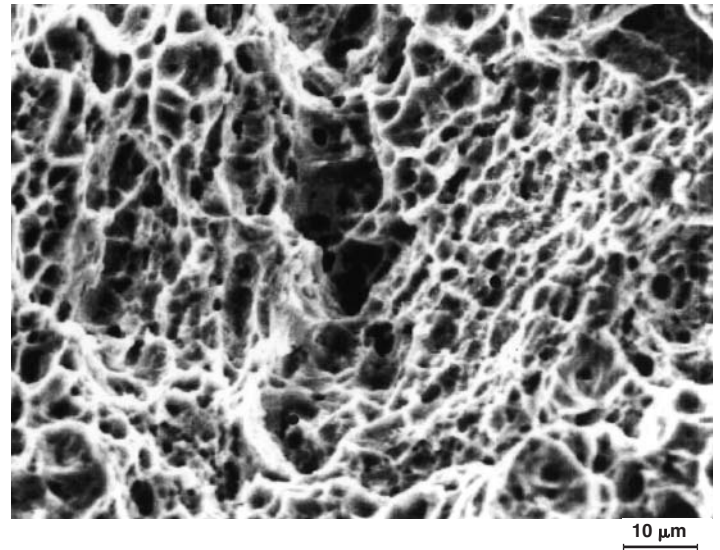
Fig. CH6.4 SEM fractograph of the bolt shown in Fig. CH6.3, showing dimples typical of overload fracture

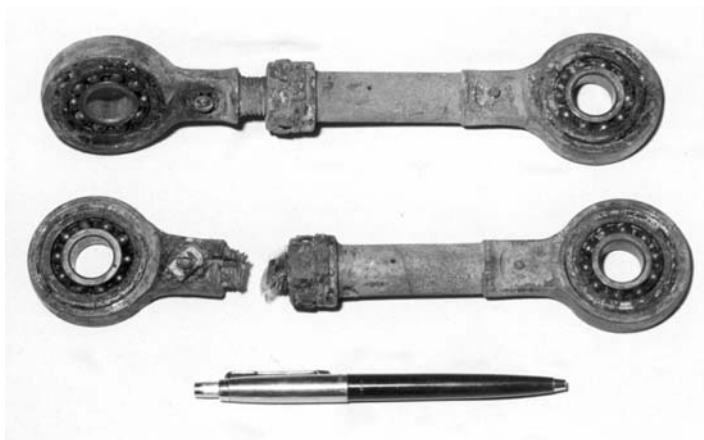
Fig. CH7.1 Starboard stabilizer link rod and broken port stabilizer link rod

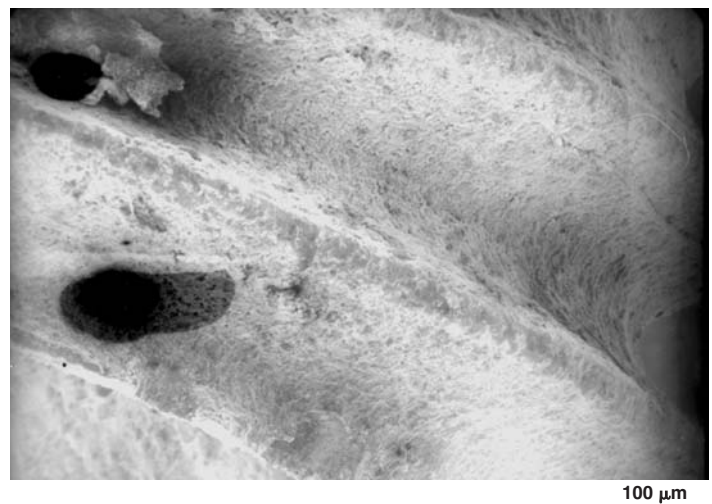
Fig. CH7.2 Damage to the threads of the link rod, near the fracture surface, as a result of bending

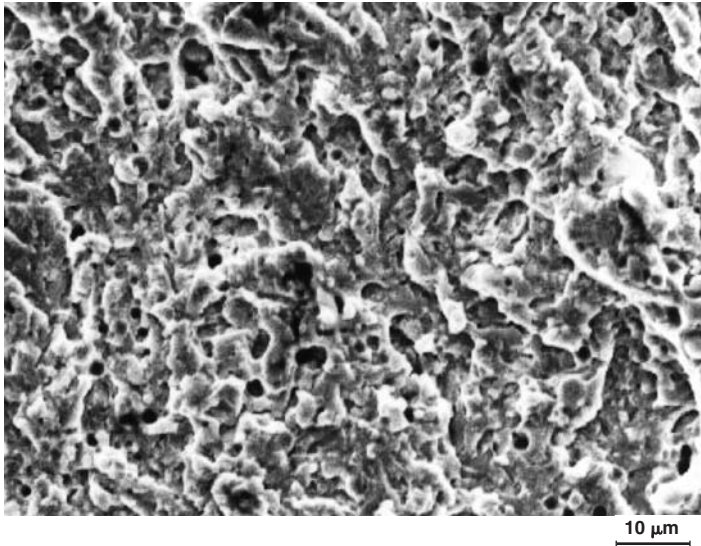
Fig. CH7.3 SEM fractograph showing dimples characteristic of overload fracture

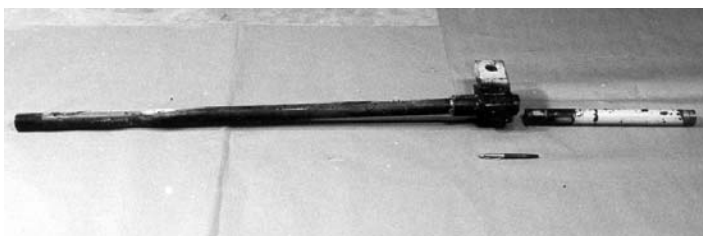
Fig. CH8.1 The broken tie-rod of the developmental aircraft towing tractor

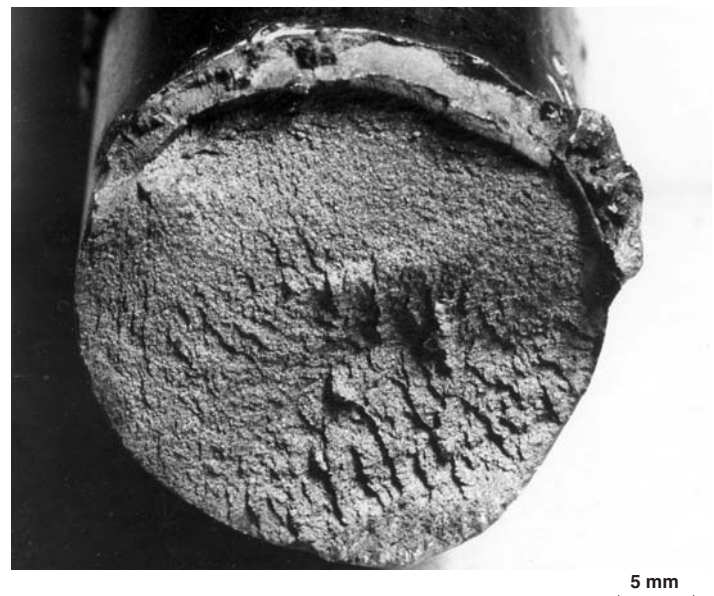
Fig. CH8.2 Close-up view of the fracture surface

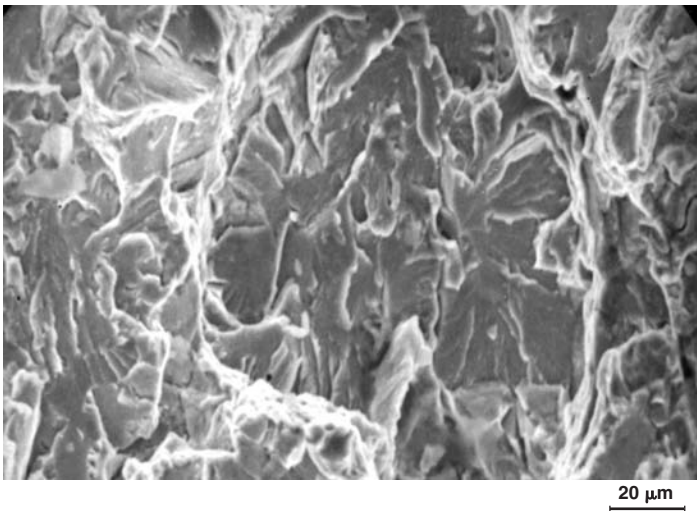
Fig. CH8.3 SEM fractograph showing the brittle nature of fracture

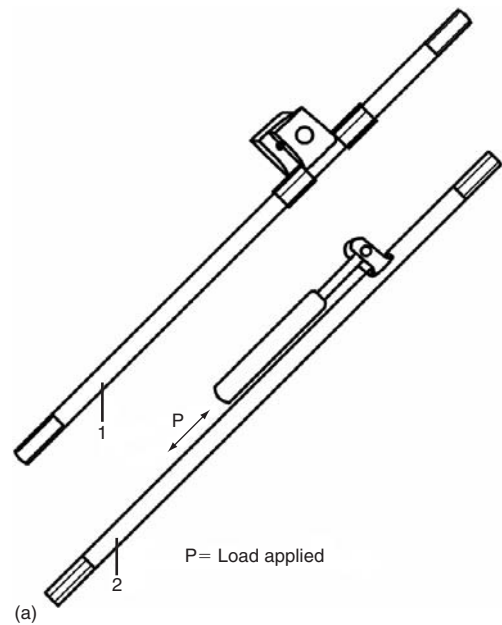
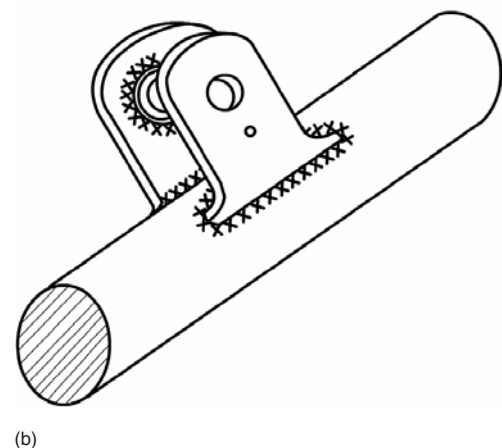
Fig. CH8.5 (a) 1. Original tie-rod that failed in the trial run. 2. Modified tie-rod. (b) Modified design of fork end
