Failure Analysis of Engineering Structures

Methodology and Case Histories

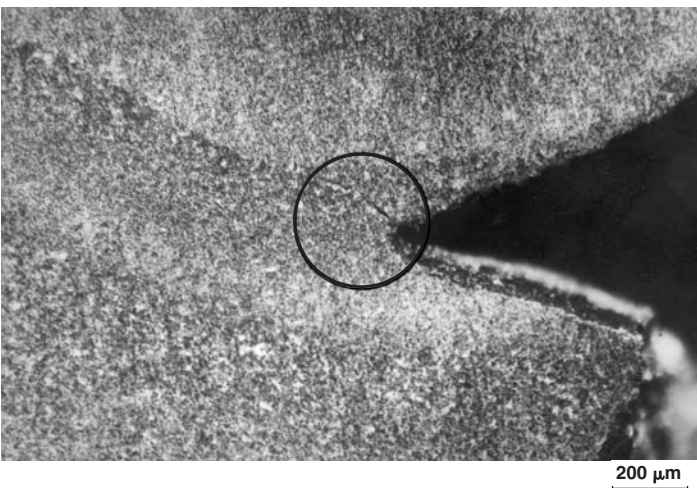
Fig. CH8.4 Optical micrograph of the weld zone showing a crack and the heat-affected zone

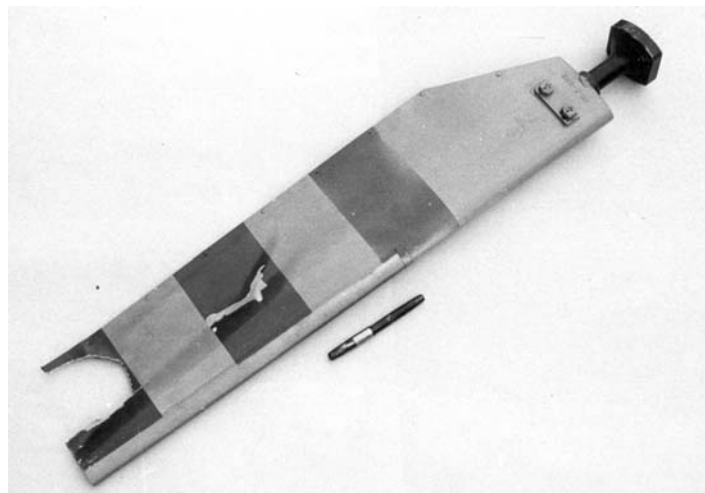
Fig. CH9.1 Damaged tail rotor blade

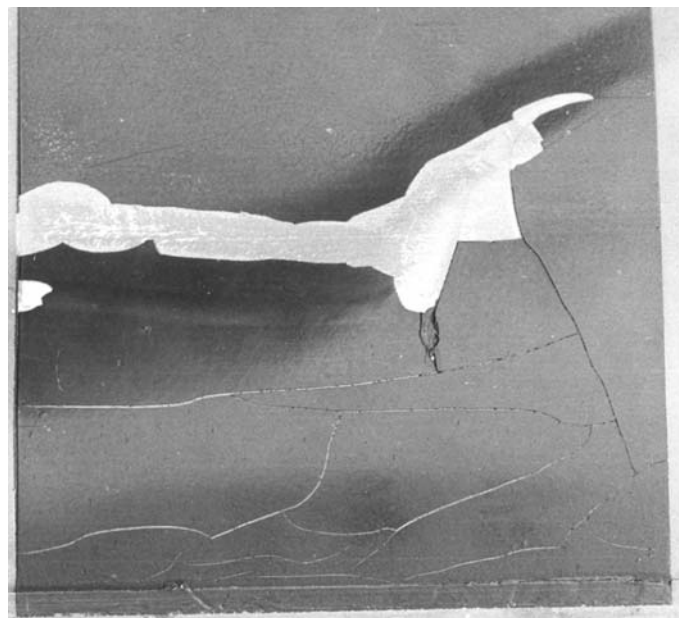
Fig. CH9.2 Cracking of paint on the airfoil surface

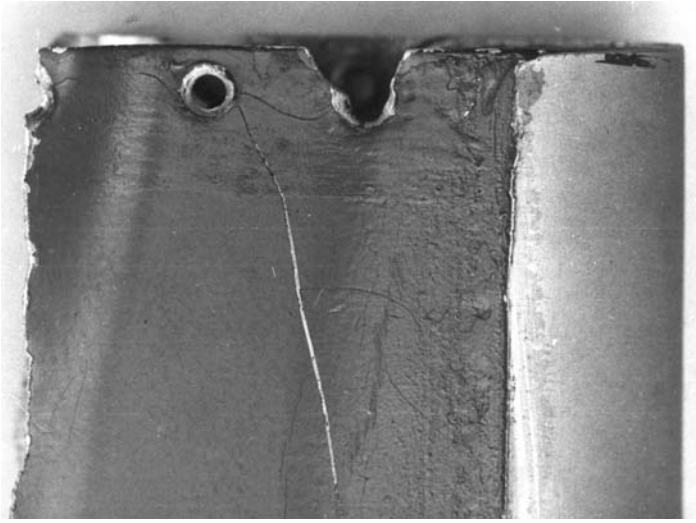
Fig. CH9.3 Tear damage at the blade tip

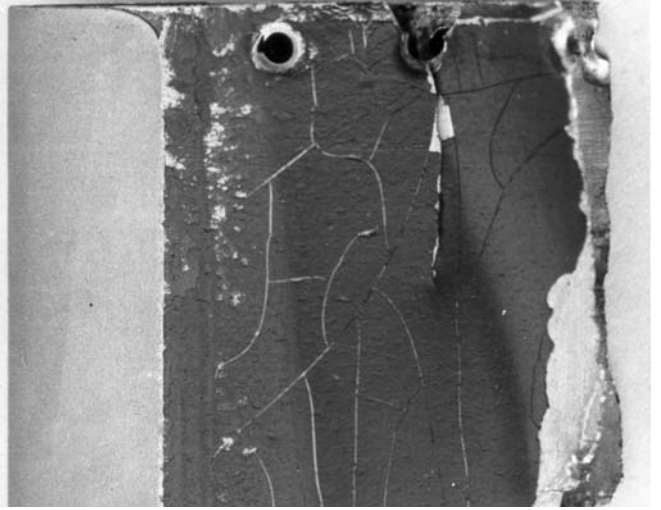
Fig. CH9.4 Tear damage at the blade tip, side opposite that in Fig. CH9.3. Cracking of the paint can also be seen.

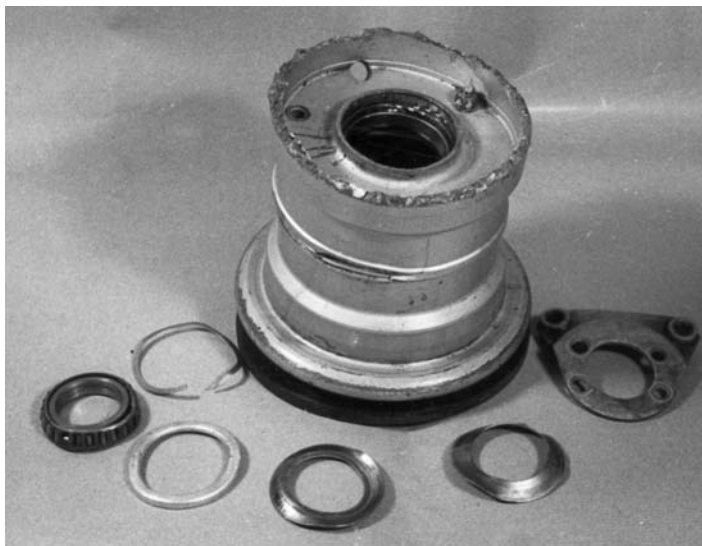
Fig. CH10.1 Damaged hub in the as-received condition

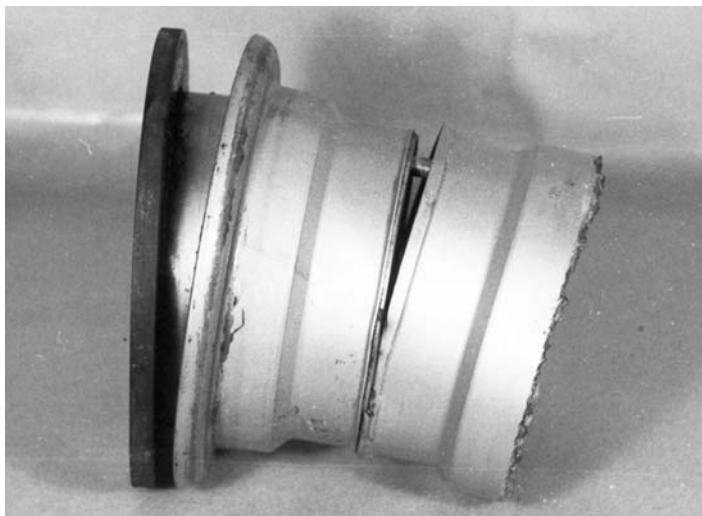
Fig. CH10.2 Separation of the hub

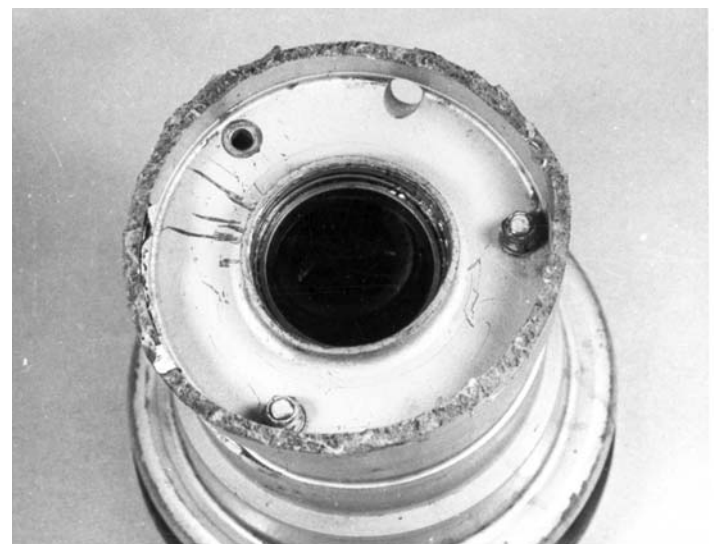
Fig. CH10.3 Fracture surface of the hub

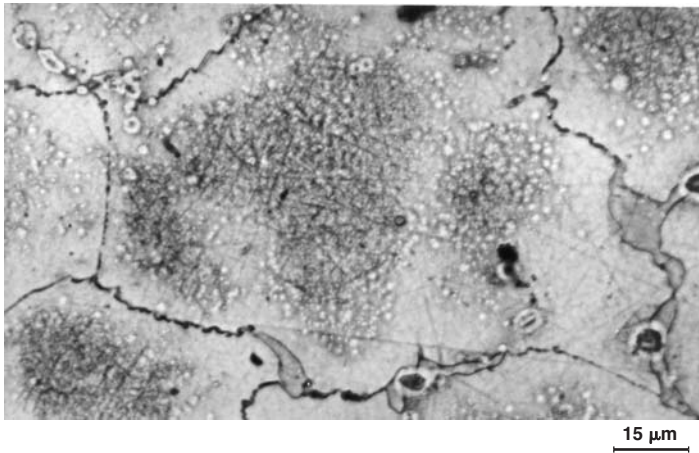
Fig. CH10.4 Microstructure of the hub material

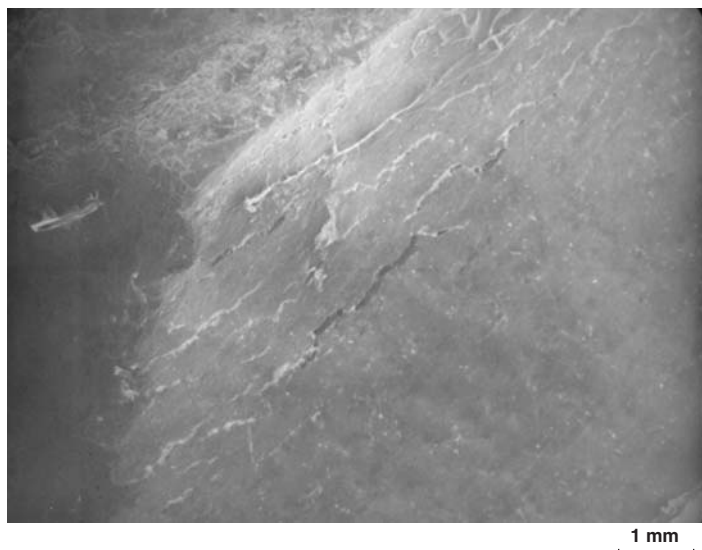
Fig. CH10.5 Circumferential cracks near the fracture surface

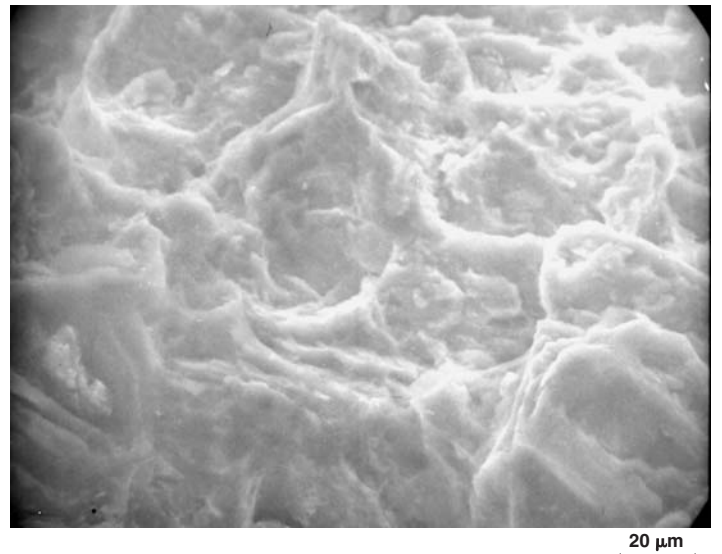
Fig. CH10.6 SEM fractograph near the periphery, showing dimples

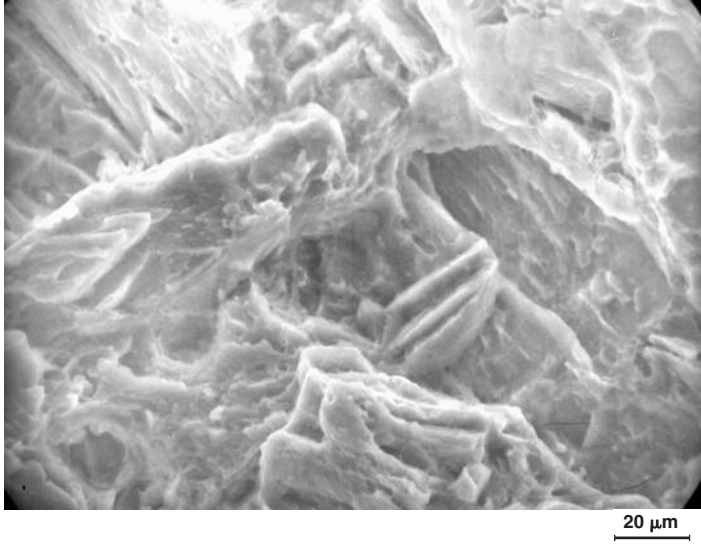
Fig. CH10.7 SEM fractograph on the interior, showing cleavage

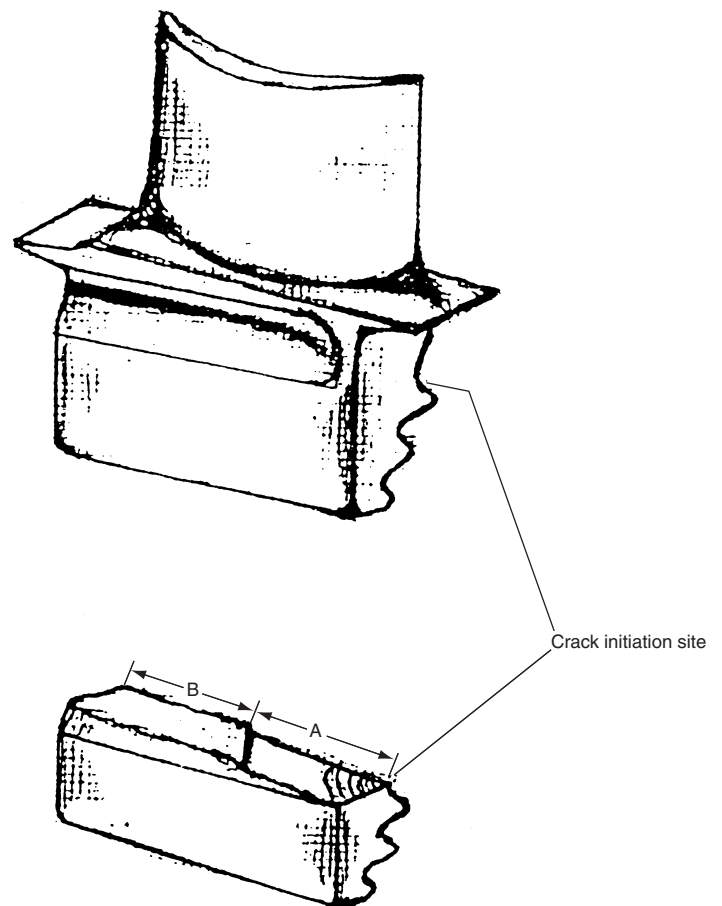
Fig. CH11.1 Schematic diagram showing location of fracture

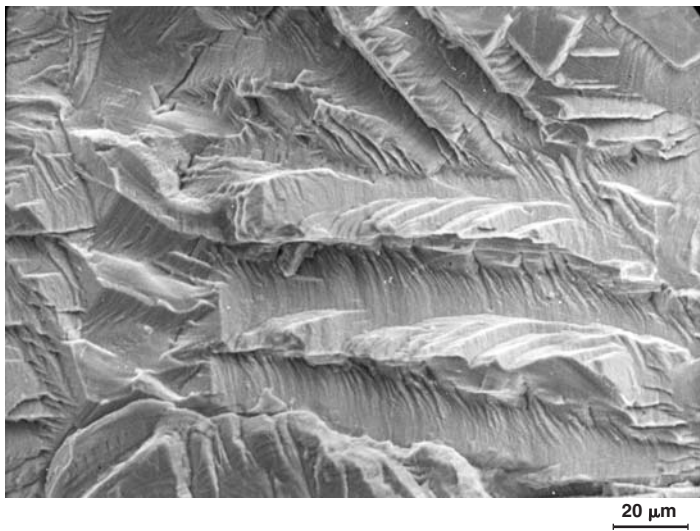
Fig. CH11.2 SEM fractograph of the failed blade

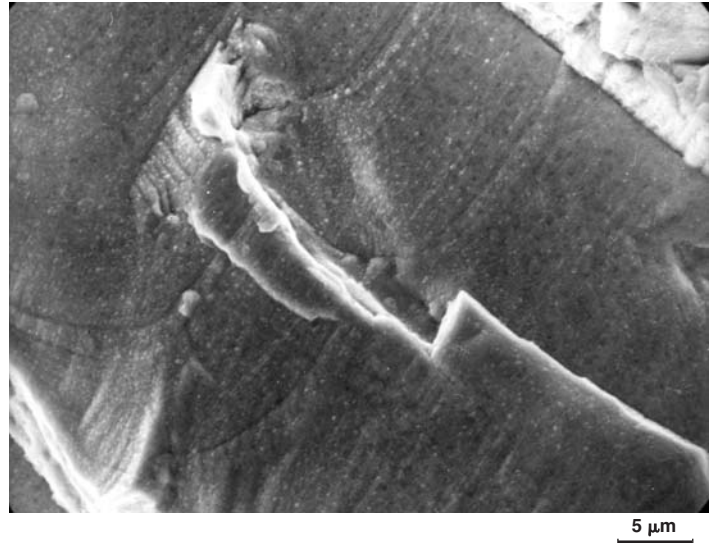
Fig. CH11.3 SEM fractograph of the failed blade, showing fatigue striations

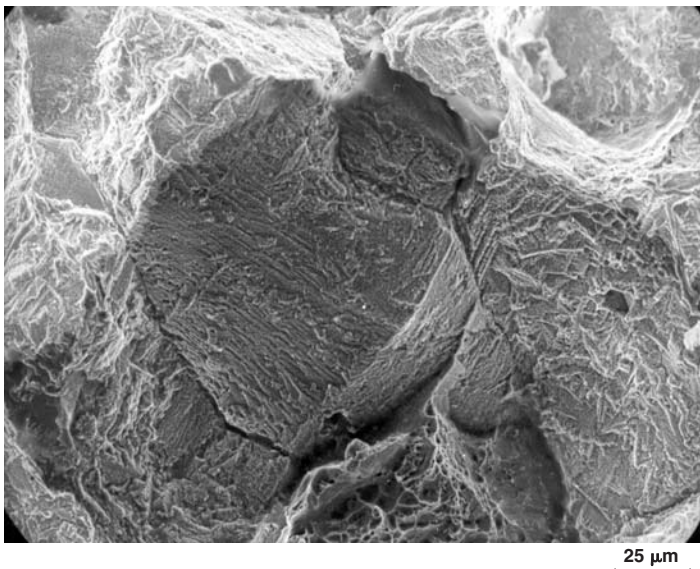
Fig. CH11.4 SEM fractograph of the fast-fracture region

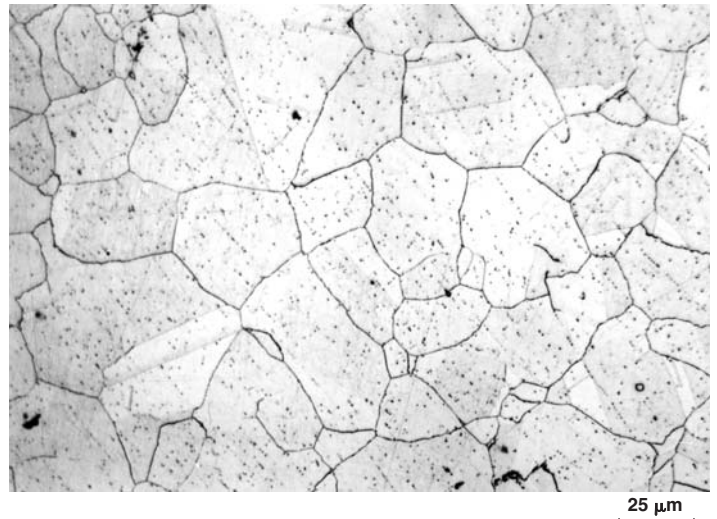
Fig. CH11.5 Microstructure of the failed blade

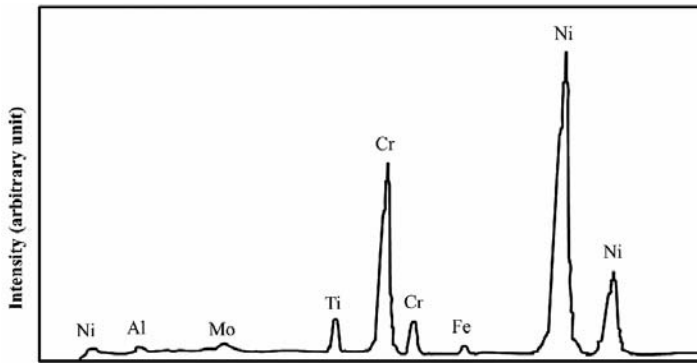
Fig. CH11.6 Energy-dispersive spectrum of the blade material

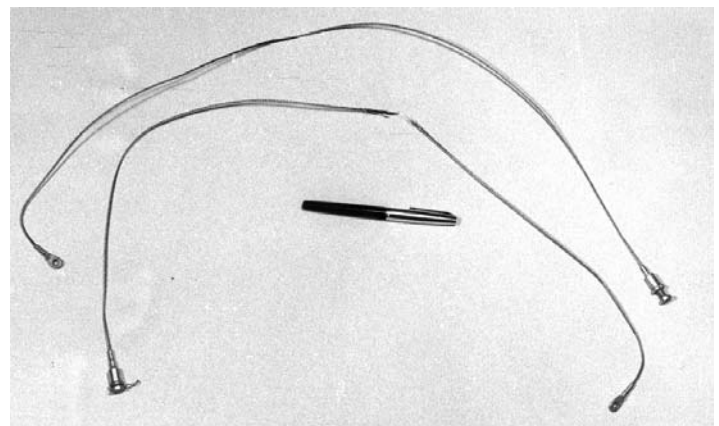
Fig. CH12.1 Snapped aileron control cable and another cable in service

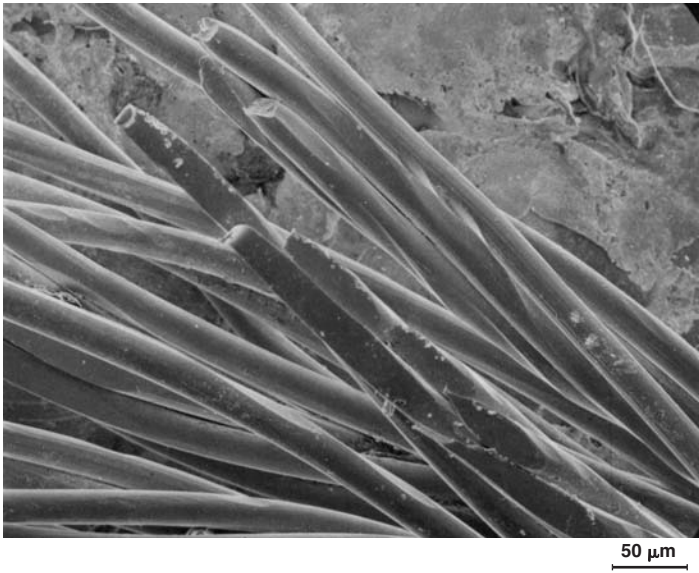
Fig. CH12.2 SEM fractograph showing strands thinned and broken

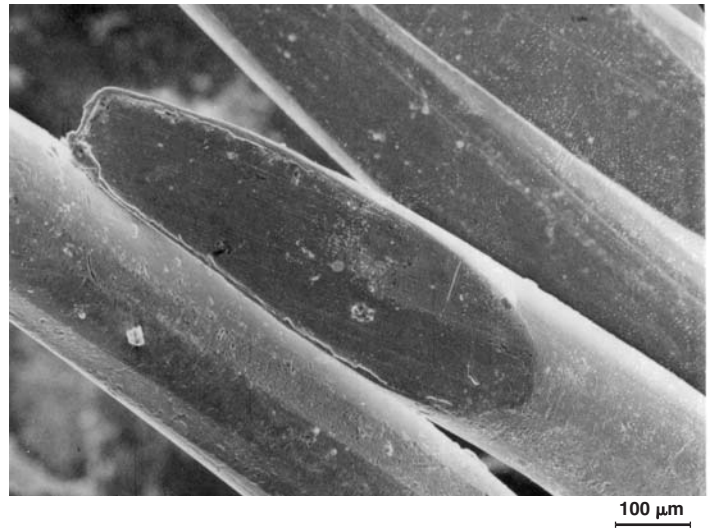
Fig. CH12.3 SEM photograph showing the extent of wear in a few wires

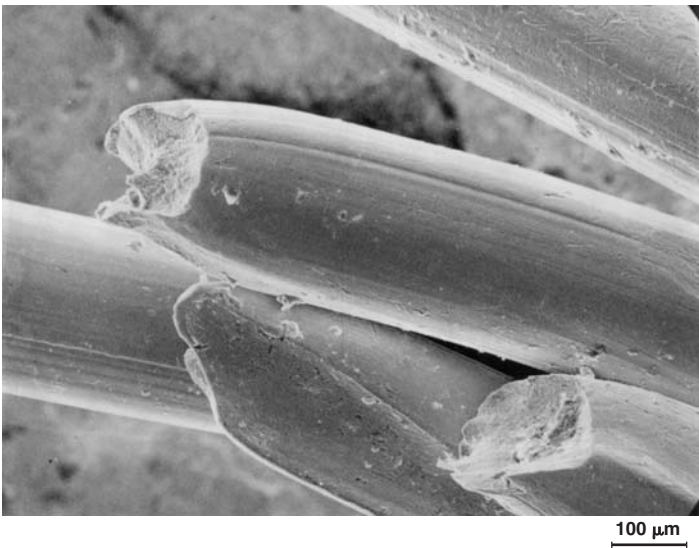
Fig. CH12.4 Some of the wires failed in tension, showing cup and cone fracture

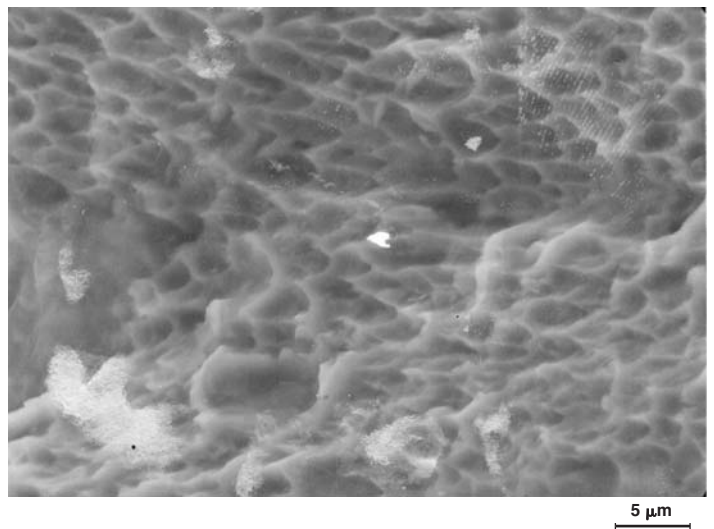
Fig. CH12.5 Fracture surface of one of the wires showing dimples characteristic of tensile failure

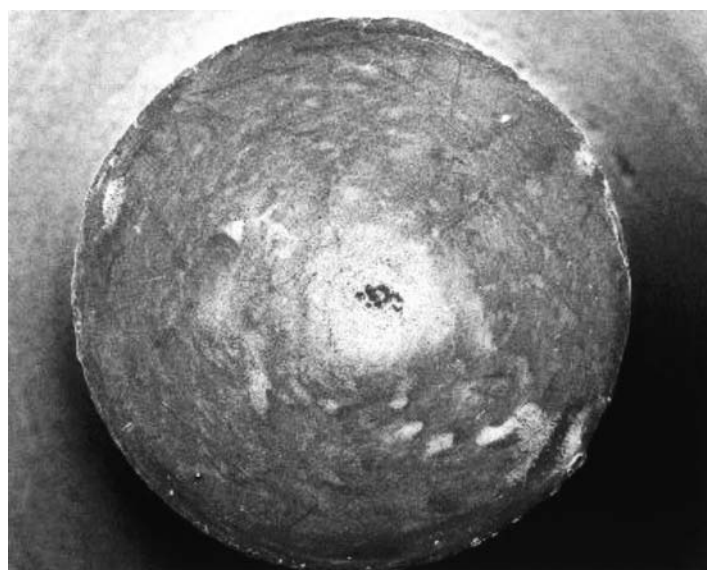
Fig. CH13.1 Fracture surface of the quill shaft

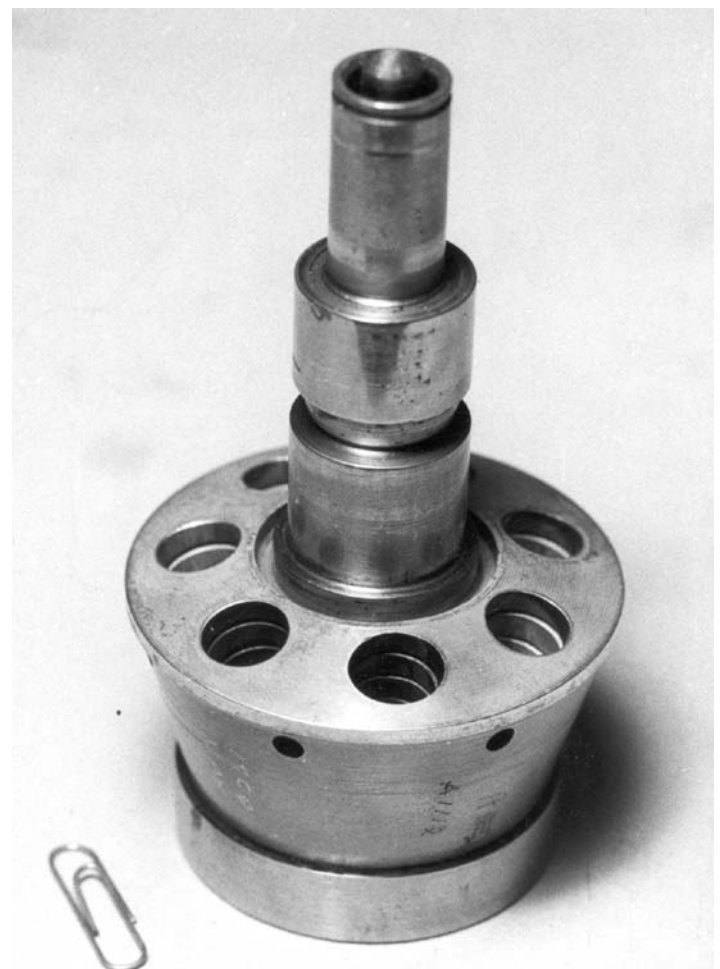
Fig. CH13.2 Rotor of the fuel pump

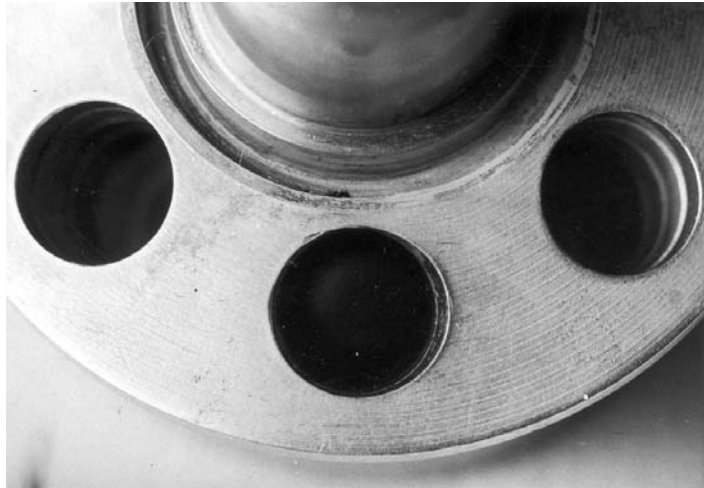
Fig. CH13.3 Deformation and metal flow around the piston hole

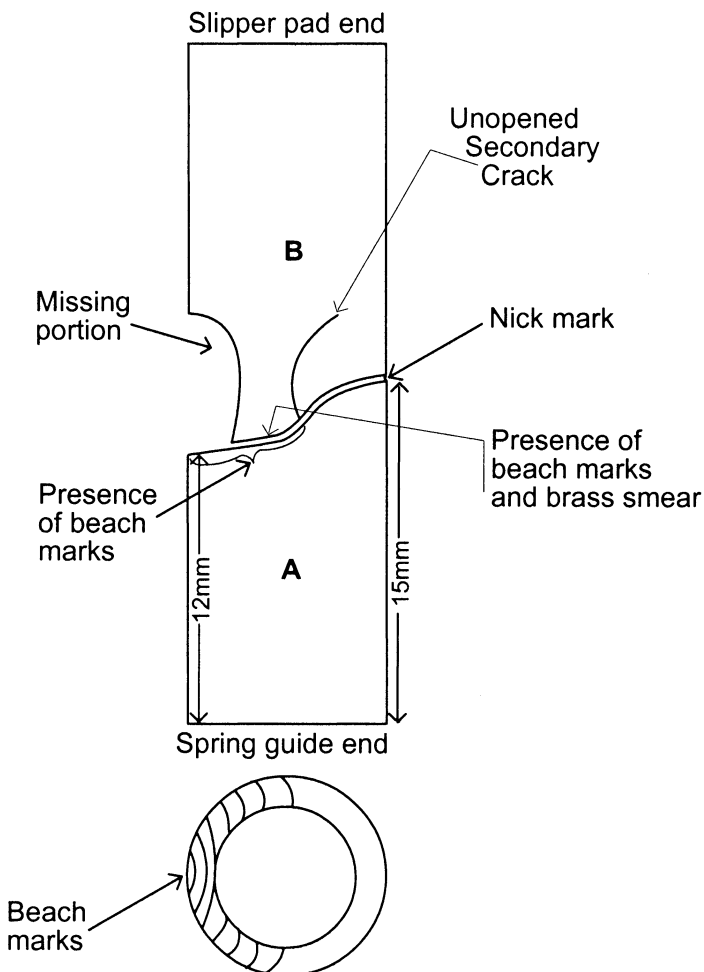
Fig. CH13.4 Sketch showing the fracture pattern of the failed piston

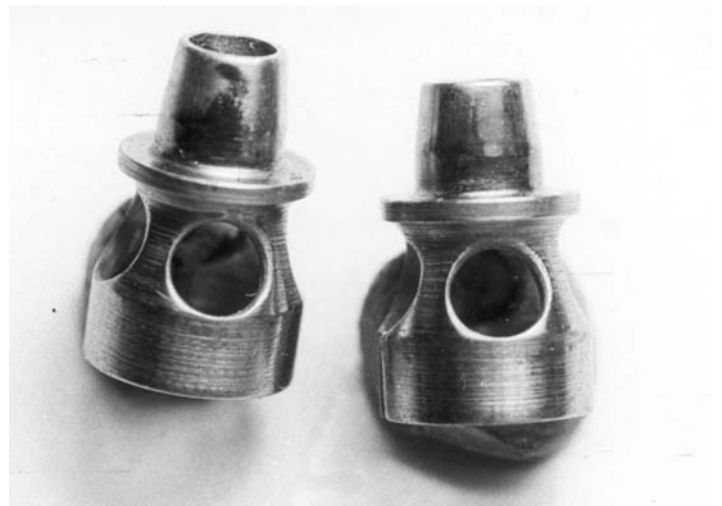
Fig. CH13.5 Wear on the spring guides

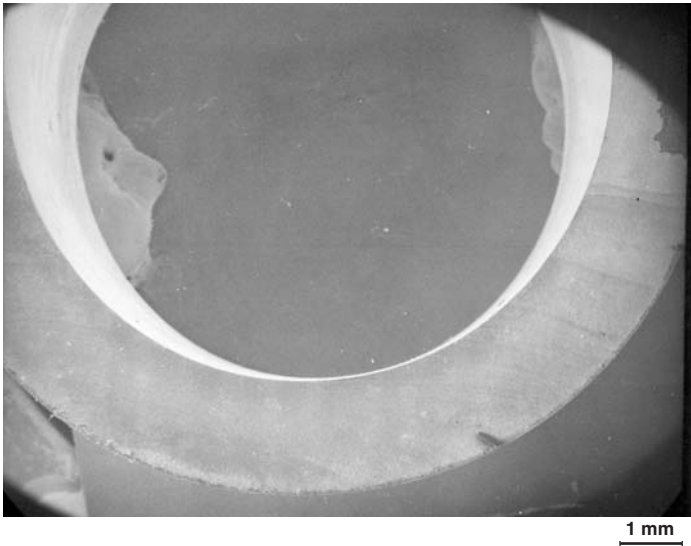
Fig. CH13.6 Features resembling beach marks on the fracture surface of the failed piston. SEM fractograph

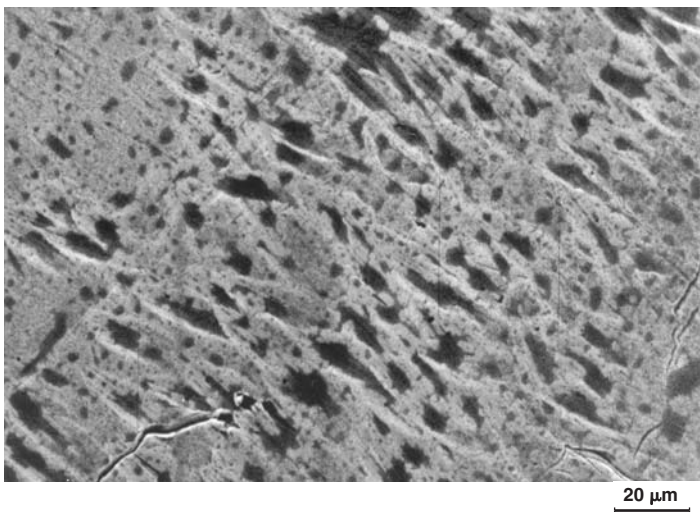
Fig. CH13.7 Fretting damage on the barrel surface of the failed piston. SEM photograph

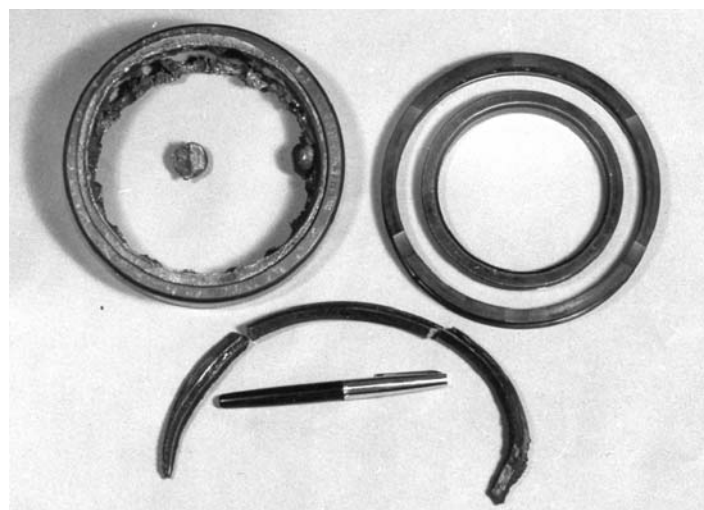
Fig. CH14.1 Severely damaged bearing parts. Note the broken inner ring and the severely rubbed ball bearing.

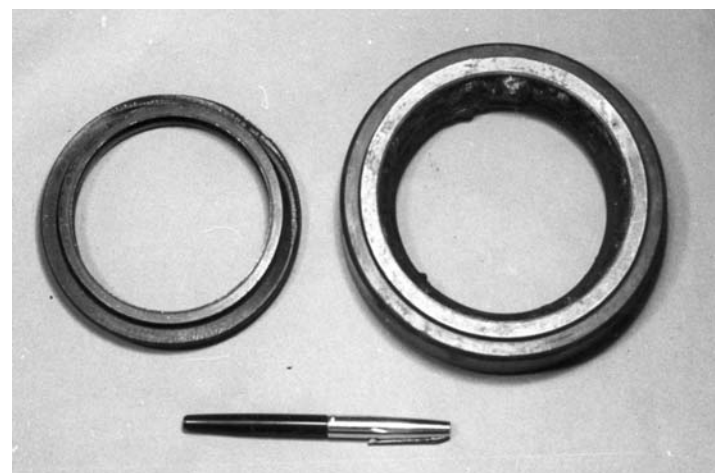
Fig. CH14.2 The second bearing with deformed inner ring

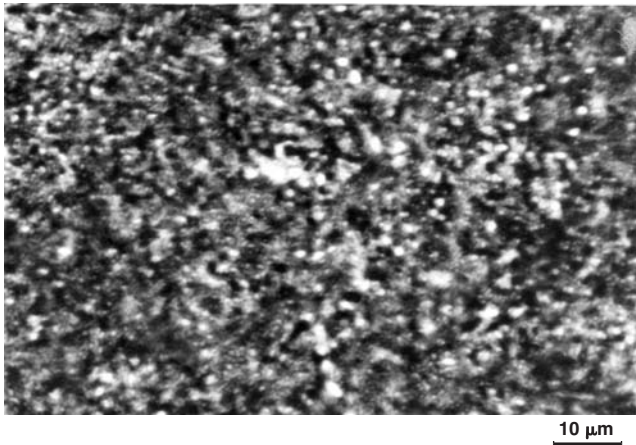
Fig. CH14.3 Microstructure of the damaged outer ring, showing tempered structure. Nital etch

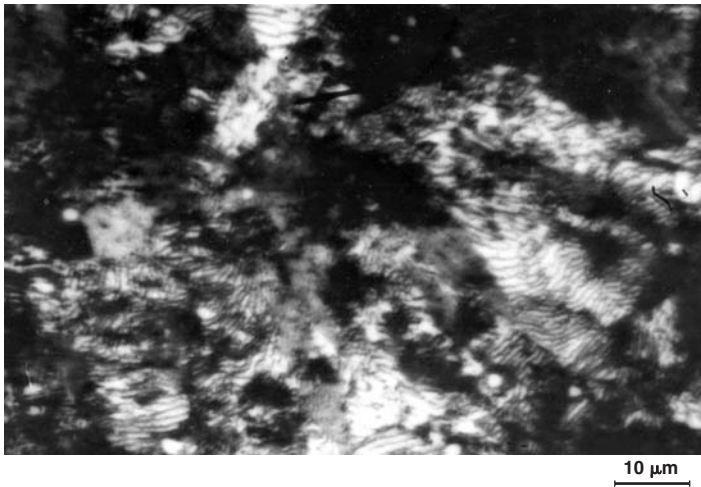
Fig. CH14.4 Microstructure of the broken inner ring showing resolved pearlite and spheroidal carbide. Nital etch

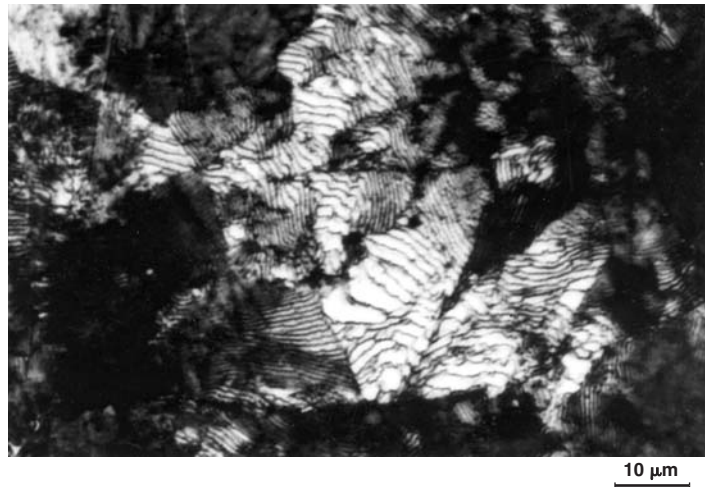
Fig. CH14.5 Microstructure of the damaged ball bearings showing resolved pearlite and spheroidal carbide. Nital etch

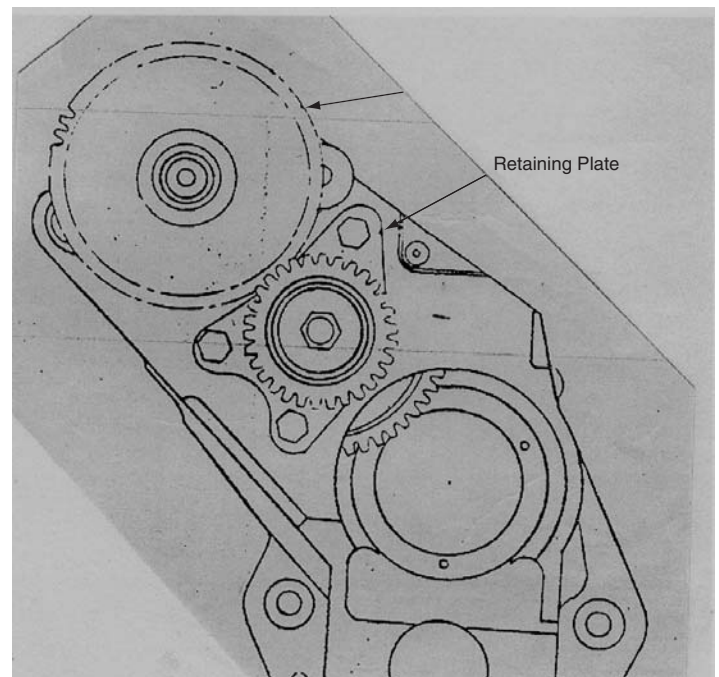
A wavy washer positioned below the inner bearing showed excessive grooving along the periphery at the ridges (Fig. CH15.5). The shim washer also showed signs of chatter (Fig. CH15.6).

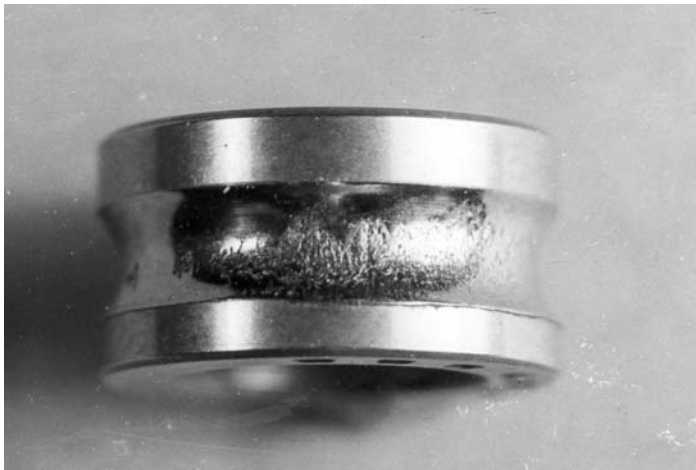
This rotation comes about by excessive clearance between the outer race and the steel housing abetted by insufficient lubrication in the bearings. Once grooving sets in, the tension on the wavy washer is altered from the set value. This would further assist in the rotation of the outer race inside the housing. The material removed by wear would show up during the analysis of the lubricating oil for metal particles.

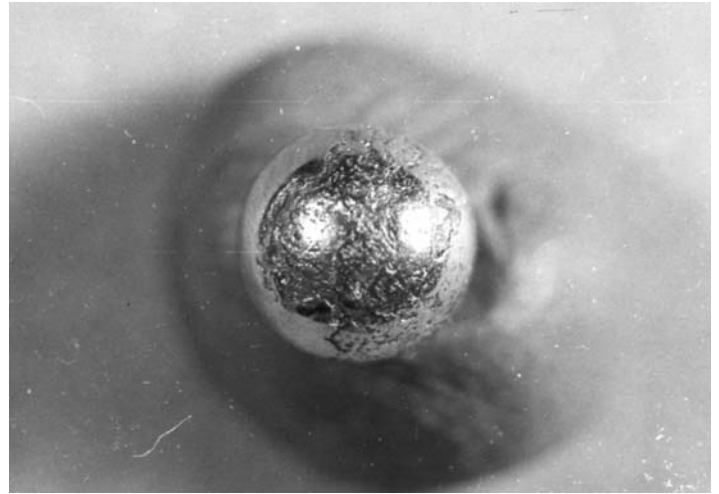
Fig. CH15.3 One of the balls of the inner bearing showing excessive wear

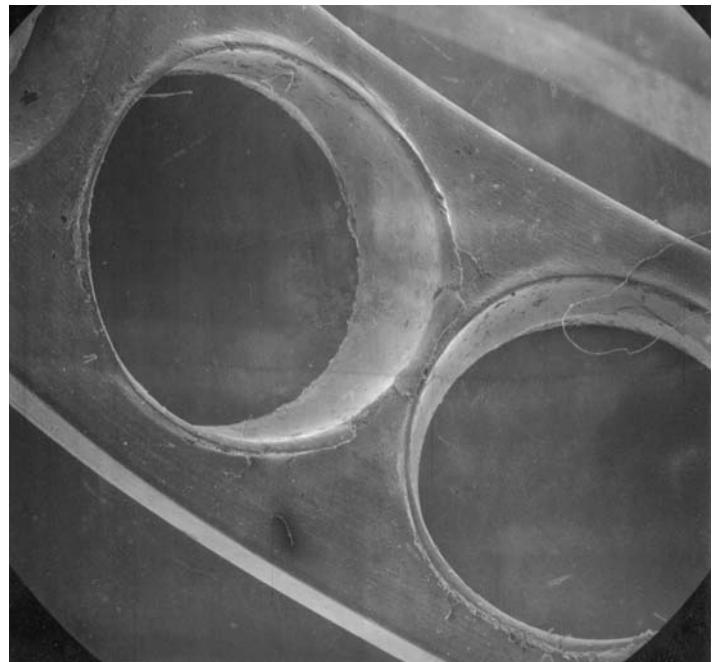
Fig. CH15.4 Wear and deformation of the cage of the inner bearing

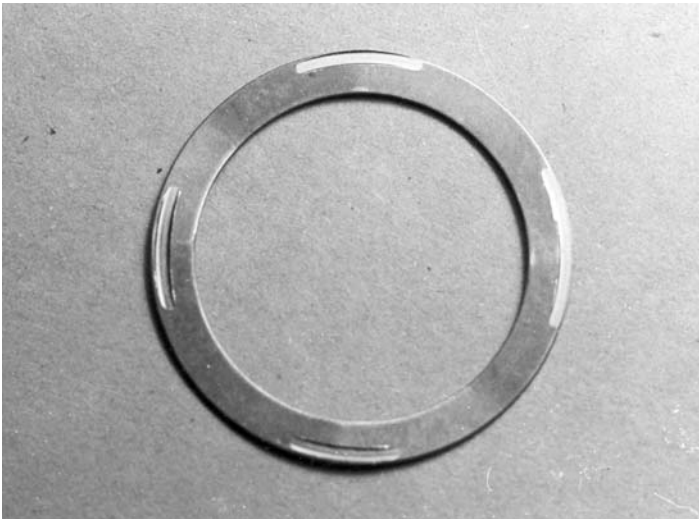
Fig. CH15.5 Wavy washer showing extensive grooving

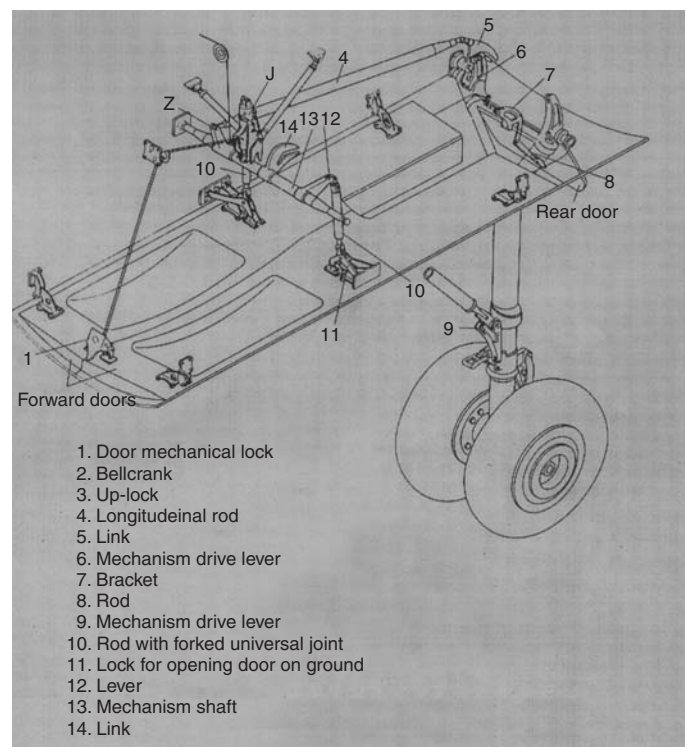
Fig. CH16.1 Starboard undercarriage door control mechanism, indicating the region of fracture of the link rod

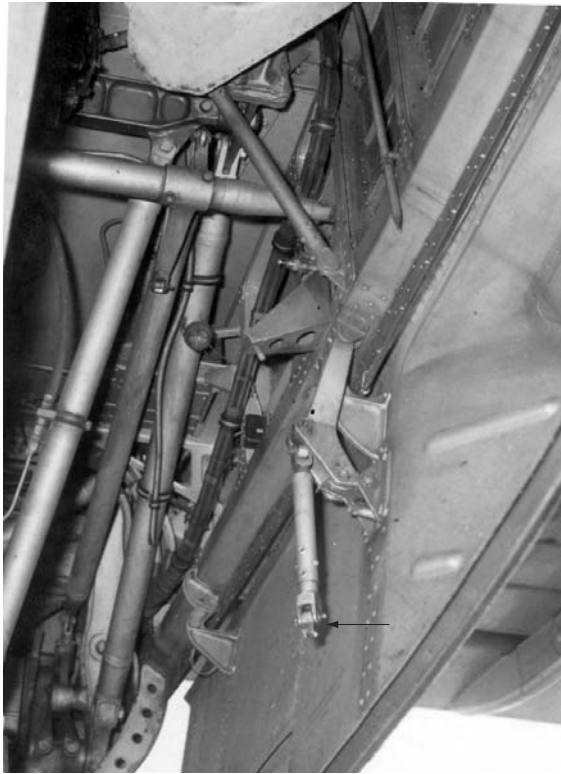
The universal joint on the actuating link rod of the starboard undercarriage fractured due to a preexisting fatigue crack coupled with overload.

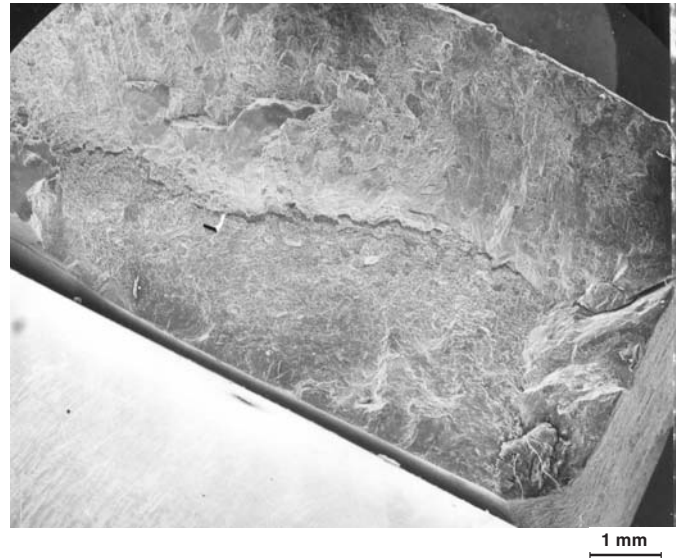
Fig. CH16.3 SEM fractograph showing the relatively smooth fatigue fracture region

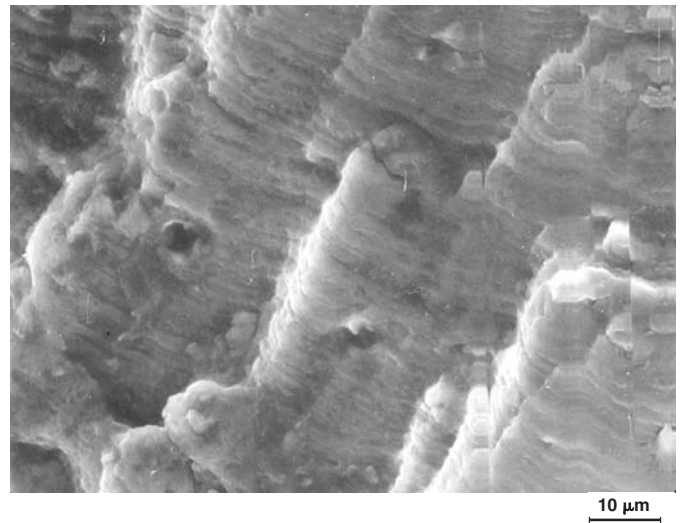
Fig. CH16.4 SEM fractograph showing fatigue striations in the region shown in Fig. CH16.3.

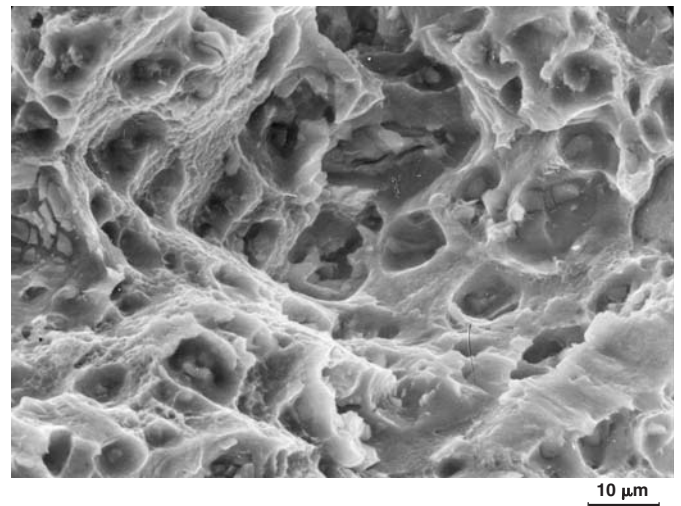
Fig. CH16.5 SEM fractograph of the rapid fracture region showing dimples characteristic of tensile overload failure

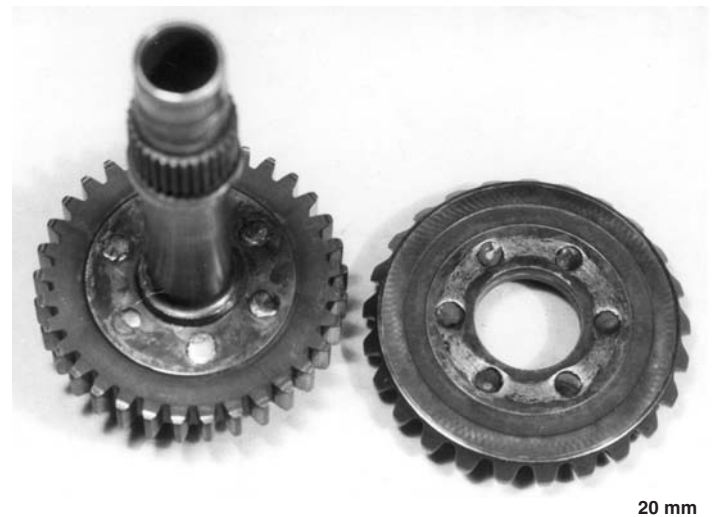
Fig. CH17.1 Bevel and spur gears with the failed dowel bolts

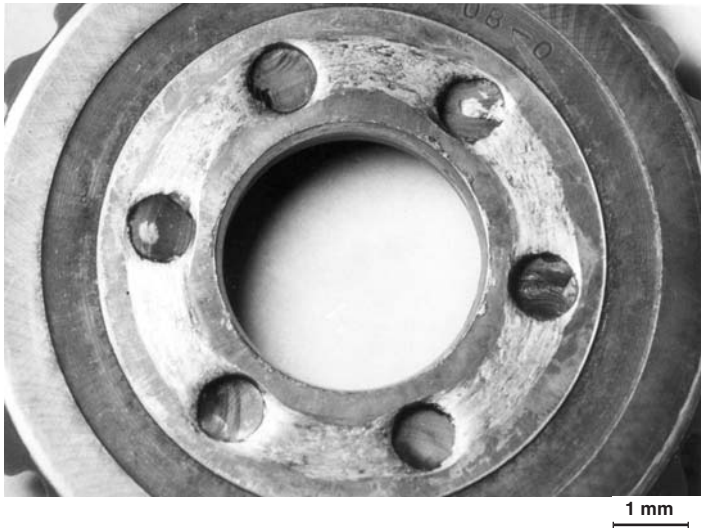
Fig. CH17.2 Failed bolts in the bevel gear

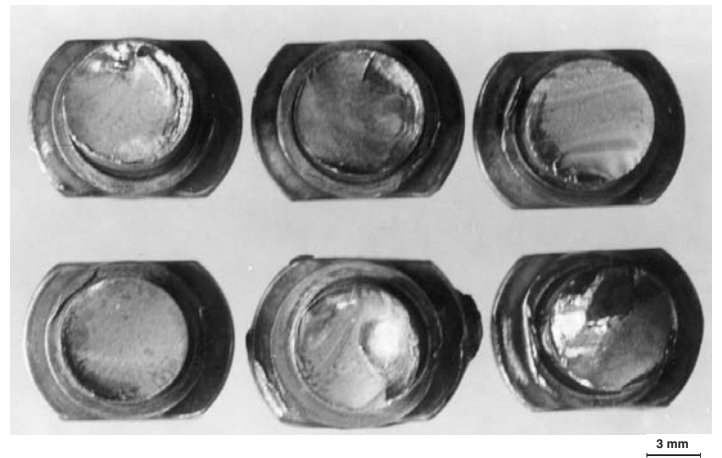
Fig. CH17.3 Fracture surfaces of the six failed bolts in the bevel gear

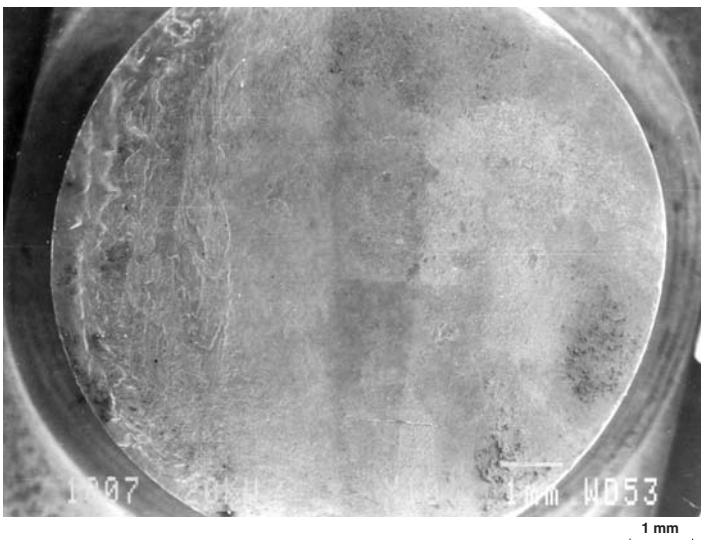
Fig. CH17.4 SEM fractograph showing crack initiation at the outer periphery and propagation inward

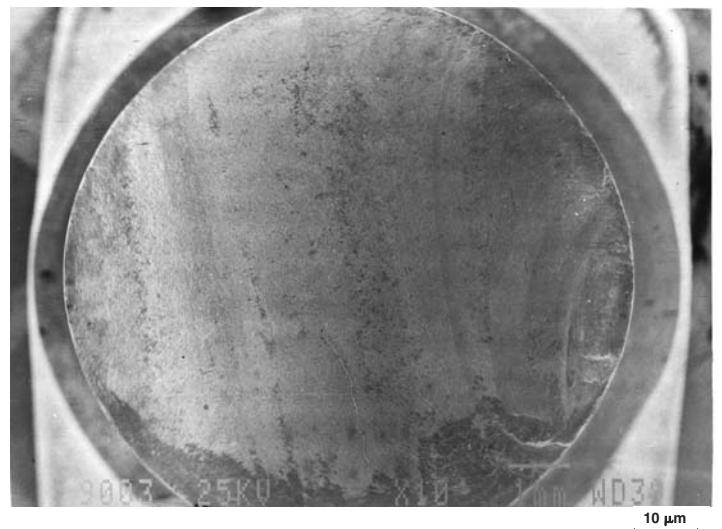
Fig. CH17.5 Two diametrically opposite fracture origins found in some bolts

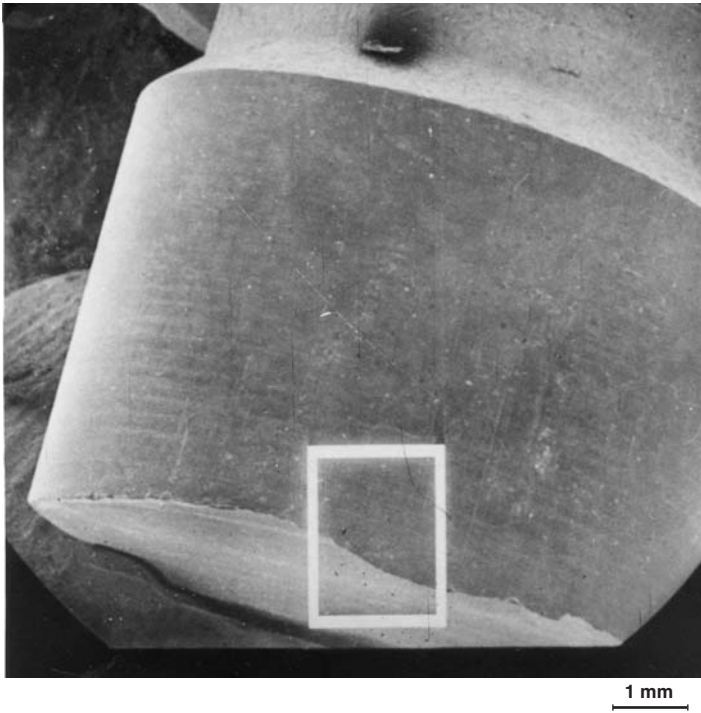
Fig. CH17.6 Circumferential grooves on the shanks of the bolts

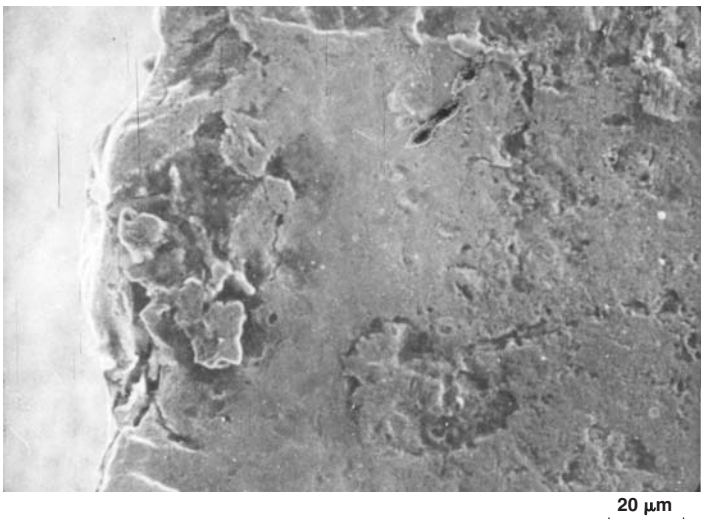
Fig. CH17.8 Fretting marks and debris at the fracture origin in some bolts

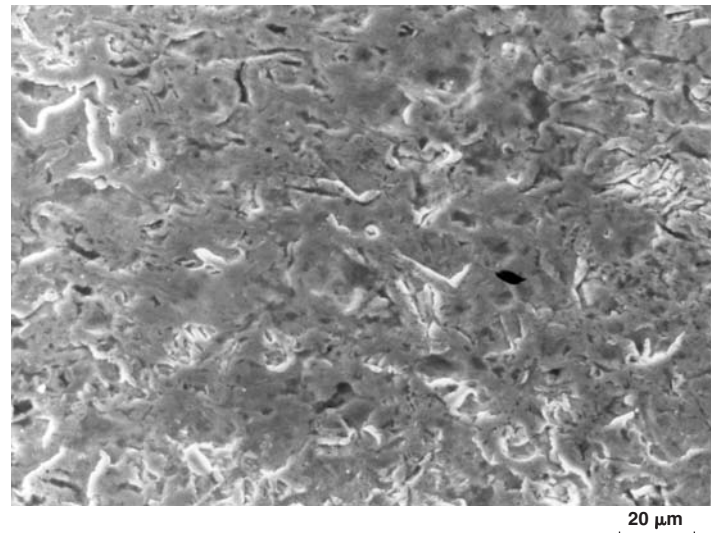
Fig. CH17.9 Wear marks in the bolt holes

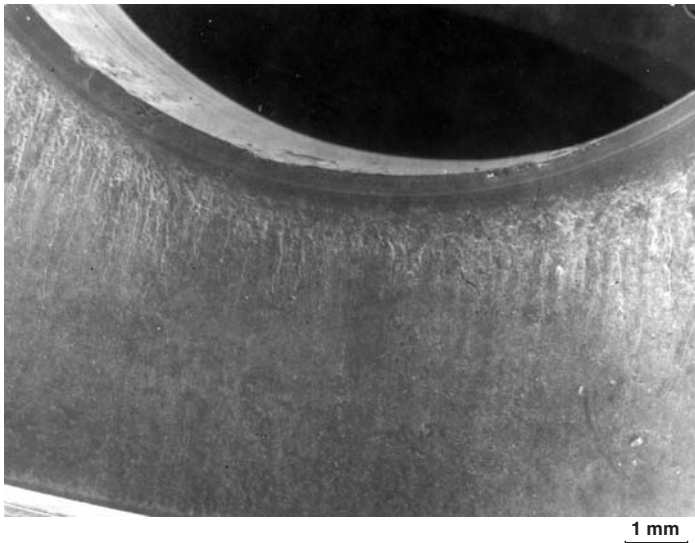
Fig. CH17.10 Marks resembling erosion tracks with the origin at the bolt hole

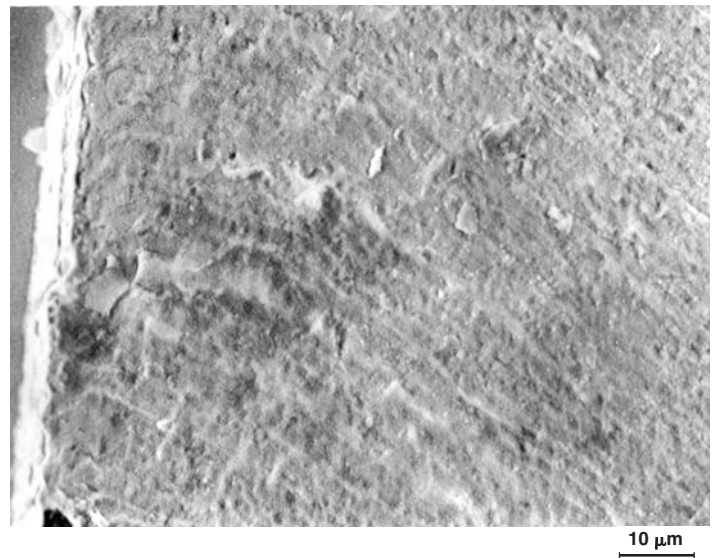
Fig. CH17.11 Fatigue striations in a failed bolt, at the fracture origin

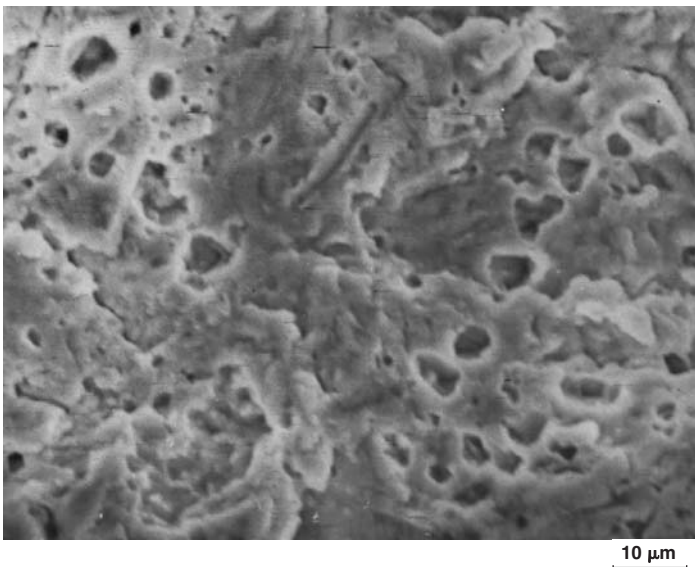
Fig. CH17.12 Dimple rupture at the central region of the fracture with double origins
