Failure Analysis of Engineering Structures

Methodology and Case Histories

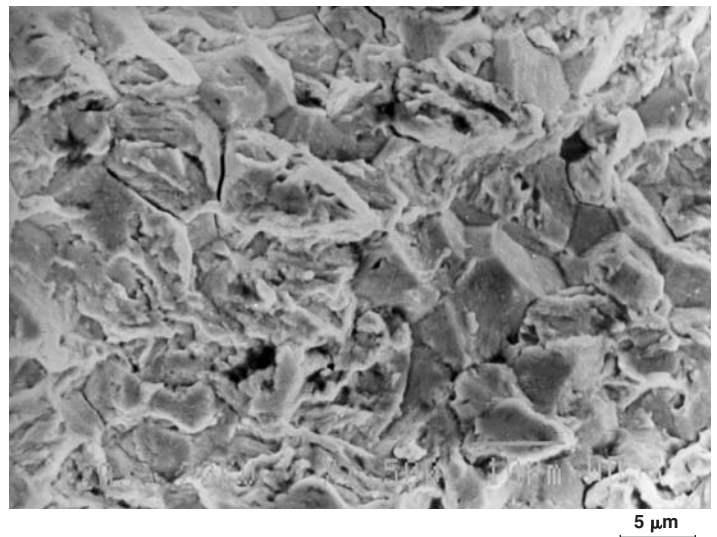
Fig. CH17.13 Mixed intercrystalline and transcrystalline fracture ahead of the beach marks in a bolt

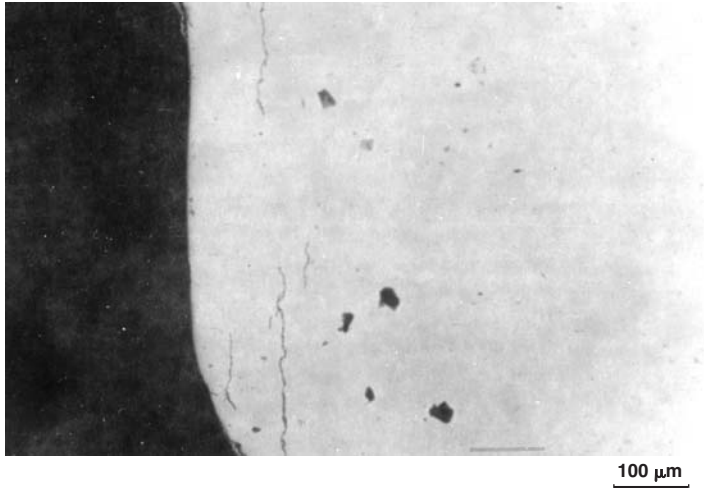
Fig. CH17.14 Cracks on the barrel surface of a failed bolt, close to the fracture surface, propagating in intercrystalline and transcrystalline modes

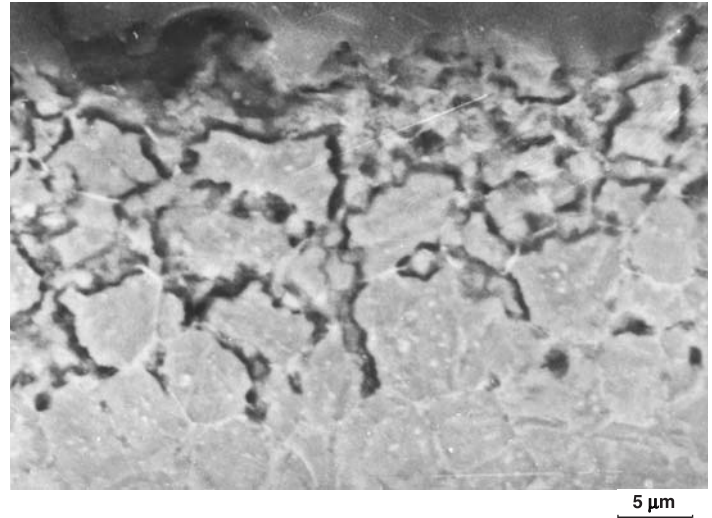
Fig. CH17.15 Intergranular oxidation on bolts chosen at random

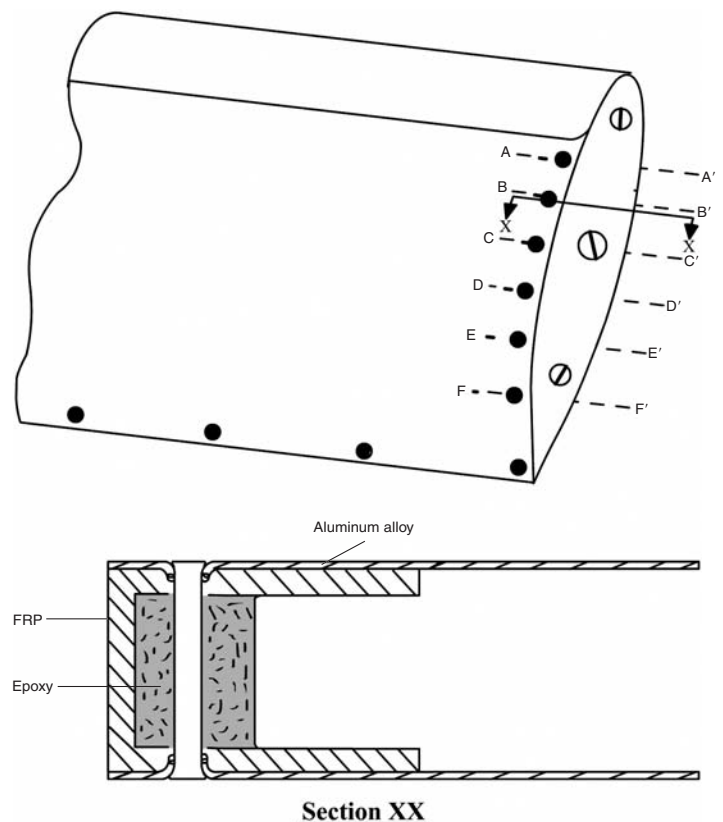
Fig. CH18.1 Sketch showing the fastening of the rib to the blade

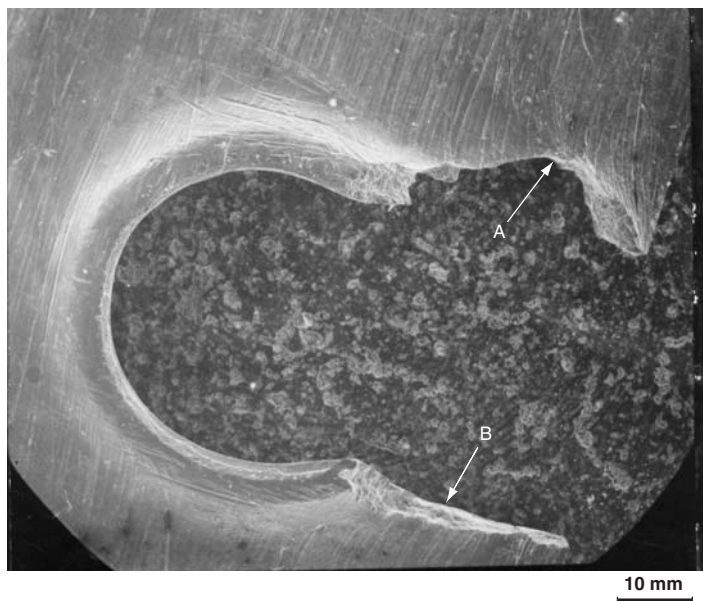
Fig. CH18.2 A typical tear in a rivet hole of a blade

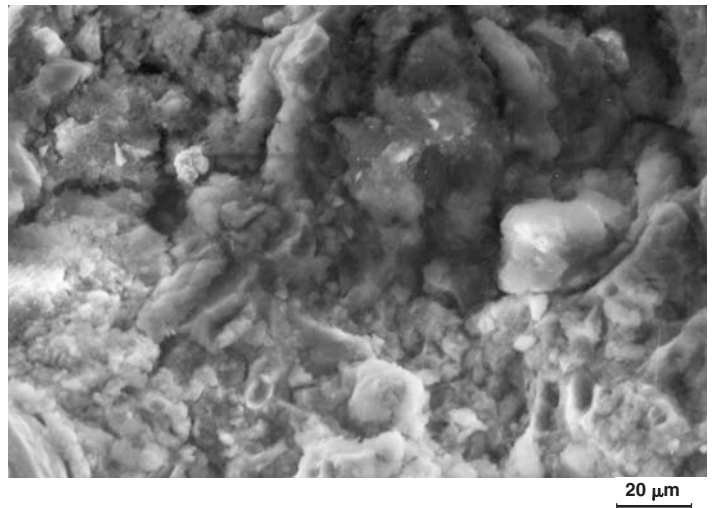
Fig. CH18.3 SEM fractograph showing corrosion products on the fracture surface A shown in Fig. CH18.2

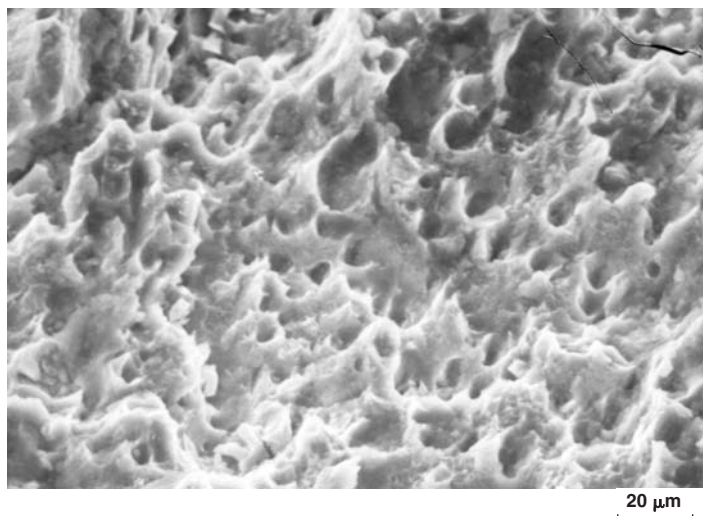
Fig. CH18.4 SEM fractograph showing ductile overload failure on the fracture surface B shown in Fig. CH18.2

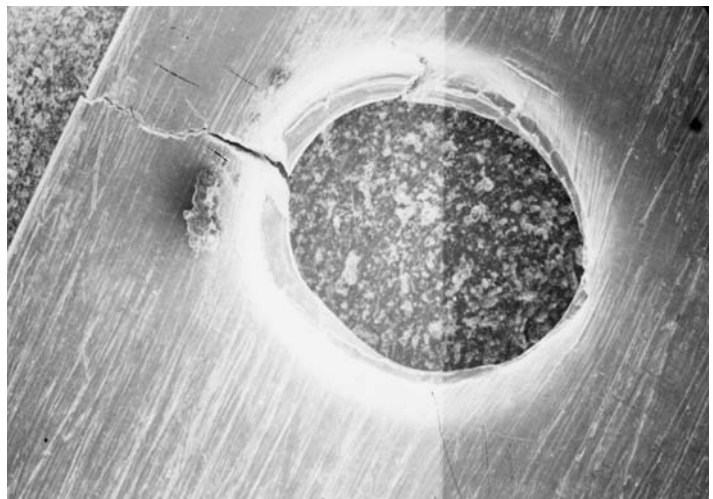
Fig. CH18.5 Cracks emanating from a rivet hole in a blade

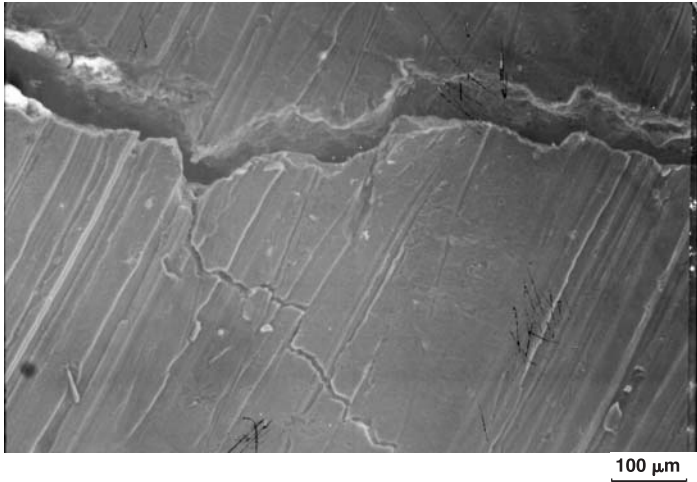
Fig. CH18.6 Magnified image of the larger crack in Fig. CH18.5

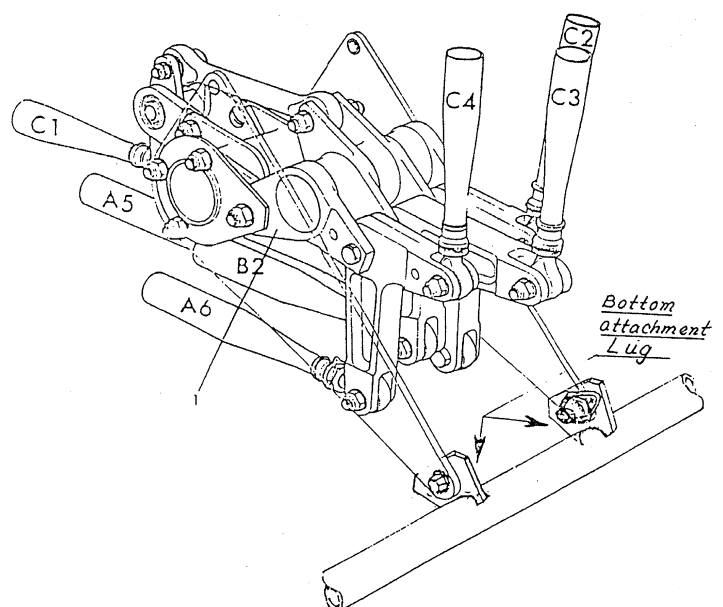
Fig. CH19.1 Tubular structure holding the two bottom lugs

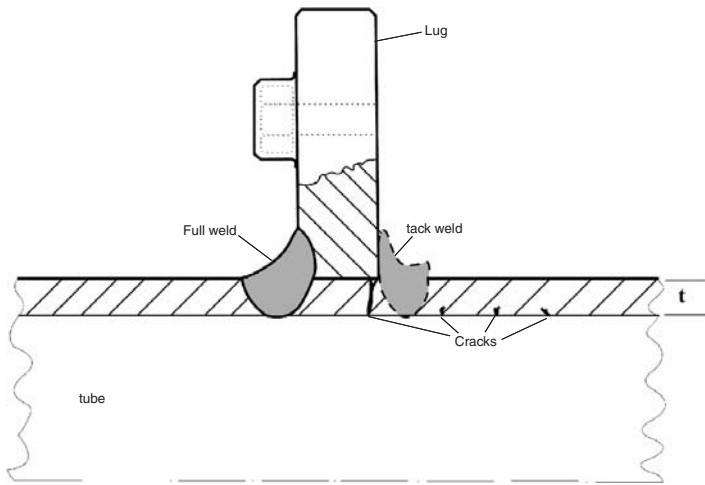
Fig. CH19.2 Sketch showing the location of the cracks on the tube

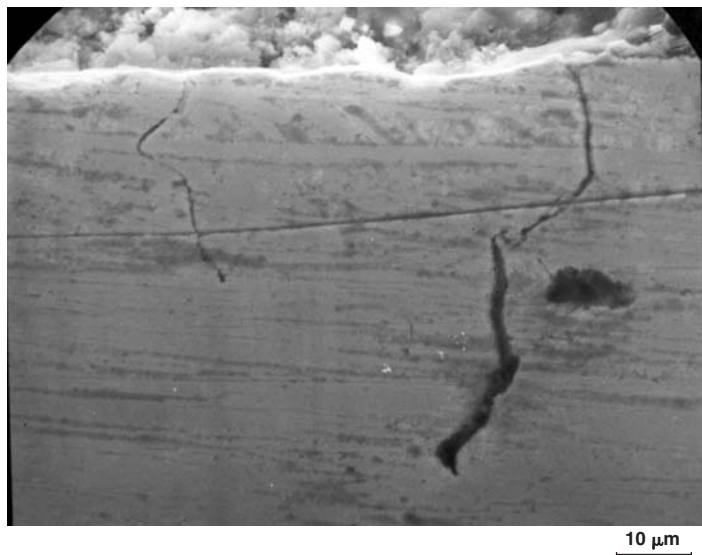
Fig. CH19.4 SEM photograph showing cracks in the tube wall

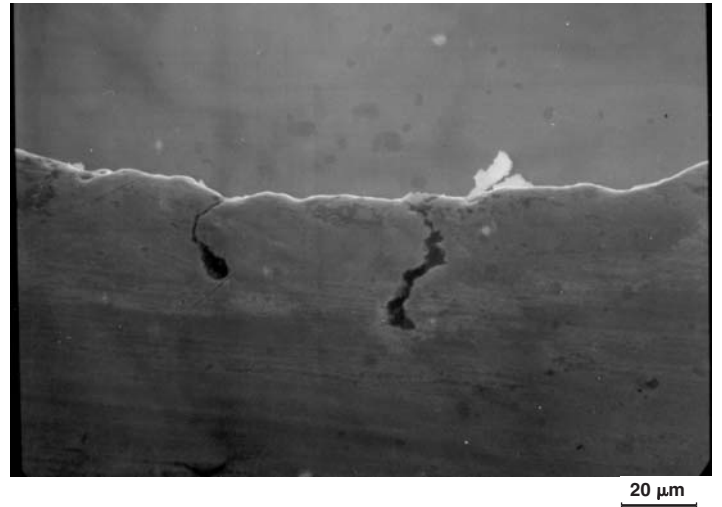
Fig. CH19.3 SEM photograph showing cracks in the tube wall

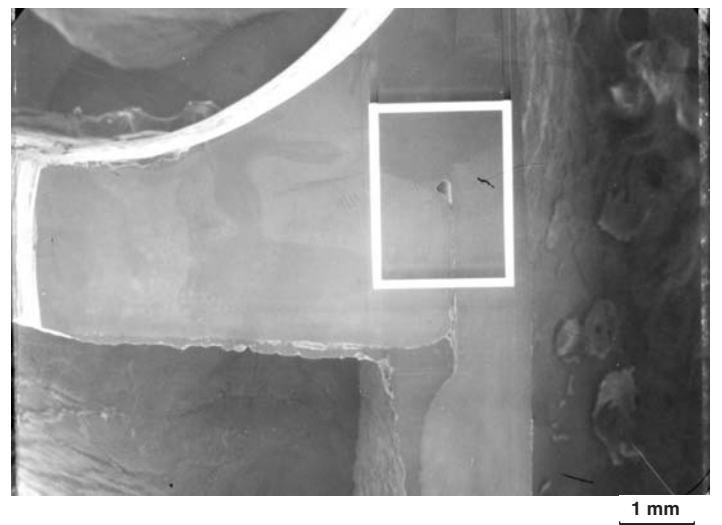
Fig. CH19.5 SEM photograph showing a crack emanating from the weld toe at the starboard lug

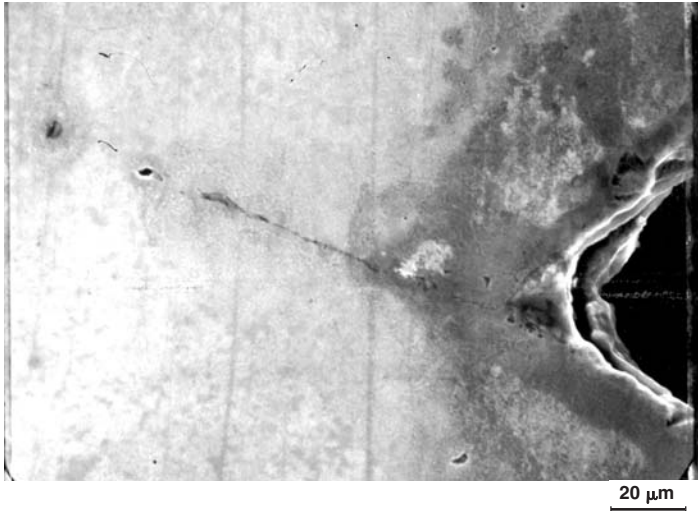
Fig. CH19.6 SEM photograph showing a crack emanating from the weld toe at the starboard lug

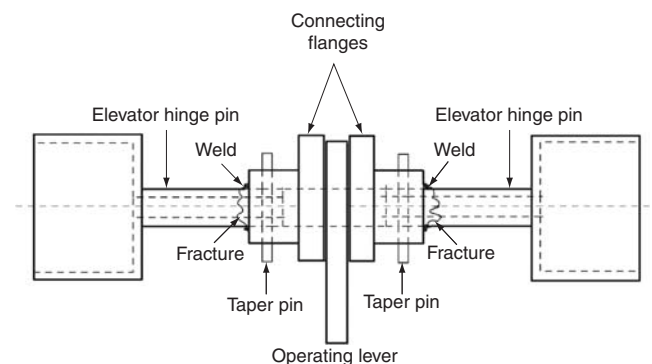
Fig. CH20.1 Schematic diagram of the elevator-hinge pin-connecting flange assembly

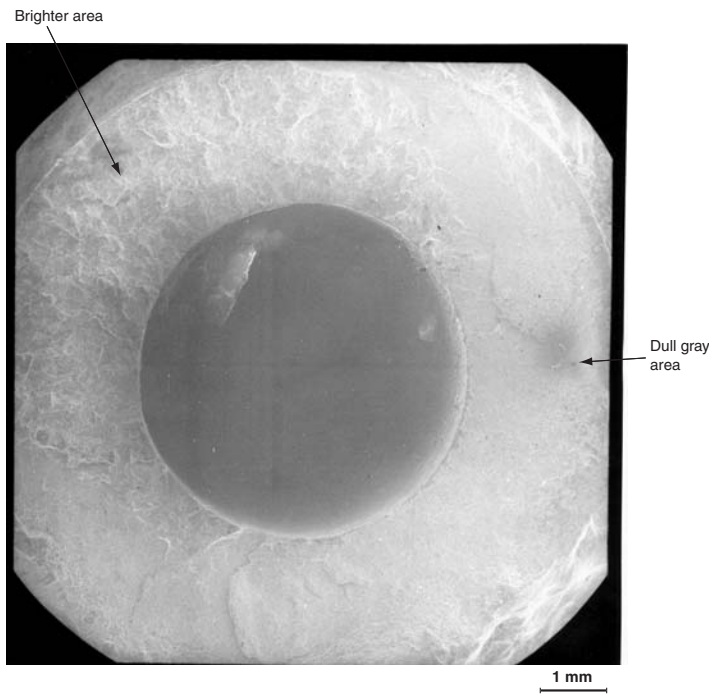
Fig. CH20.2 Fracture surface of the hinge pin

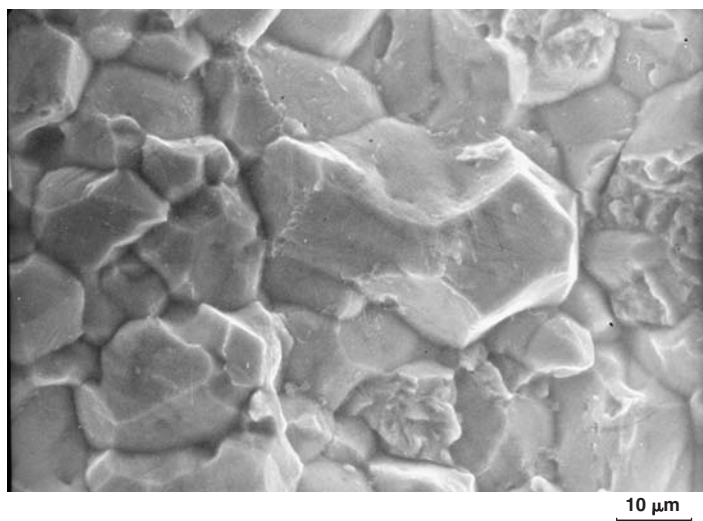
Fig. CH20.3 Intergranular fracture in the dull gray area shown in Fig. CH20.2

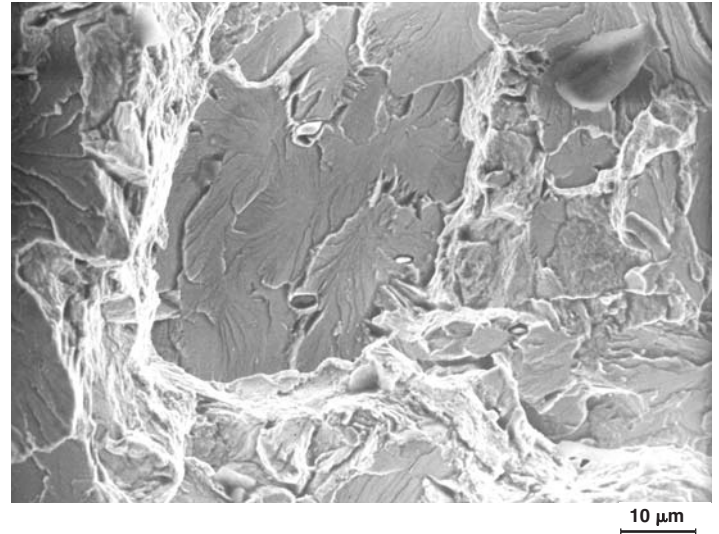
Fig. CH20.4 Brittle fracture features from the brighter area shown in Fig. CH20.2

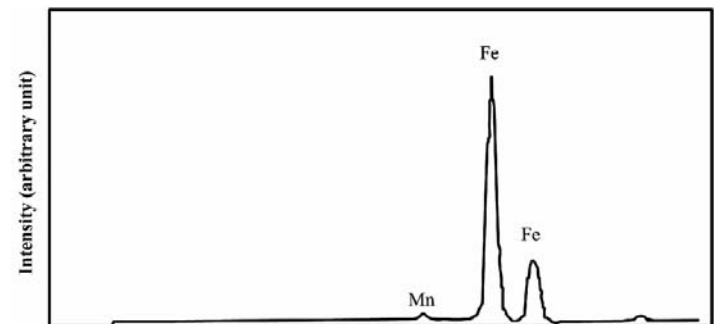
Fig. CH20.5 Energy spectrum and semiquantitative analysis of a failed hinge pin

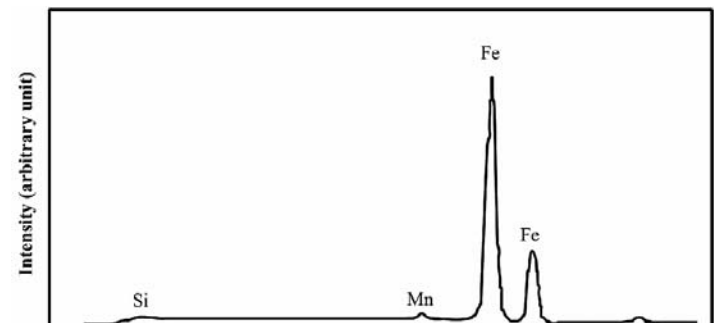
Fig. CH20.6 Energy spectrum and semiquantitative analysis of a connecting flange

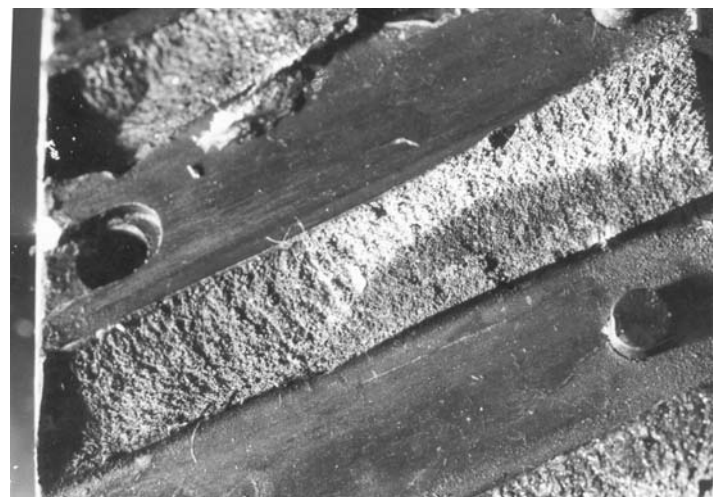
Fig. CH21.2 Close-up view of one of the fractured dovetails in rotor A showing regions of slow crack growth and rapid fracture

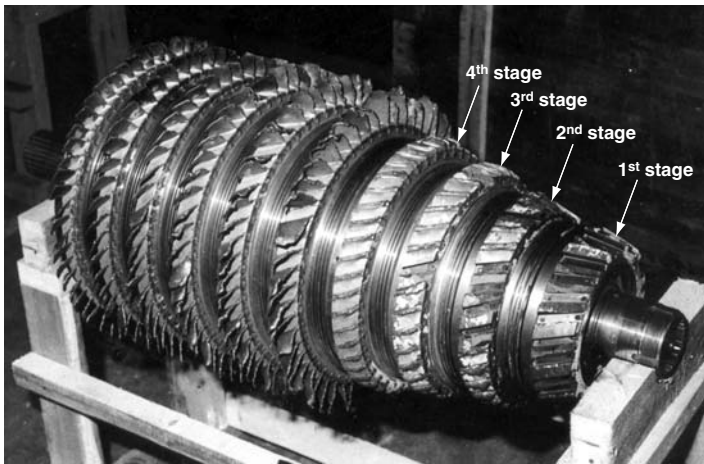
Fig. CH21.3 A view of compressor rotor B showing blades sheared in the first four stages

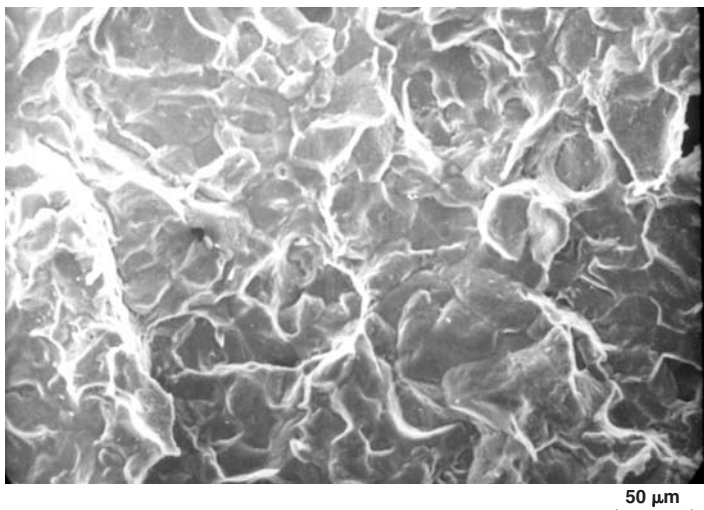
Fig. CH21.4 SEM fractograph showing intergranular fracture in the slow-crack-growth region

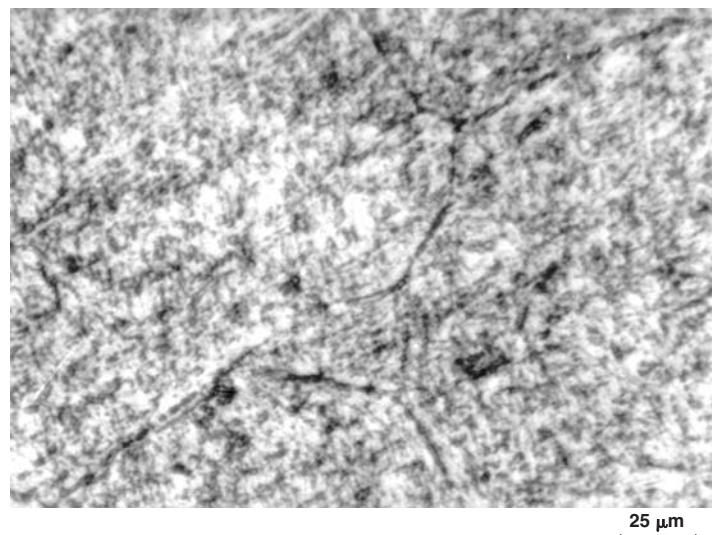
Fig. CH21.5 Microstructure of dovetail material showing tempered martensite with grain boundary carbide

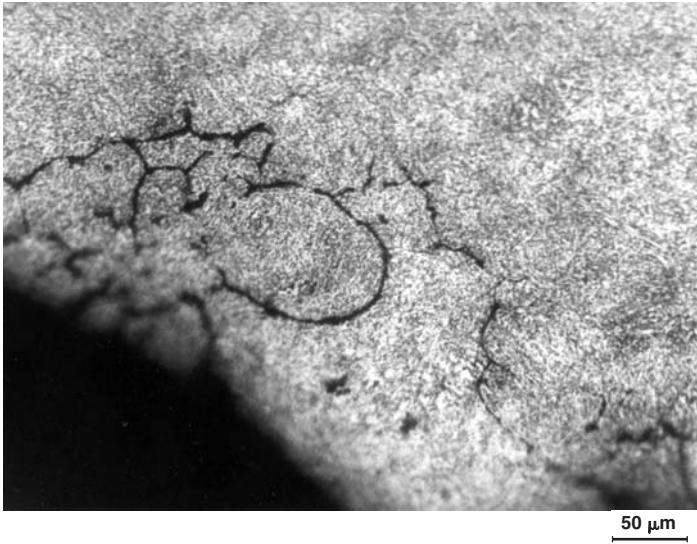
Fig. CH21.6 Intergranular branching cracks in the dovetail region

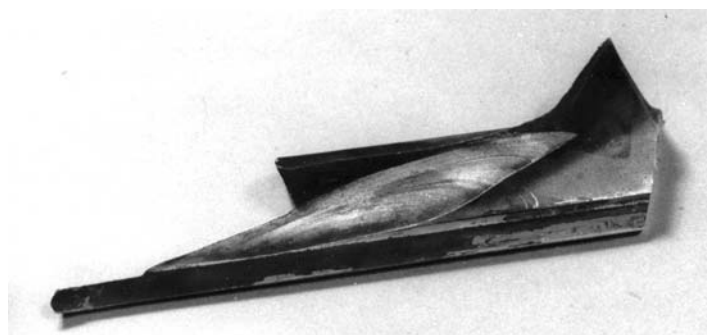
Fig. CH22.1 Failed compressor blade showing beach marks indicative of fatigue

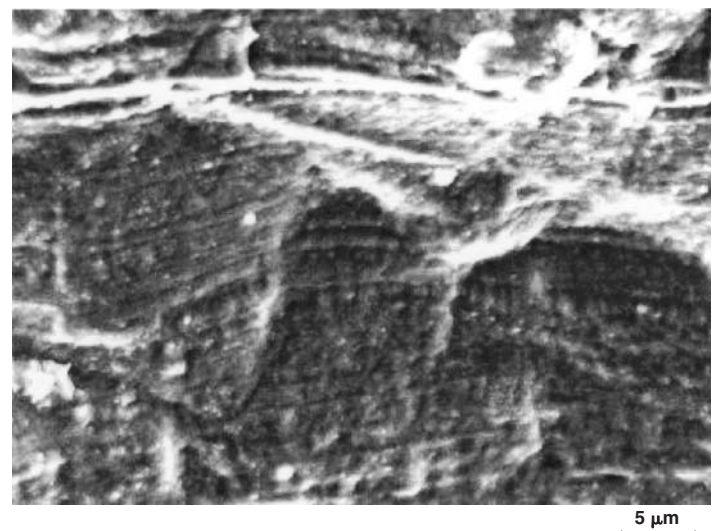
Fig. CH22.2 Striations typical of fatigue seen on the fracture surface

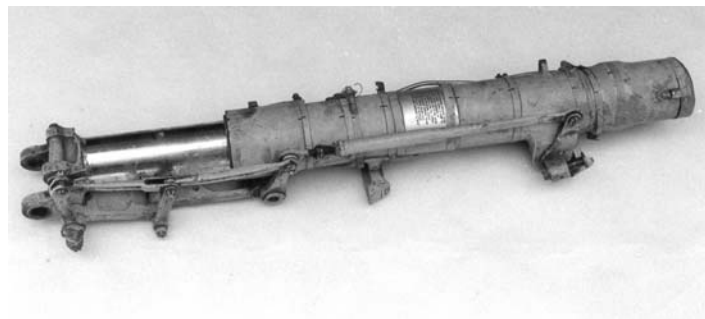
Fig. CH23.1 The fractured starboard strut

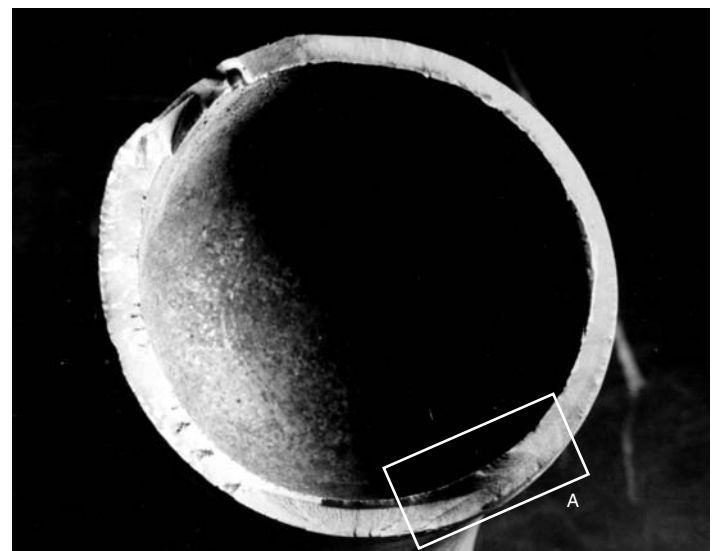
Fig. CH23.2 Fracture surface of the failed starboard strut

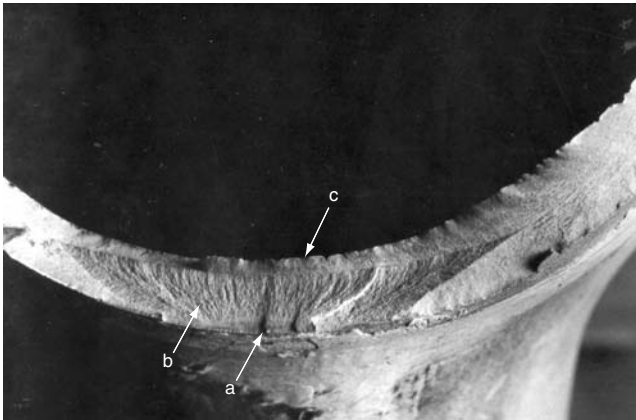
Fig. CH23.3 Close-up view of region A of Fig. CH23.2 showing three distinct zones: (a) half-moon-shaped region, (b) chevron marks, and (c) shear lip

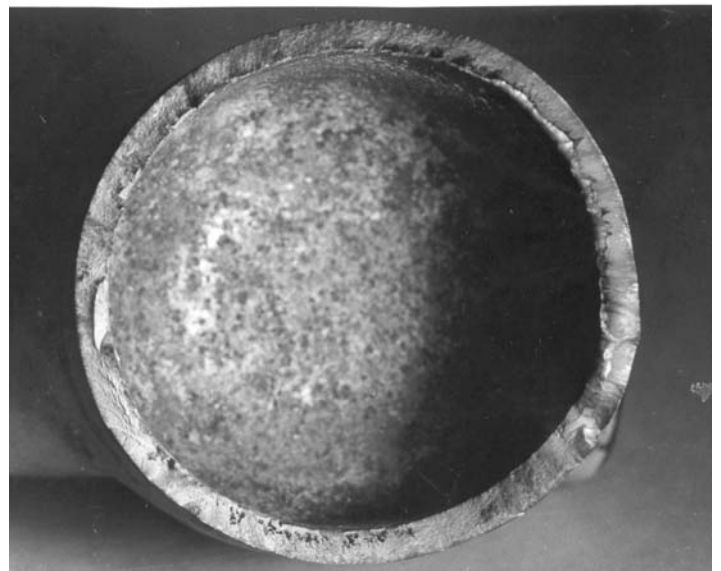
Fig. CH23.5 Fracture surface of the port side strut

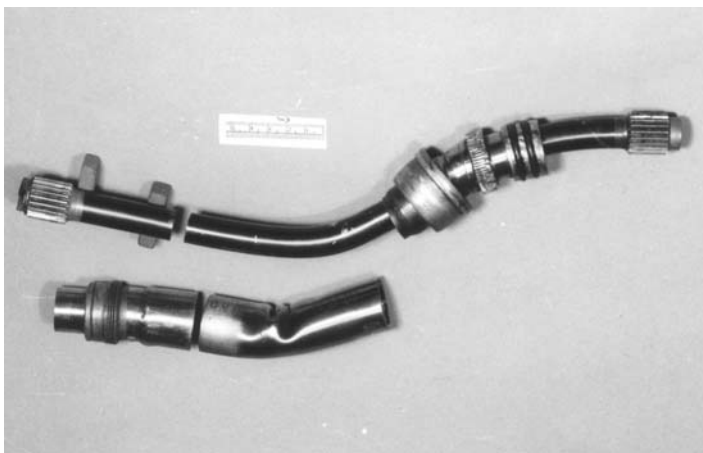
Fig. CH24.1 Broken quill shaft and damaged sleeve

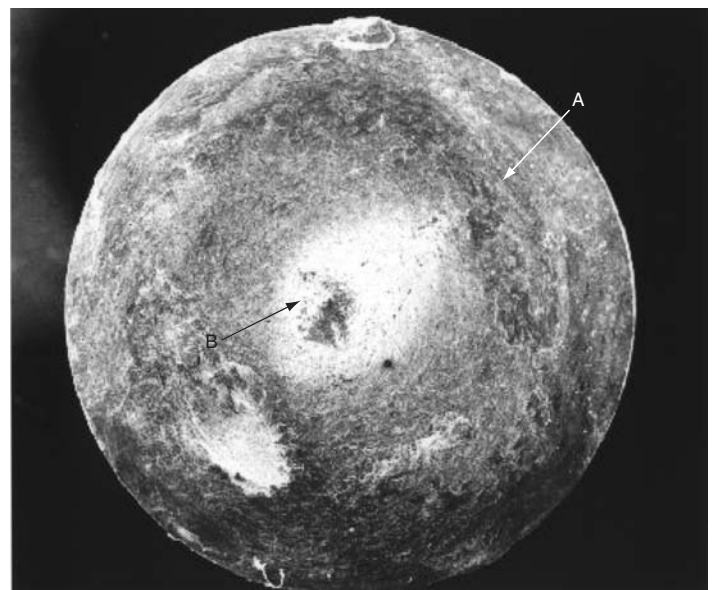
Fig. CH24.2 Fracture surface of the shaft

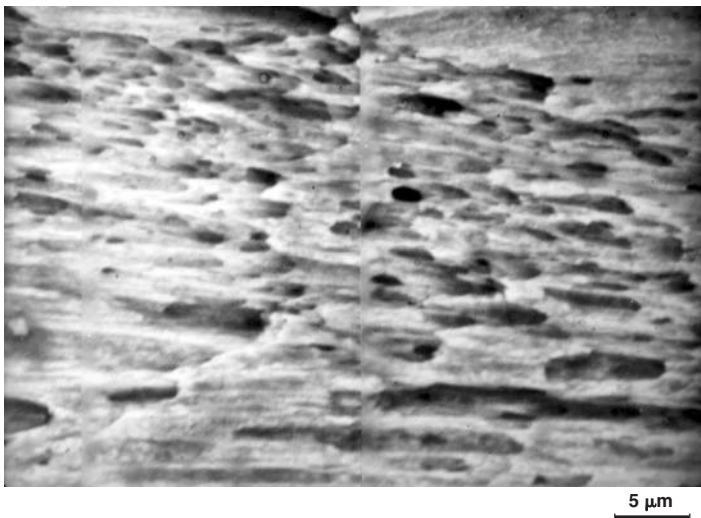
Fig. CH24.3 SEM fractograph showing elongated dimples in region A of Fig. CH24.2

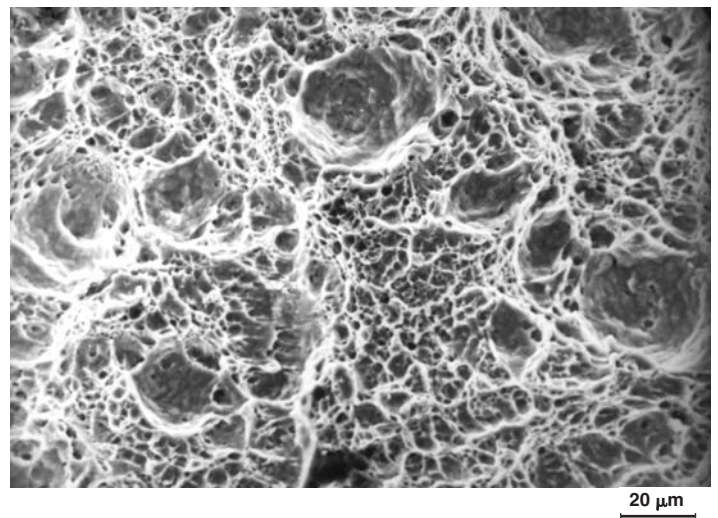
Fig. CH24.4 SEM fractograph showing equiaxed dimples in the final fracture region B of Fig. CH24.2

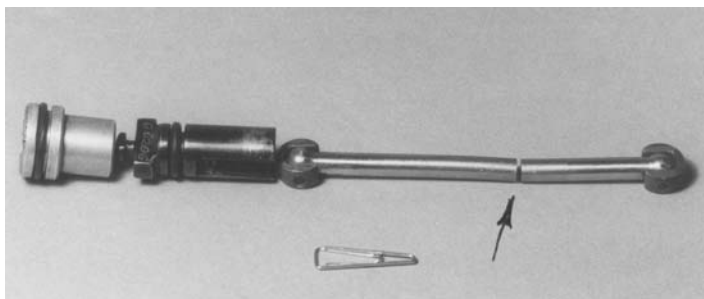
Fig. CH25.1 Failed shaft showing the location of fracture

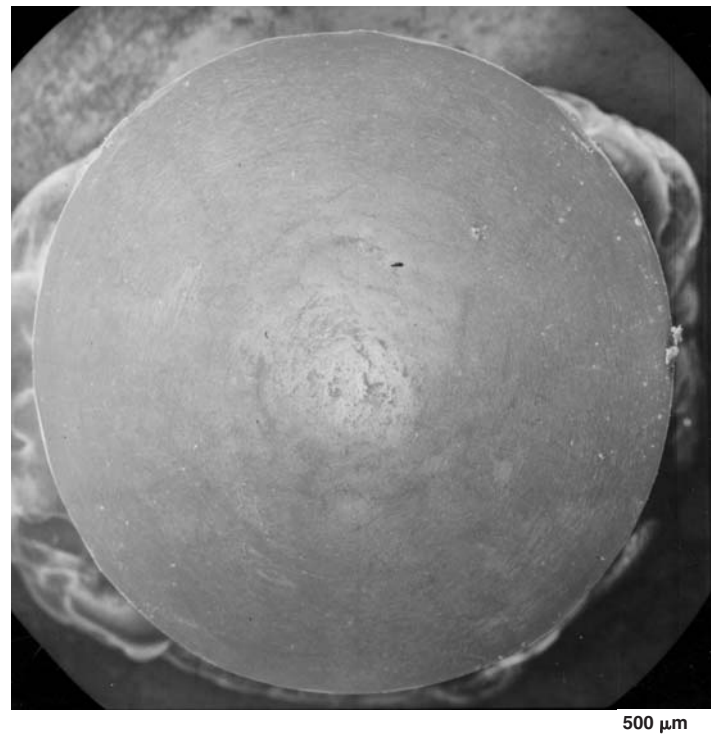
Fig. CH25.2 SEM fractograph showing features typical of torsional overload

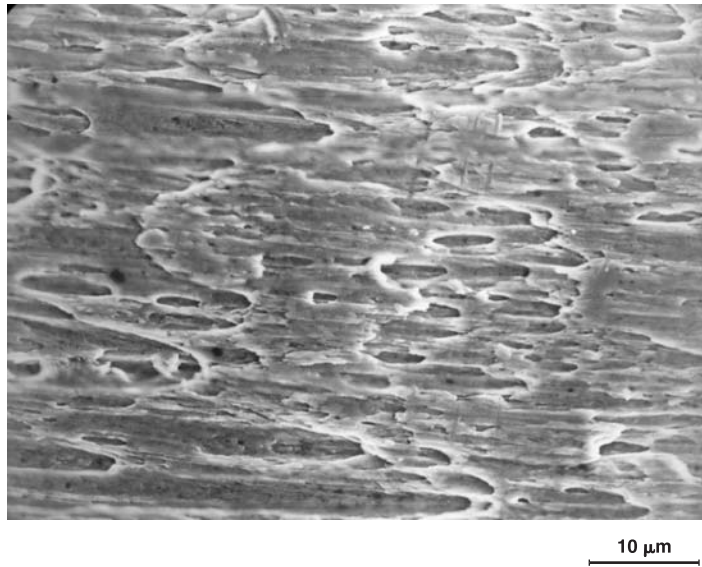
Fig. CH25.3 Elongated dimples with rub marks seen at the periphery of the fracture surface

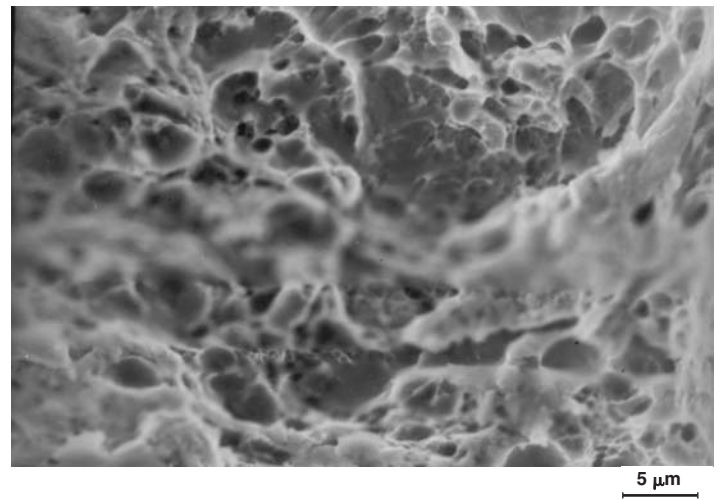
Fig. CH25.4 Equiaxed dimples seen at the center of the shaft corresponding with the region of final fracture

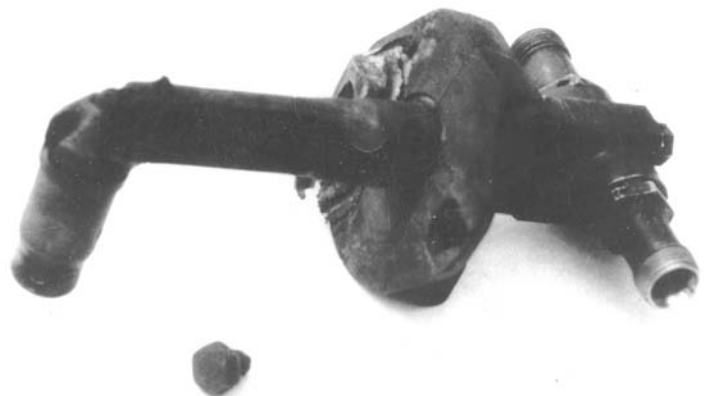
Fig. CH26.1 Damaged fuel nozzle

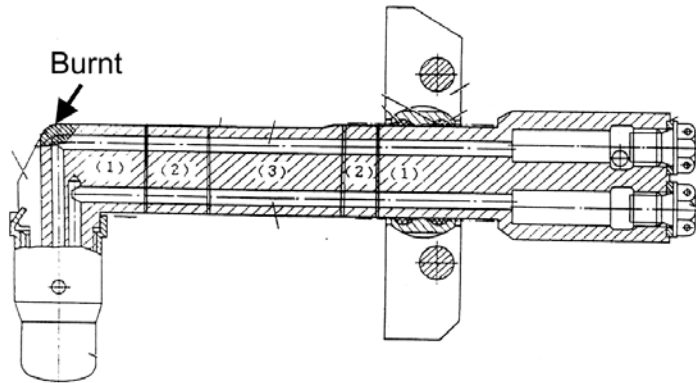
Fig. CH26.2 Sketch of the nozzle assembly showing zone 1, Widmanstätten/basket weave microstructure (hardness, 320 HV); zone 2, spheroidized microstructure (hardness, 410 HV); and zone 3, martensitic microstructure (hardness, 520 HV)

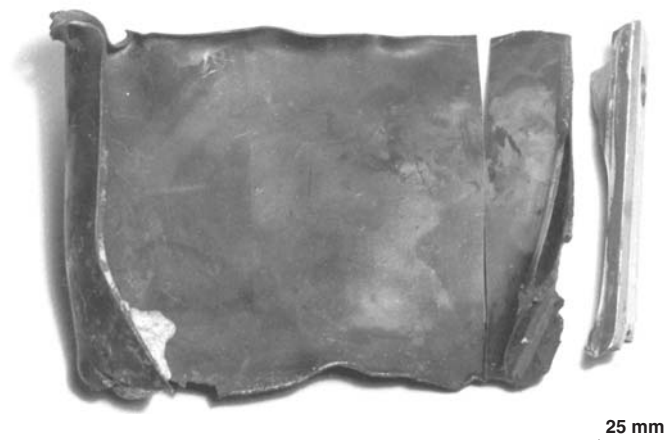
Fig. CH27.1 Failed first-stage compressor blade

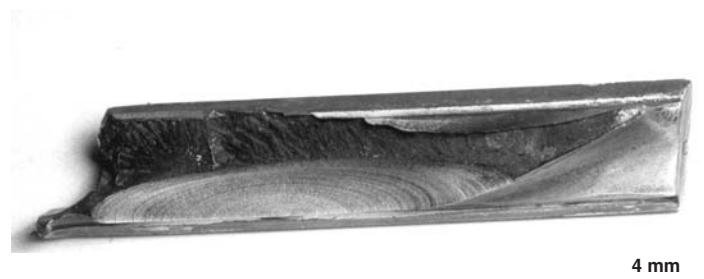
Fig. CH27.2 Fracture surface of the blade showing two distinct regions

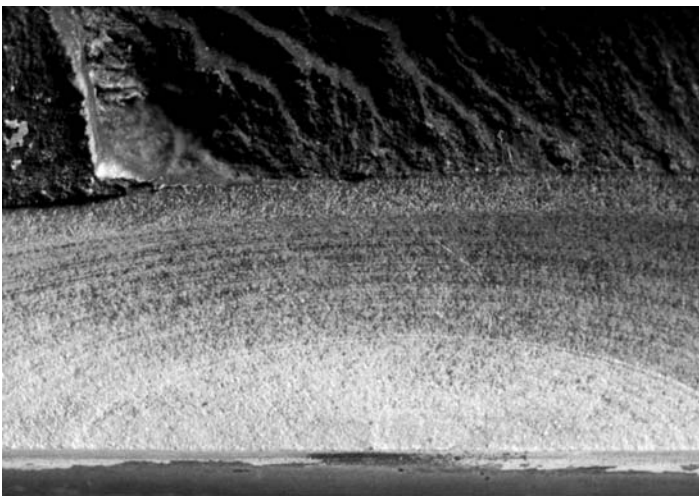
Fig. CH27.3 Beach marks in the smooth region, typical of fatigue

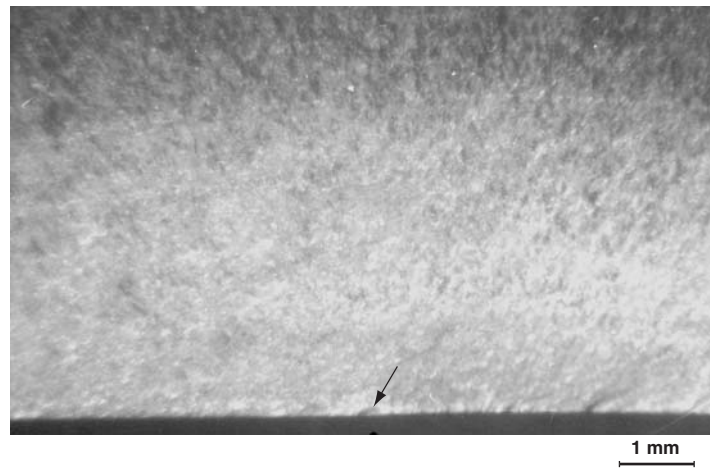
Fig. CH27.4 Corrosion pit seen at the region of fracture origin

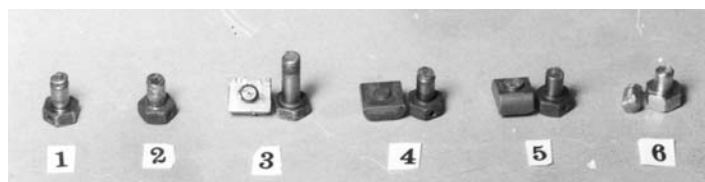
Fig. CH28.1 Failed bolts in the as-received condition, marked 1 to 6

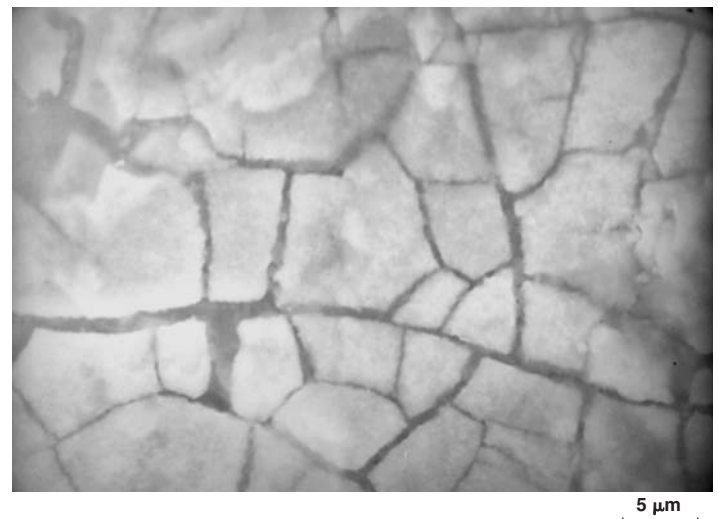
Fig. CH28.2 Fracture surface of bolt No. 2 showing mud cracks

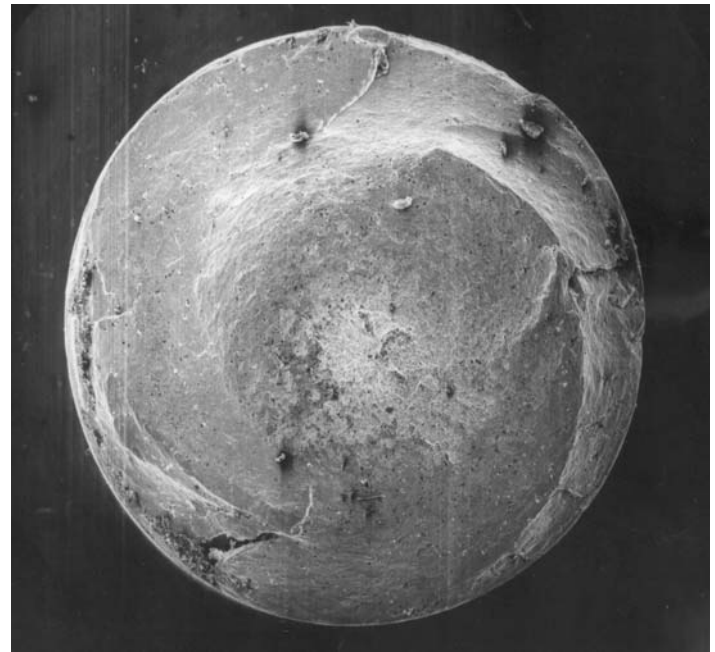
Bolts 1 to 5 failed by SCC, and the new bolt by torsional overload.

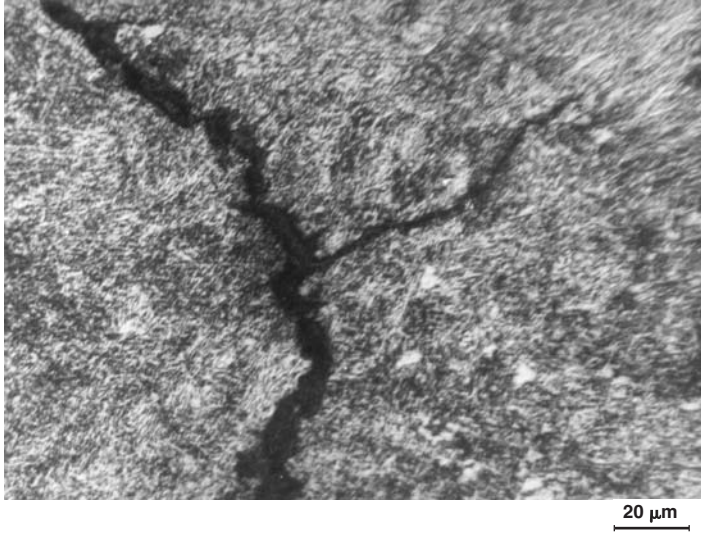
Fig. CH28.5 Branching cracks close to the fracture surface seen in bolt No. 2

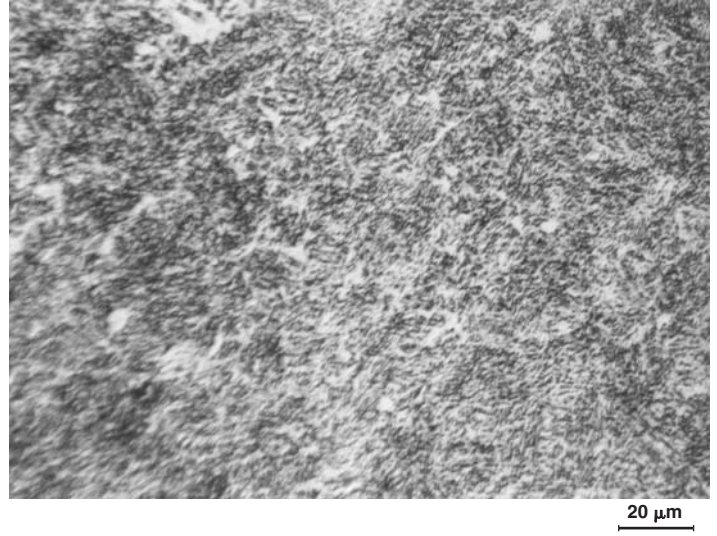
Fig. CH28.6 Microstructure of the bolt material showing tempered martensite with partial spheroidization

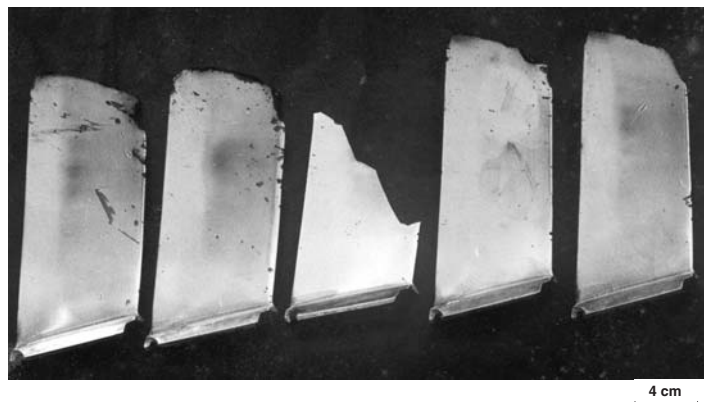
Fig. CH29.1 Second-stage compressor blade failed in an engine, along with the adjacent blades

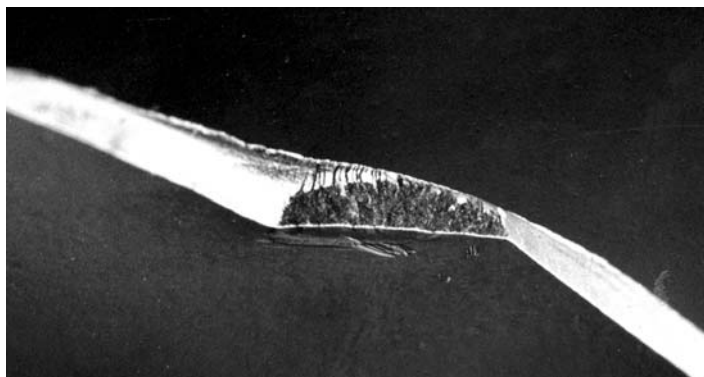
Fig. CH29.2 Close-up view of the discolored area on the fracture surface of the failed blade

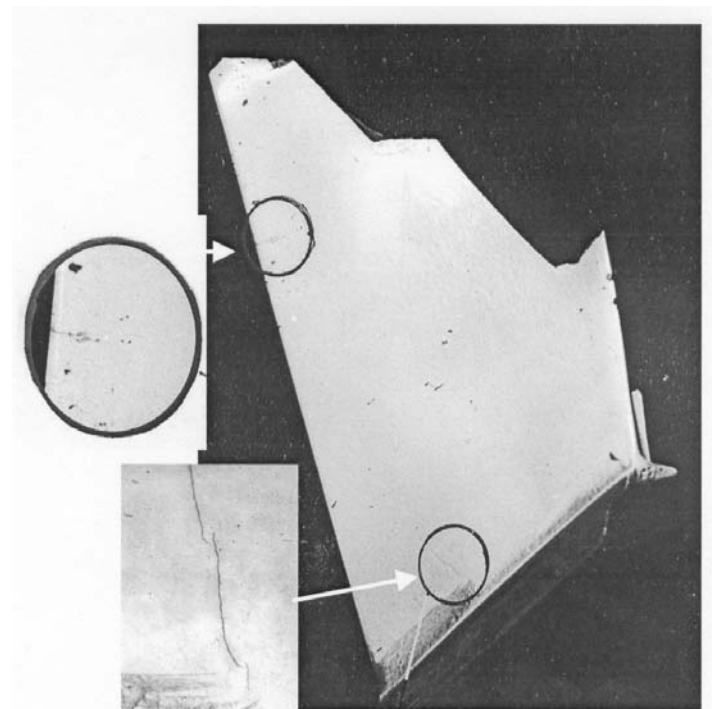
Fig. CH29.3 Cracks in other areas of the failed blade. Insets show enlarged areas of some of these cracks.

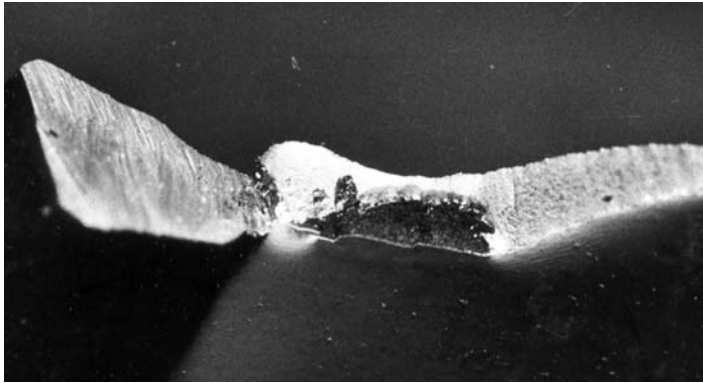
Fig. CH29.4 Crack shown in Fig. CH29.3 opened up. The discoloration is similar to that noticed on the fracture surface of the failed blade.

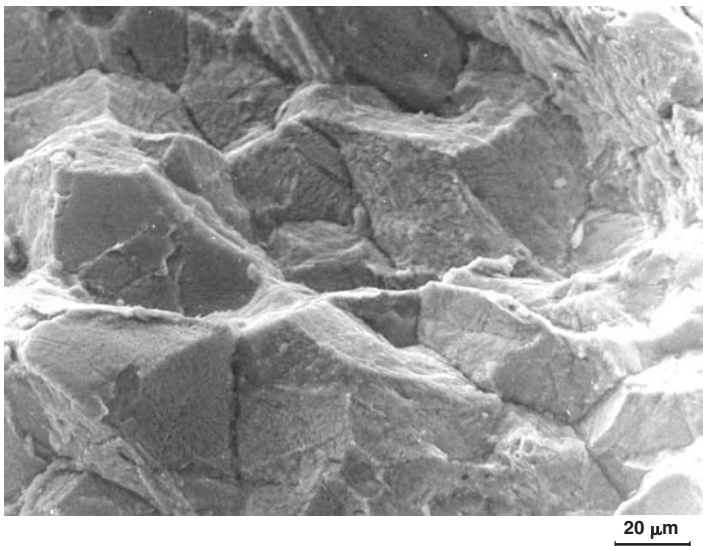
Fig. CH29.5 SEM fractograph showing the intergranular cracking in the dark brown region in the failed blade

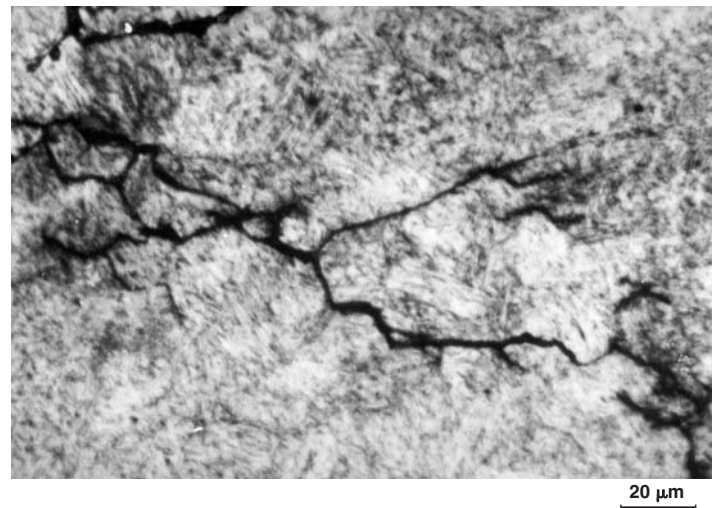
Fig. CH29.6 Optical micrograph of the cracks noticed on the blade surface

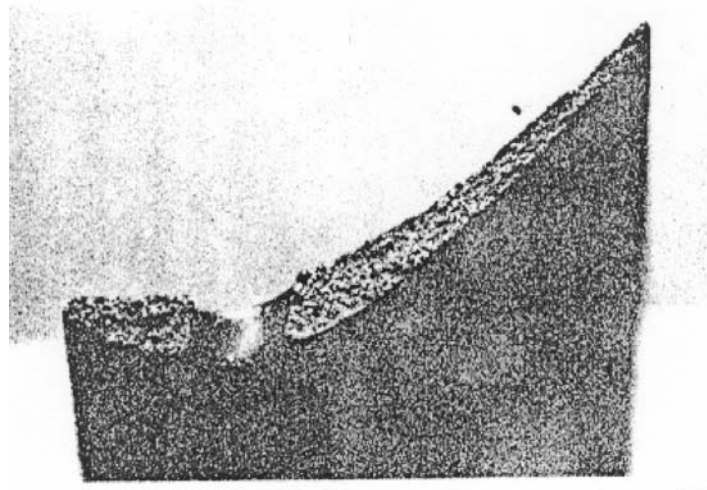
Fig. CH30.1 Fracture surface of failed blade

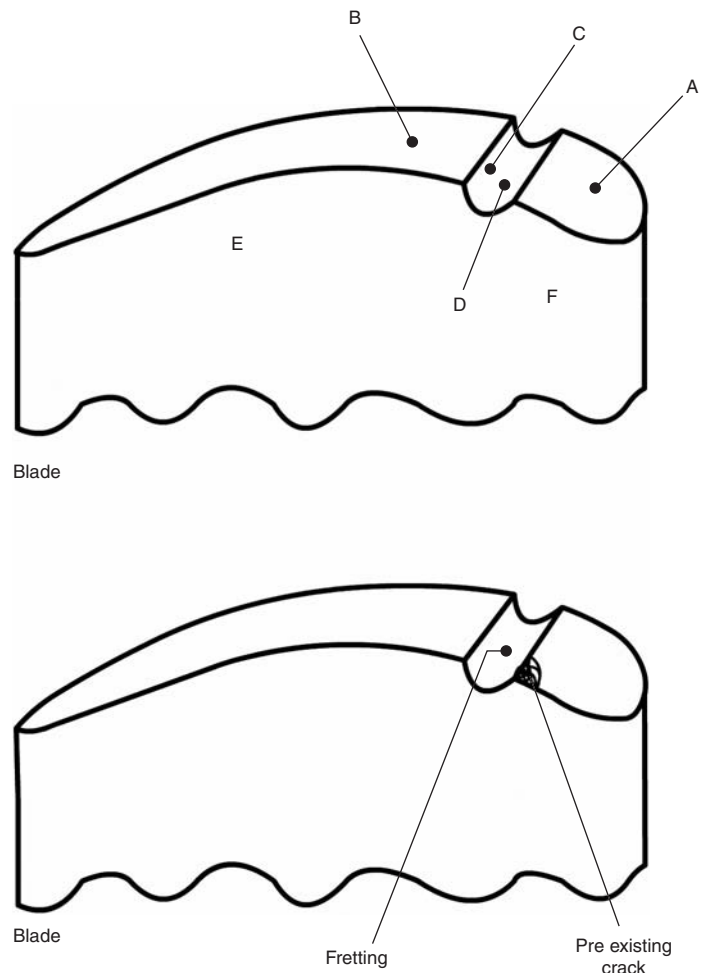
Fig. CH30.2 Schematic representation of fracture in the failed blade

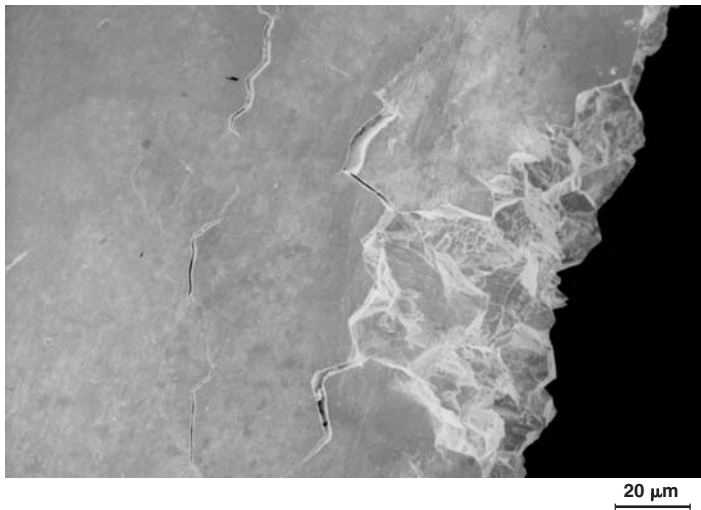
Fig. CH30.3 Cracks and deformation in region E (Fig. CH30.2)

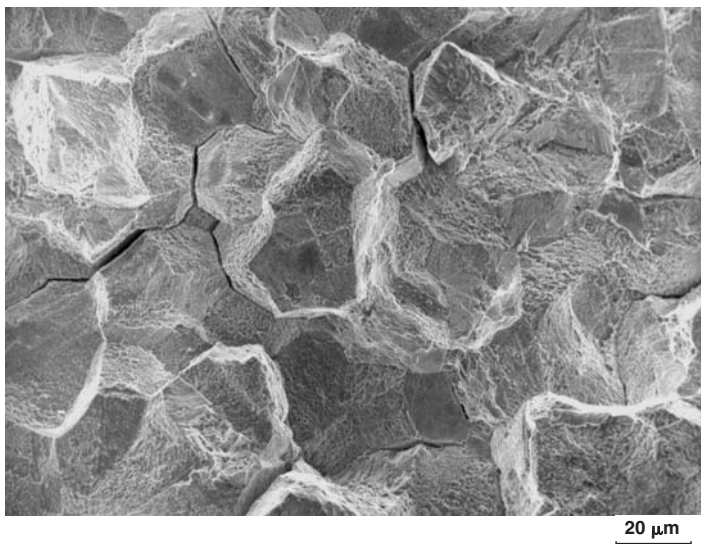
Fig. CH30.4 SEM fractograph of the failed blade, showing intergranular fracture
