Failure Analysis of Engineering Structures

Methodology and Case Histories

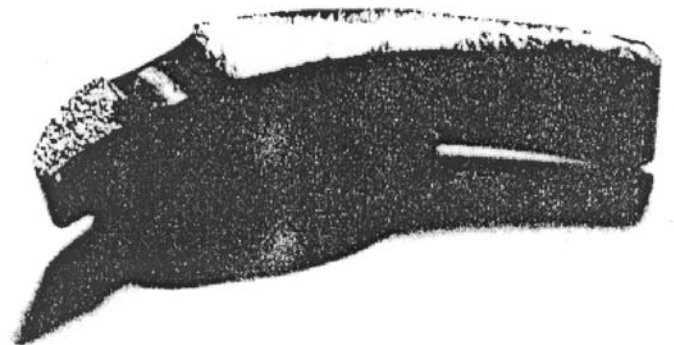
Fig. CH30.5 Preexisting crack (dark region) in one adjacent blade after opening

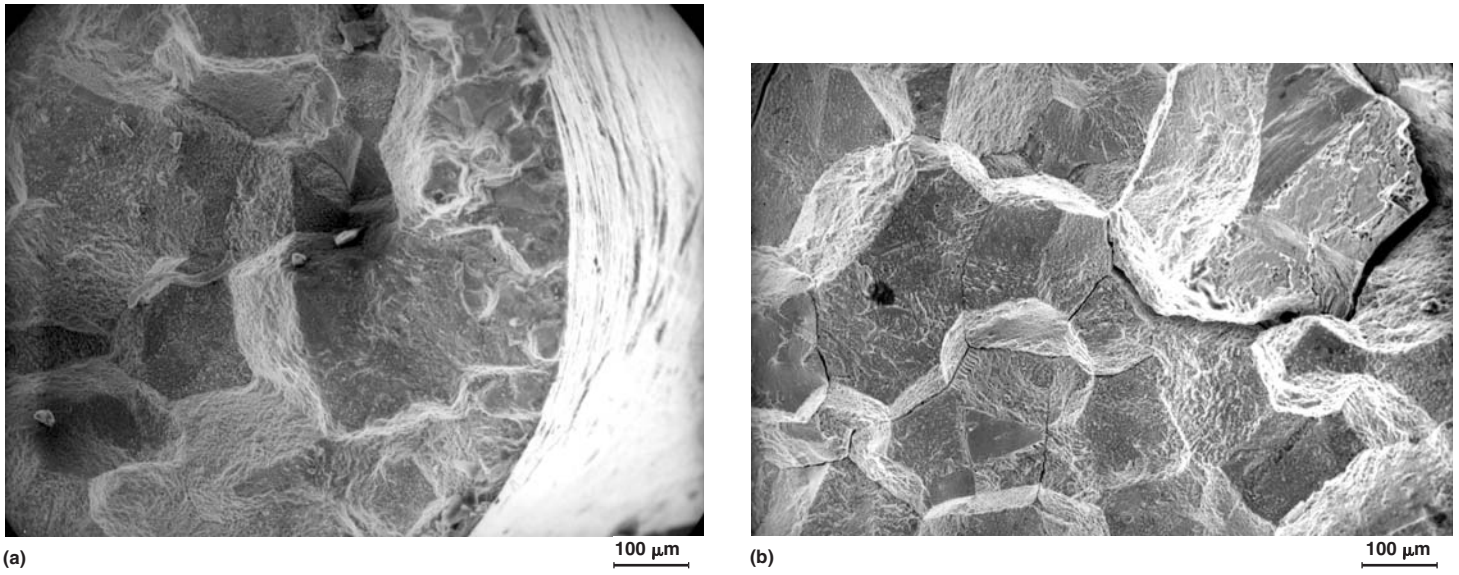
Fig. CH30.6 (a) SEM fractograph at the origin of the preexisting crack (dark region) shown in Fig. CH30.5. (b) SEM fractograph, taken slightly inward within the dark region

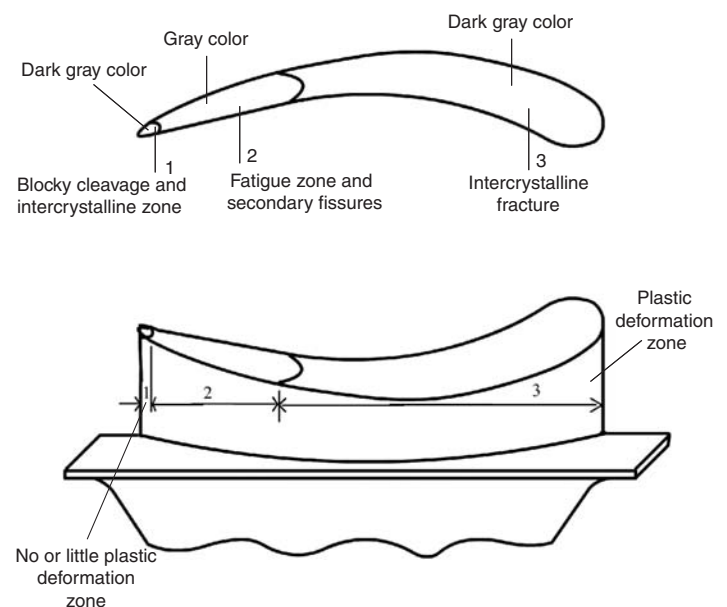
Fig. CH31.1 Sketch showing the zones in the failed turbine blade

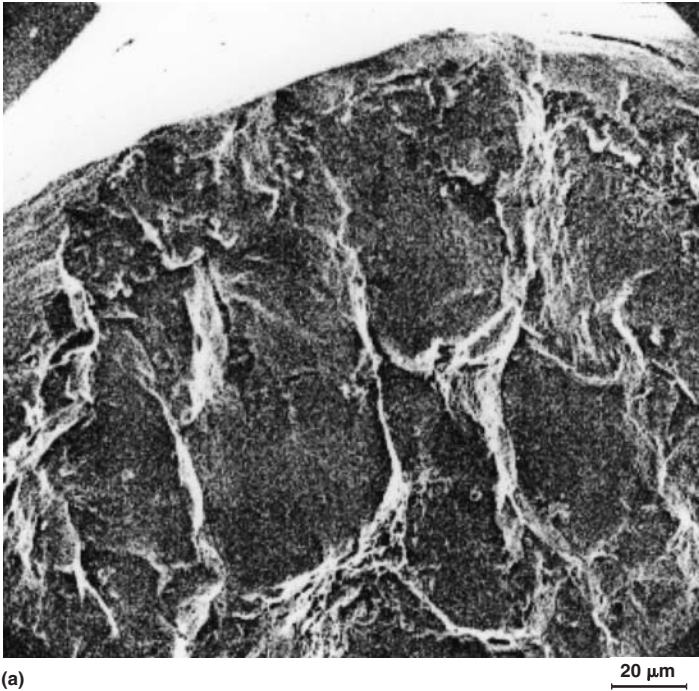
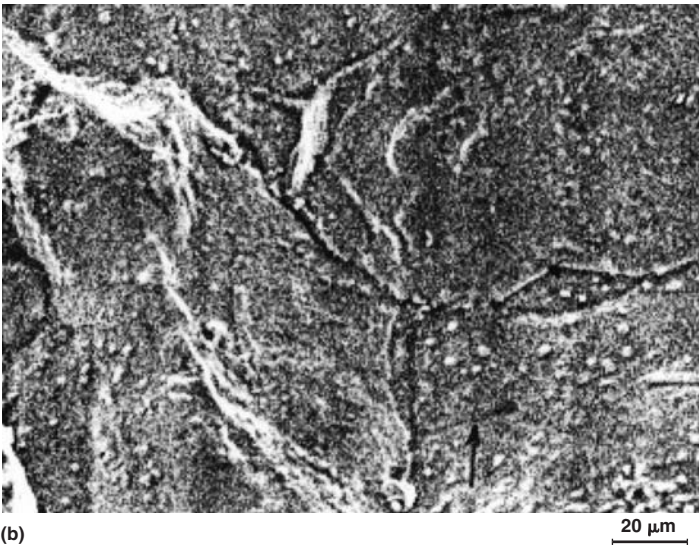
Fig. CH31.2 (a) SEM fractograph of trailing edge tip in region 1. (b) SEM fractograph showing crack within the blade, indicated by arrow

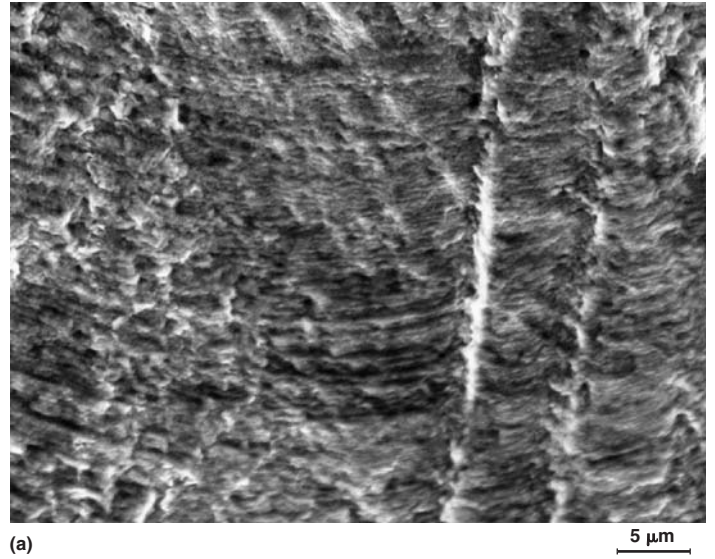
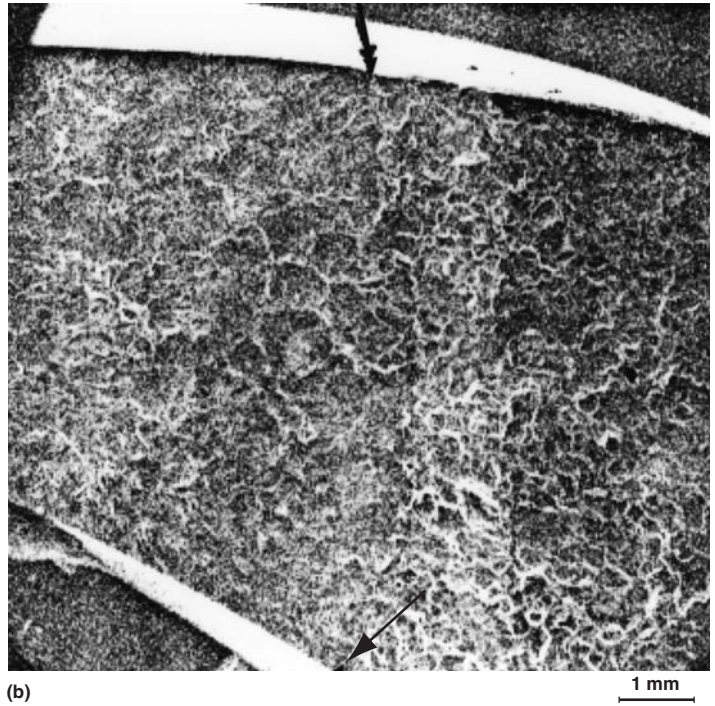
Fig. CH31.3 (a) SEM fractograph showing low-cycle fatigue striations in zone 2. (b) SEM fractograph showing the transition from fatigue to intercrystalline fracture. Arrows indicate the transition.

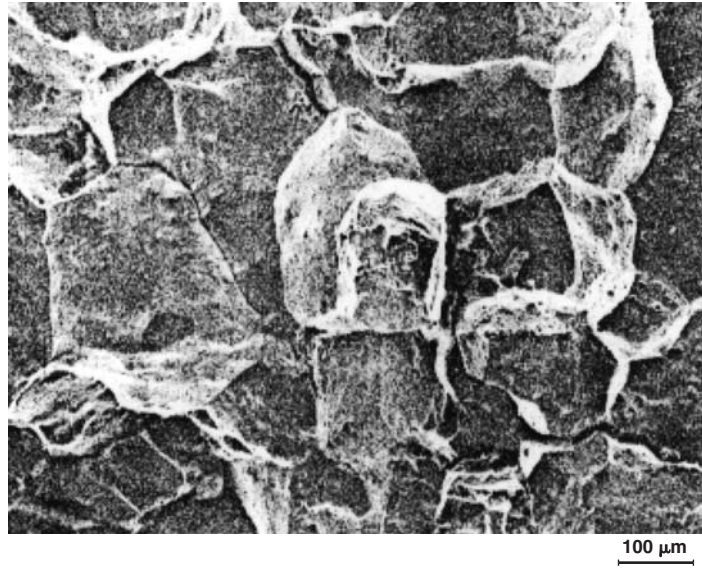
Fig. CH31.4 SEM fractograph of region 3 showing intercrystalline mode of fracture

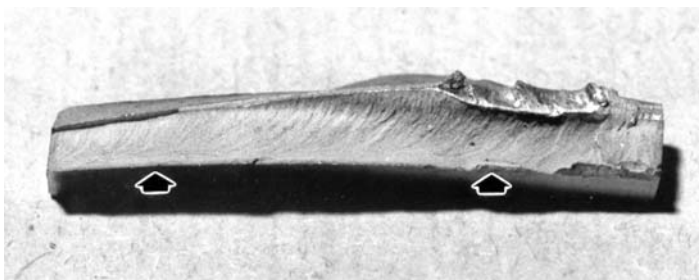
Fig. CH32.1 Fracture surface of the blade showing chevron marks

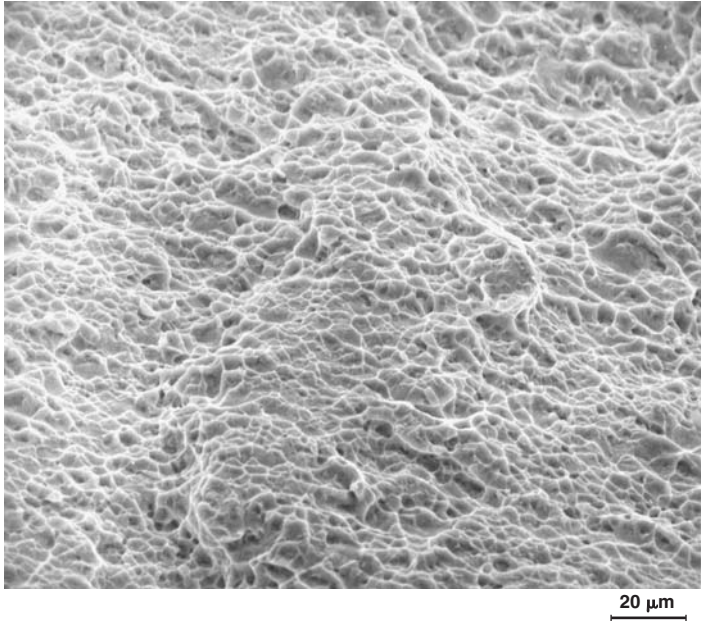
Fig. CH32.2 SEM fractograph of the fracture surface showing dimpled rupture

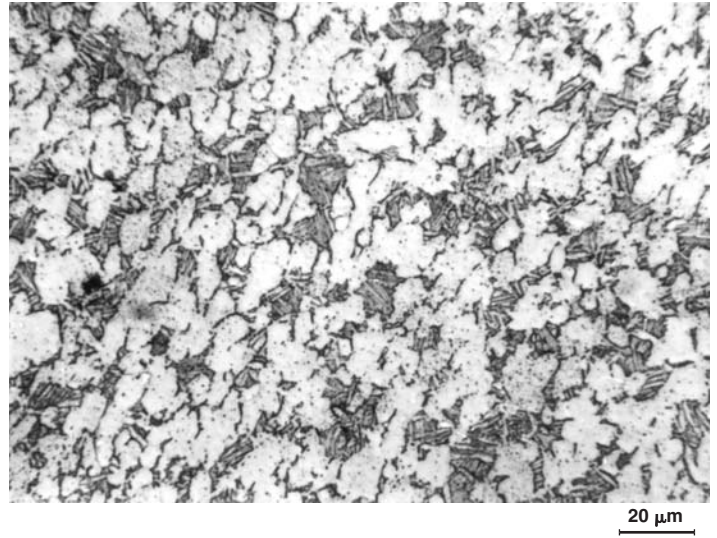
Fig. CH32.3 Microstructure of the blade material at the root showing well-dispersed α and β structure

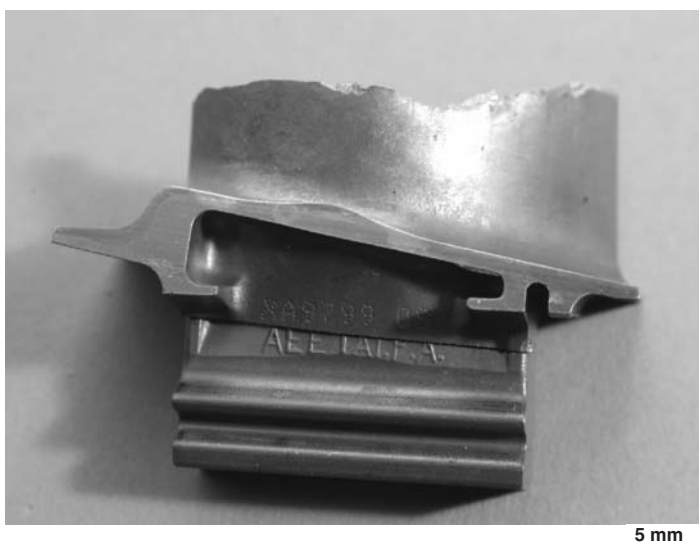
Fig. CH33.1 Photograph of the failed LPTR blade

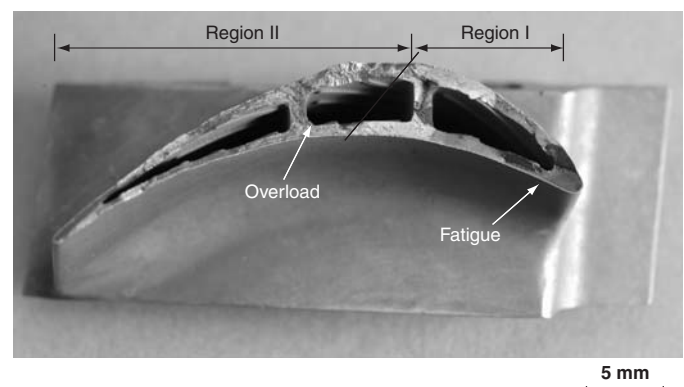
Fig. CH33.2 Fracture surface showing two fracture zones

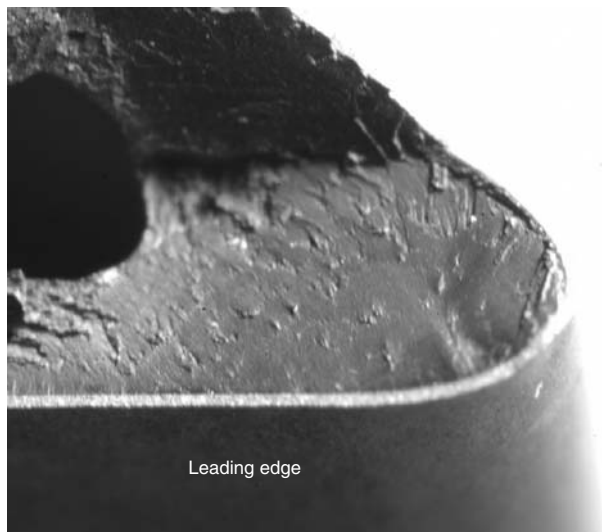
Fig. CH33.3 Photograph showing beach marks emanating from the leading edge of the blade

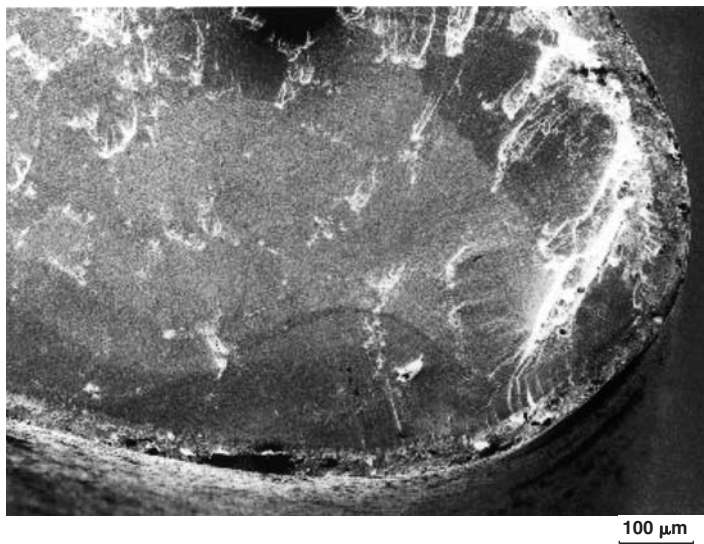
Fig. CH33.5 SEM fractograph at the fatigue crack origin

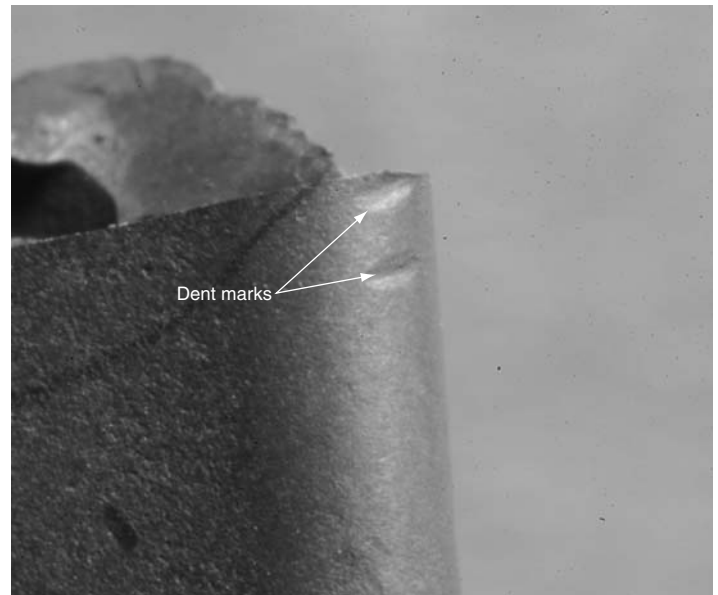
Fig. CH33.4 Photograph showing dent marks at the crack origin

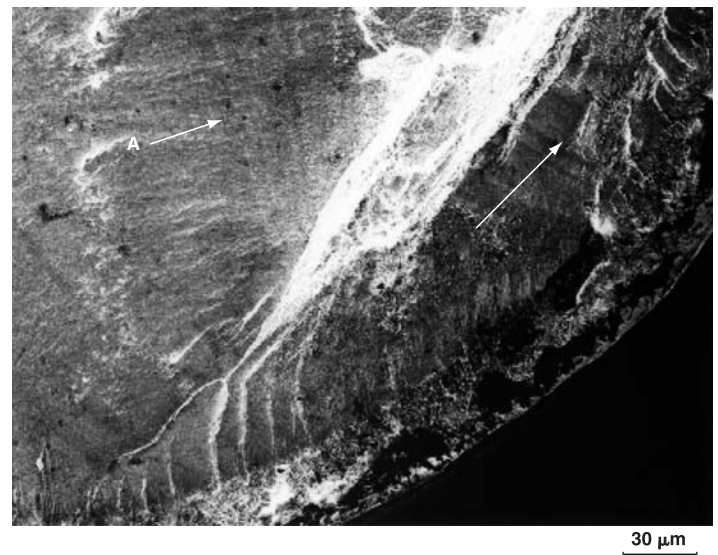
Fig. CH33.6 SEM fractograph showing two fatigue cracks

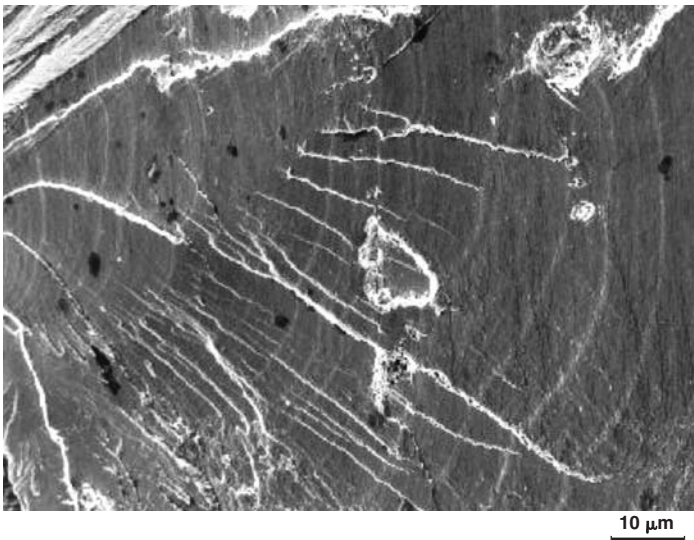
Fig. CH33.7 SEM fractograph showing fatigue striations at location A shown in Fig. CH33.6

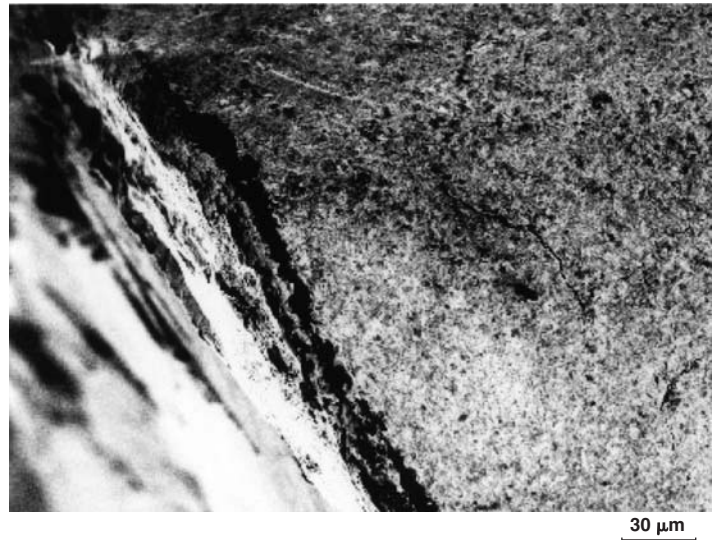
Fig. CH33.8 SEM picture showing network of crack around the mechanical dent

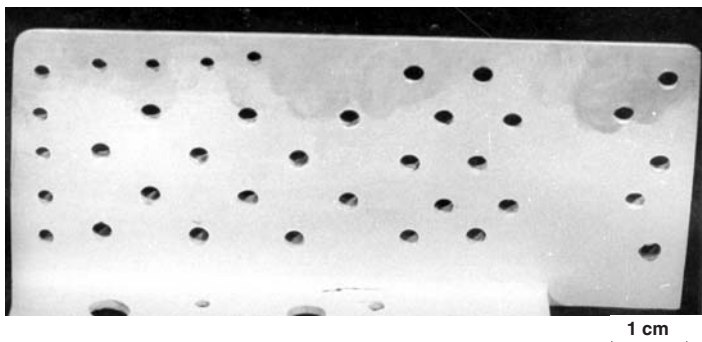
Fig. CH34.1 The bottom wing root joint

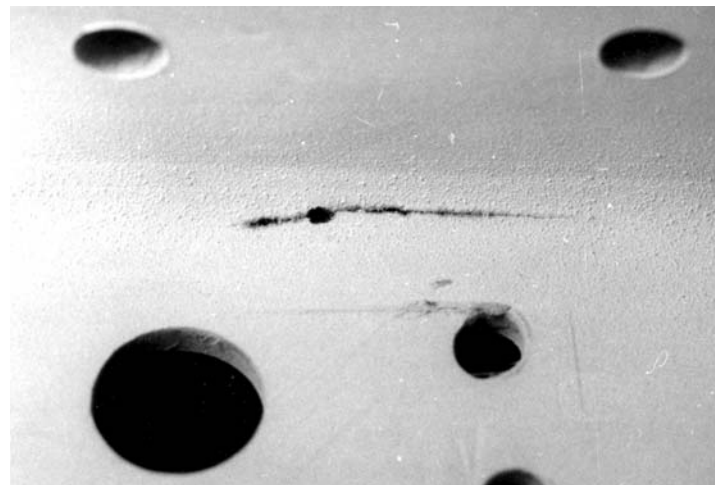
A portion of the fitting was cut and the crack was opened to observe the fracture surface. The fracture surface showed dis-

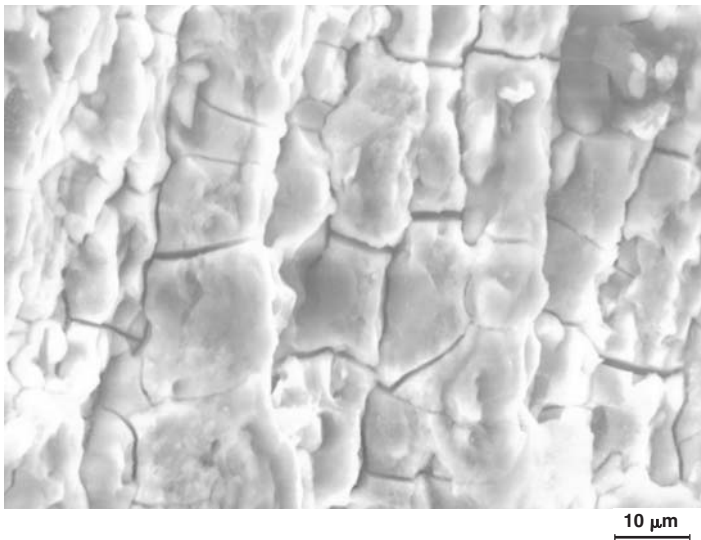
Fig. CH34.3 Mud cracking on the oxide layer of fracture surface

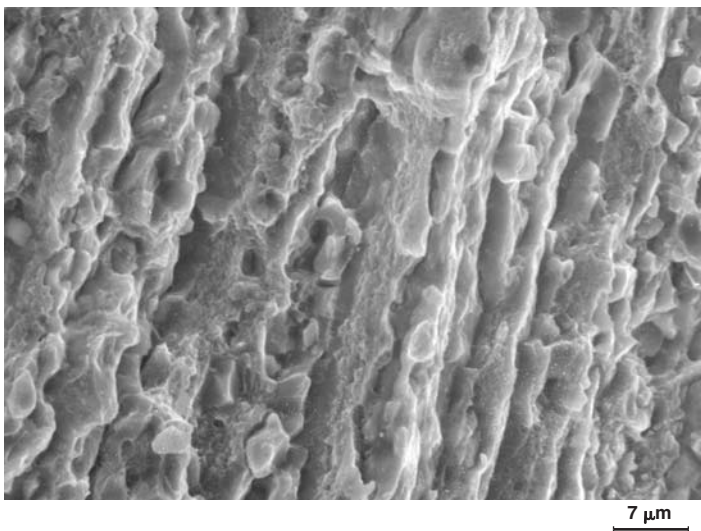
Fig. CH34.5 Freshly fractured surface showing dimpled features

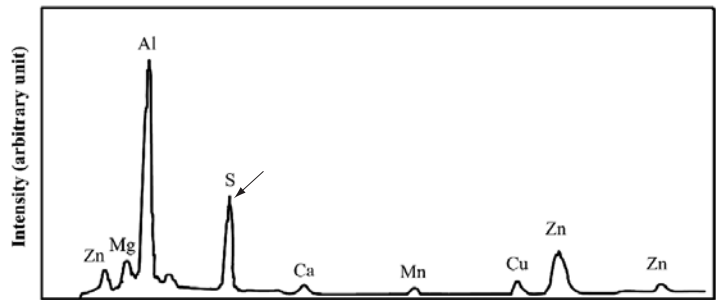
Fig. CH34.4 Energy-dispersive x-ray spectrum of the fracture surface. Note the presence of sulfur (arrow).

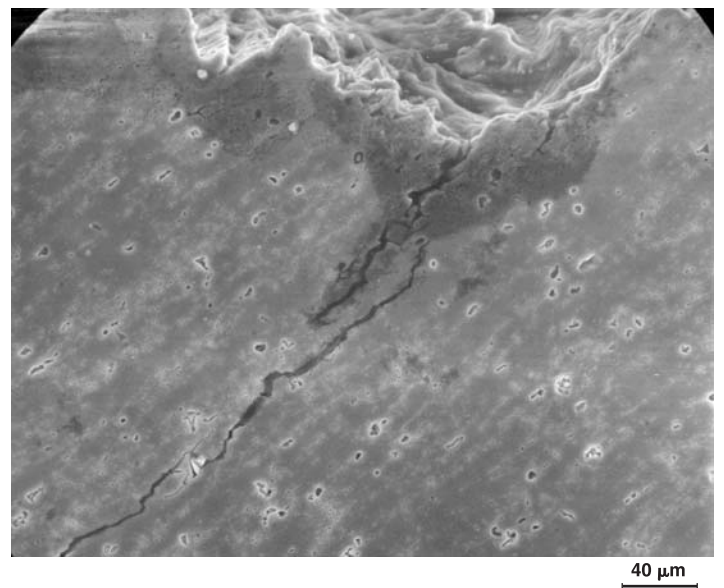
Fig. CH34.6 Secondary cracking below the fracture surface

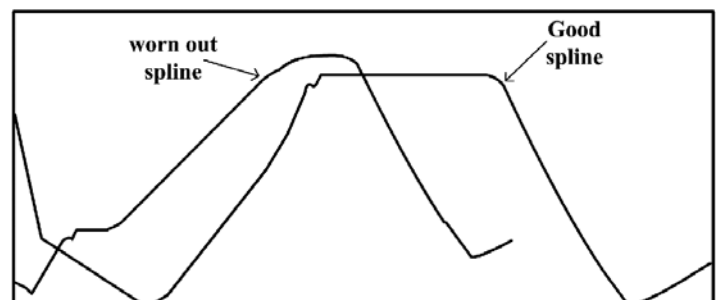
Fig. CH35.1 Traces of the profiles of the splines taken in a contourograph

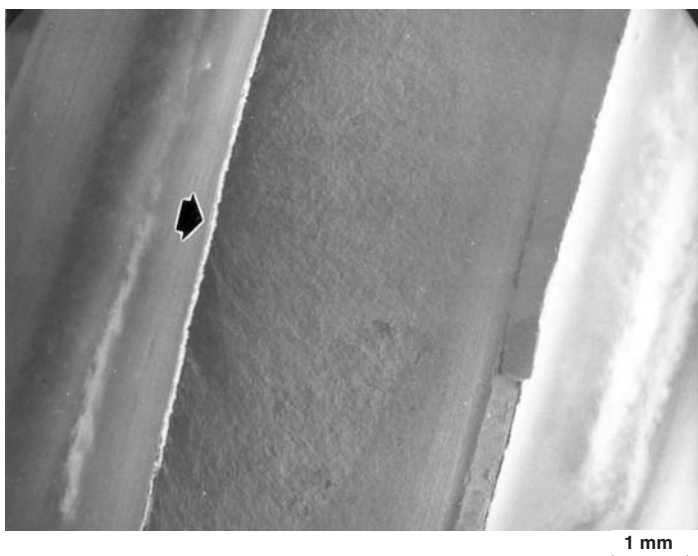
Fig. CH36.1 Fracture surface showing the fracture origin

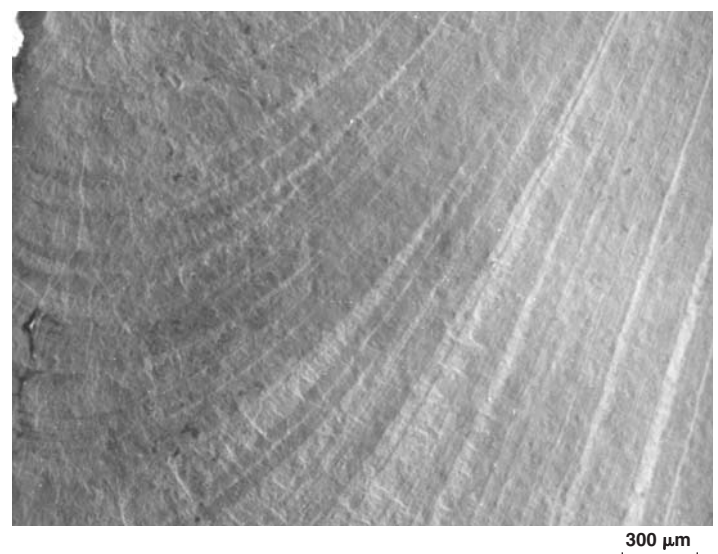
Fig. CH36.2 Well-defined beach marks on the fracture surface

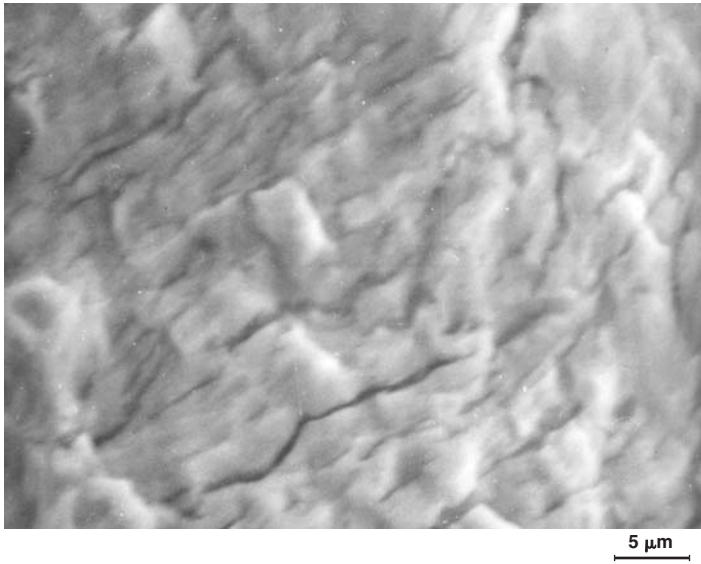
Fig. CH36.3 SEM fractograph near the origin showing fatigue striations along with cracking

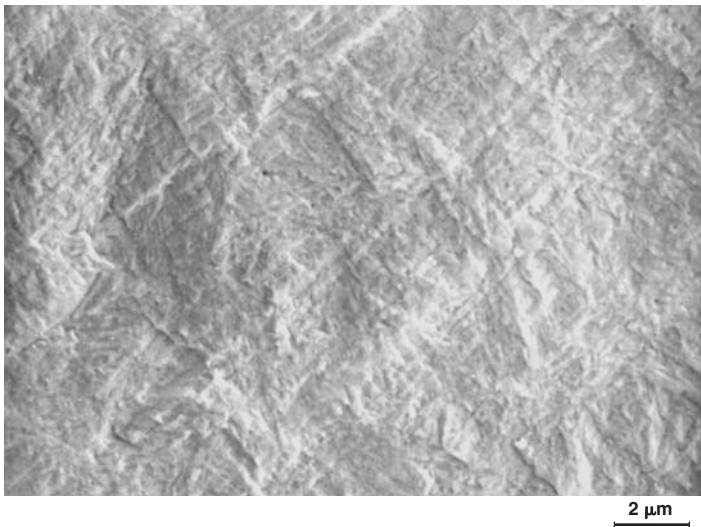
Fig. CH36.4 SEM fractograph farther away from the origin showing very-fine fatigue striations

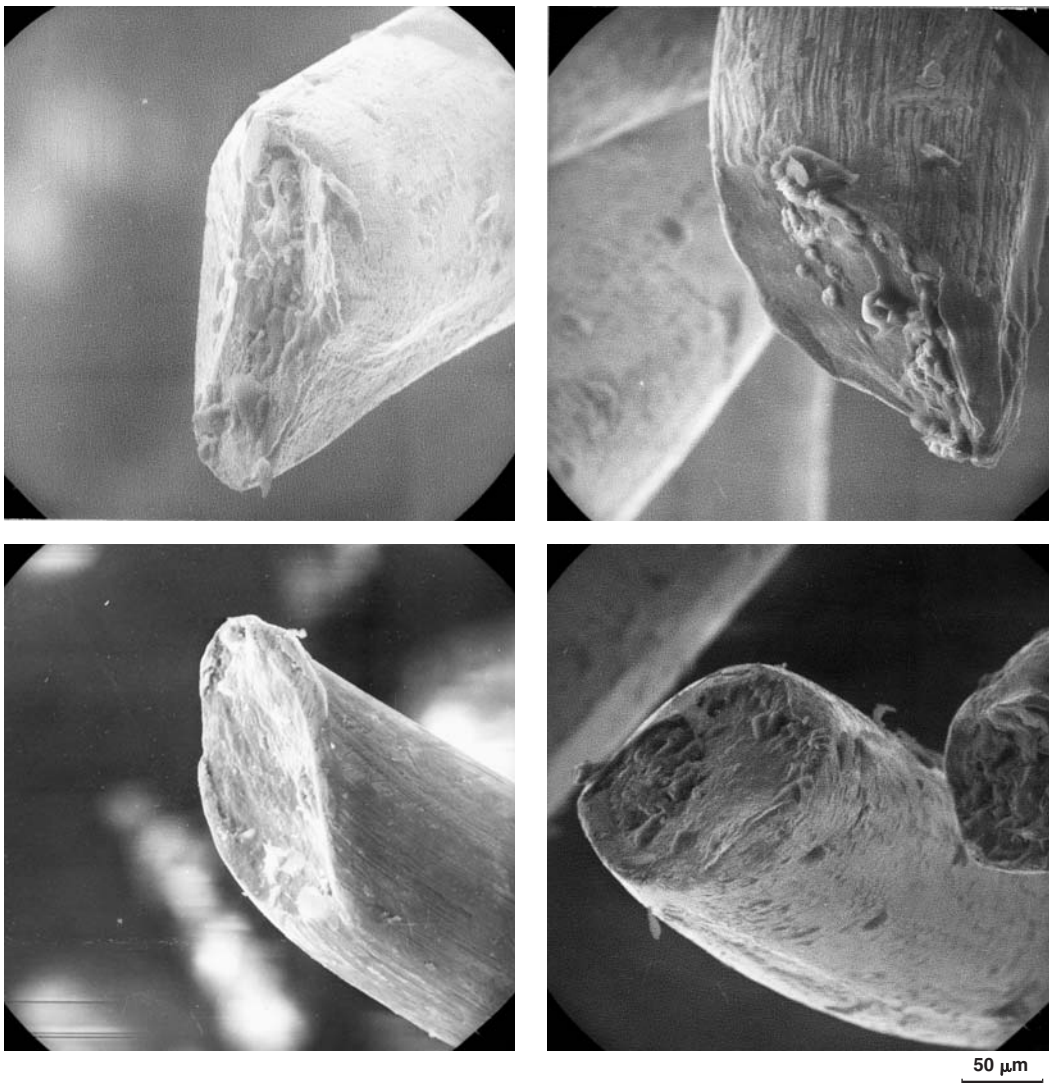
Fig. CH37.1 SEM photographs of broken ends of individual wires showing shear fracture

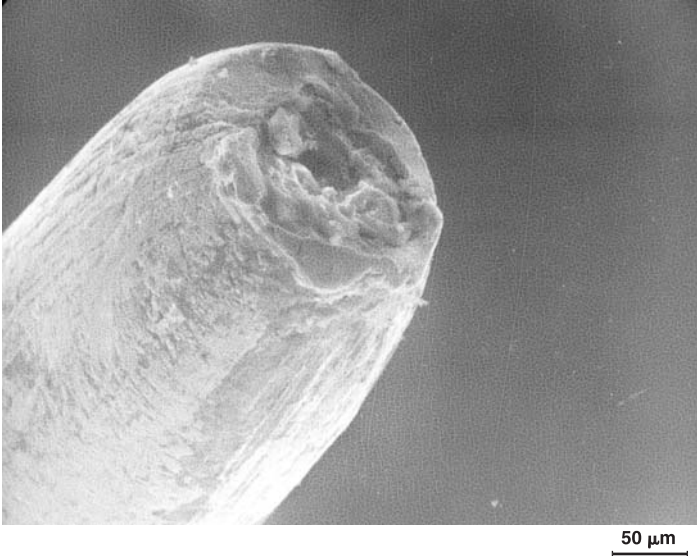
Fig. CH37.2 SEM photograph of broken end of a wire showing tensile fracture preceded by necking (typical cup and cone fracture)

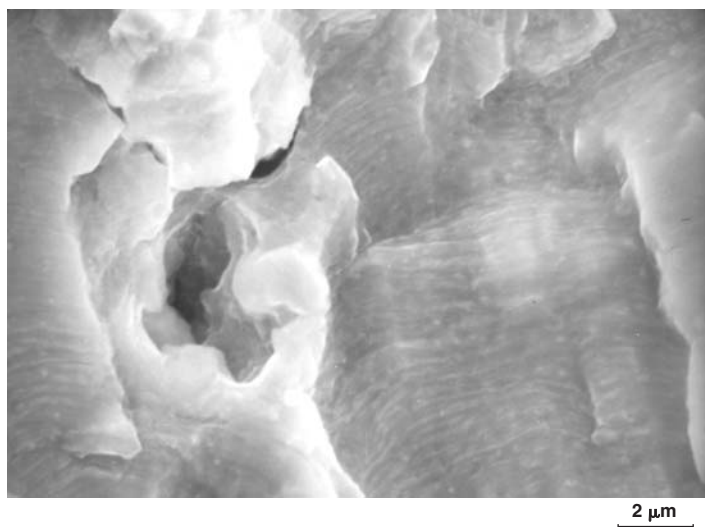
Fig. CH38.1 Fatigue striations on the sandwiched trailing edge center sheet near the rivet hole

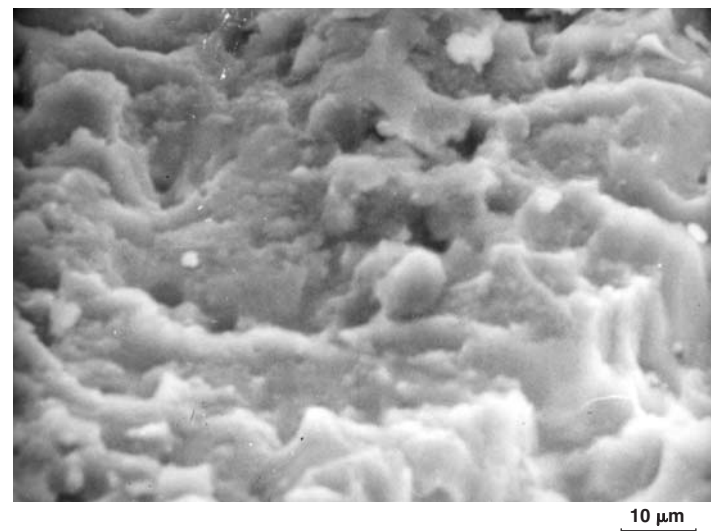
Fig. CH38.2 Shear dimples indicative of overload fracture on the outer skin region away from the rivet hole toward the leading edge

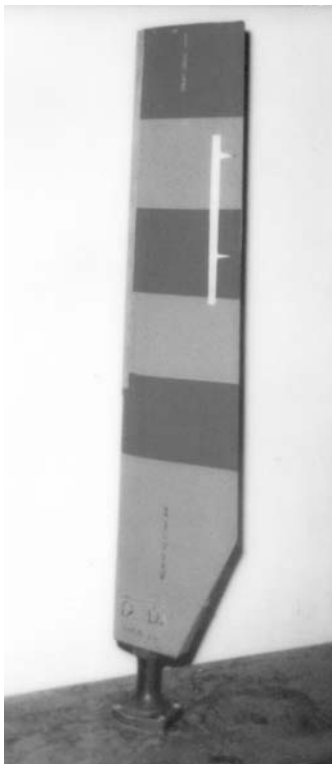
Fig. CH39.1 Tail rotor blade in the as-received condition

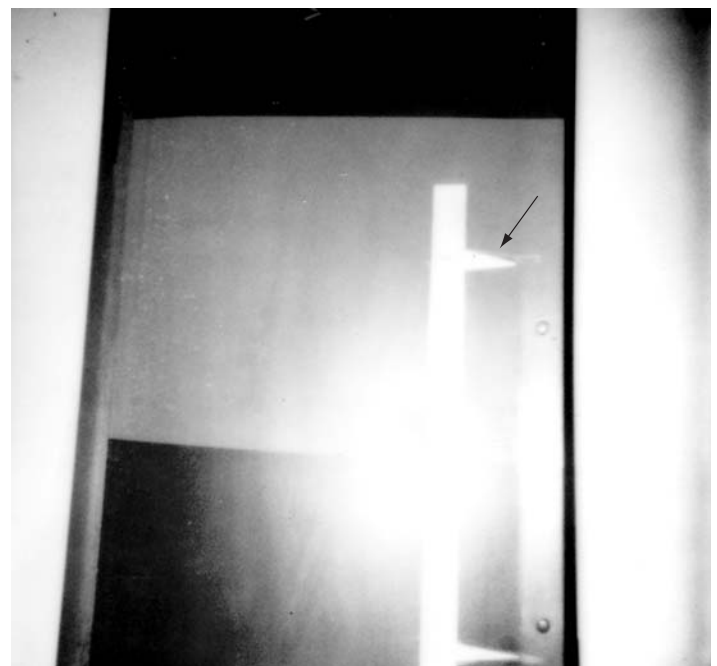
Fig. CH39.2 Tail rotor blade with cracking at the joggled line (arrow)

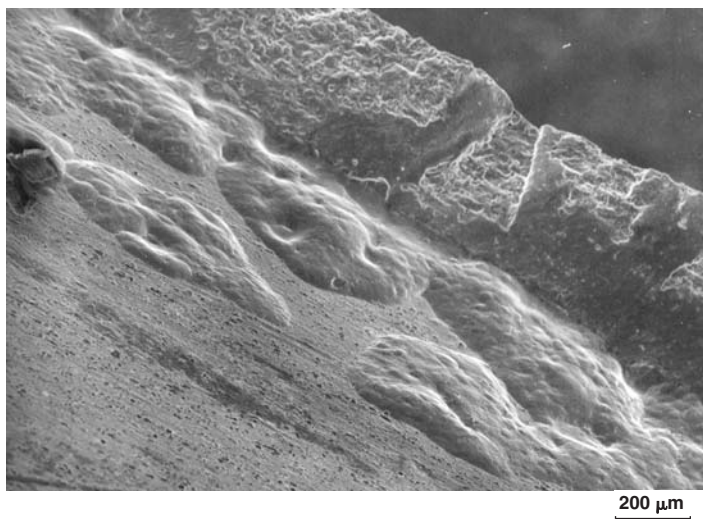
Fig. CH39.3 SEM of the inside surface of the skin at the cracked region showing localized pitting

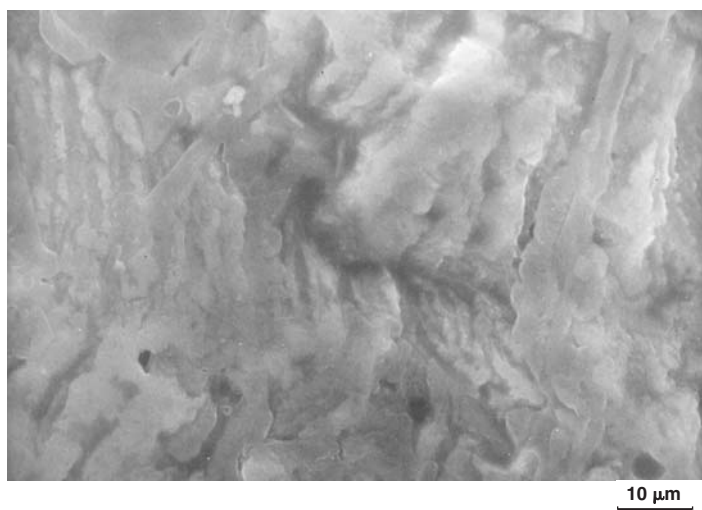
Fig. CH39.4 SEM fractograph showing fine fatigue striations

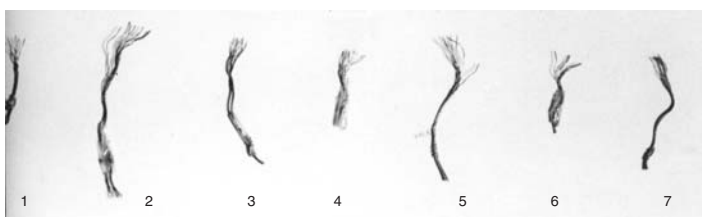
Fig. CH40.1 Strands of wires found snapped in a wing control cable

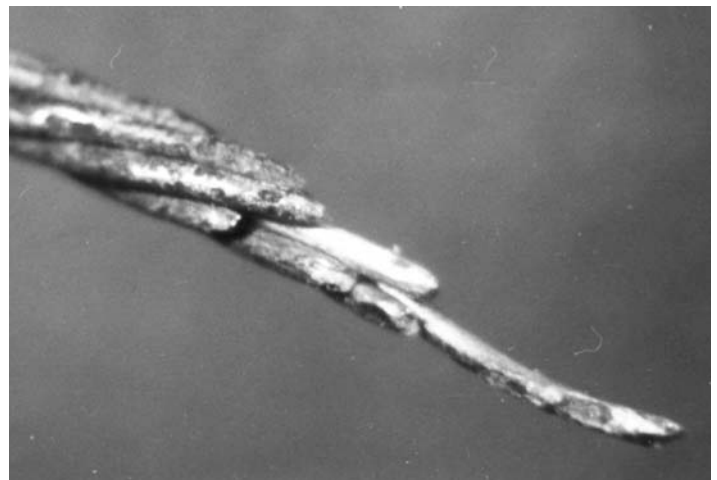
Fig. CH40.2 Corrosion observed on a failed strand from the general location of the fracture of the cable

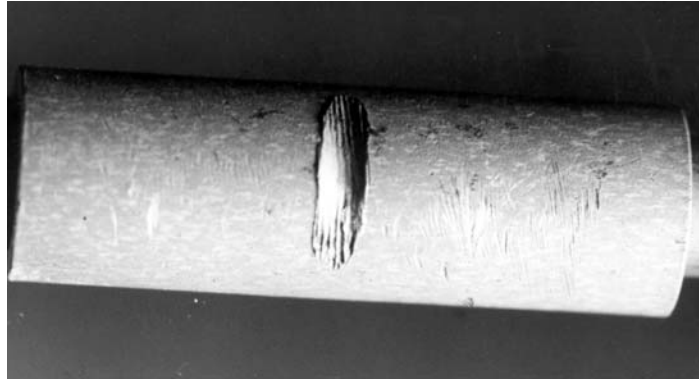
Fig. CH40.3 Wire rope impression imprinted on the spacer tube due to digging in of wire rope

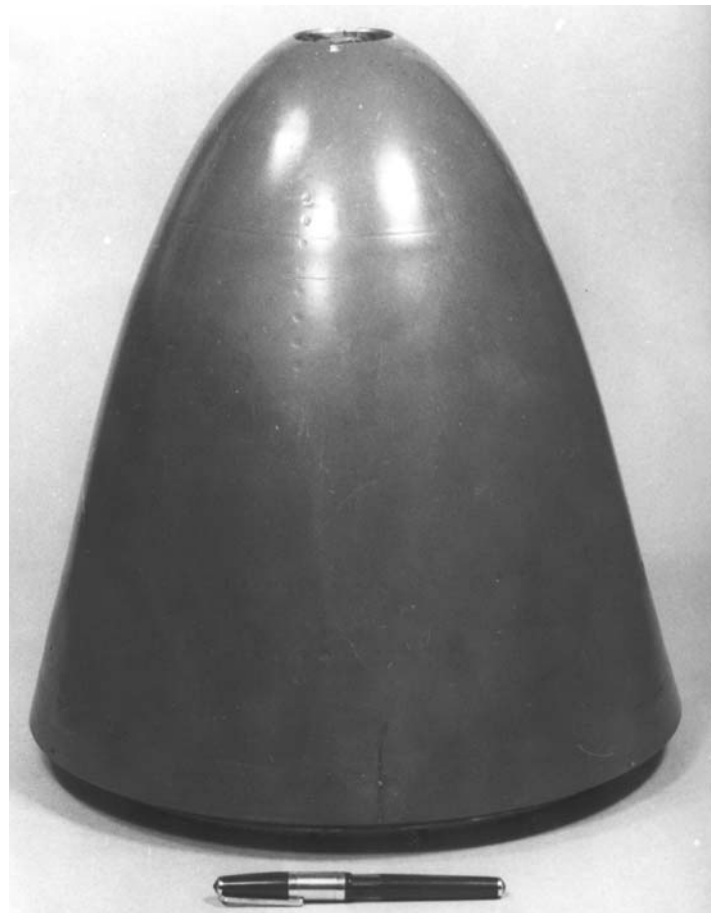
Fig. CH41.1 The cracked nose bullet of the aircraft engine

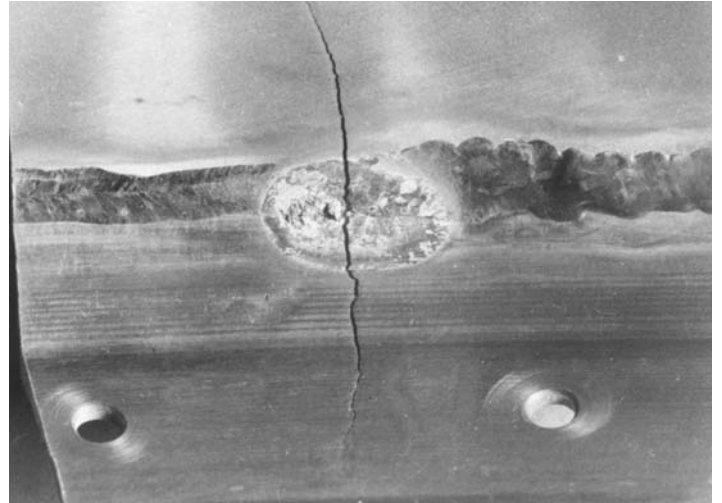
Fig. CH41.3 Rework in the welded region from where the crack had originated

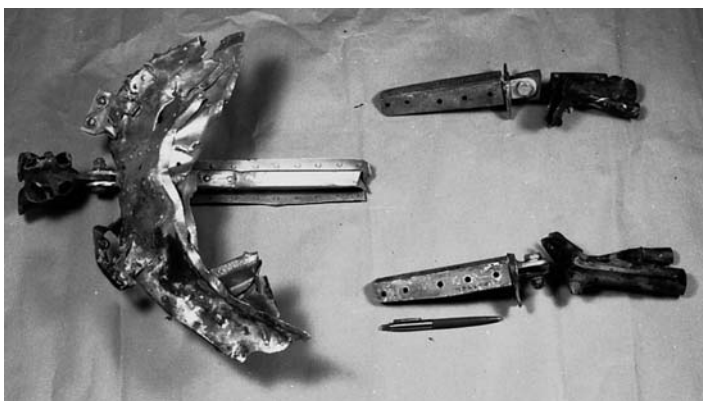
Fig. CH42.1 Failed components from the tail boom

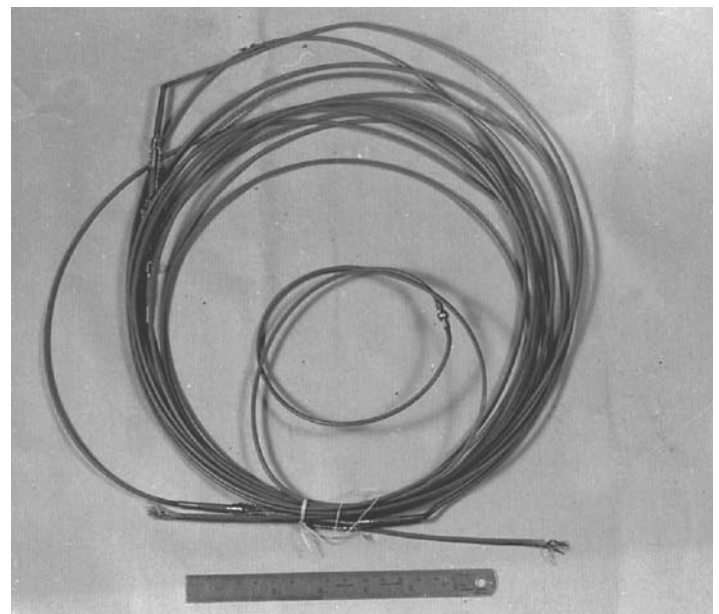
Fig. CH42.2 Snapped tail rotor pitch control cables

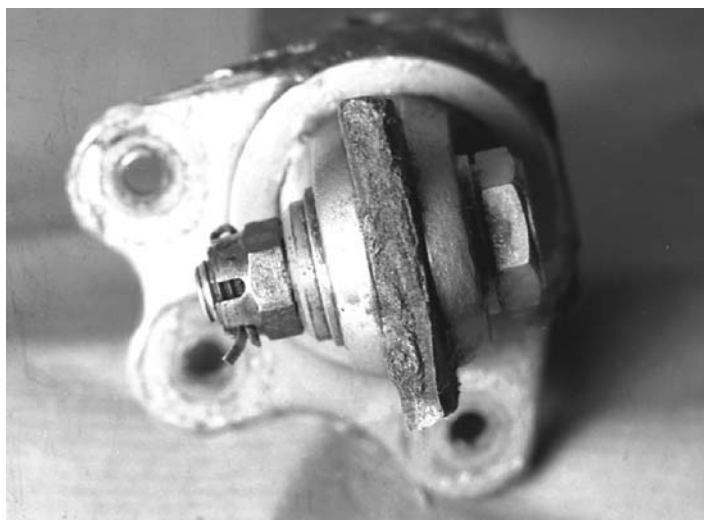
Fig. CH42.3 Fracture surface of the gusset plate, right-hand side

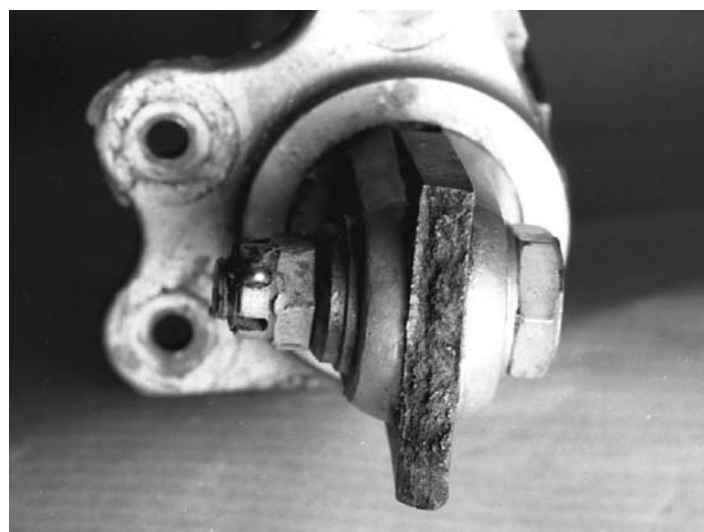
Fig. CH42.4 Fracture surface of the gusset plate, left-hand side

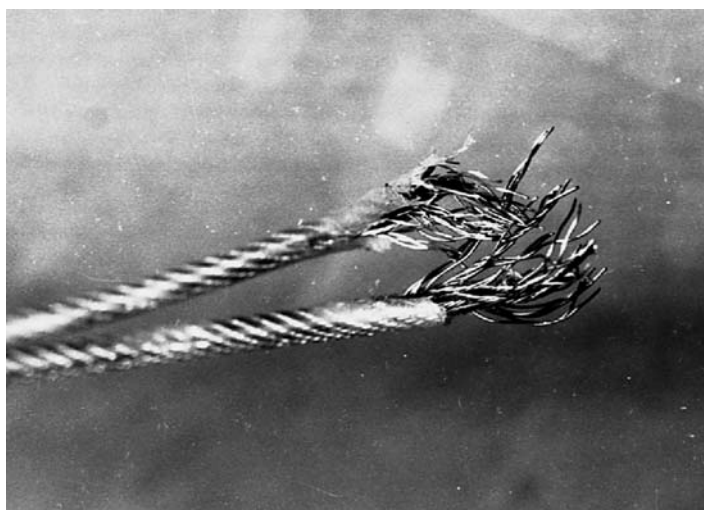
Fig. CH42.5 Broken strands of the tail rotor pitch control cable

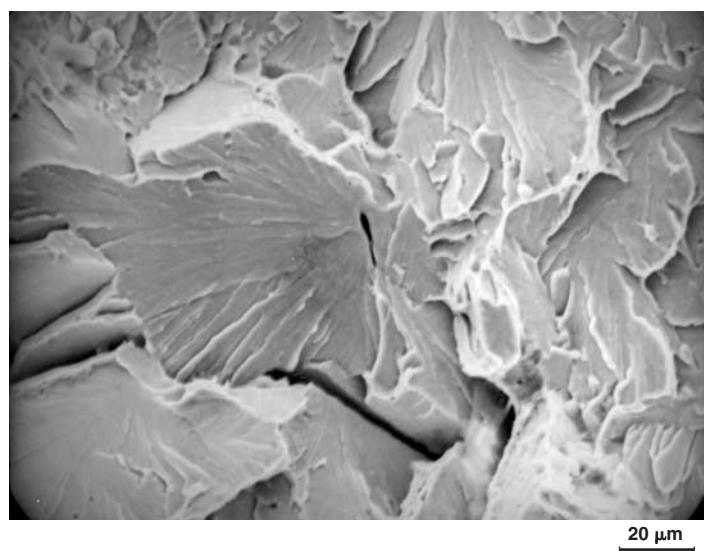
Fig. CH42.6 SEM fractograph of the failed gusset plate, left-hand side

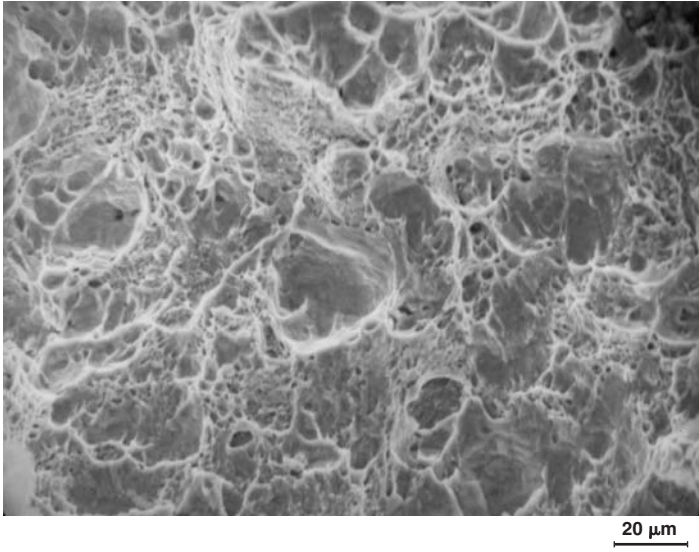
Fig. CH42.7 SEM fractograph of the failed gusset plate, right-hand side

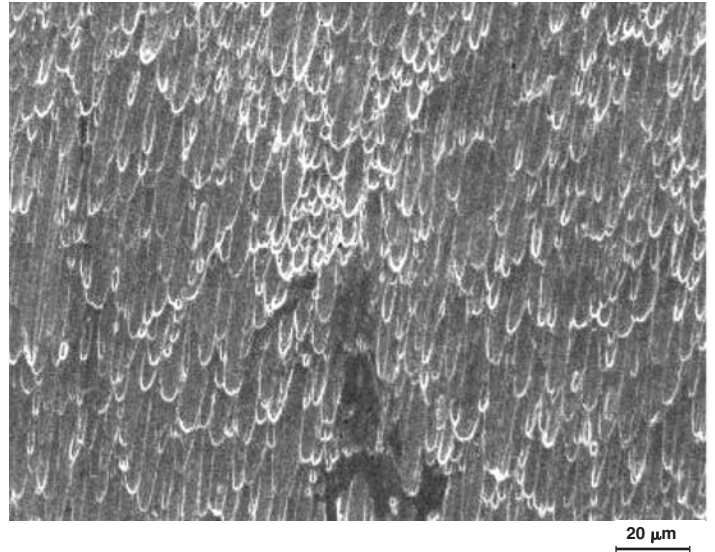
Fig. CH42.8 SEM fractograph of the hat section

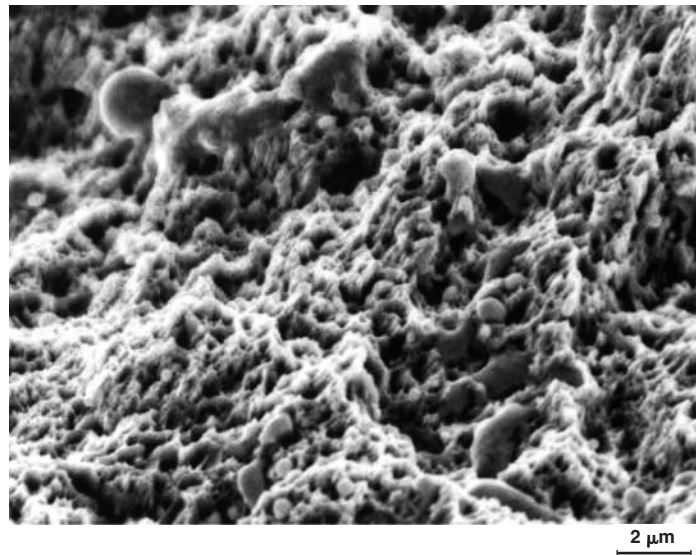
Fig. CH42.9 SEM fractograph of a broken strand

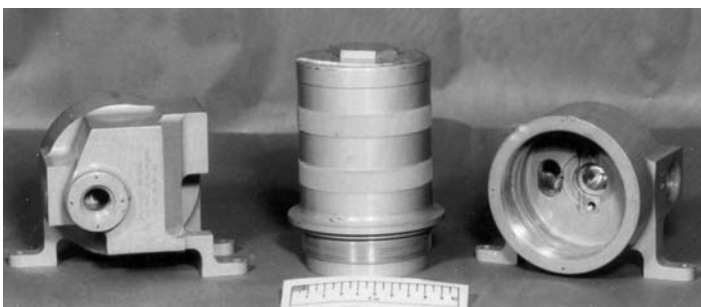
Fig. CH43.1 Low- and high-pressure filter heads and low-pressure bowl

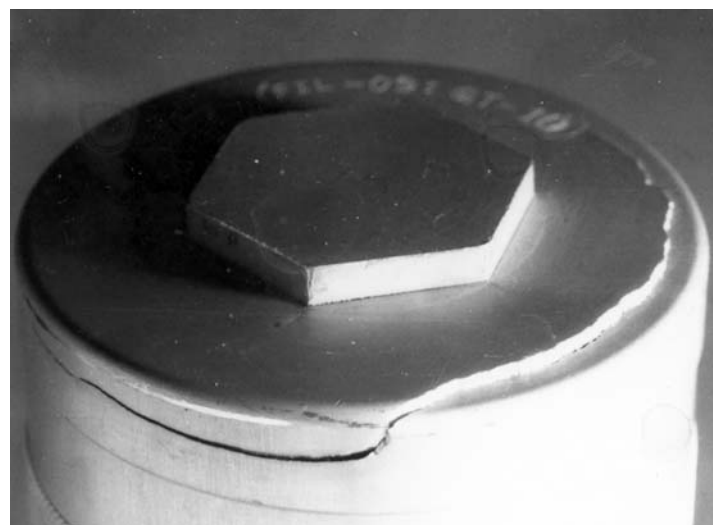
Fig. CH43.2 Cracking in the low-pressure bowl in the region of transition at the head

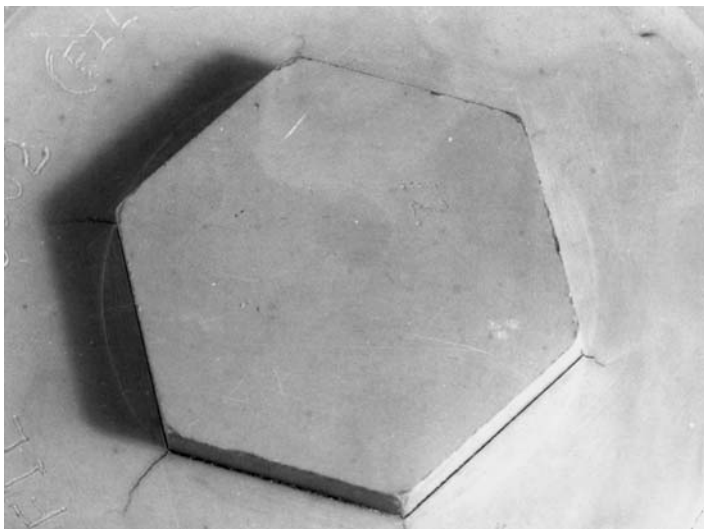
Fig. CH43.3 Radial cracks emanating from the sharp corners of the hexagon

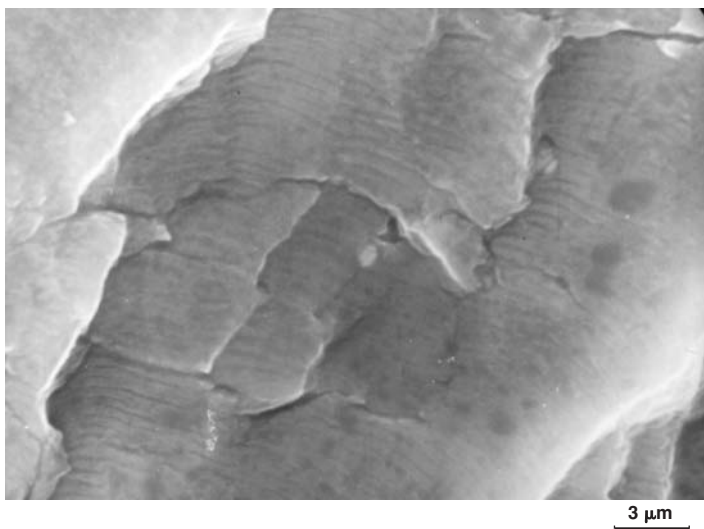
Fig. CH43.5 Well-defined, uniformly spaced striations in the slow crack growth region, typical of fatigue

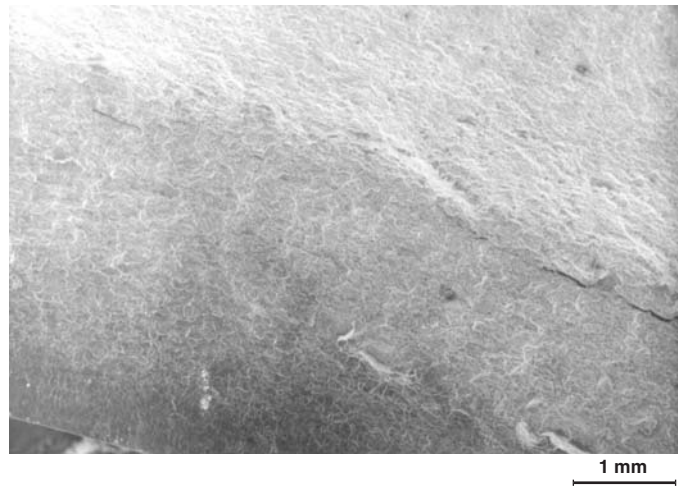
Fig. CH43.4 SEM fractograph showing the slow crack growth (flat) and overload (slant) regions
