Failure Analysis of Engineering Structures

Methodology and Case Histories

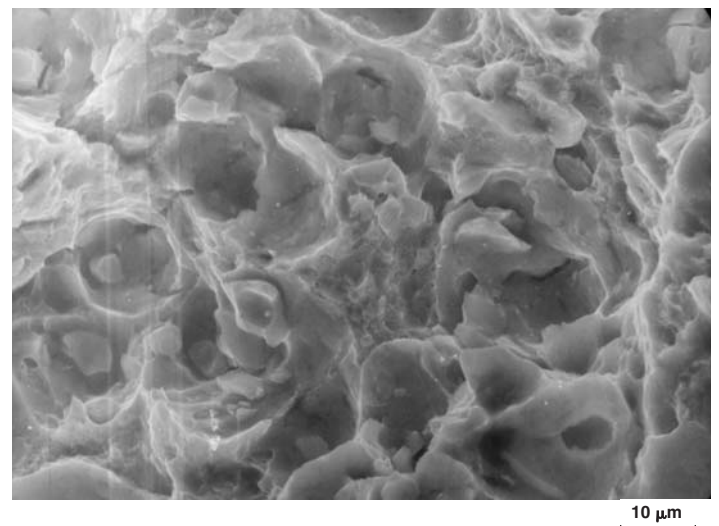
Fig. CH43.6 Dimple rupture in the overload (slant) region

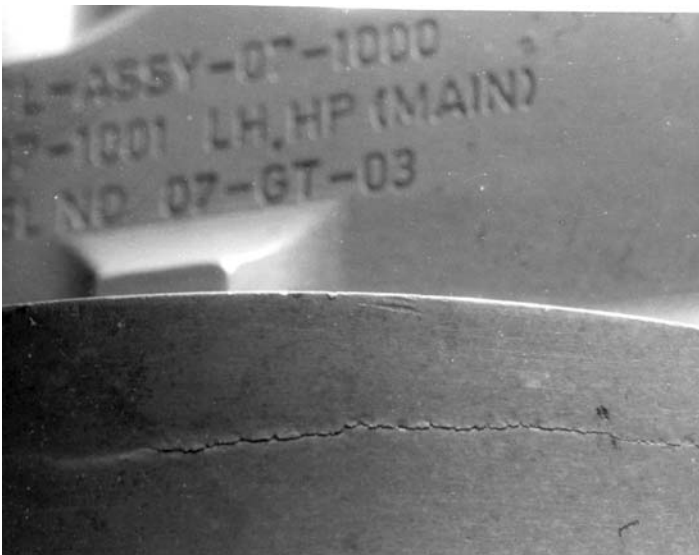
Fig. CH43.7 Circumferential crack close to the bullet end in the high-pressure filter head

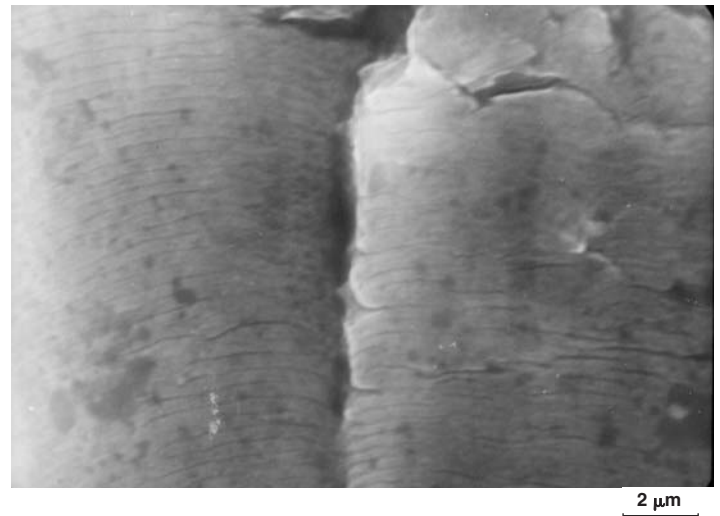
Fig. CH43.8 Fatigue striations in the slow crack growth (flat) region

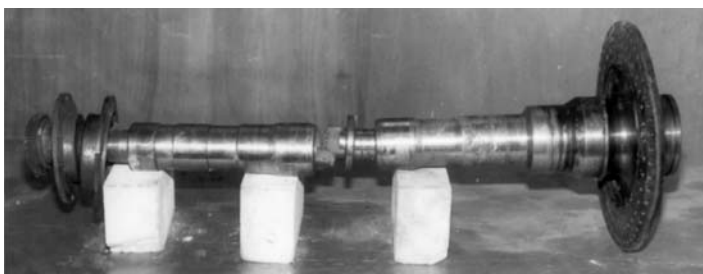
Fig. CH44.1 Fractured drive shaft with damaged seal carrier and coupling

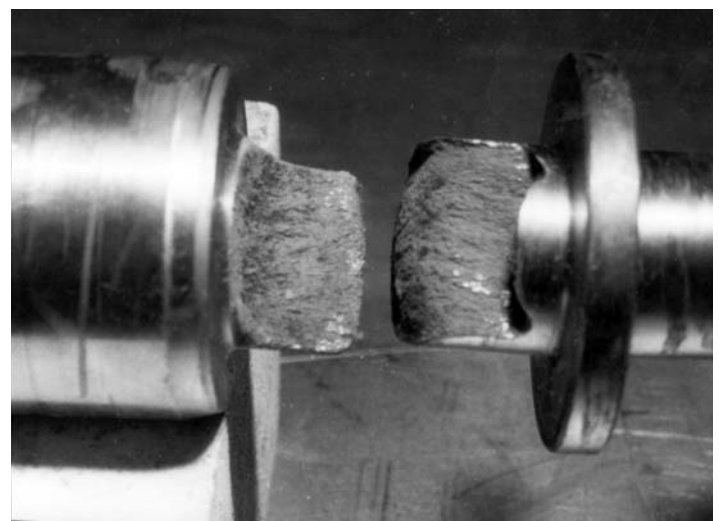
Fig. CH44.2 Close-up view of the fracture surface. The fracture features are typical of tensile/bending overloads.

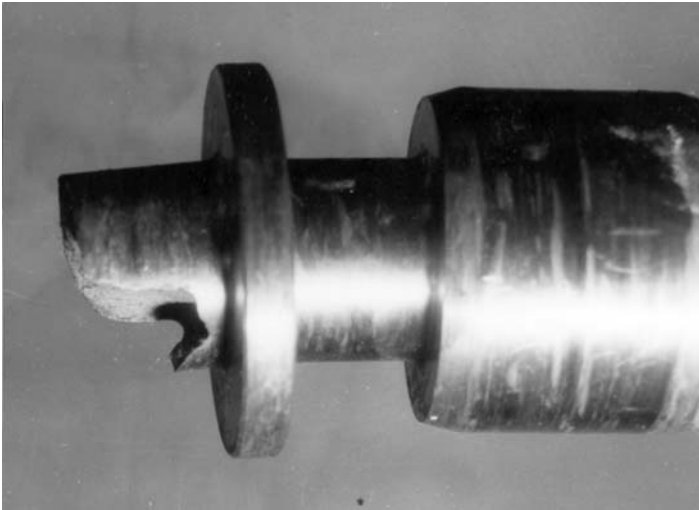
Fig. CH44.3 Location of fracture. Note the slight bending on the shaft close to the region of fracture.

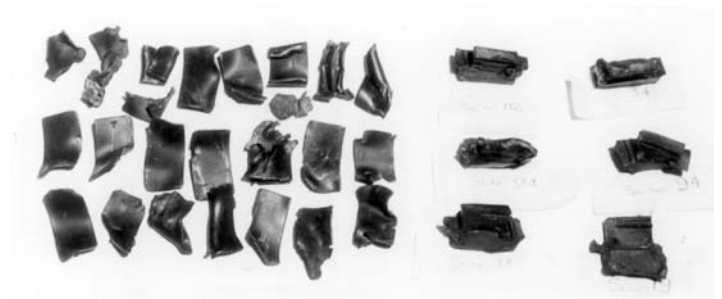
Fig. CH44.4 Damaged retaining plates

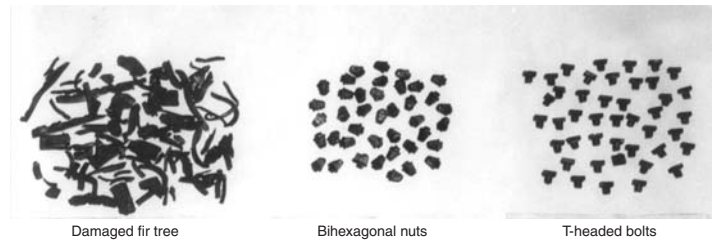
Fig. CH44.6 The damaged T-head bolts. Bihexagonal nuts and fir tree portions are also shown.

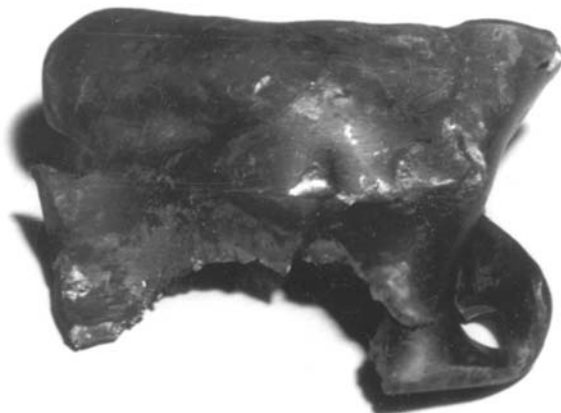
Fig. CH44.5 Damaged locking plate. The damages are secondary in nature

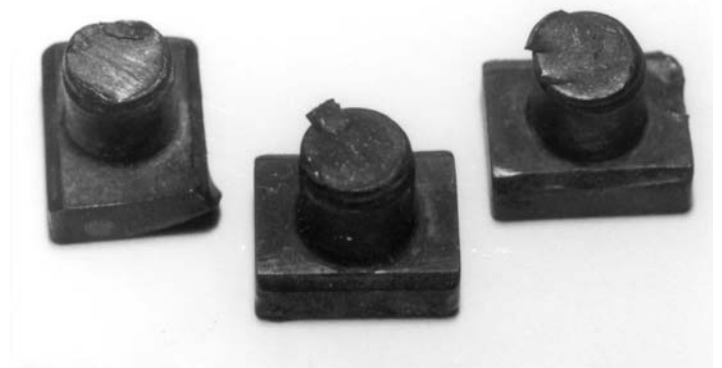
Fig. CH44.7 Fracture surfaces of some of the T-headed bolts. Gross features of fracture indicate shear loads.

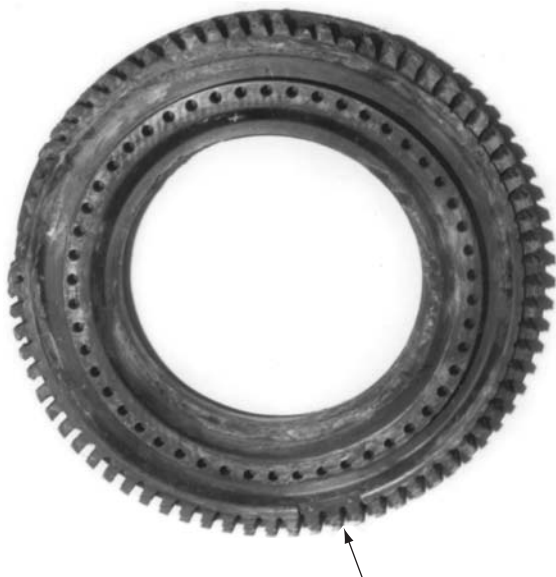
Fig. CH44.8 Damaged low-pressure turbine disc. Arrow indicates the locking plates region that suffered practically no damage.

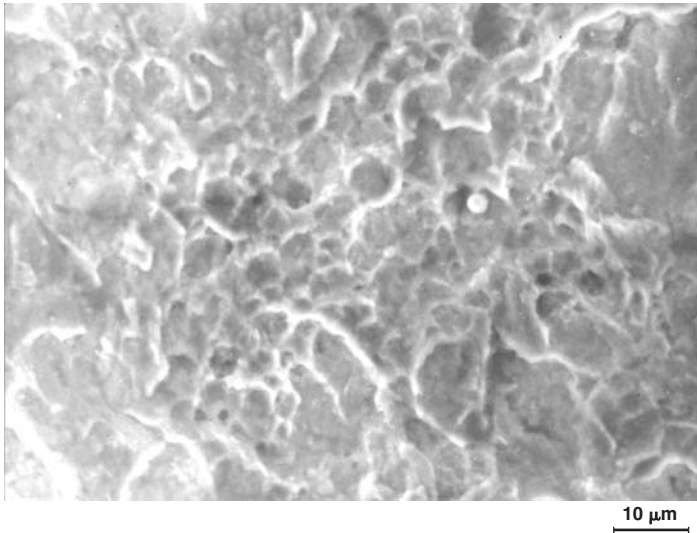
Fig. CH44.10 SEM fractograph of the stud. Elongated dimples indicate failure due to shear loads.

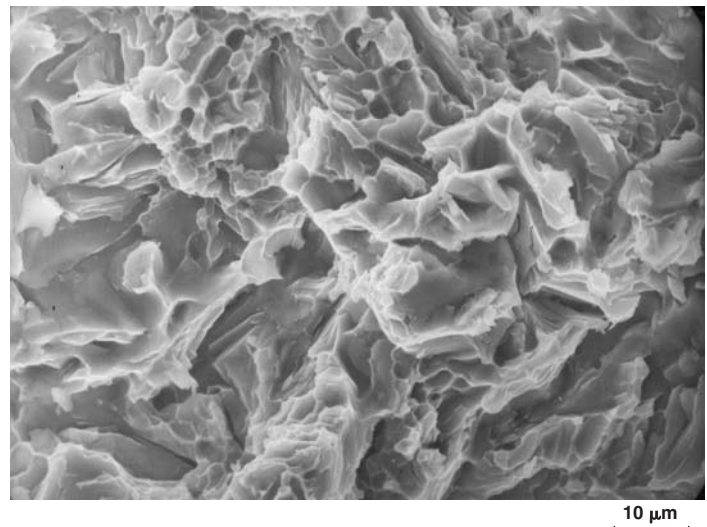
Fig. CH45.1 SEM fractograph of the fin showing cleavage-like features

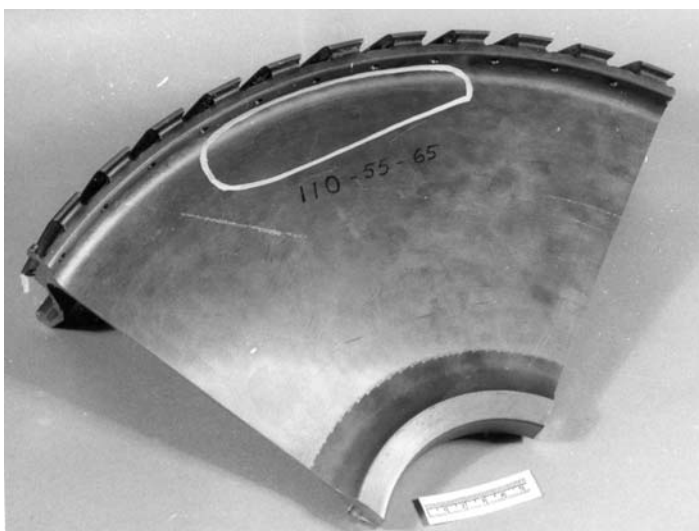
Fig. CH46.1 Disc segment containing the crack

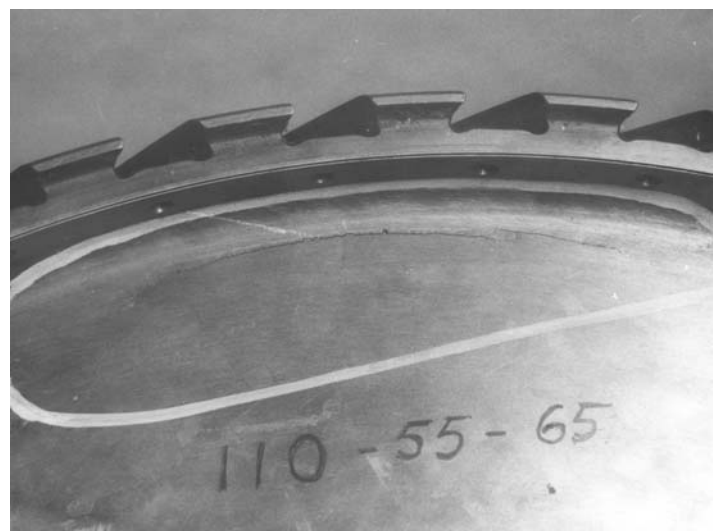
Fig. CH46.2 Close-up view of the cracked region

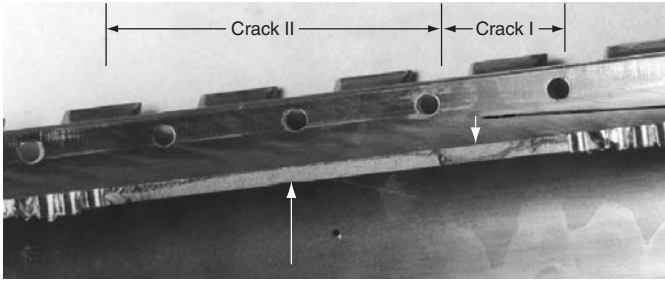
Fig. CH46.3 Fracture surface opened up for investigation, showing two fatigue cracks initiating on opposite sides of the disc diaphragm

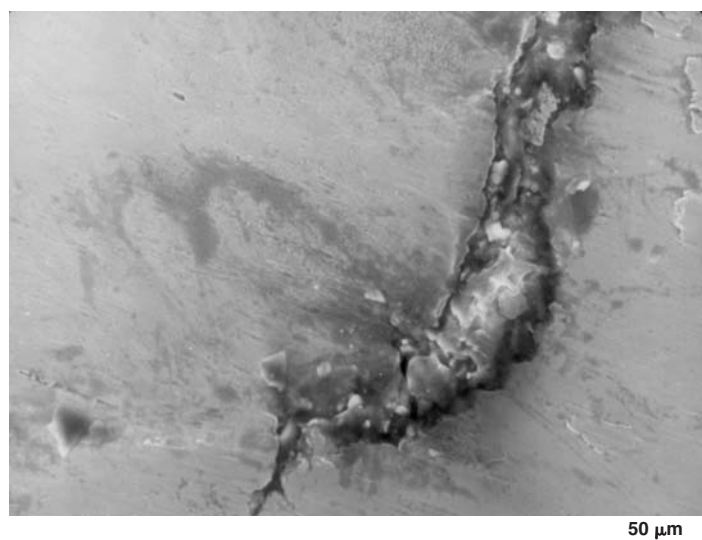
Fig. CH47.1 Cracking and corrosive damage seen on the body of the plunger

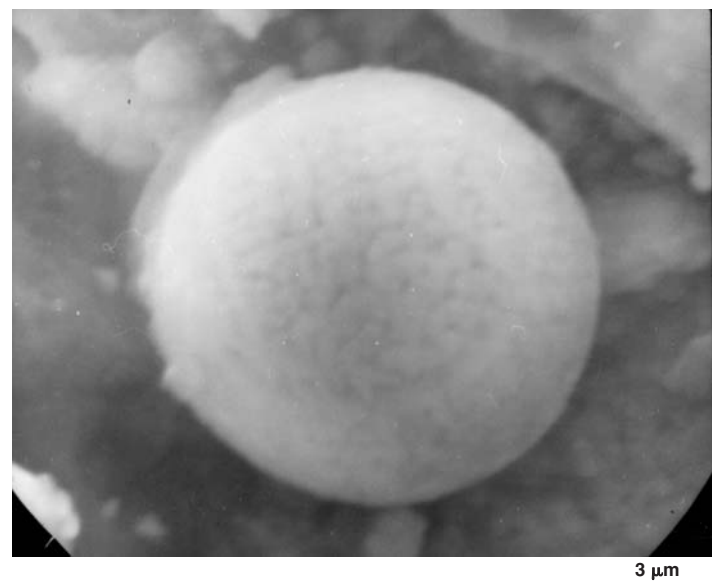
Fig. CH47.2 Loose spherical particles seen in the damaged region. Particles are of the same composition as the plunger material.

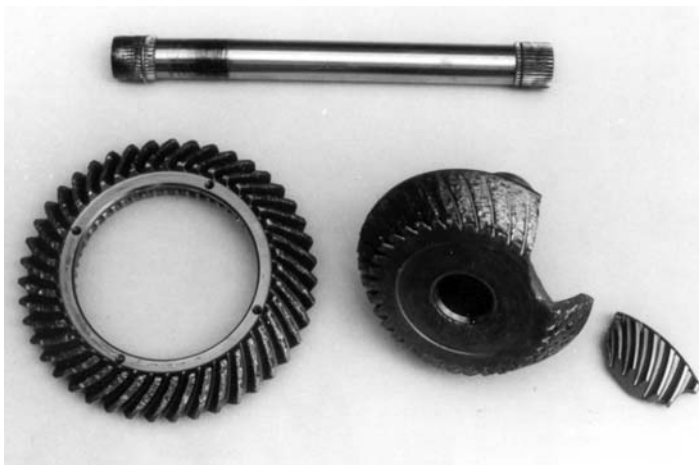
Fig. CH48.1 Damaged driving gear, damaged shaft, and fractured driven gear

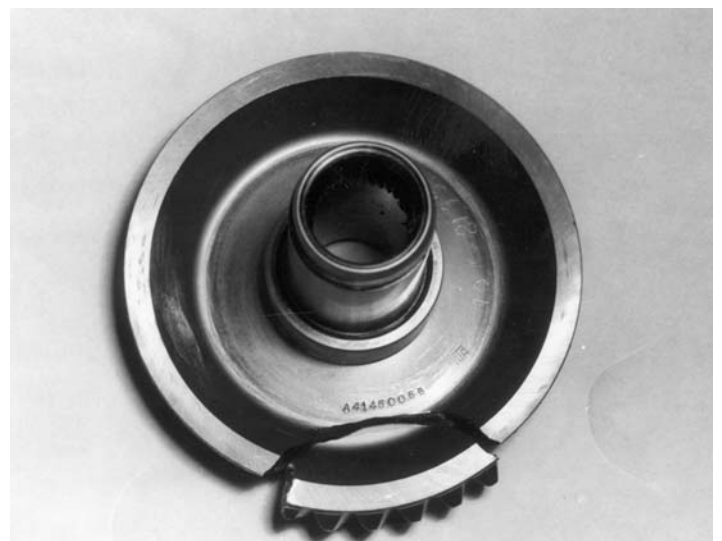
Fig. CH48.2 Failed driven gear showing the area of fracture

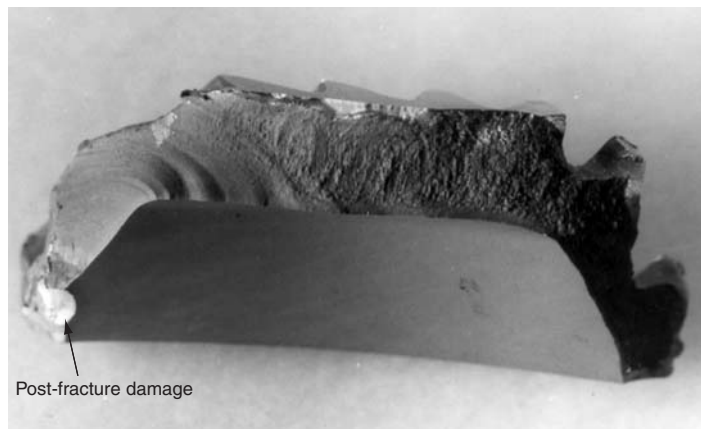
Fig. CH48.3 Fractured segment. Note the secondary (post-fracture) damage at the fracture origin.

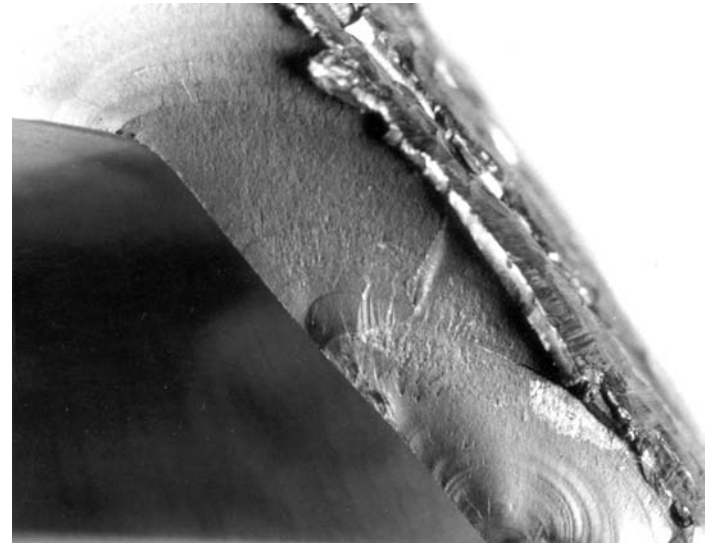
Use a cleaner material. Avoid case hardening the entire exposed surface of the gear blank and verify whether specification provides for case hardening in the rim surface.

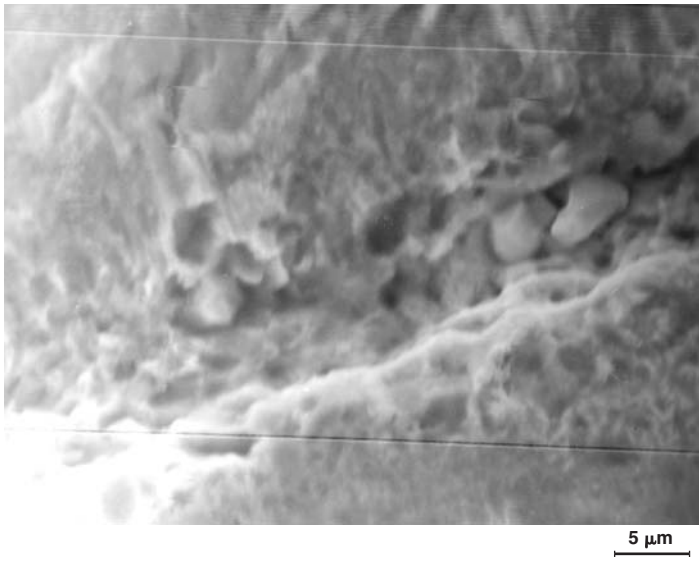
Fig. CH48.5 The region near the origin of fatigue crack. A stringer-like inclusion can be seen close to the origin.

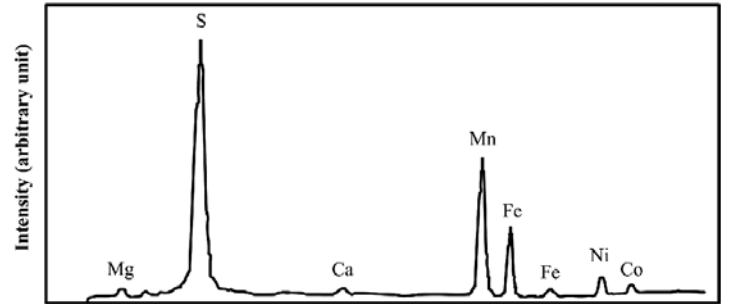
Fig. CH48.6 Energy-dispersive spectrum showing the presence of MnS inclusion

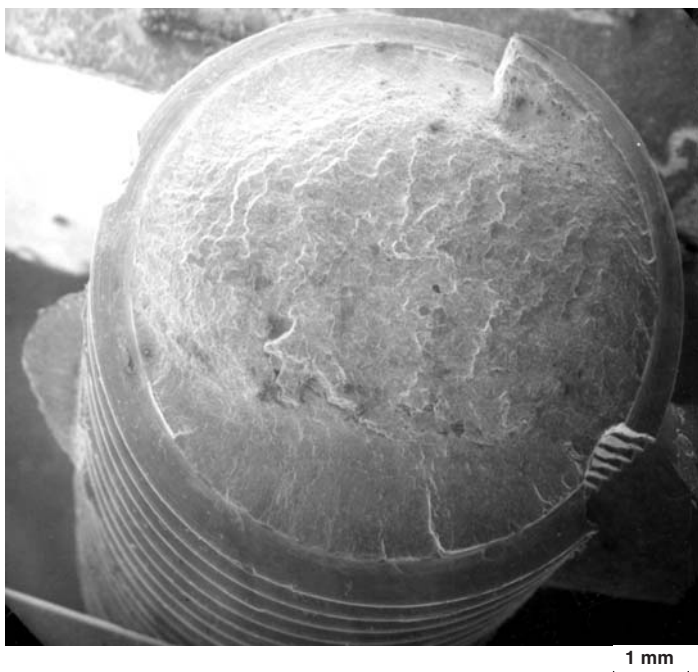
Fig. CH49.1 Fracture surface of the failed stud showing the fatigue zone

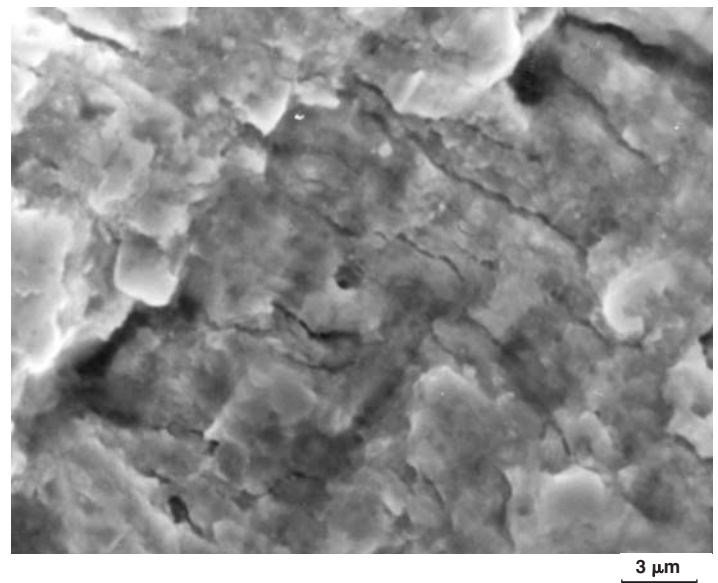
Fig. CH49.2 Striations in the fatigue region

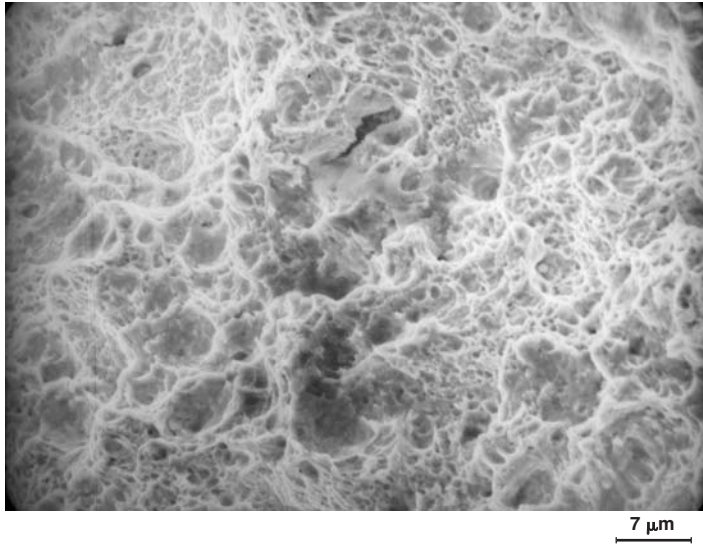
Fig. CH49.3 Final fracture region showing dimpled rupture

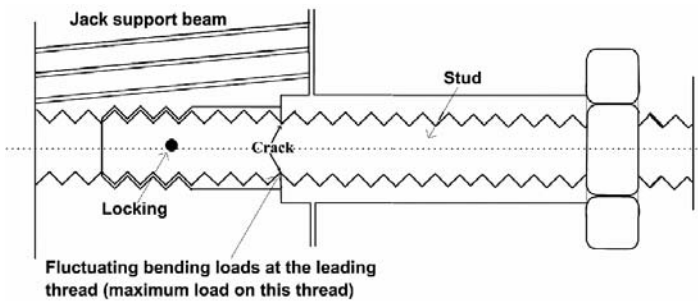
Fig. CH49.4 Sketch showing the location of leading thread in the stud

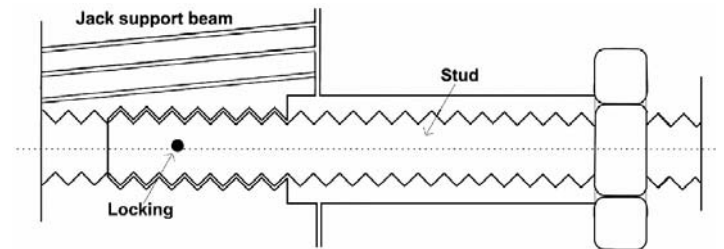
Fig. CH49.5 Sketch showing correct engineering design

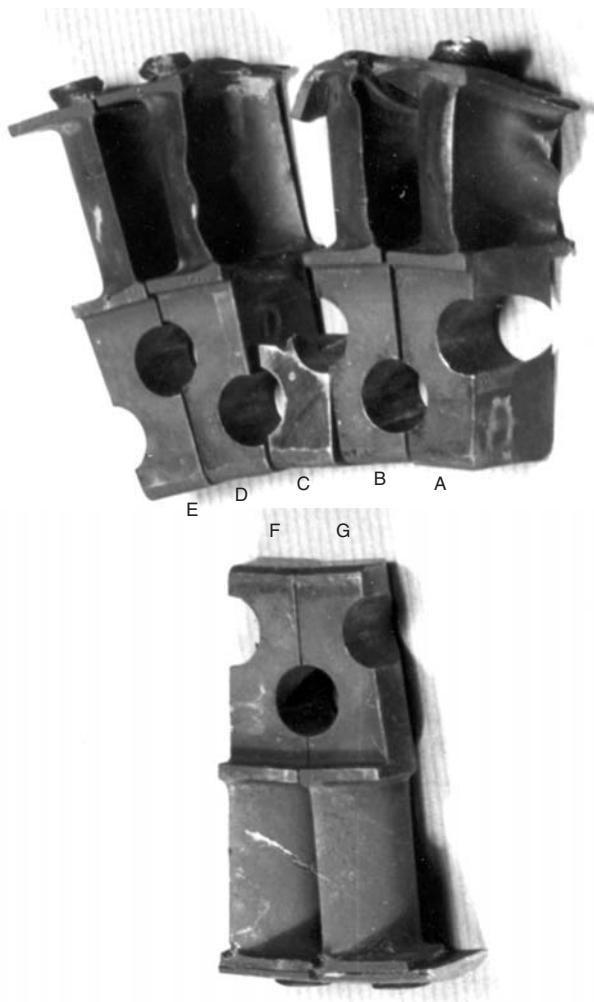
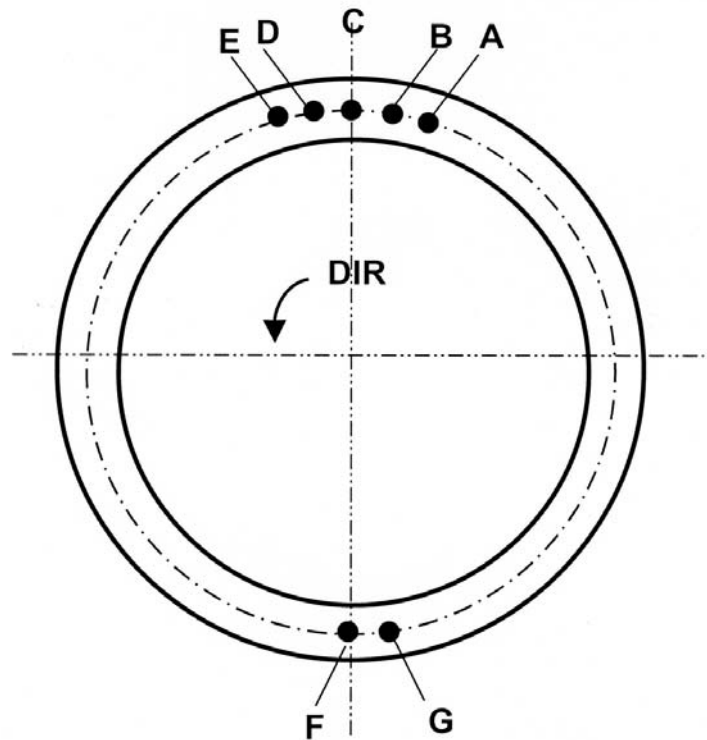
Fig. CH50.1 (a) Root portion of the failed blade, C; neighboring blades, A, B, D, E; blades diametrically opposite, F, G. (b) Sketch showing the location of blades

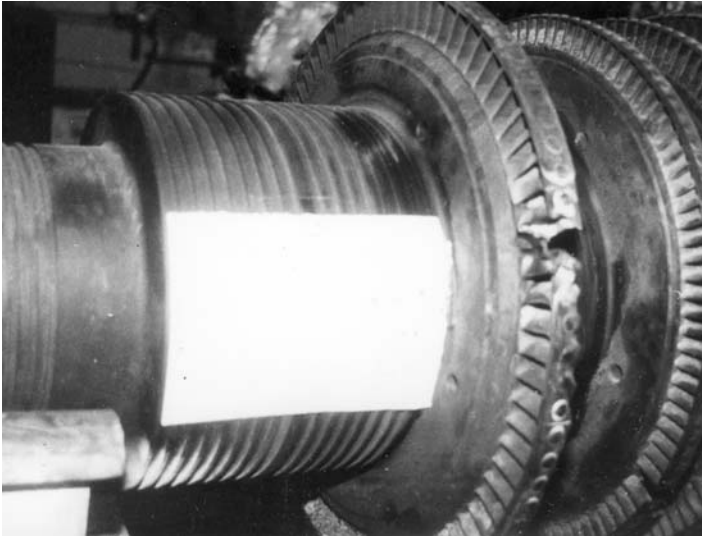
Fig. CH50.2 Damaged rotor C

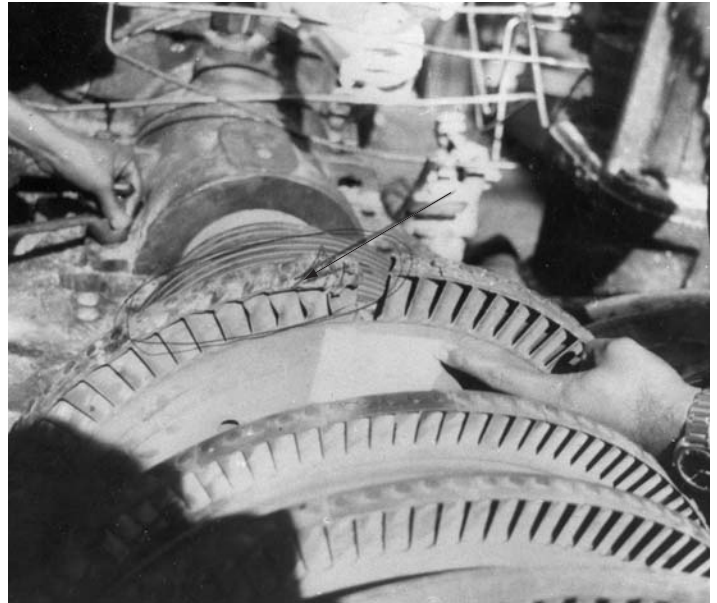
Fig. CH50.3 Close-up view of the damage to the first-stage disc

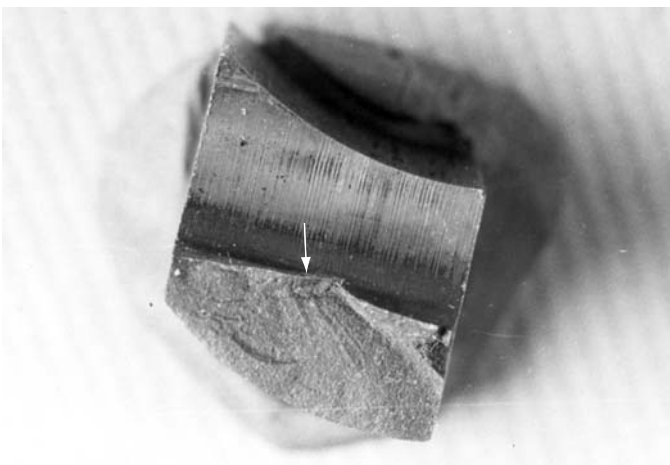
Fig. CH50.4 Microstructure from the root of blade C showing tempered martensite

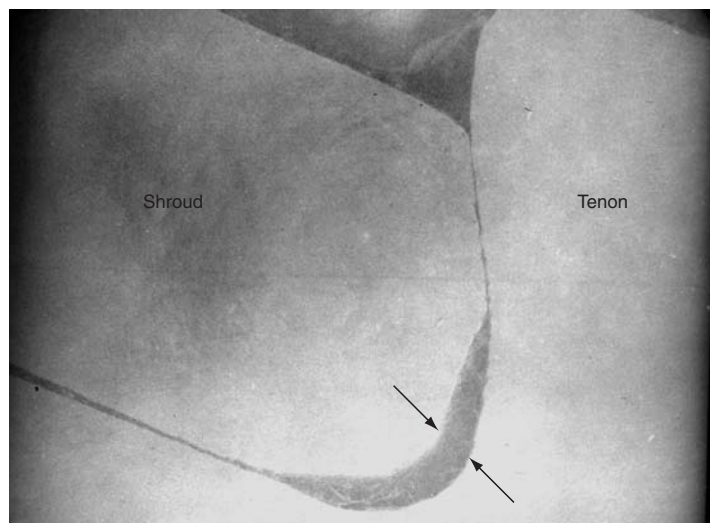
Fig. CH50.6 A section view of blade G at the tenon end showing the gap between the tenon and shroud plate

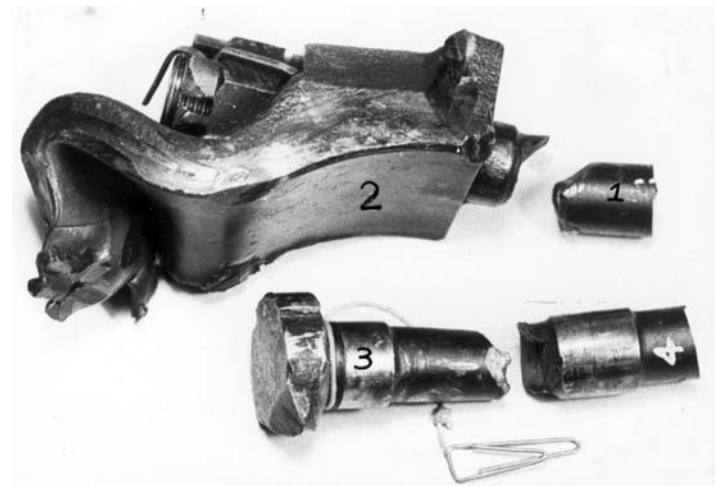
Fig. CH51.1 Failed En 24 steel bolts

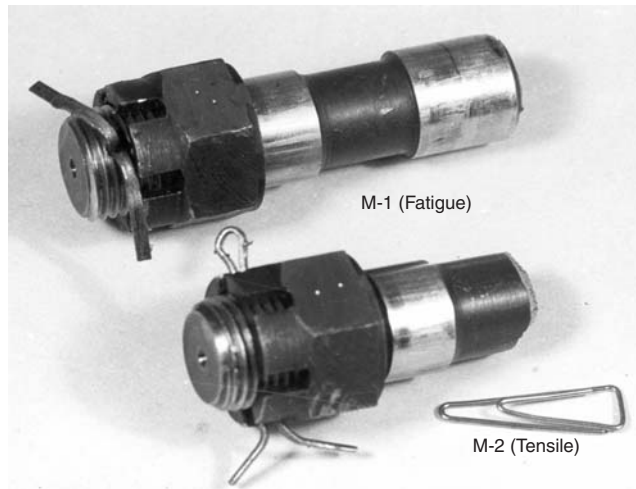
Fig. CH51.3 Failed maraging steel bolts

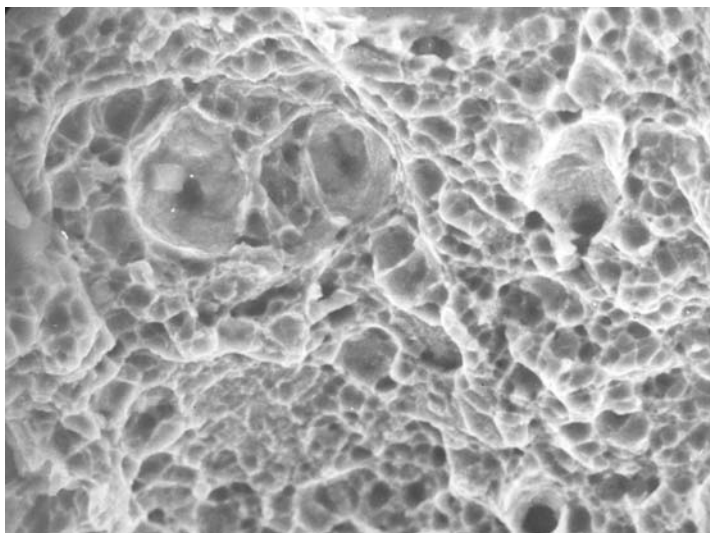
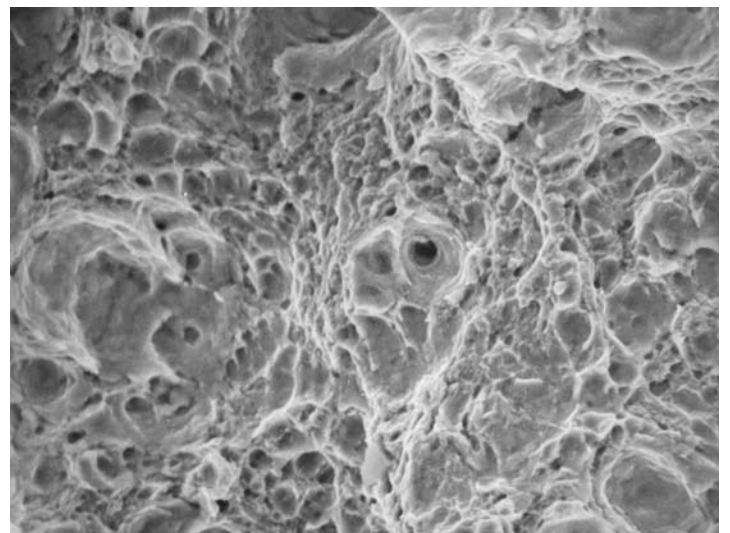
Fig. CH51.4 (a) Fracture surface of bolt M-1. (b) Fracture surface of bolt M-2

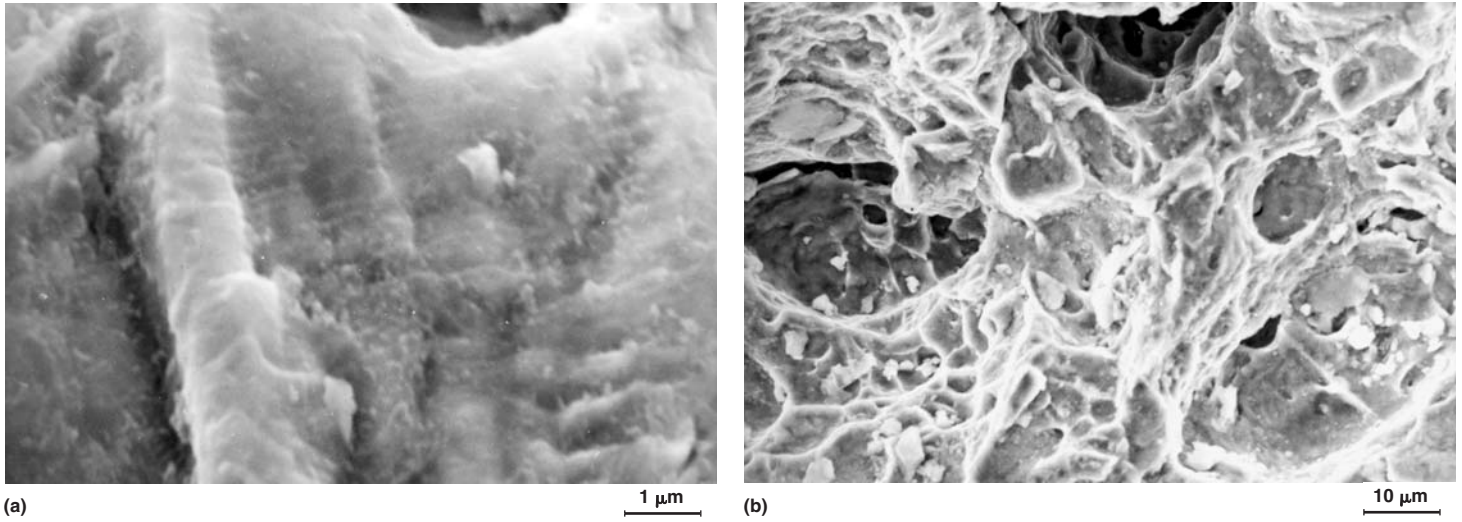
Fig. CH51.6 (a) SEM fractograph of bolt M-1 showing fatigue striations. (b) SEM fractograph of bolt M-1 showing dimples in the fast-fracture region

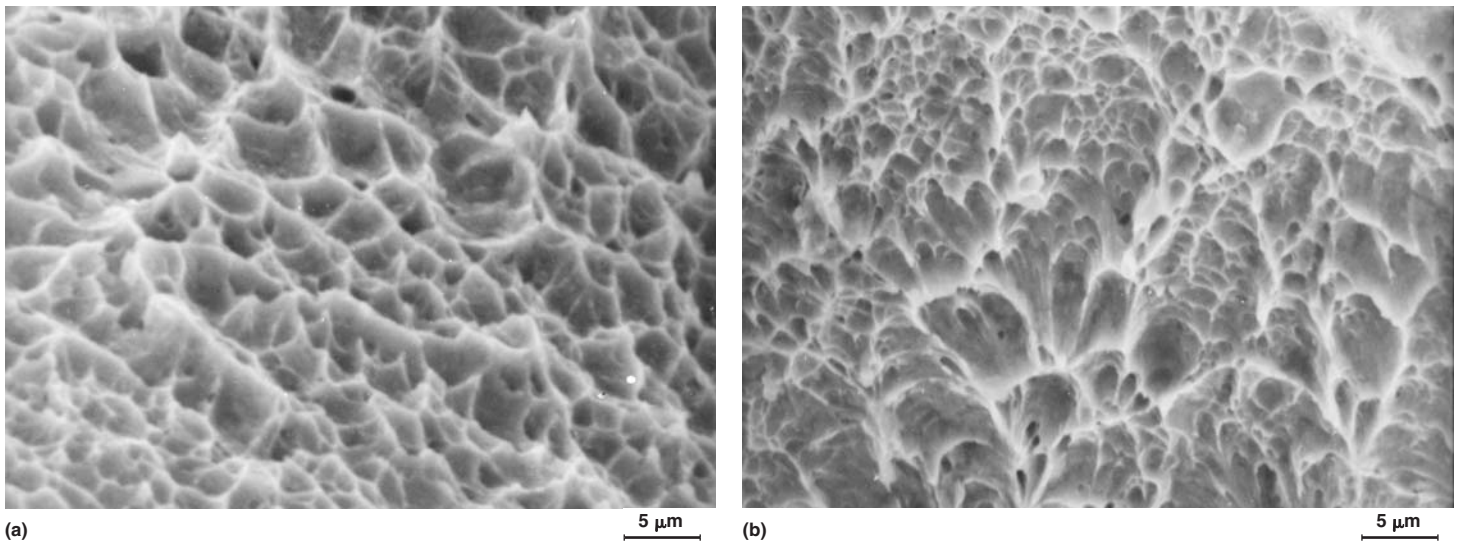
Fig. CH51.7 (a) SEM fractograph of bolt M-2 showing equiaxed dimples at the core. (b) SEM fractograph of bolt showing elongated dimples close to the edge

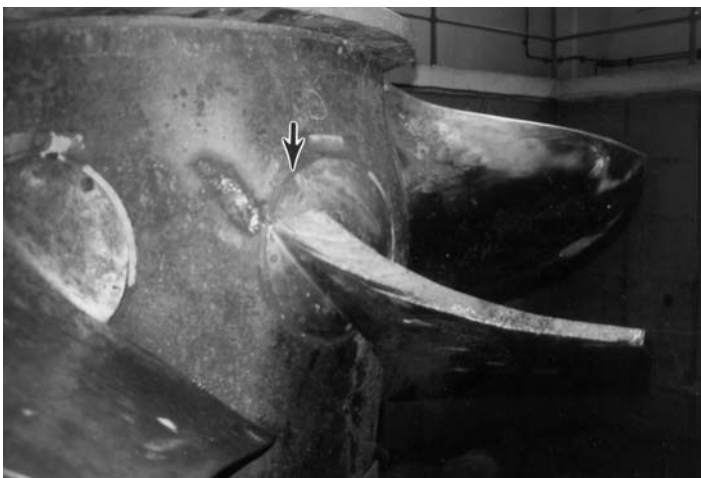
Fig. CH52.1 Failed runner showing the broken vane. Arrow indicates the origin of fatigue.

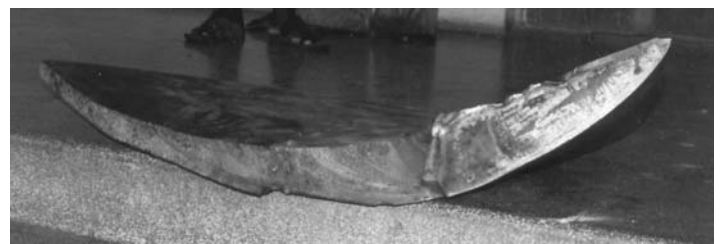
Fig. CH52.2 Fracture surface showing the fatigue and rapid-fracture zones

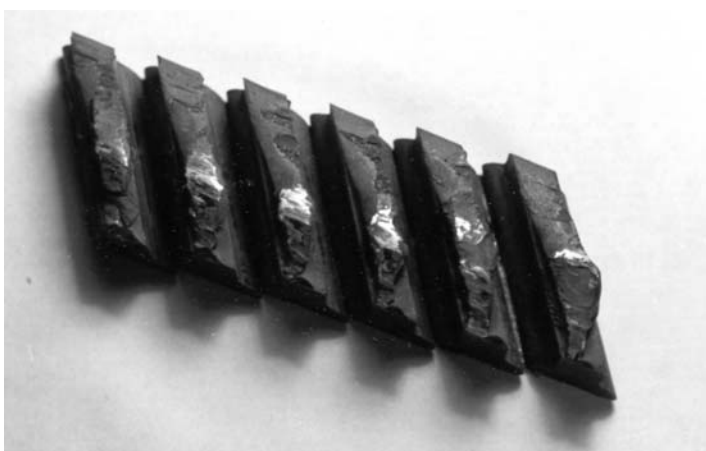
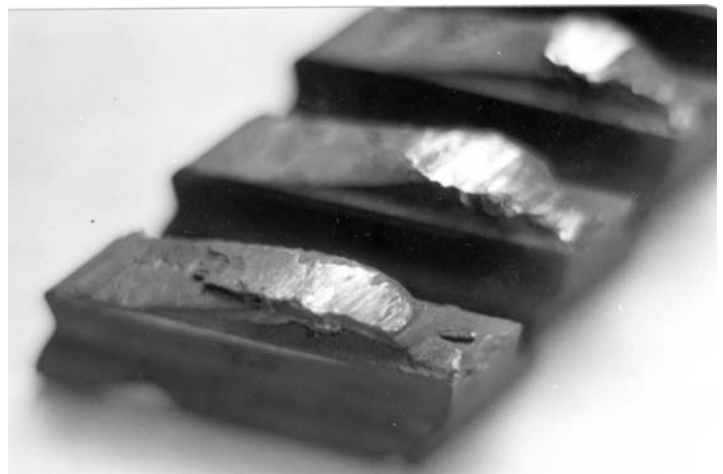
The gap had increased to about 30 mm, with deposits of burnt/molten metal. Farther down on the first-stage turbine blades, some deposits of molten metal were found, similar to those between the 18th and 19th stages.

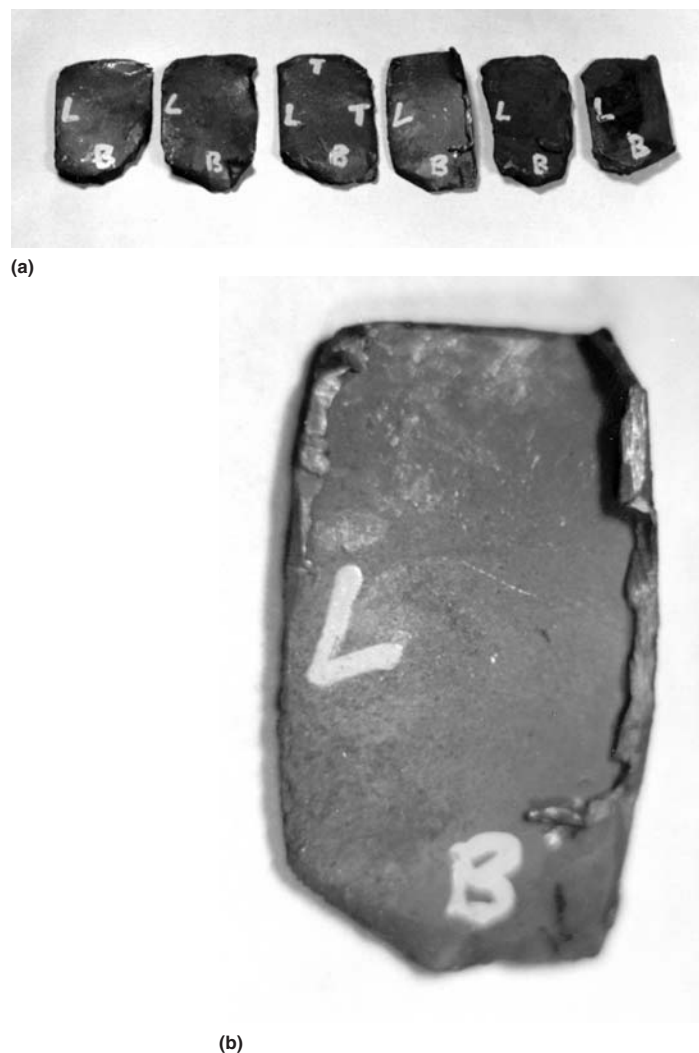
Fig. CH53.2 (a) Fractured airfoil sections. (b) Close-up view of one of the sections

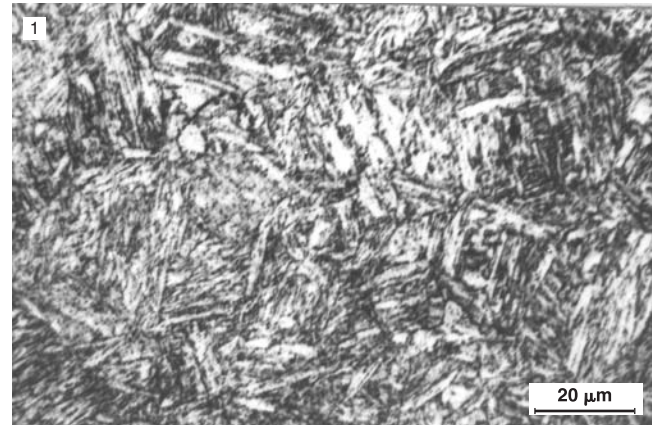
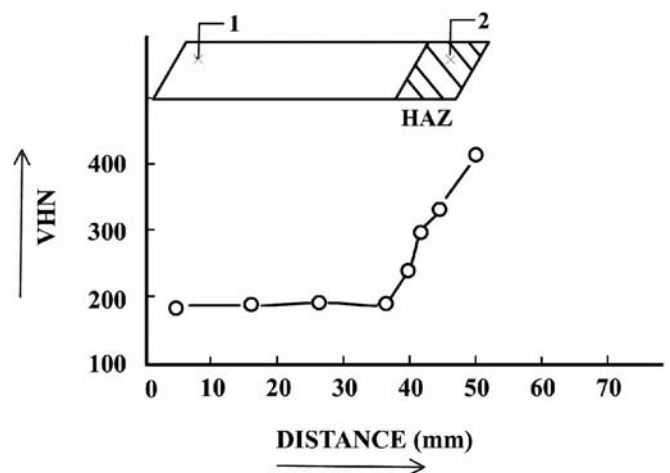
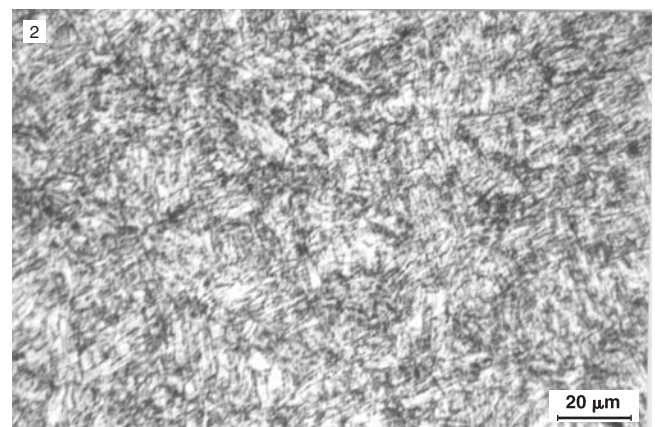
Fig. CH53.3 Hardness profile and microstructures across the transverse section at the root of a blade of 19th stage

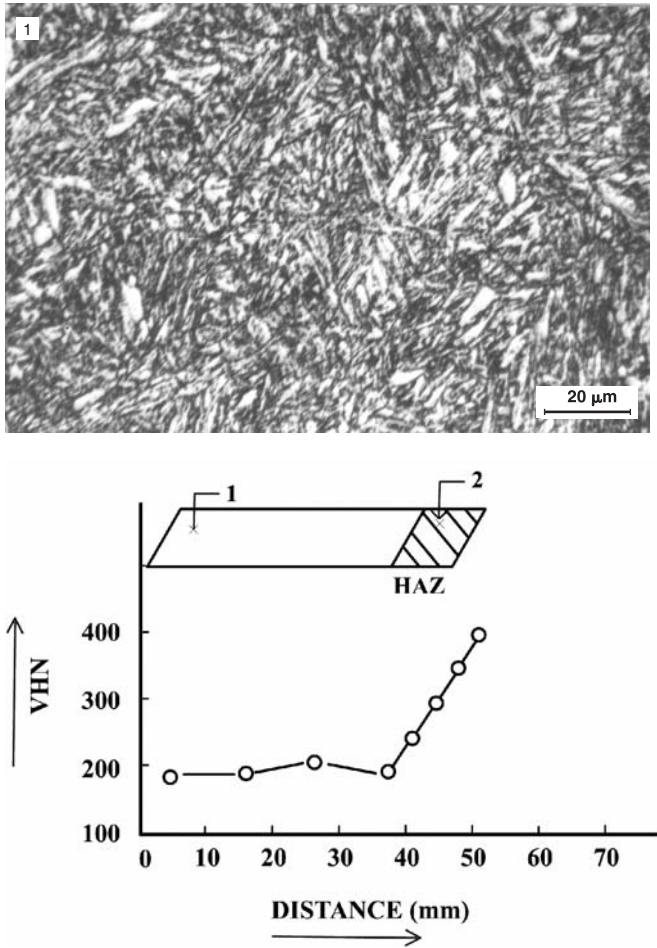
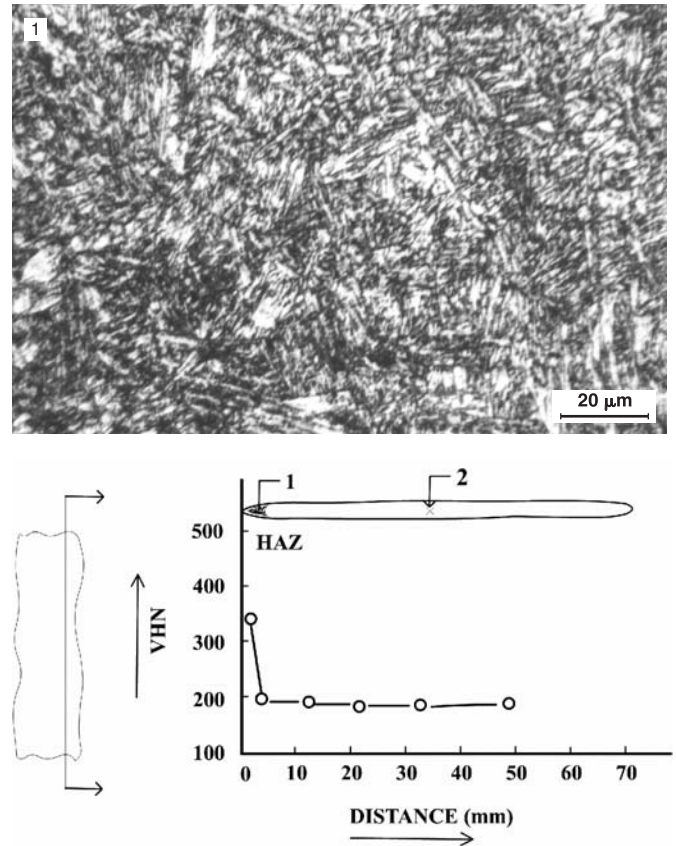
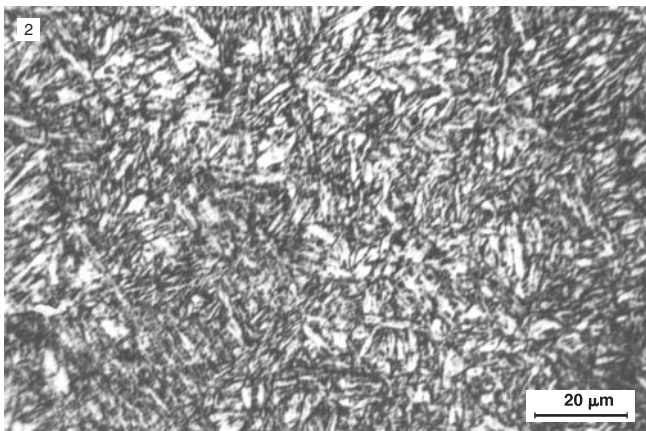
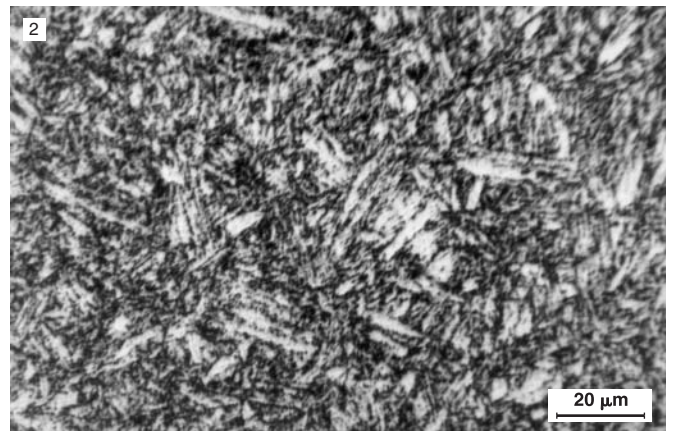
Fig. CH53.4 Hardness profile and microstructures across the transverse section at the root of another blade of 19th stage

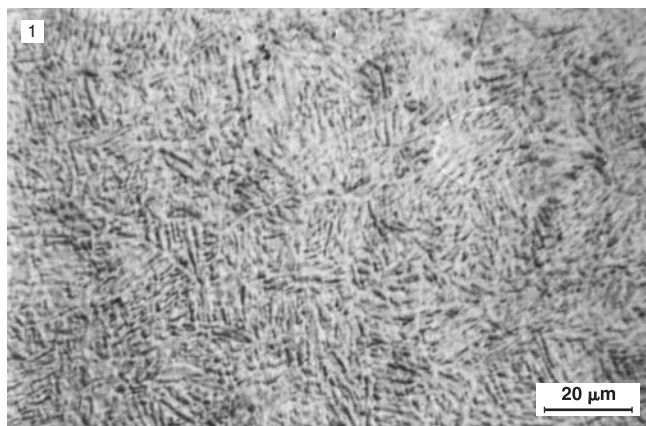
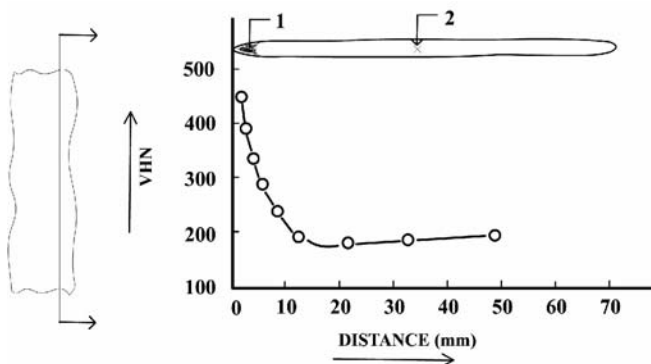
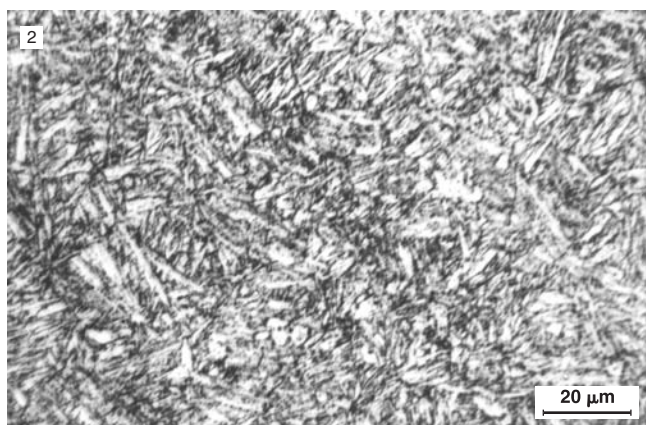
Fig. CH53.6 Hardness profile and microstructures along the longitudinal section of the airfoil region of a blade

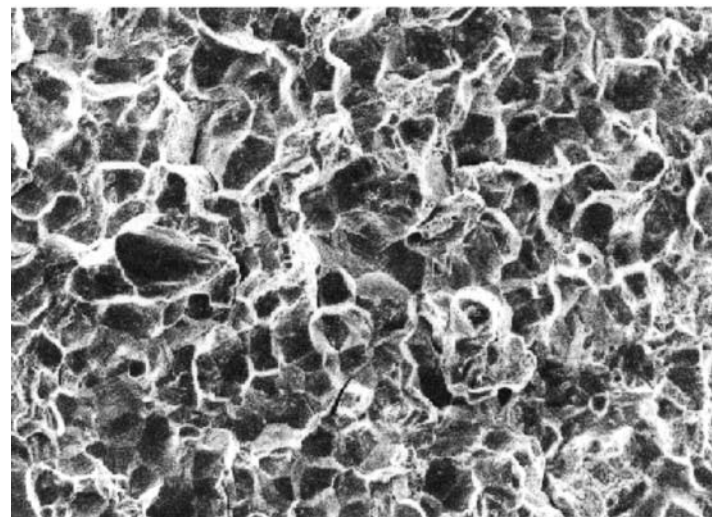
Fig. CH54.1 SEM fractograph of the failed screw showing intergranular fracture facets with partially formed dimples

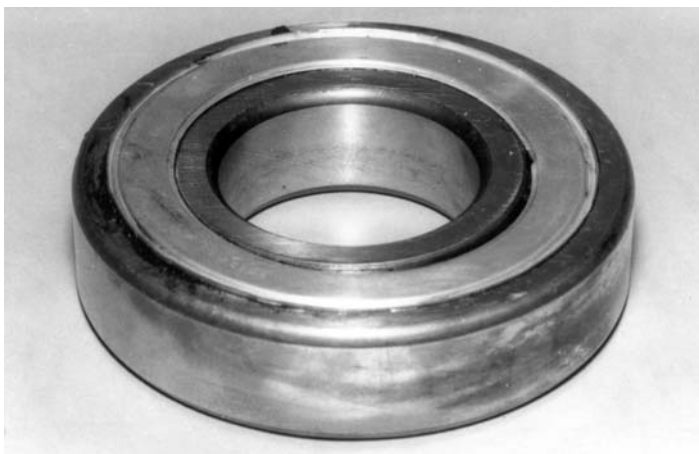
Fig. CH55.1 Failed bearing

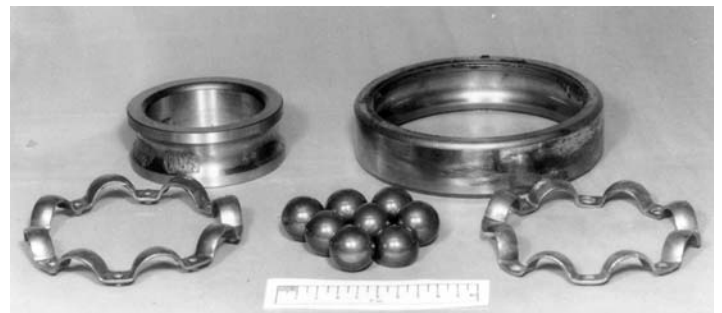
Fig. CH55.2 The bearing in the dismantled condition showing the inner and outer ring raceways, the split cage, and the bearing balls

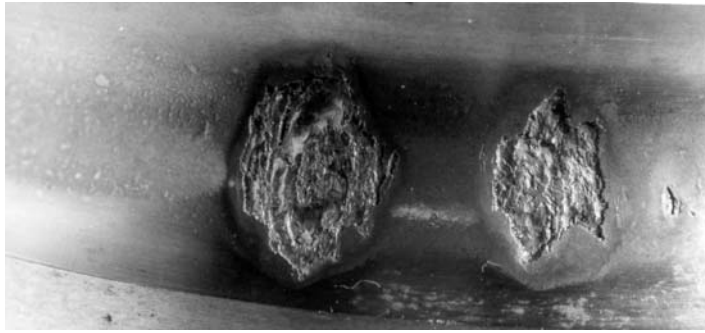
Fig. CH55.3 Craters and metal bruising seen on the inner ring raceway

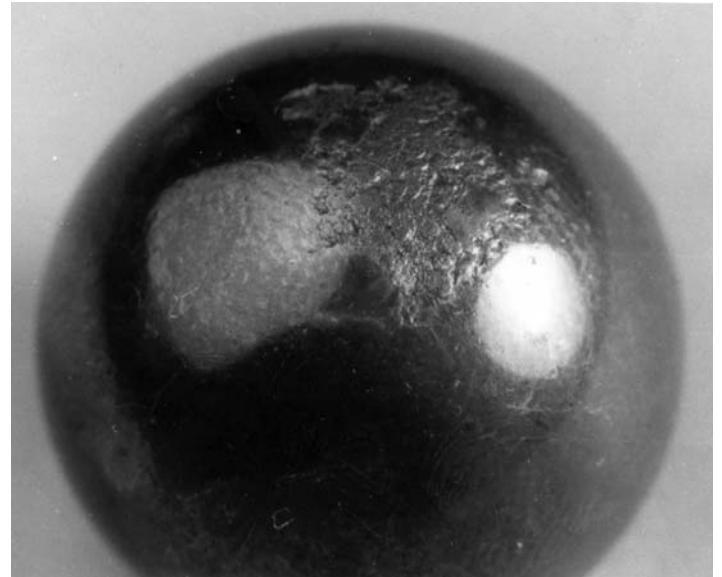
Fig. CH55.4 Craters seen on one of the bearing balls
