The 2016 Mw 7.1 Kumamoto Earthquake

A Photographic Atlas of Coseismic Surface Ruptures
Related to the Aso Volcano, Japan

Aiming Lin
Department of Geophysics
Kyoto University
Kyoto, Japan

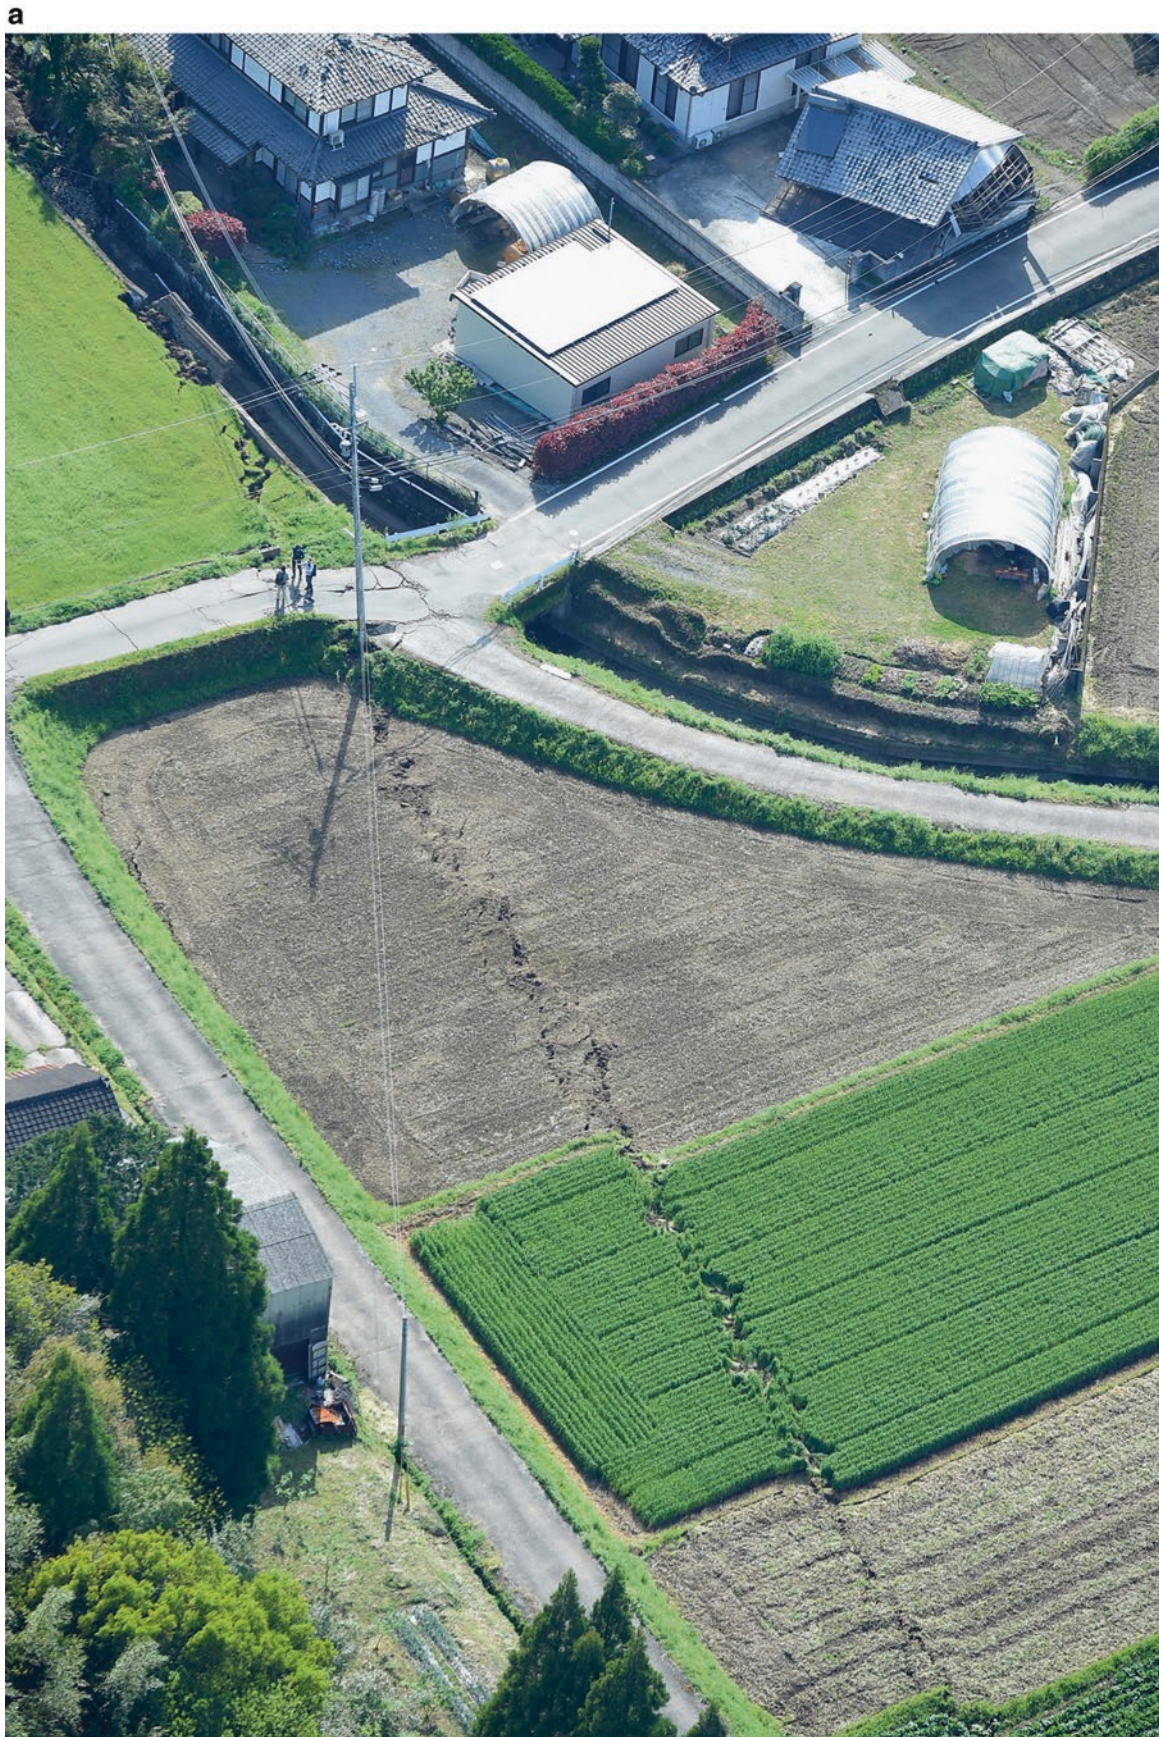
Figure Plate 3 Right-lateral strike-slip offset of wheat fields in the coseismic surface rupture zone. (a) Aerial photograph (with permission from The Mainichi Newspapers). (b, c) Strike-slip offset of field paths,

measuring ~2.5 m, which was the maximum displacement in the 2016 coseismic surface rupture zone

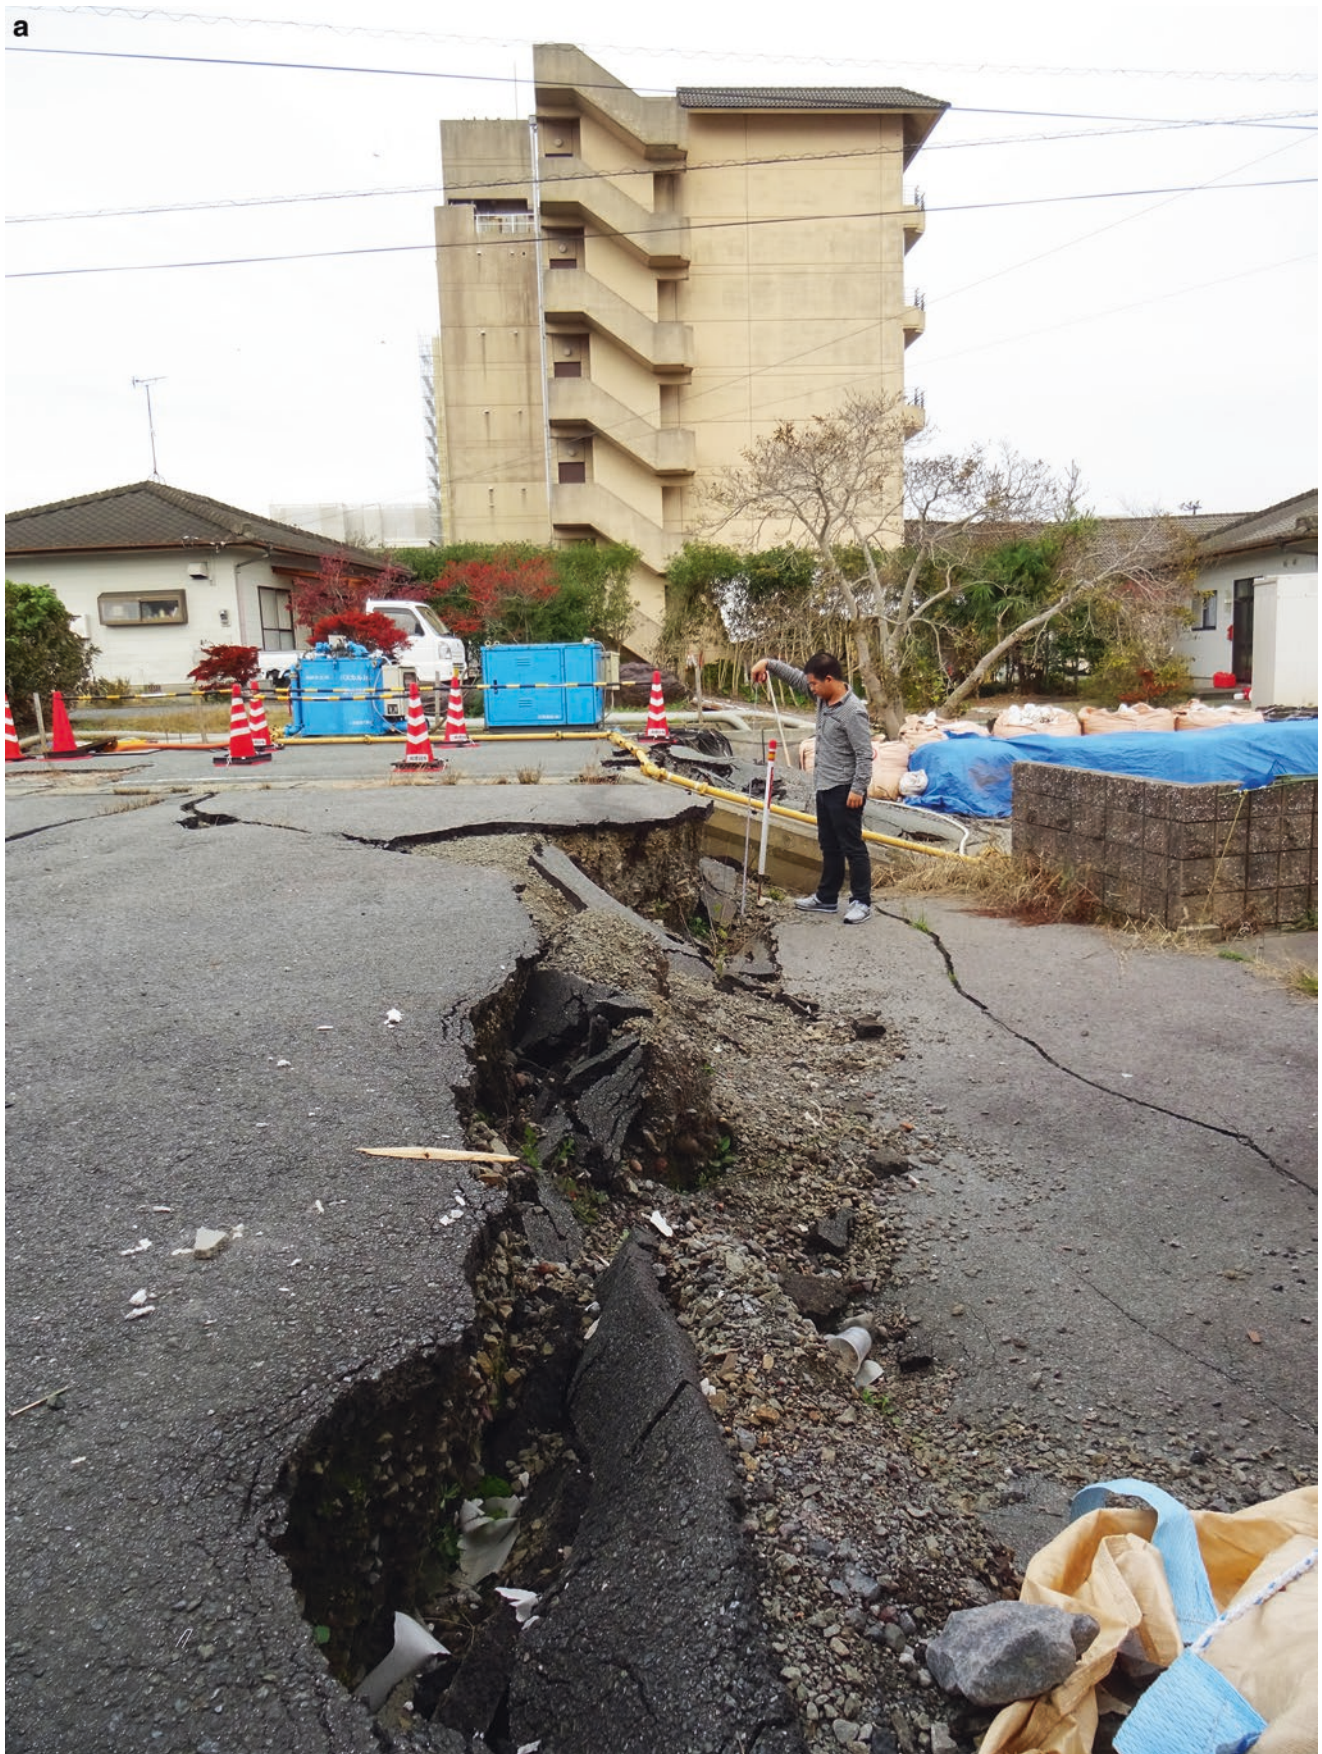
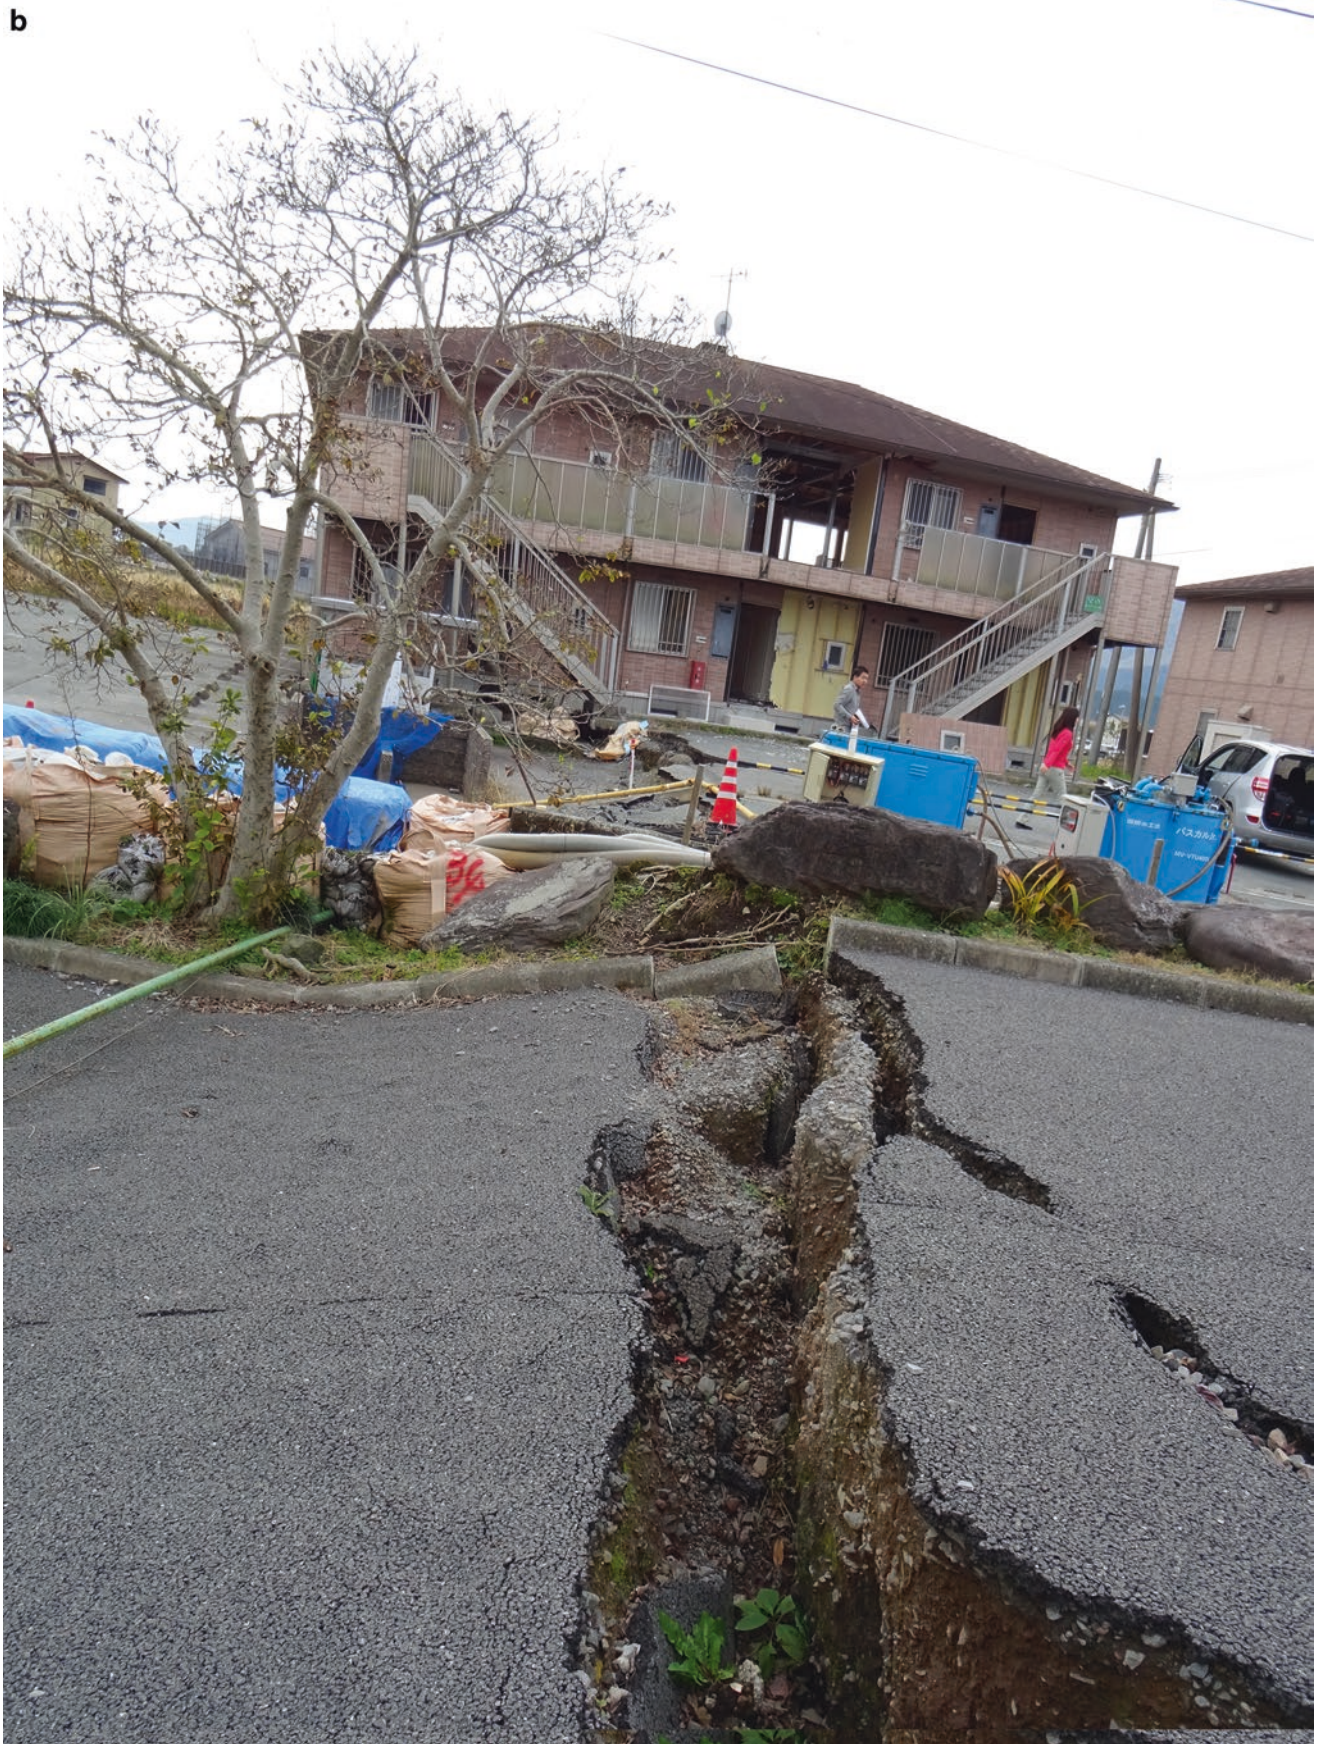
Figure Plate 4 Damaged building (a) and house (b) on the same coseismic fault scarp (vertical offset ~ 0.7 m)

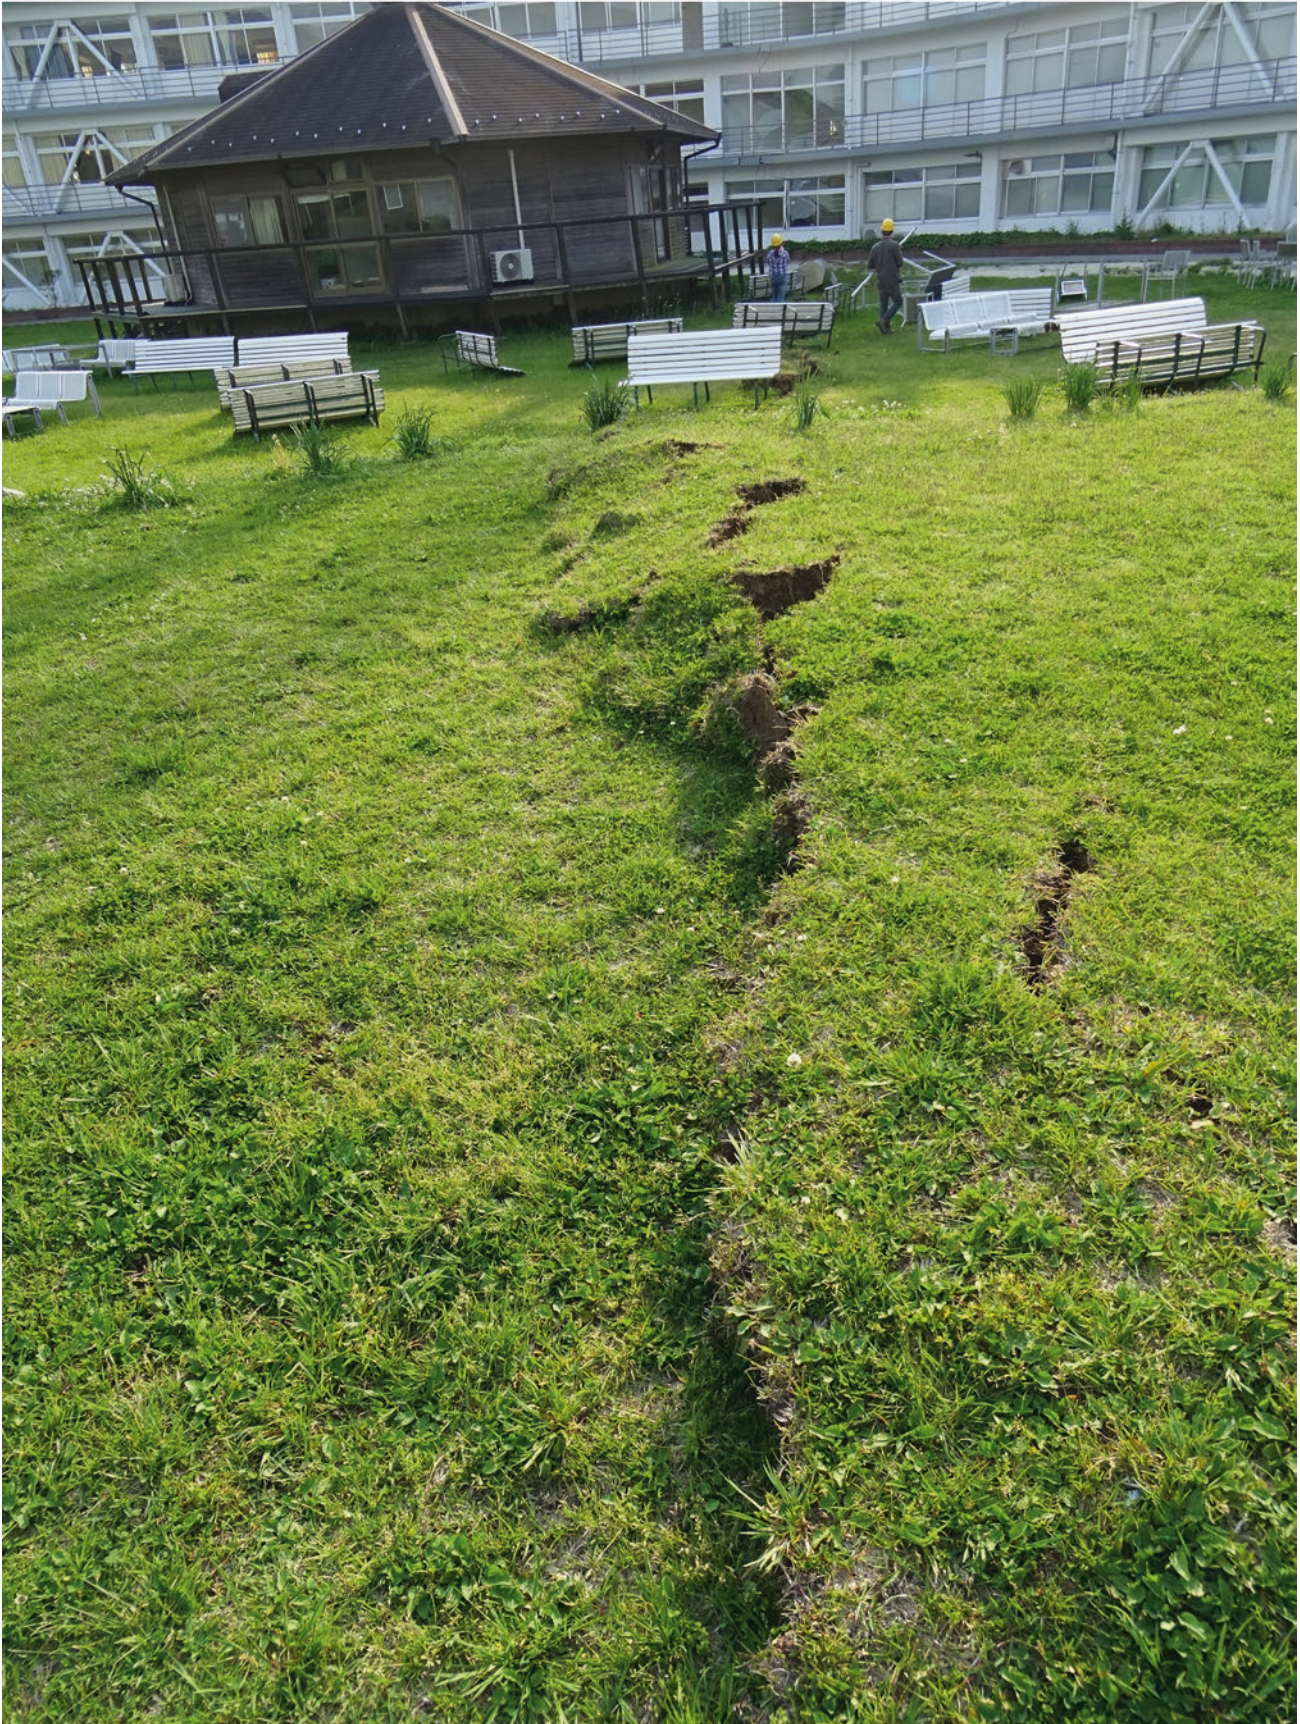
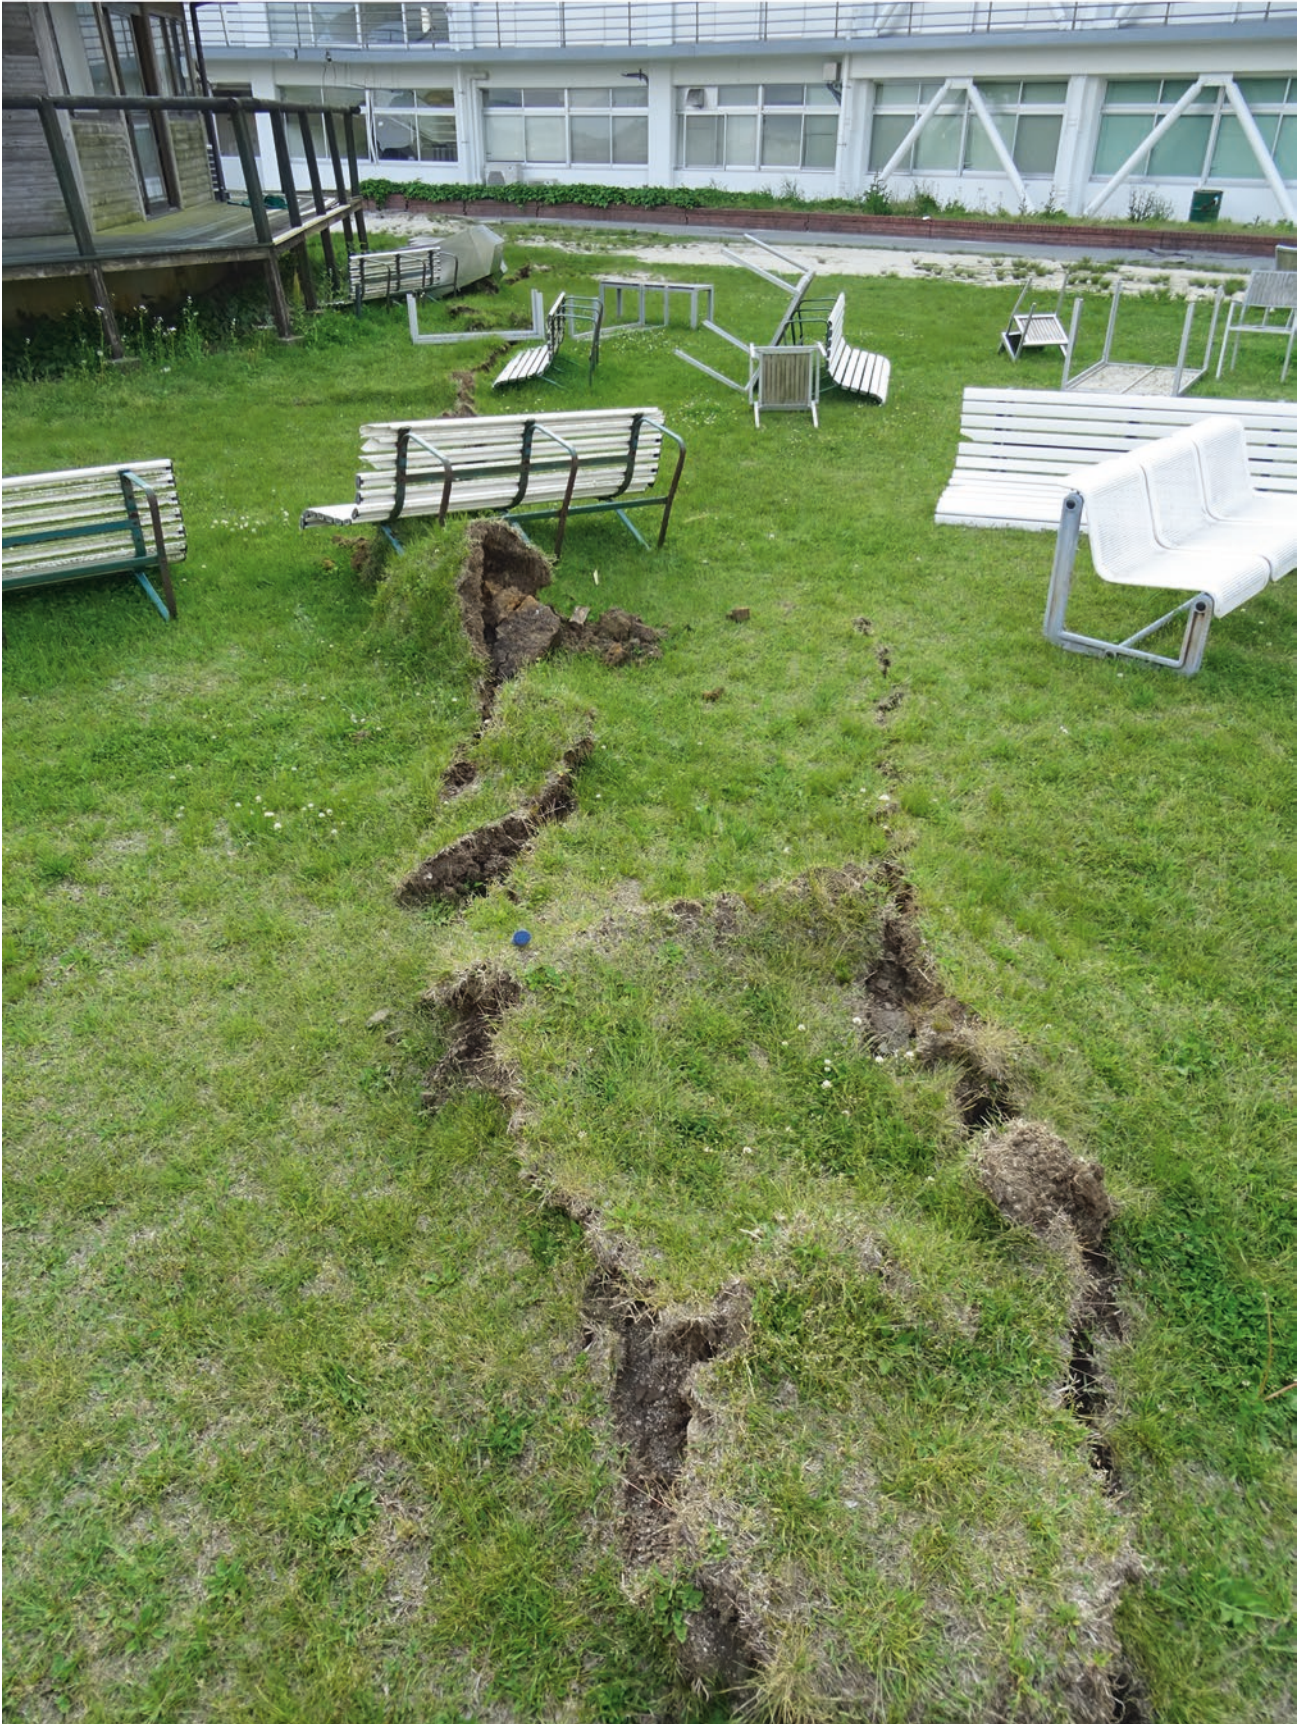
Figure Plate 5 (a) Coseismic surface ruptures and a damaged building in the schoolyard at the Aso campus of Tokai University. (b) Mole track structure in the surface rupture zone in the schoolyard

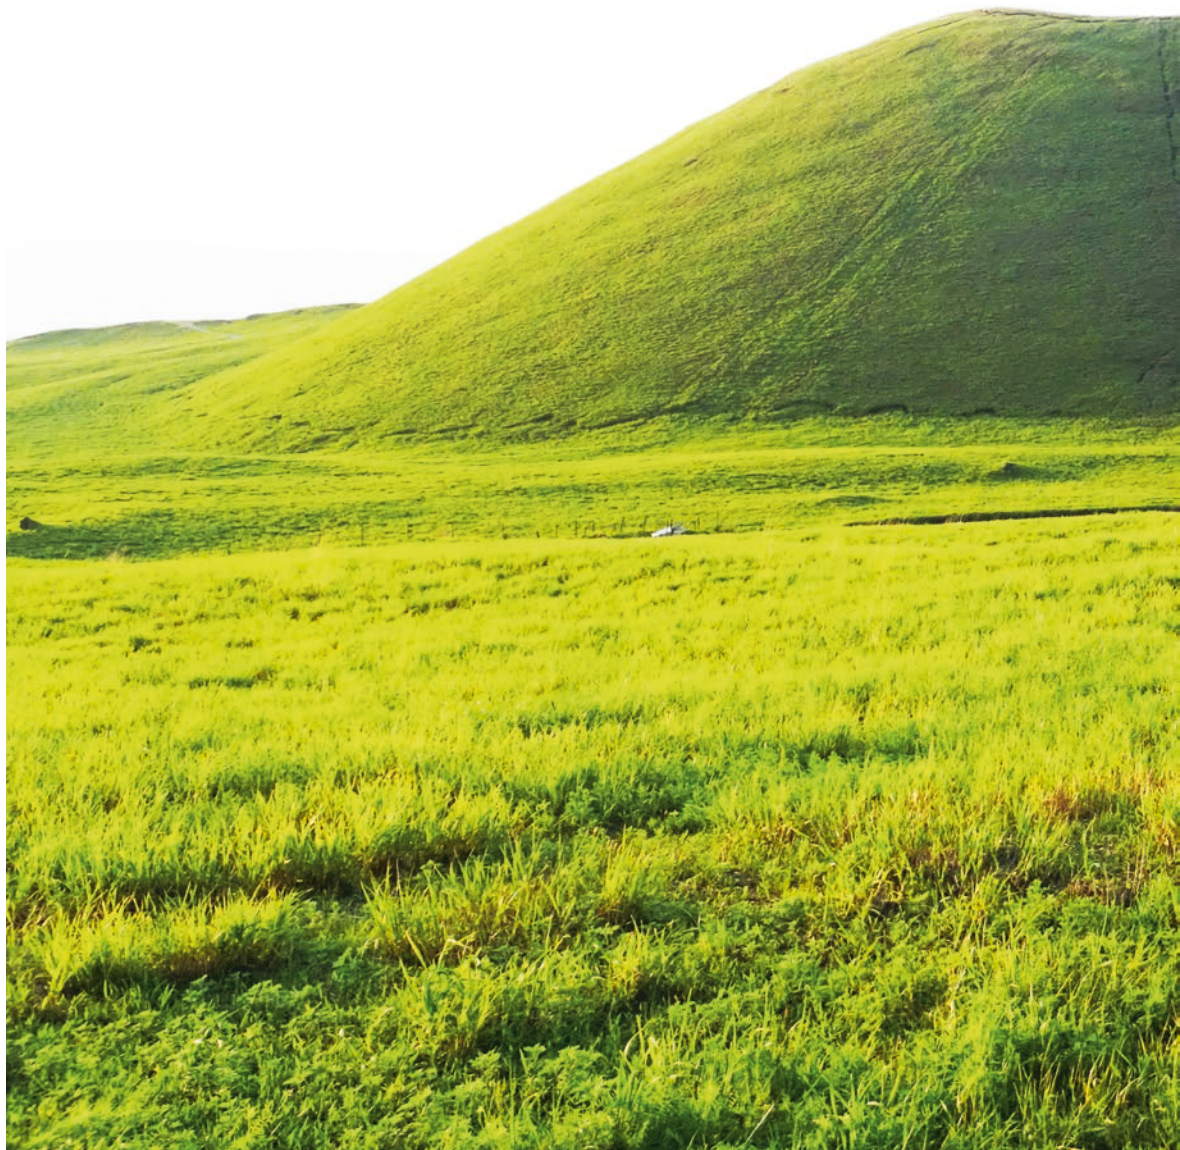
Figure Plate 6 Drone image showing an overview of the Komezuka volcanic cone ruptured by the 2016 Kumamoto earthquake

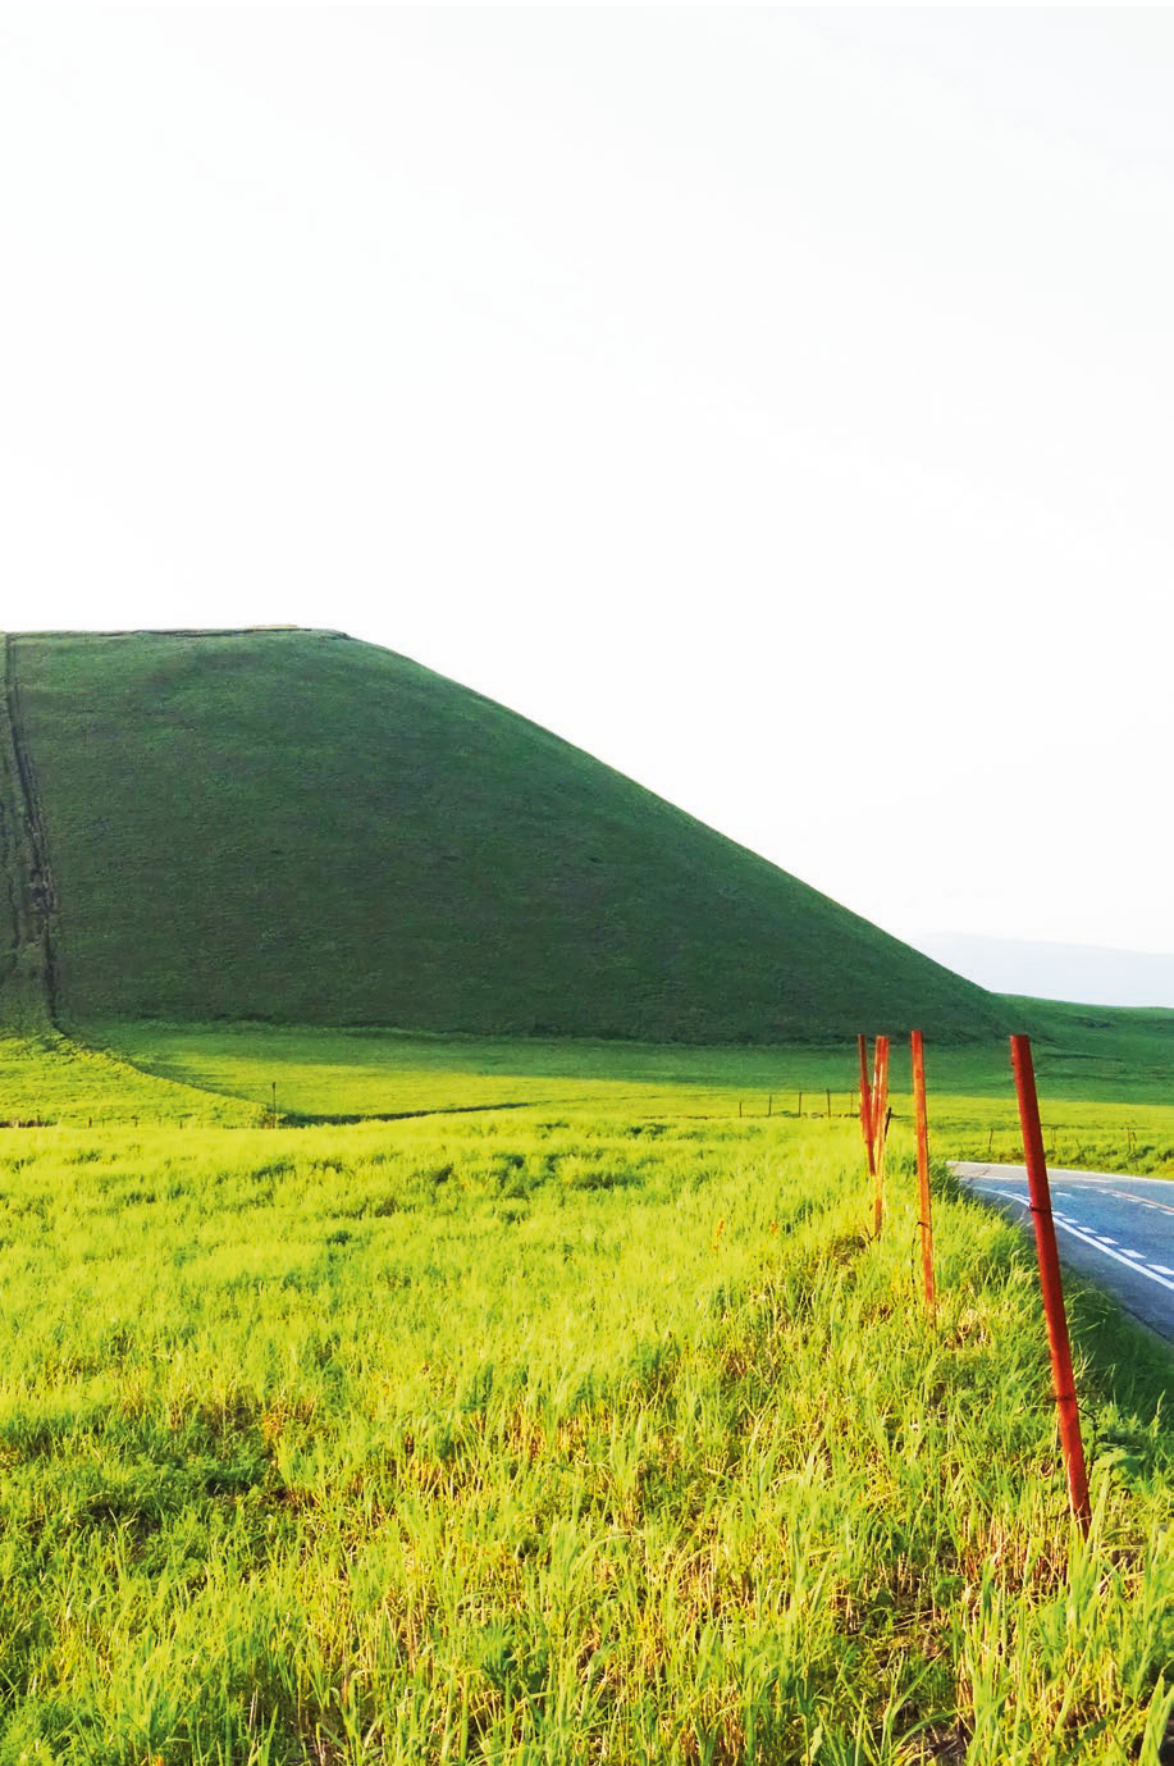
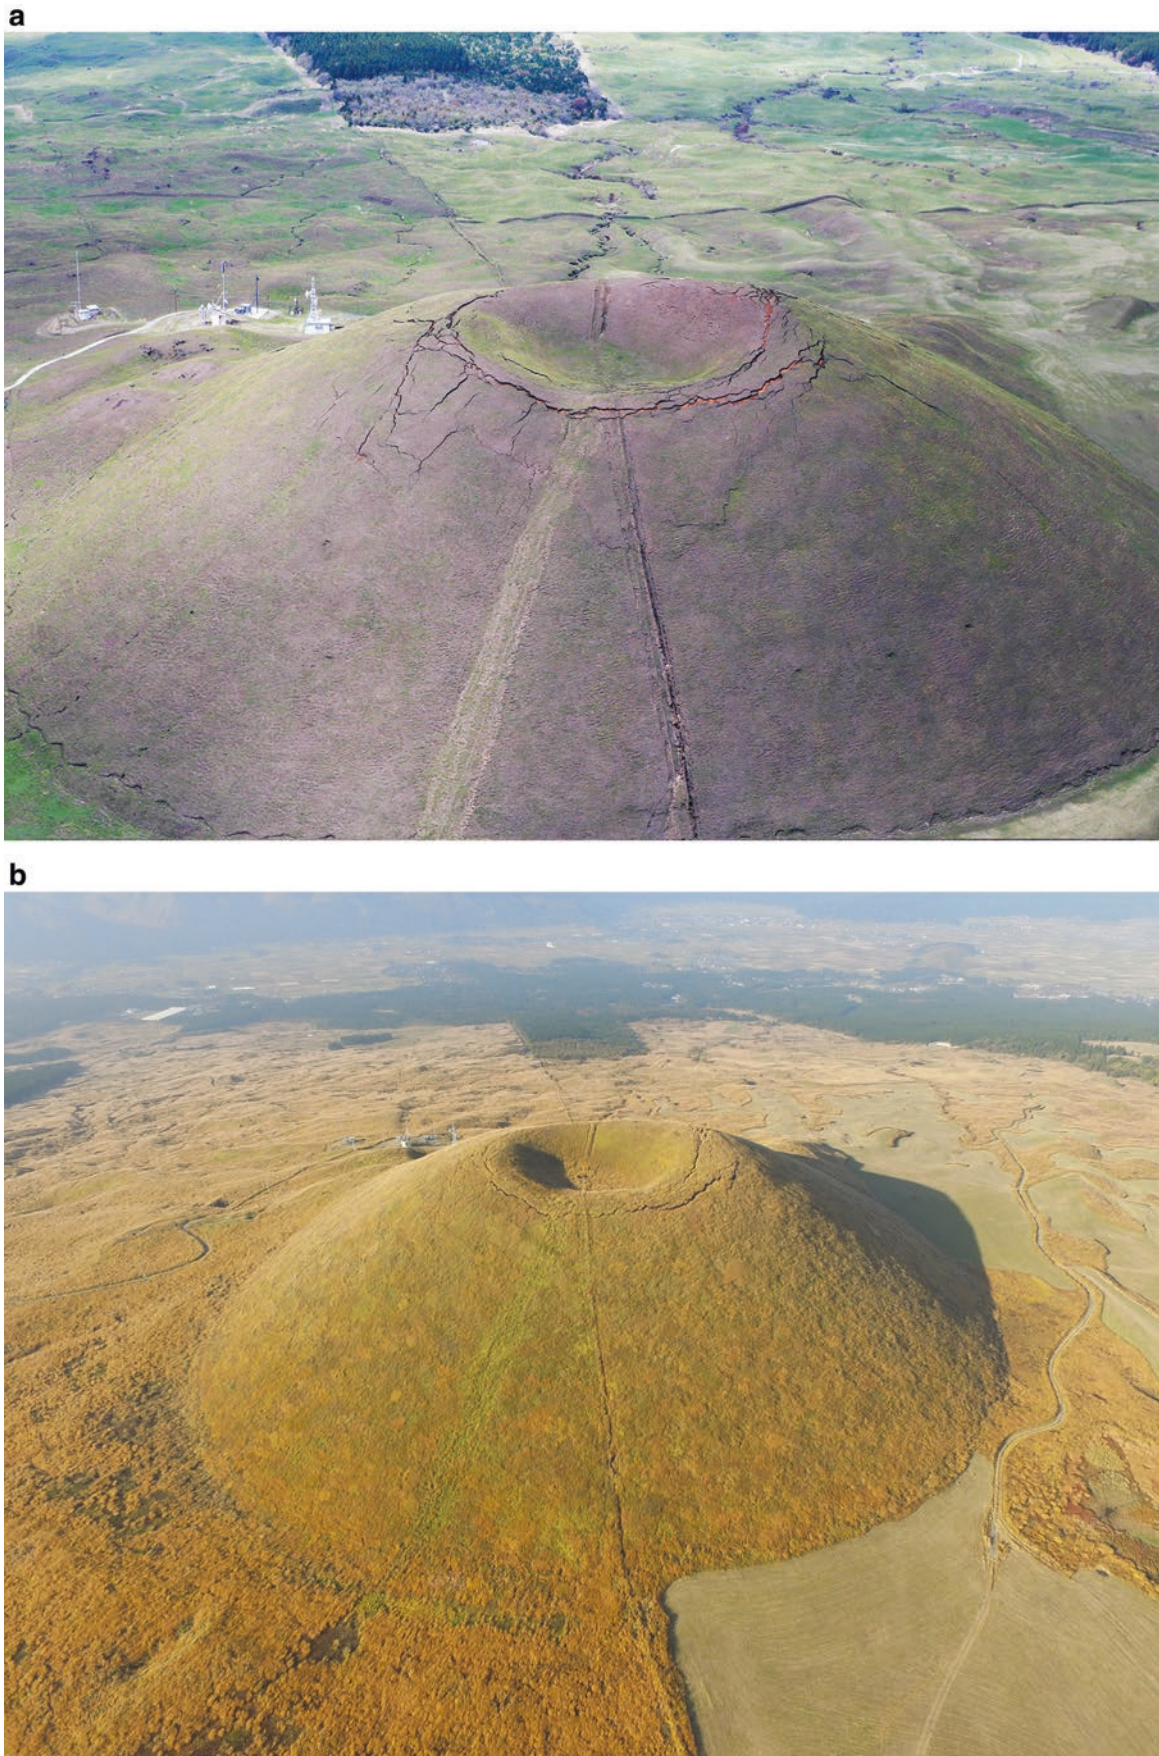
Figure Plate 7 Coseismic surface ruptures on both the top and the foot of the Komezuka caldera. (a) Aerial photograph acquired on April 17, 2016 (with kind permission from Jiji Press). (b) Drone image taken on November 16, 2016

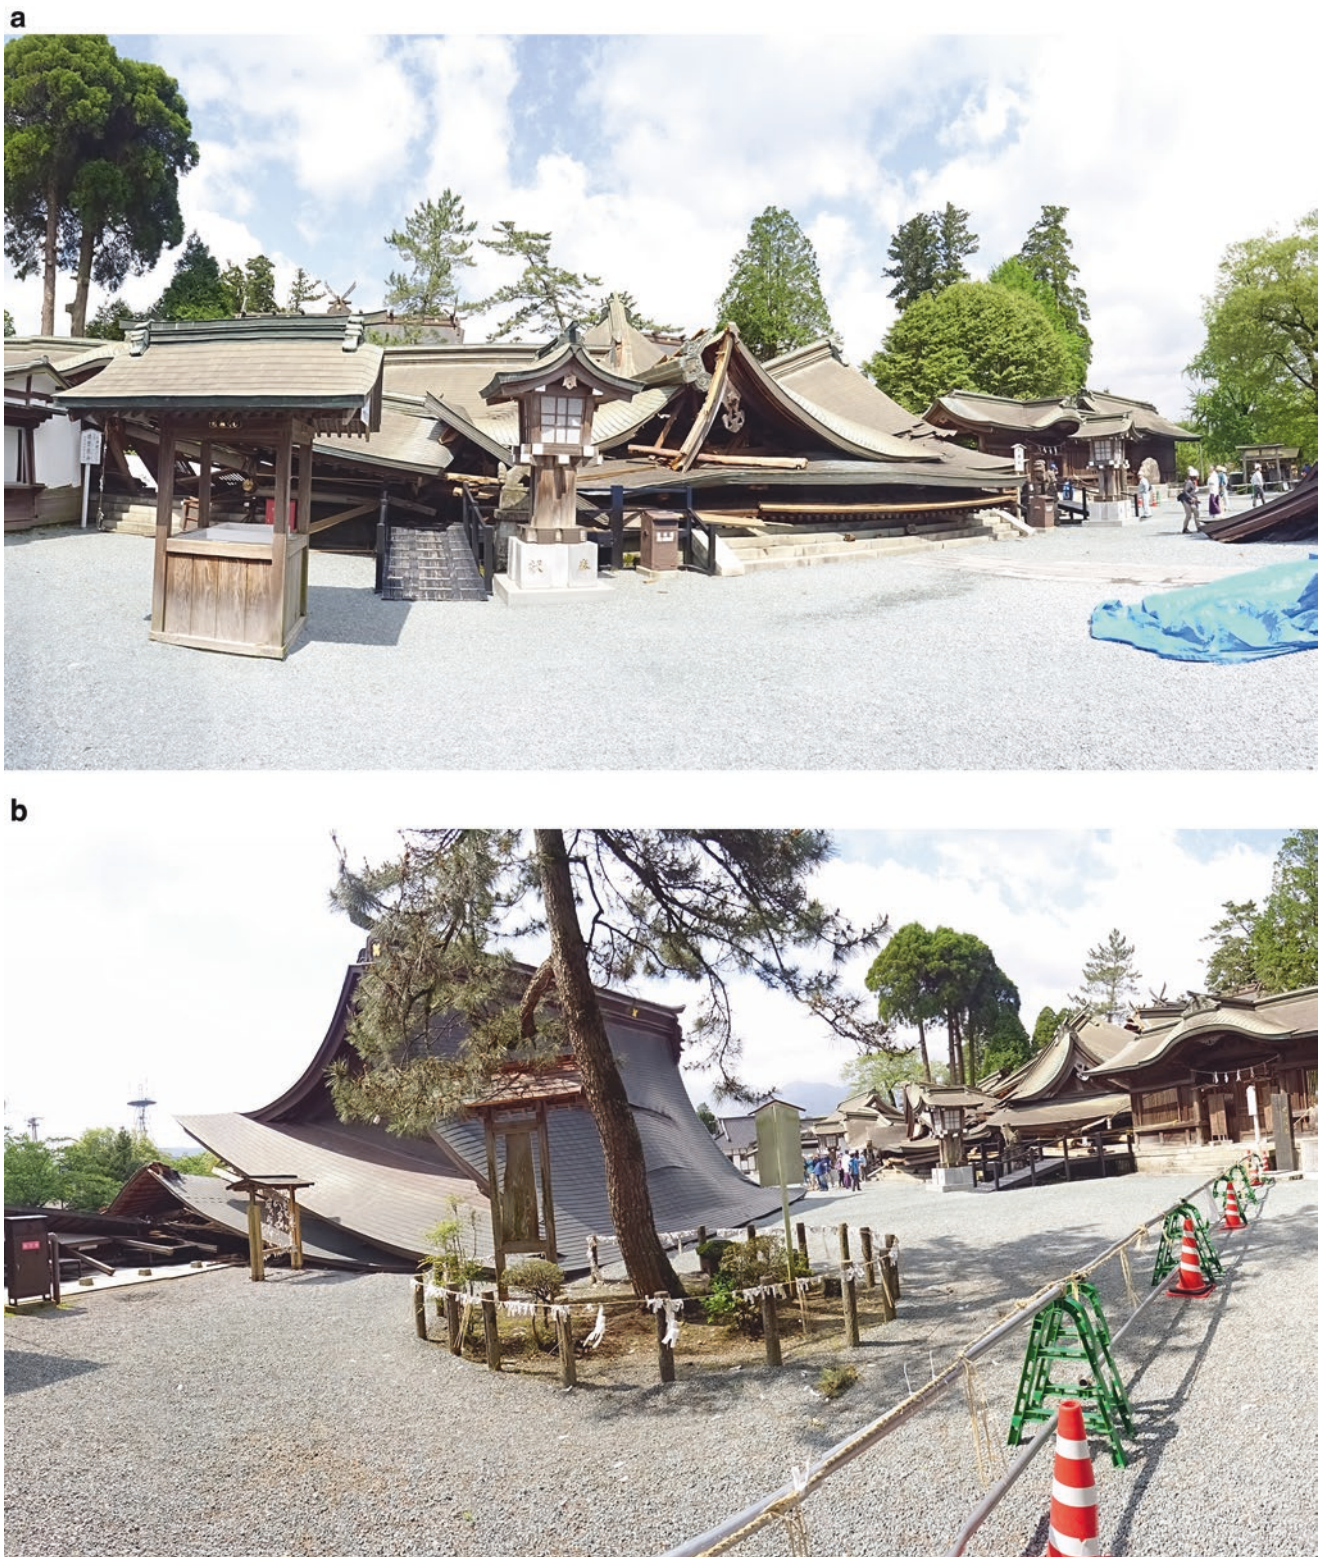
Figure Plate 11 Aso Shrine collapsed by the Kumamoto earthquake (a, b). (a) Overview of damaged Aso shrine. (b) Damaged shrine tower gate

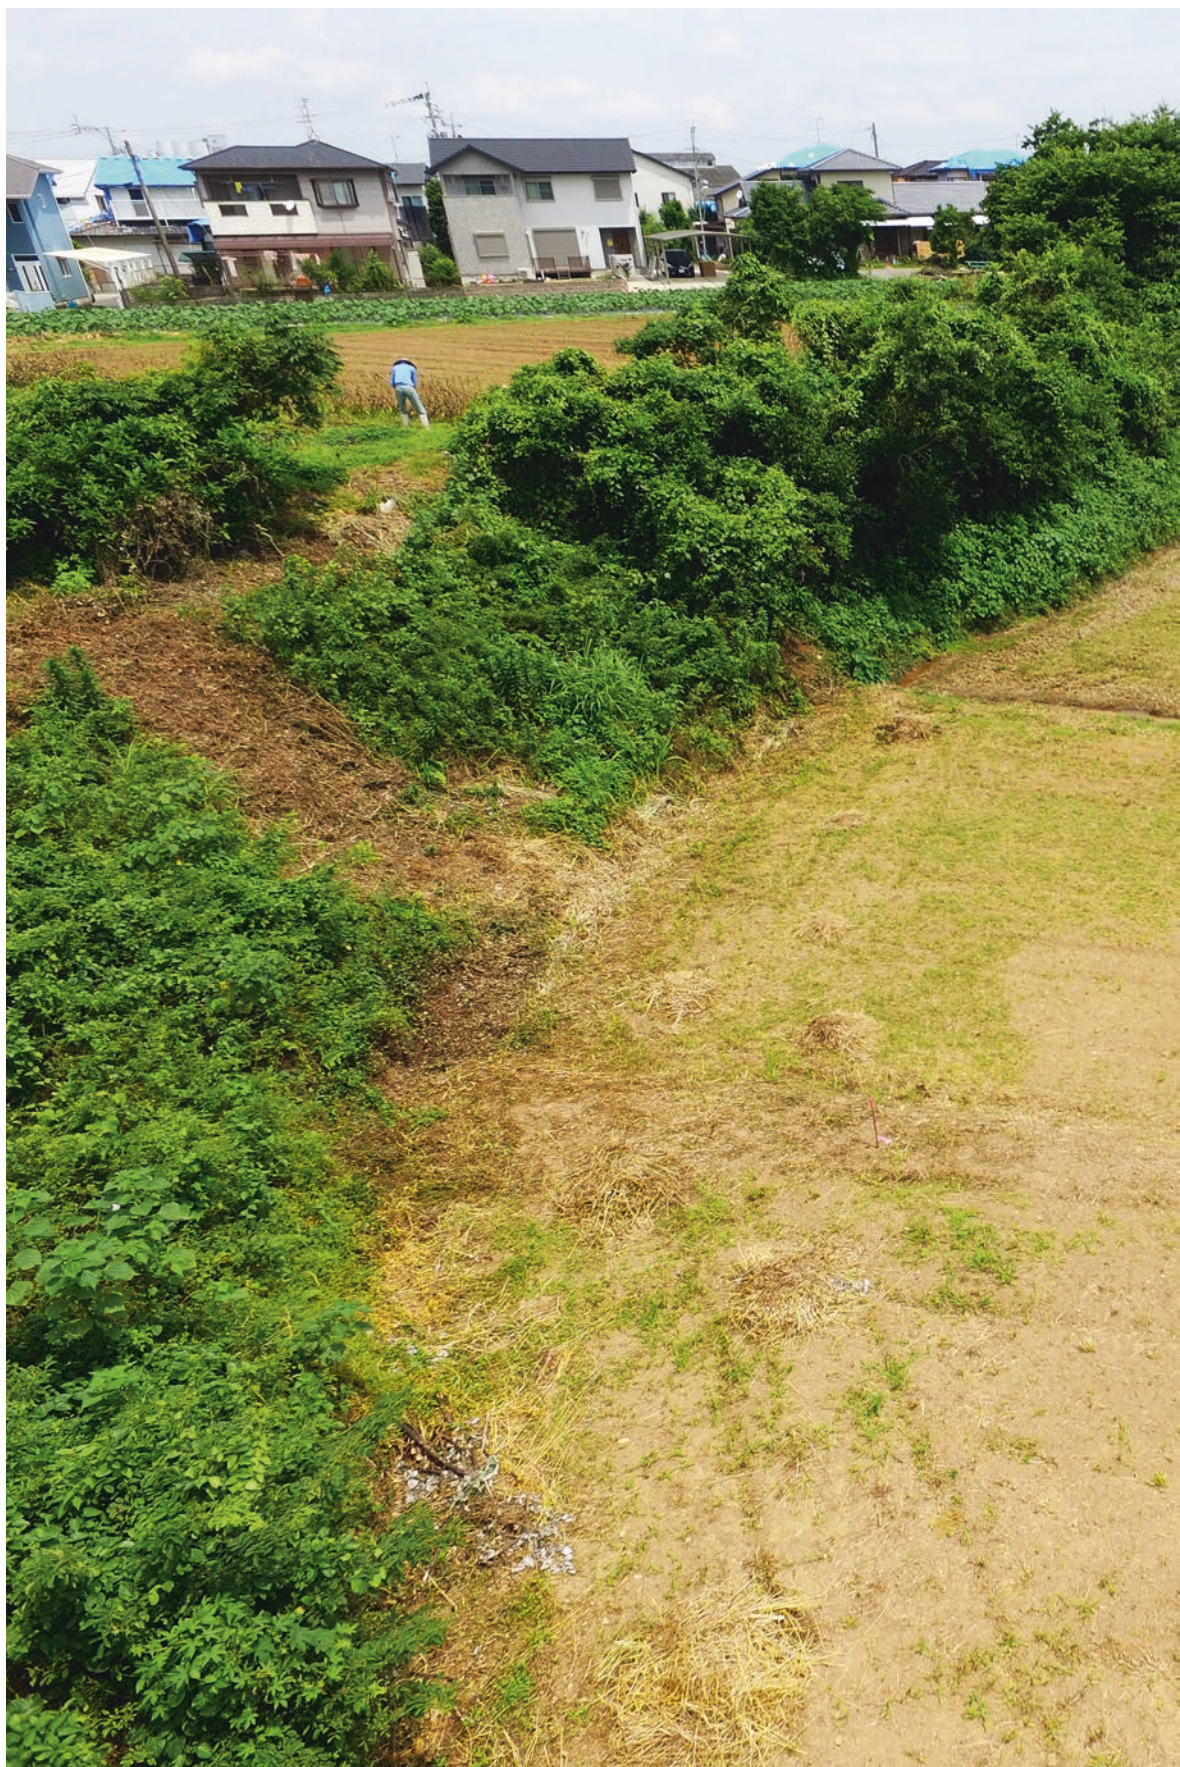
Fig. 5 Drone image showing the left-stepping tension cracks along the coseismic surface rupture zone in rice fields
