The 2016 Mw 7.1 Kumamoto Earthquake

A Photographic Atlas of Coseismic Surface Ruptures
Related to the Aso Volcano, Japan

Aiming Lin
Department of Geophysics
Kyoto University
Kyoto, Japan

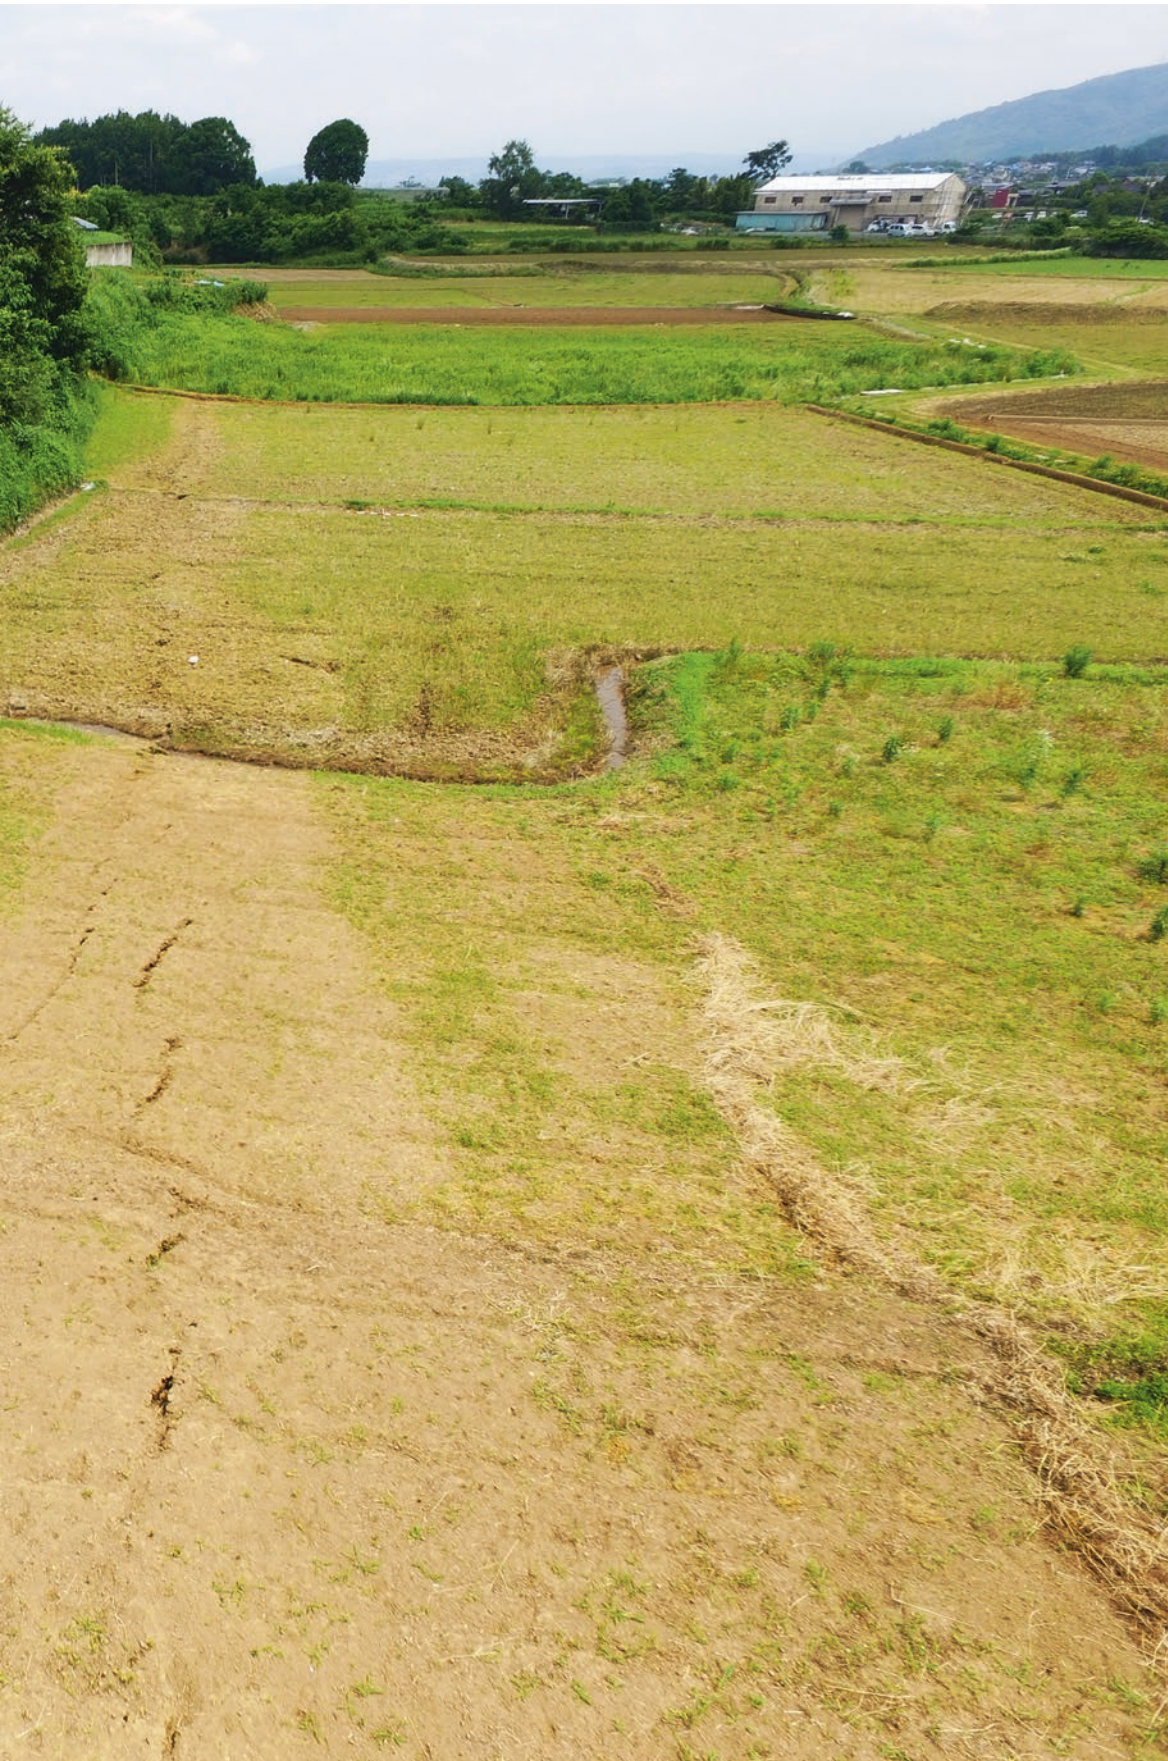
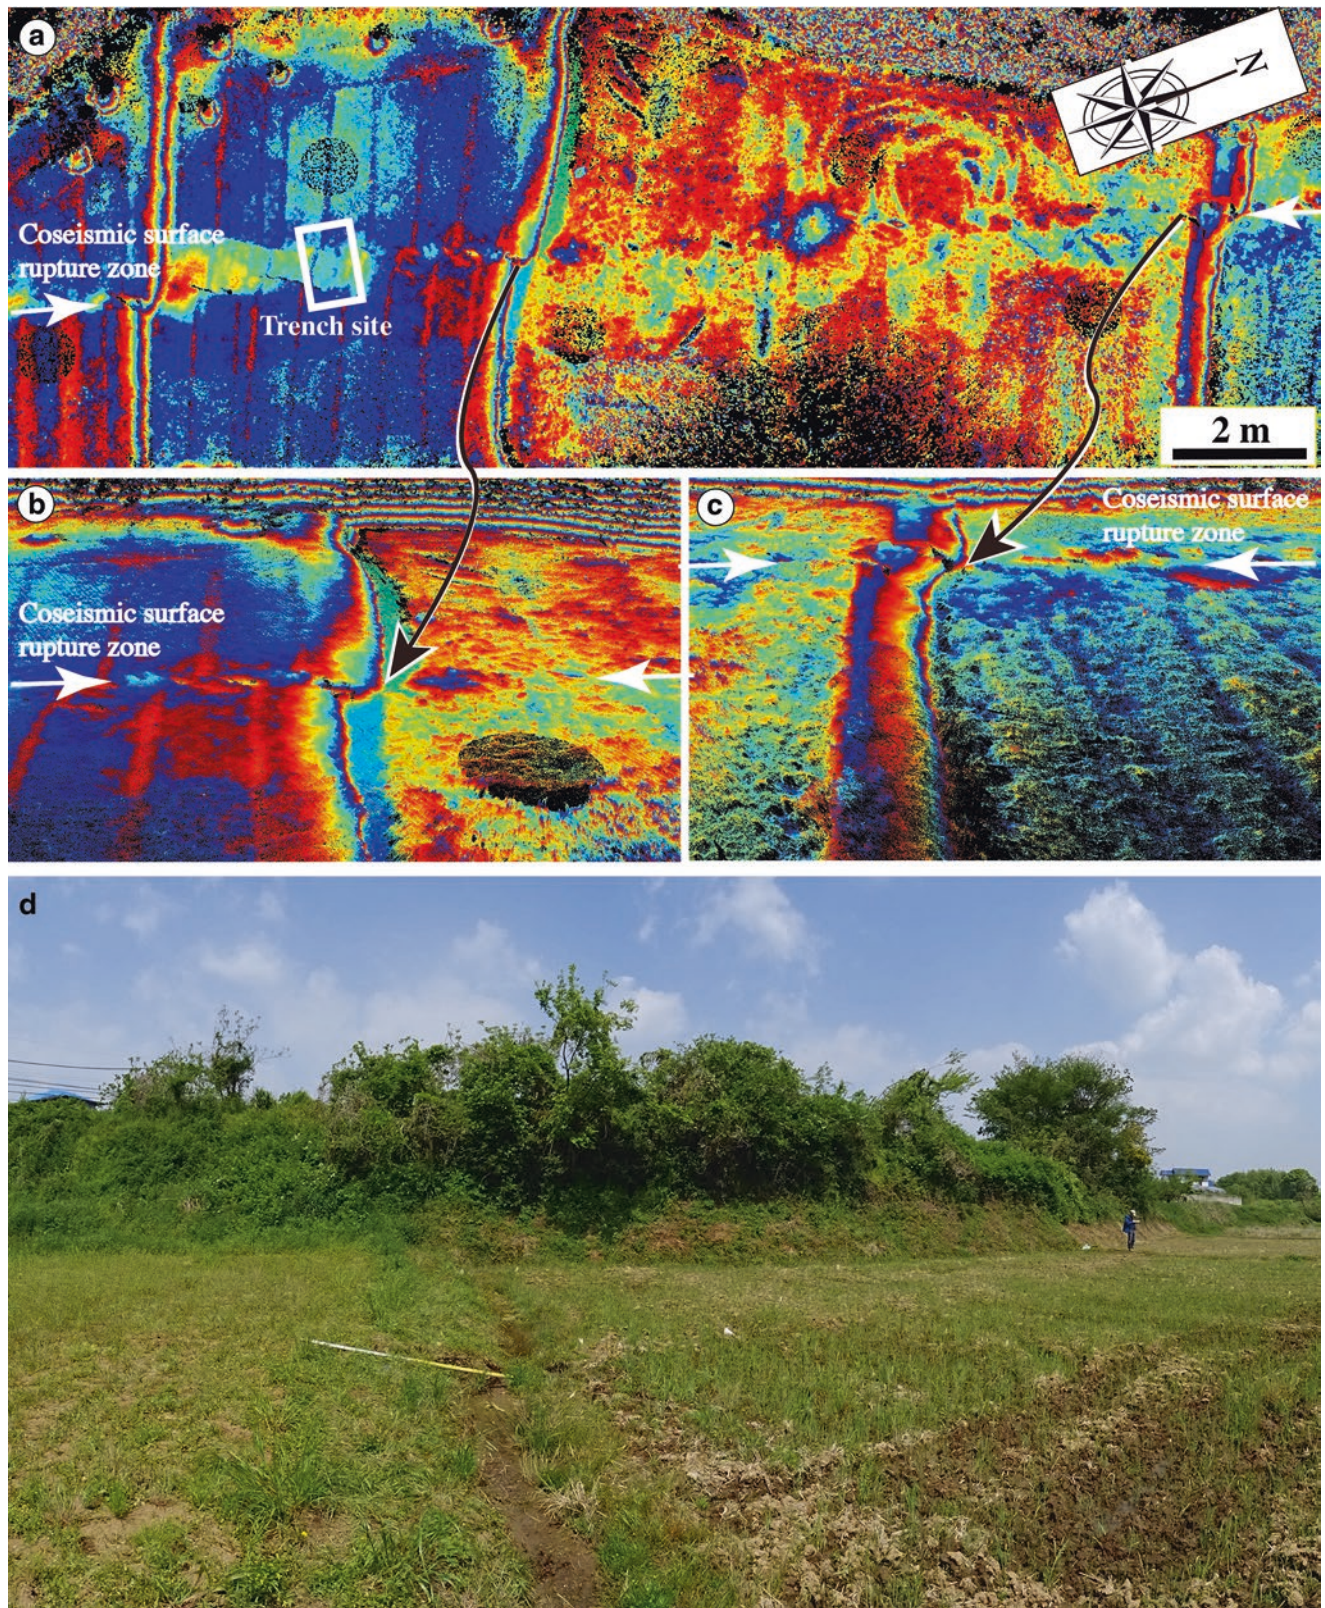
Fig. 6 3D color shaded relief images and photographs showing the deformation features of coseismic surface rupture zone in rice fields. (a–c) 3D images acquired by Trimble TX5 3D laser scanner. (d–f) Right-lateral offset of paths (offset ~0.6 m)

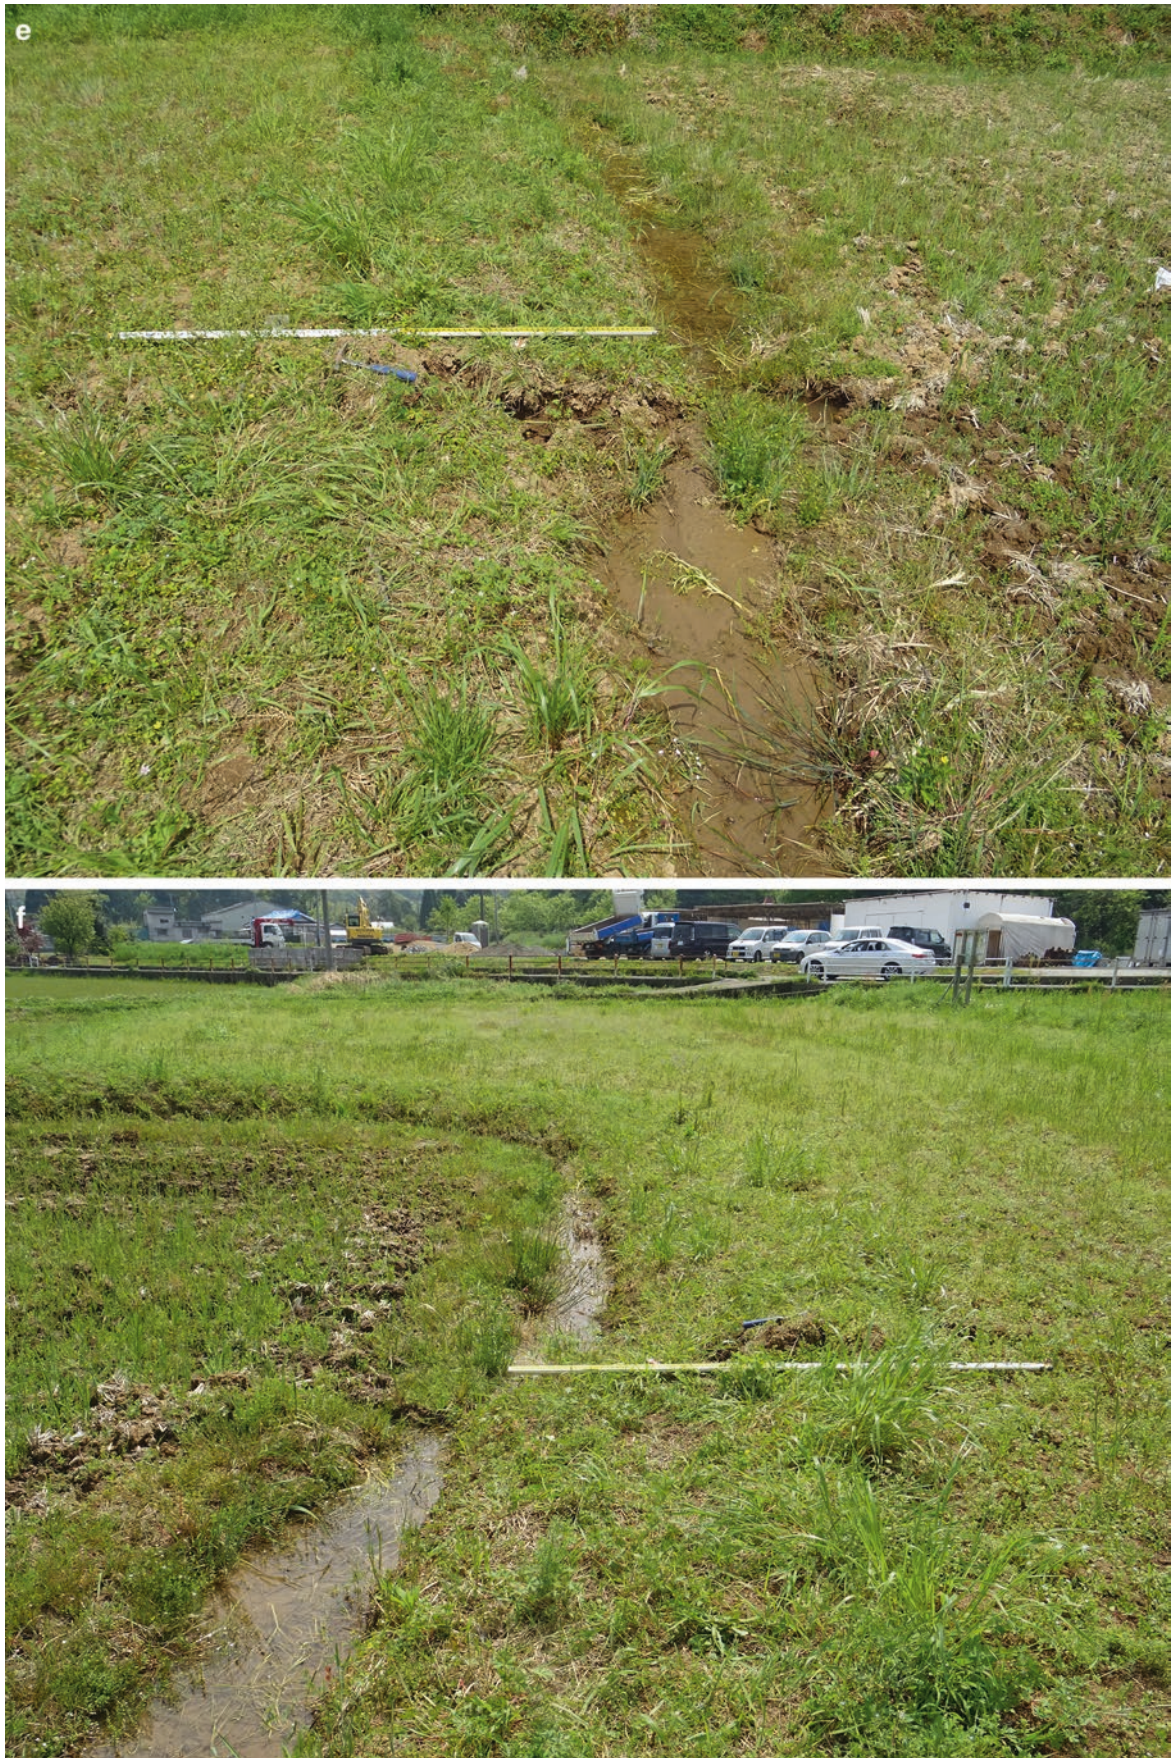
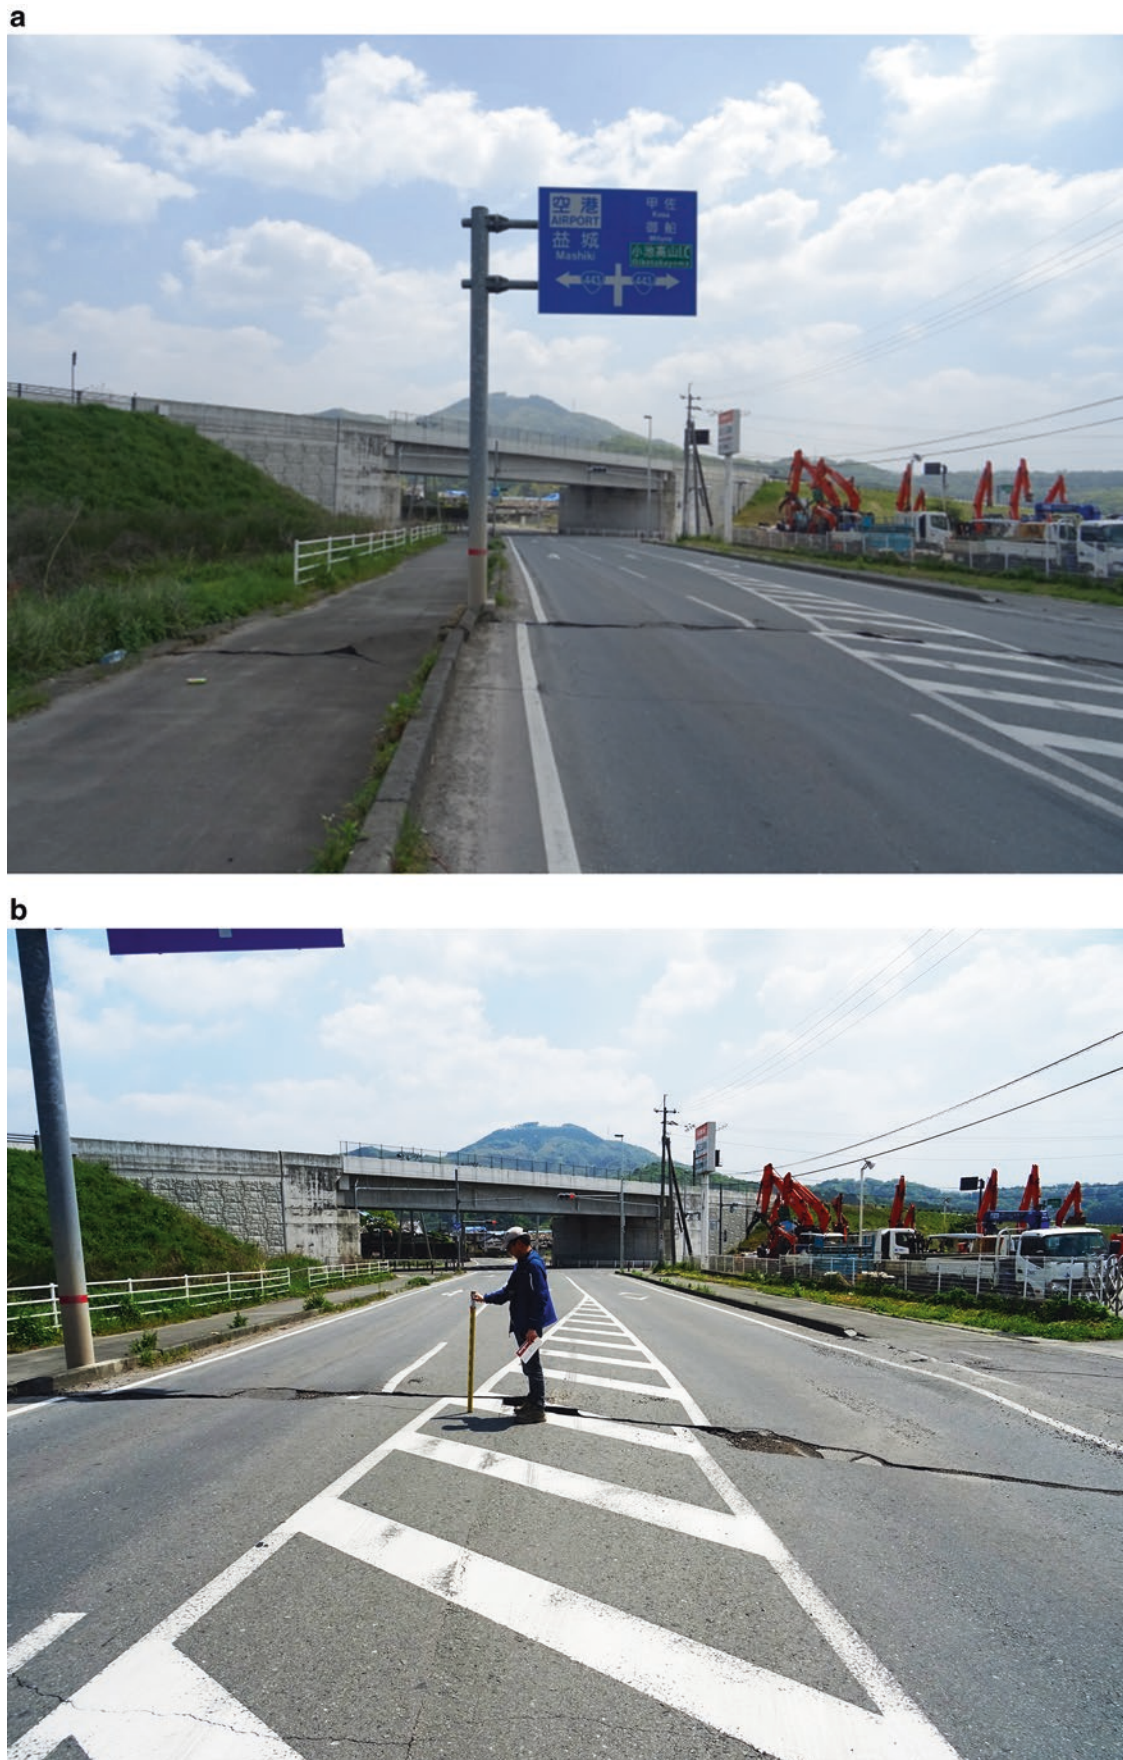
Fig. 7 Right-lateral offset of a road. (b, c) Close-up view of (a) (offset ~0.3 m)

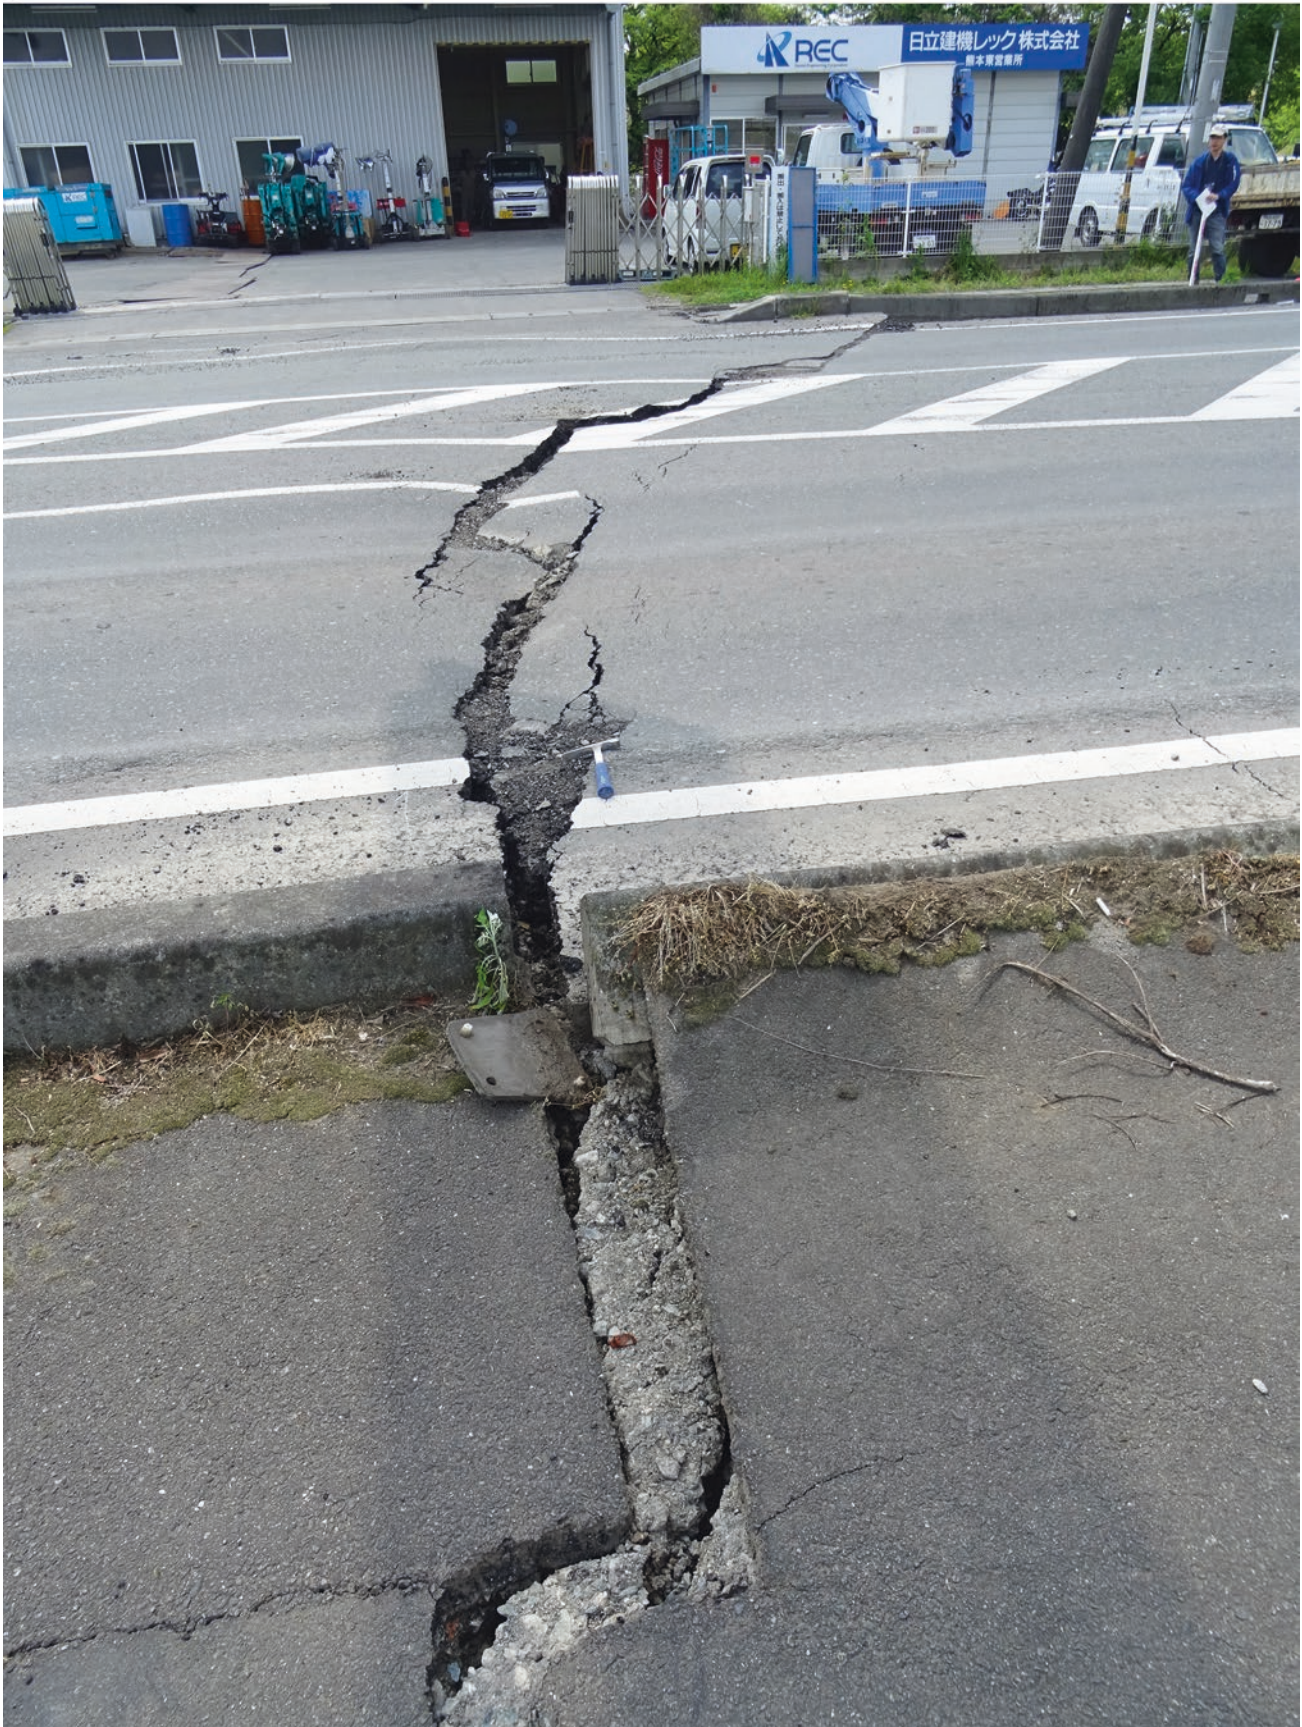
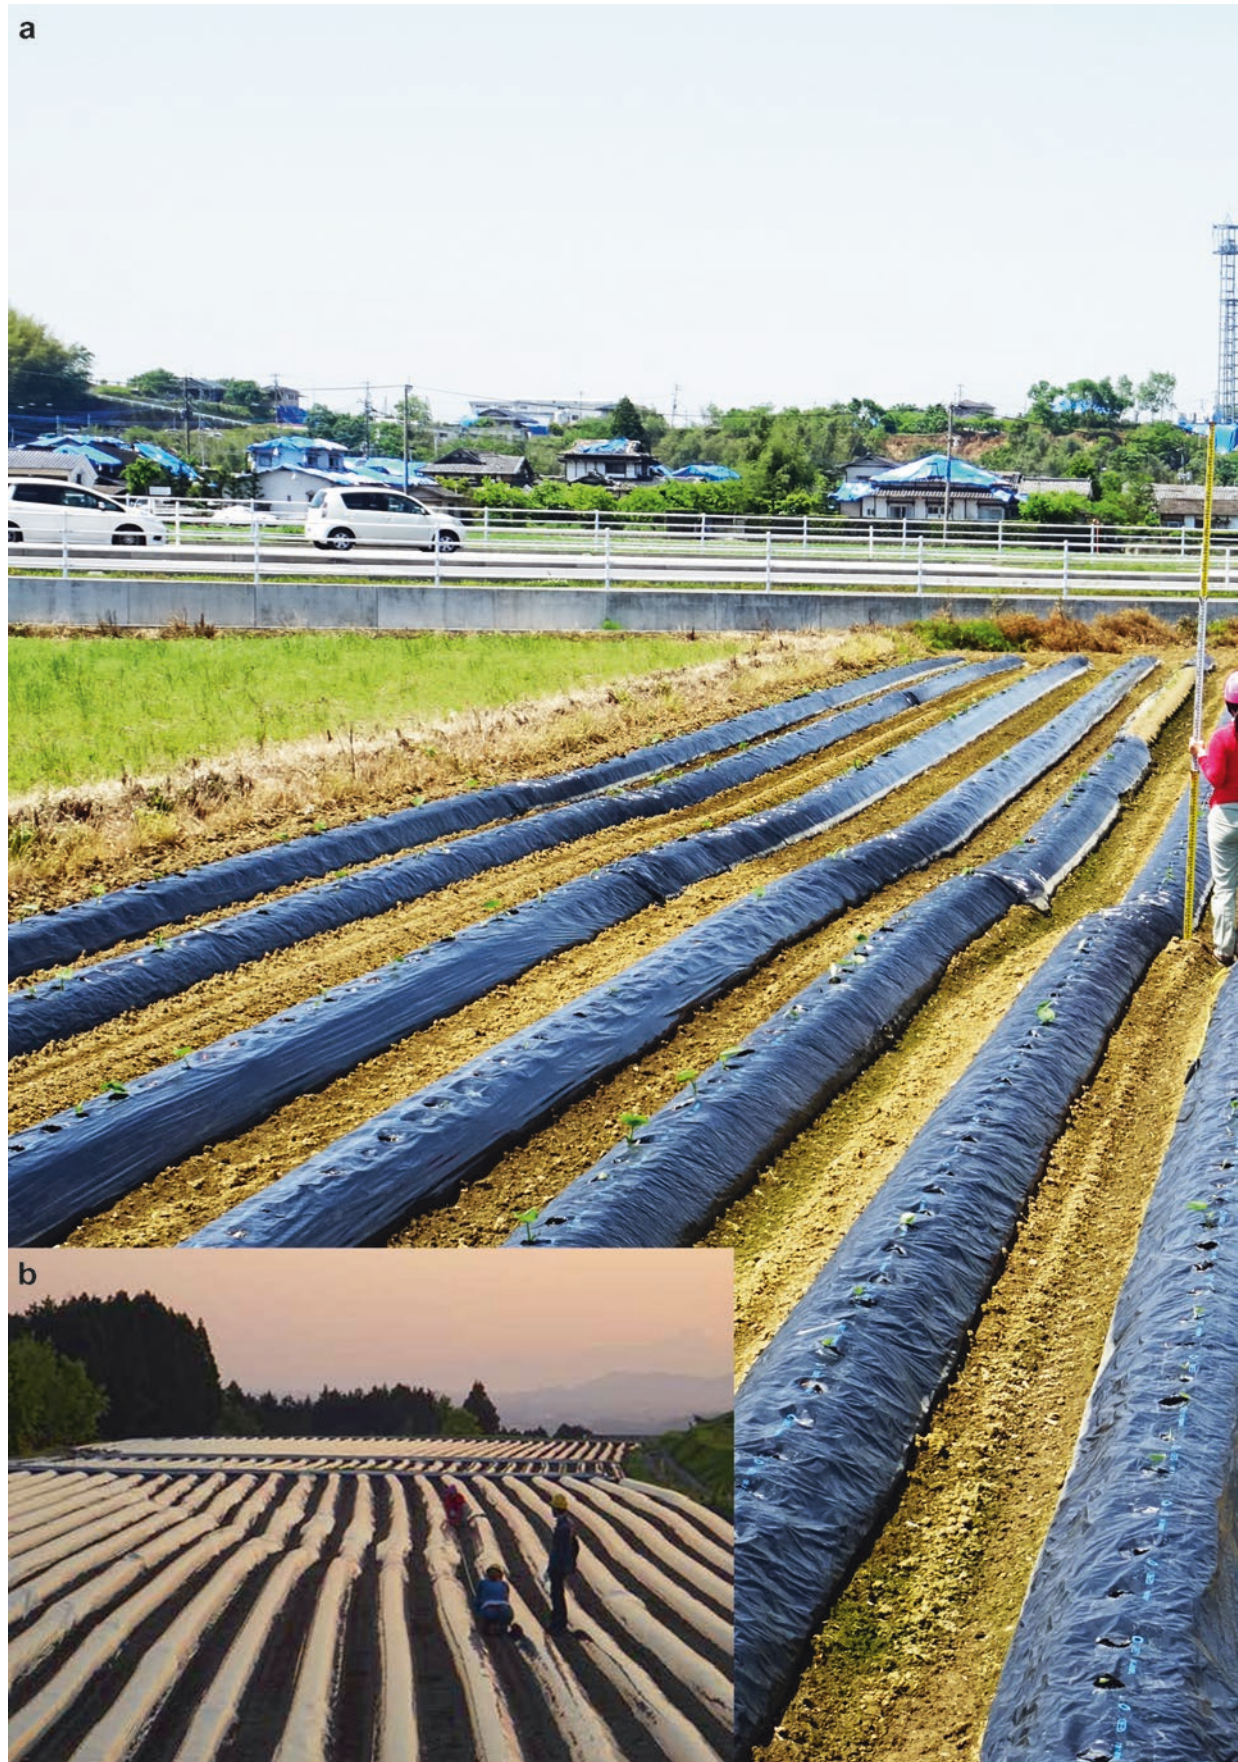
Fig. 8 Right-lateral offset of vegetable rows. (a) Right-lateral offset of vegetable rows at the southwestern end area of the coseismic surface rupture zone along the Hinagu fault (offset ~0.25 m). (b) Right-lateral

offset of vegetable rows in the central segment along the Futagawa fault (offset ~0.15 m)

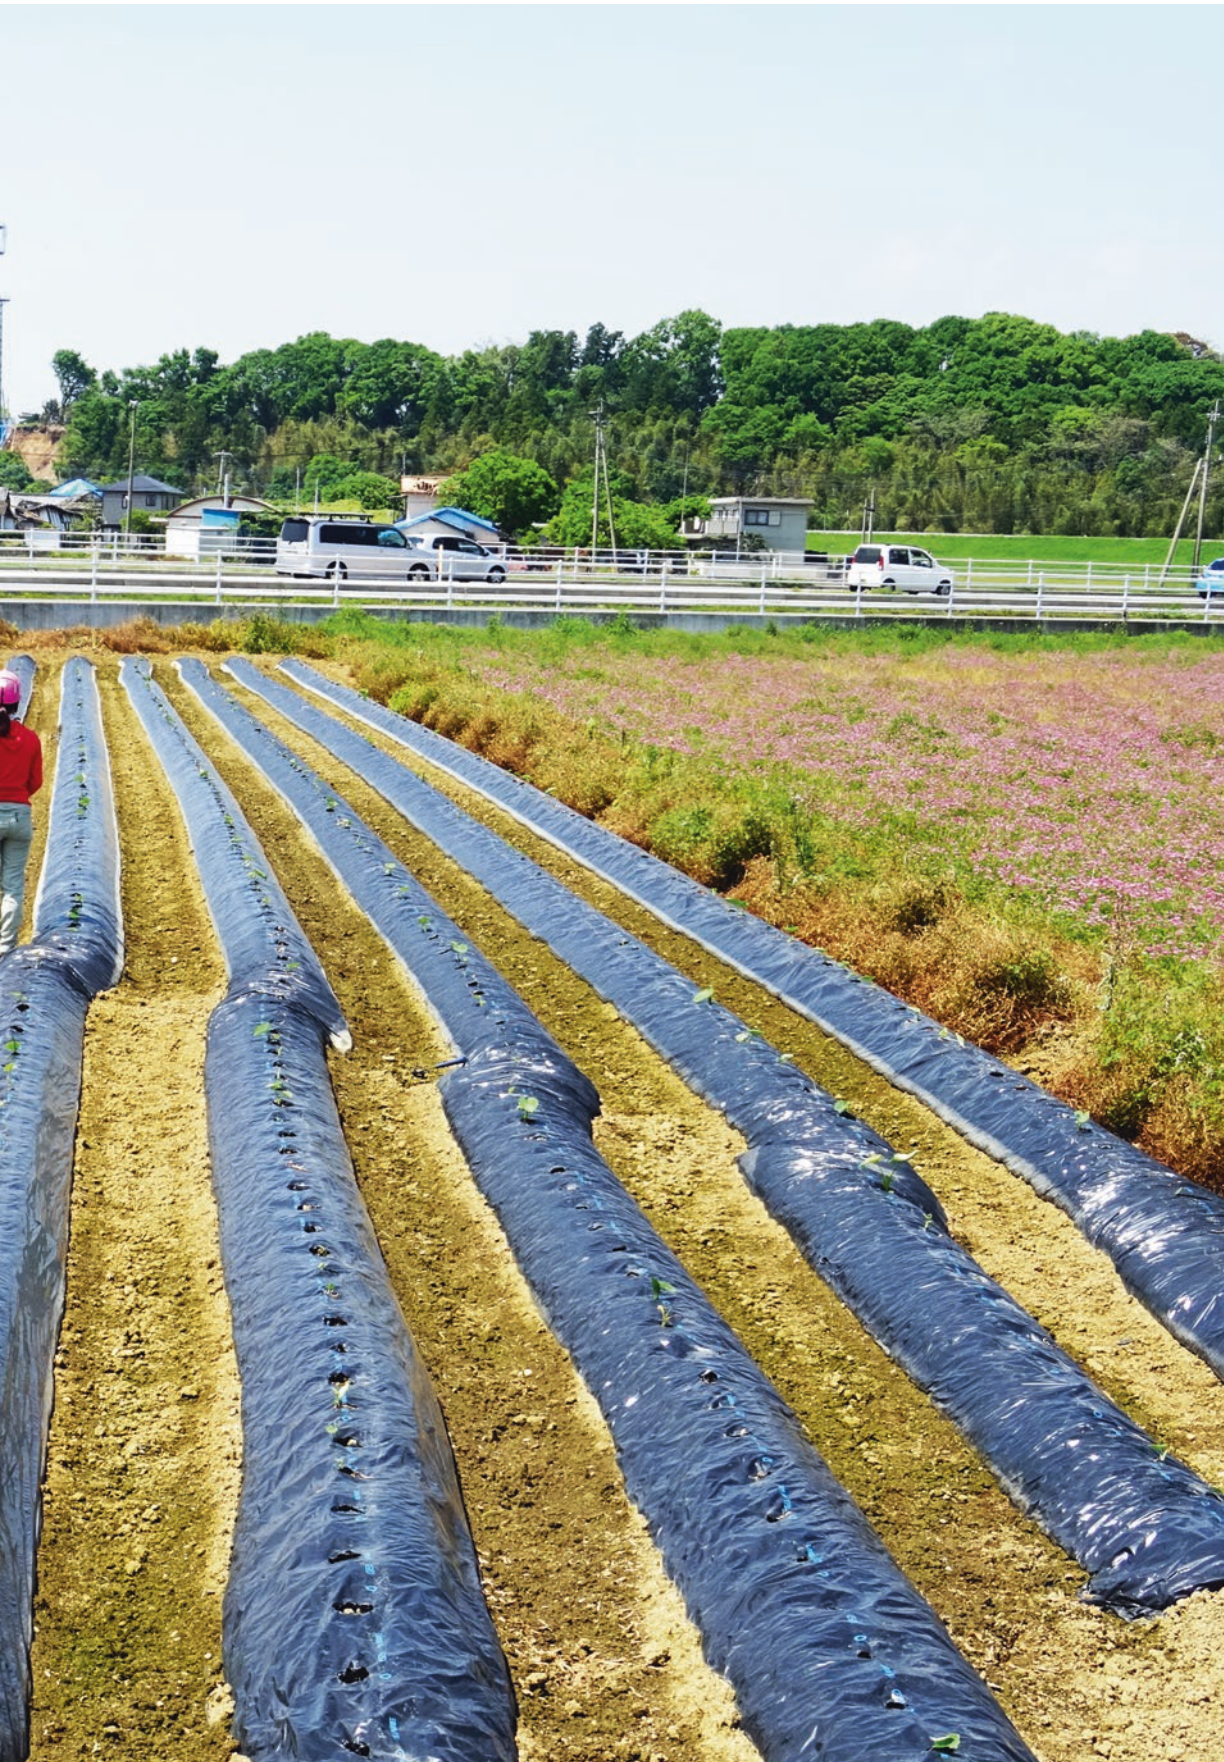
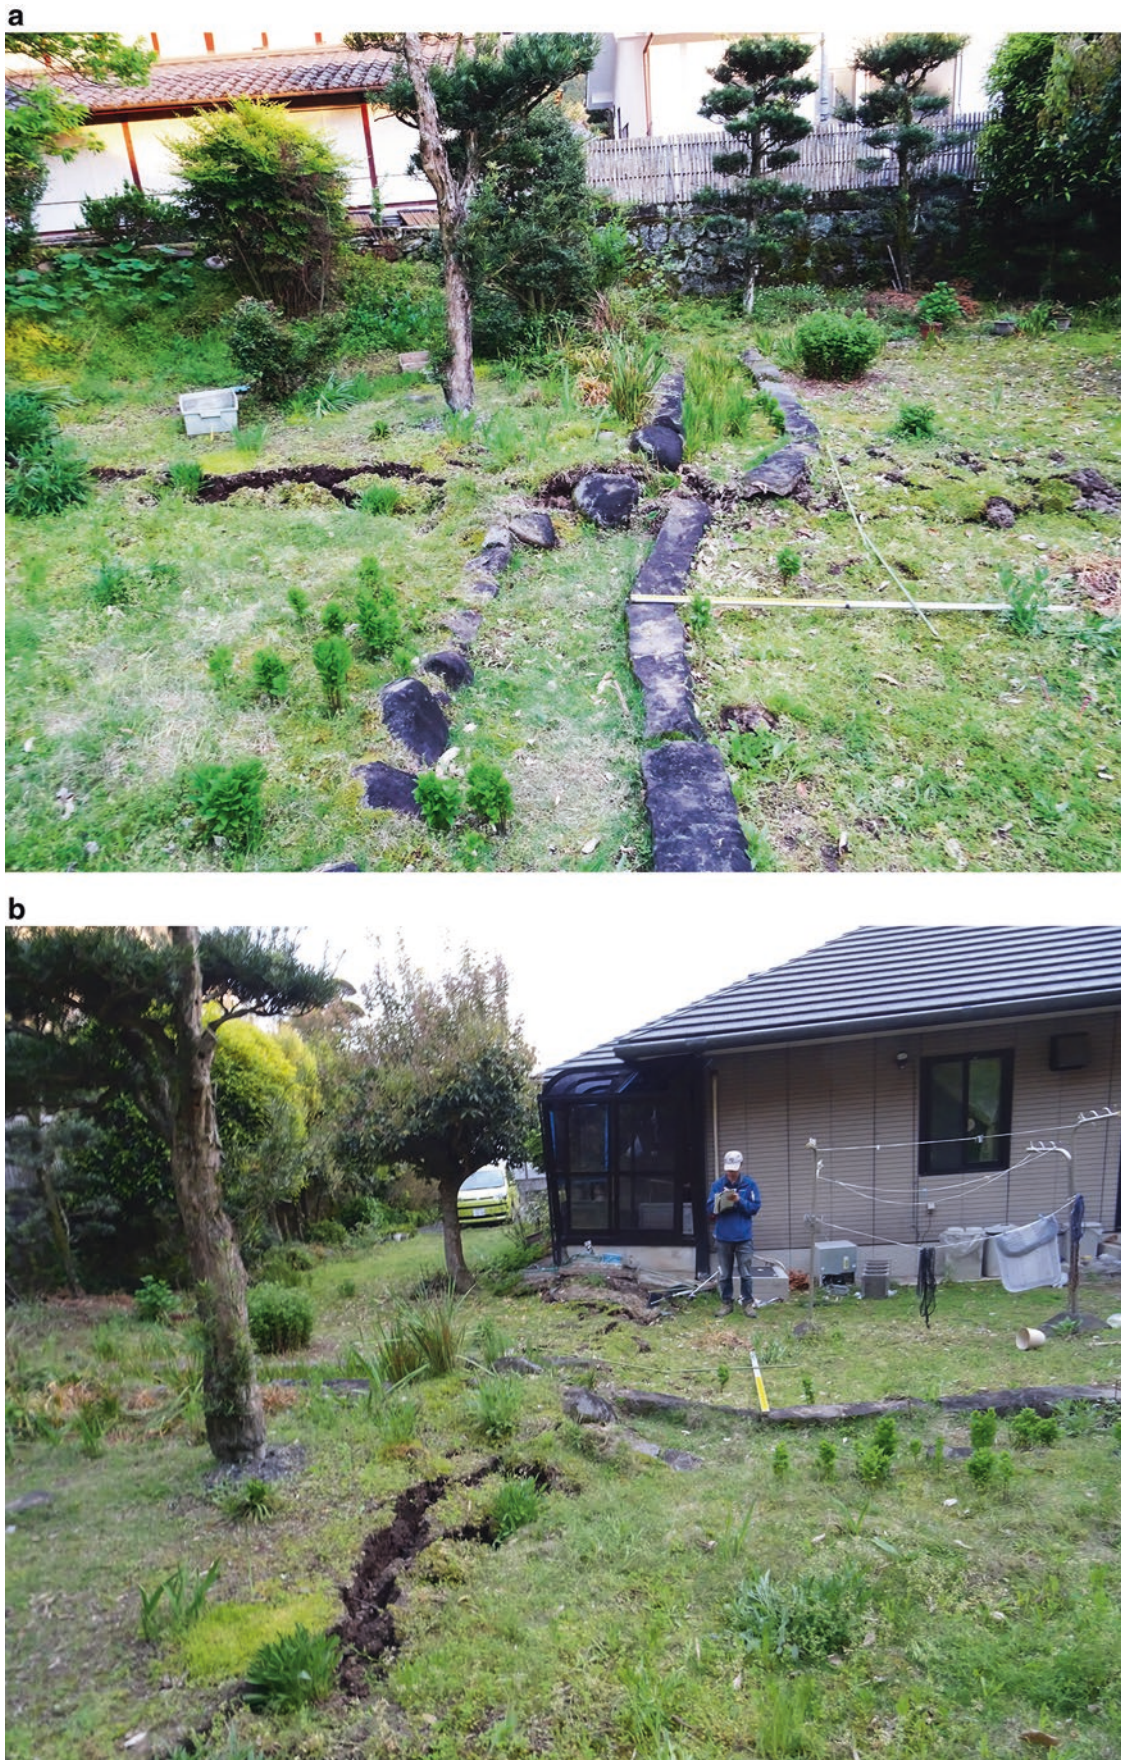
Fig. 9 Right-lateral offset of ditch slope and damaged parking area in a house garden. **(a, b)** Dextral offset ~ 1.3 m with a vertical component of ~ 0.30 m. **(c)** Right-lateral offset of ditch slope (offset ~ 0.9 m). **(d)** Right-lateral offset of parking area (offset ~ 1.1 m)

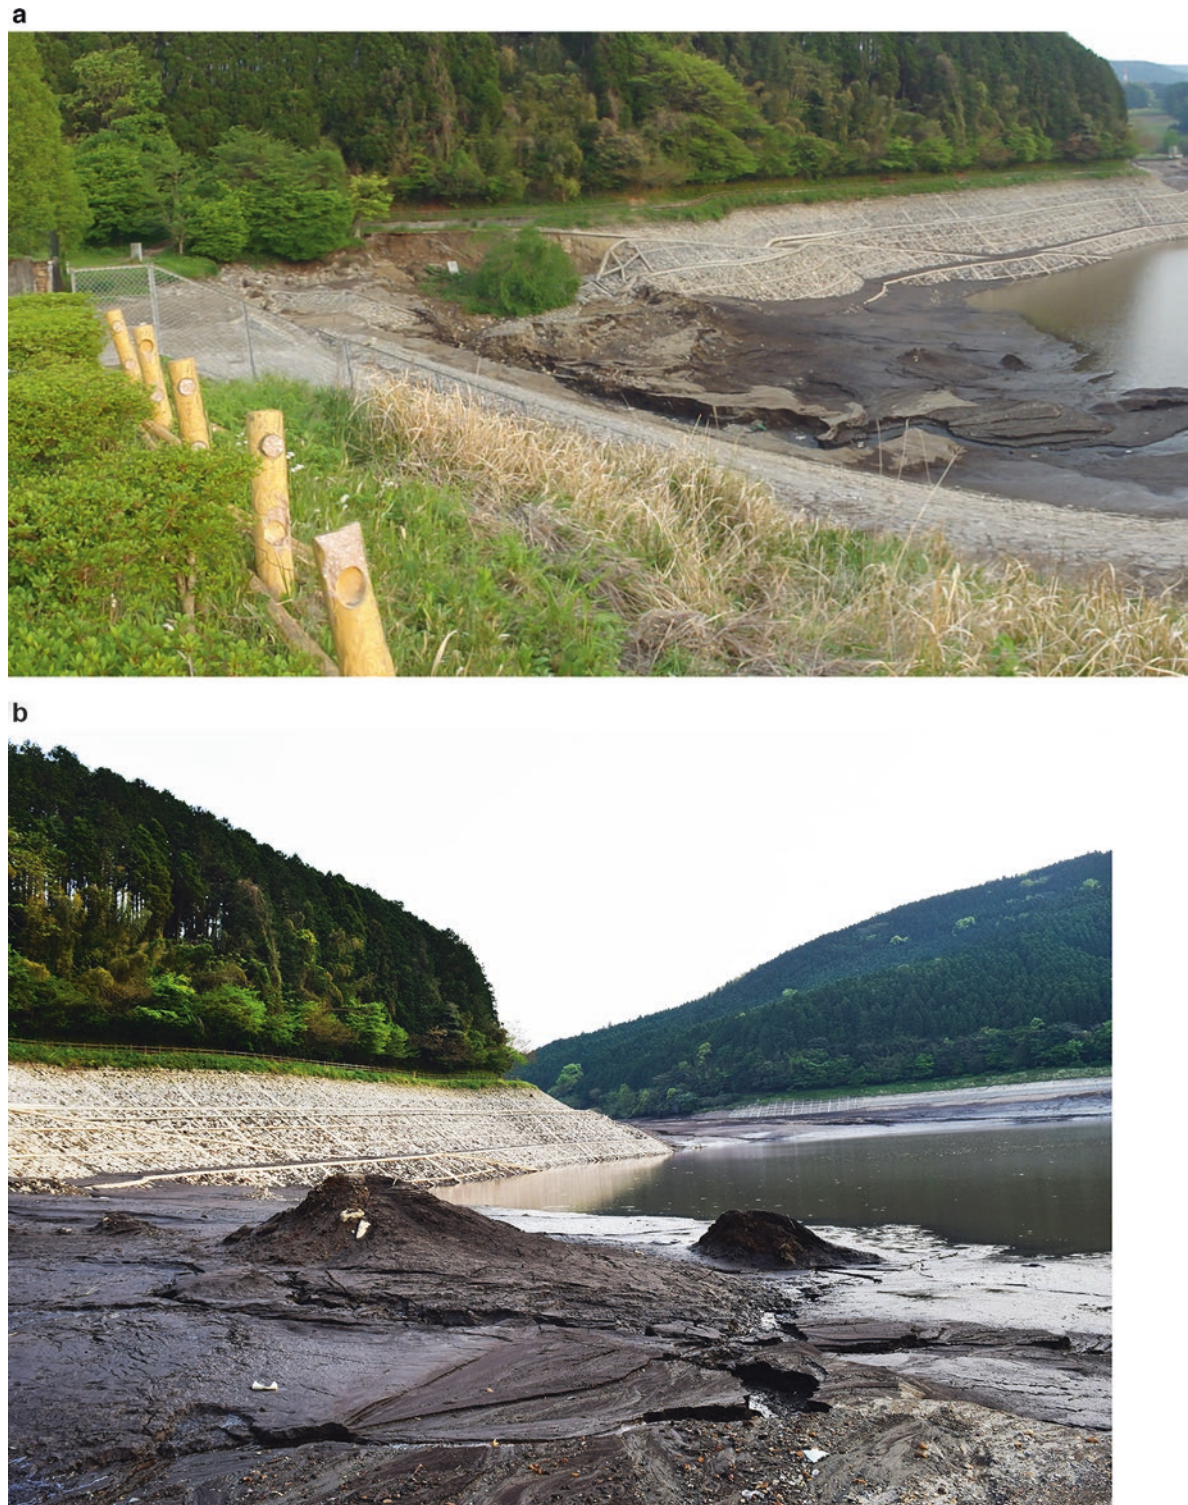
Fig. 29 Earthquake-induced liquefaction that occurred inside a dam. (a) Overview of the Okirihata dam that was damaged by the coseismic surface rupture zone. (b, c) Sand boils occurred inside the dam

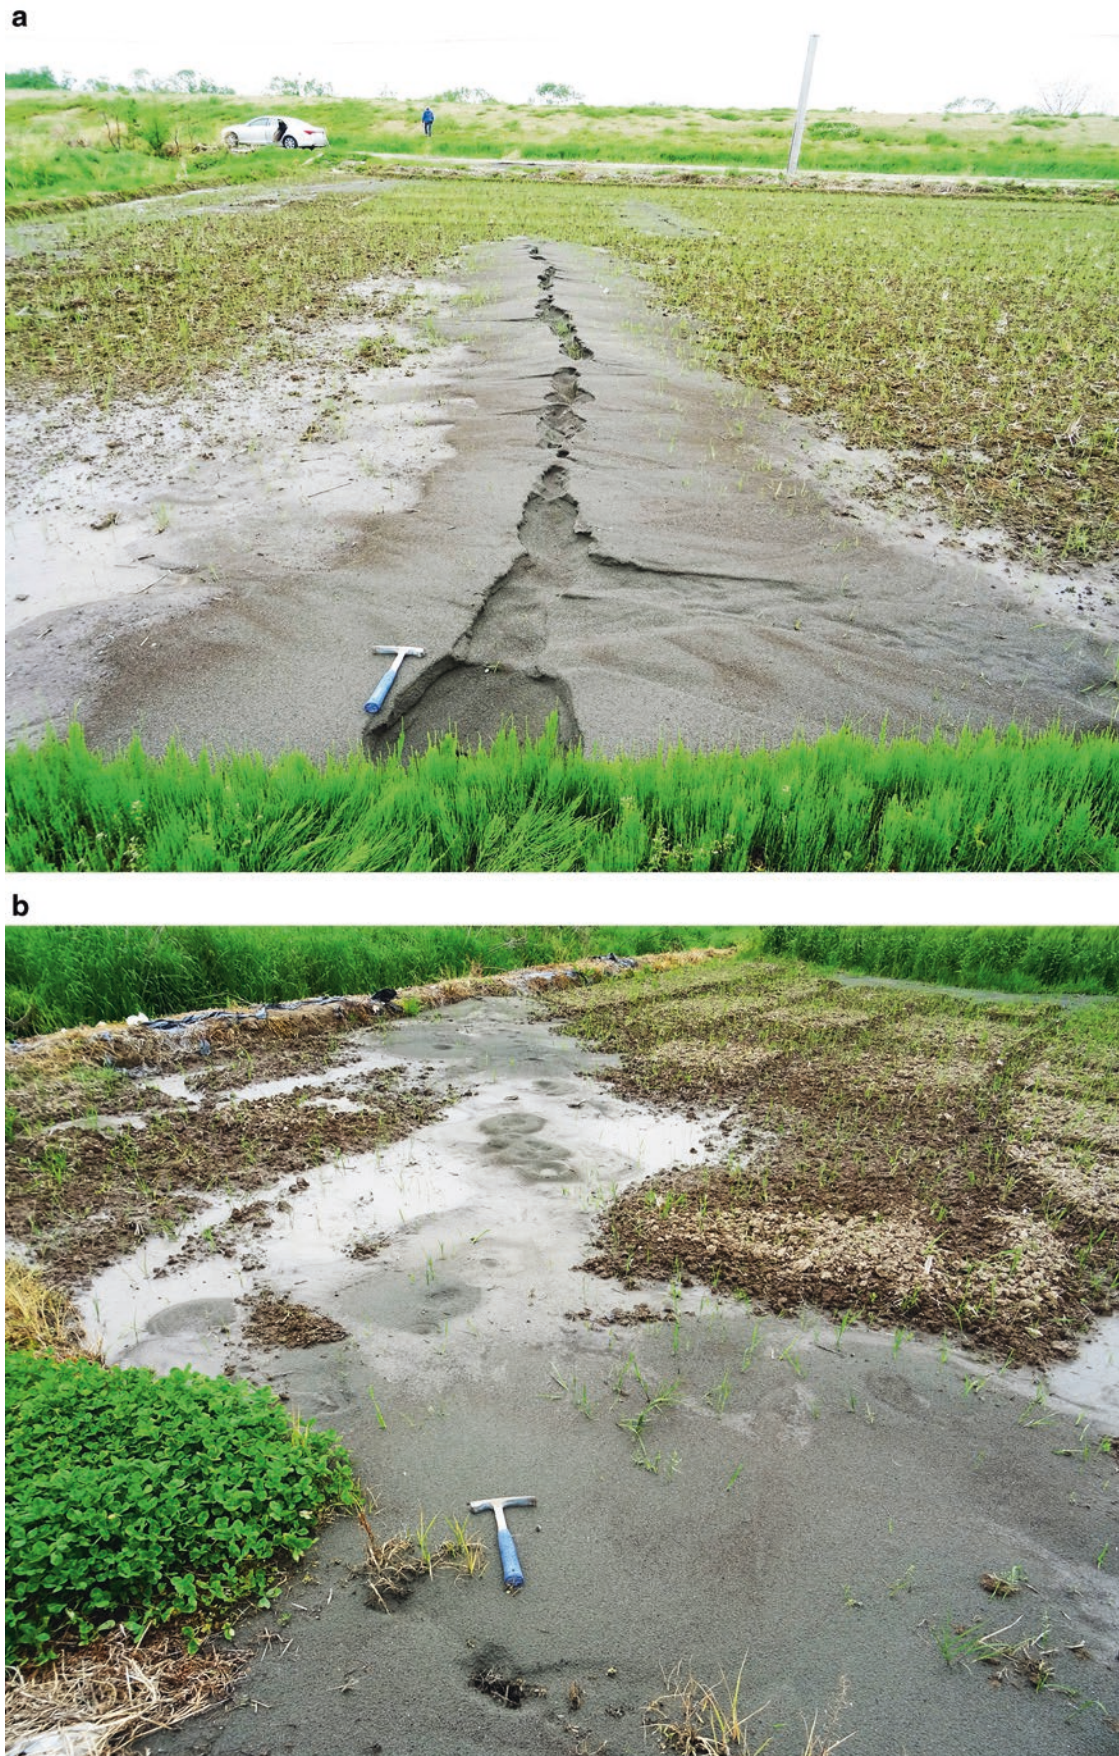
Fig.30 Earthquake-induced sand boils. (a–c) Sand boils occurred in association with earthquake-induced liquefaction that occurred within extensional cracks in vegetable fields. (d) Sand boils occurred in a lowland of river bank

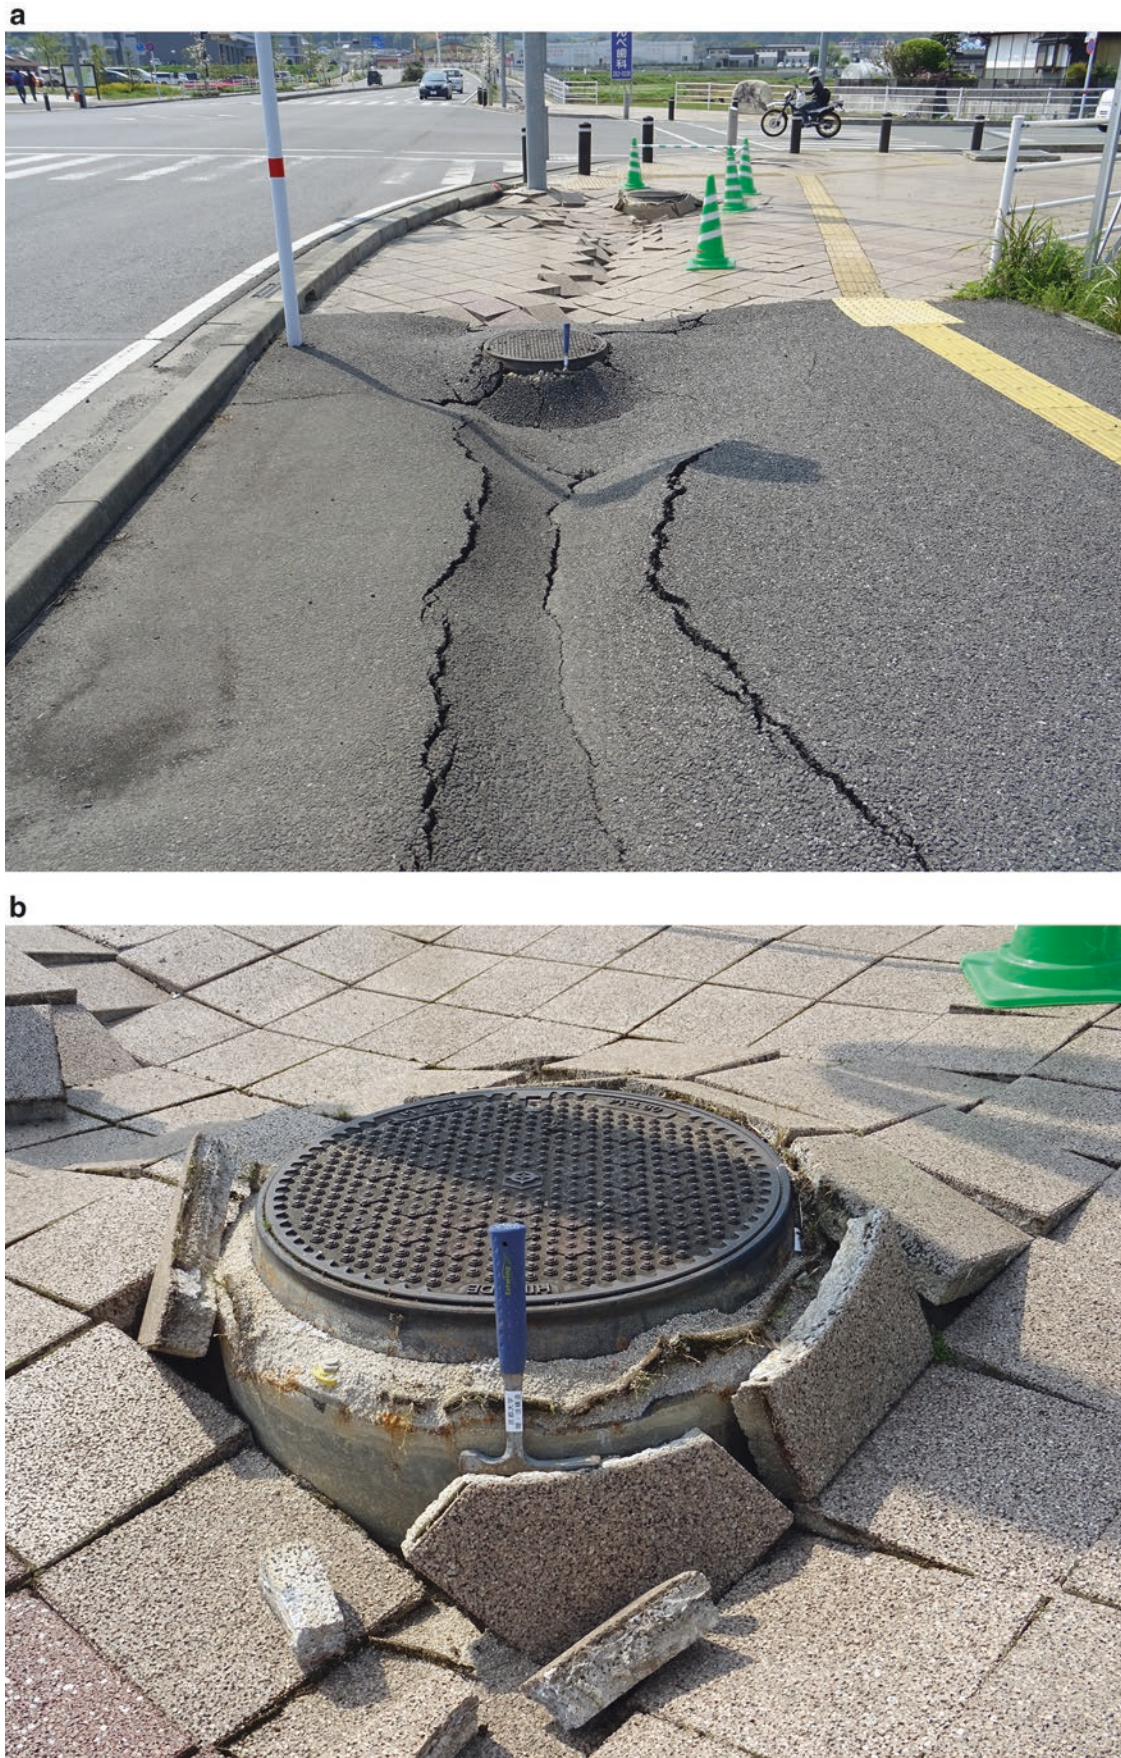
Fig. 31 Ground subsidence caused by earthquake-induced liquefaction. (a) Manhole uplift along the extensional crack. (b) Close-up view of (a)
