The 2016 Mw 7.1 Kumamoto Earthquake

A Photographic Atlas of Coseismic Surface Ruptures
Related to the Aso Volcano, Japan

Aiming Lin
Department of Geophysics
Kyoto University
Kyoto, Japan

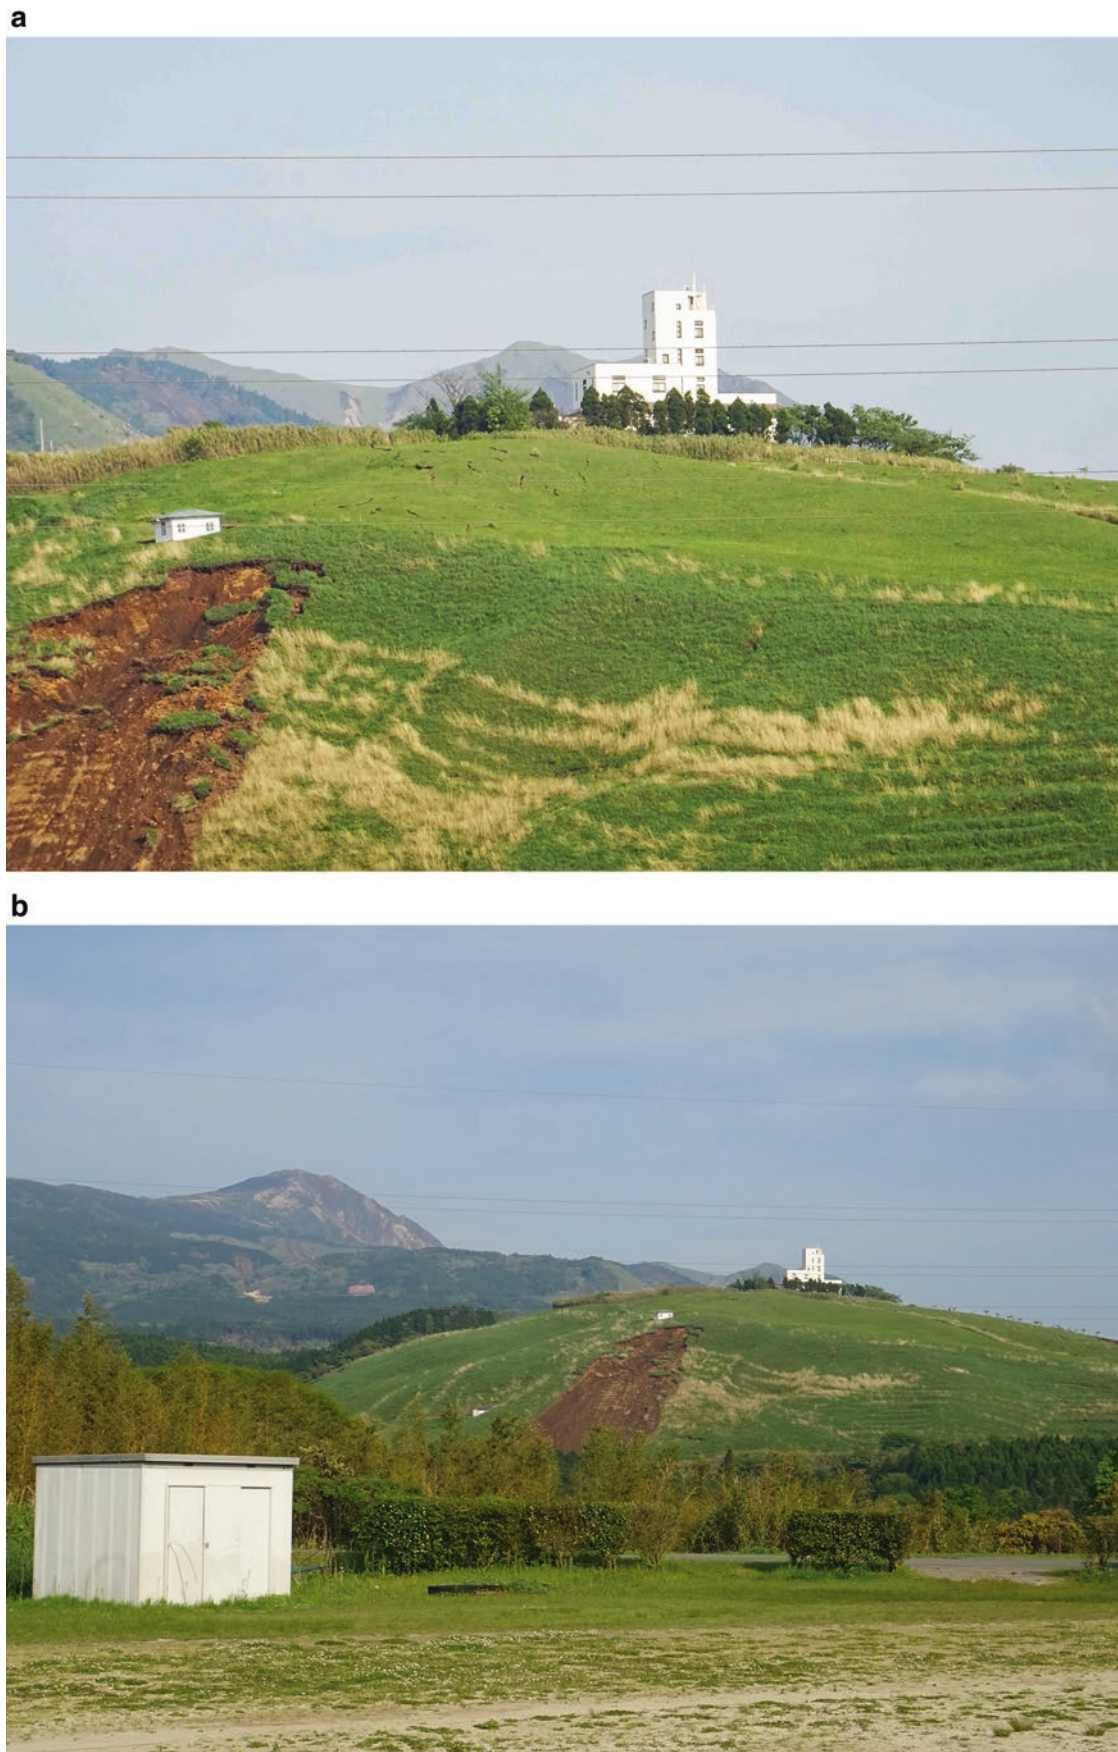
Fig. 68 Houses and buildings damaged along coseismic cracks. (a, b) Eastward view of the damaged buildings of the Volcanological Laboratory, Institute of Geothermal Sciences, Kyoto University, where numerous of

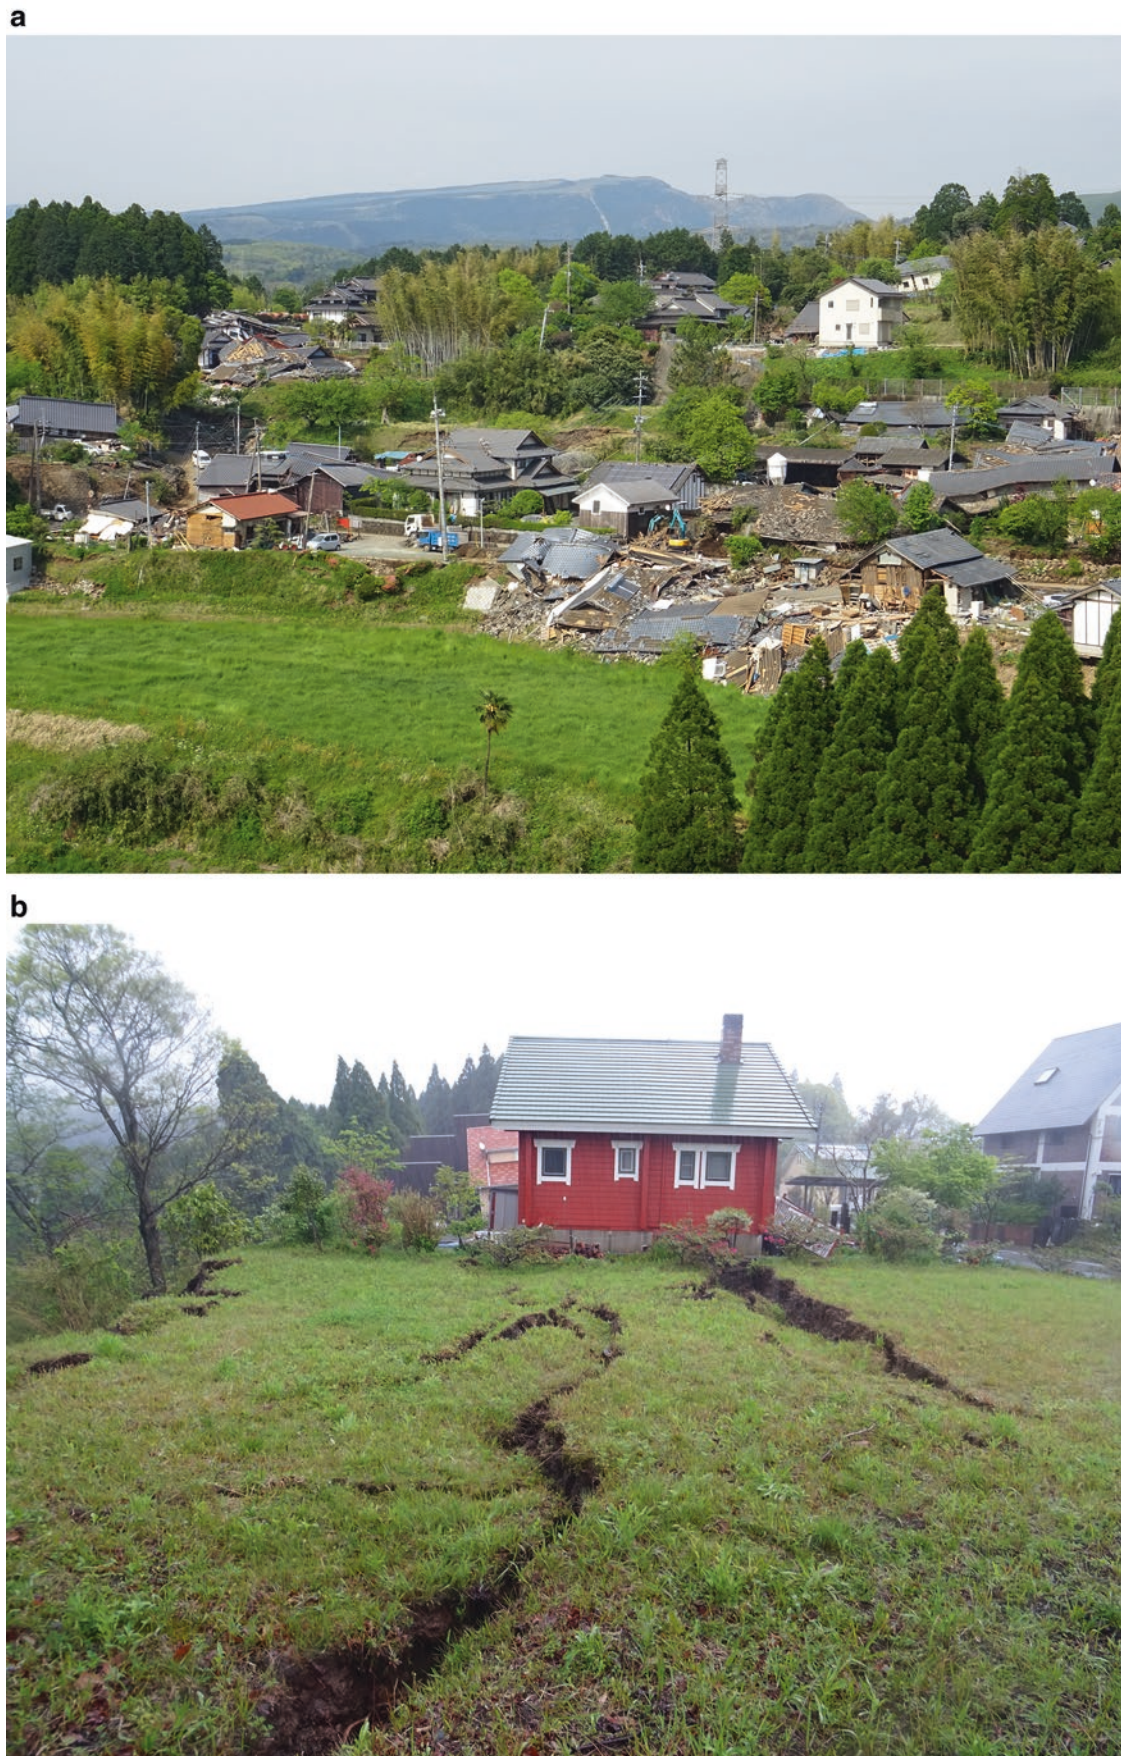
Fig. 70 Houses collapsed along a coseismic surface rupture zone. (a) Houses collapsed along the coseismic surface ruptures along a preexisting fault scarp of the Futagawa fault. (b–d) Houses collapsed and slanted along the coseismic surface ruptures

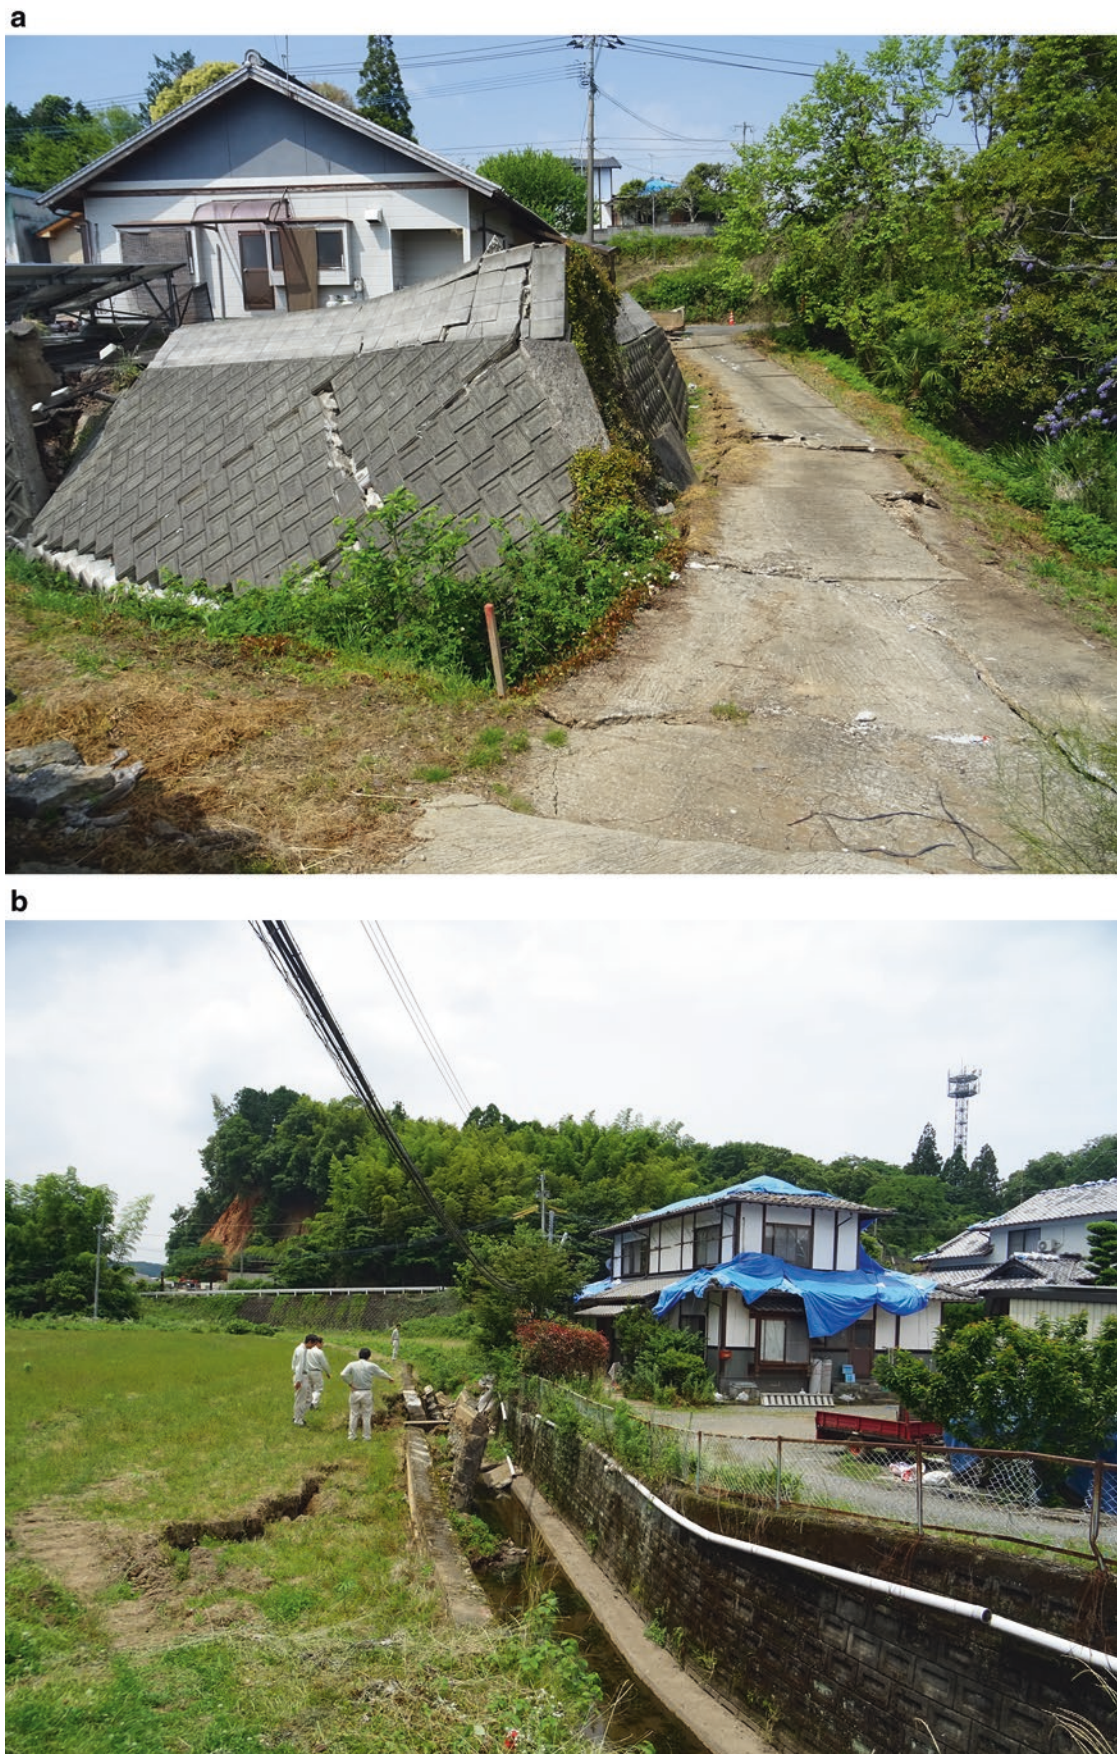
Fig. 71 Houses damaged and collapsed along the coseismic surface ruptures. (a, b) House damaged on the coseismic surface ruptures. (c)

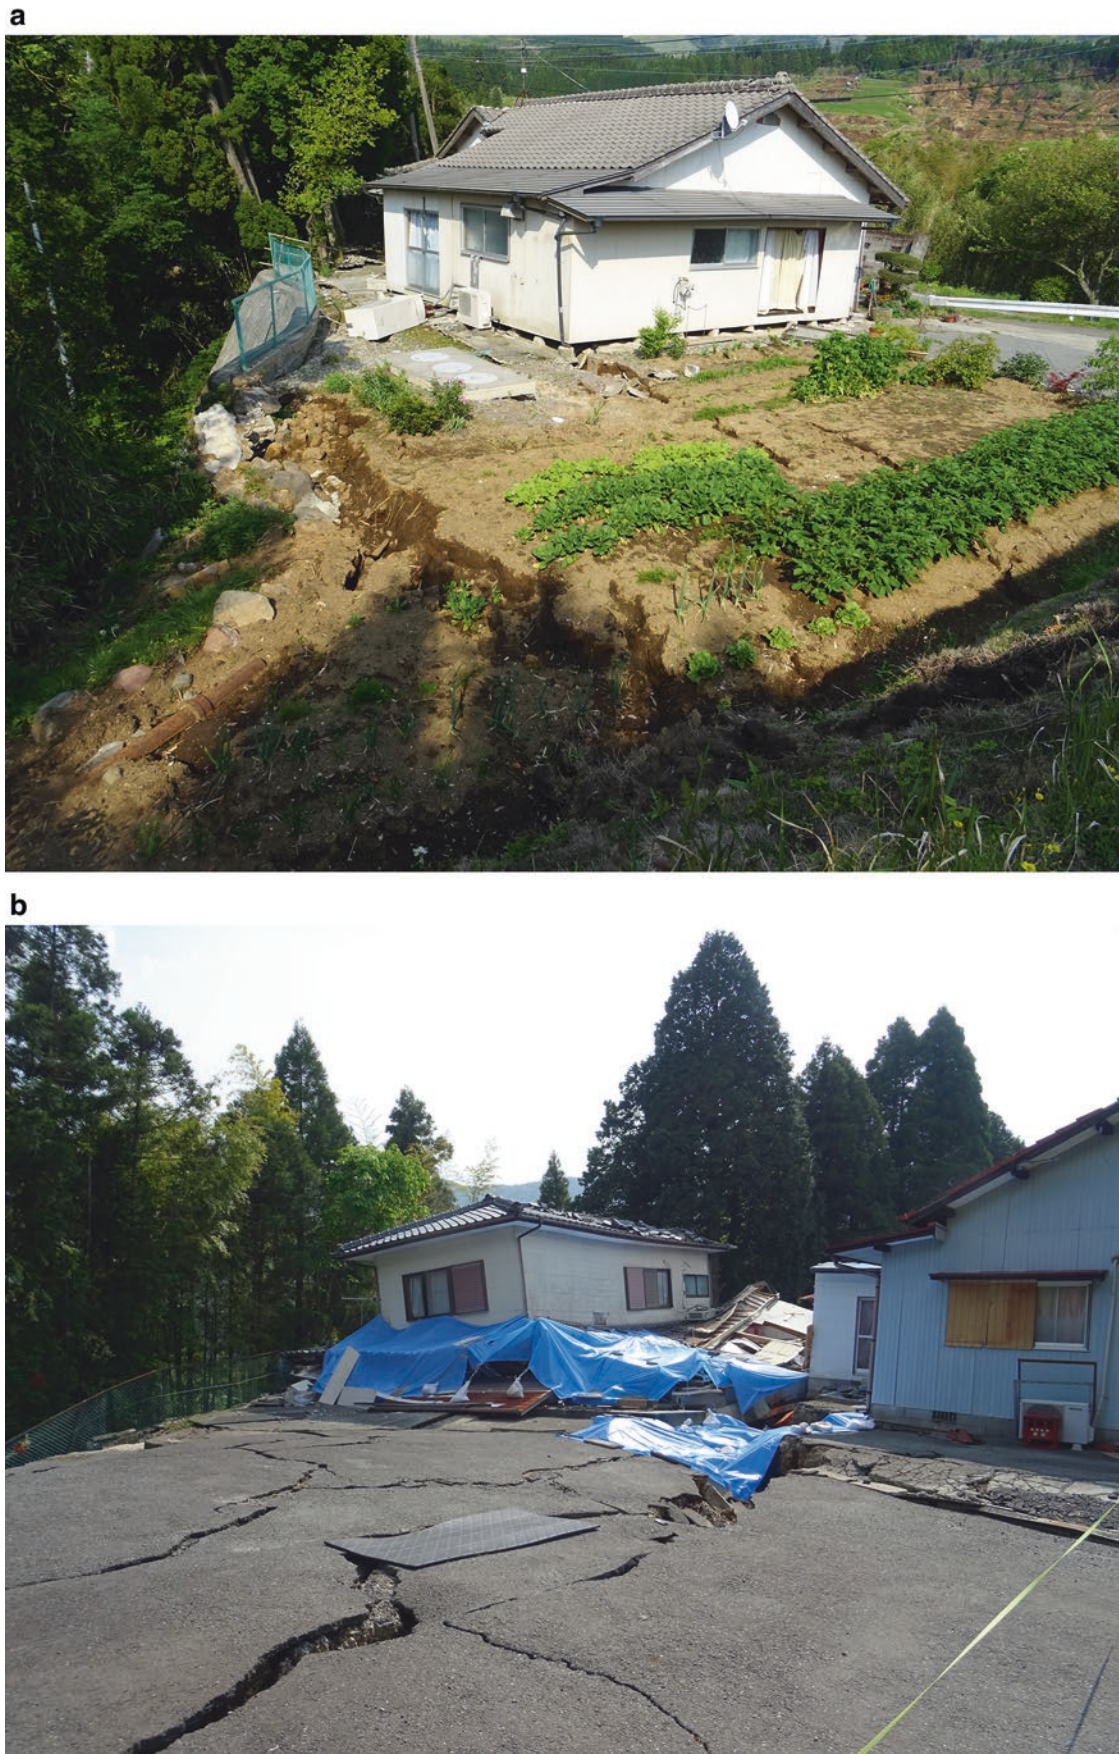
Fig. 72 Houses damaged on the coseismic surface ruptures. (a–c) Houses damaged on the coseismic surface ruptures. (d) Judgment card of dangerous house that cannot be inhabited again

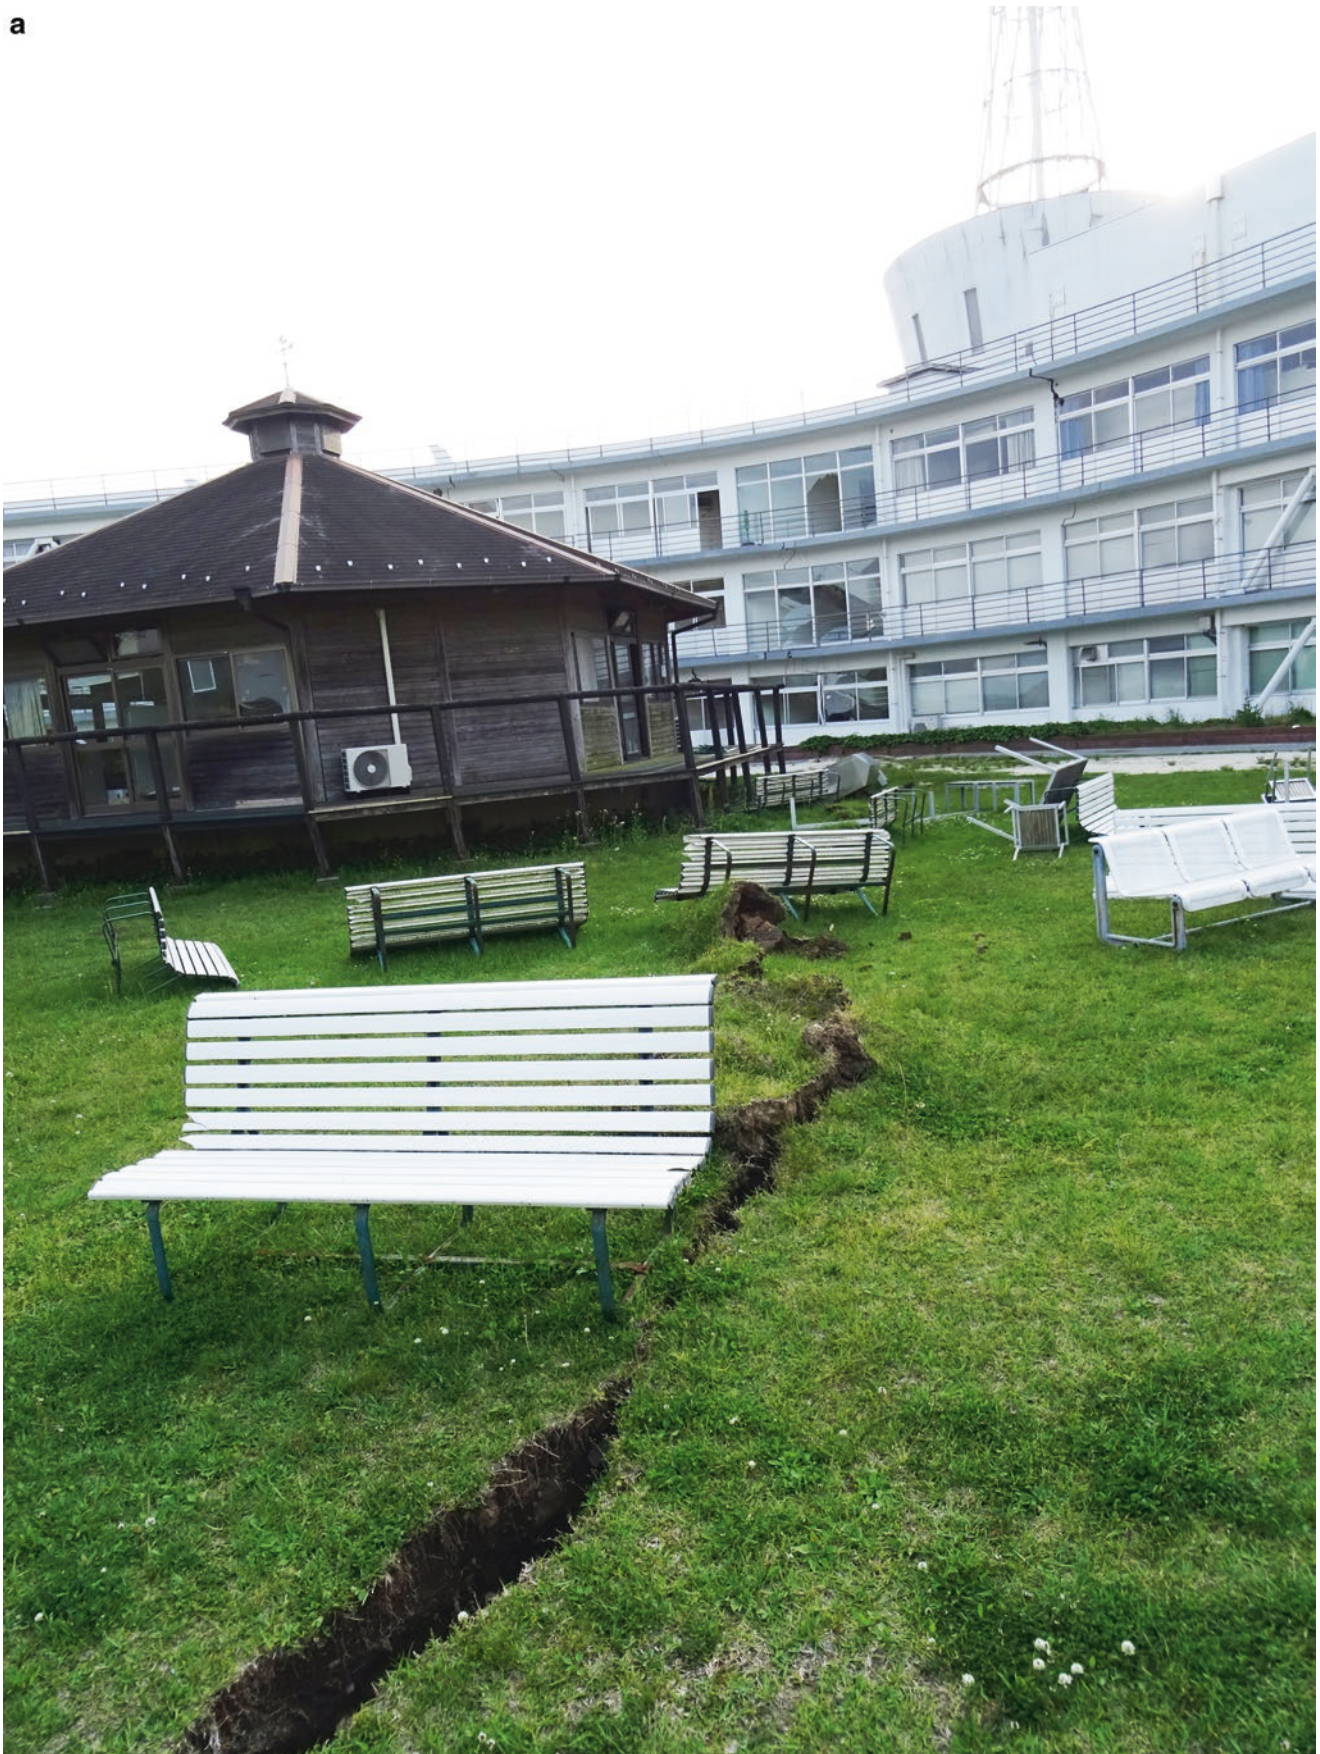
Fig. 73 Coseismic surface ruptures and damaged building of Tokai University at the Kumamoto Aso campus. **(a)** Coseismic surface ruptures occurred in a schoolyard throughout the base of the building. **(b)**

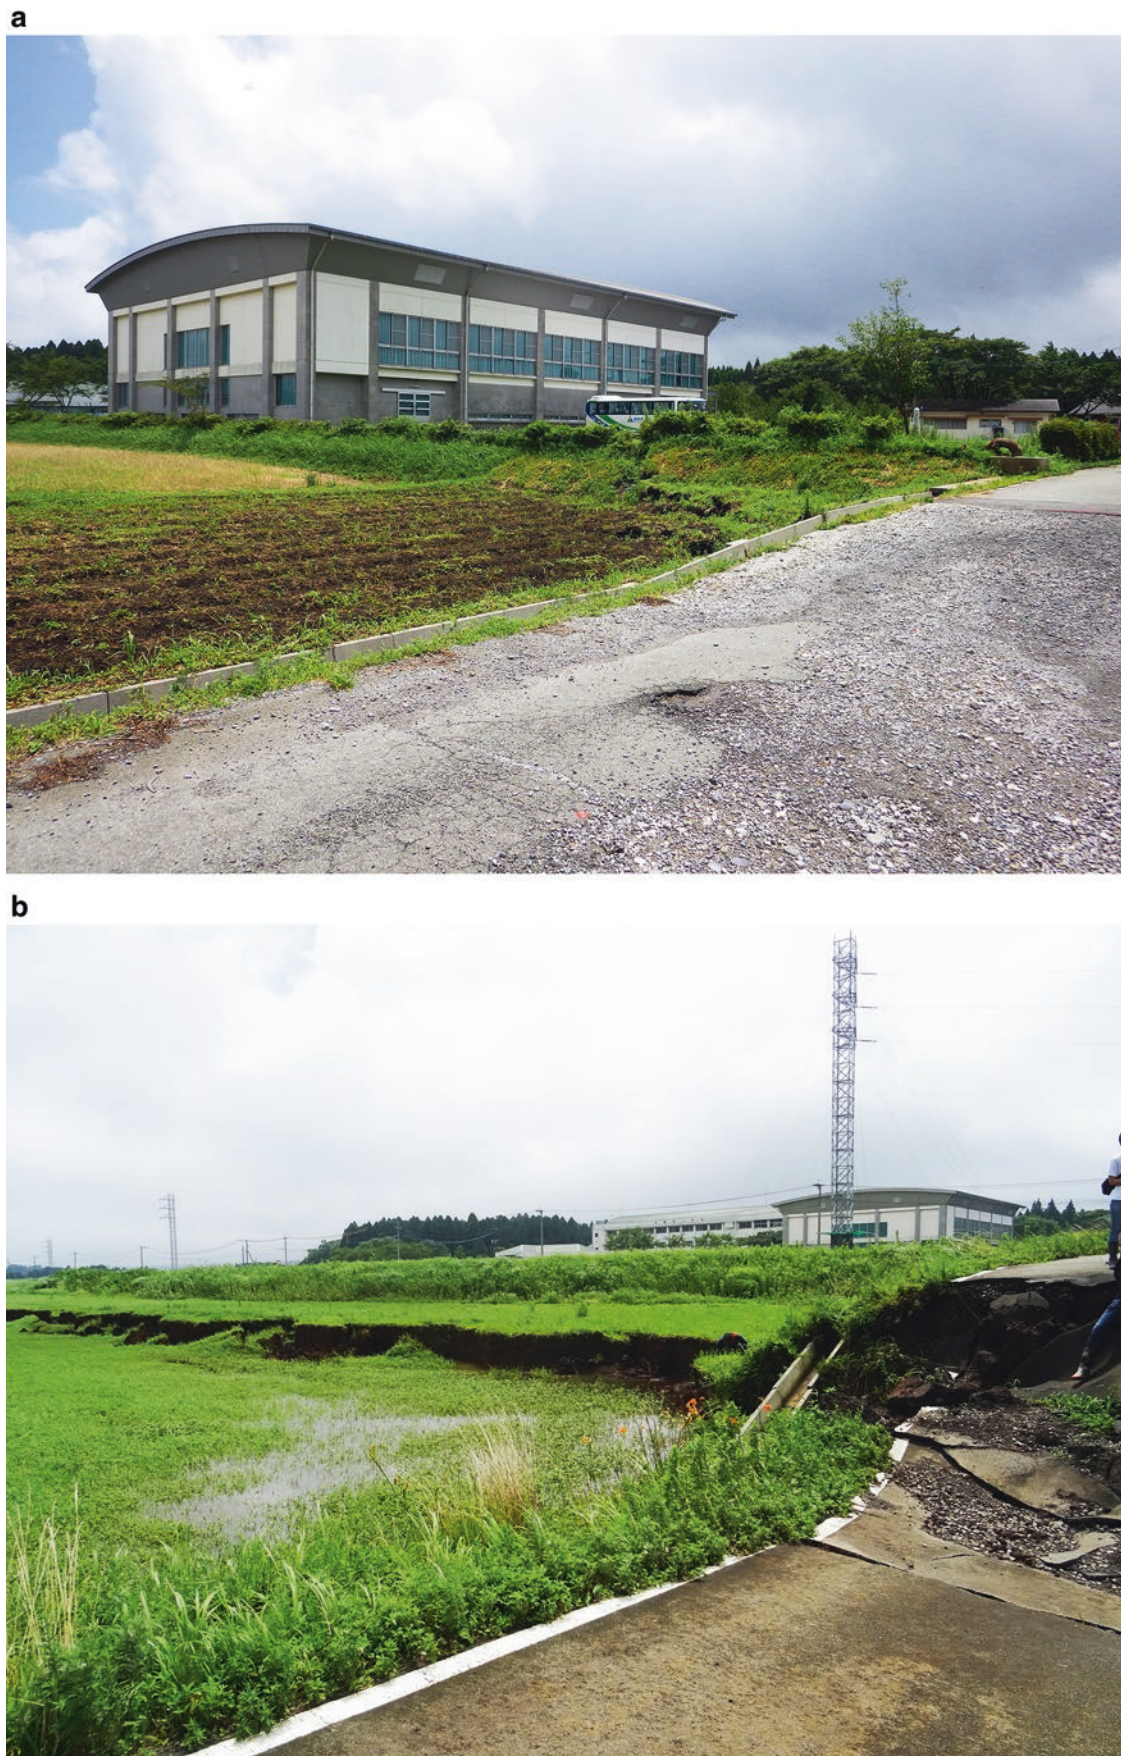
Fig. 74 Coseismic surface ruptures and damaged school house in a site near the Aso Nishi primary school. (a) Coseismic surface ruptures crosscut a road and fields (right side uplift ~50 cm). (b) A continuous

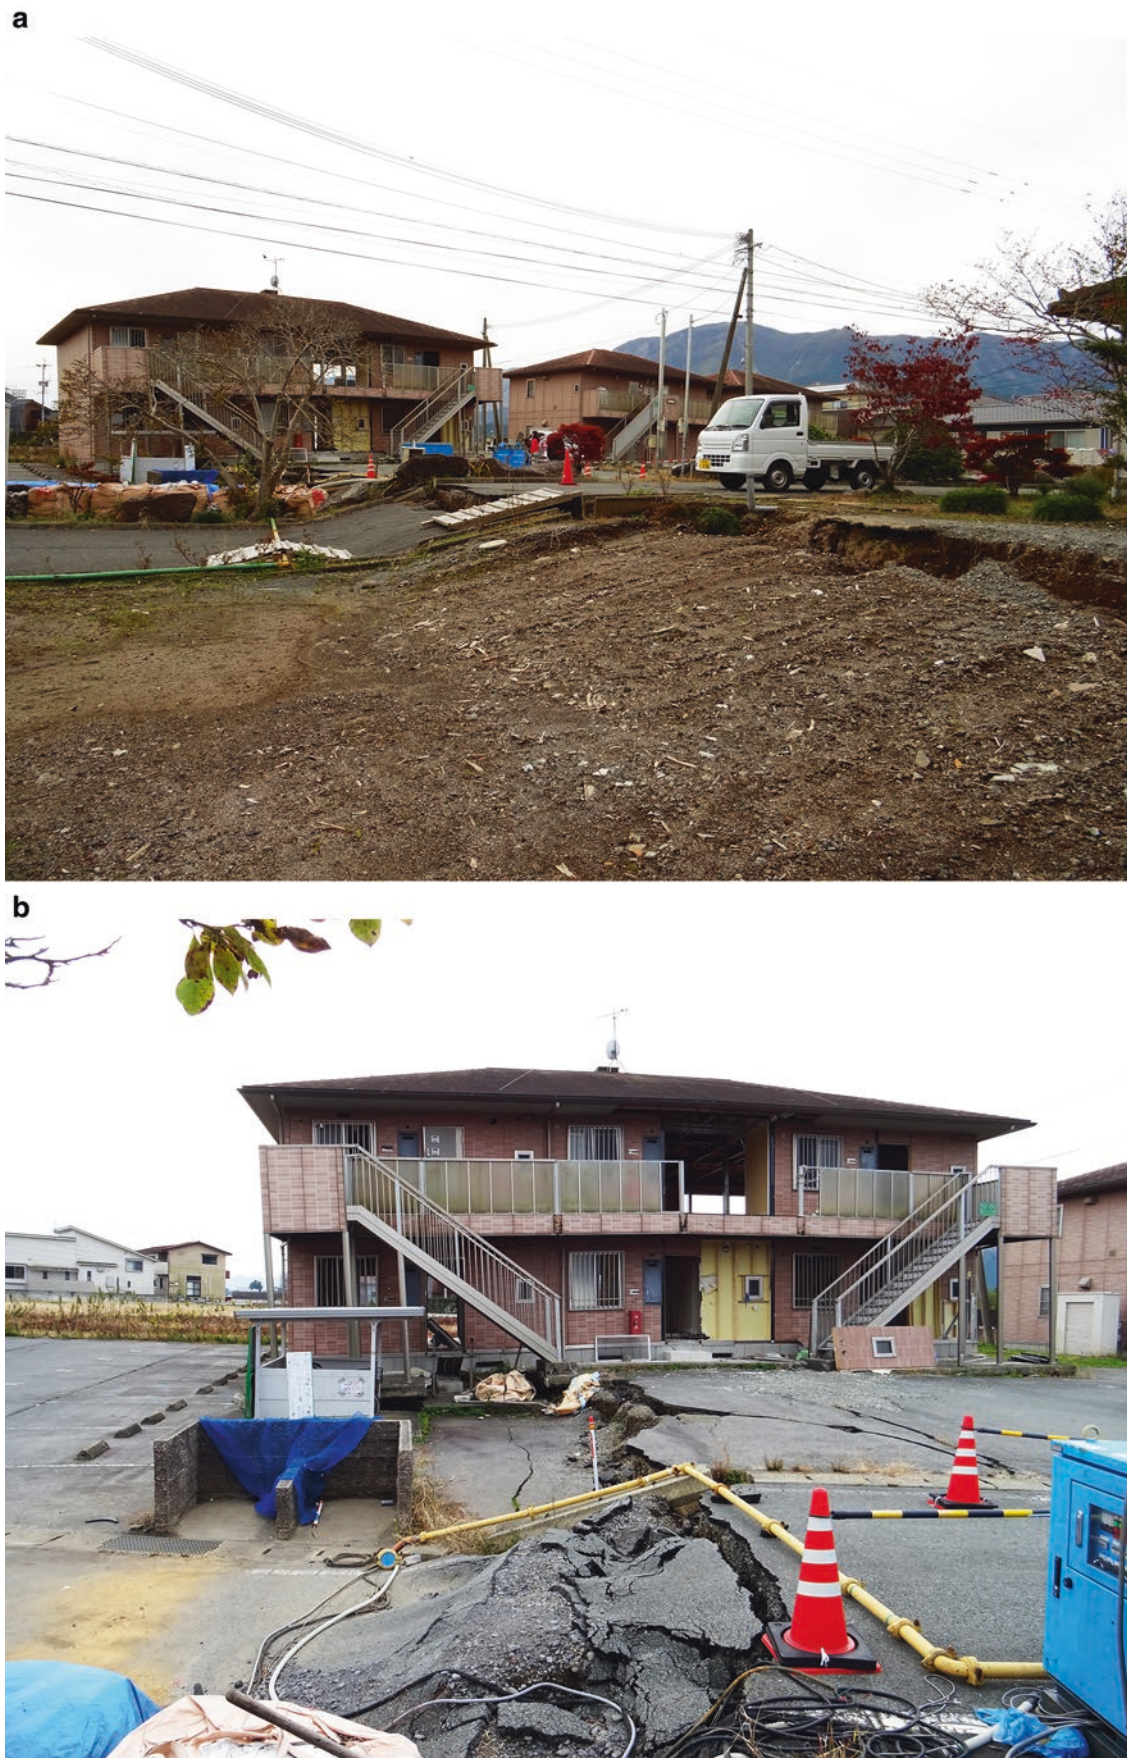
Fig. 76 Damaged houses on a coseismic normal fault scarp. (a) A damaged house located on a coseismic normal fault scarp. (b) Close-up view of (a). (c) A house inclined to a coseismic normal fault scarp,

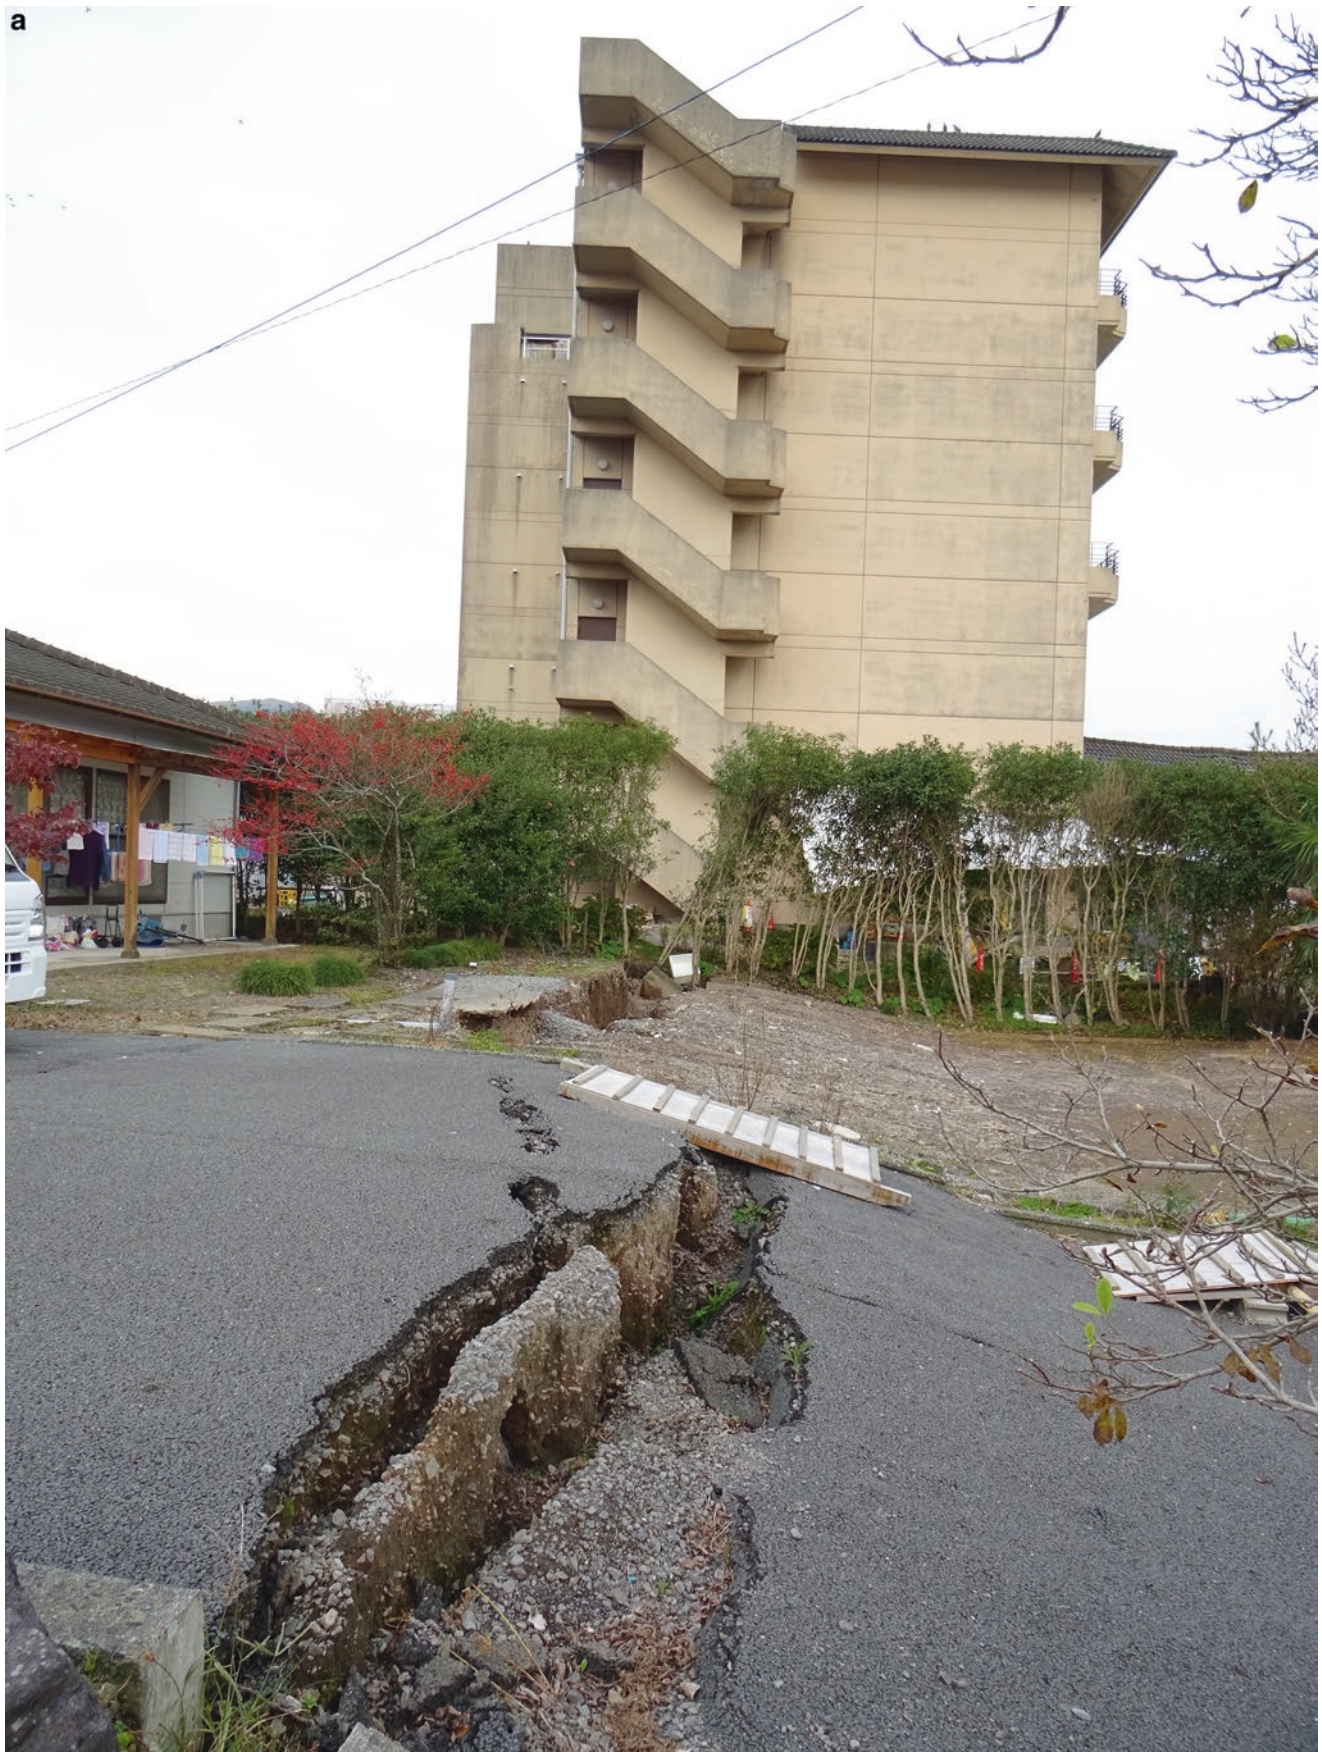
Fig. 77 Damaged building on a coseismic normal fault scarp. (a) A building on a coseismic normal fault scarp. (b) The building shown in (a) was uplifted $\sim 0.5 \sim 0.7$ m on a coseismic normal fault scarp (right side uplift). (c) Coseismic cracks occurred on a wall of building shown in (a, b)
