Asset Management of Bridges

Edited by Khaled M. Mahmoud

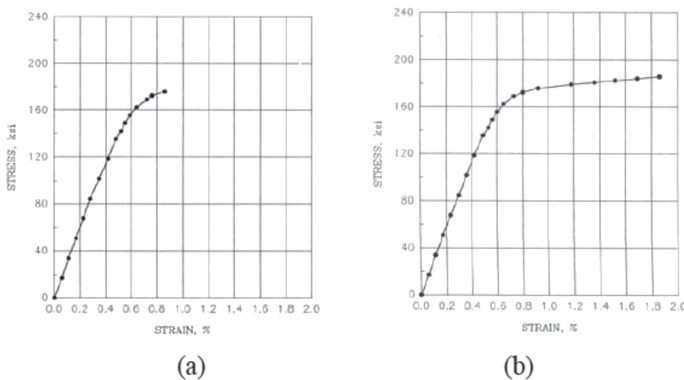
Figure 1. Stress-strain curves for tested wire specimens.

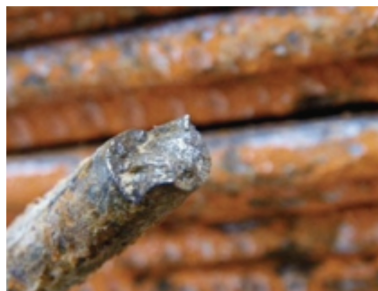
Figure 2. Embrittled wire break.

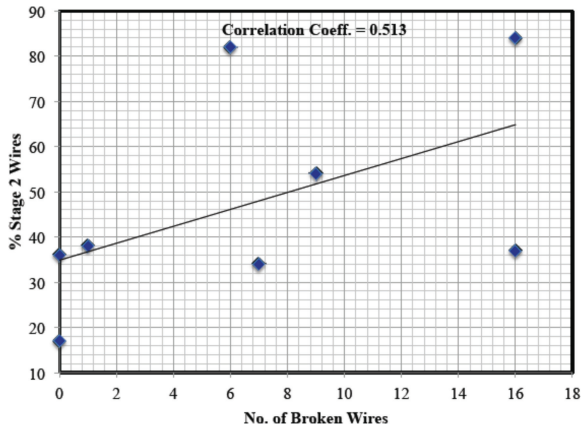
Figure 3. Correlation between number of broken wires and % stage 2 wires.

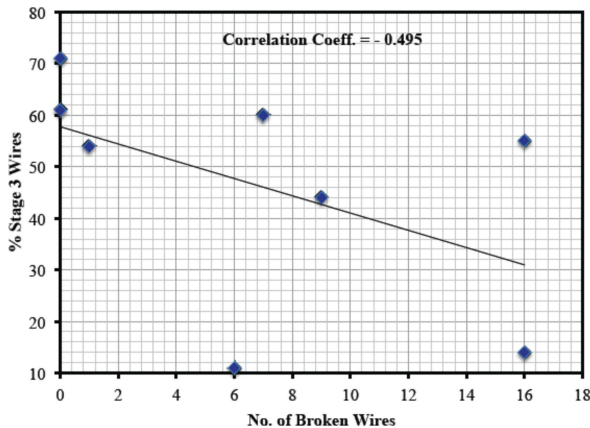
Figure 4. Correlation between number of broken wires and % stage 3 wires.

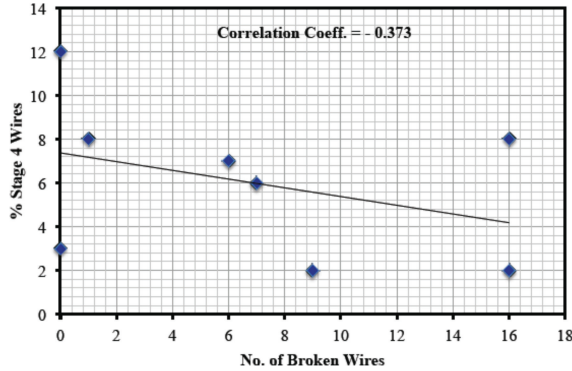
Figure 5. Correlation between number of broken wires and % stage 4 wires.

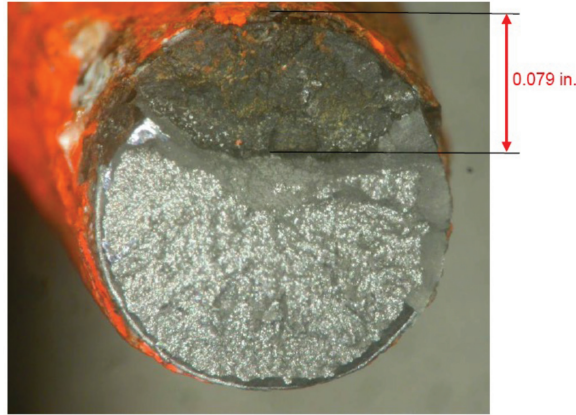
Figure 6. Preexisting crack in a tested wire specimen.

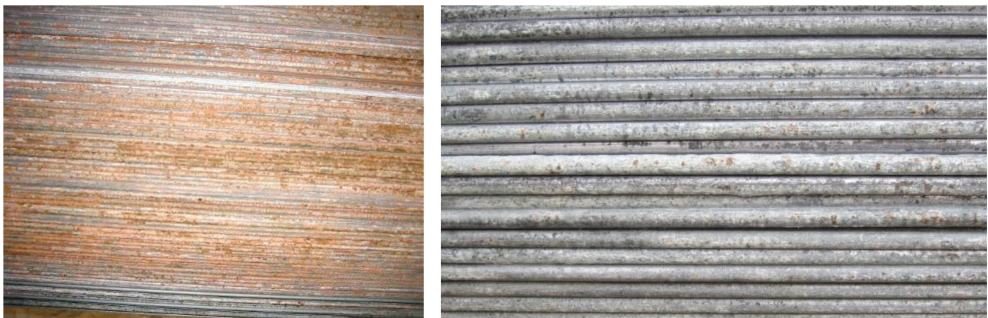
Figure 1. Corrosion on main cables, roughly 30 (left) and 15 (right) years old.

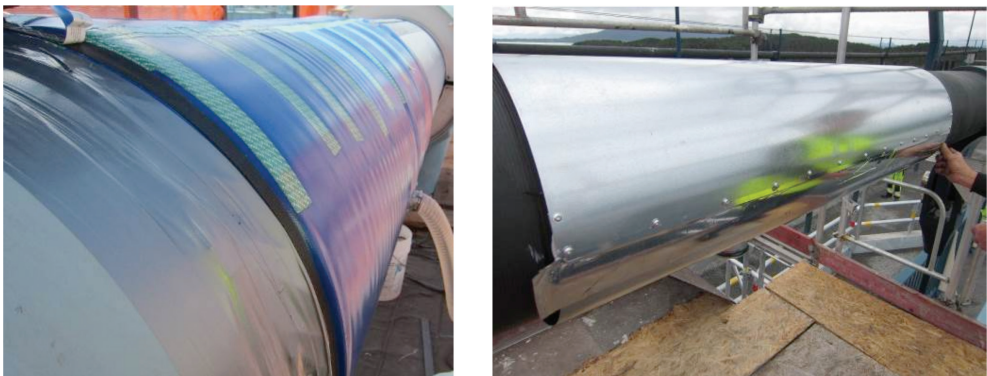
Figure 2. Temporary injection sleeves, flexible (left) and stainless steel (right).

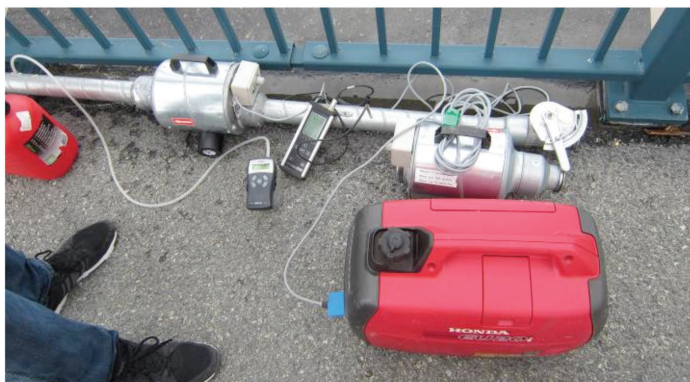
Figure 3. Equipment for flow test.

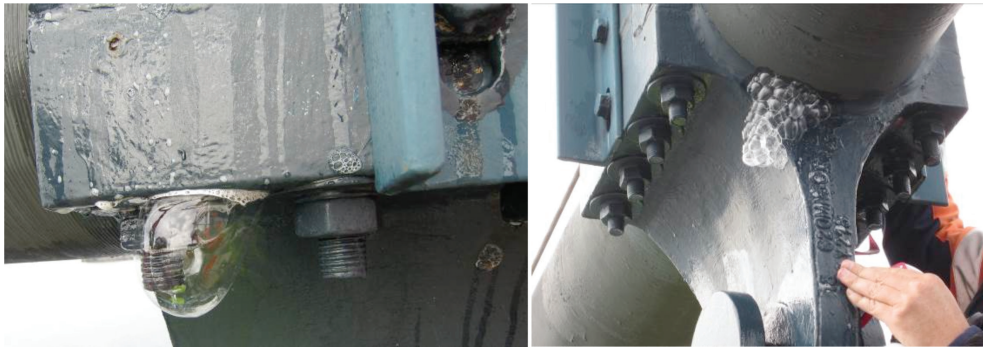
Figure 4. Leakage at cable band bolt (left) and at drain hole (right).

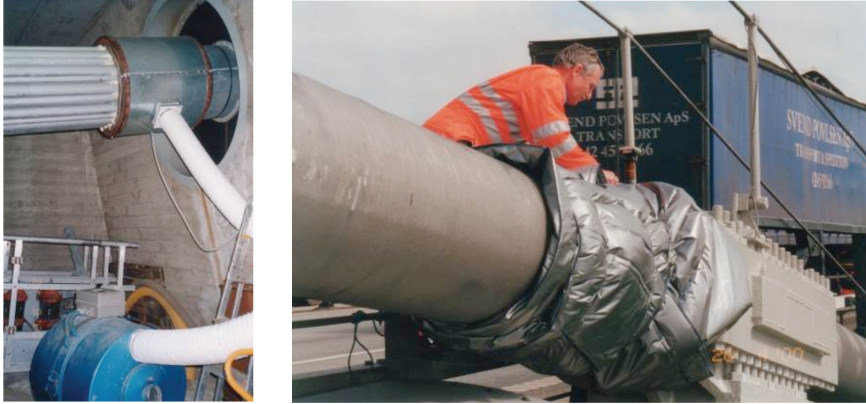
Figure 5. Flow test in 2001 on Little Belt Bridge, Denmark.

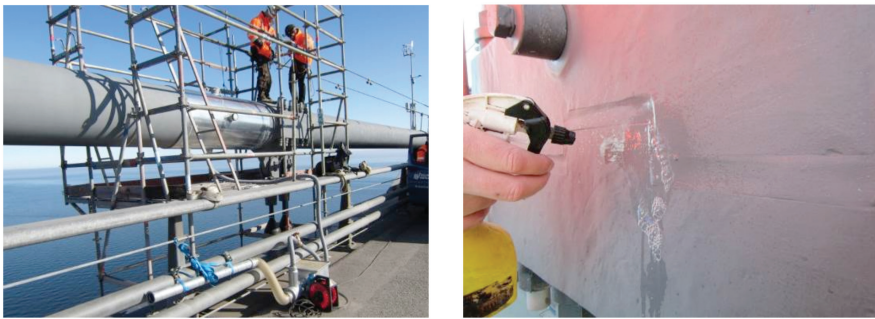
Figure 9. Storebælt Bridge, equipment setup for flow test and leakage at longitudinal joint.

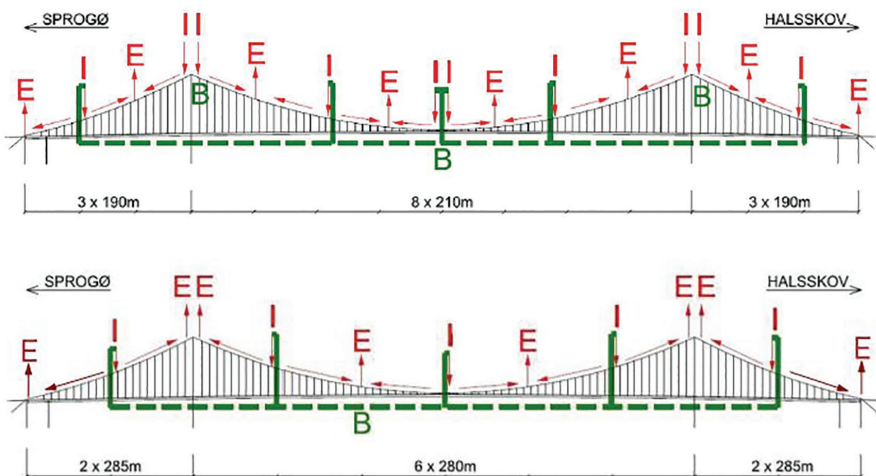
Figure 10. Storebælt Bridge, Conceptual Design (above) and Final Design (below).

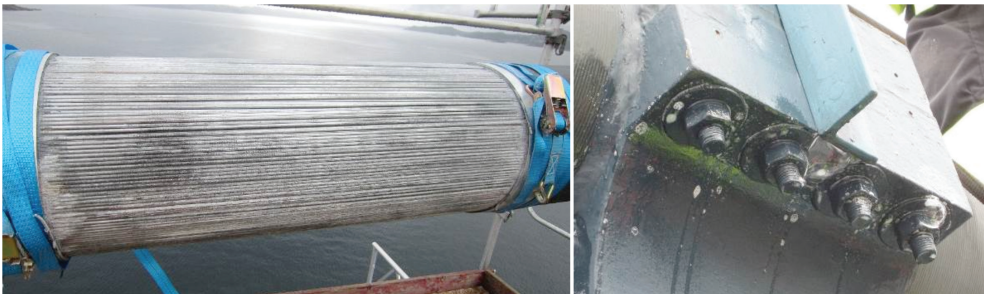
Figure 11. Storda Bridge, cleaned cable at injection point and leakage at washer on cable band.

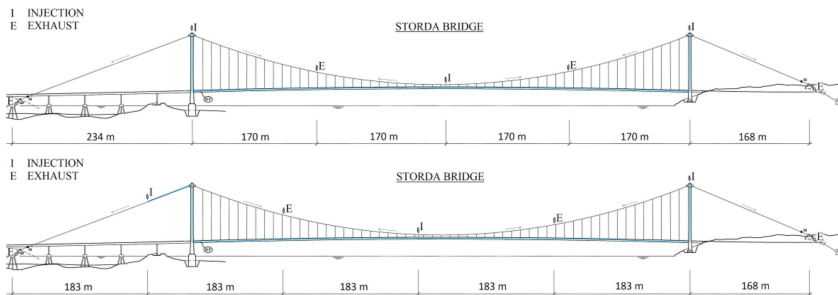
Figure 12. Storda Bridge, Conceptual Design (upper) and Final Design (lower).

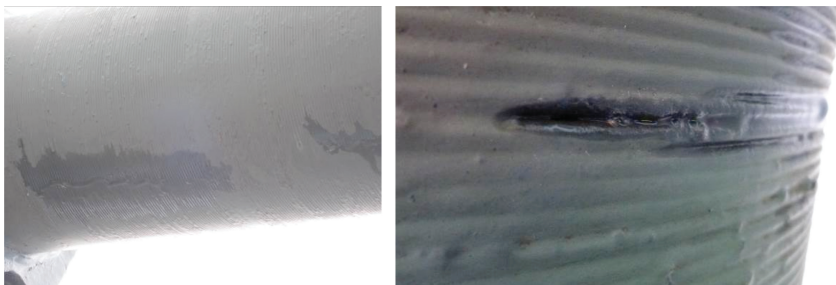
Figure 13. Water on bottom of main cable and close-up off defective wrapping wire and paint.

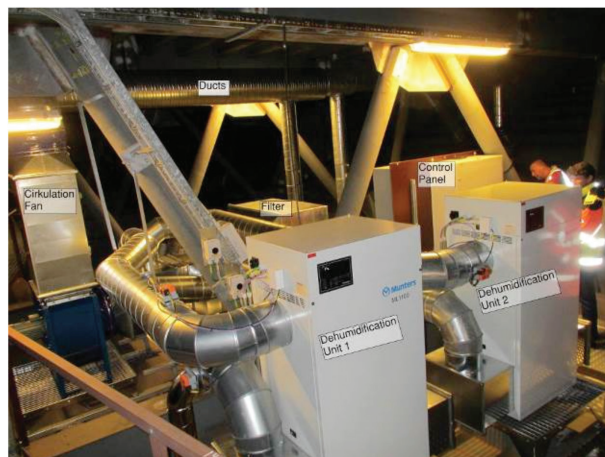
Figure 14. Dehumidification plant for main cables, Storebælt Bridge.

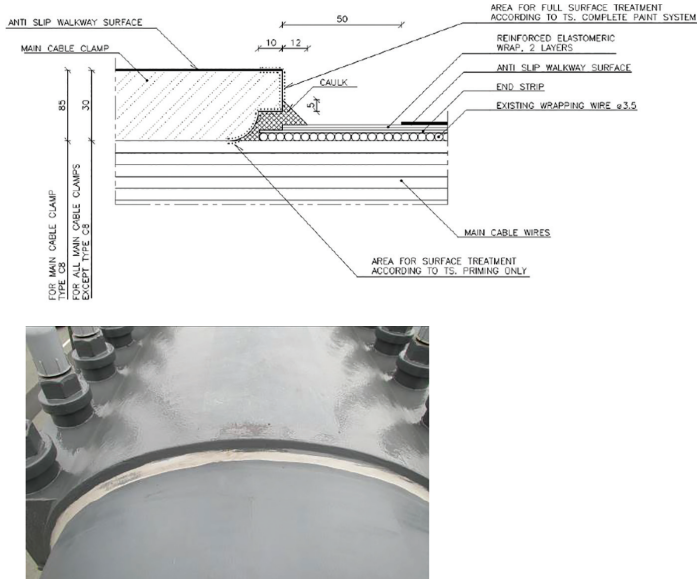
Figure 15. Drawing and picture of detail at cable band.

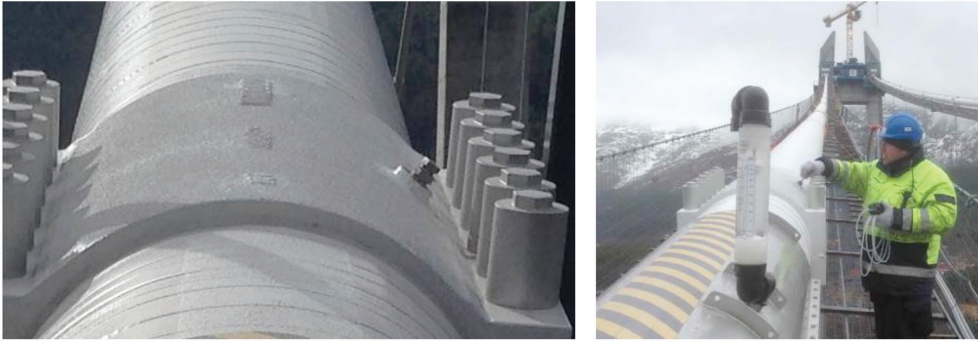
Figure 16. Nipple for pressure gauge and installation of pressure gauge during flow testing.

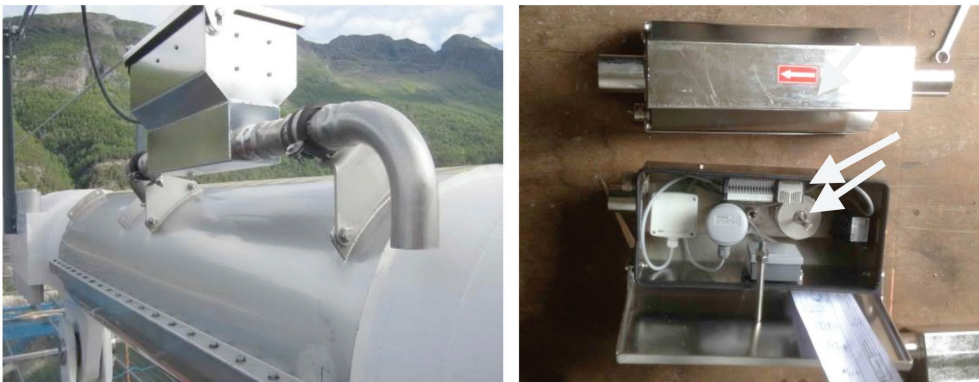
Figure 17. Exhaust sleeve with damper, bolt for adjustment of damper – see arrow, Hardanger Bridge.

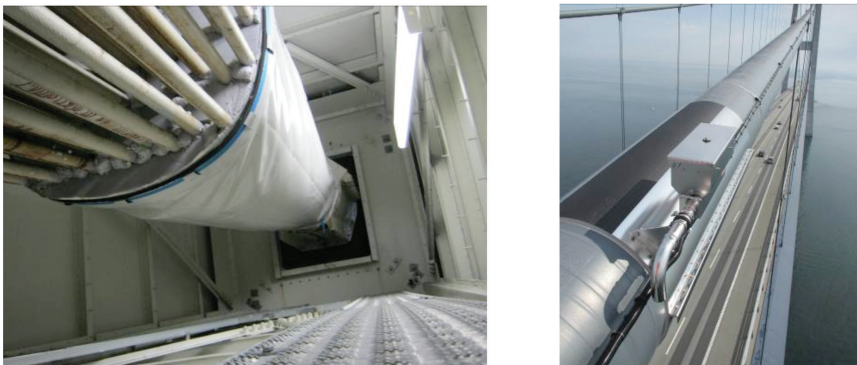
Figure 18. Enclosure of strands, Älvsborg Bridge and monitoring sleeve, Storebælt Bridge.

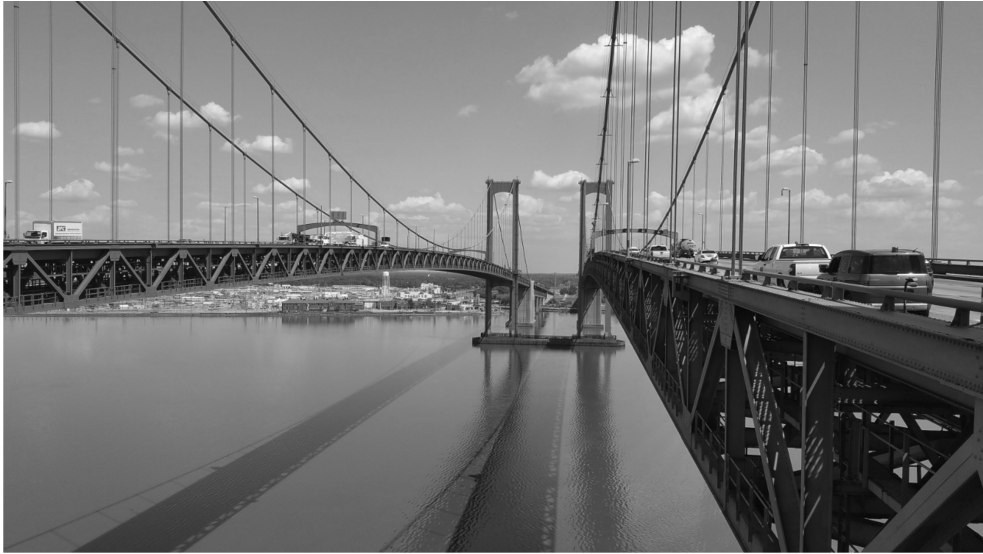
Figure 1. Structure 1 and 2 making up the Delaware Memorial Bridge, looking towards New Jersey. Structure 1 is on the right.

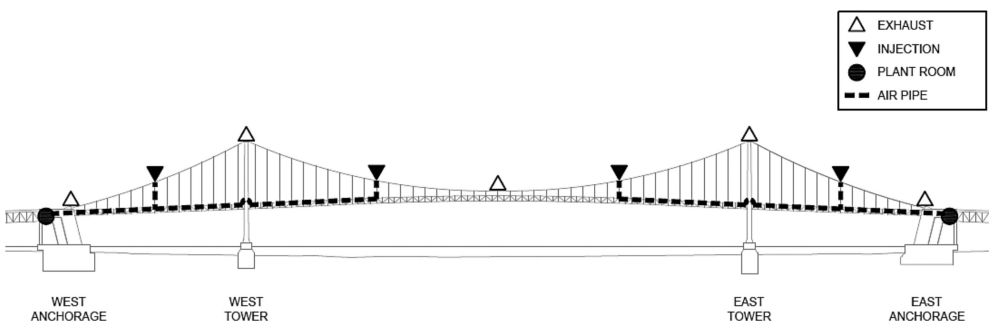
Figure 2. Elevation showing plant room, air pipe and injection/exhaust point locations.

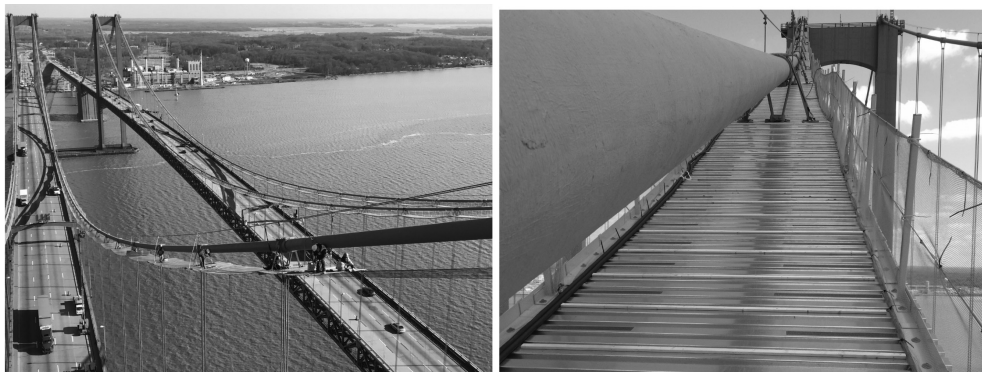
Figure 3. Cable access being erected (left); completed cable access platform (right).

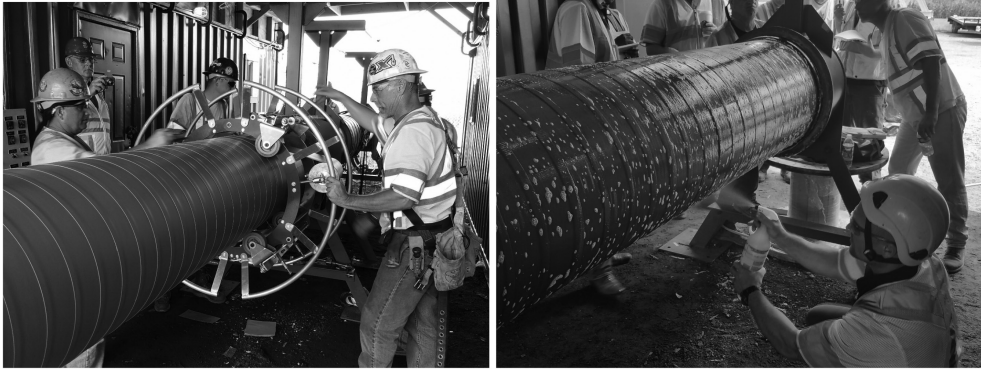
Figure 4. Trial wrapping on test rig (left); soapy water test on trial wrapping (right).

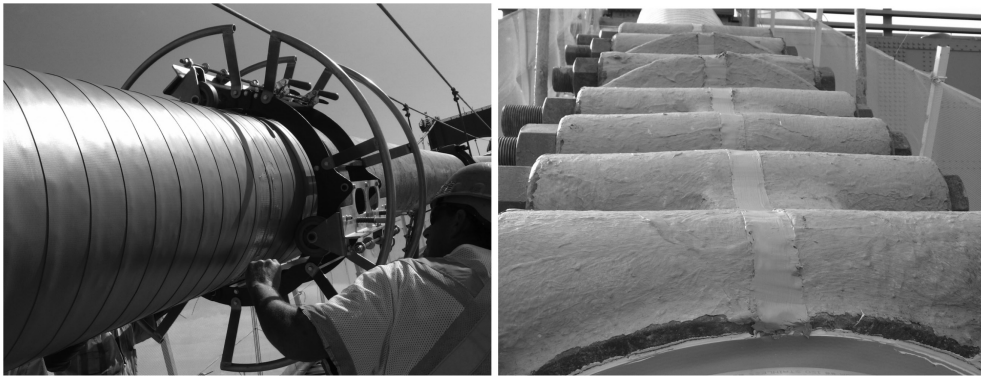
Figure 5. Skewmaster used to wrap cableguard on main cable (left); caulking on cable bands (right).

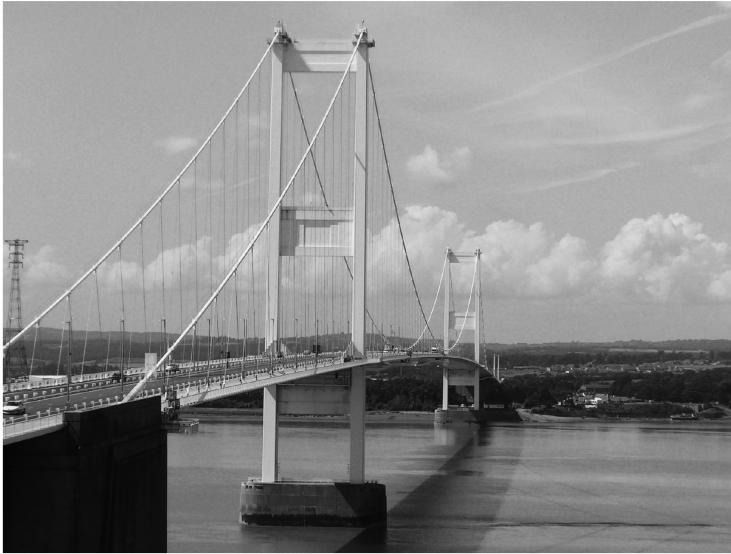
Figure 1. M48 Severn Bridge.

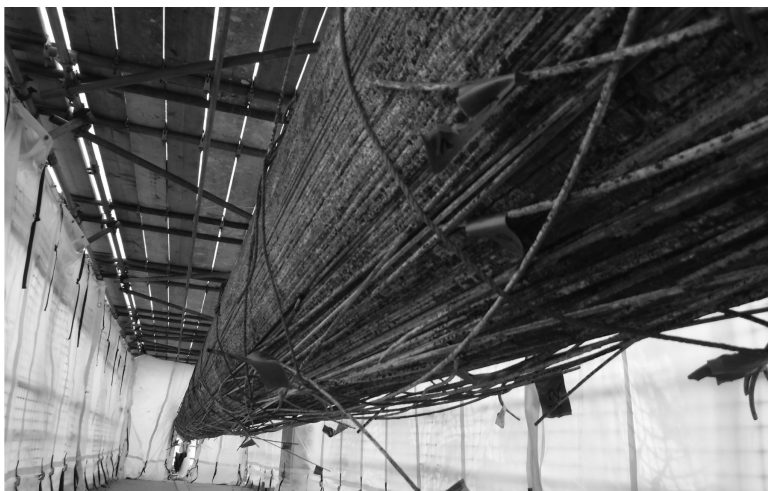
Figure 2. Broken wires.

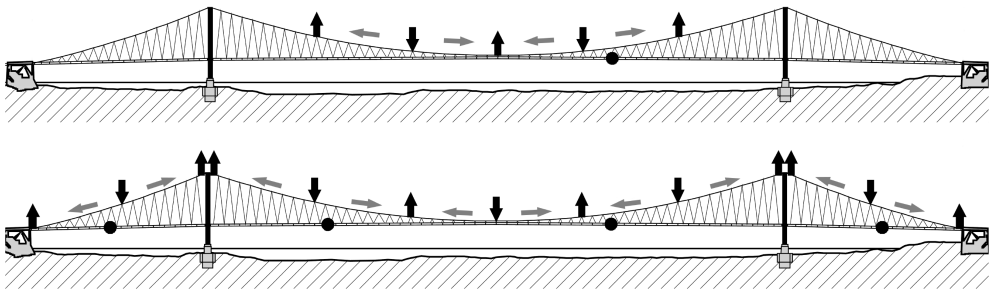
Figure 4. Layout of partial (top) and full (bottom) dehumidification systems.

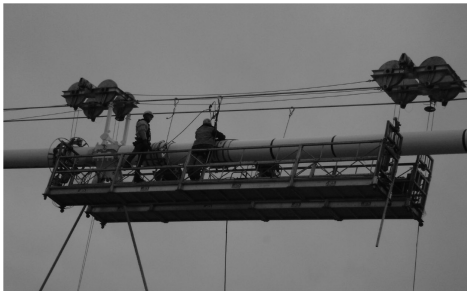
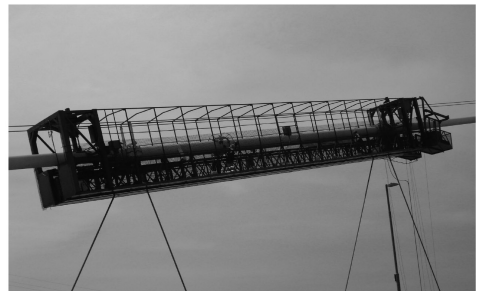
Figure 5. Access systems for advance works contract (left) and full system contract (right).

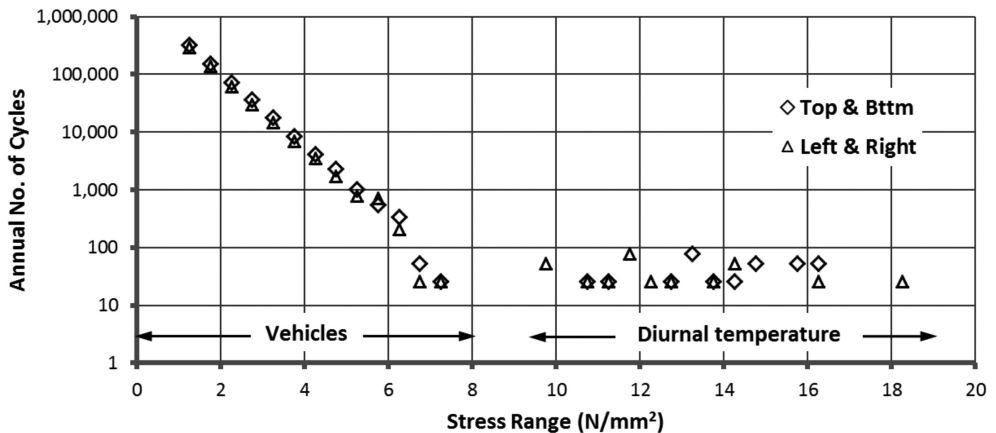
Figure 6. Cable strain measurements.

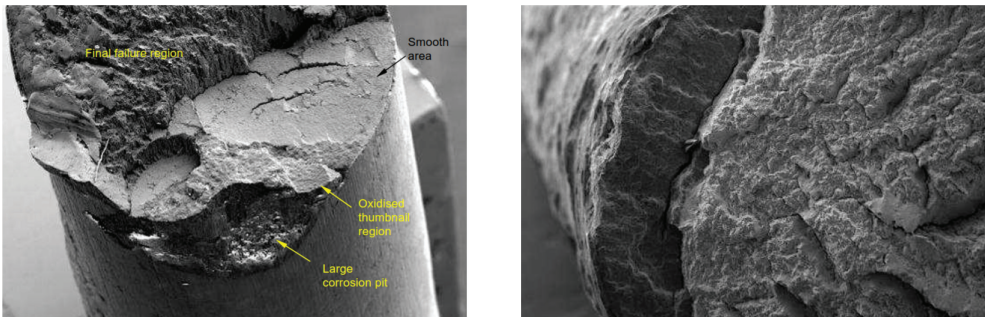
Figure 7. SEM images of fracture surfaces—left 0.9 mm pre-existing crack + fatigue growth; right 0.75 mm pre-existing crack—no fatigue growth.

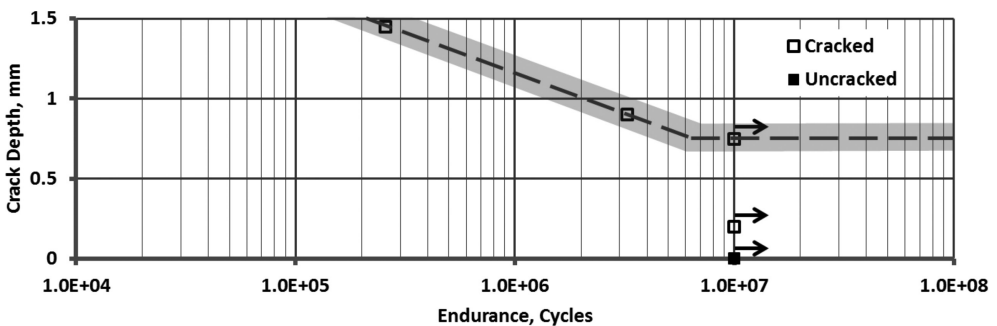
Figure 8. Possible crack depth—endurance relationship.

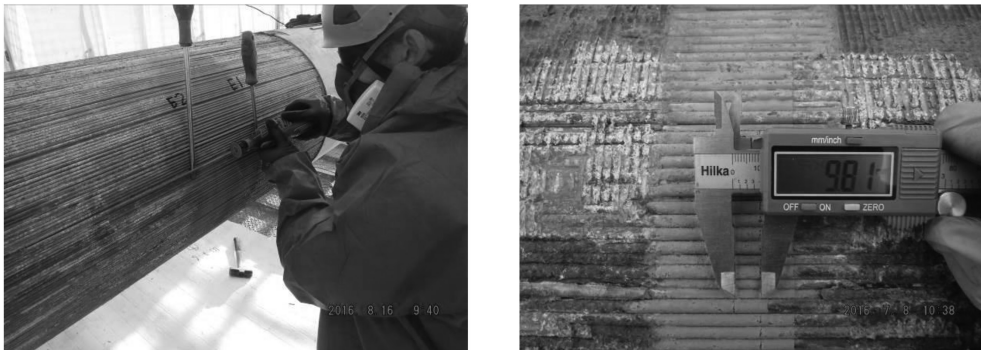
Figure 10. Wire cutting and wire slip measurement.

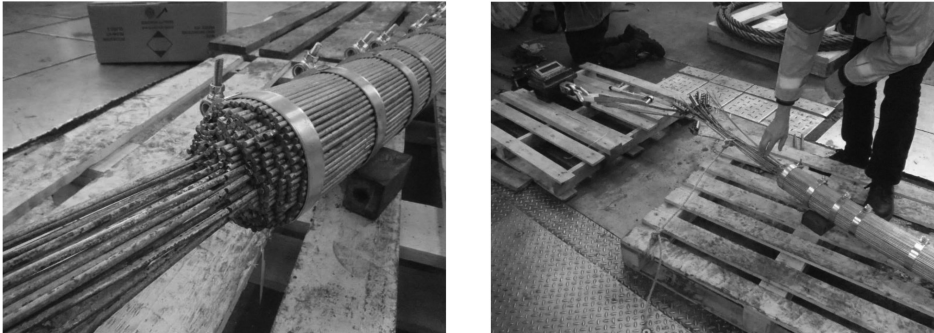
Figure 11. Mock-up cable friction test.

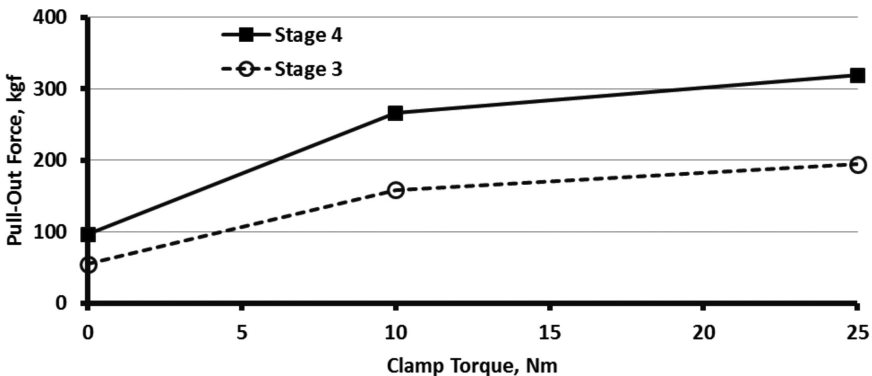
Figure 12. Mock-up cable friction test results.

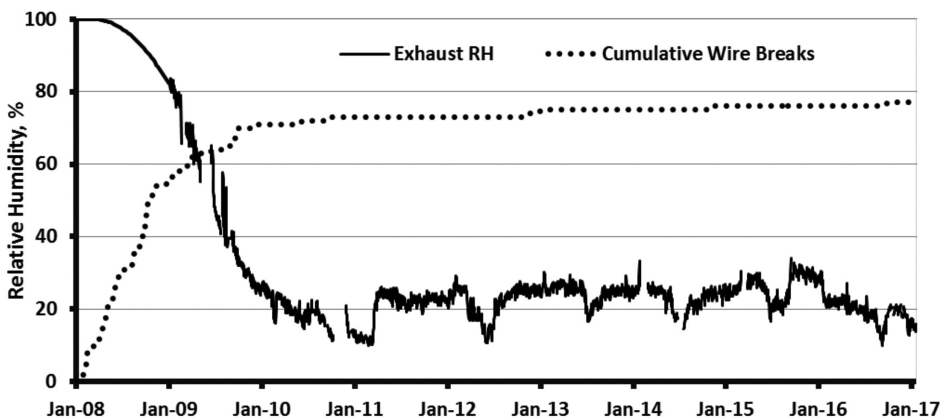
Figure 13. Cable humidity and cumulative acoustic monitoring results.

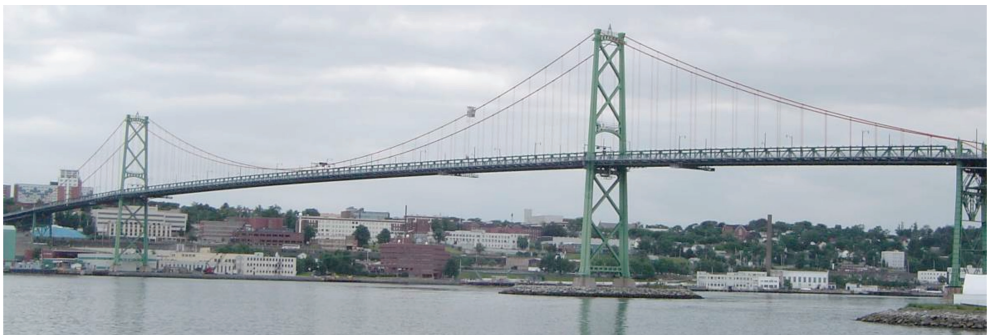
Figure 1. Angus L. Macdonald Bridge—pre-superstructure replacement photo.

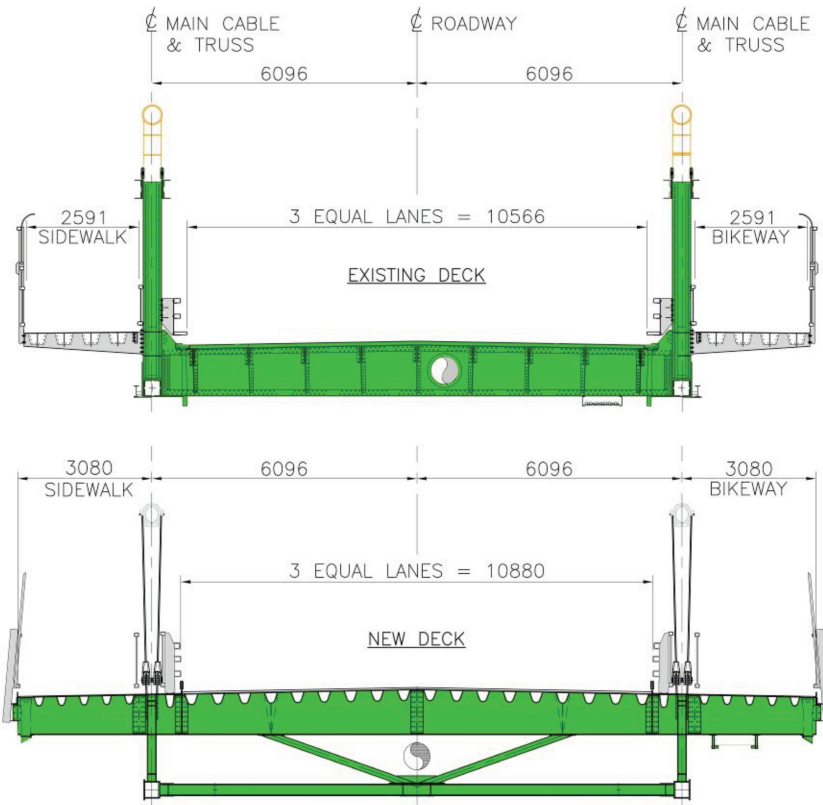
Figure 3. Existing and new deck cross-sections.

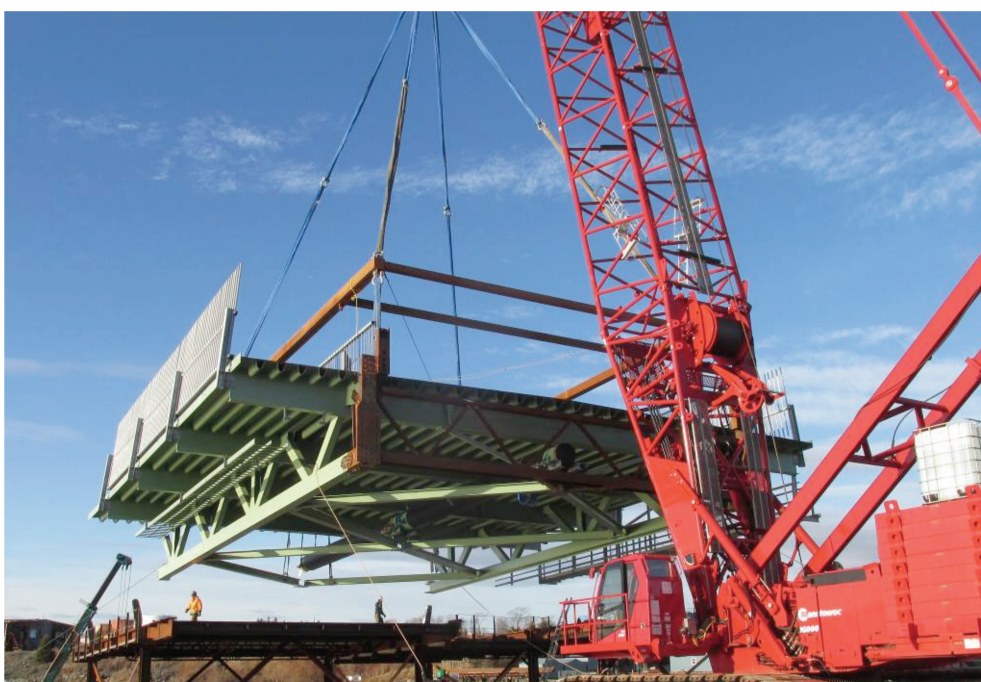
Figure 7. Loading of a new deck segment with appurtenances onto the barge.

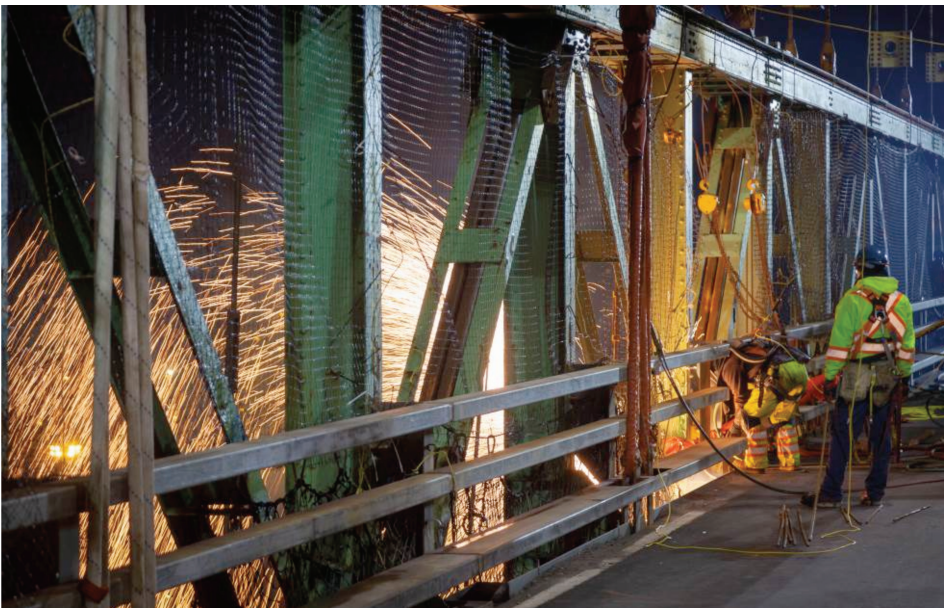
Figure 8. Existing truss bottom chord cutting.

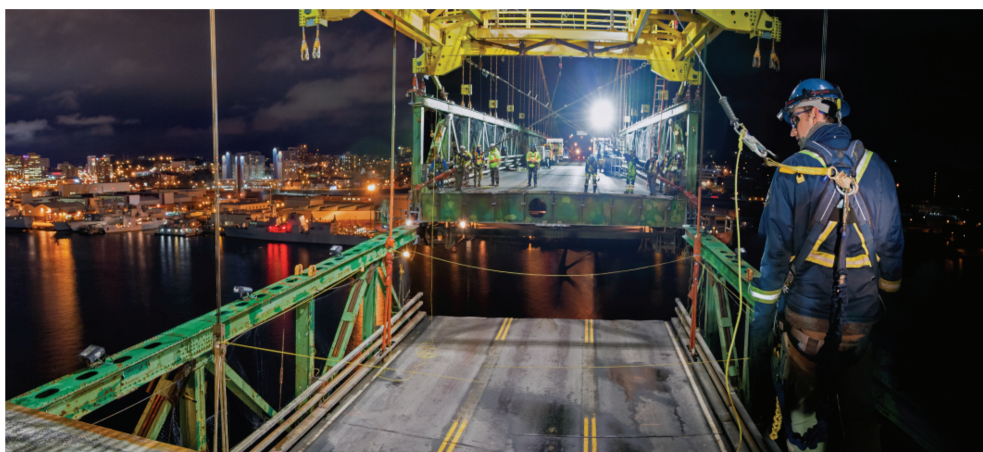
Figure 10. Gap in the superstructure during segment replacement.

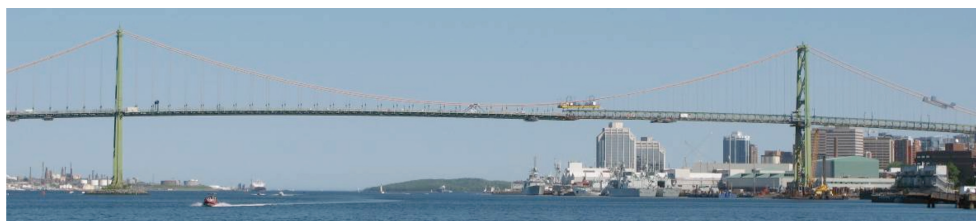
Figure 14. Bridge during construction—elevation following a typical segment replacement.

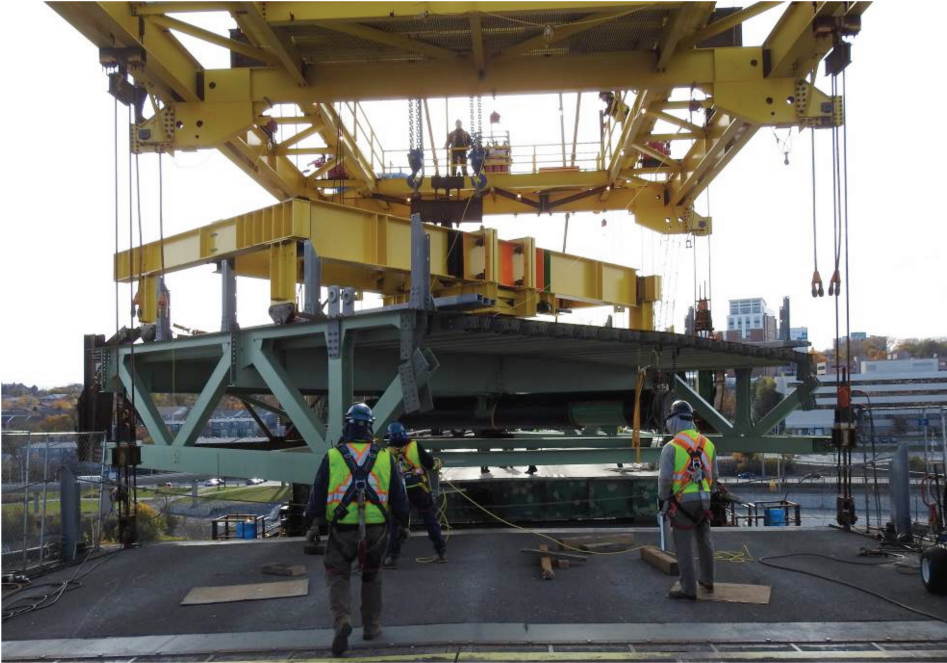
Figure 18. New Halifax side span segment rotation during installation (roadway view).

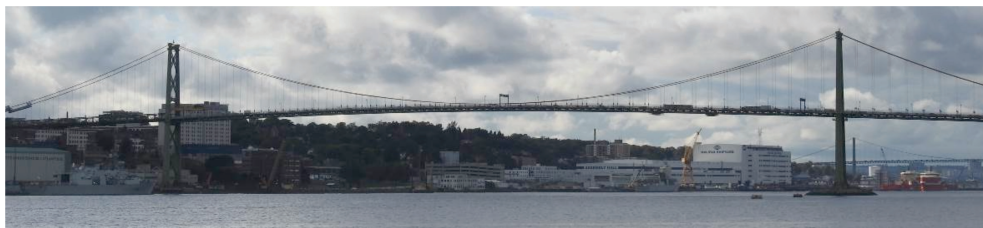
Figure 20. Bridge superstructure elevation after raising of the main span.

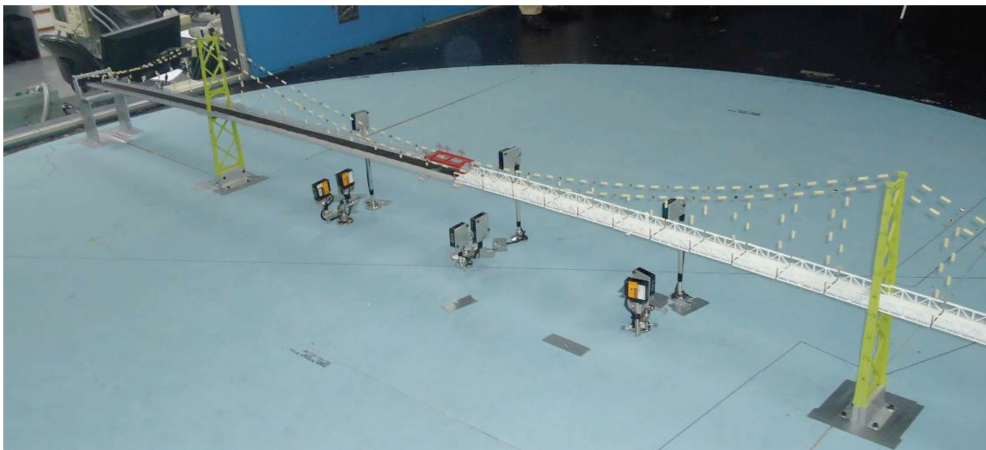
Figure 21. Aeroelastic model of the bridge during erection—erection front at midspan.

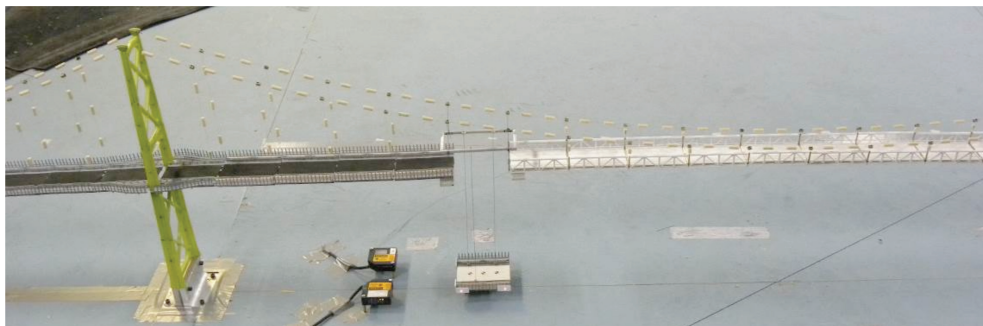
Figure 22. Aeroelastic model of the bridge during erection—gap in the deck at main span quarter point.

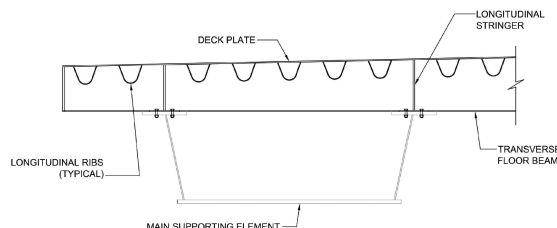
Figure 1. Generic orthotropic steel deck cross-section.

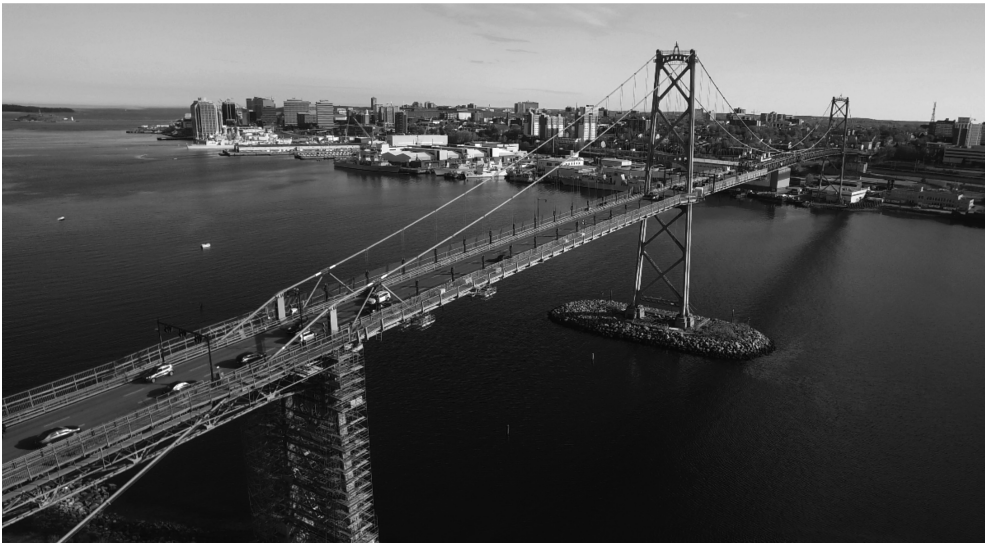
Figure 2. Aerial view of the Macdonald Bridge; part way through redecking.

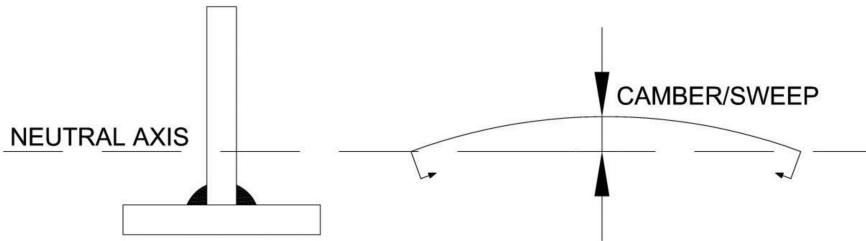
Figure 4c. Camber/sweep caused by welding.

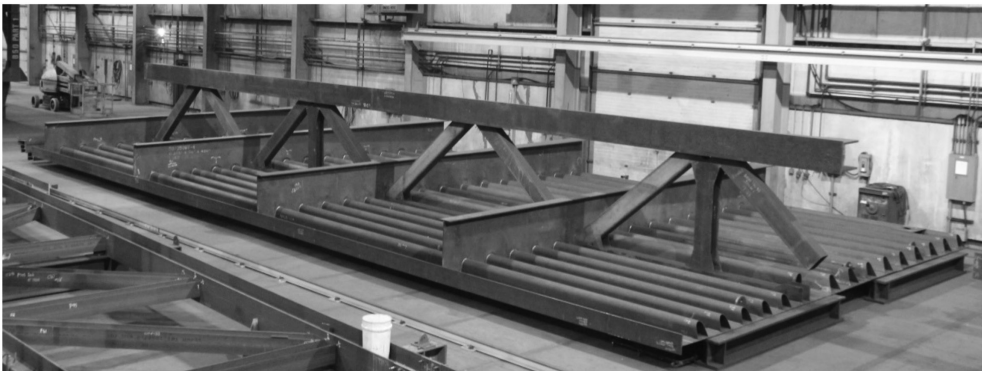
Figure 5. Prototype section of Macdonald Bridge deck section.

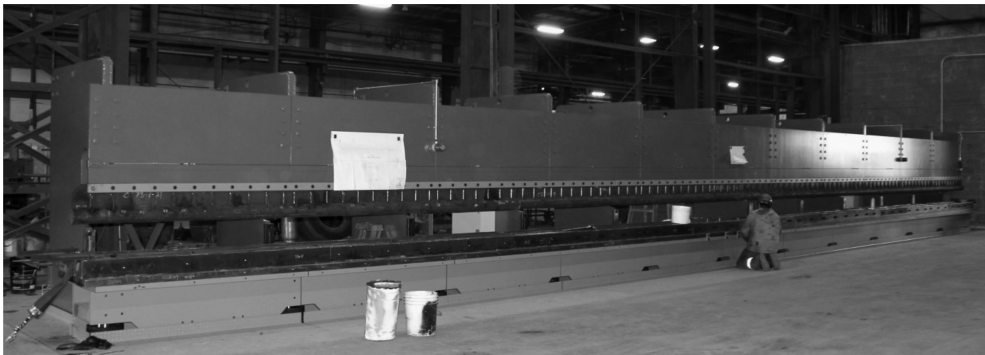
Figure 7. Purpose-built press for bending 20 m long plate.

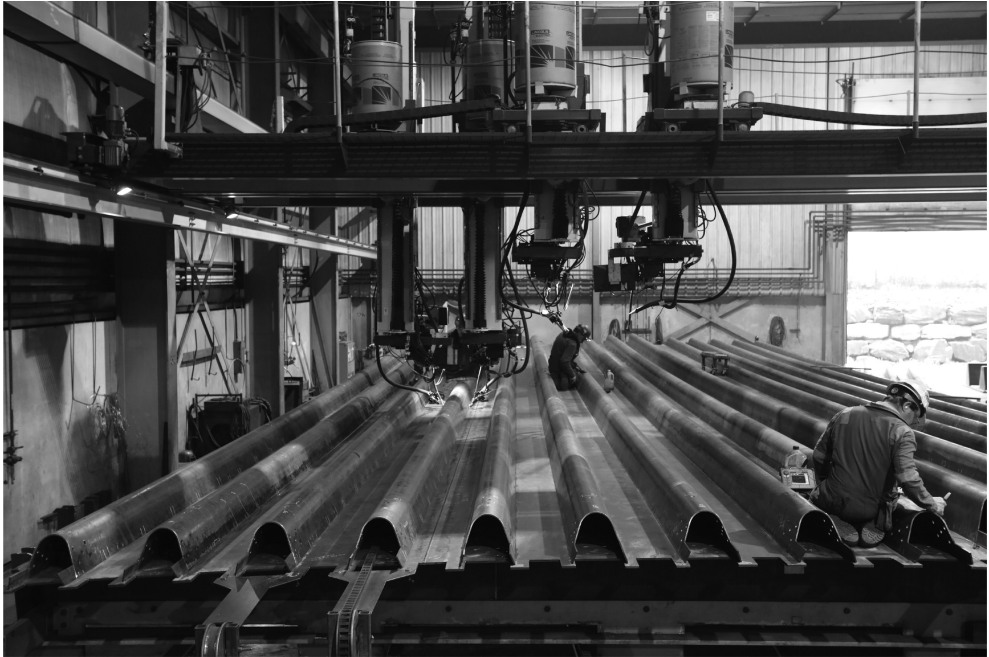
Figure 8. Rib to deck weld process.

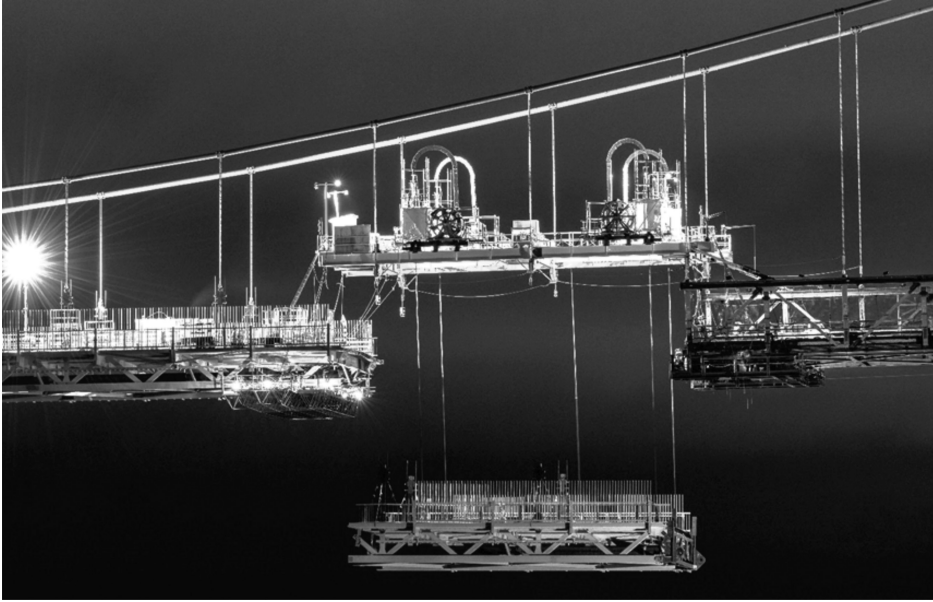
Figure 13. New deck segment being lifted in place.

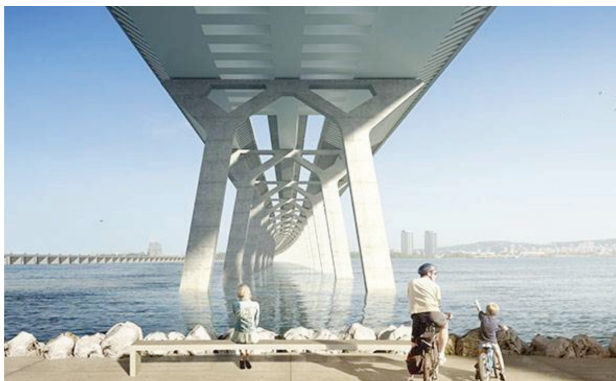
Figure 4. Rendering of distinctive pier shape.

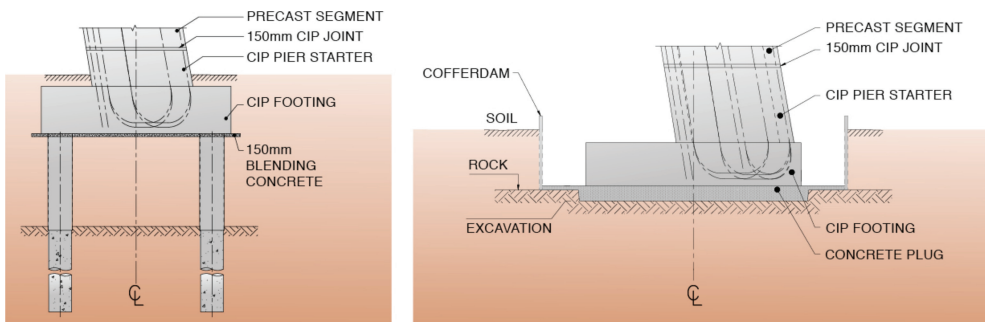
Figure 5. Drilled shafts (left) and spread footing (right).

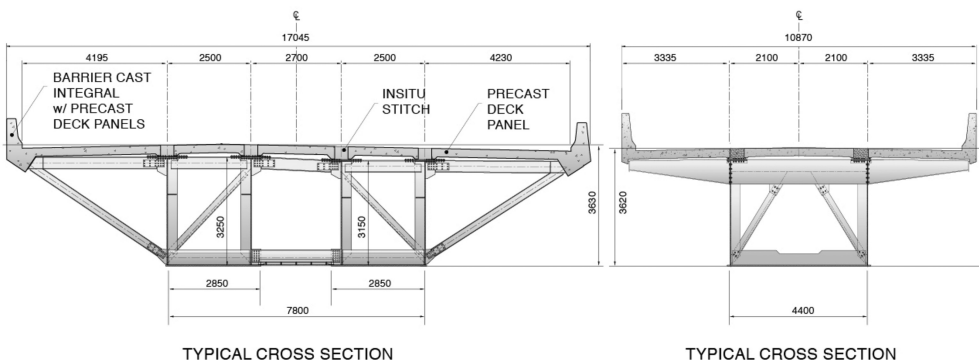
Figure 8. Cross sections of southbound highway corridor (left) and central transit corridor (right)/northbound corridor supporting multi-use path (not shown).

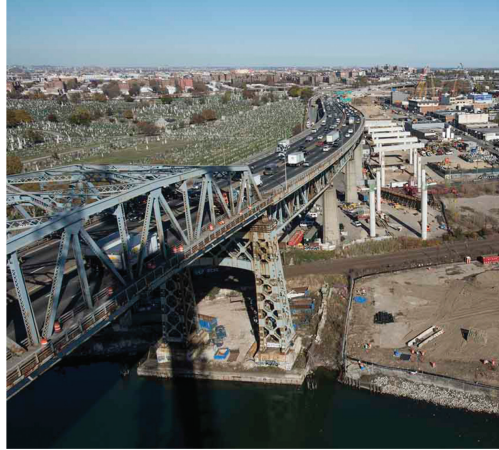
Figure 1. Existing Kosciuszko Bridge looking east into Queens with new Queens Approach substructure.

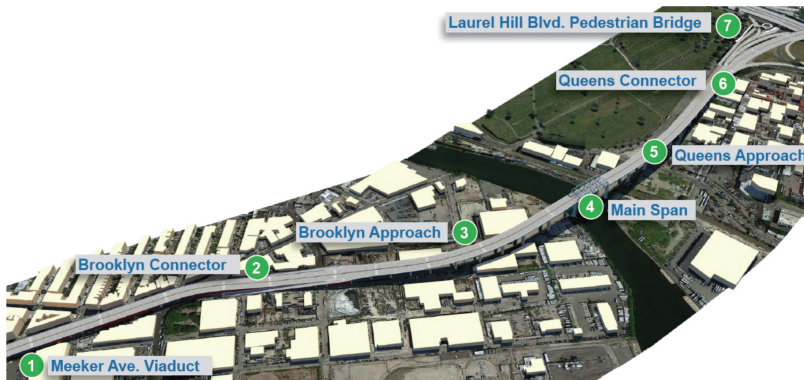
Figure 2. Overall site plan view highlighting different areas of the project.

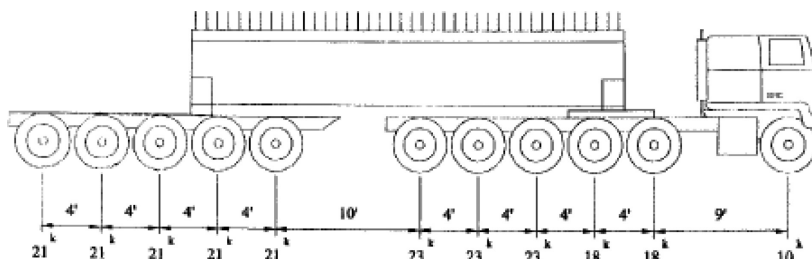
Figure 4. NYSDOT permit vehicle axle loads and spacing.

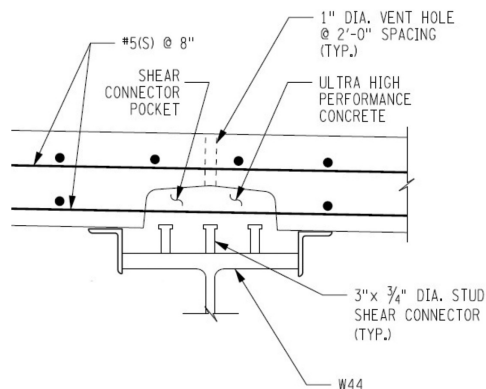
Figure 6. Precast panel with hidden pockets for shear connectors.

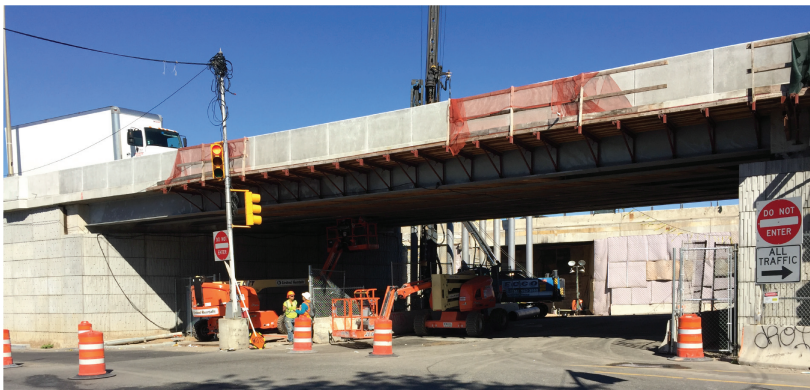
Figure 7. Vandervoort first stage completed and pile installation for the second stage in the back.

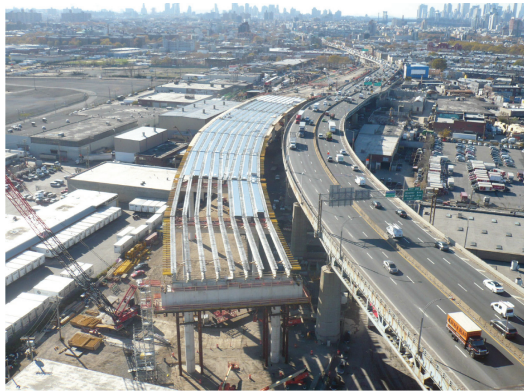
Figure 11. Aerial view of new Brooklyn Approaches with stay-in-place formwork being laid out over the prestressed girder superstructure.

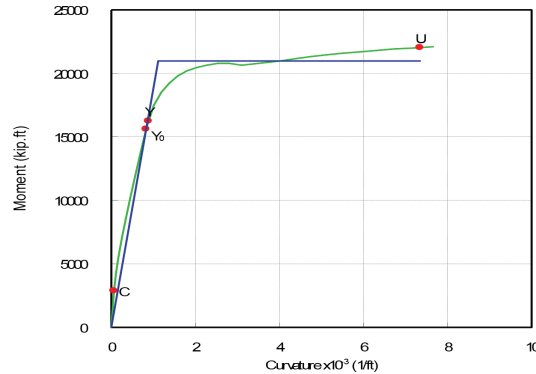
Figure 15. Moment curvature diagram for individual pier under SEE demands generated with MIDAS.

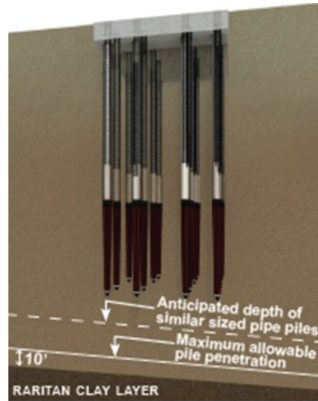
Figure 16. Tapered steel piles with minimum tip above other similarly sized piles.
