Asset Management of Bridges

Edited by Khaled M. Mahmoud

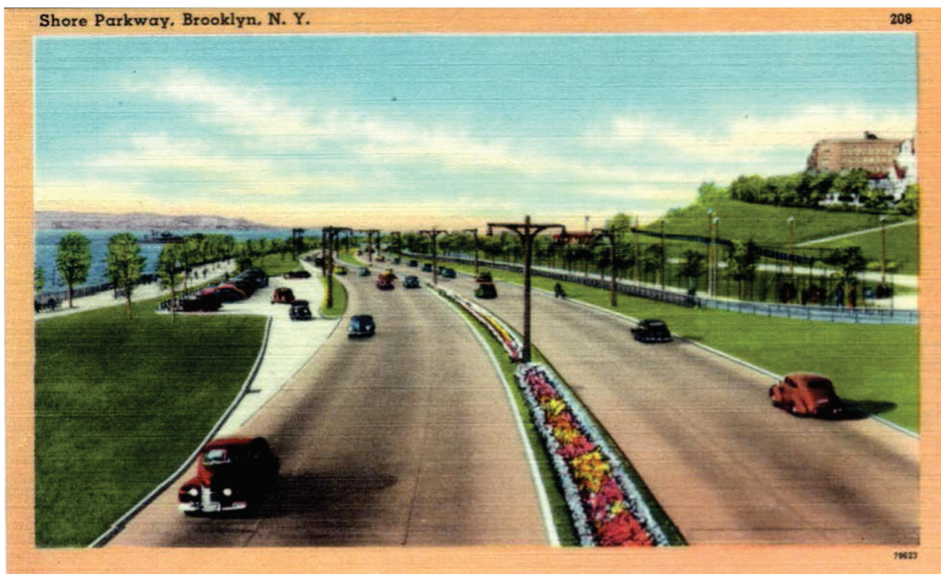
Figure 1. Original Belt Parkway (Late 1940s).

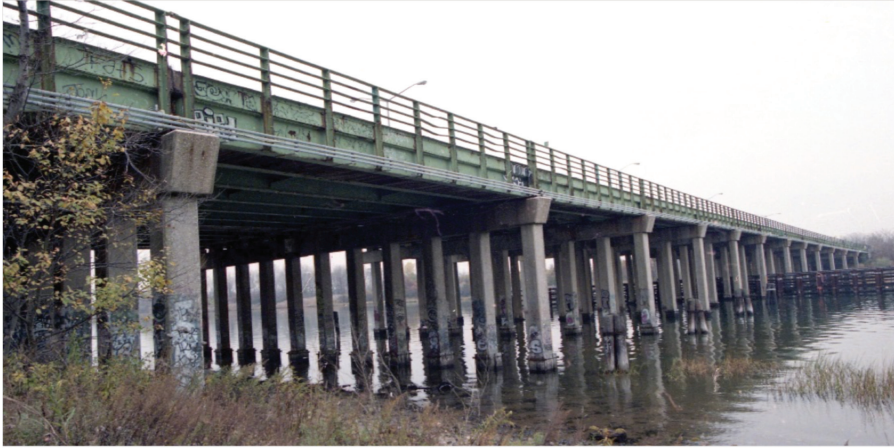
Figure 3. Original Belt Parkway Bridge over Paerdegat Basin (2005).

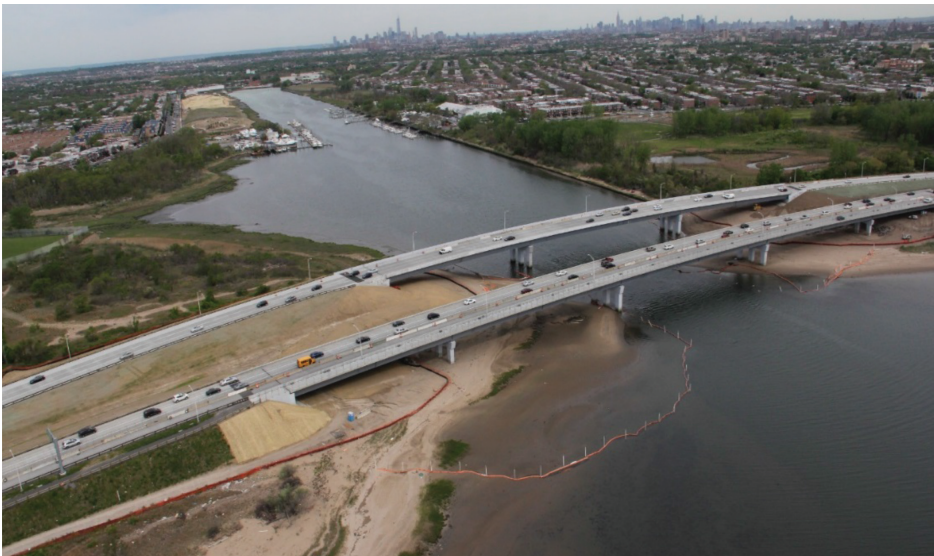
Figure 4. Replacement Belt Parkway Bridges over Paerdegat Basin (2013).

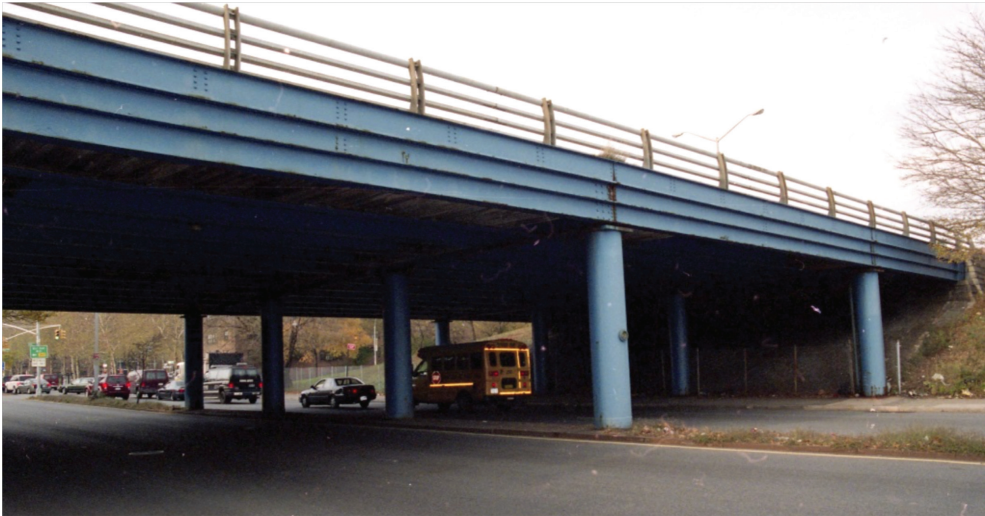
Figure 5. Original Belt Parkway Bridge over Rockaway Parkway (2005).

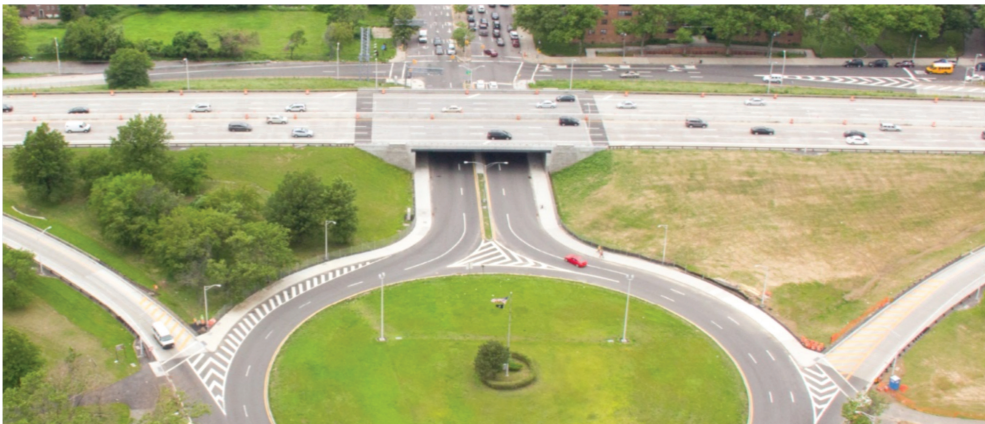
Figure 6. Replacement Belt Parkway Bridge over Rockaway Parkway (2013).

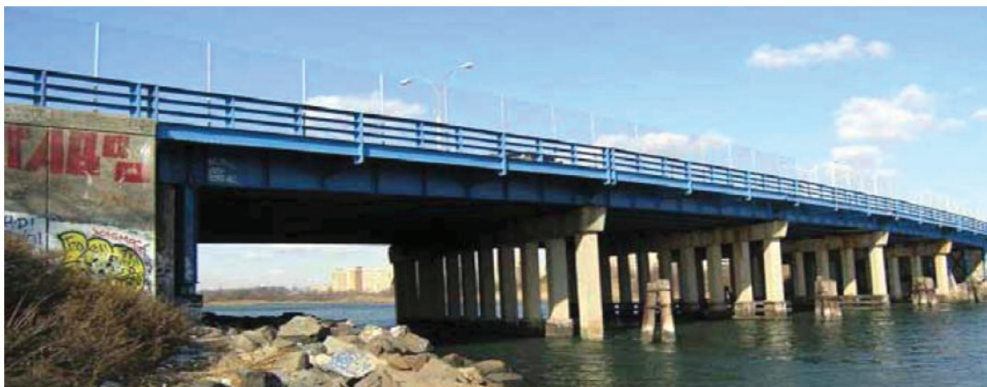
Figure 7. Original Belt Parkway Bridge over Fresh Creek Basin (2005).

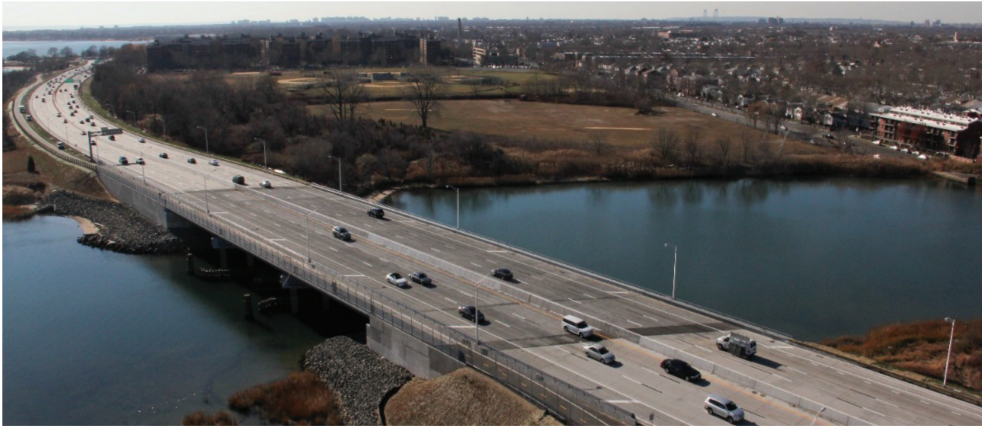
Figure 8. Replacement Belt Parkway Bridge over Fresh Creek Basin (2013).

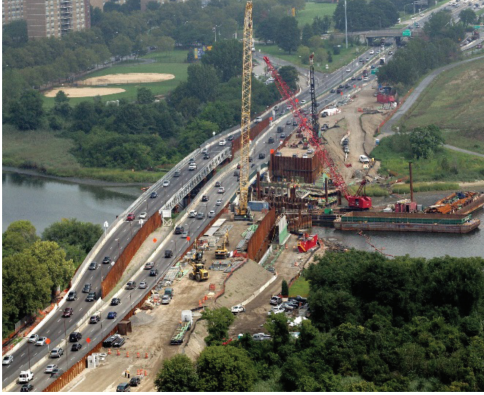
Figure 9. Belt Parkway Bridge over Fresh Creek Basin temporary bridge (2012).

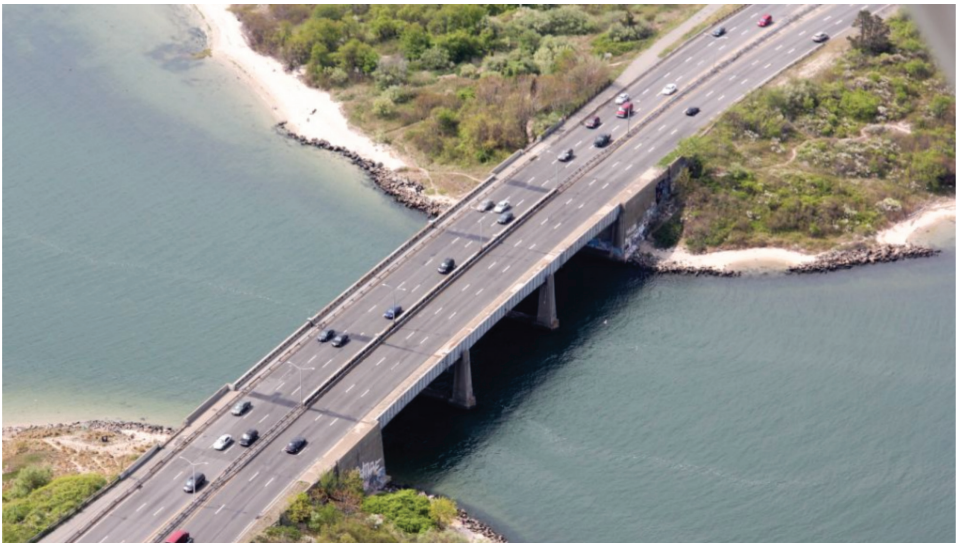
Figure 11. Original Belt Parkway Bridge over Gerritsen Inlet (2010).

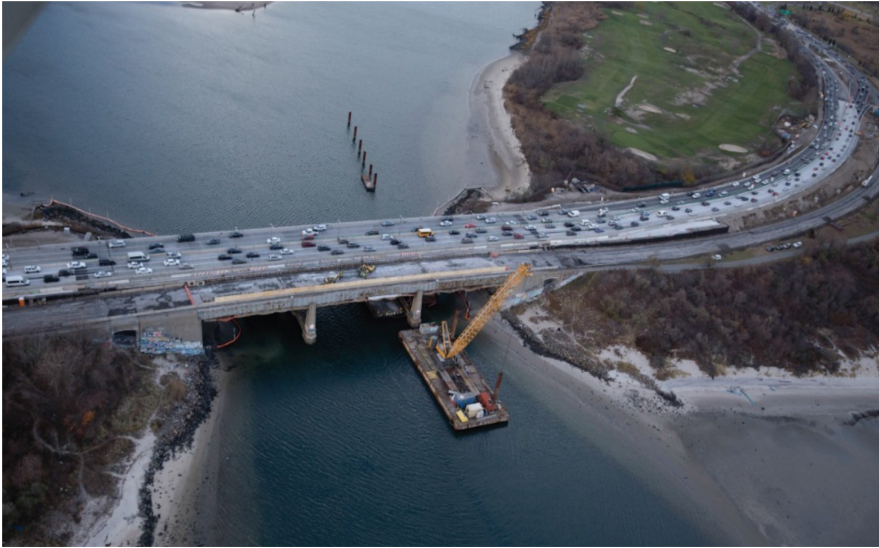
Figure 12. Replacement of Belt Parkway Bridge over Gerritsen Inlet—Stage 3 (January 2017).

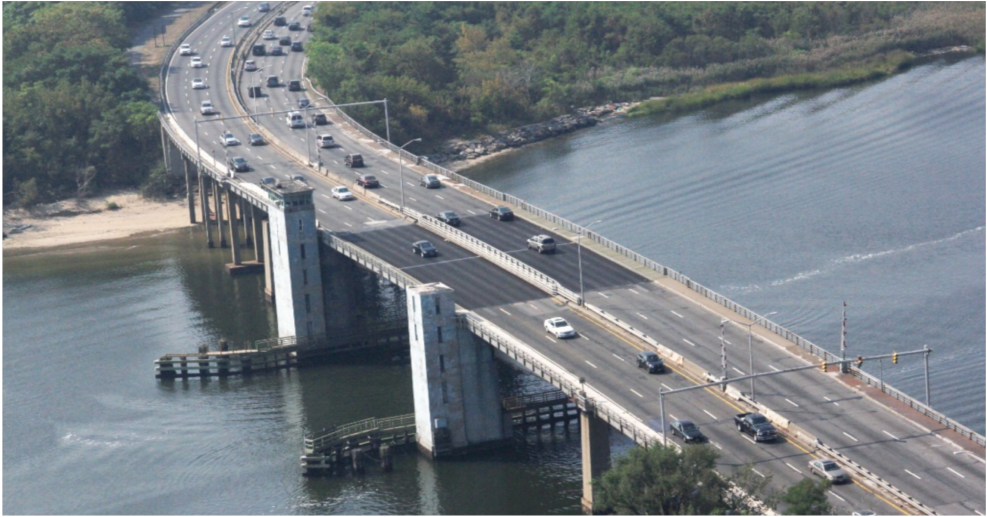
Figure 13. Original/existing Belt Parkway Bridge over Mill Basin (2012).

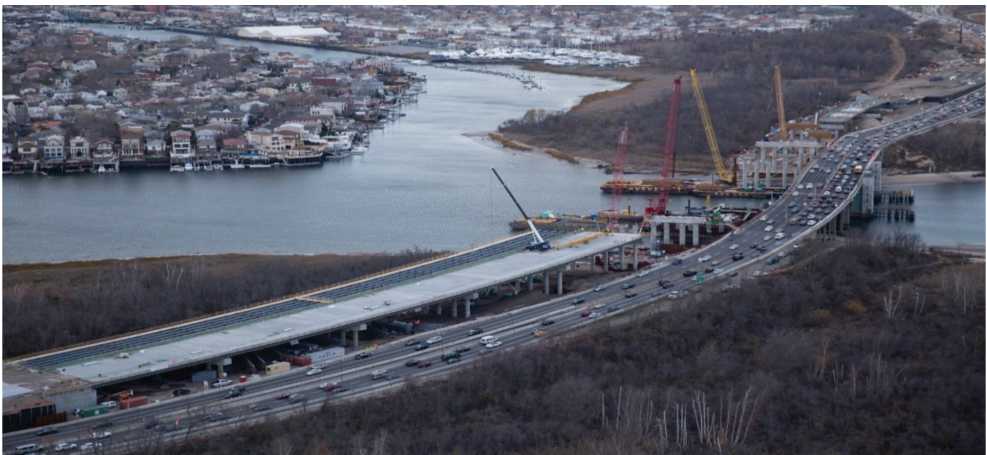
Figure 14. Replacement of Belt Parkway Bridge over Mill Basin—Stage 2 (December 2016).

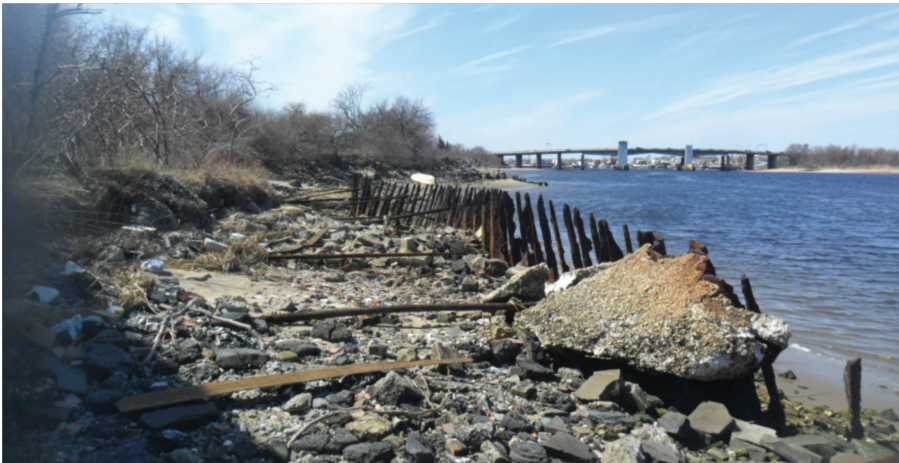
Figure 16. Pre-construction conditions at Floyd Bennett Field (2009).

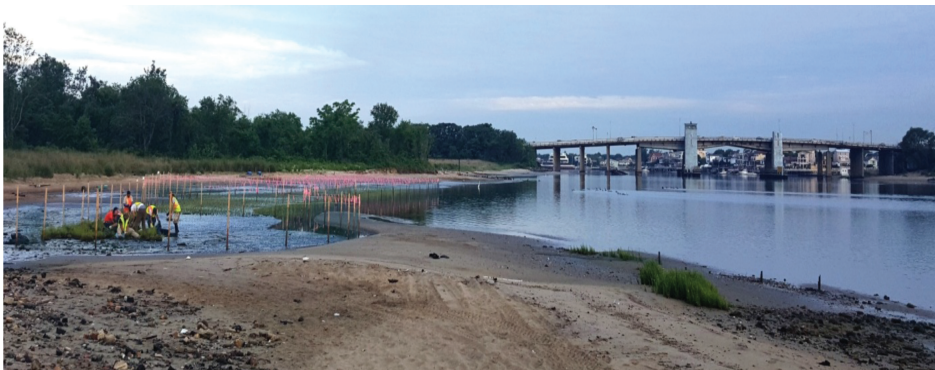
Figure 17. Tidal wetland mitigation plantings at Floyd Bennett Field (2015).

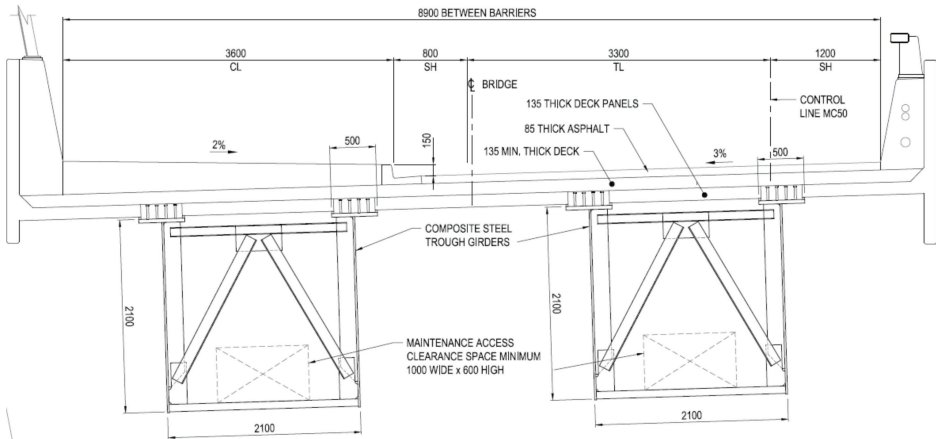
Figure 2. Bridge cross section.

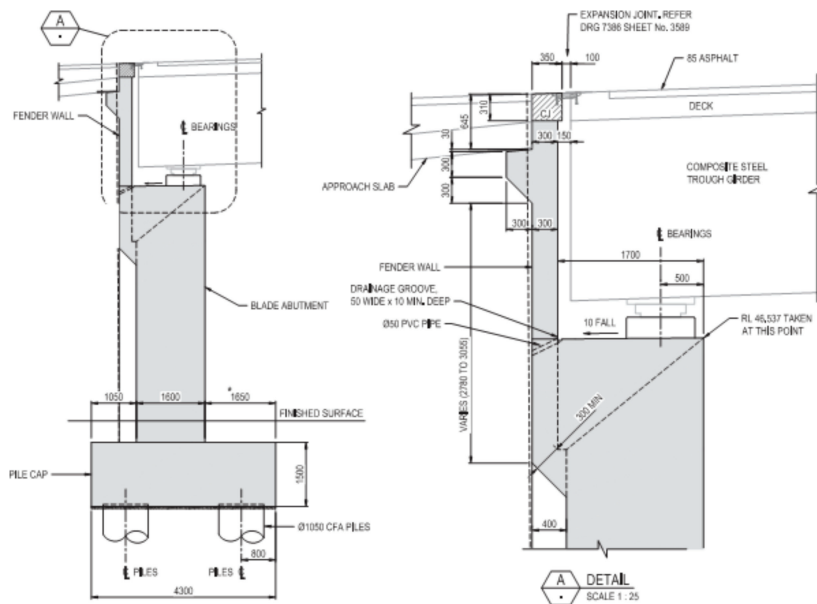
Figure 3. Abutment cross-section and details.

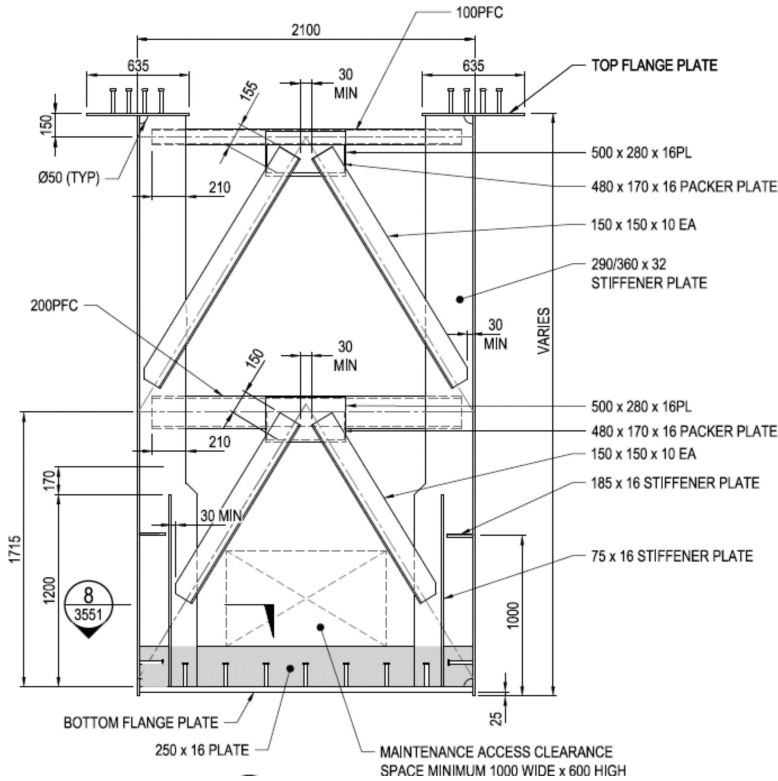
Figure 6. Double-composite section over pier 1.

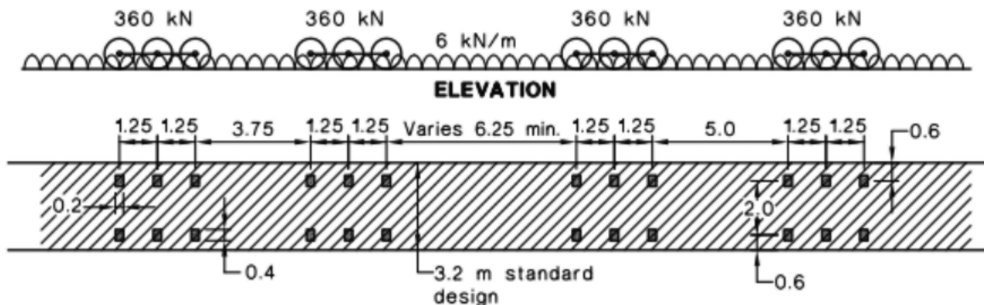
Figure 7. AS 5100.2 M1600 moving traffic load configuration.

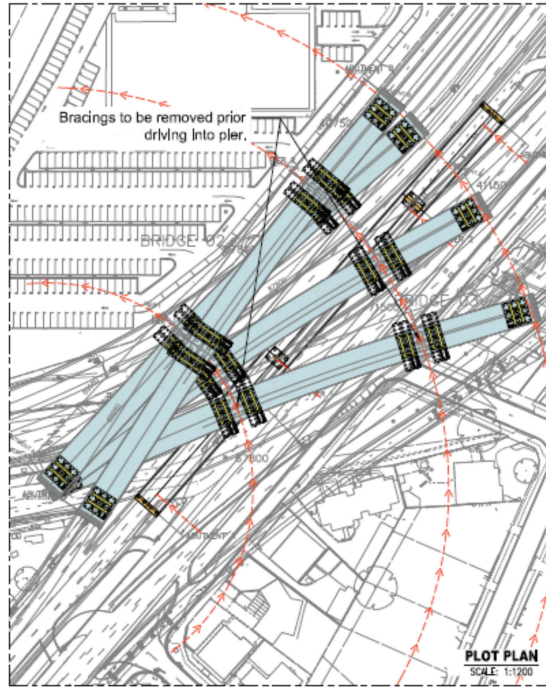
Figure 10. SPMT bridge moves.

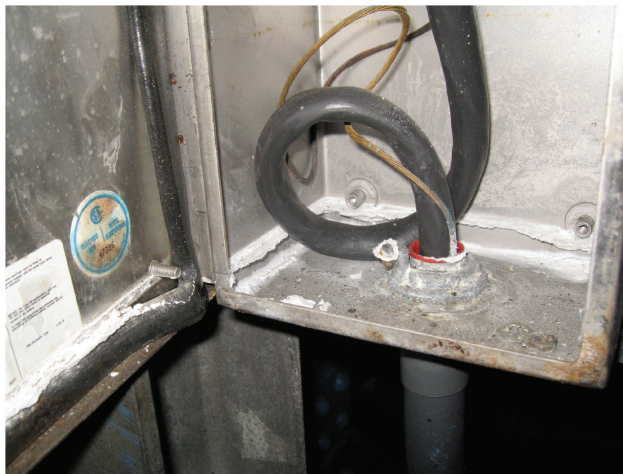
Figure 5. Electrical box with salt/debris build up and corrosion to conduit.

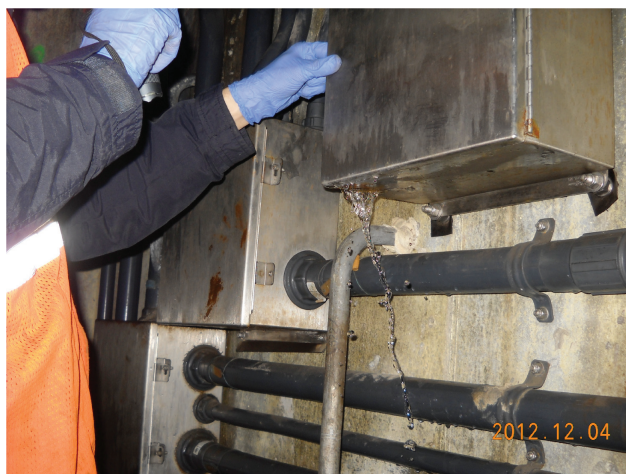
Figure 6. Electrical box in tail lock area with water still flowing out after 1 month.

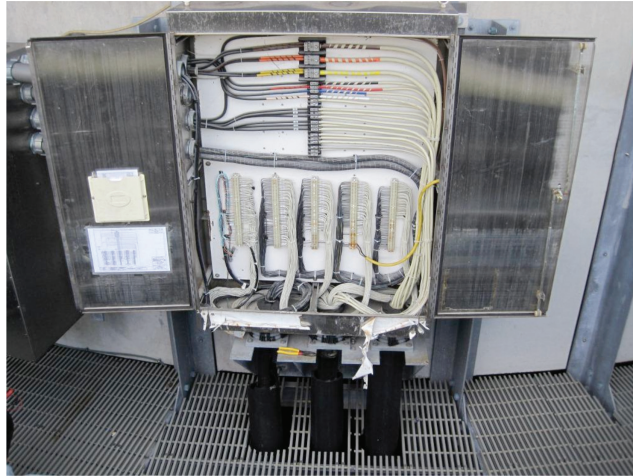
Figure 7. Submarine cable terminal box partially submerged—note clear line showing water elevation.

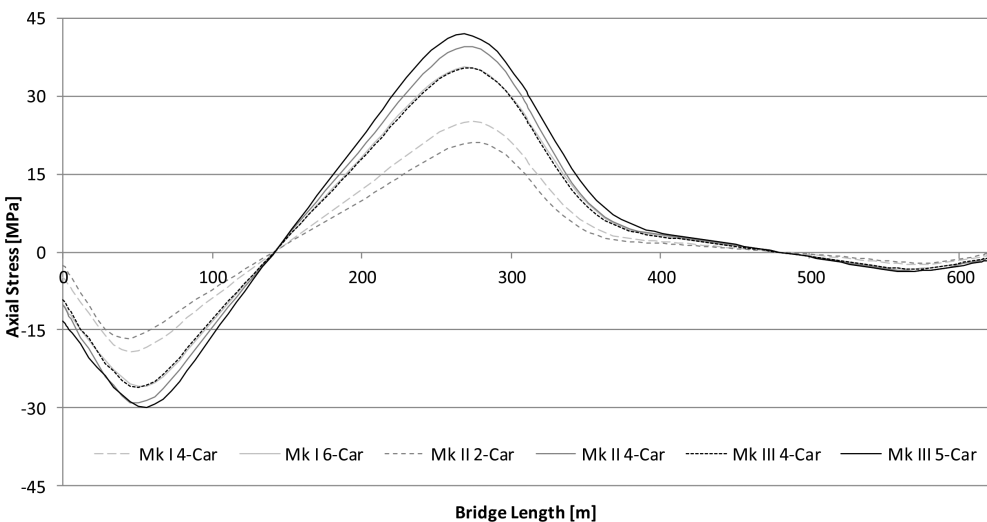
Figure 2. Backstay cable stress reversal.

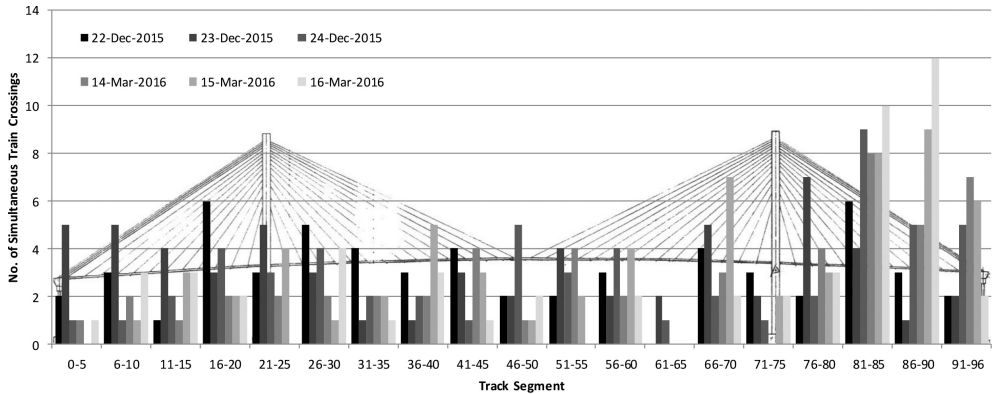
Figure 3. Simultaneous train passage survey data.

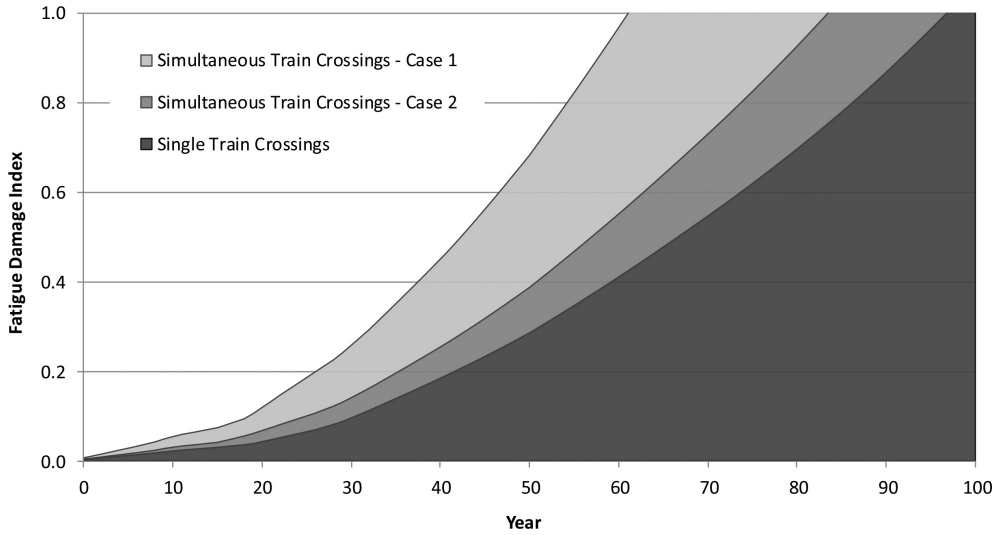
Figure 4. Fatigue damage index for backstay cable.

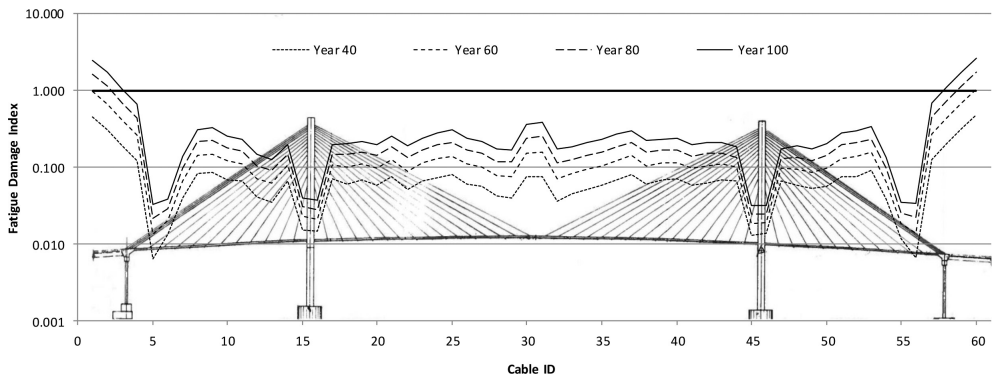
Figure 5. Cumulative fatigue damage summary.

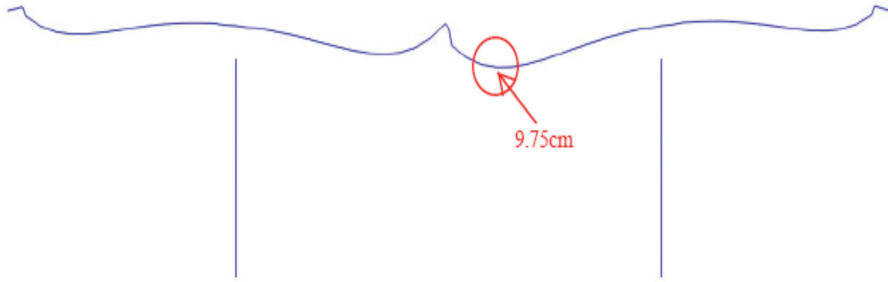
Figure 8. Maximum displacement curve for deck.
Construction stage no. 20, displacement curve (36000 days-100 years).

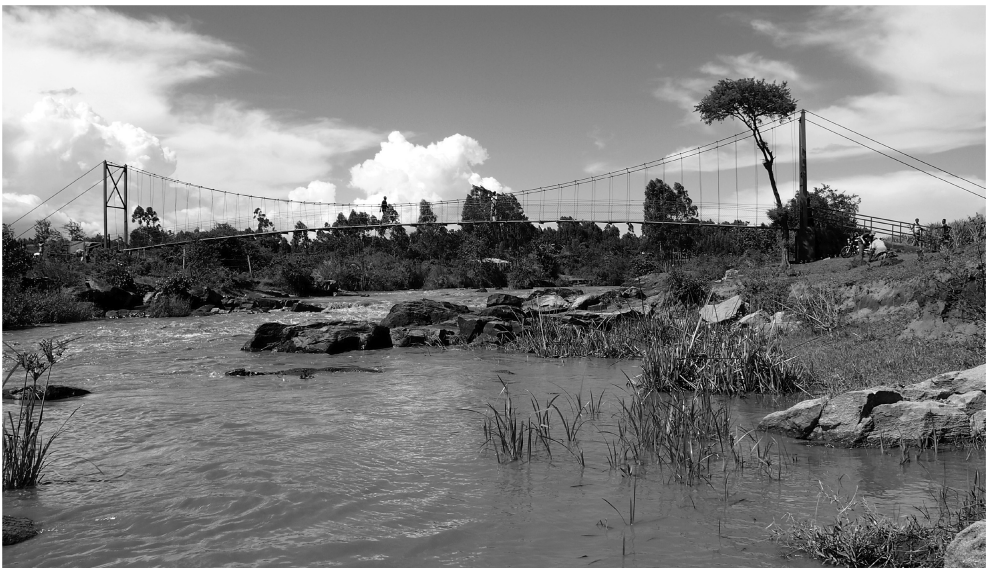
Figure 1. Profile of the Peace Bridge.

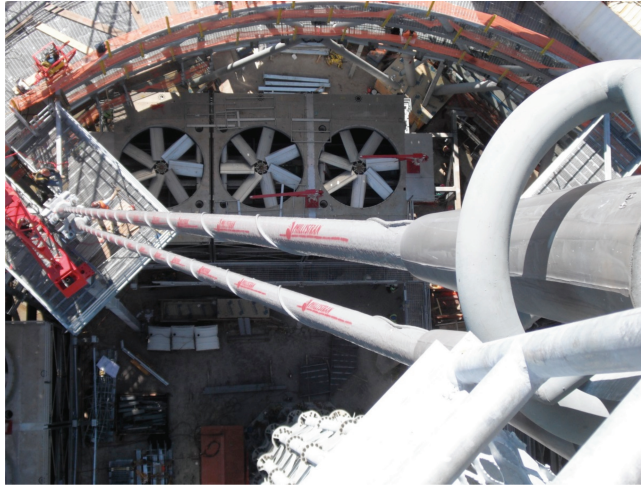
Figure 6. Fiber assemblies installed on roof structure.

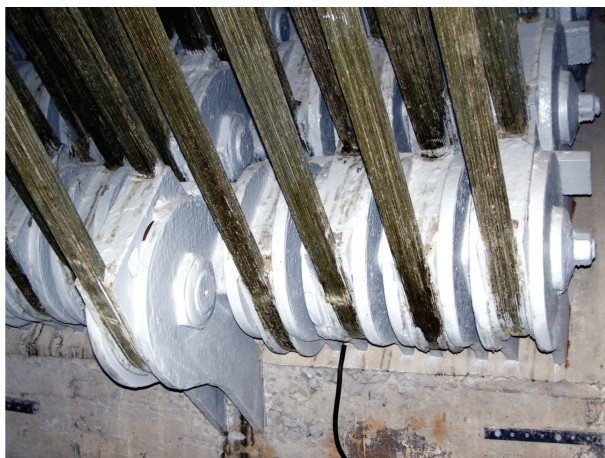
Figure 2. Anchorage of suspension cable built by the air-spinning method.

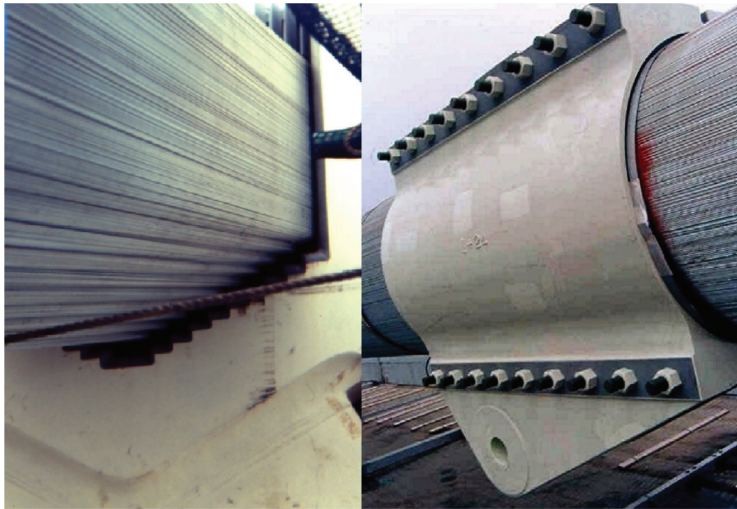
Figure 3. Profiled tower saddle, cable and cable band on the Akashi-Kaikyo Bridge.

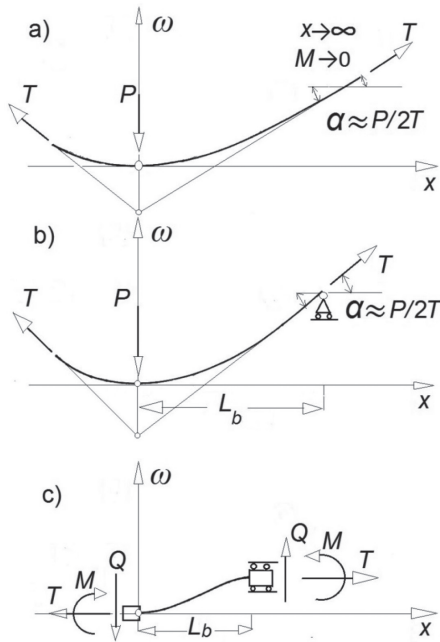
Figure 8. Models of string deflection: a) Local bending effect, decaying as $x \rightarrow \infty$; b) Local bending effect, sufficiently decaying as $x \rightarrow L_b/2$; c) Bending effect extending over the distance L_b between cable bands.

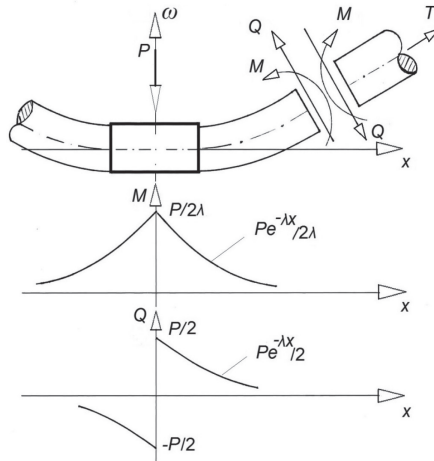
Figure 9. Decay of M and Q with respect to x .

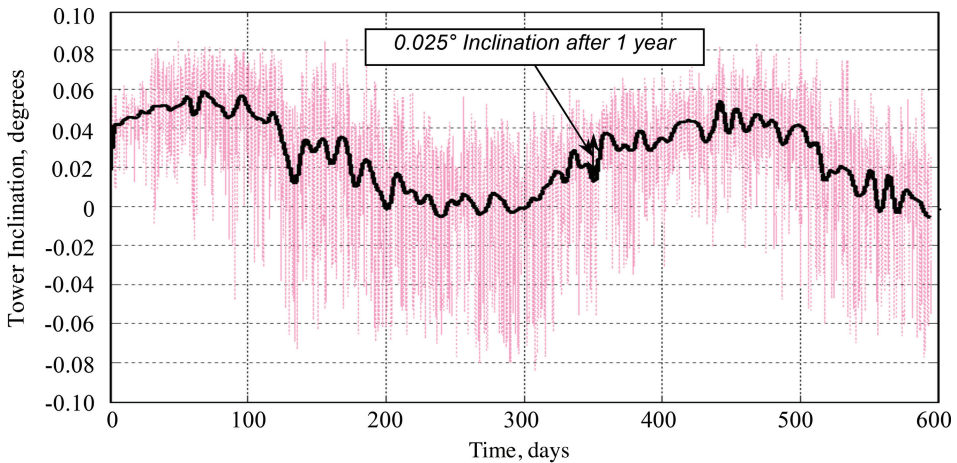
(a) West Virginia North Tower

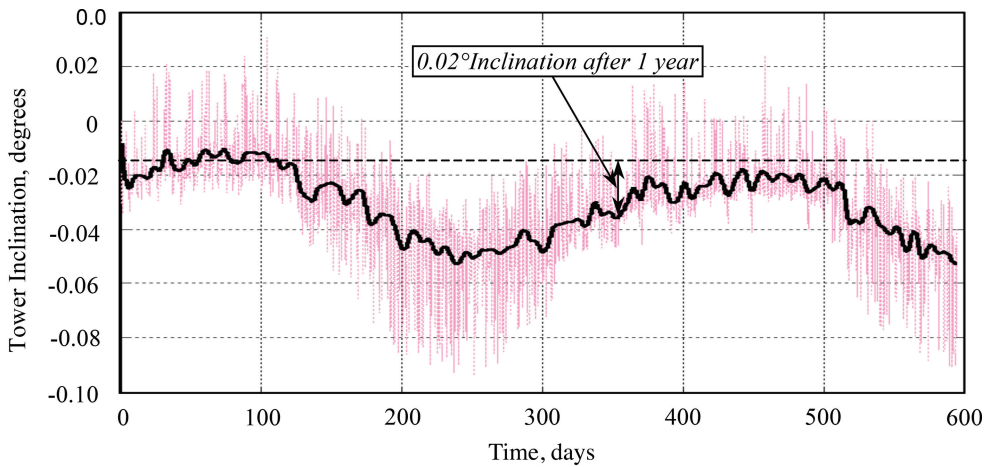
(a) West Virginia North Tower

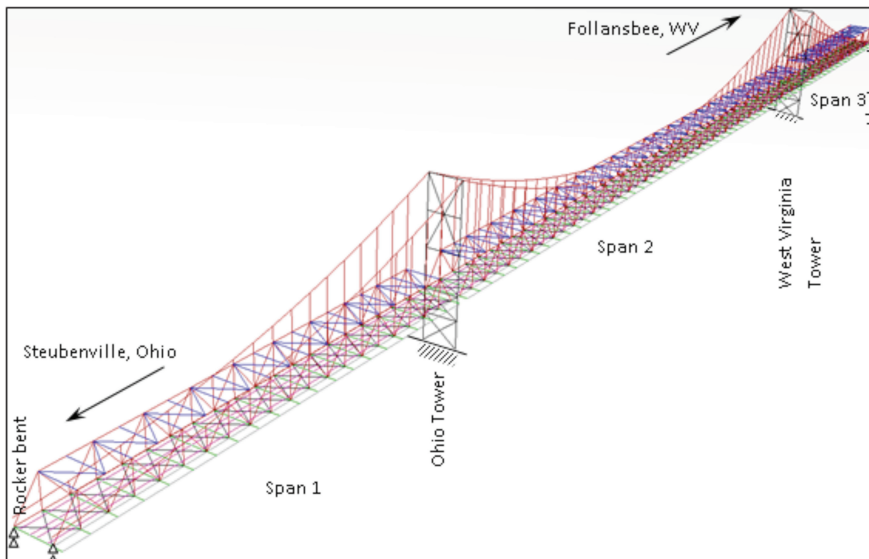
Figure 7. Three dimensional model of the suspended bridge spans.

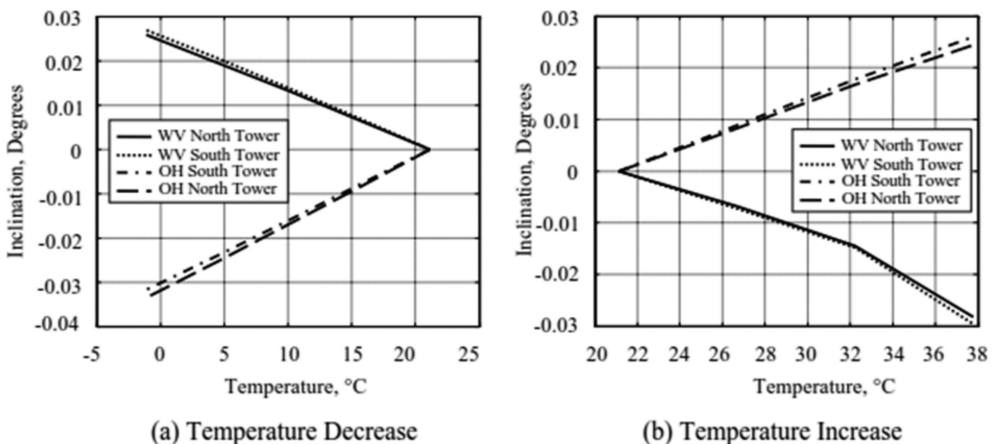
Figure 8. Relative inclination of towers vs temperature (Reference position at 21°C).

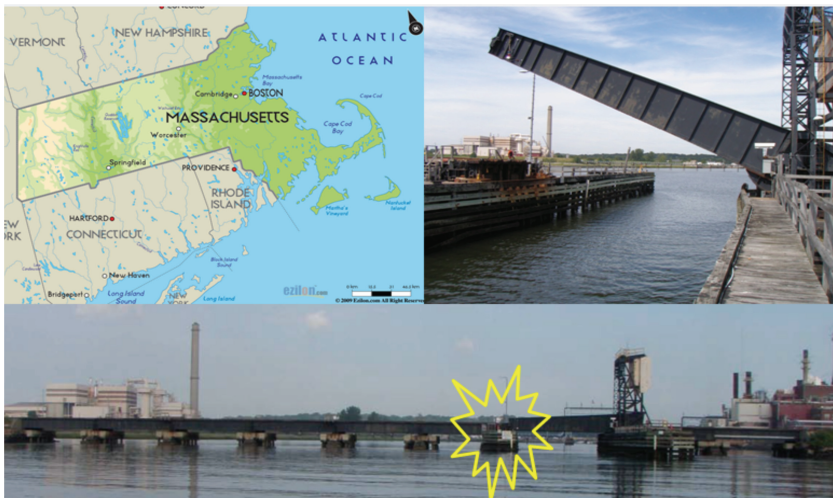
Figure 1. Project location map.

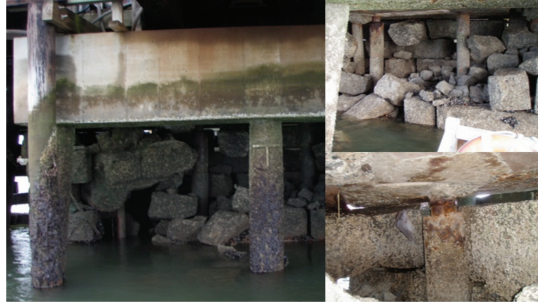
Figure 2. Rest pier “as-inspected” condition.

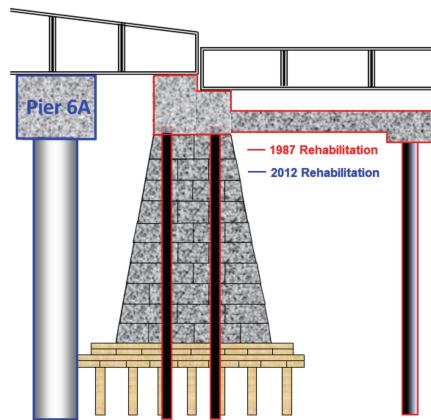
Figure 3. Rest pier interim repair.

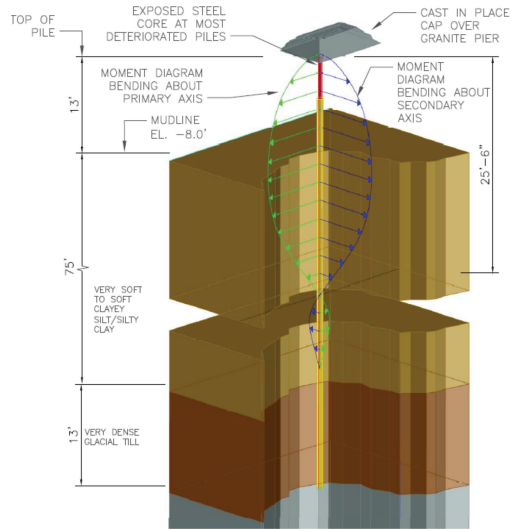
Figure 5. Soil structure analyses.

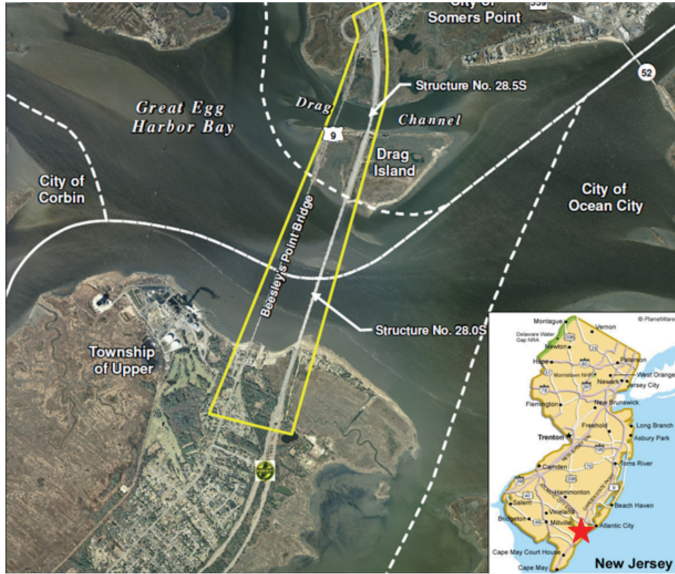
Figure 6. Project location map.

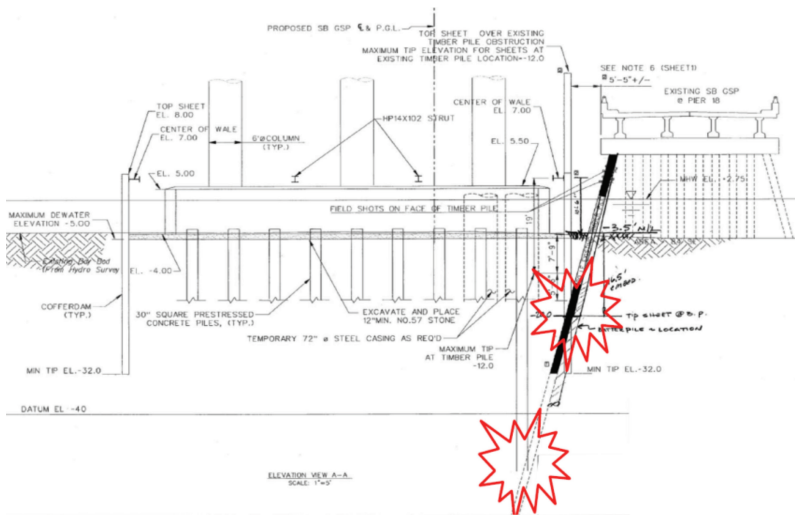
Figure 7. Planned pile driving activities.

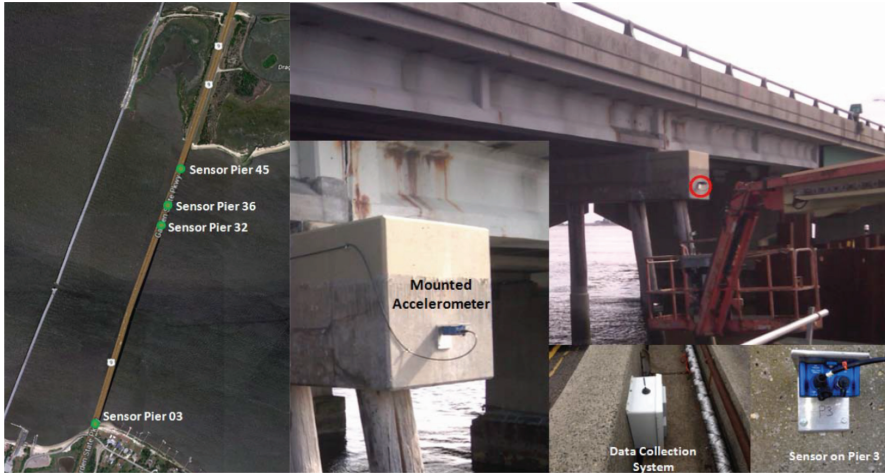
Figure 8. Monitoring and data collection system and sensor locations.

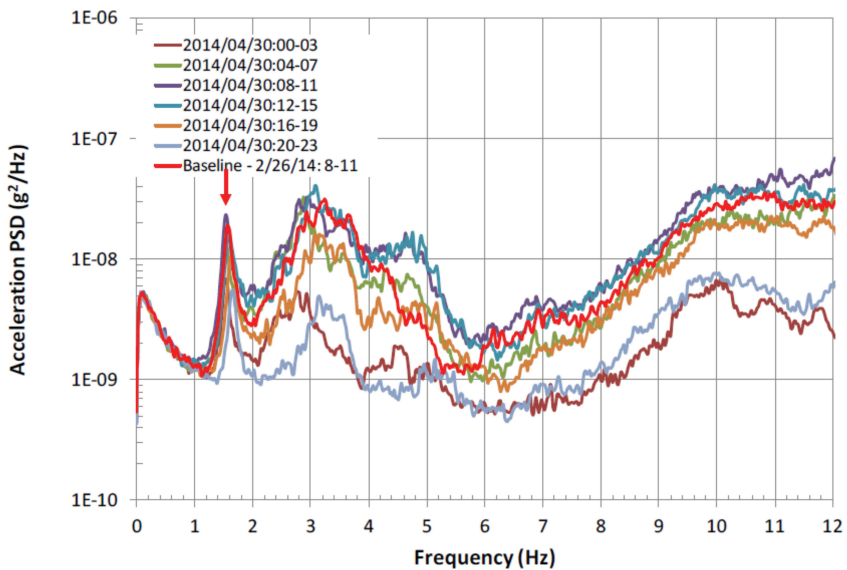
Figure 9. Pier 03 spectral response in the transverse direction.

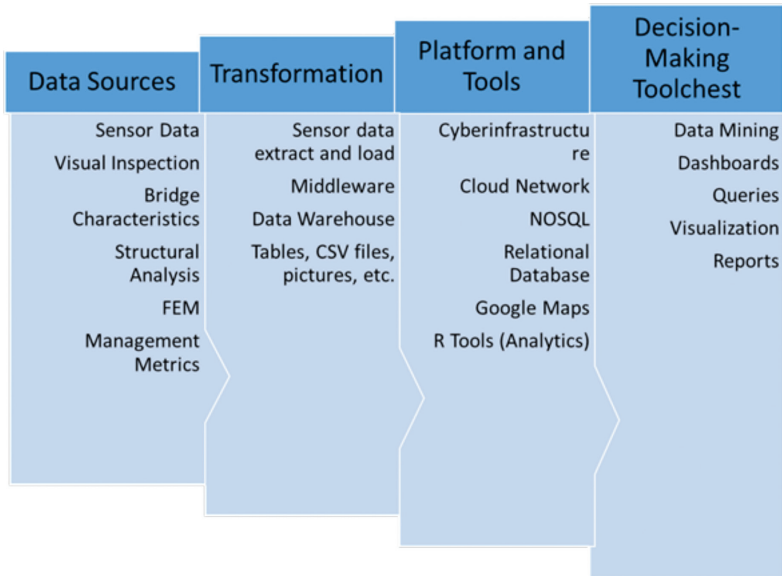
Figure 3. Applied architecture of big data analytics in SHM.

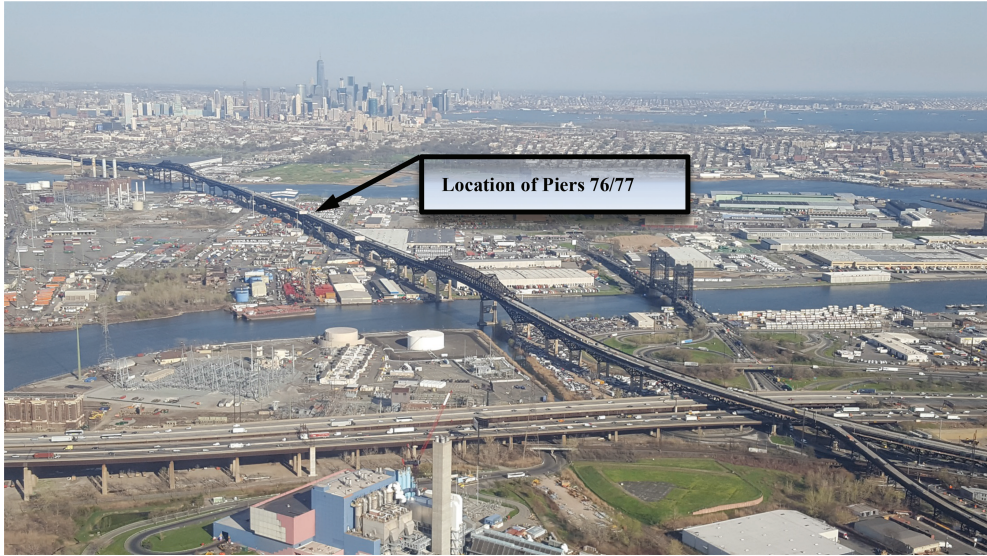
Figure 1. Aerial photo of the Pulaski Skyway (looking east).

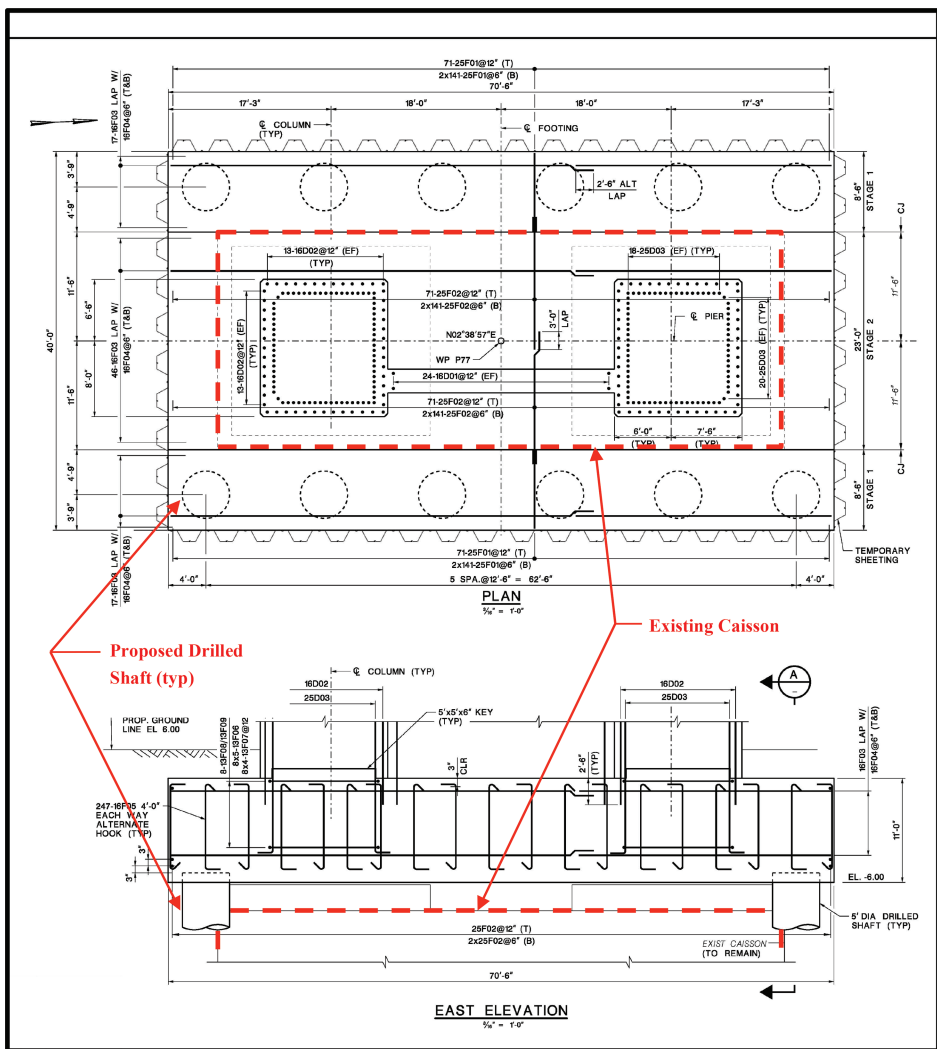
Figure 3. Proposed foundation plan/elevation for Pier 77 (Pier 76 similar).

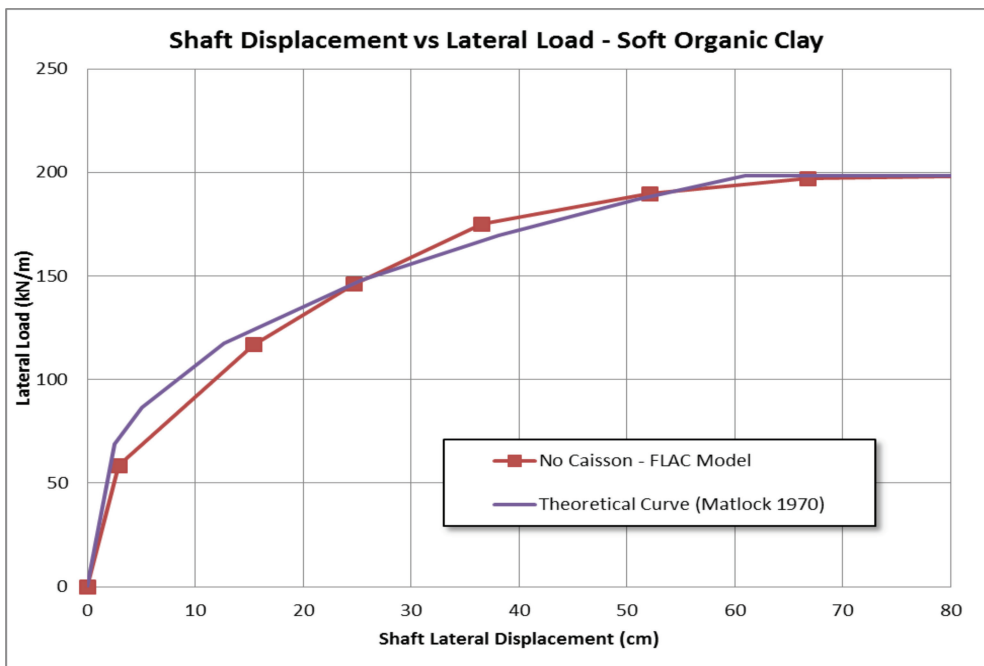
Figure 5. Calibration of p-y curve in soft organic clay.

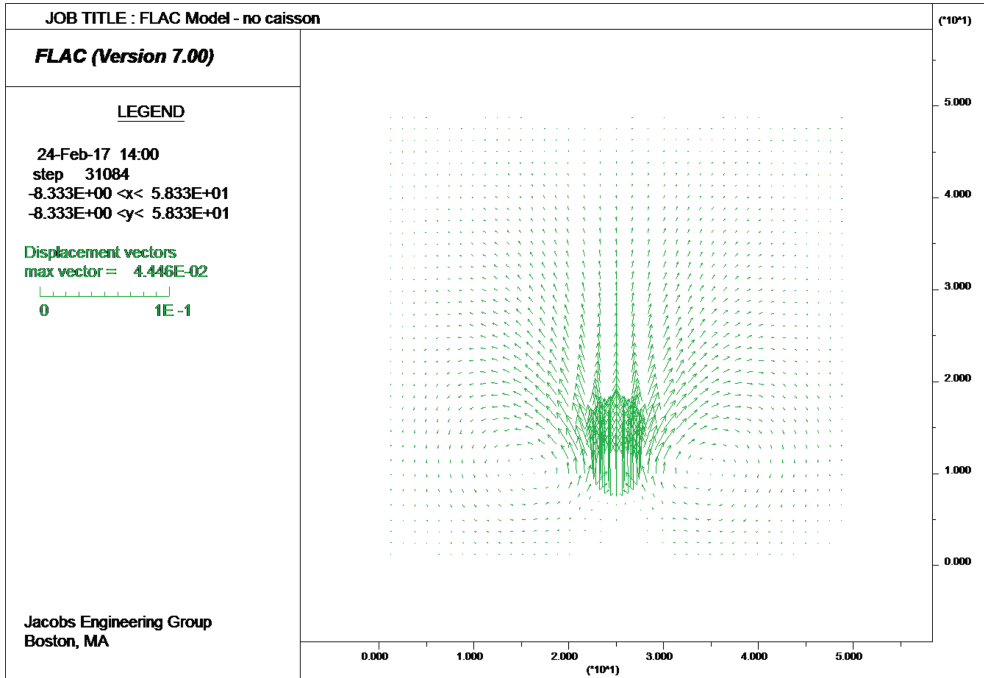
Figure 8. Displacement vectors in medium stiff clay (at 146 kN/m load, no caisson).

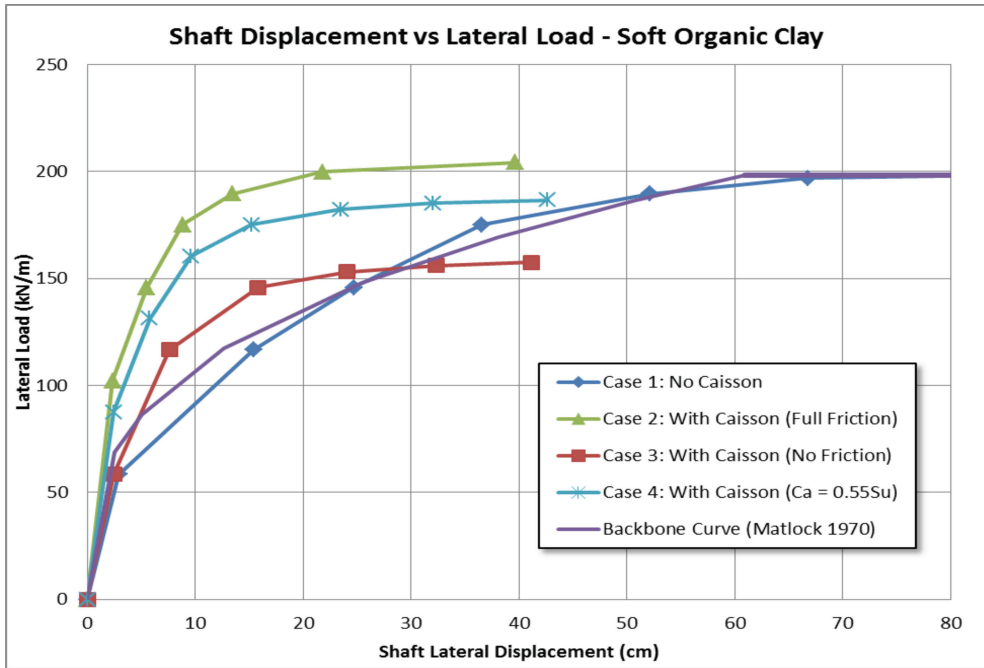
Figure 11. Comparison of p-y curves in soft organic clay.
