Asset Management of Bridges

Edited by Khaled M. Mahmoud

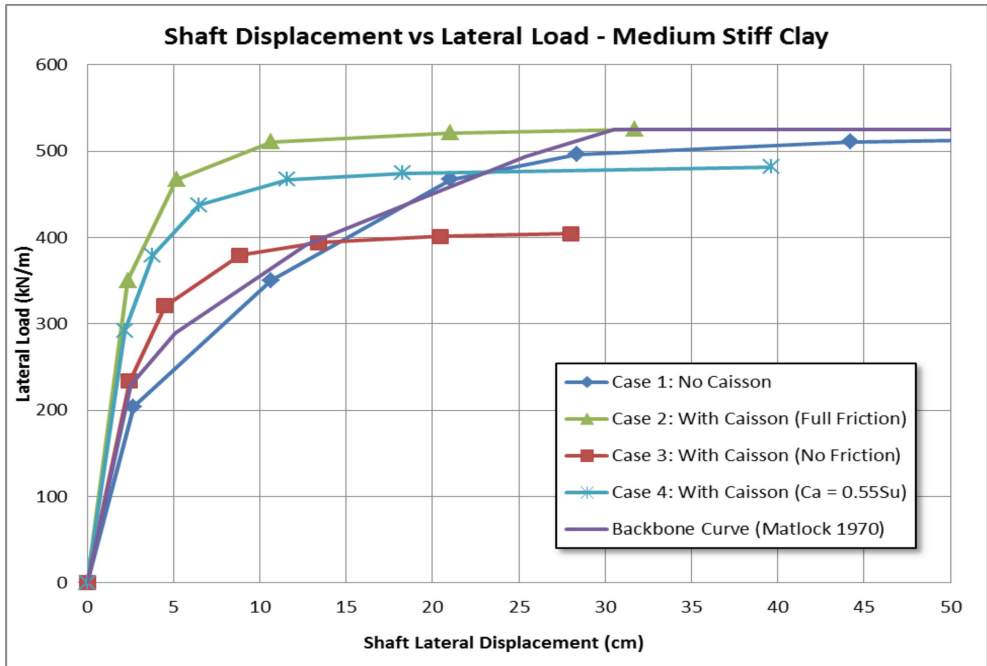
Figure 12. Comparison of p-y curves in medium stiff clay.

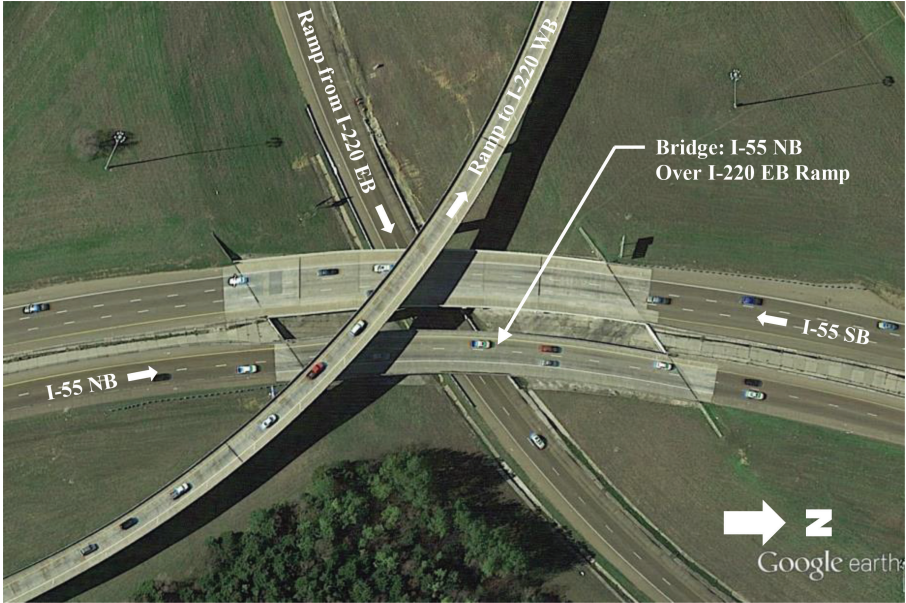
Figure 1. Aerial view of I-55 and I-220 interchange.

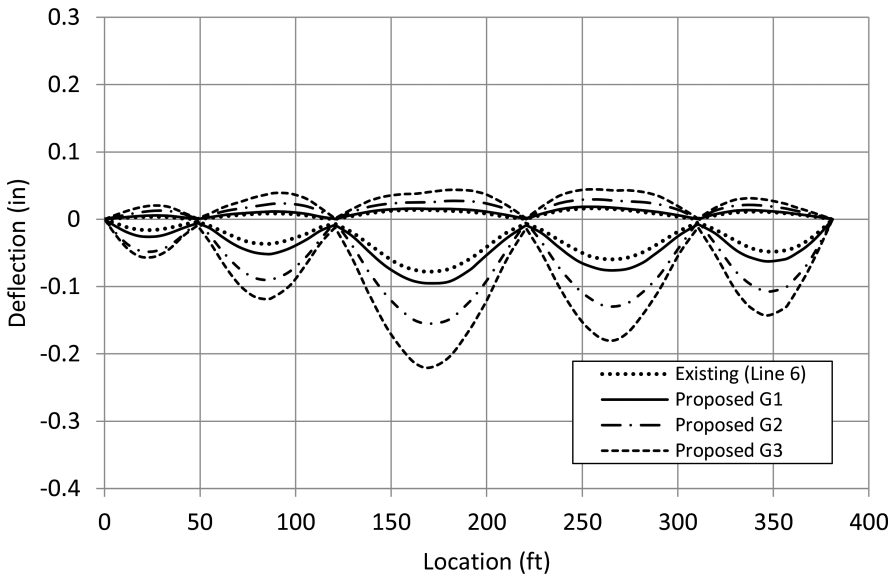
Figure 6. Comparison of single lane live load deflections at proposed girders and existing web line.

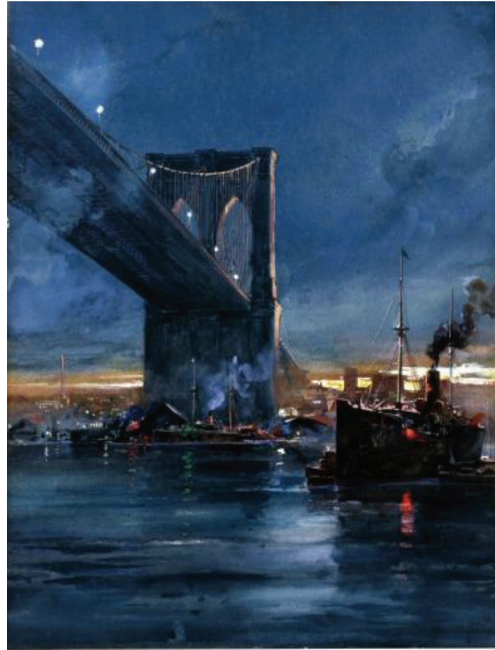
Figure 2. William L Sonntag Jr, *Brooklyn Bridge*, 1895, Museum of City of New York.

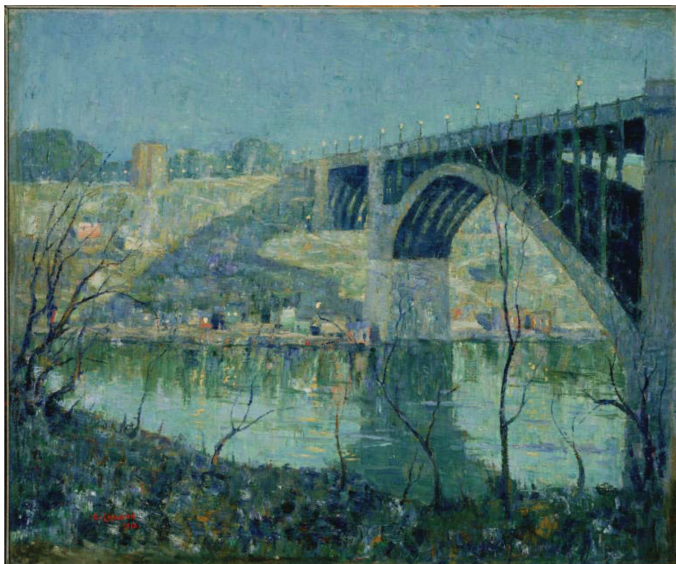
Figure 4. Ernest Lawson, *Spring Night, Harlem River*, 1913, The Phillips Collection, Washington DC.

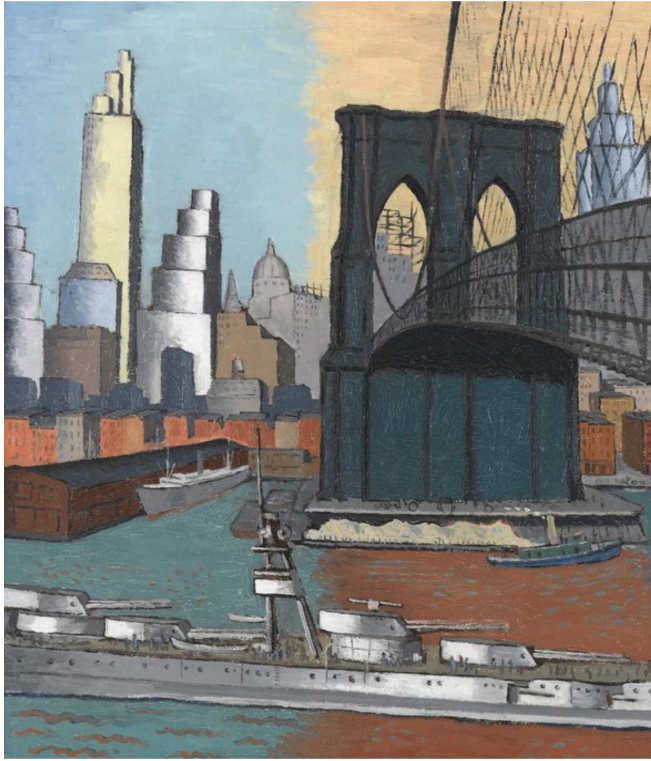
Figure 5. Glenn O. Coleman *Bridge Tower*, 1929, Brooklyn Museum.

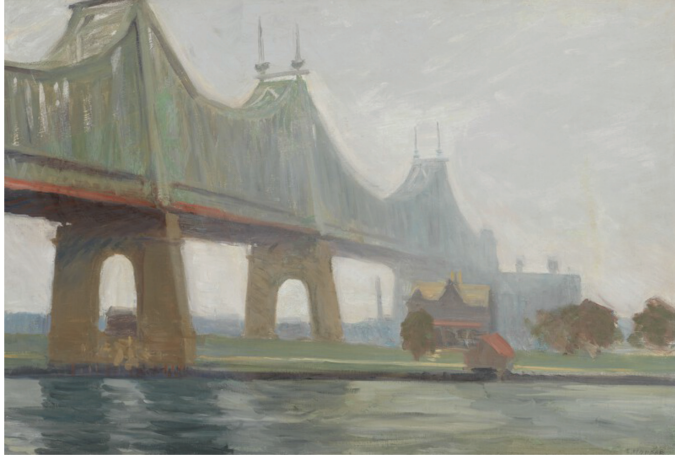
Figure 6. Edward Hopper *Queensborough Bridge*, 1913, Whitney Museum of American Art.

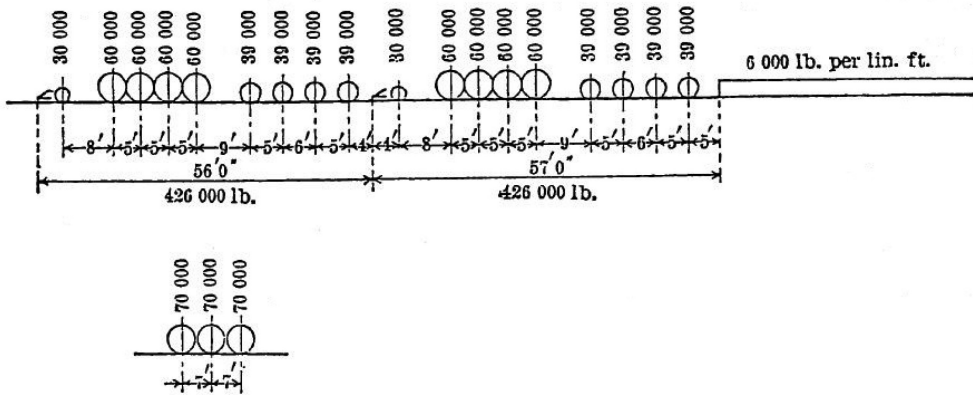
Figure 9. Diagram of assumed live load.

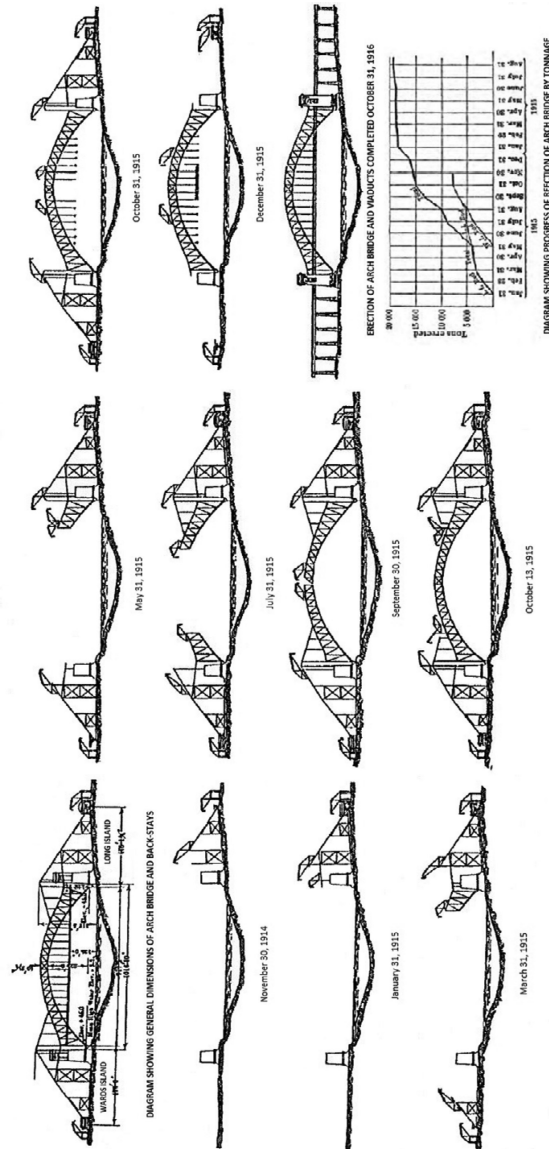
Figure 11 Progress diagram of erection of Hell Gate Bridge (Ammann 1918).

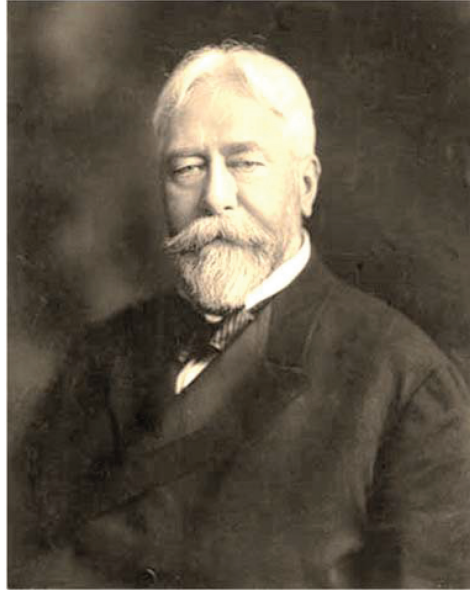
Figure 14. Gustav Lindenthal (Wildman 1921).

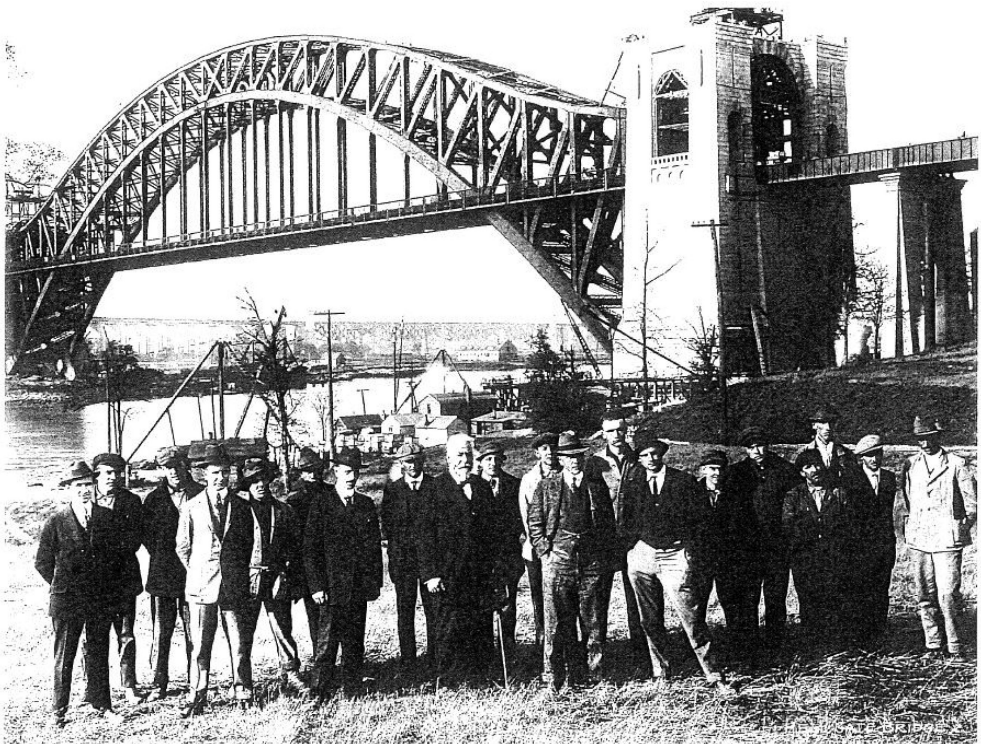
Figure 15. Gustav Lindenthal with staff (Rastorfer, 2000).

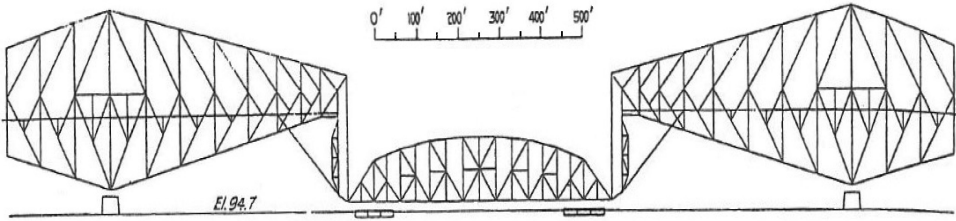
Figure 9. General scheme for hoisting the Quebec Bridge suspend span.

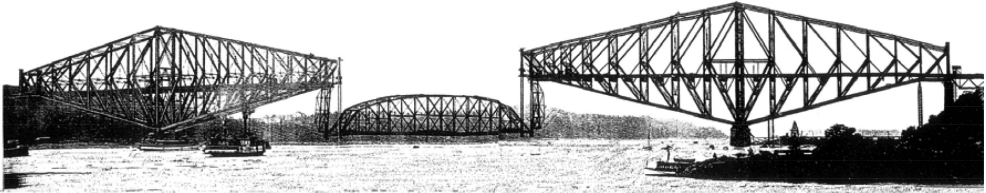
Figure 10. The span linked to the chains and raised clear of the scows, attempting the last hazardous operation in the construction of the bridge.

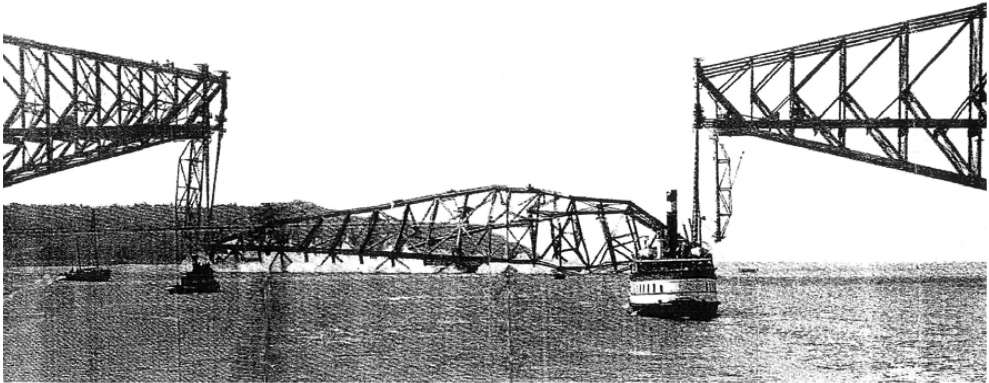
Figure 11. The falling span snapped by a lucky newspaper man a moment before the southeast corner of the span tore loose from its seat.

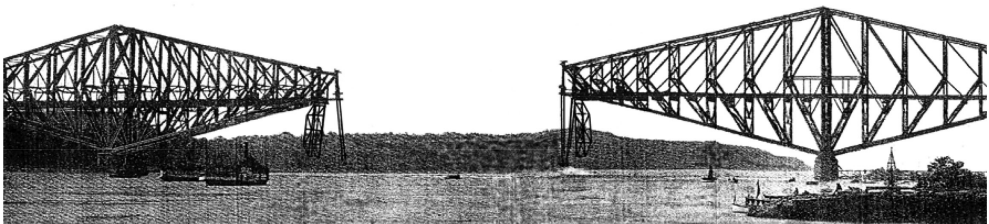
Figure 12. A few seconds after the fall.
