Dimension Stone Use in Building Construction

STP 1499

| Investigation of Masonry Failure of a Granite and Limestone Clad Historic Church in Eastern Pennsylvania —J. L. ERDLY AND E. R. VALENTINO | 77 |

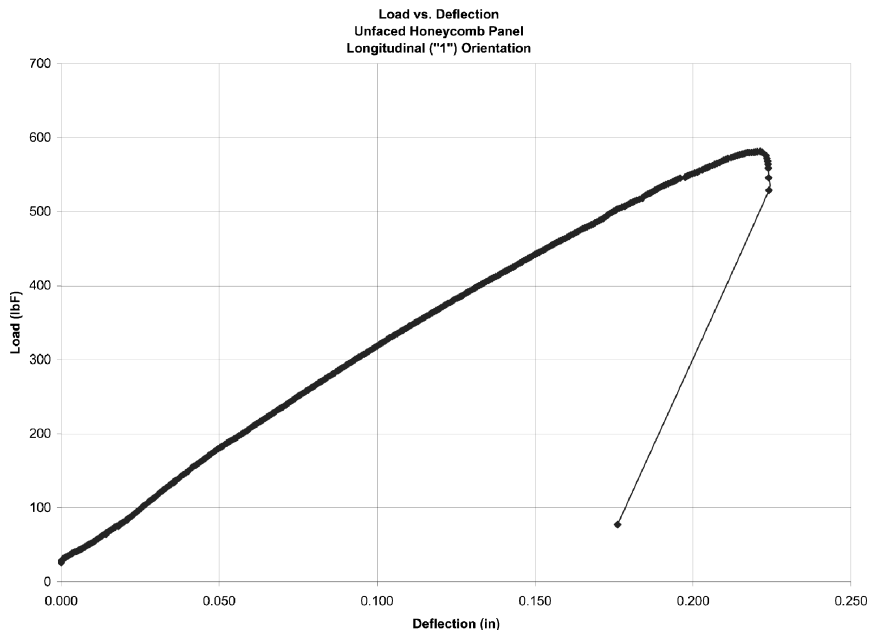
FIG. 3—Load versus deflection unfaced honeycomb panel longitudinal (“1”) orientation.

Load/Deflection Measurements—Load and deflection were measured during flexural strength testing. Deflection readings were measured through the use of a Linear Variable Deflection Transducer (LVDT) with a precision of ± 0.0254 mm (0.001 in.)/V and plotted against the corresponding test loads. To prevent interference of the LVDT with the load head of the test machine, deflection measurements were taken at the end of a projecting aluminum angle which was glued to the top side of each specimen. Figure 3 shows the load/deflection curve for an unfaced honeycomb core specimen. Figure 4 shows the load/deflection curve for a new travertine composite panel specimen. Figure 5 shows the load/deflection curve for an old travertine composite panel specimen. Figure 6 shows the load/deflection curve for a new granite composite panel specimen. Figures 3–6 represent specimens tested with the honeycomb oriented in the longitudinal (“1”) direction. All the graphs show similar load deflection curves. There are slight offsets in the curves for

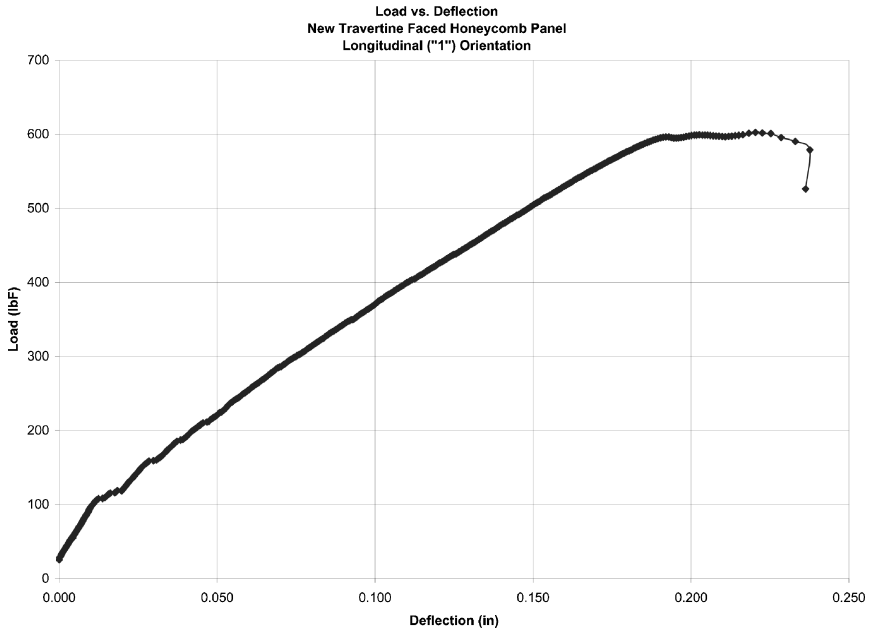
FIG. 4—Load versus deflection new travertine faced honeycomb panel longitudinal ("1") orientation.

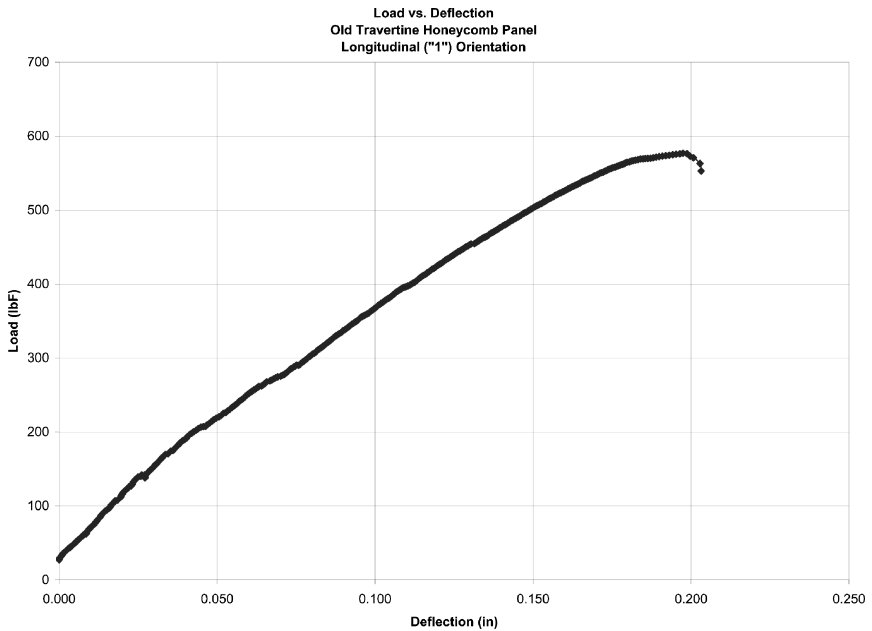
FIG. 5—Load versus deflection old travertine honeycomb panel longitudinal ("1") orientation.

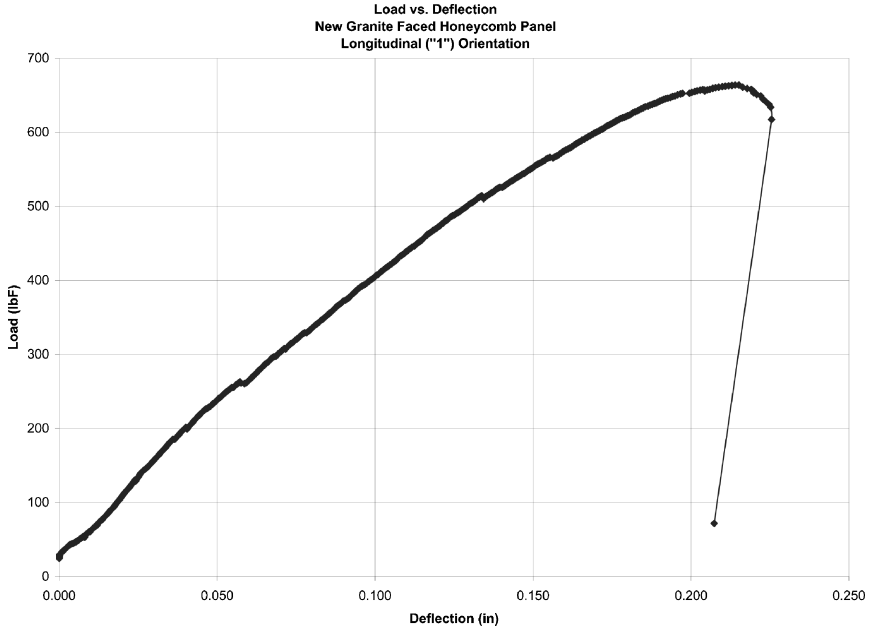
FIG. 6—Load versus deflection new granite faced honeycomb panel longitudinal (“1”) orientation.

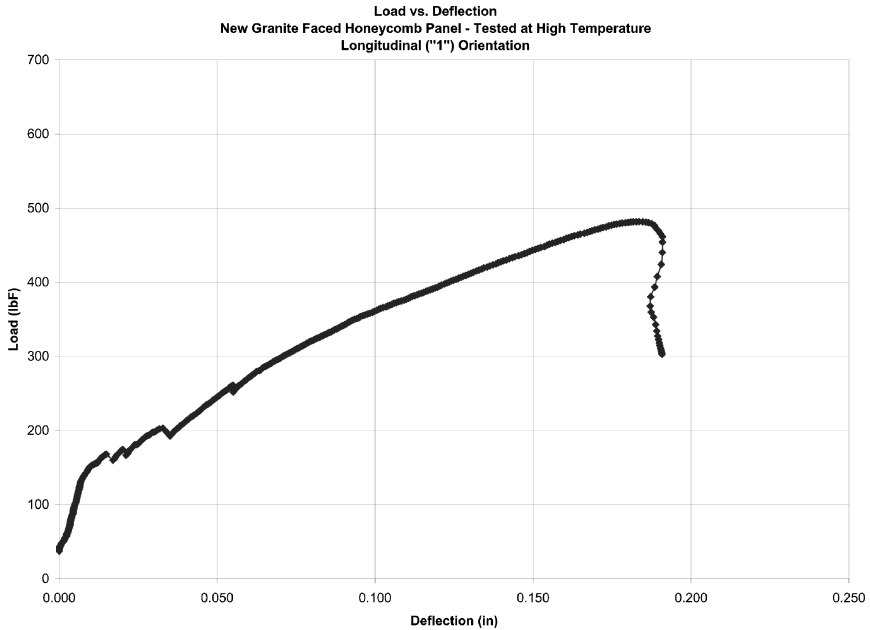
FIG. 7—Load versus deflection new granite faced honeycomb panel-tested at high temperature longitudinal ("1") orientation.

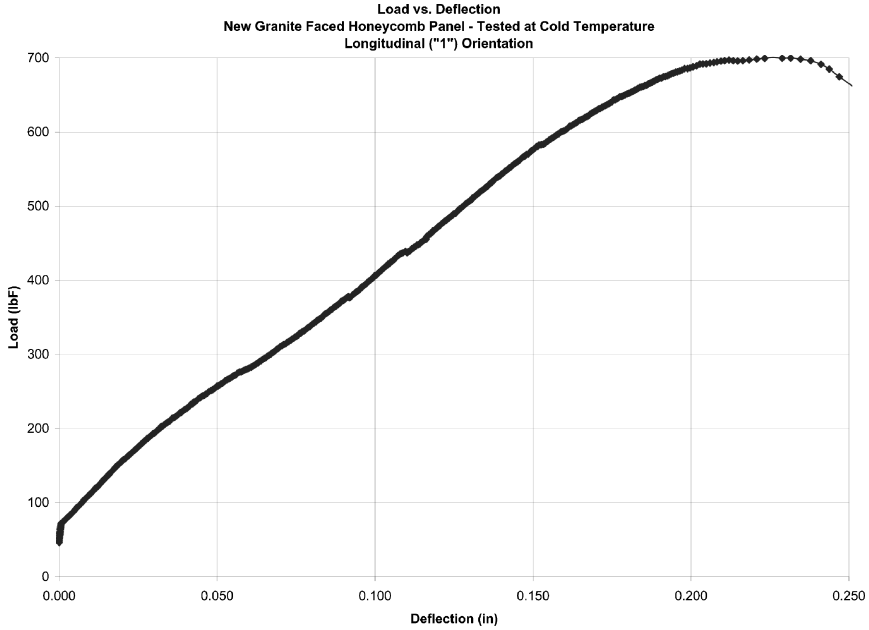
FIG. 8—Load versus deflection new granite faced honeycomb panel-tested at cold temperature longitudinal ("1") orientation.

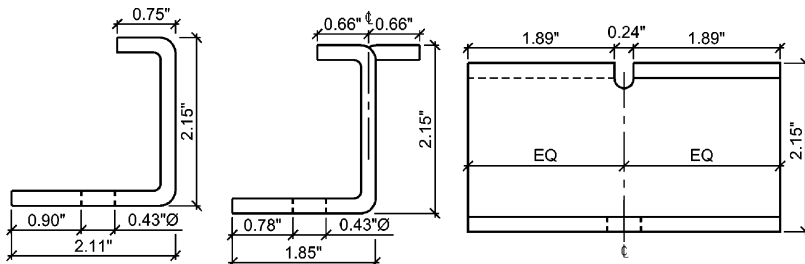
FIG. 2—Four-in. long strap anchor (left), split-tail anchor end view (middle), and split-tail anchor side view (right). Anchors are 0.19-in. thick.

Tests were performed using stainless steel strap anchors and split-tail anchors installed in a continuous kerf (refer to Fig. 2 for anchor dimensions) to simulate both wind pressure and wind suction. The test configuration for wind suction is shown in Fig. 3. The stone rift orientation was not indicated on the samples received. All specimens were tested after being in dry storage for over one month, with no additional wetting or drying procedures used. The anchors were bolted to a proprietary cold-formed channel support which was attached to a heavy steel reaction frame using threaded rods. During testing, the authors verified that the cold-formed channel support did not undergo appreciable vertical or lateral

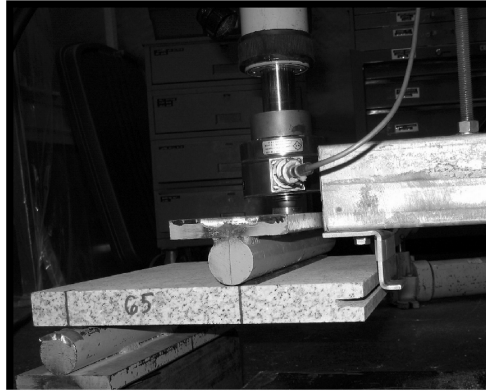
FIG. 3—ASTM C 1354 test configuration simulating wind suction with a split-tail anchor and 12-in. square stone specimen.

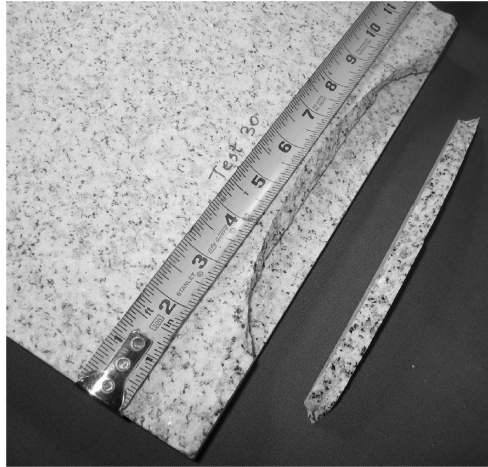
FIG. 4—Spall generated during an ASTM C 1354 test using a 4-in. long strap anchor.

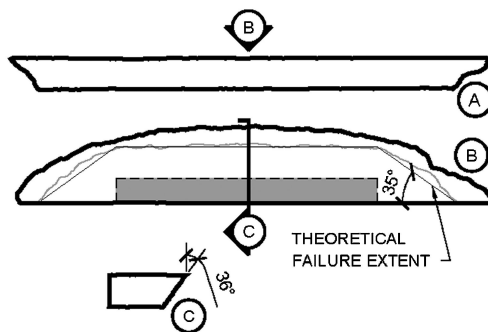
FIG. 5—Tracing of a spall generated during an ASTM C 1354 test using a 4-in. strap anchor. Edge view (A), surface view (B), and section view (C) shown. Shaded area represents anchor location in kerf slot. Light line in B shows theoretical failure extent.

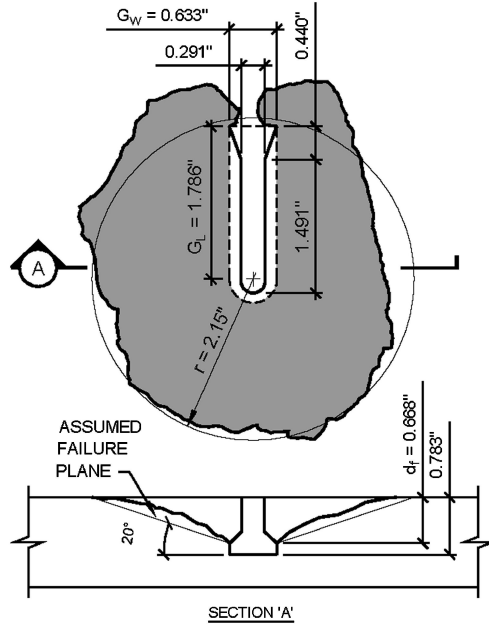
FIG. 6—Spall trace for Type 31 anchor test with stone section view (bottom) and surface view (top). Idealized spall location shown with lighter lines.

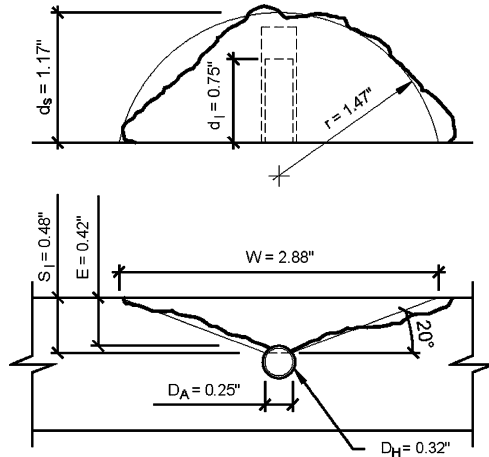
FIG. 7—Surface view (top) and edge view (bottom) of edge dowel test showing spall geometry and predicted failure.

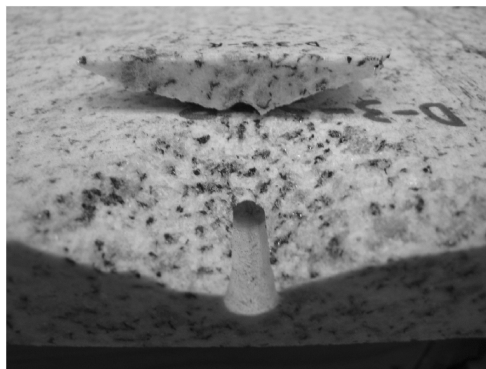
FIG. 8—Spall from edge dowel test.

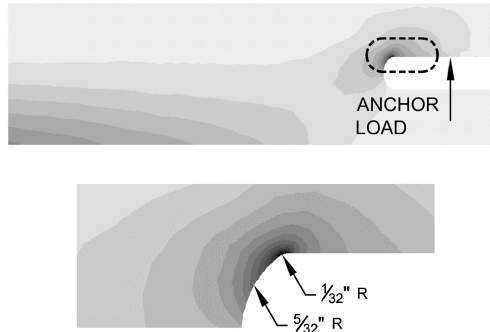
FIG. 9—Kerf anchorage two-dimensional finite element model using membrane elements. Shade of gray depicts principal tensile stress magnitude (darker means higher tensile stress).

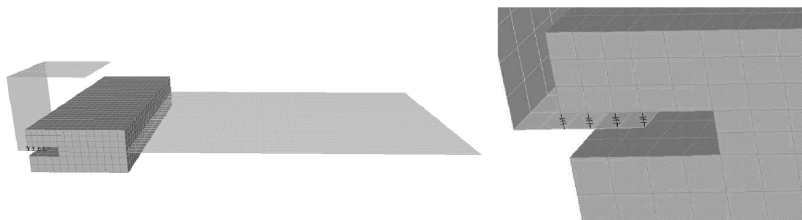
FIG. 10—Kerf anchorage three-dimensional finite element model using a symmetry boundary condition along the centerline of the anchor.

Three-dimensional finite element models (Fig. 10) representative of discrete strap anchors in a continuous kerf were developed to investigate the behavior of the ASTM C 1354 test configuration similar to that shown in Fig. 3. The anchor and stone geometry were modeled to approximately match the stone and 4-in. (10.2-cm) wide strap anchors previously discussed. Additional strap anchors 2, 6, and 8-in. (5.1, 15.2, and 20.3-cm) wide were also analyzed. The anchor bearing surfaces were modeled as perfectly planar and parallel to the stone kerf surface. This is an unlikely condition to encounter in the field or even in laboratory tests due to anchor imperfections and installation misalignment. Each model included the following components: a load spreader modeled as a frame element, a stone specimen modeled as a combination of solid elements and shell elements, a steel strap anchor modeled as shell elements, and the contact region between the stone and the anchor modeled using compression-only springs. Only a portion of the test configuration was modeled by using a symmetry boundary condition in order to control model size. The region of the stone adjacent to the continuous kerf was modeled using solid elements, and the remaining portion of the stone was modeled using shell elements in order to further control model size. The transition between the solid and shell elements was made by using constraints. The interaction between the stone and the anchor was modeled using springs that provide compression resistance in the axial direction only (refer to Fig. 10), and resistance that may be provided by friction or sealant restraining the anchor from moving further in or out of the kerf slot was neglected. Unlike the two-dimensional

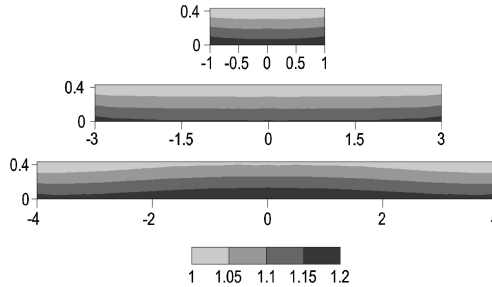
FIG. 11—Bearing pressure contours for sealant-set strap anchors in a continuous kerf for 2-in. (top), 6-in. (middle), and 8-in. (bottom) anchors. Pressures are normalized by the anchor minimum bearing pressure. The origin is at the intersection of the anchor centerline and the stone edge.

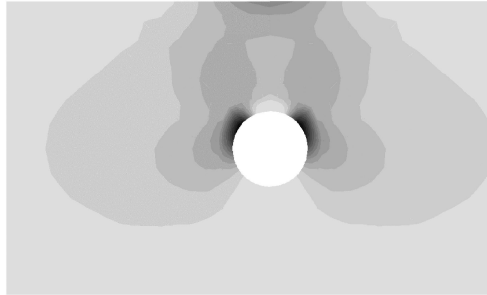
FIG. 12—Edge view of three-dimensional solid model of edge dowel anchor hole depicting principal tensile stress magnitudes (darker means higher tensile stress).

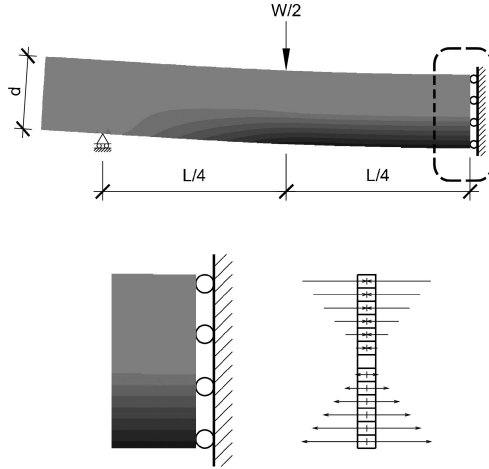
FIG. 13—Finite element model of ASTM C 880 test using a symmetry boundary condition. Arrows shown indicate direction and magnitude of the principal stresses at the plane of symmetry. Shade of gray depicts principal tensile stress magnitude (darker means higher tensile stress).

A finite element model using a mid-span symmetry boundary condition is shown in Fig. 13. Although most commercially available stones are naturally anisotropic and heterogeneous, the finite element model constructed by the authors assumed a homogeneous and isotropic material. Stress output values from the model were normalized by the flexural stress predicted by Eq 7. The normalized principal stresses along

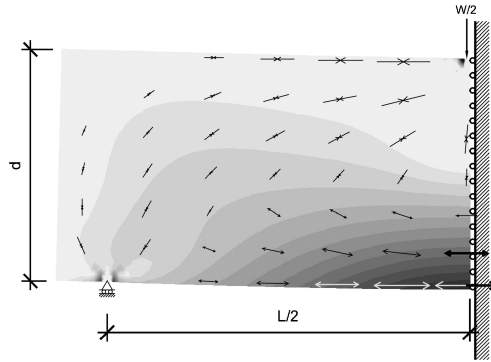
FIG. 14—Finite element model of ASTM C 99 test using a symmetry boundary condition. Arrows shown indicate direction and magnitude of the principal stresses of greatest magnitude. Shade of gray depicts principal tensile stress magnitude (darker means higher tensile stress).

A finite element model using a mid-span symmetry boundary condition is shown in Fig. 14. The maximum bottom fiber stress occurs at mid-span and, when normalized by the modulus of rupture deter-

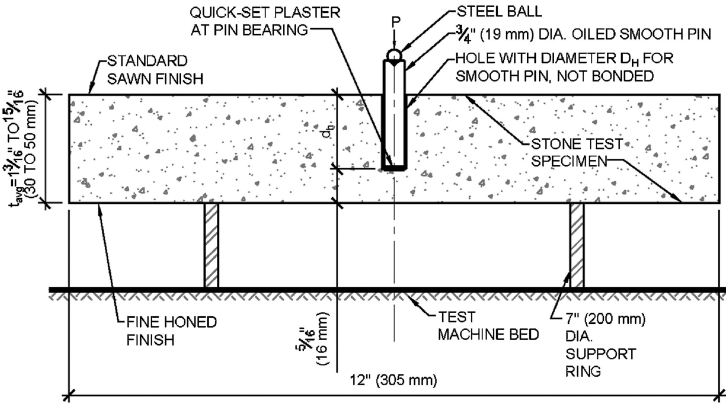
FIG. 15—Punching shear test configuration.

The punching shear test currently under consideration by ASTM Subcommittee C18.01 was developed to evaluate the strength of stone in a configuration similar to the states of stress present in certain stone

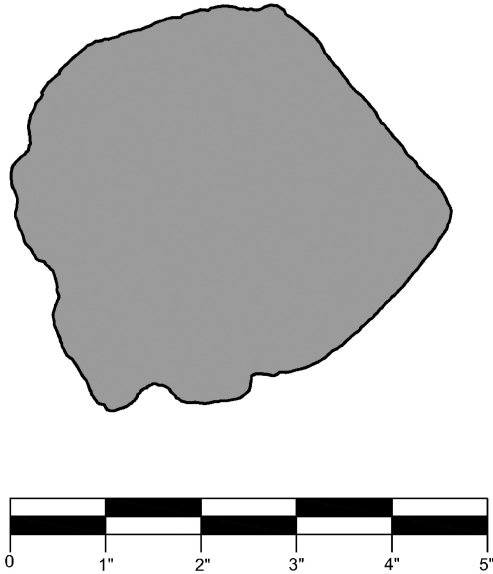
FIG. 16—Punching shear spall trace digitized in CAD software.

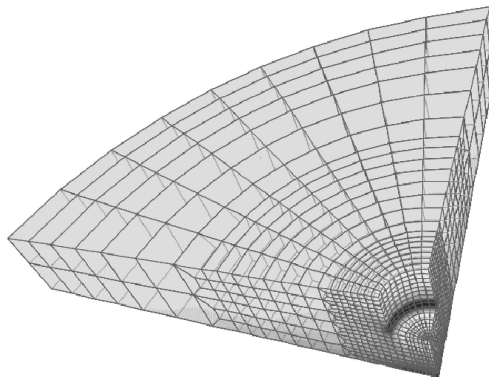
FIG. 17—Finite element model of punching shear test using solid elements. Shade of gray depicts principal tensile stress magnitude (darker means higher tensile stress).

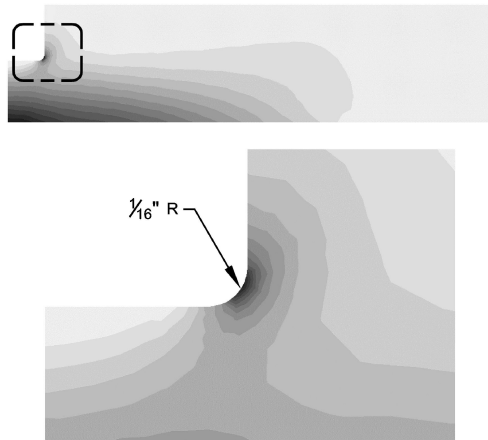
FIG. 19—Two-dimensional finite element model of punching shear test modeled using a symmetry boundary condition. Shade of gray depicts principal tensile stress magnitude (darker means higher tensile stress).

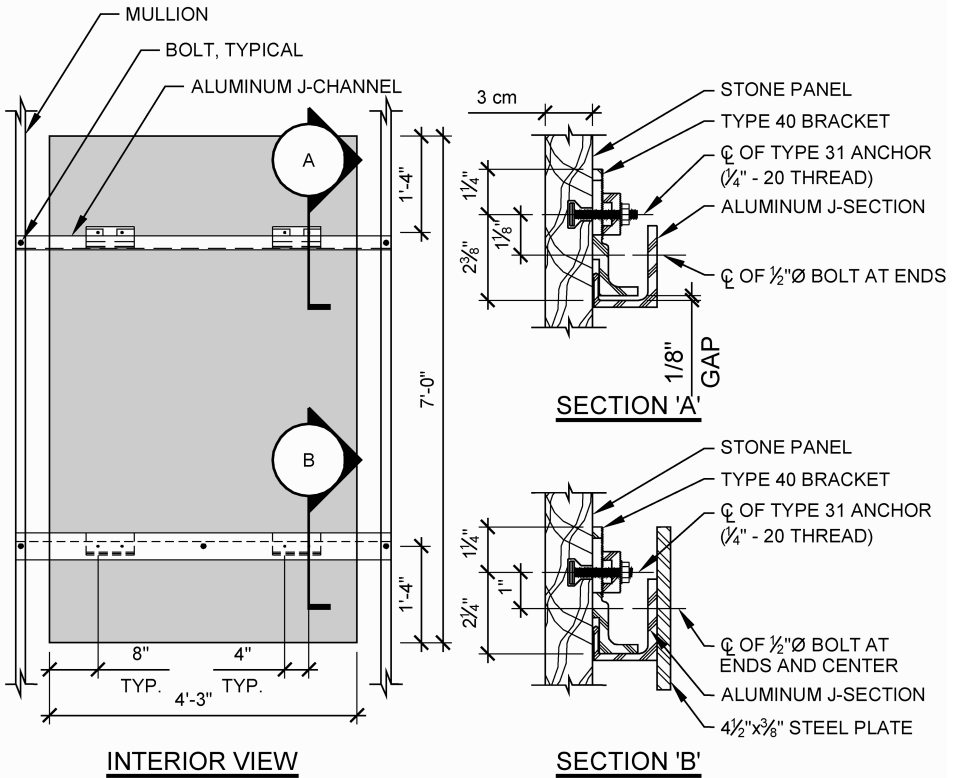
FIG. 1—Details of panel with Type 31 anchors used in the Example A structural performance tests.

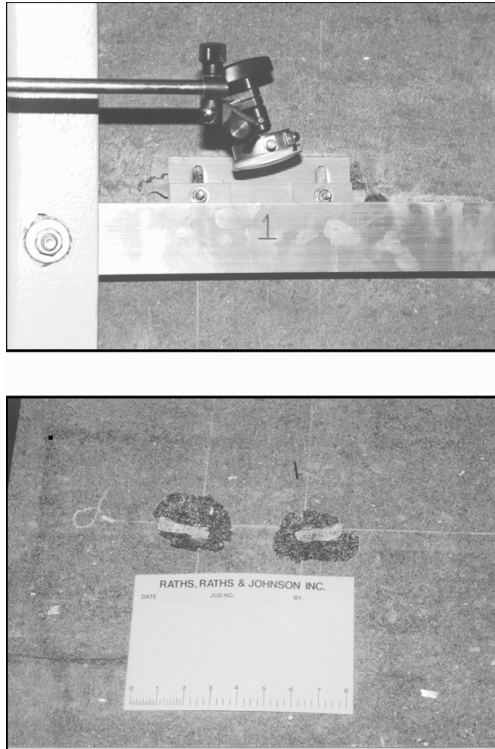
FIG. 2—Spalling located at Type 31 anchor under negative wind pressures.

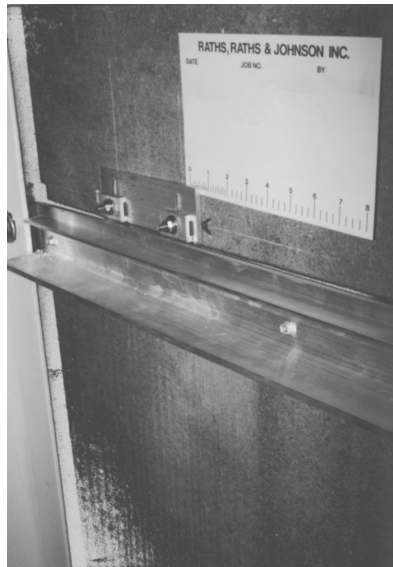
FIG. 3—View of aluminum J-section used to stiffen the upper J-section.

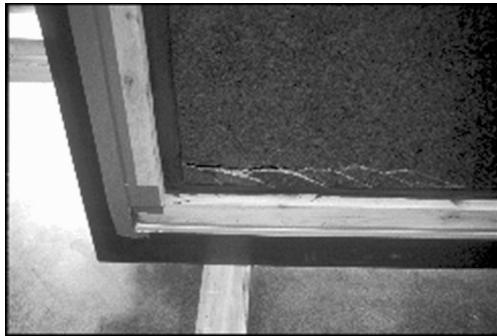
FIG. 6—“Unzipping” failure at a panel edge.

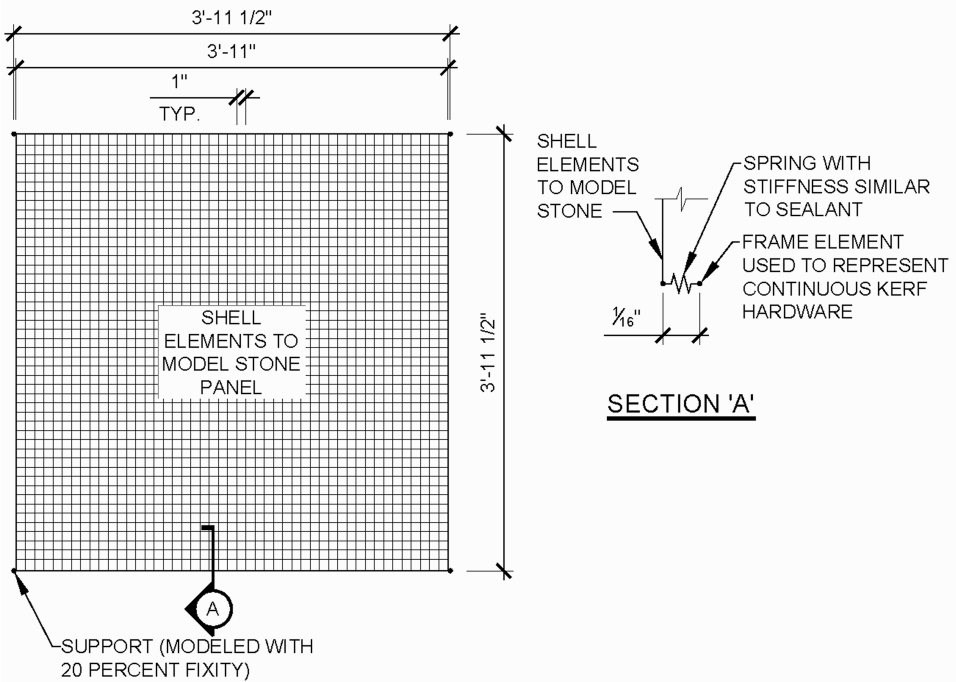
FIG. 8—View of SAP2000 computer model used to simulate cladding panels.

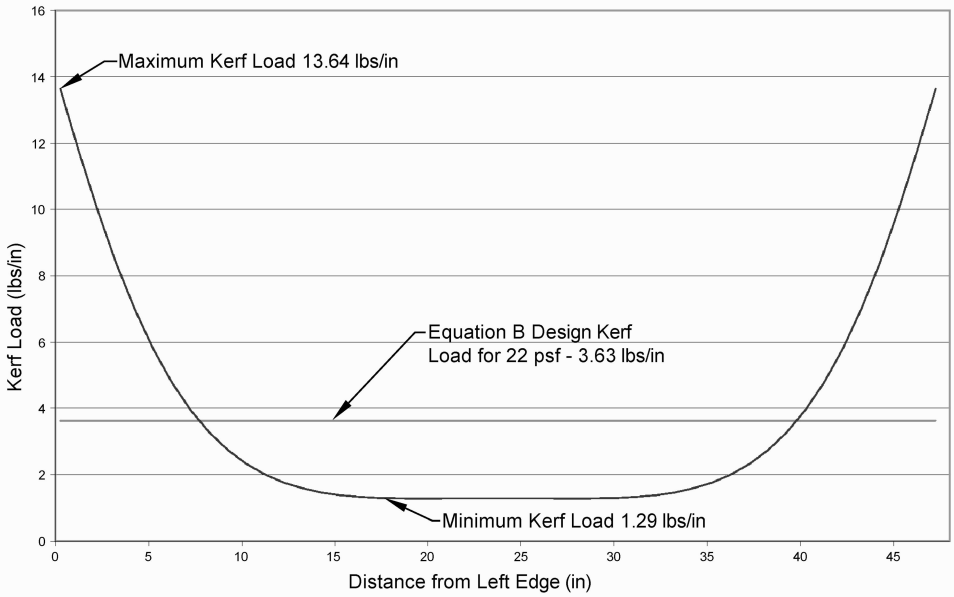
FIG. 9—Kerf loads obtained from SAP2000 model along a 47-in. wide panel with a uniform load of 22 psf.

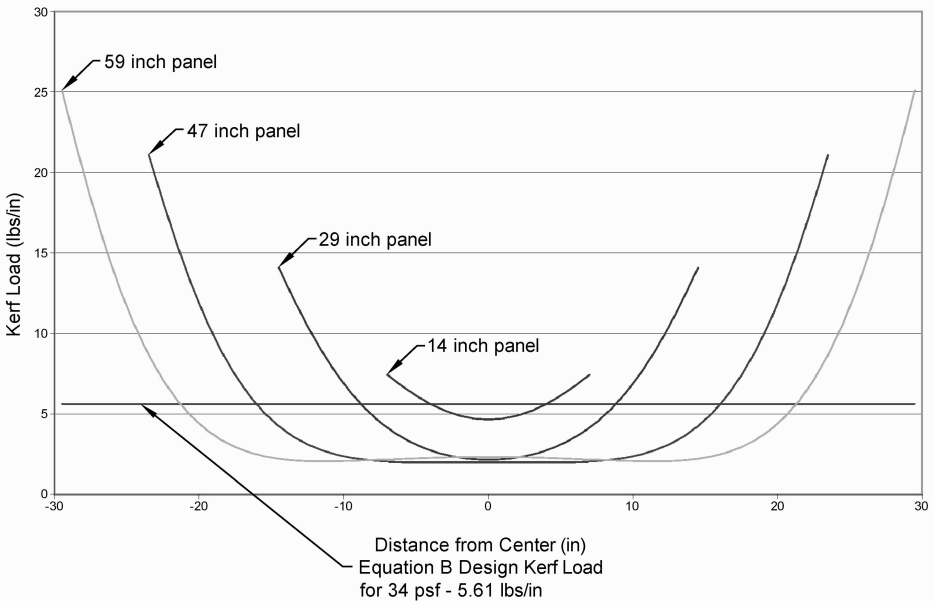
FIG. 10—Kerf loads obtained from SAP2000 for various panel widths.

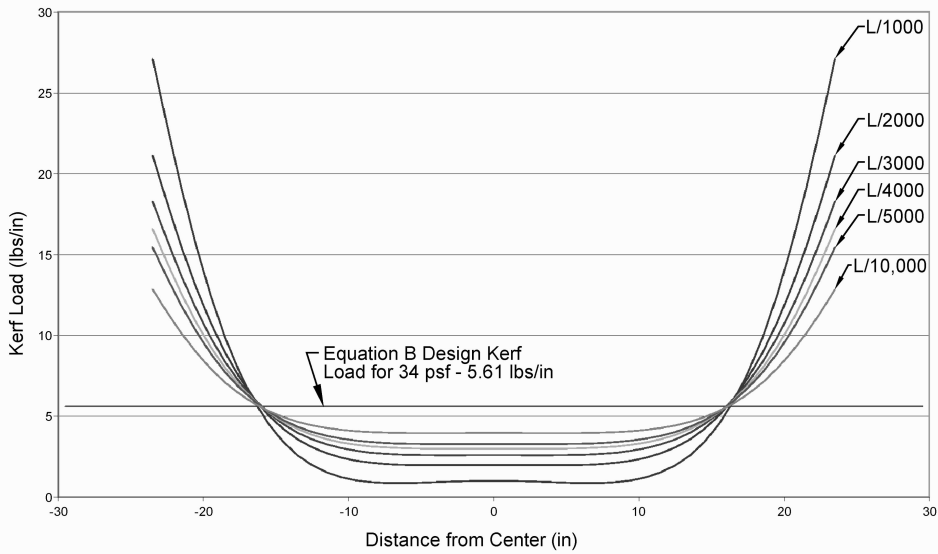
FIG. 11—Kerf loads obtained from SAP2000 model along a 47-in. wide panel with varying kerf extrusion stiffnesses.

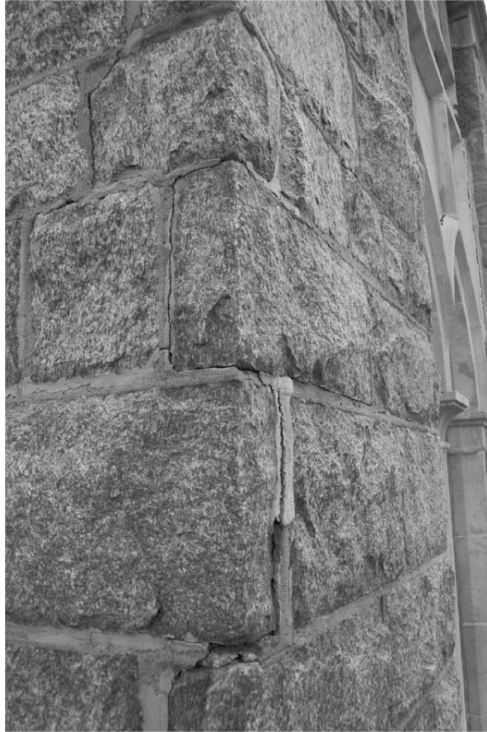
FIG. 2—Areas of previous mortar joint repointing that were applied too thin and have deteriorated.

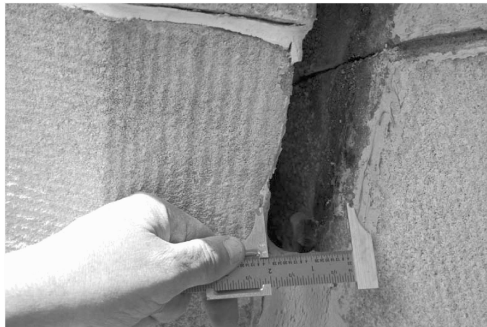
FIG. 3—Displaced limestone opening at joint, nearly 2 in. wide. Note sealant was installed covering widened joint.

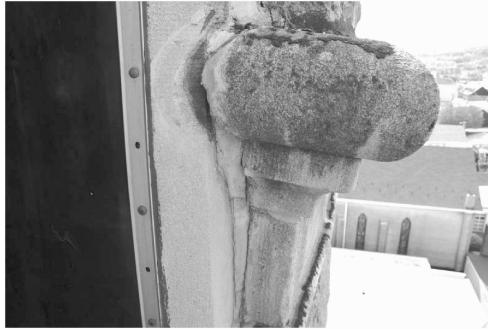
FIG. 4—Outwardly displaced limestone, nearly 3 in. Note joint opened by displaced masonry was filled with mortar during repair efforts, which will both conceal and cause further outward displacement.

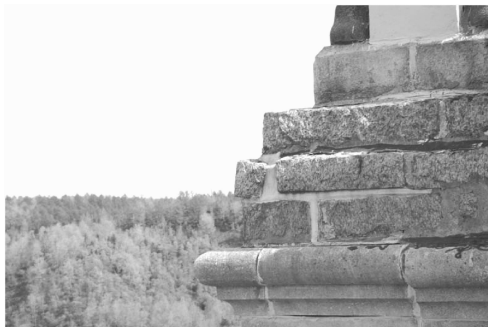
FIG. 5—Displaced granite at tower corner. Note sealant was installed around granite at mortar joints.

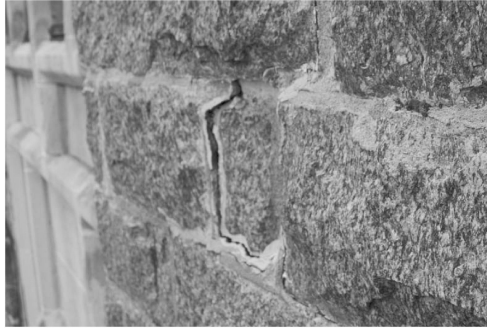
FIG. 6—Outwardly displaced (nearly 3/4 in.) granite at top of tower.

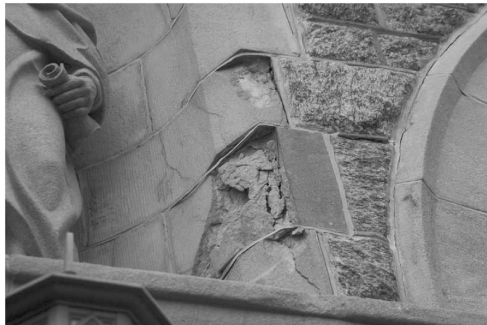
FIG. 7—Spalled limestone at alcove adjacent to granite.

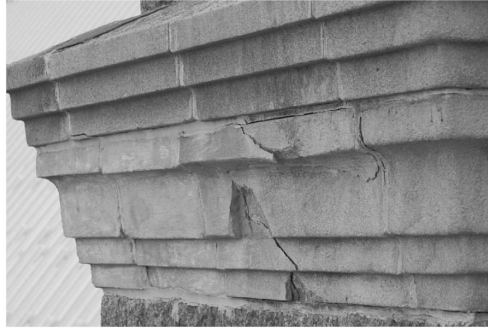
FIG. 8—Cracked and spalled limestone at upper portion of tower.

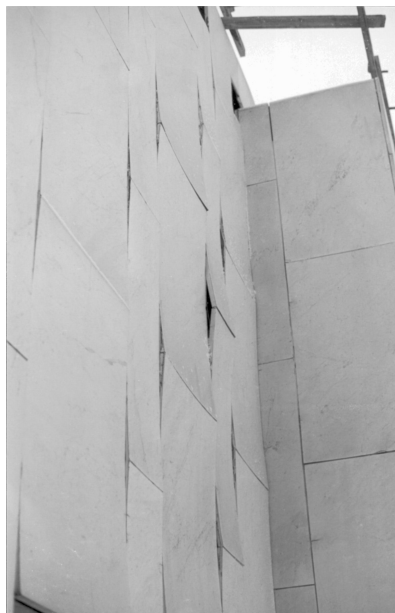
FIG. 1—Bowling of marble panels (1998) on the Finlandia Hall, Helsinki, Finland. Photo by Bent Grelk.

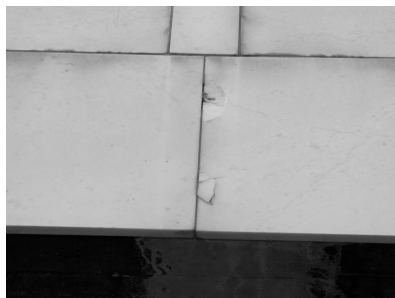
FIG. 3—Expansion of the marble panels creating cracking and spalling around the anchoring points, on a building façade in Malmo, Sweden. Photo by Bent Grelk.

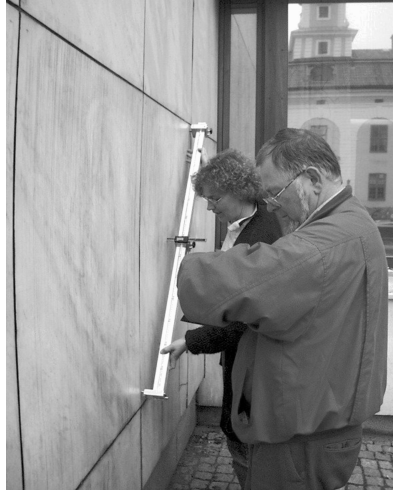
FIG. 12—Measurements of bowing amplitudes on a marble façade with the use of a “Bow-meter.” Photo by Björn Schouenborg.

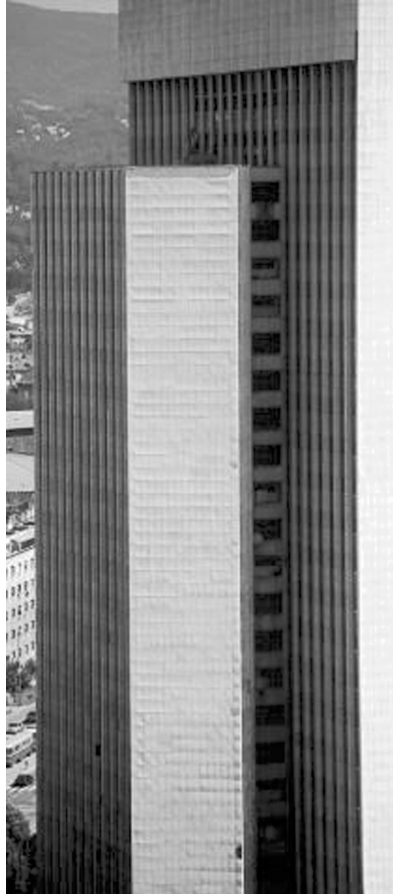
FIG. 14—Zagrepcanka building in Zagreb with concave bowing on the lower part and convex bowing of the upper part of the façade. Photo by Jan Anders Brundin.

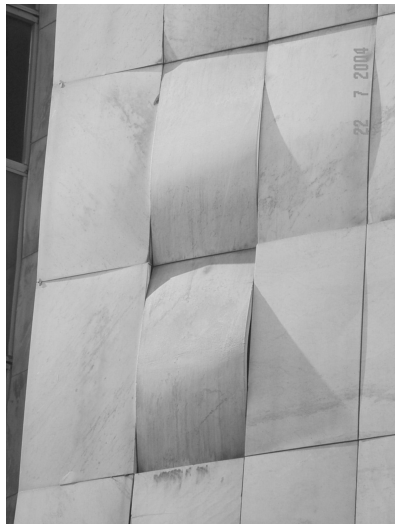
FIG. 15—Zagrepcanka building in Zagreb. Close-up of the façade with panels showing significant different bowing behavior. Photo by Jan Anders Brundin.

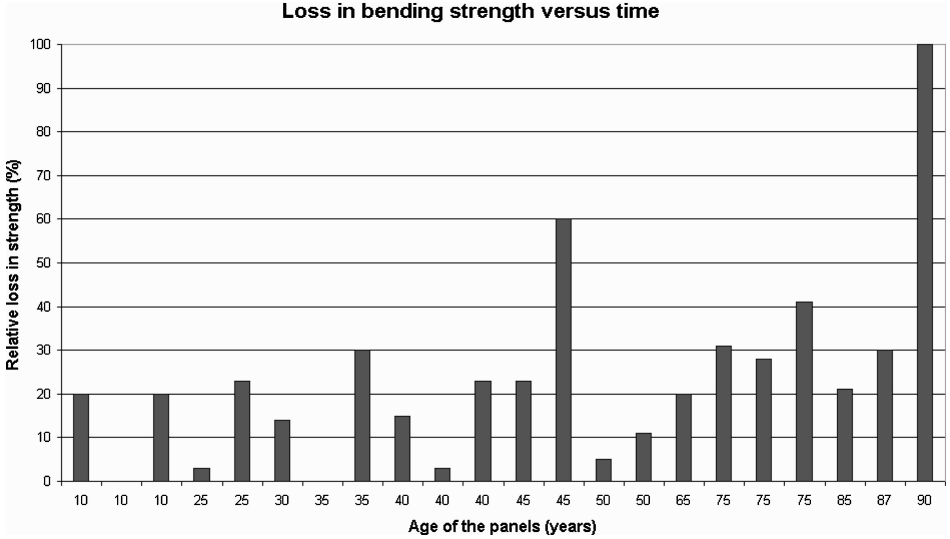
FIG. 2—The relative loss in flexural strength, and modulus of rupture, recorded from different marble clad buildings. The initial strength values are generally data provided by the producer.

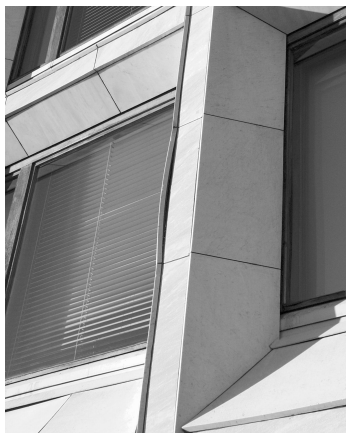
FIG. 5—*The same marble can display different bowing patterns on the same building. Horizontal panels are concave and the vertical ones are convex.*

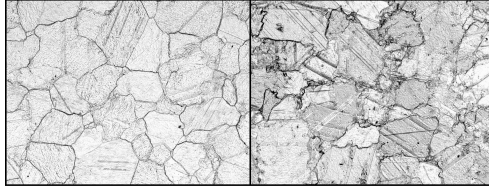
FIG. 6—The favorable microtexture of the marble to the right is caused by complex grain boundaries in combination with a range of different sizes of the grains. The marble to the left is prone to bowing due its quite simple structure with, more or less, mono-sized grains and straight grain boundaries [17,18]. The image corresponds to an area of 1.3 by 1.0 mm².

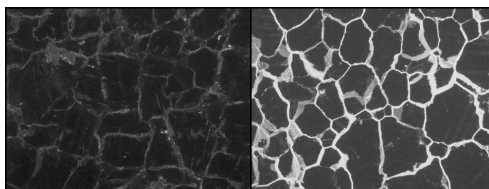
FIG. 7—Fluorescent microphoto of nonbowing marble to the left and a bowing one to the right. The marble to the right has a high proportion of cracks between the individual grains. The image corresponds to an area of 1.3 by 1.0 mm².

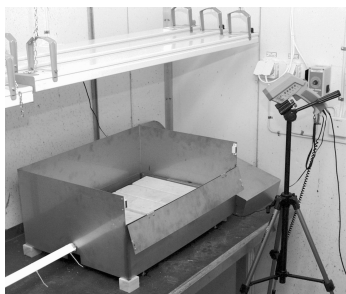
FIG. 8—Laboratory bow-test equipment for combining a wet underside with cyclic heating from above. Sample sizes are 30 by 100 by 400 mm.

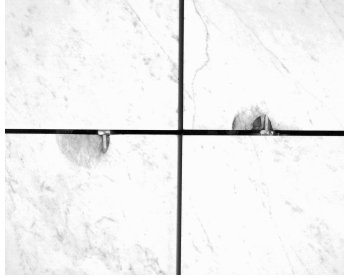
FIG. 9—Cracking at anchoring points due to excessive expansion in relation to the dimensions of “dilatation” joints.

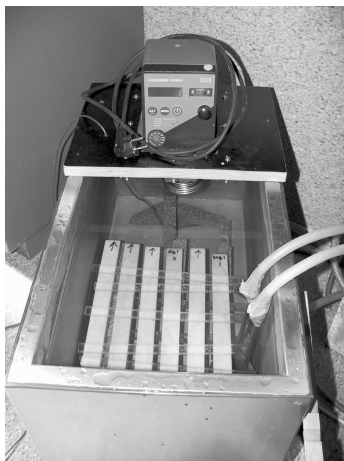
FIG. 10—Laboratory test for moisture and heat-induced expansion, providing relevant data for dimensioning of dilatation joints. Sample sizes are 30 by 30 by 200 mm.

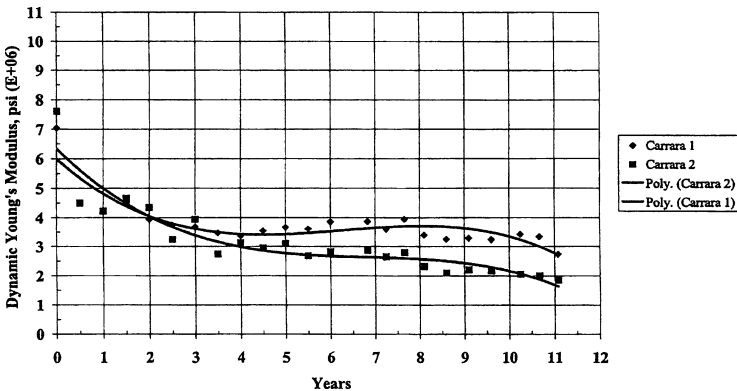
FIG. 3—Natural weathering studies—Marbles.

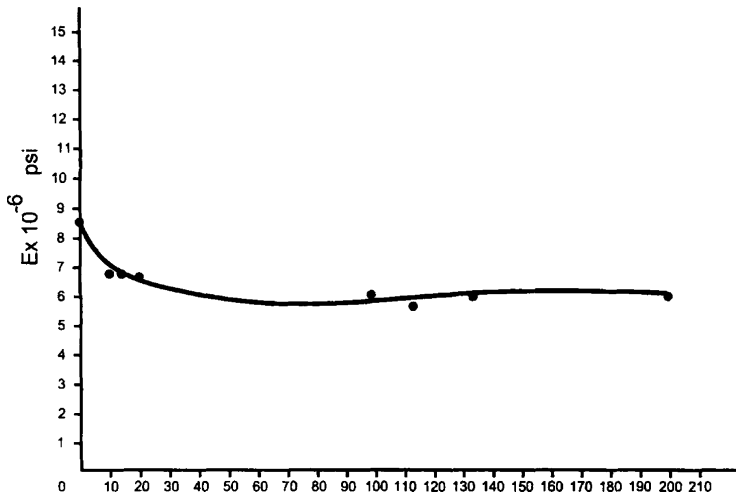
FIG. 10—Heating and Cooling Cycles. 200 Cycles values modulus of elasticity for unweathered Carrara Marble.

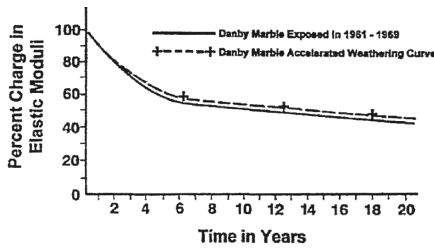
FIG. 12—Natural weathering results for Marquis Gray Danby Marble.

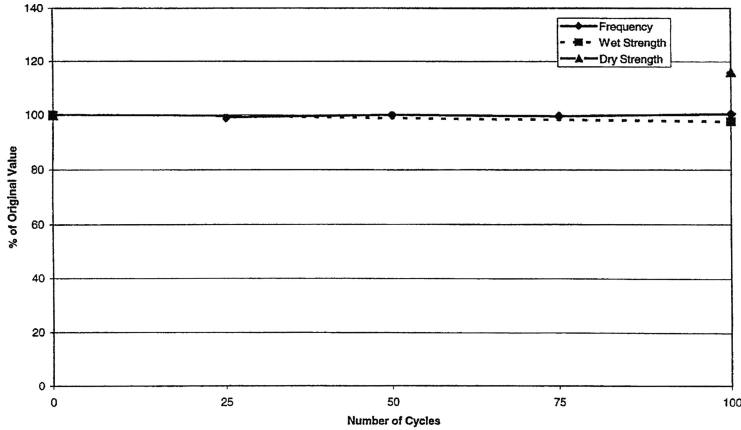
FIG. 14—Cottonwood Falls, Kansas limestone—perpendicular frequency versus strength loss 100 cycles.

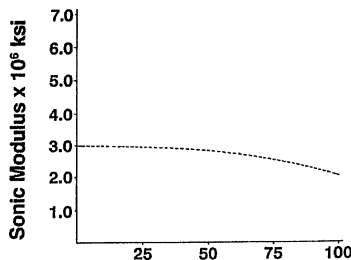
FIG. 15—Accelerated weathering to limestone.

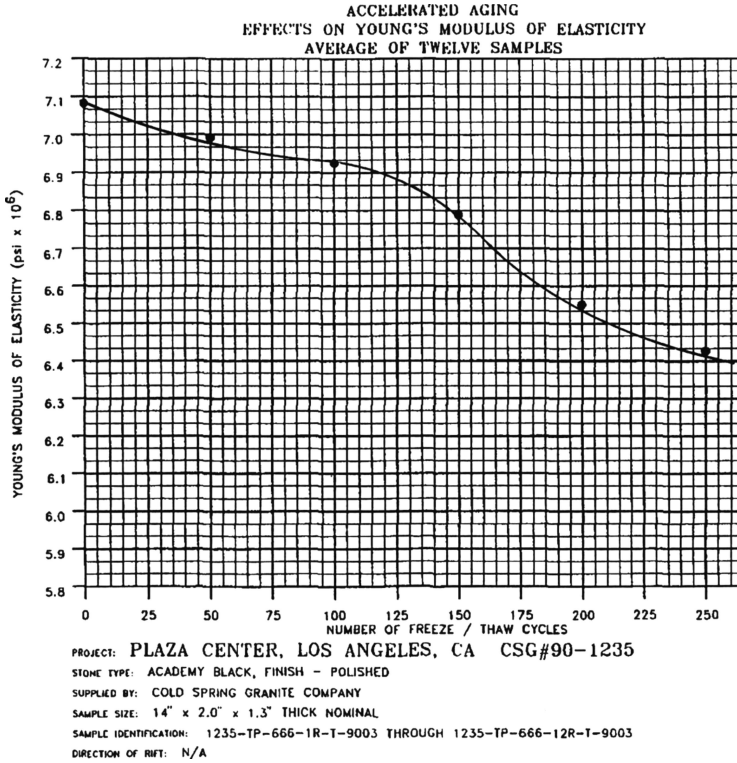
FIG. 16—Accelerated durability test results for Academy Black Granite.

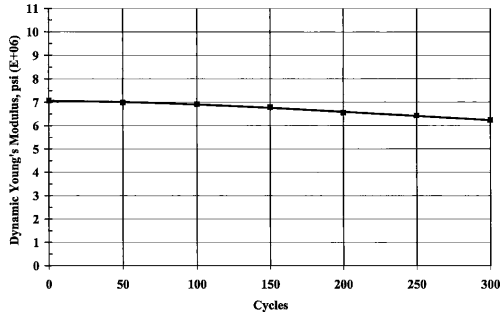
FIG. 18—Weathering studies granite.

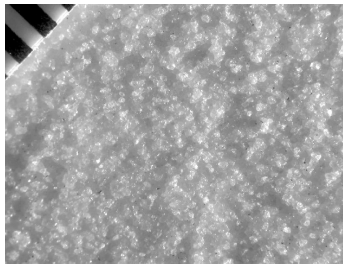
FIG. 19—Sugaring of marbles surface. Millimetre scale.

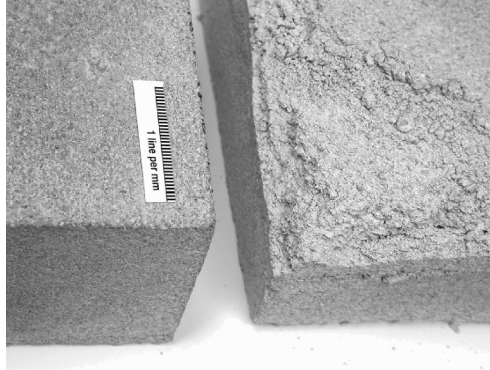
FIG. 25—Photomicrograph of Indiana Limestone from two different locations shown after accelerated weathering.
