3D Echocardiography of Structural Heart Disease

An Imaging Atlas

Hakimeh Sadeghian

Zahra Savand-Roomi

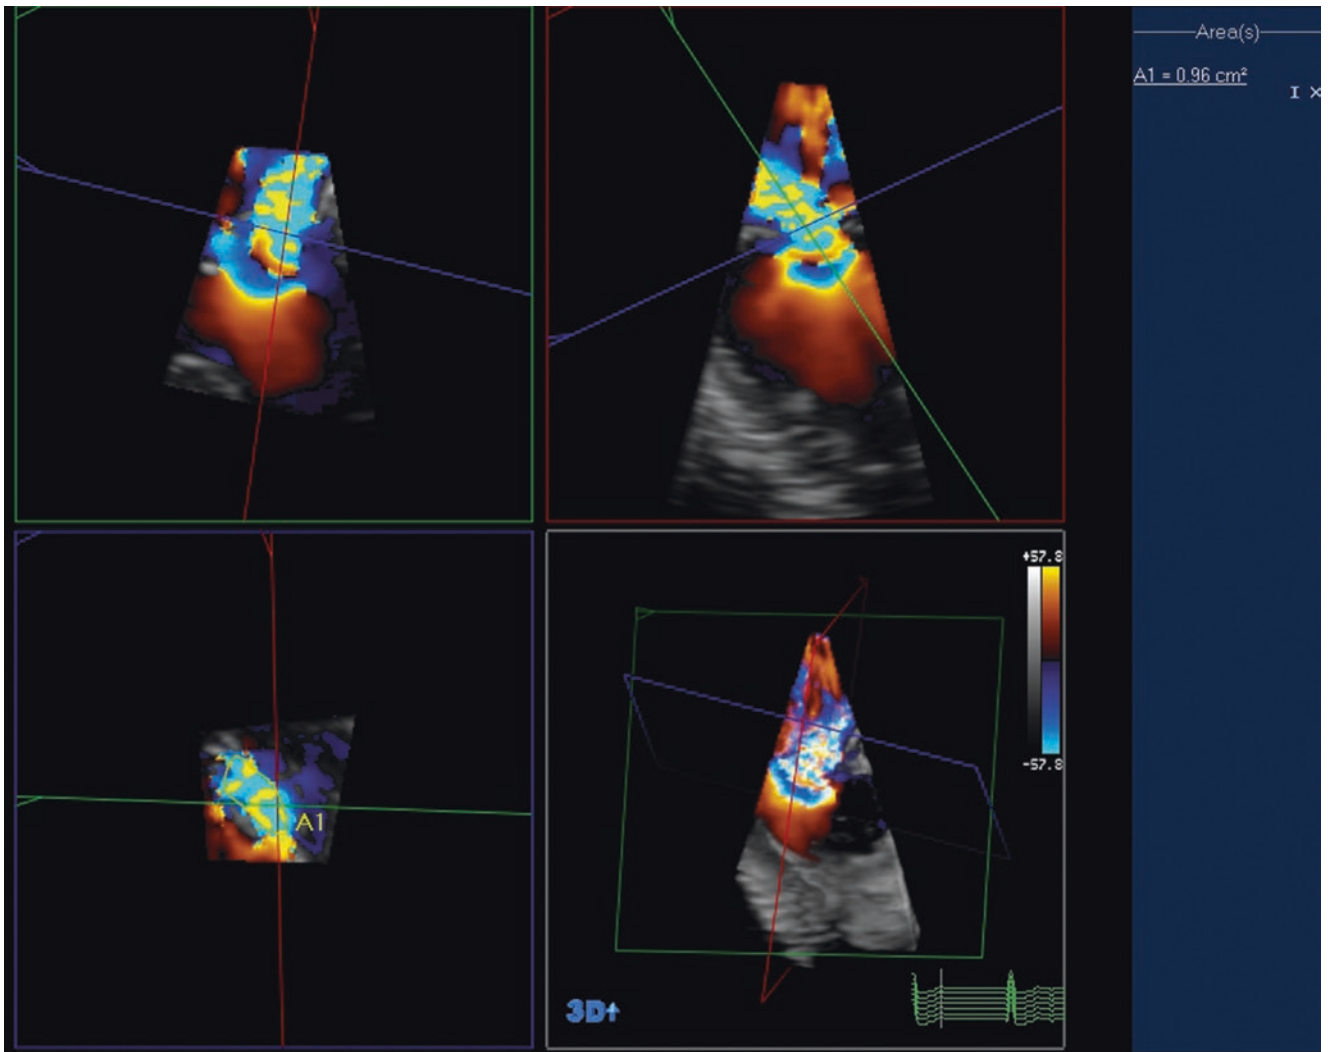
Fig. 1.21 Vena contracta area measures 0.96 cm² by color Doppler full volume 3DQ in favor of severe MR

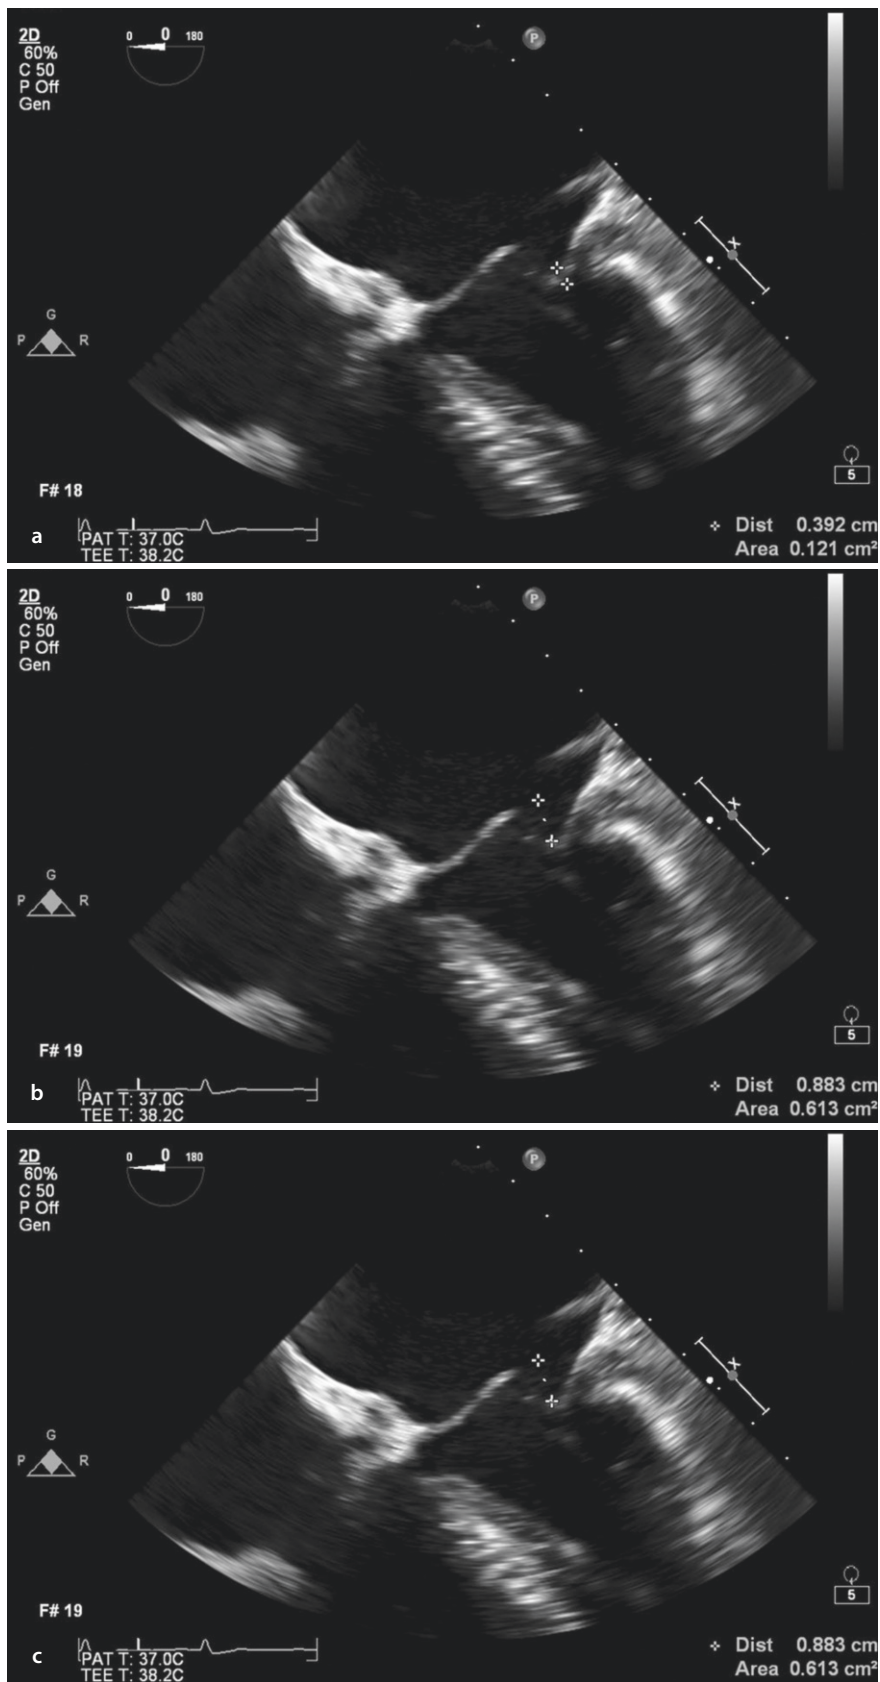
■ Fig. 1.22 Zona coapta measures 3.9 mm in TEE 0° view a and flail gap measures 8.8 mm in this view b and coaptation height measures 7.6 mm in this view c

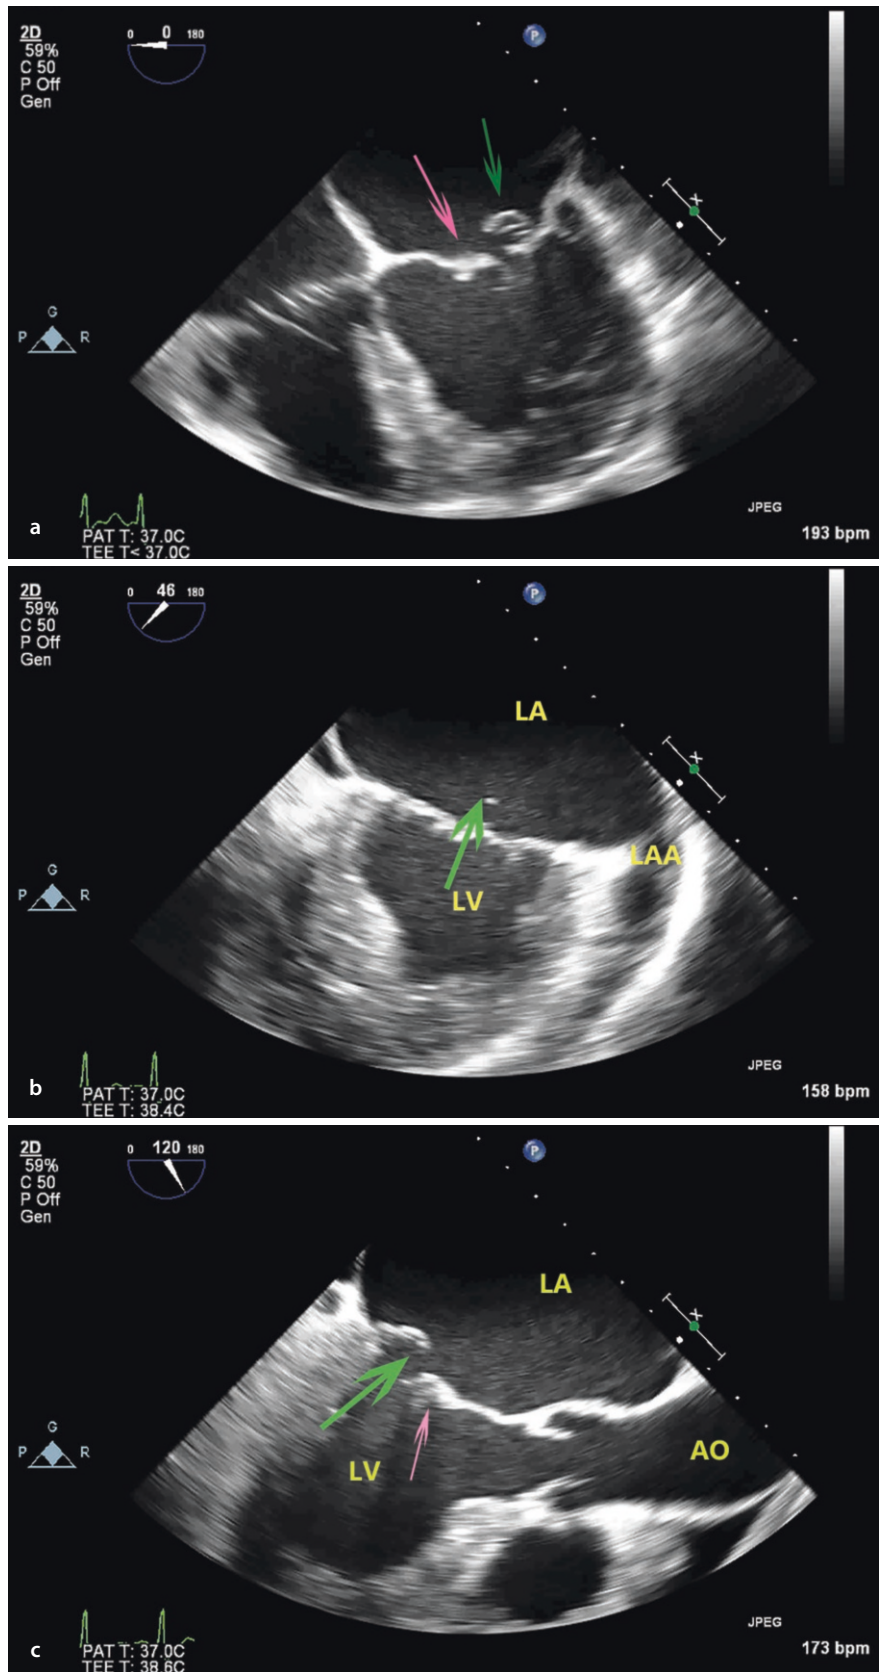
■ Fig. 1.33 The head of posterior mitral leaflet is turned toward left atrium in systole (arrows) in favor of complete flail of posterior mitral leaflet by TEE 0° view a, TEE short-axis view b and TEE long-axis view c, A2 is also thick and prolaptic in these views (pink arrows). Involvement of other segments in addition to main flail segment is in favor of forme fruste

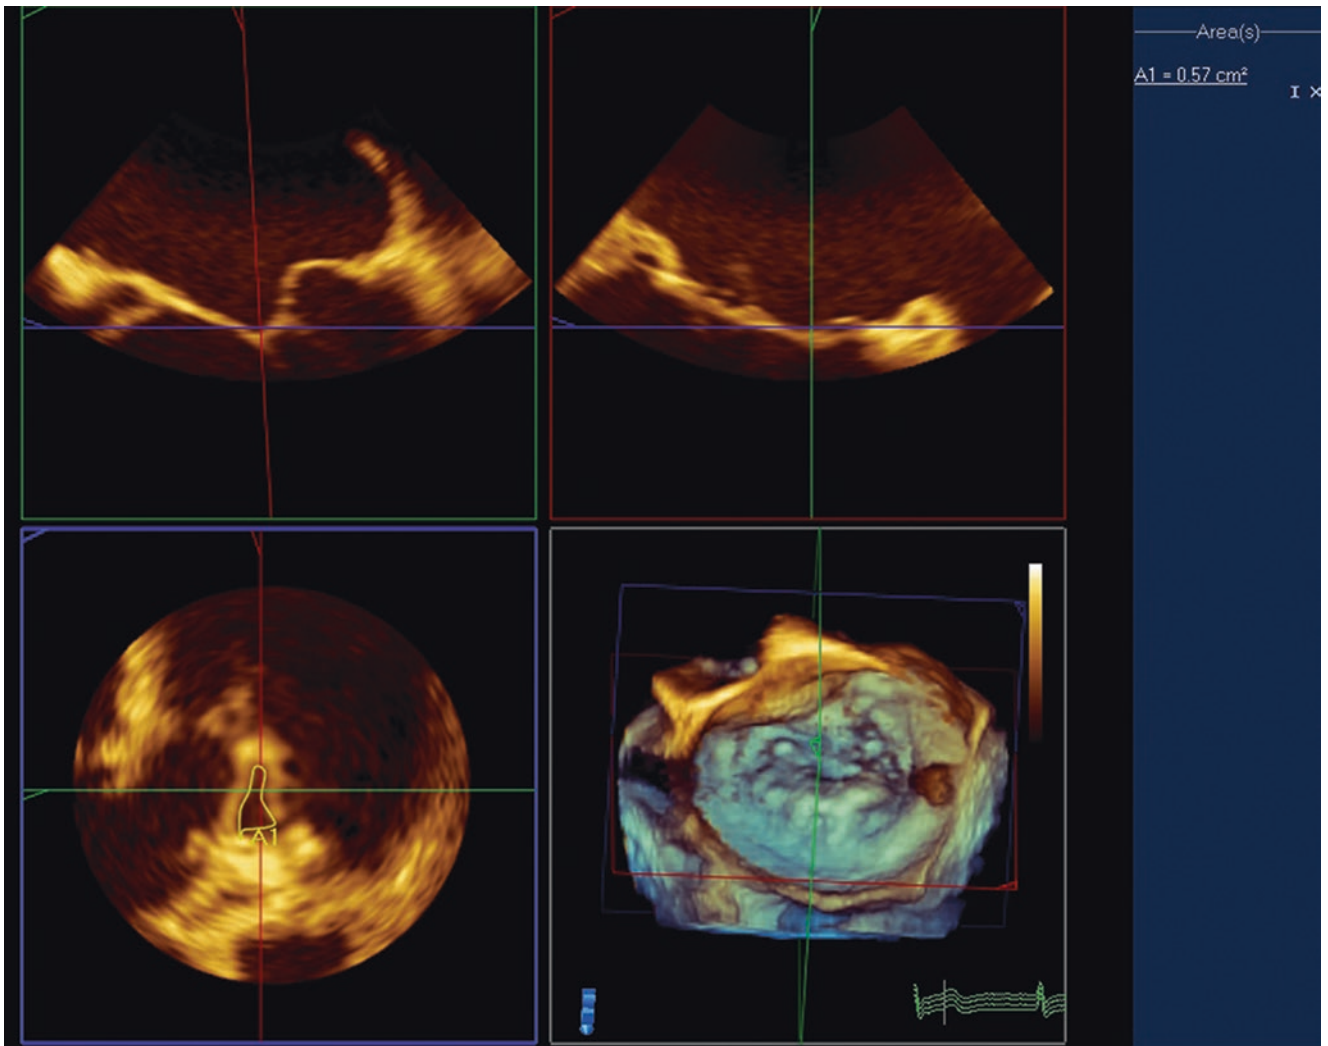
■ Fig. 1.68 Anatomic mitral regurgitation surface area measures 0.57 cm^2 and has a relatively circular shape

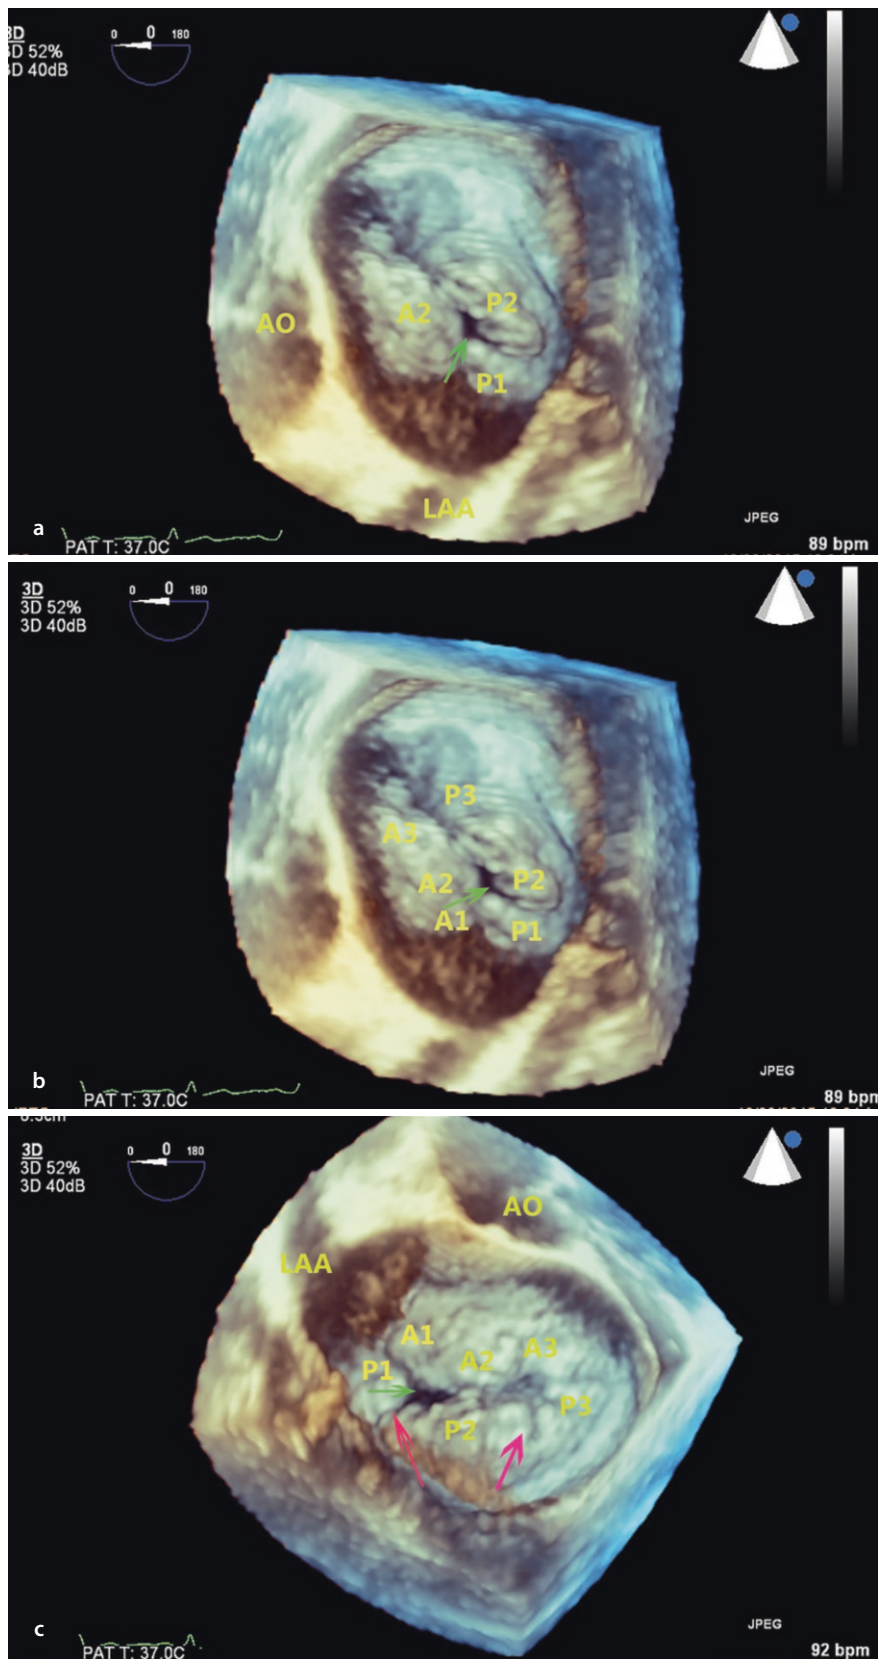
■ Fig. 1.74 P2 is more prolapsed by 3D zoom but A2 and P1 are also prolapsed a, b, failure of coaptation of MV leaflets in systole is also evident (green arrows) a, b, red and pink arrows c refers to the indentation between P1 and P2 and P2 and P3

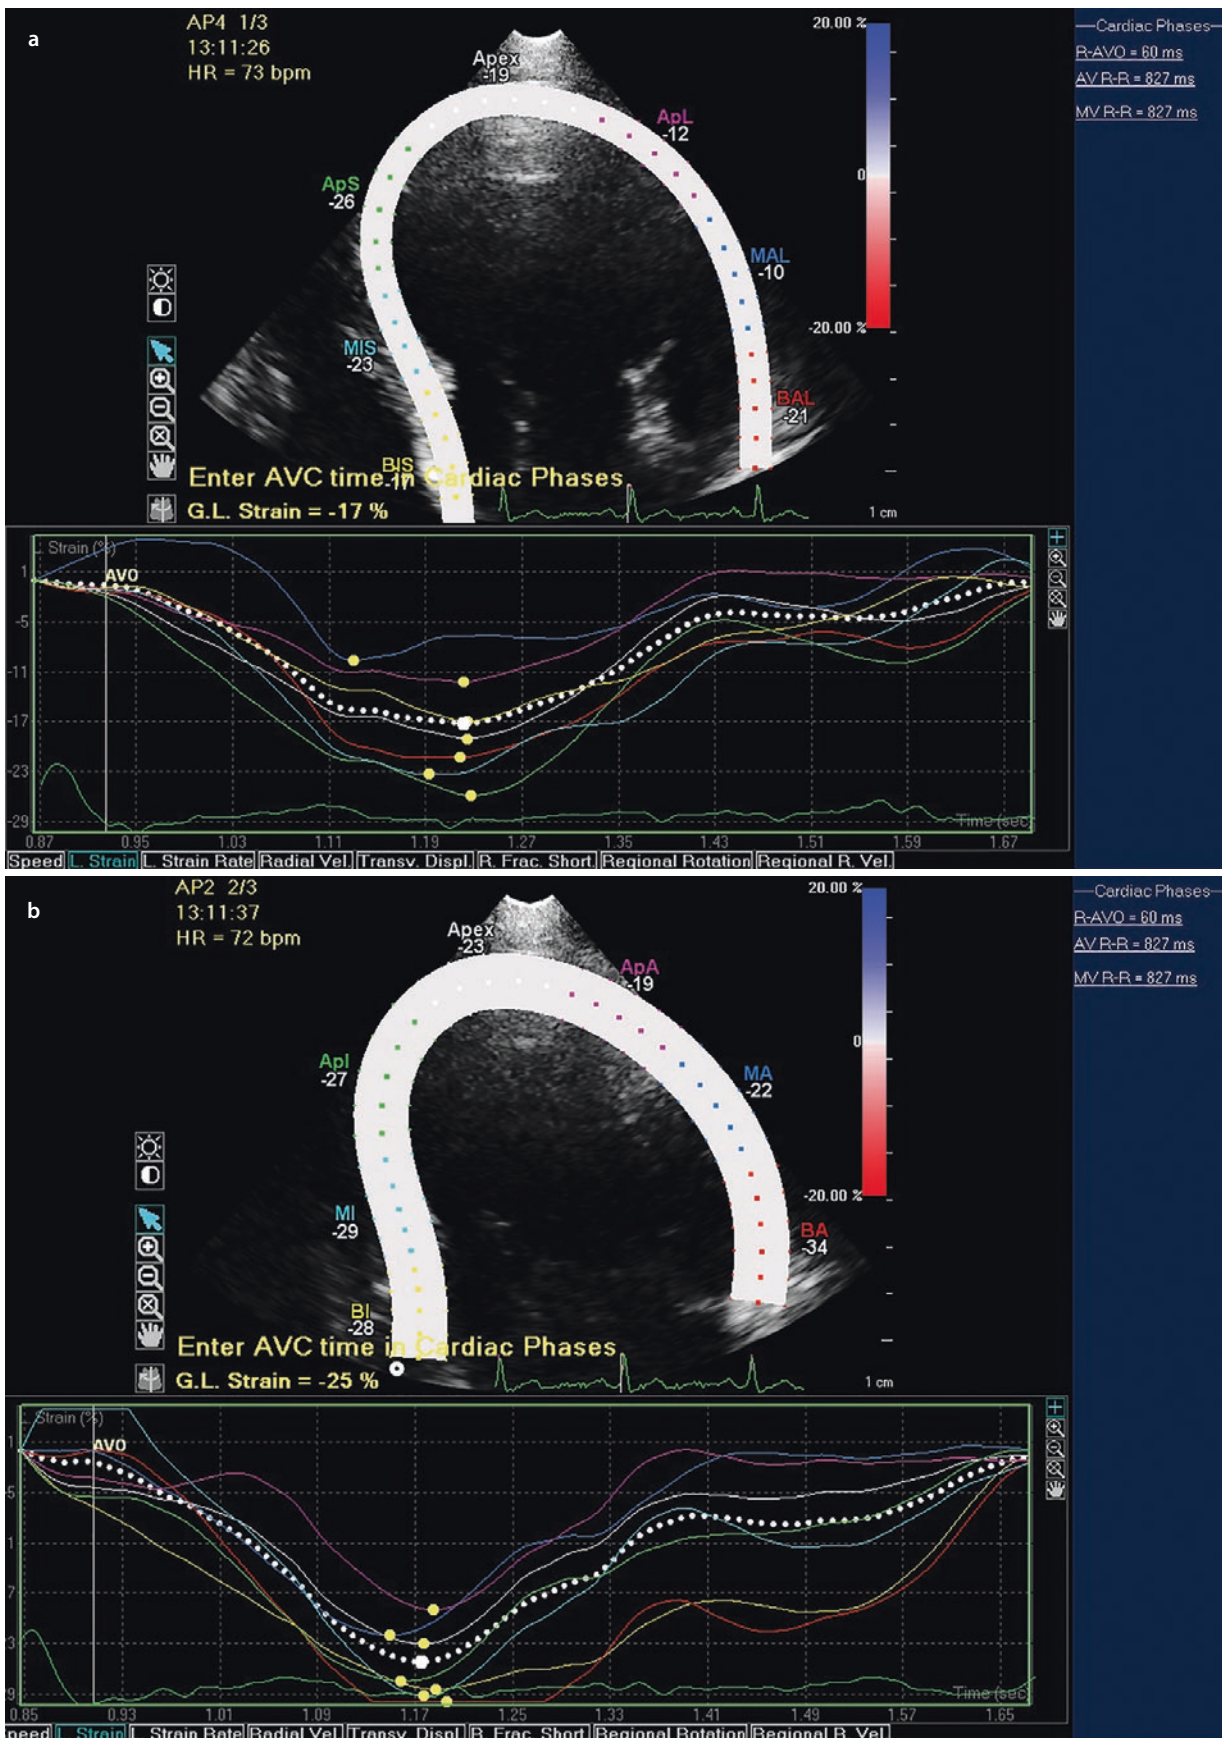
Fig. 1.76 Longitudinal strain is equal to -17% in apical four-chamber view **a**, -25% in apical two-chamber view **b** and -24% in apical three-chamber view **c**. Global longitudinal strain measures -21% **d**

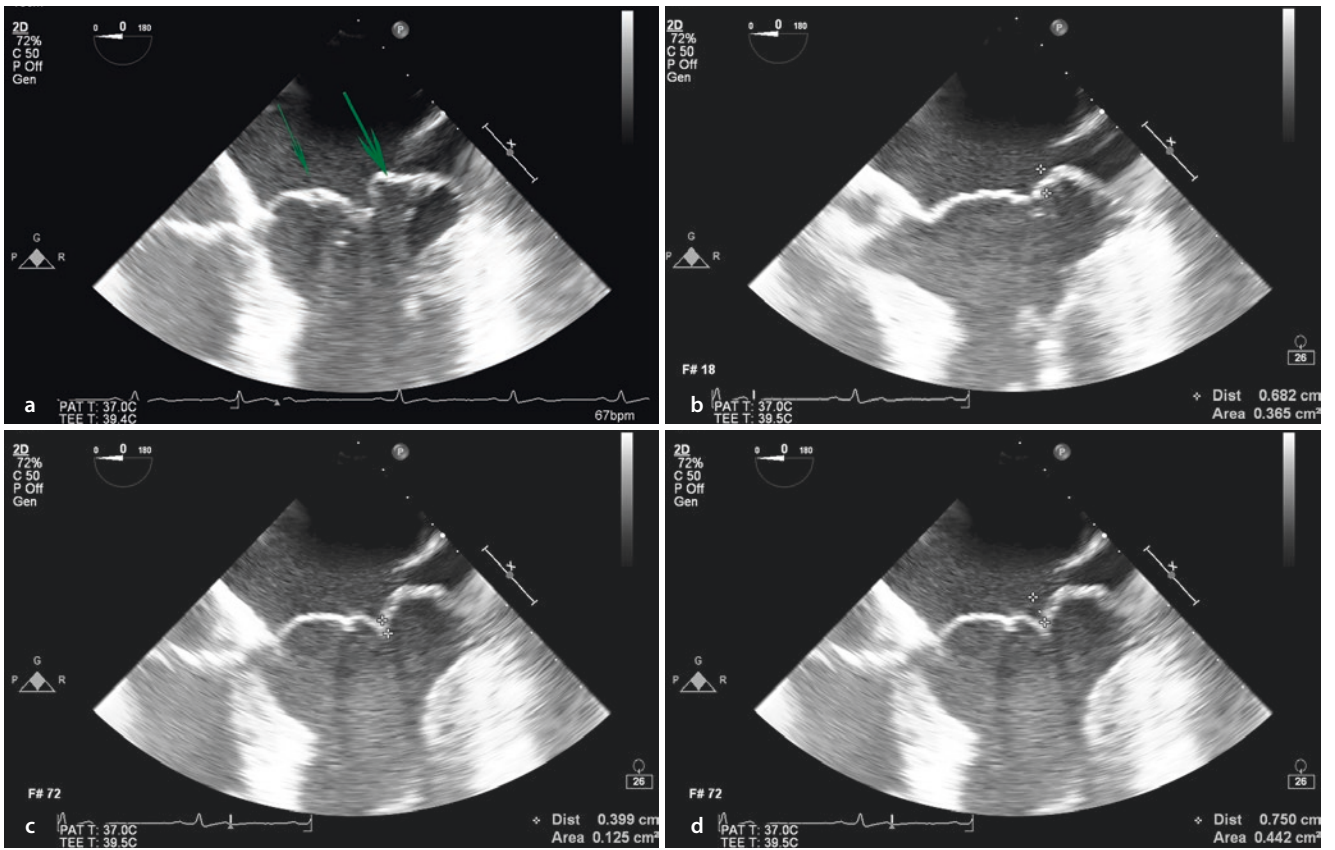
Fig. 1.78 Prolapse of A2 and P2 is evident by TEE 0° view **a**, flail gap measures 6.8 mm **b**, zona coapta measures 4 mm **c** and coaptation depth measures 7.5 mm in this view **d**

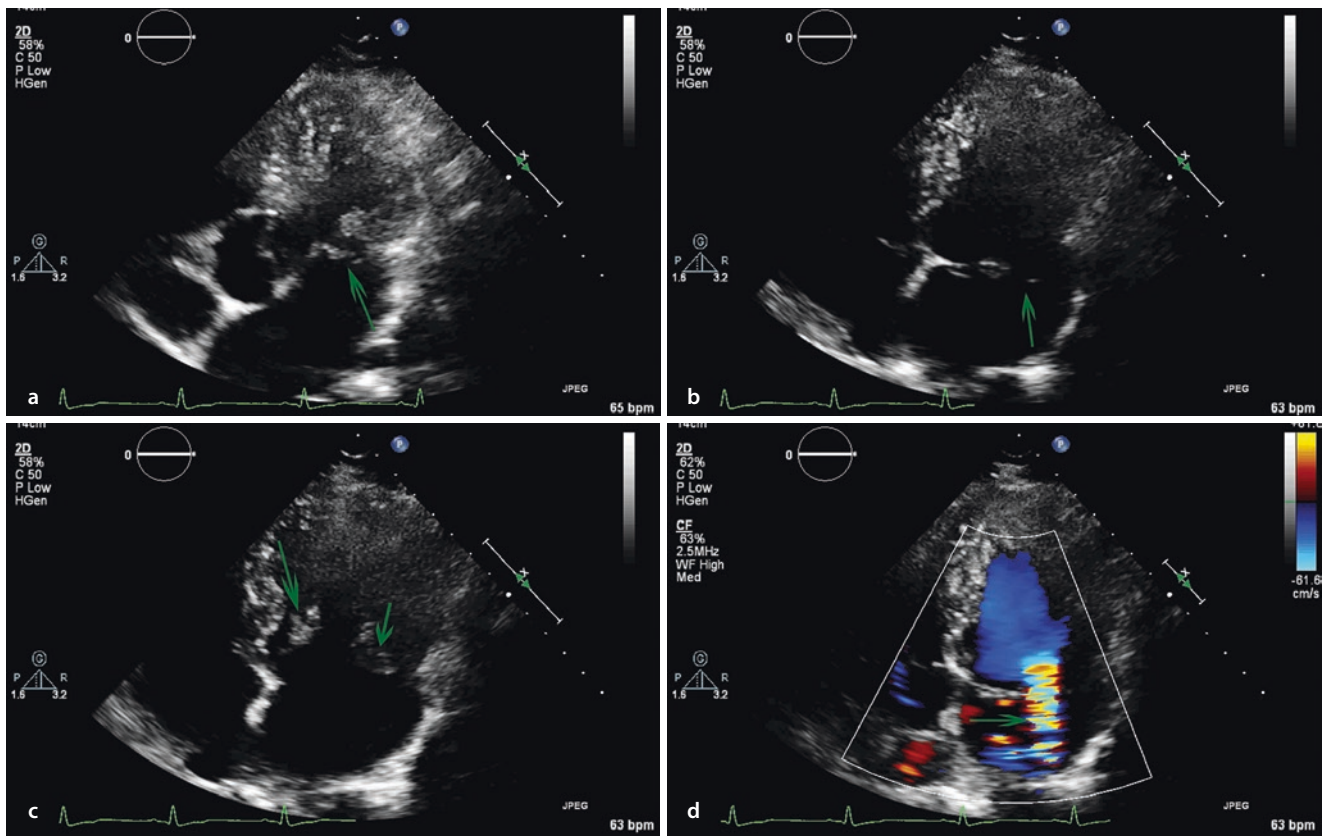
■ **Fig. 1.110** Complete flail of anterior mitral leaflet (A2) is evident in apical four-chamber views (*arrows*) **a**, **b**, severe thickening of mitral leaflets is evident in this view (*arrows*) **c**, mitral regurgitation is eccentric toward lateral wall (*arrow*) **d**

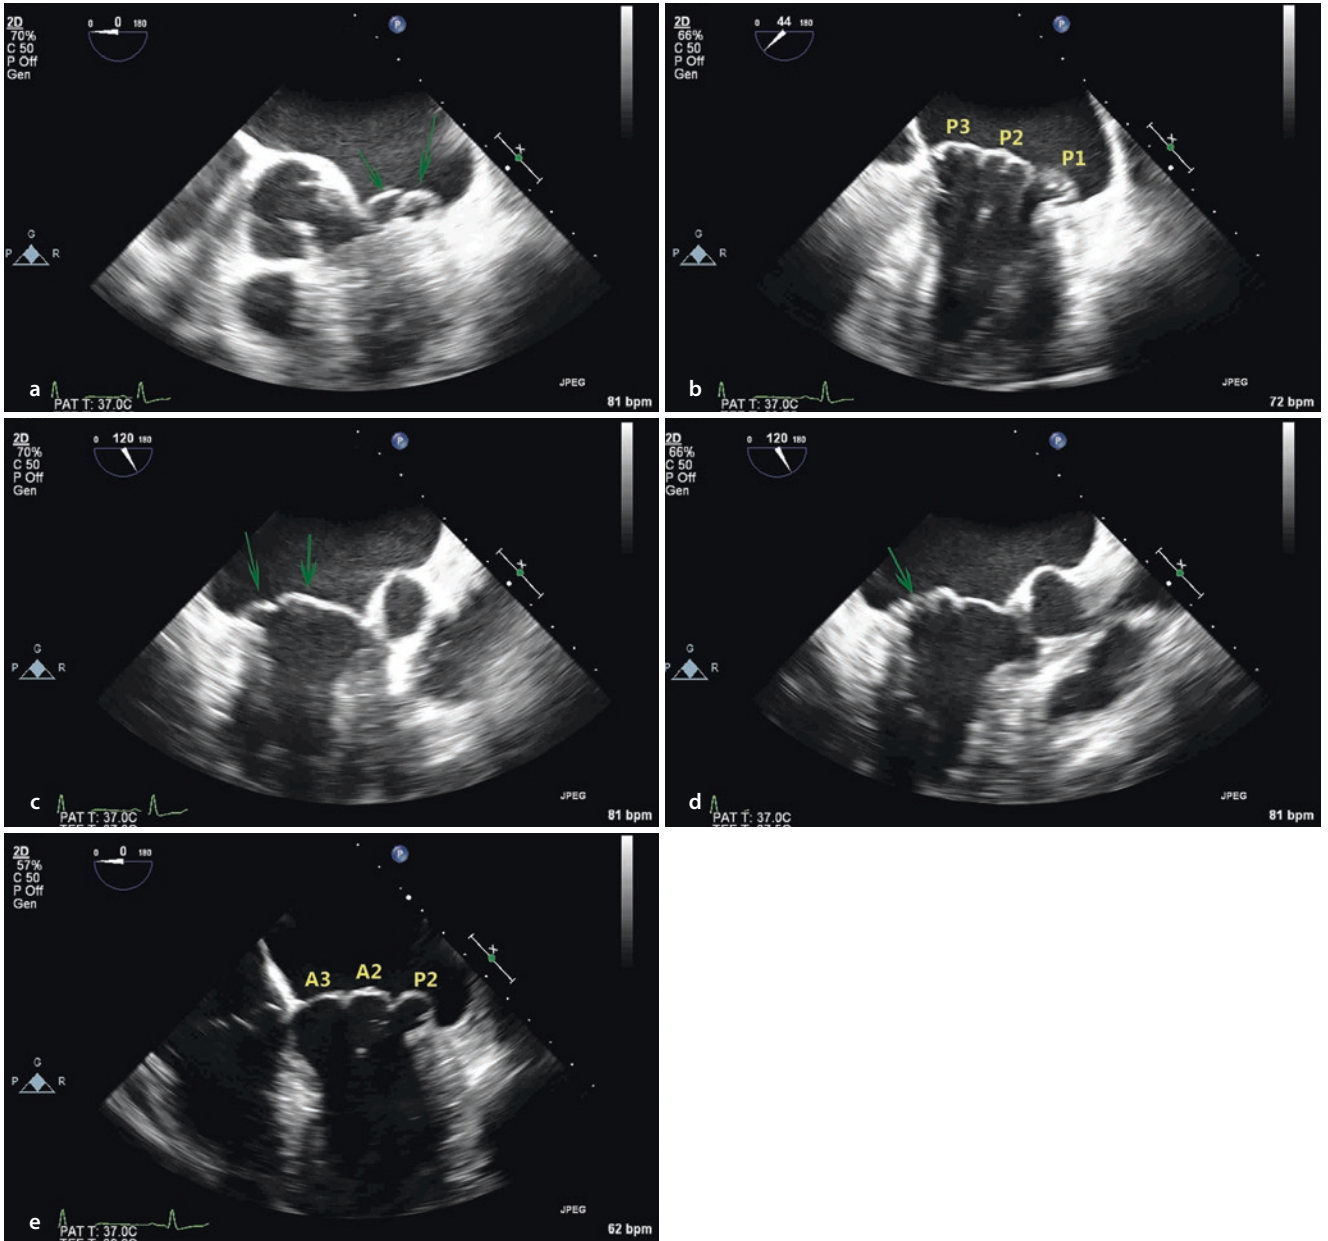
■ **Fig. 1.111** Typical prolapse and thickening of all mitral valve scallops are evident in TEE 0° view **a**, short-axis view **b** and long-axis view **c**, head of ruptured chorda on A2 is evident in TEE long-axis view (*arrow*) **d**, prolapse of P2, A2, and A3 is evident in TEE 0° view **e**

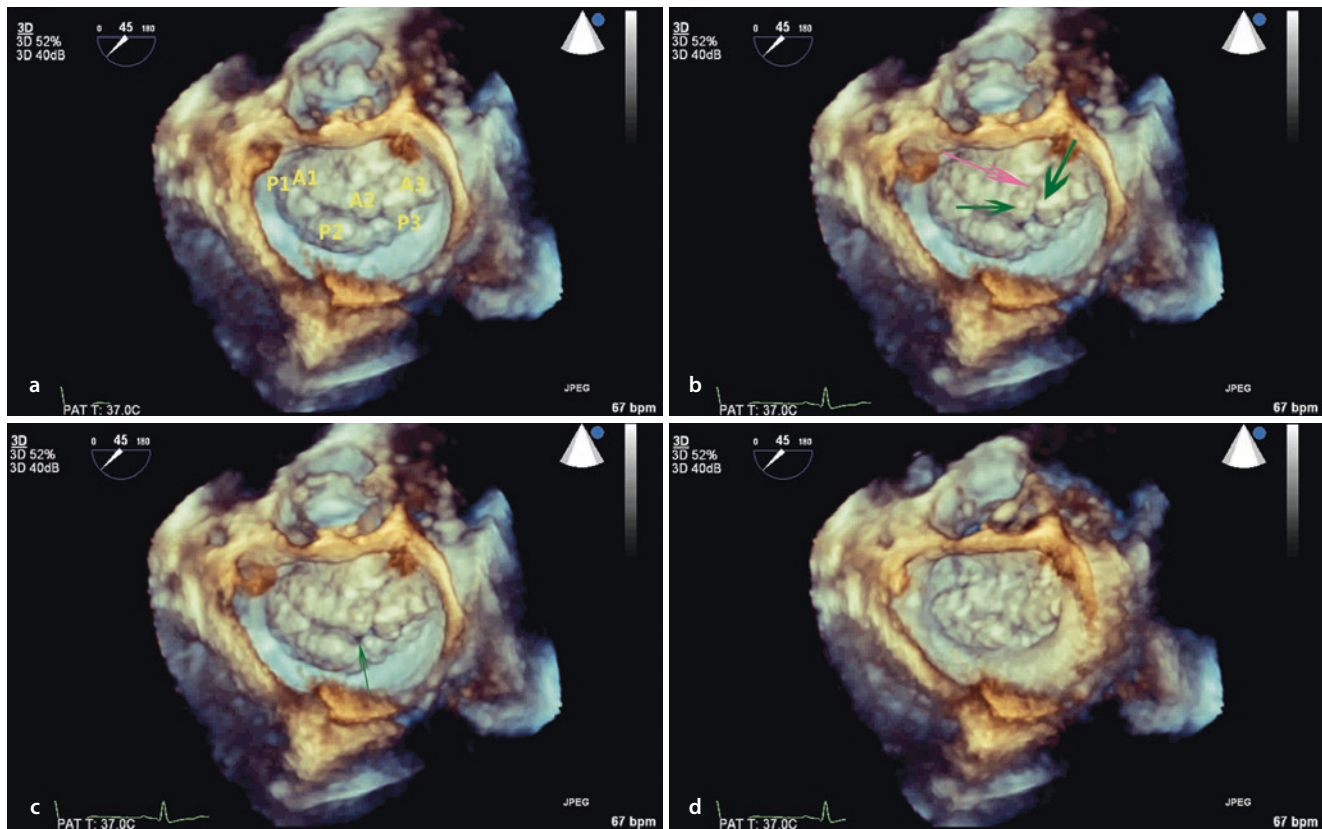
■ **Fig. 1.112** Prolapse of nearly all mitral valve scallops is evident by 3D zoom of mitral valve from left atrial side in 45° a, rupture of chorda is evident in A2 and A3 scallops (green arrows) b, the indentation between A2 and A3 is marked by a pink arrow b, failure of coaptation of mitral scallops is more prominent in late systole (green arrow) c compared to mid systole d

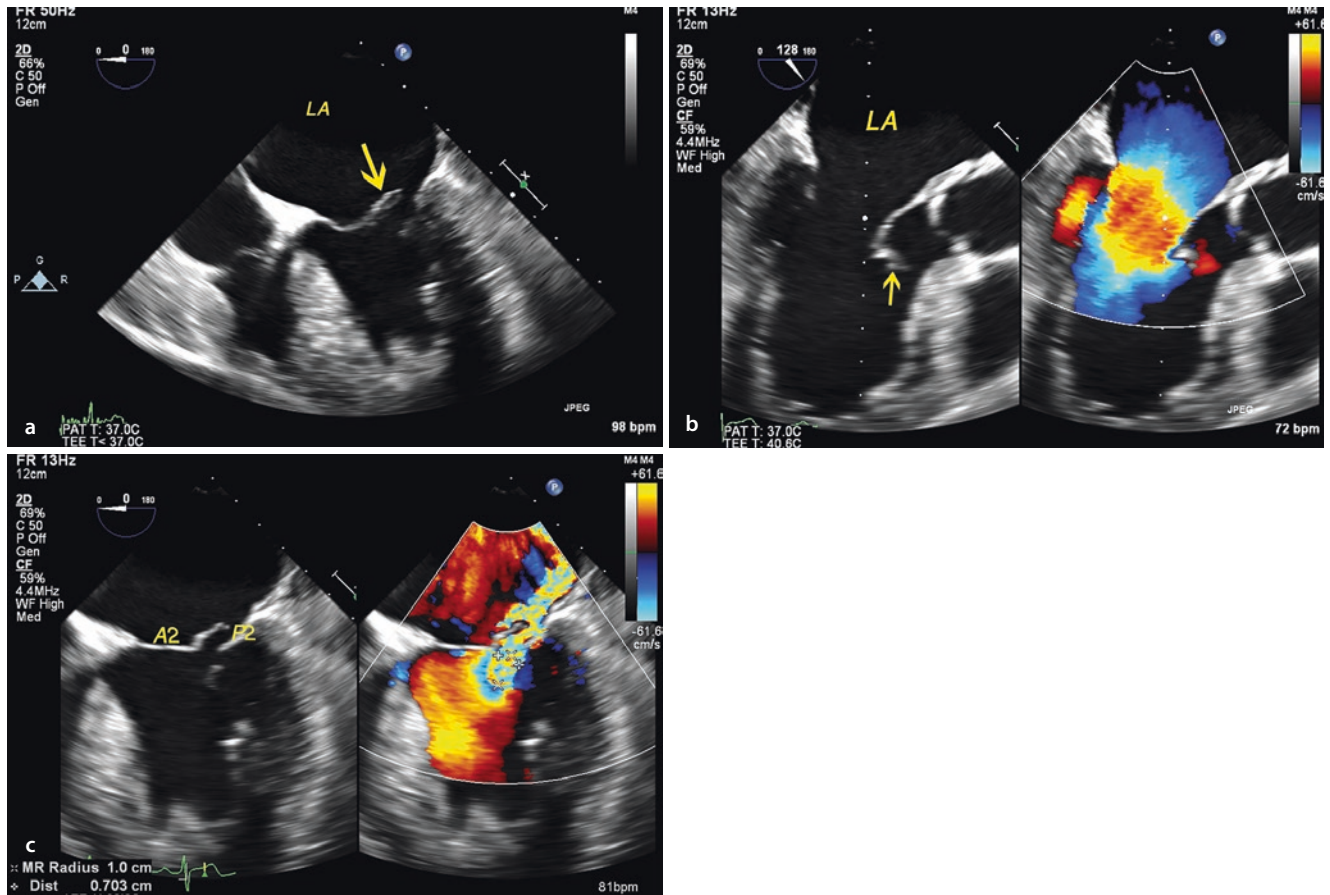
■ Fig. 1.130 Mild esophageal 0° view **a** and parasternal 120° view **b** depict flail of anterior mitral leaflet and attachment of a remnant ruptured chordae (arrow) to it at the level of A2 scallop **a** and there is not any coaptation between A2, P2 scallop in systolic time (arrow, **c**)

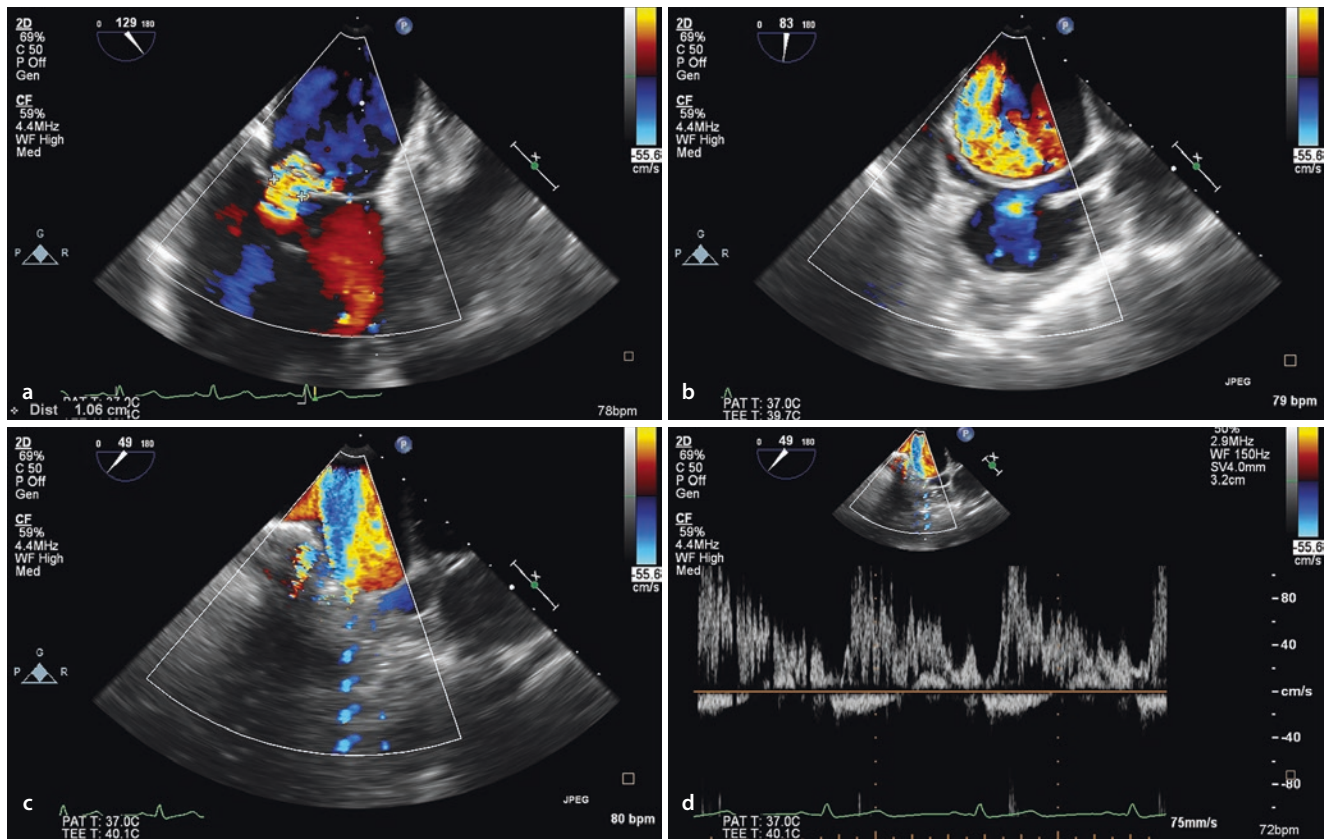
Fig. 1.150 Mid-esophageal long-axis view mitral regurgitation vena contracta is about 10 mm a and mitral regurgitation is swirling toward the inter-atrial septum b and mid-esophageal 49 depicts systolic flow reversal in right pulmonary veins c, d in favor of severe mitral regurgitation

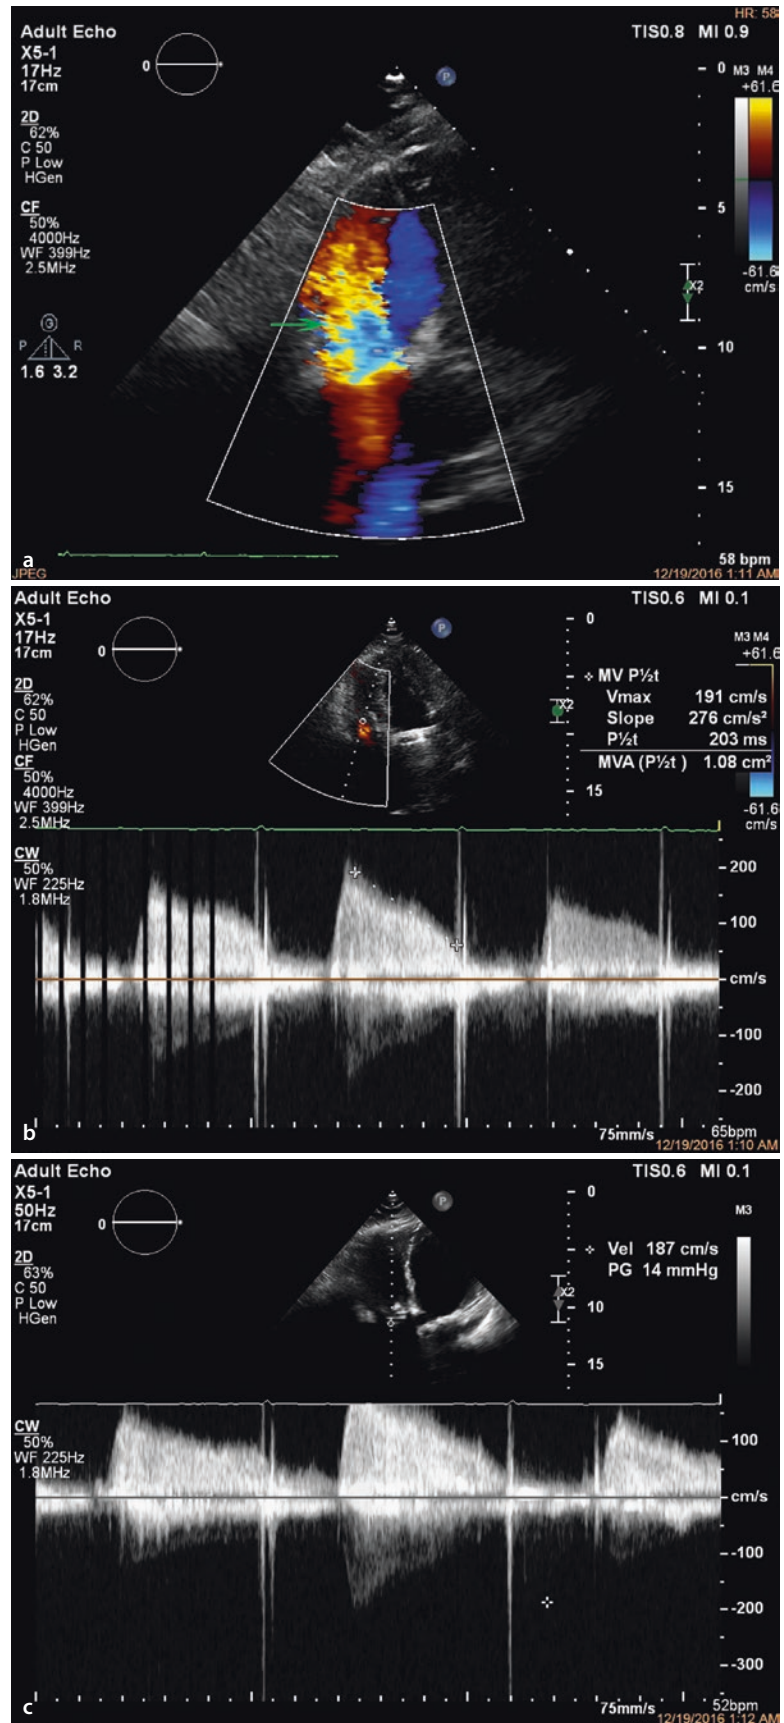
Fig. 6.3 Diastolic turbulence across bioprosthetic TV is visualized in this apical four-chamber view (arrow) a and TVA measures 1.08 cm² by PHT b. Peak and mean bioprosthetic tricuspid gradients are 10 and 5 mmHg, respectively, and TRG measures 14 mmHg c

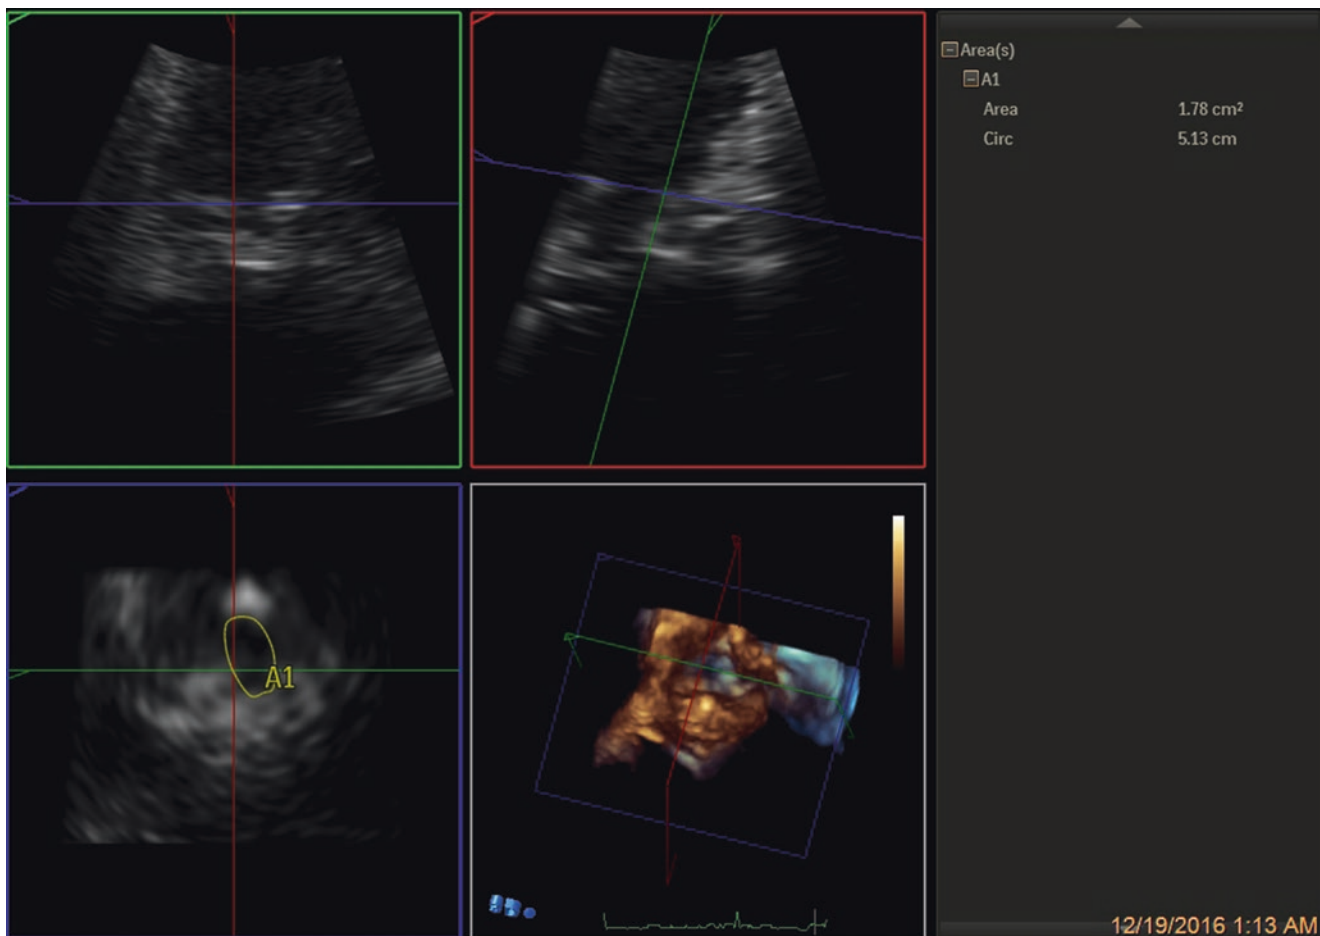
■ Fig. 6.4 TVA measures 1.78 cm² by 3DQ method

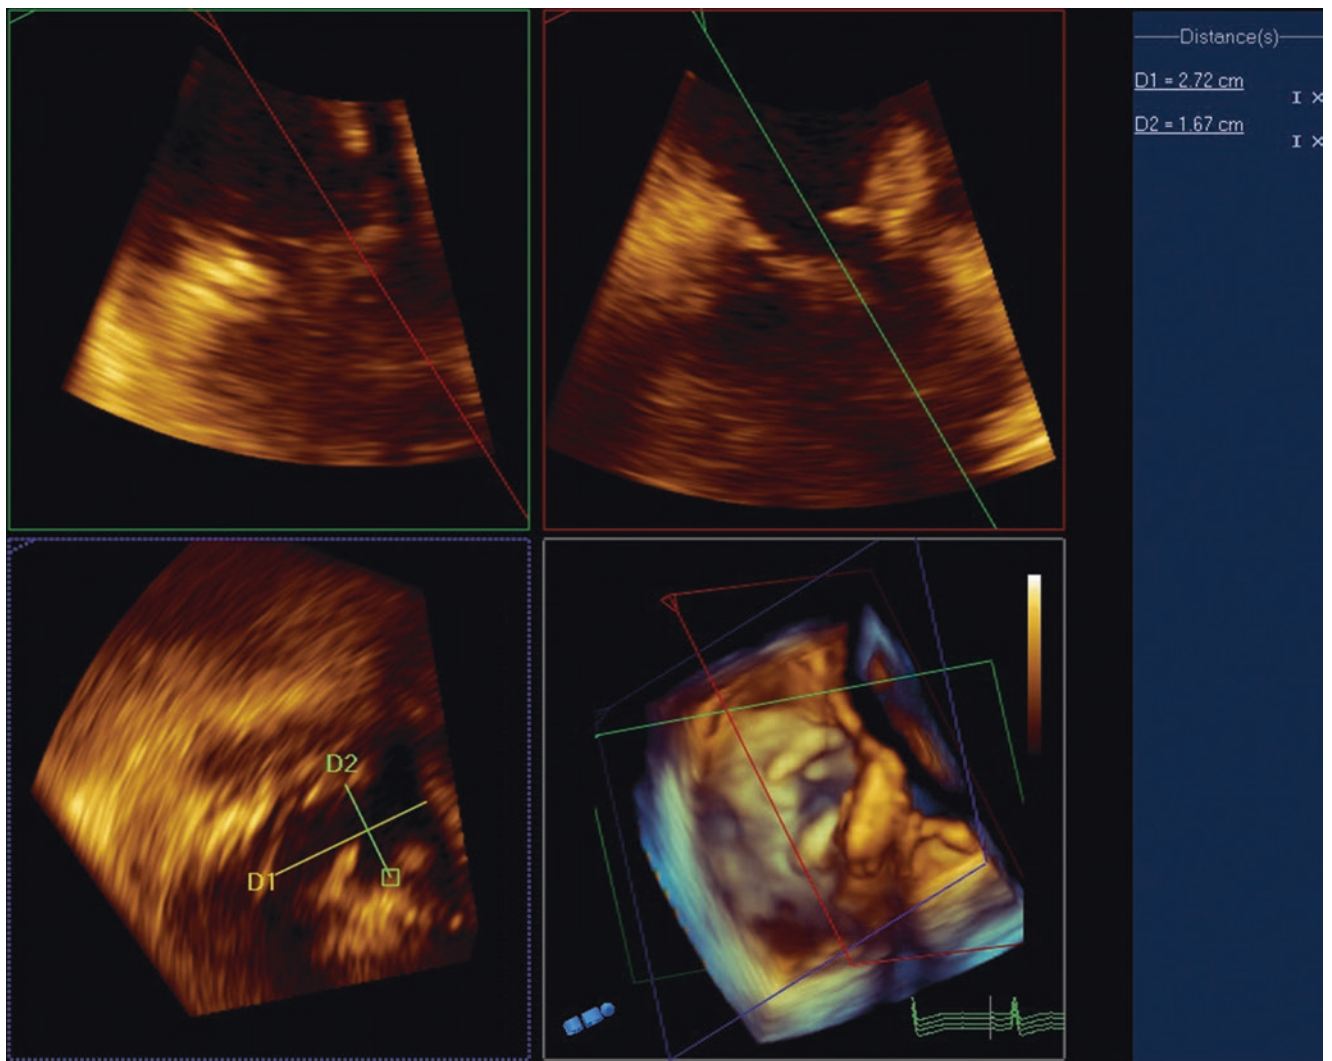
Fig. 6.16 TV ring annuloplasty measures 27*17 mm by 3DQ method

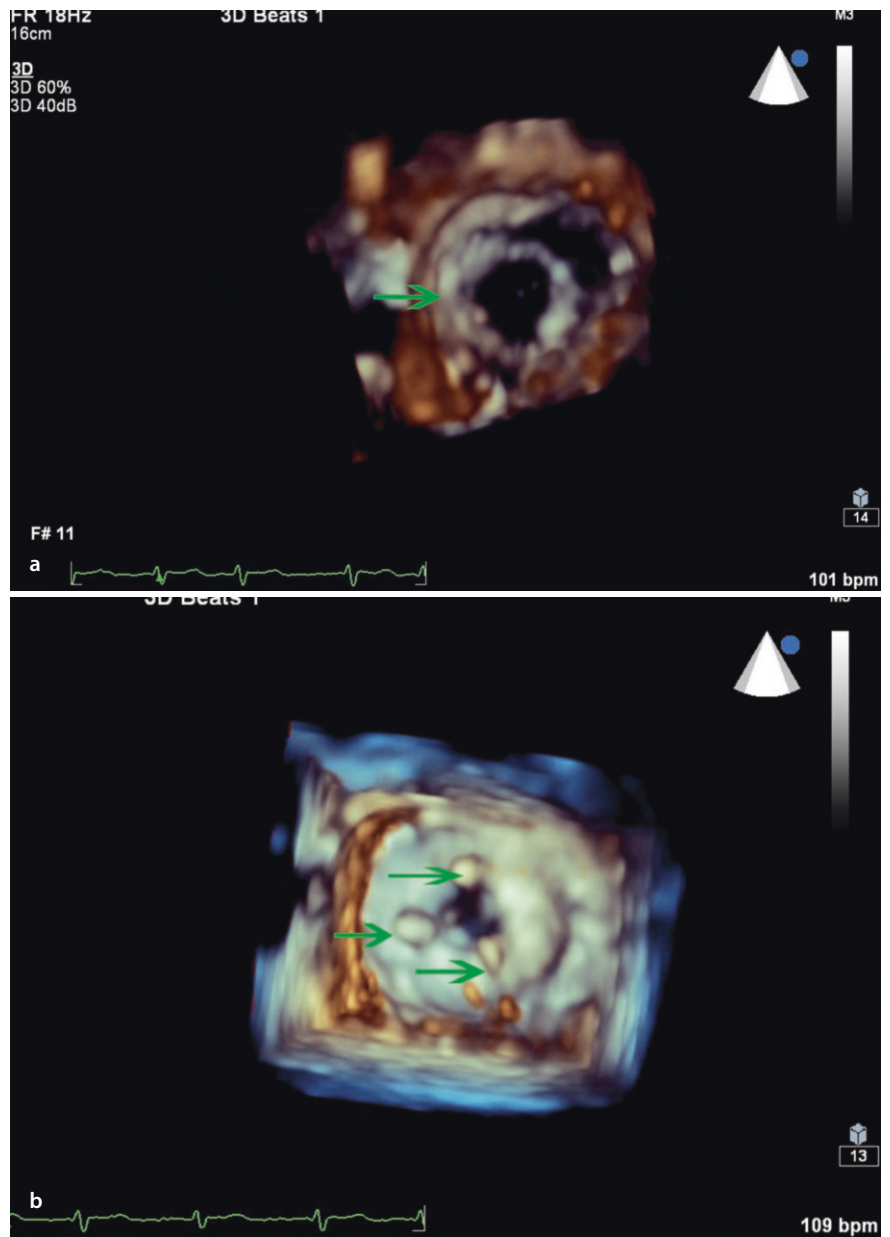
Fig. 6.28 Bioprosthetic MV is seen from LA side (*arrow*) **a** and LV side **b** with 3D zoom; three pedicles of bioprosthetic MV are seen from LV side (*arrows*) **b**
