3D Echocardiography of Structural Heart Disease

An Imaging Atlas

Hakimeh Sadeghian

Zahra Savand-Roomi

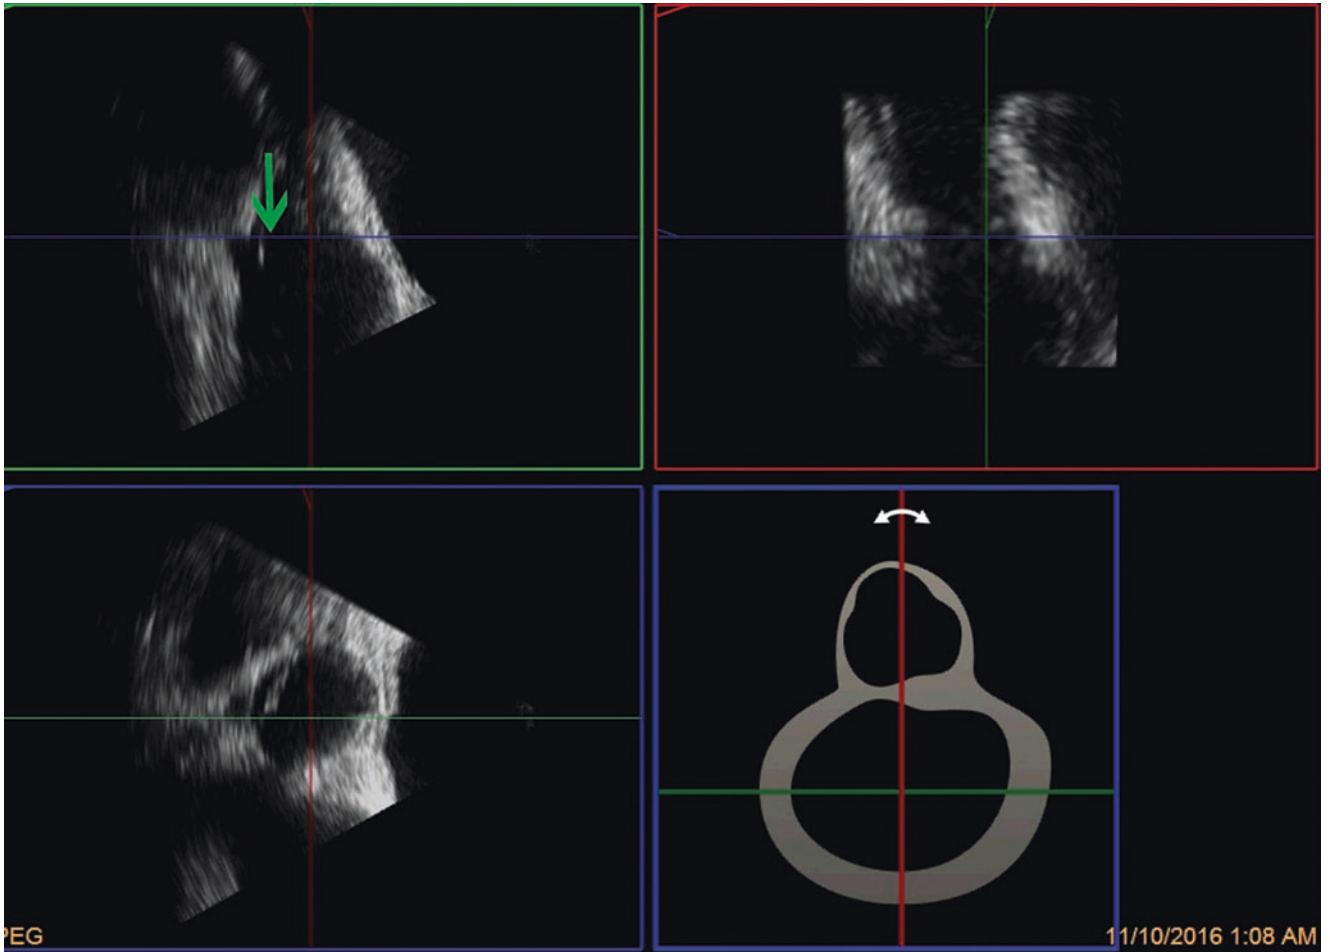
Fig. 6.31 Right coronary ostium is engaged by cusp of implanted native pulmonary valve in the site of aortic valve (arrow) by MV navigator method full volume of aortic valve

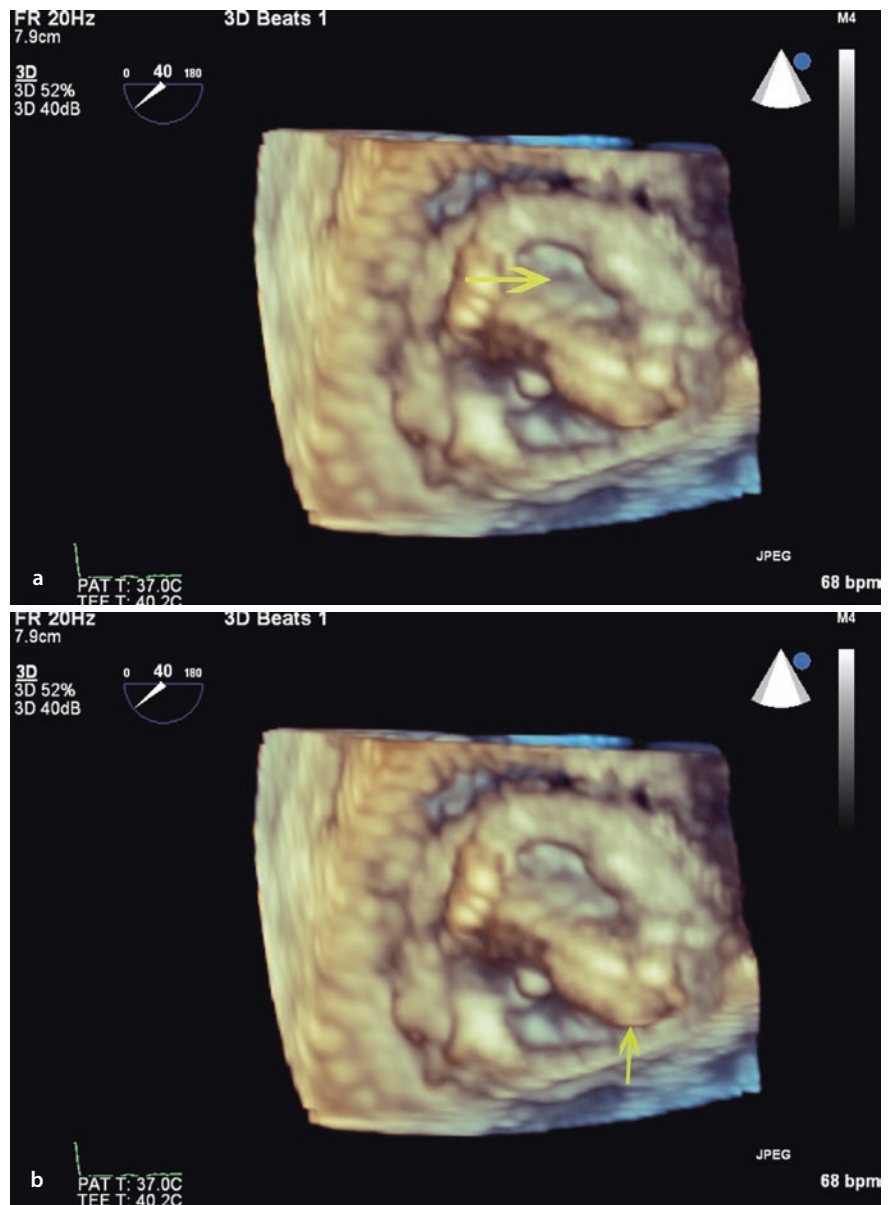
Fig. 6.39 3D zoom view from right atrial side of tricuspid valve shows bileaflet metallic valve (arrow) **a**, and there is a thrombus on it (arrow) **b**

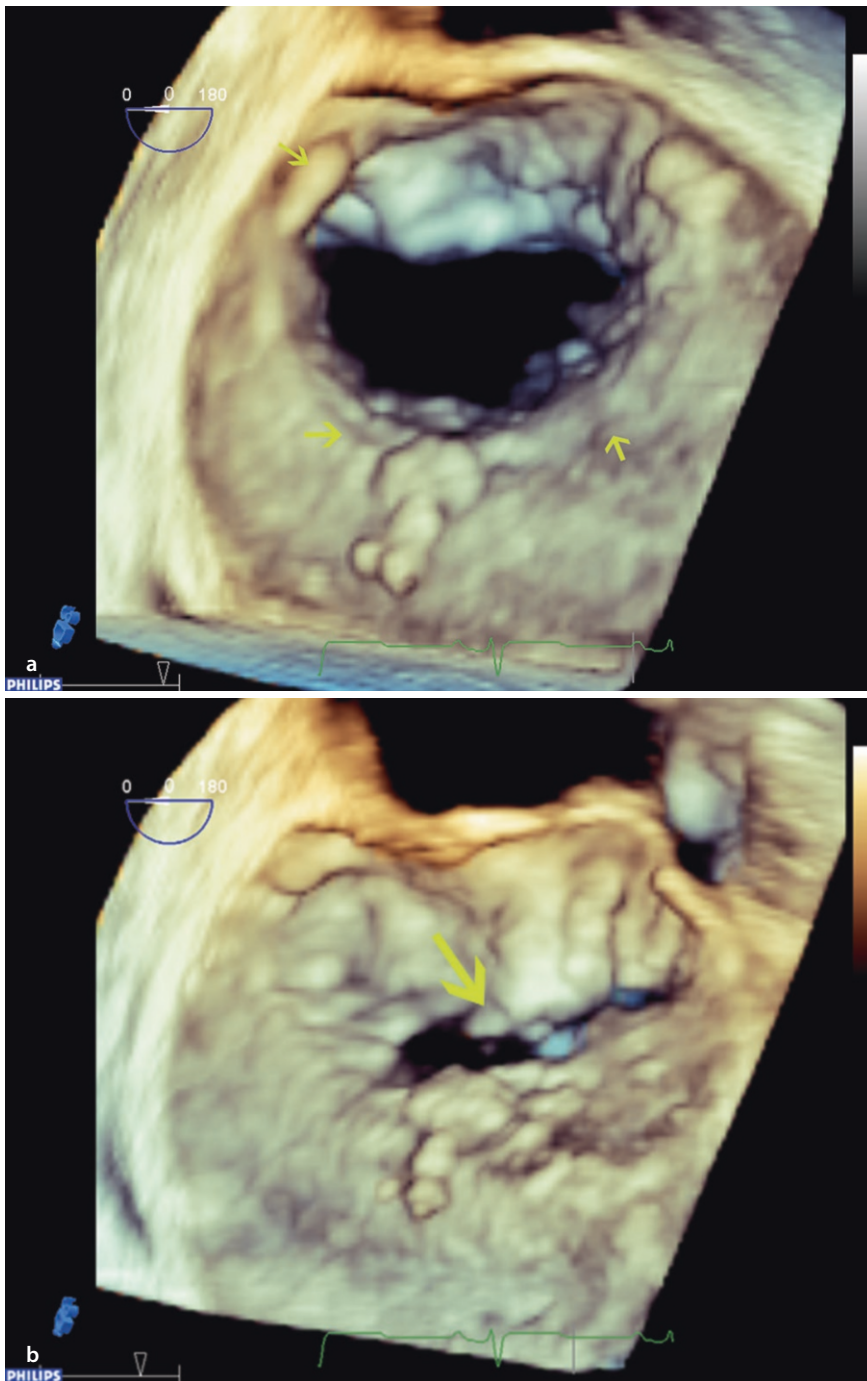
■ Fig. 6.42 3D en face view of mitral valve from left atrial side during diastolic **a** shows incomplete ring of mitral repair (*arrow*) and during systolic time **b** demonstrates incomplete closure of leaflets and a wide non-coaptation area (*a*, *arrow*) in favor of failed mitral valve repair

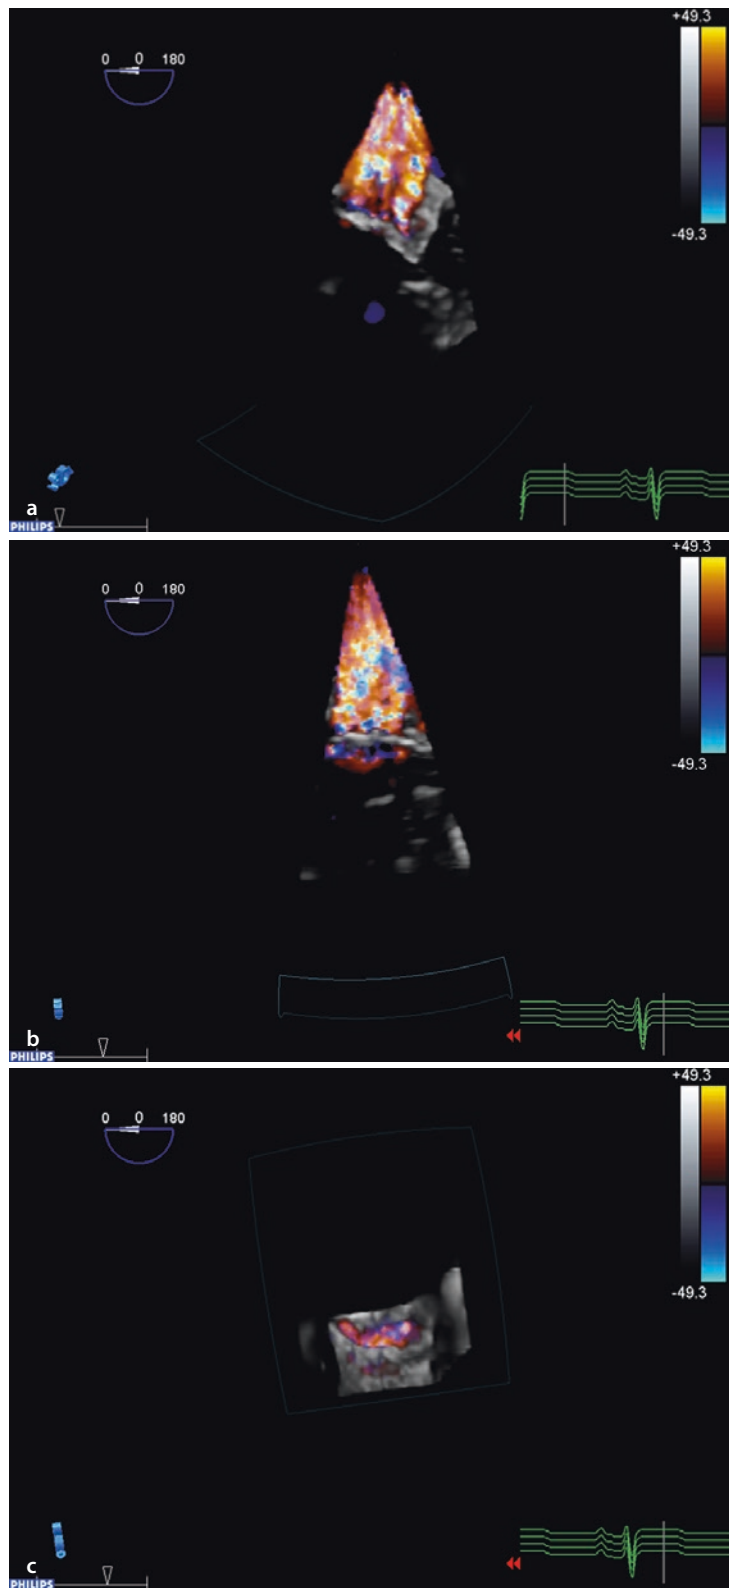
■ Fig. 6.43 3D full-volume color study a–c demonstrates that mitral regurgitation is along the coaptation area and an asymmetric PISA zone along the commissure

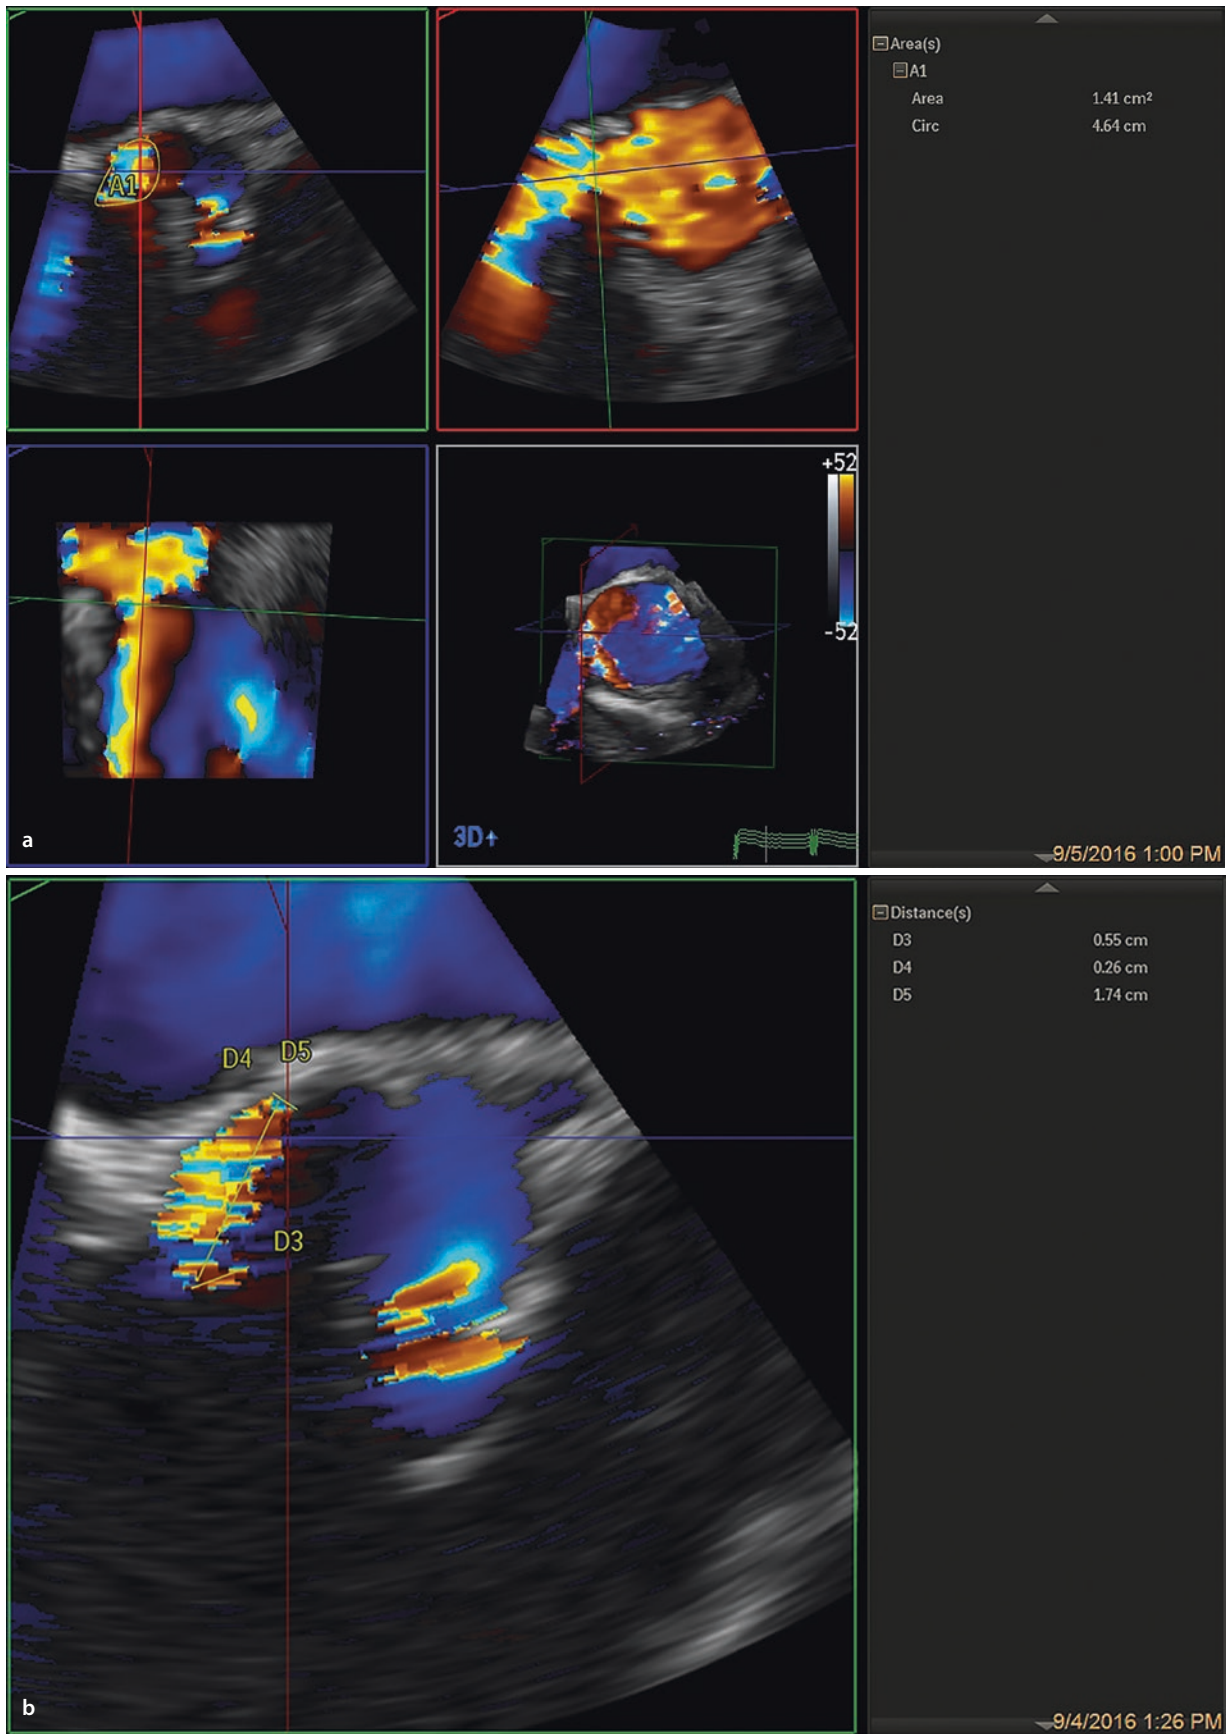
Fig. 7.6 Full volume of aortic valve by color Doppler study shows that vena contracta area measures 1.4 cm² a, and length of tract of paravalvular leak is 17 mm, D1 is 5.5 mm, and D2 is 2.6 mm b

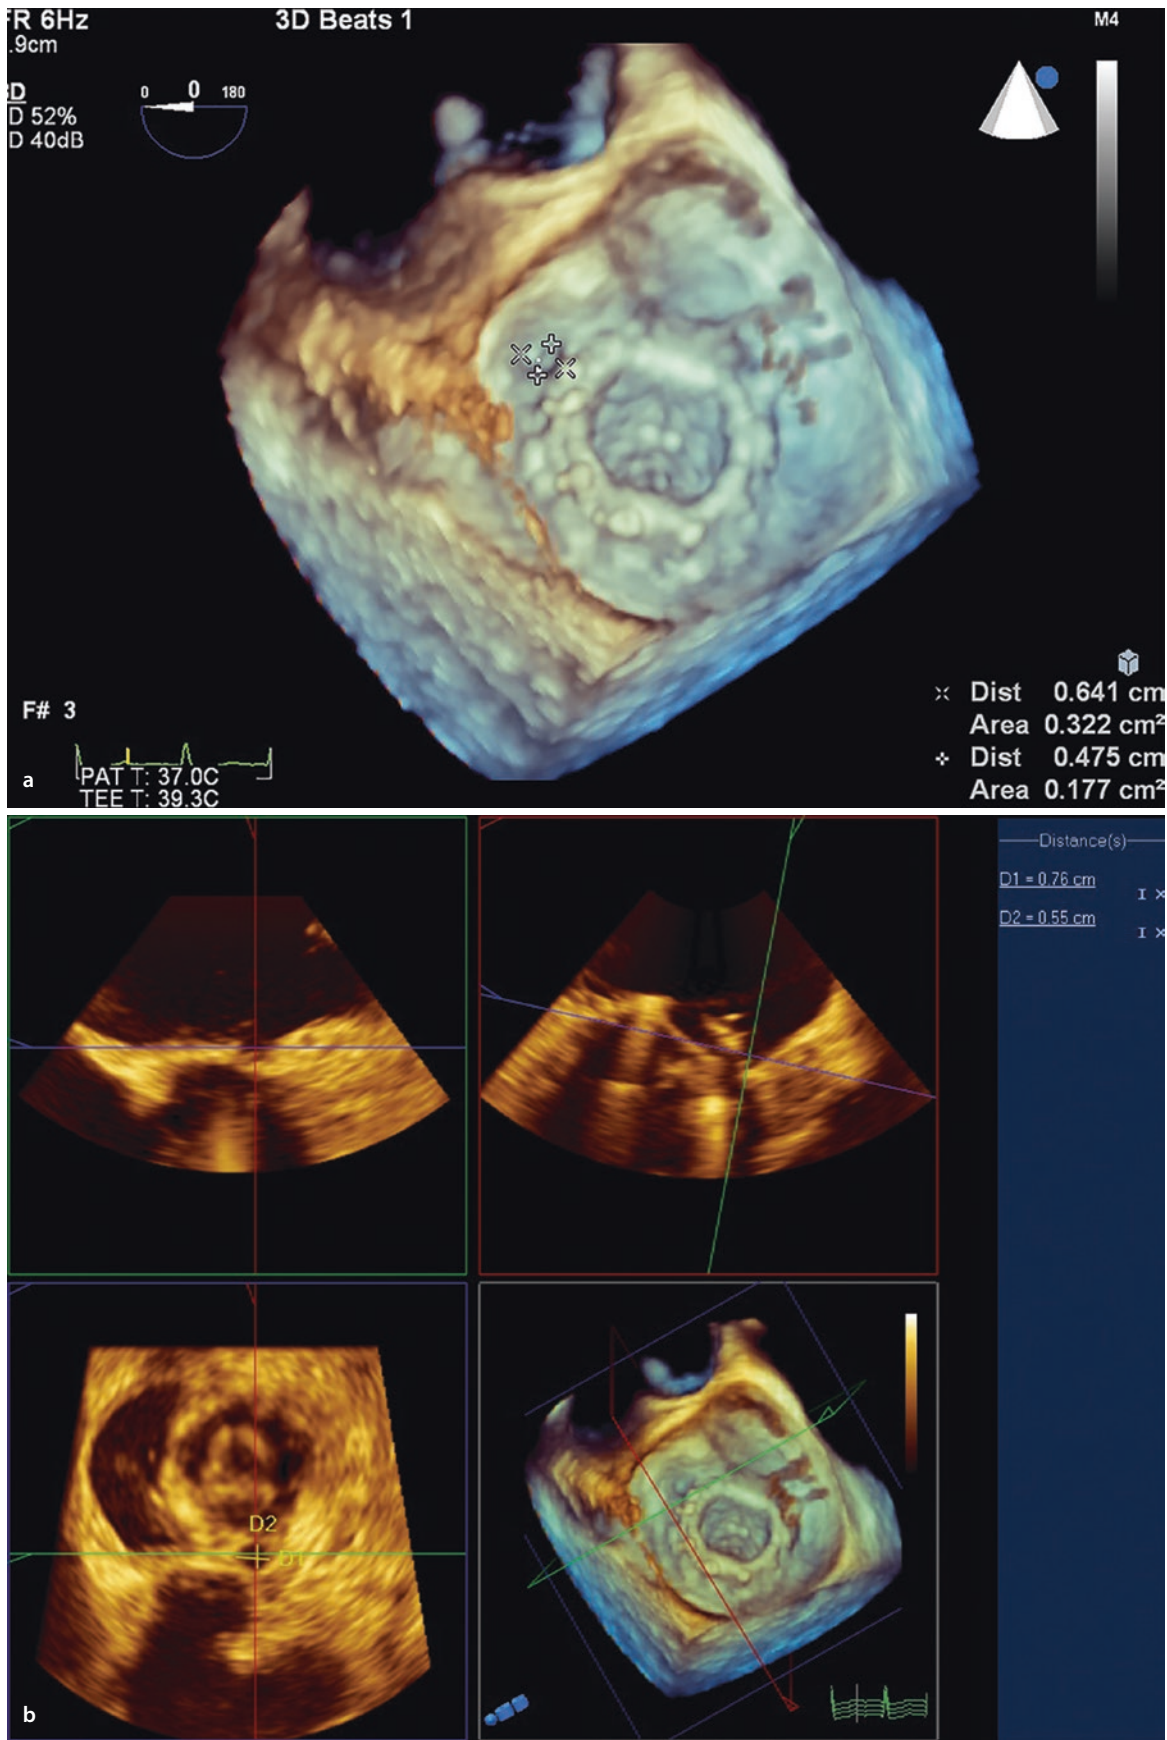
Fig. 7.9 3D zoom of prosthetic mitral valve shows site of paravalvular leak between mitral and aortic valve nearly at 10 o'clock, and its size measures 4.8*6.5 mm by direct measurement **a** and 7.5*5.5 mm by 3DQ method **b**

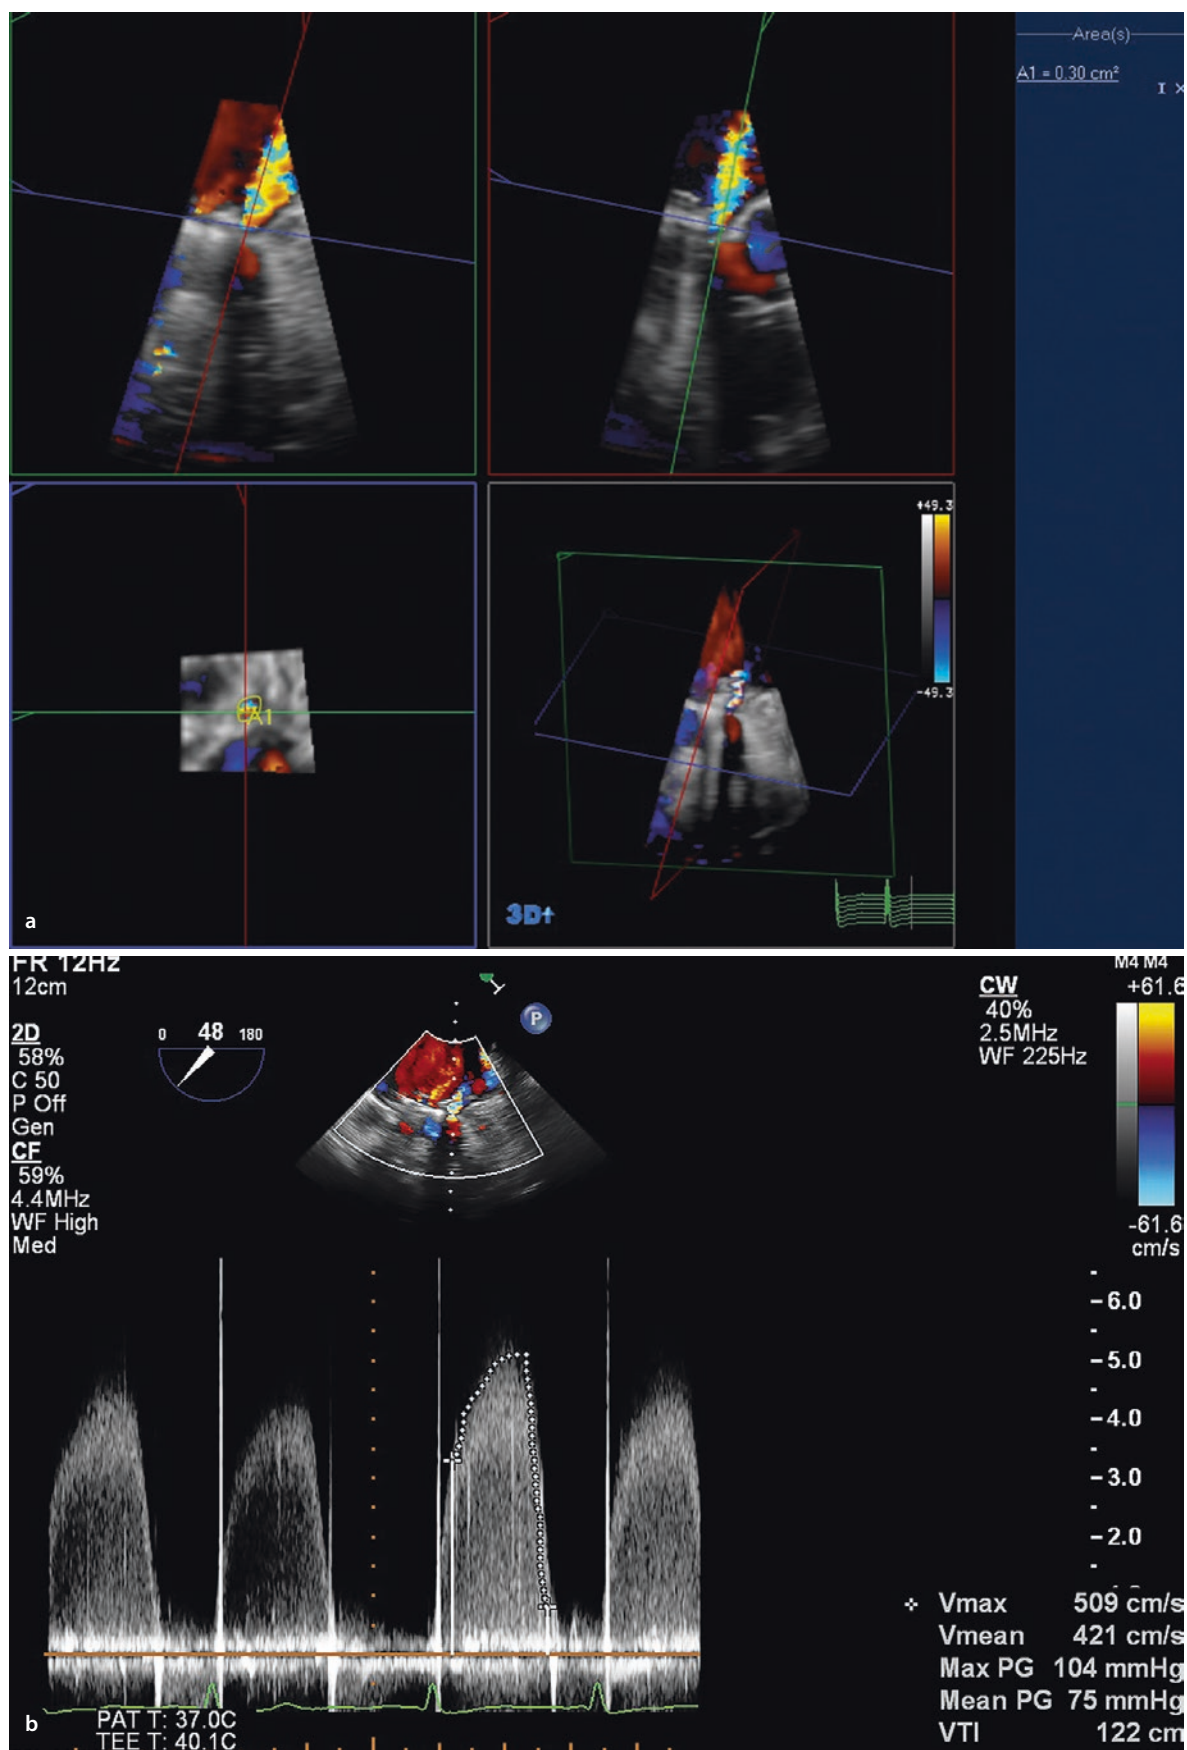
Fig. 7.10 Vena contracta area of paravalvular leak measures 0.3 cm² a, and mitral regurgitation VTI measures 122 cm b; paravalvular leak volume measures as follows: Vena contracta area*VTI = 0.3*122 = 36.6 cm³

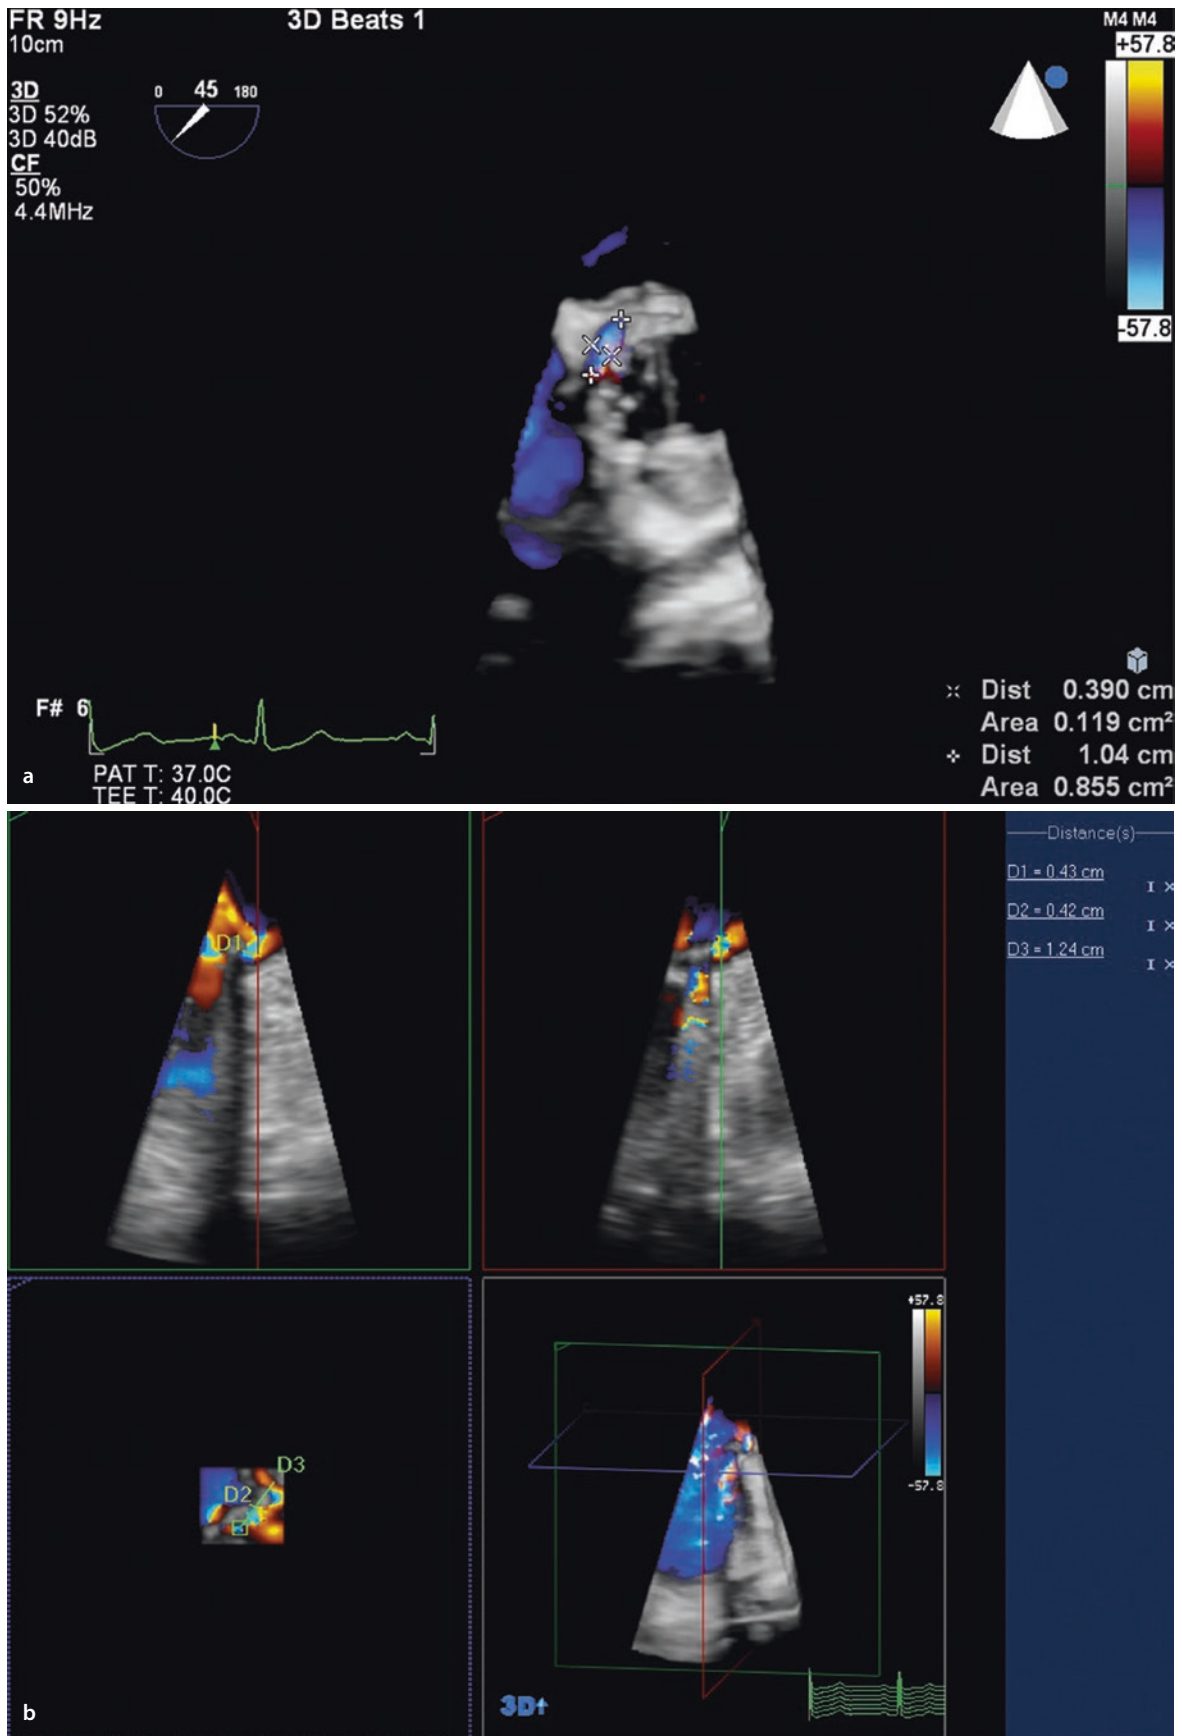
Fig. 7.13 Paravalvular leak measures 4*10 mm by live 3D by TEE short-axis of aortic valve **a**; 3DQ measurement of paravalvular leak shows that the diameter of paravalvular leak is 5 mm, and its length is 12 mm **b**

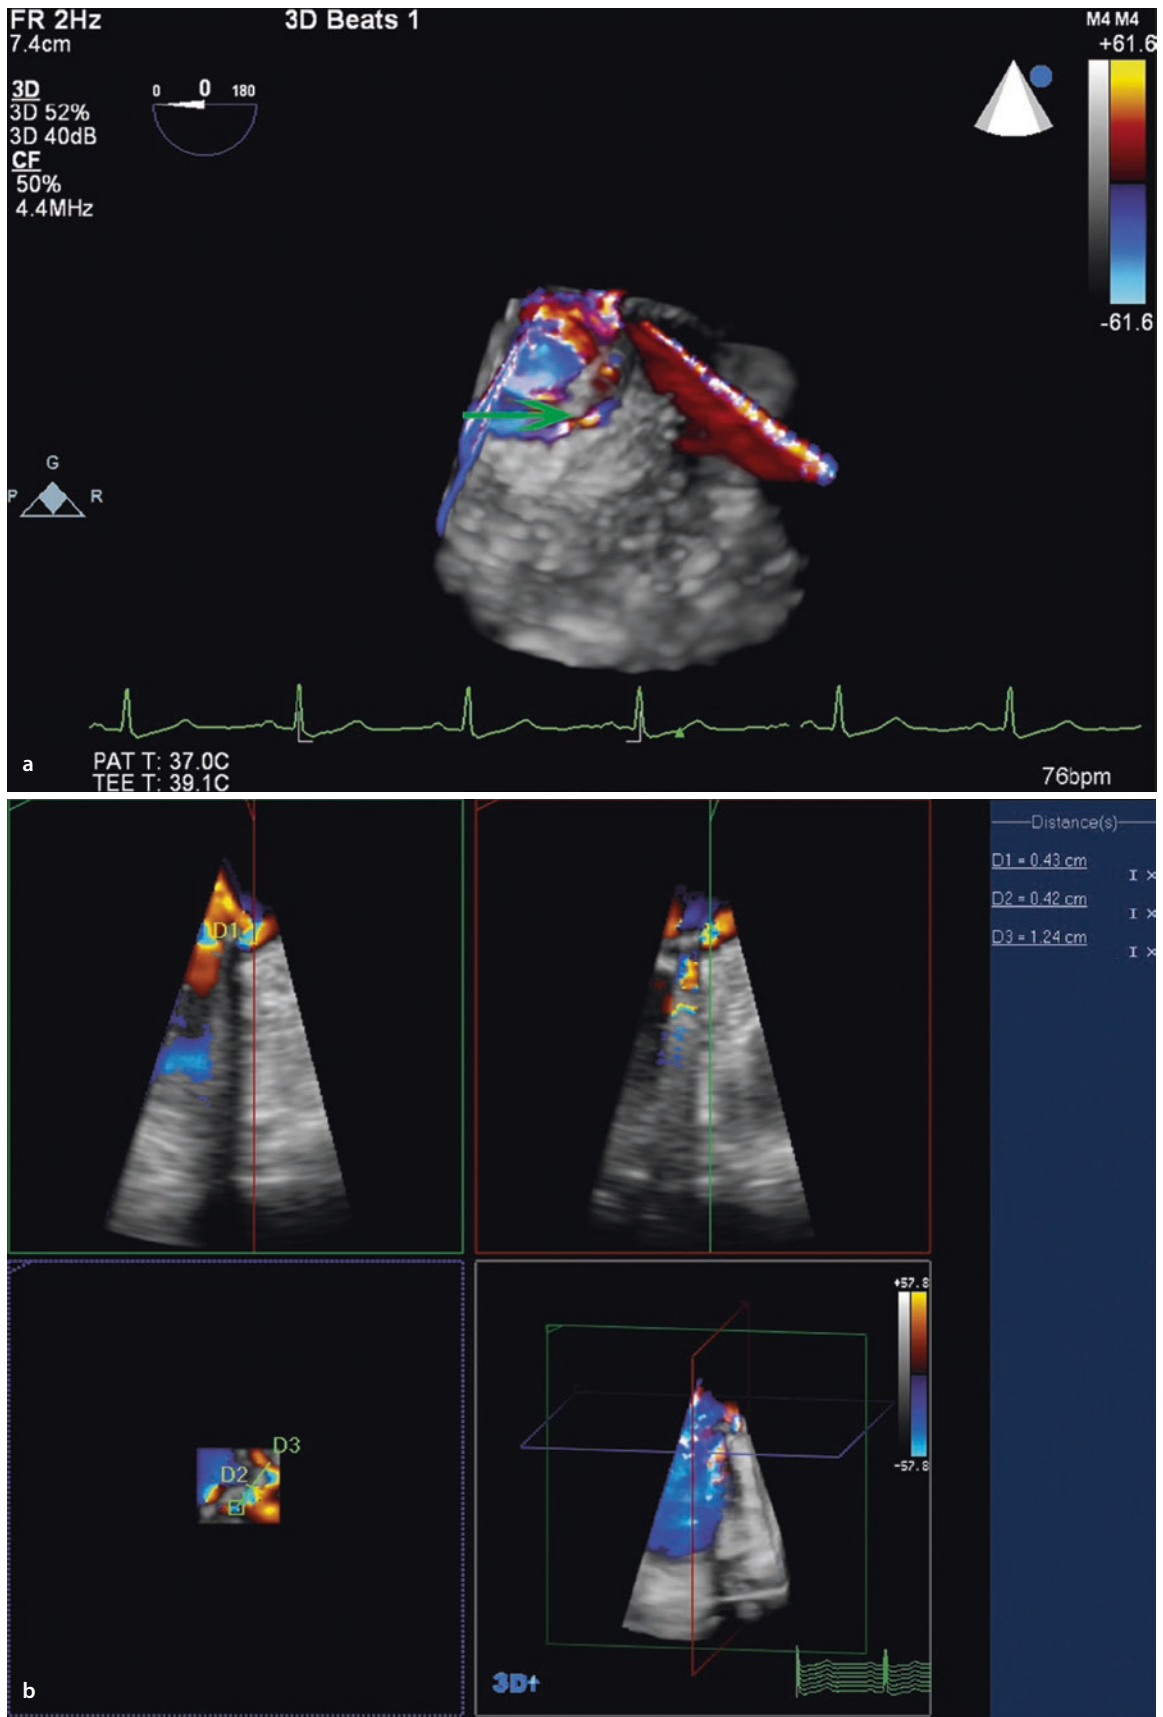
Fig. 7.15 Paravalvular leak of lateral side of prosthetic MV is crescent shaped by 3D zoom mode a, but it is of notice that with this modality (3D zoom color), frequency of image is 2 Hz and so very low. Diameter of paravalvular leak of mitral valve is 4.2 and 4.3 mm on its ends, and its length measures 12 mm by 3DQ full-volume color modality b

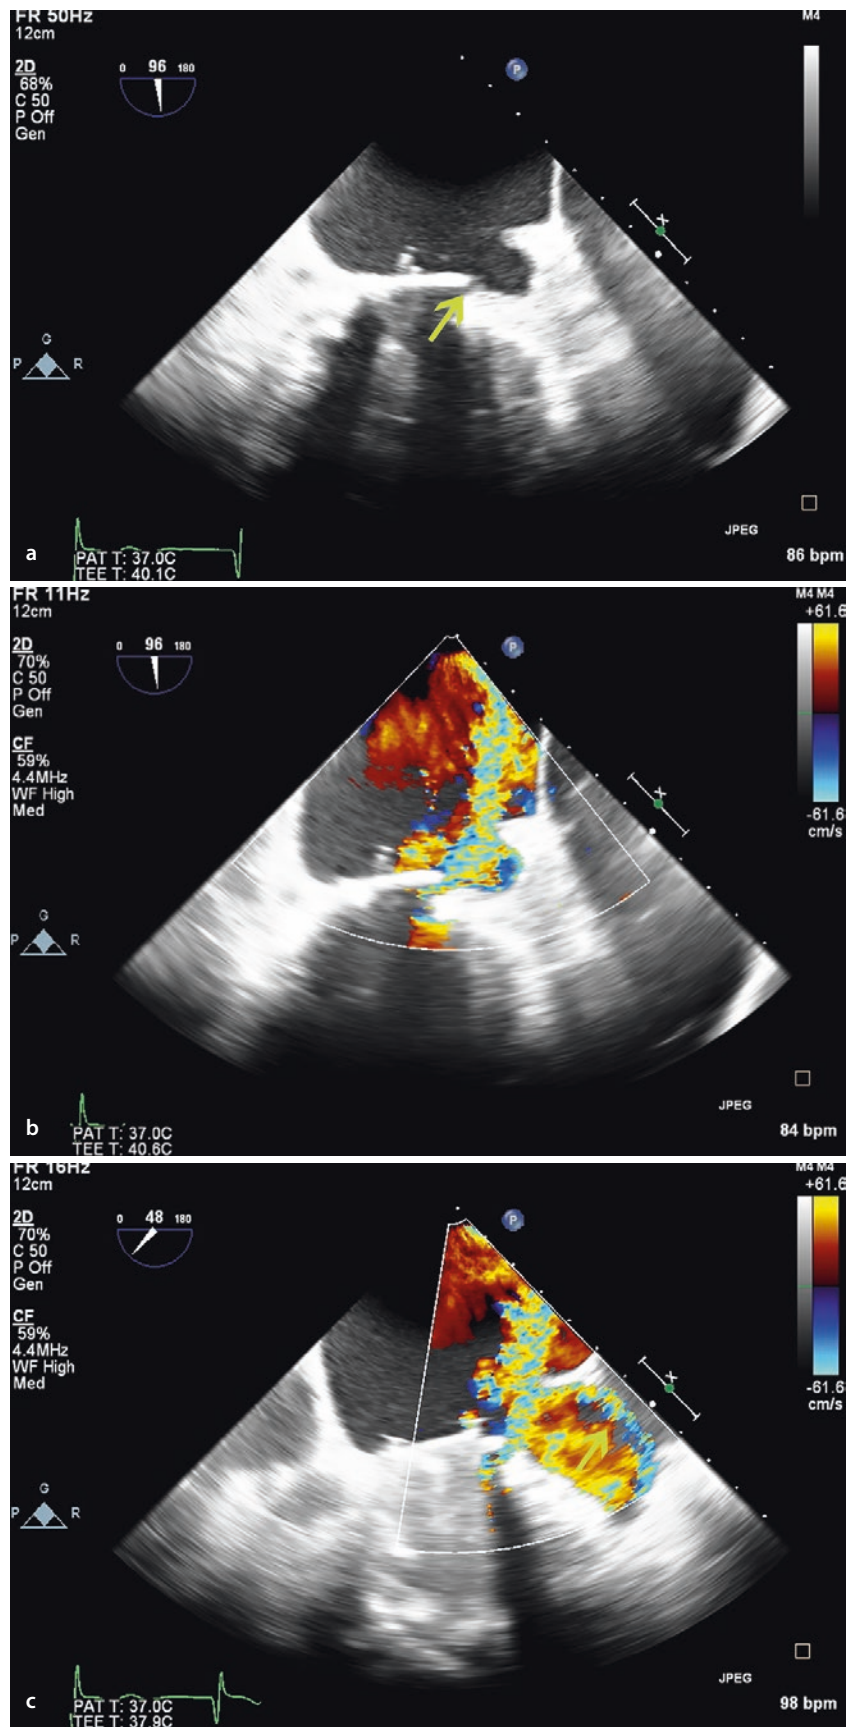
■ Fig. 7.19 Mid-esophageal 96° depicts a defect in lateral wall of swing ring near to left atrial appendage (arrow, a), and color Doppler study confirms paravalvular leakage b, and it shows swirling of paravalvular leakage to left atrial appendage (arrow, c)

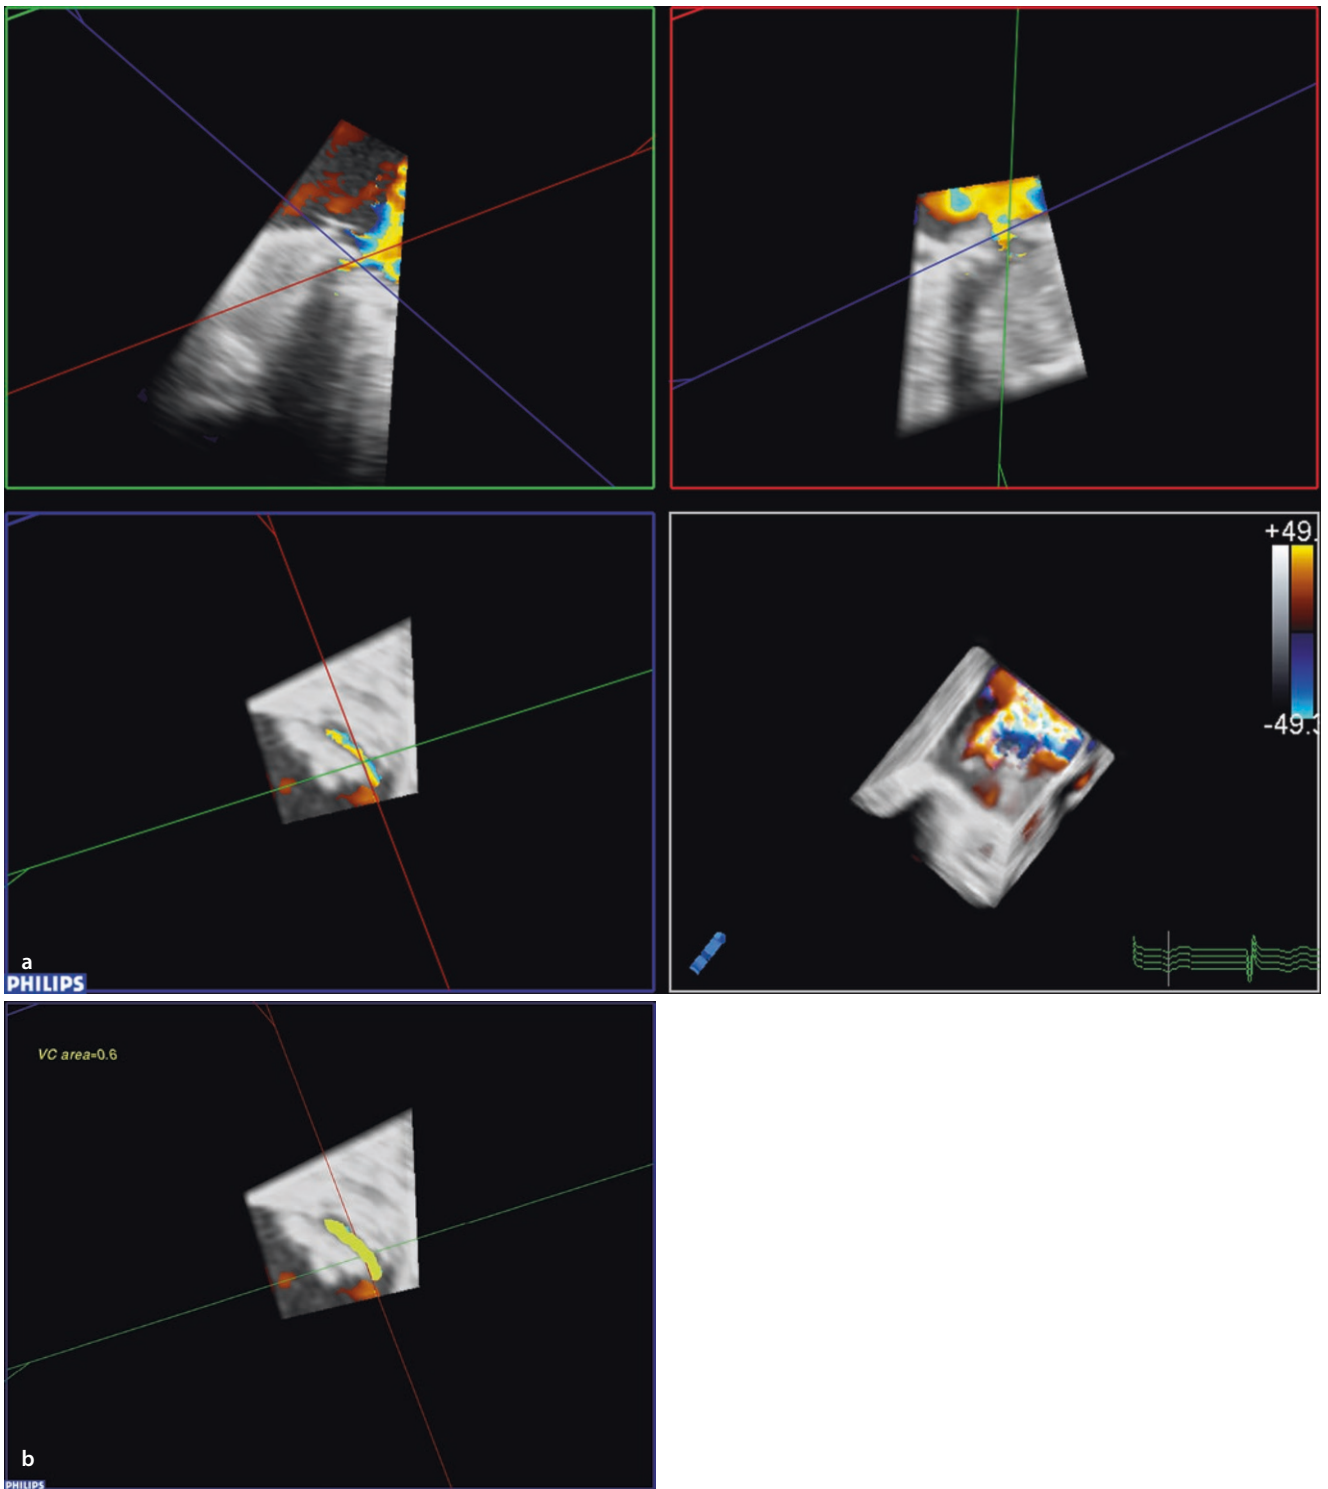
Fig. 7.21 3D full-volume color study demonstrates a crescent-shaped vena contracta with area about 0.6 cm² in favor of severe mitral regurgitation a, b

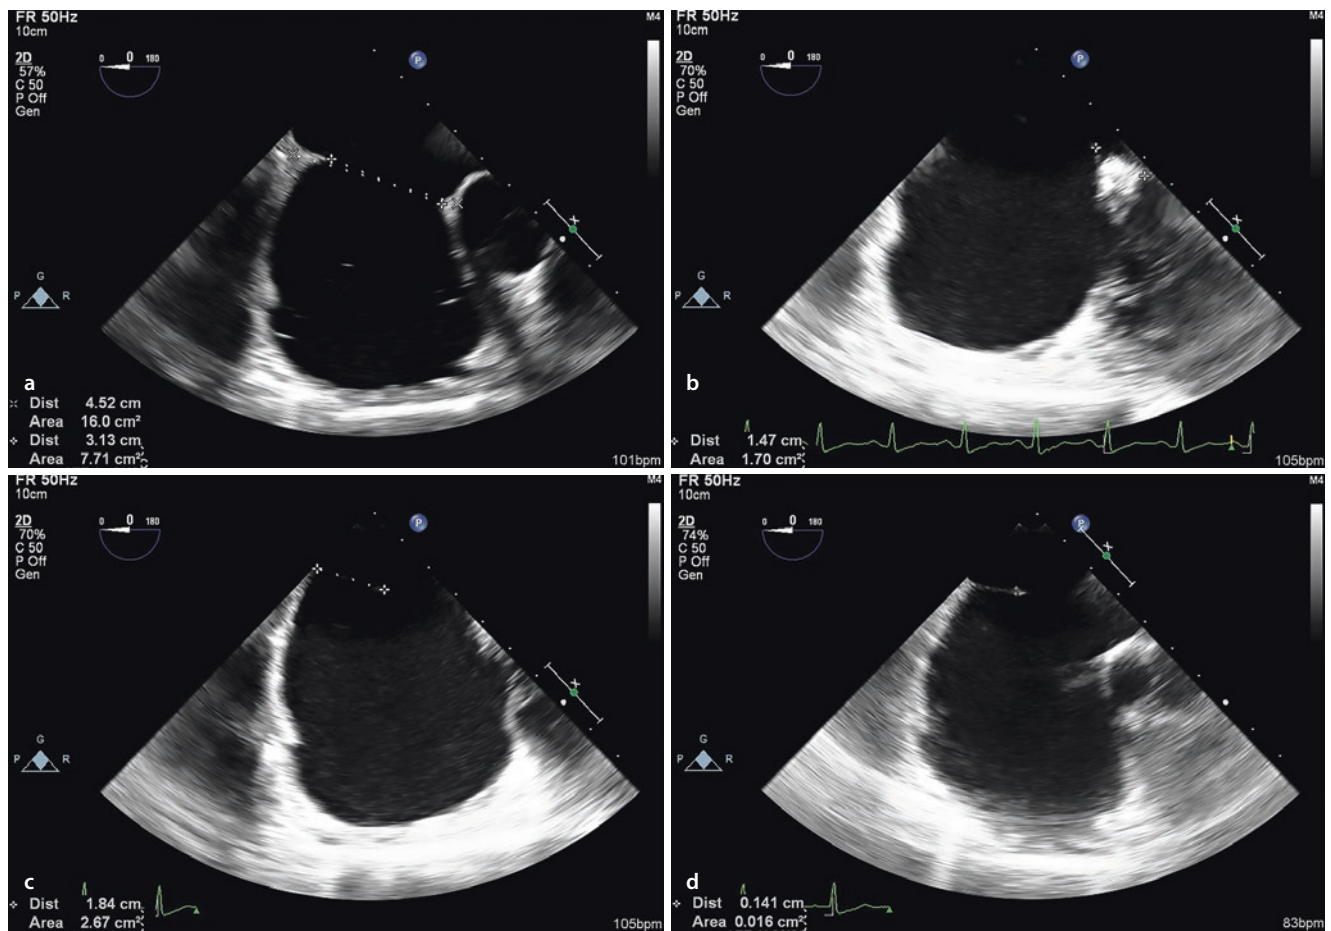
■ Fig. 9.35 ASD/IAS measures 31/45 mm in 0° view **a**, rim to mitral valve measures 15 mm **b** and posterior rim measures 18 mm **c**, posterior rim is very thin up to 1.4 mm **d**

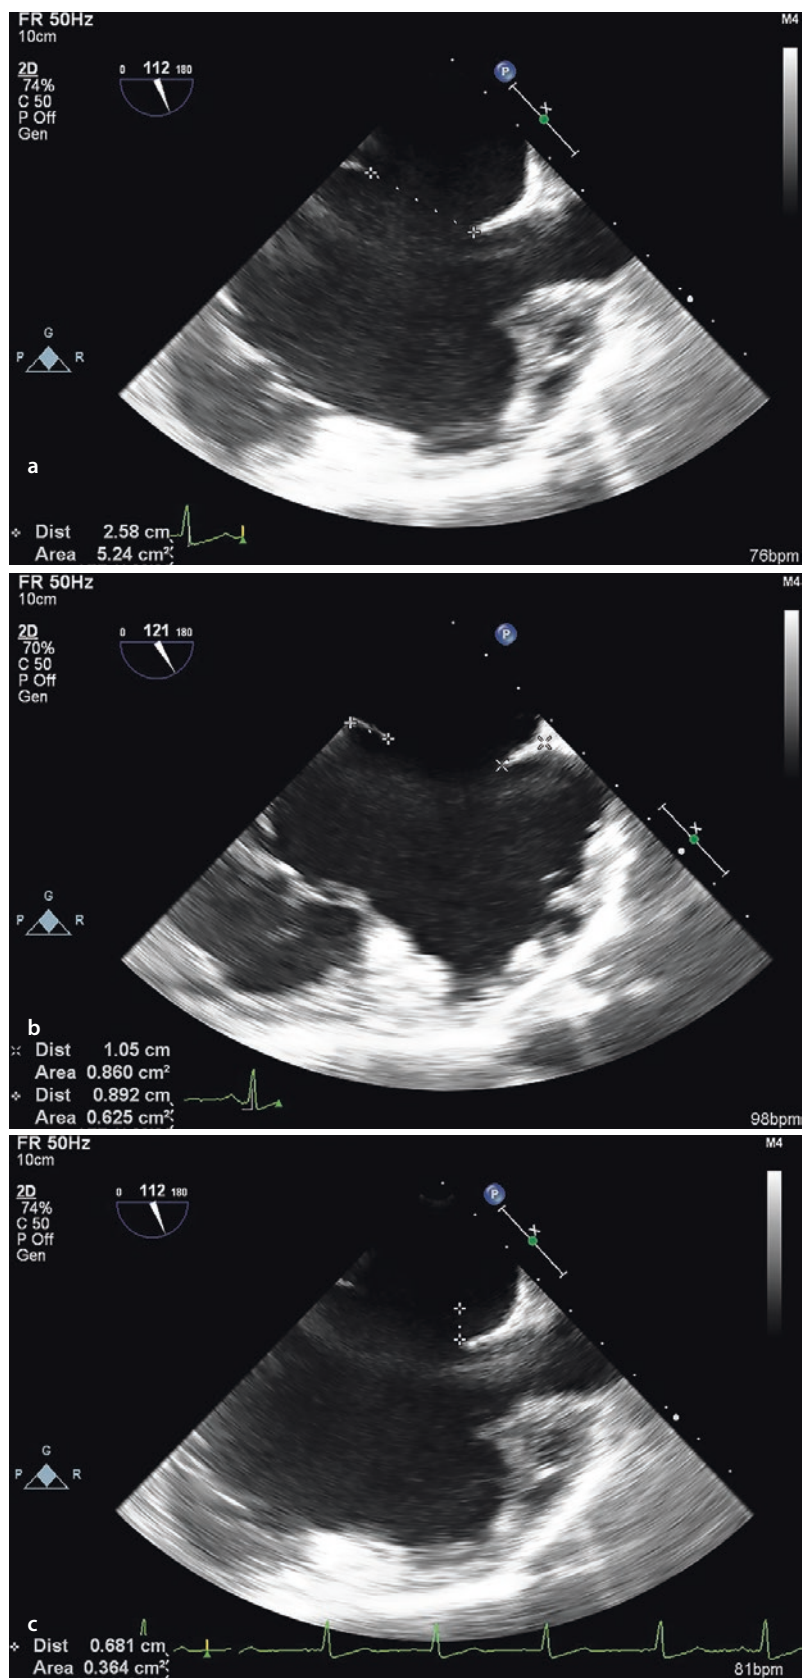
Fig. 9.37 ASD measures 26 mm in TEE bicaval view **a**, rim to SVC measures 11 mm and rim to IVC 9 mm, respectively, in this view **b**, there is interatrial septal malalignment by this view about 6.8 mm **c**

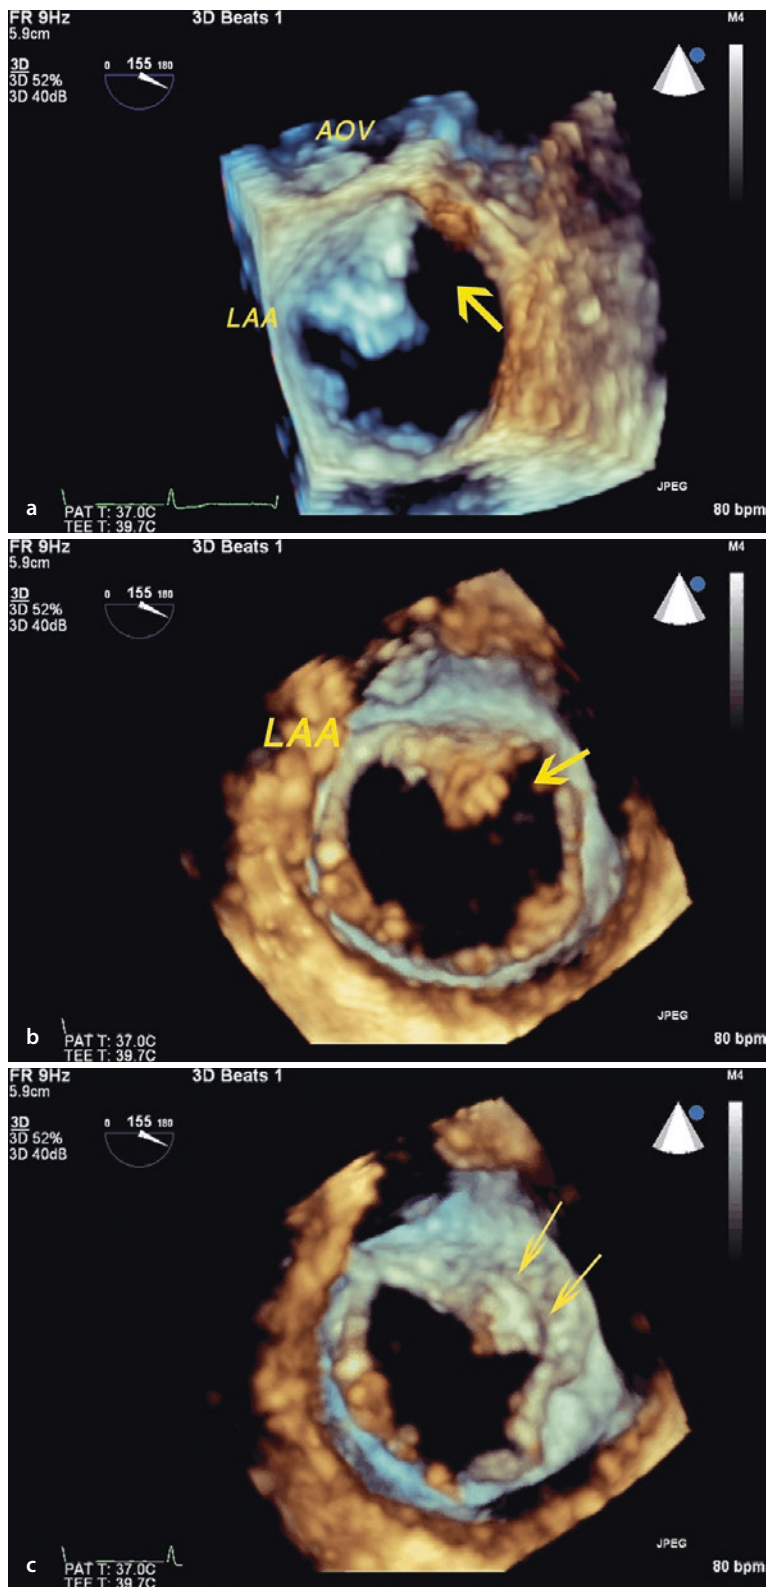
■ Fig. 9.115 3D zoom view of mitral leaflets shows a large cleft in the level of A3 (a, atrial side and b ventricular side, c during systole). AOV aortic valve, LAA left atrial appendage
