3D Echocardiography of Structural Heart Disease

An Imaging Atlas

Hakimeh Sadeghian

Zahra Savand-Roomi

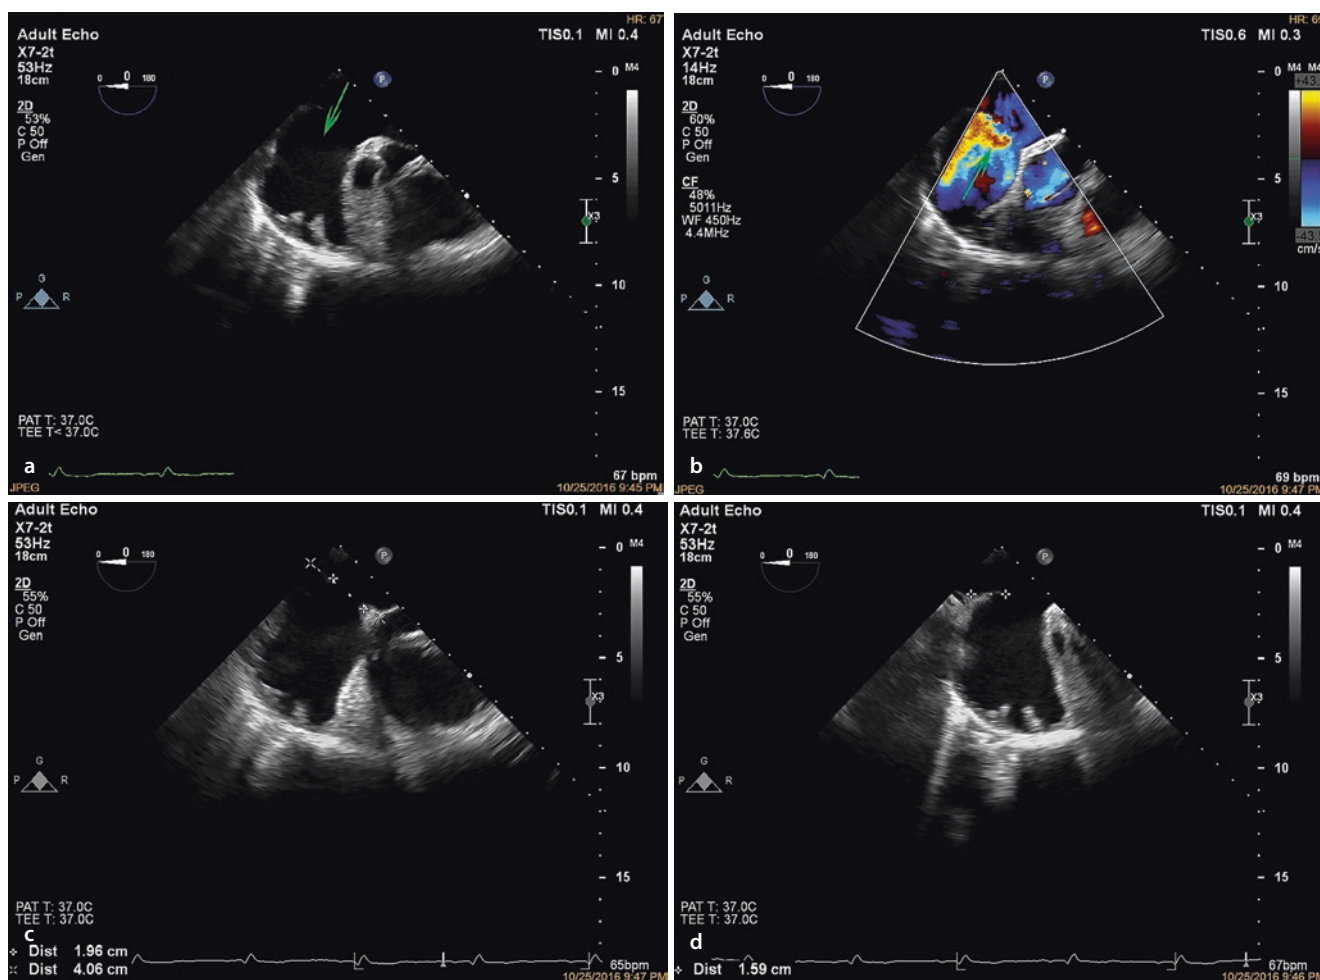
■ Fig. 12.4 The defect of interatrial septum is evident by TEE 0° view (arrows) by two-dimensional echocardiography a and color Doppler study b, ASD/IAS measures 20/41 mm in this view c and posterior rim measures 16 mm in this view d

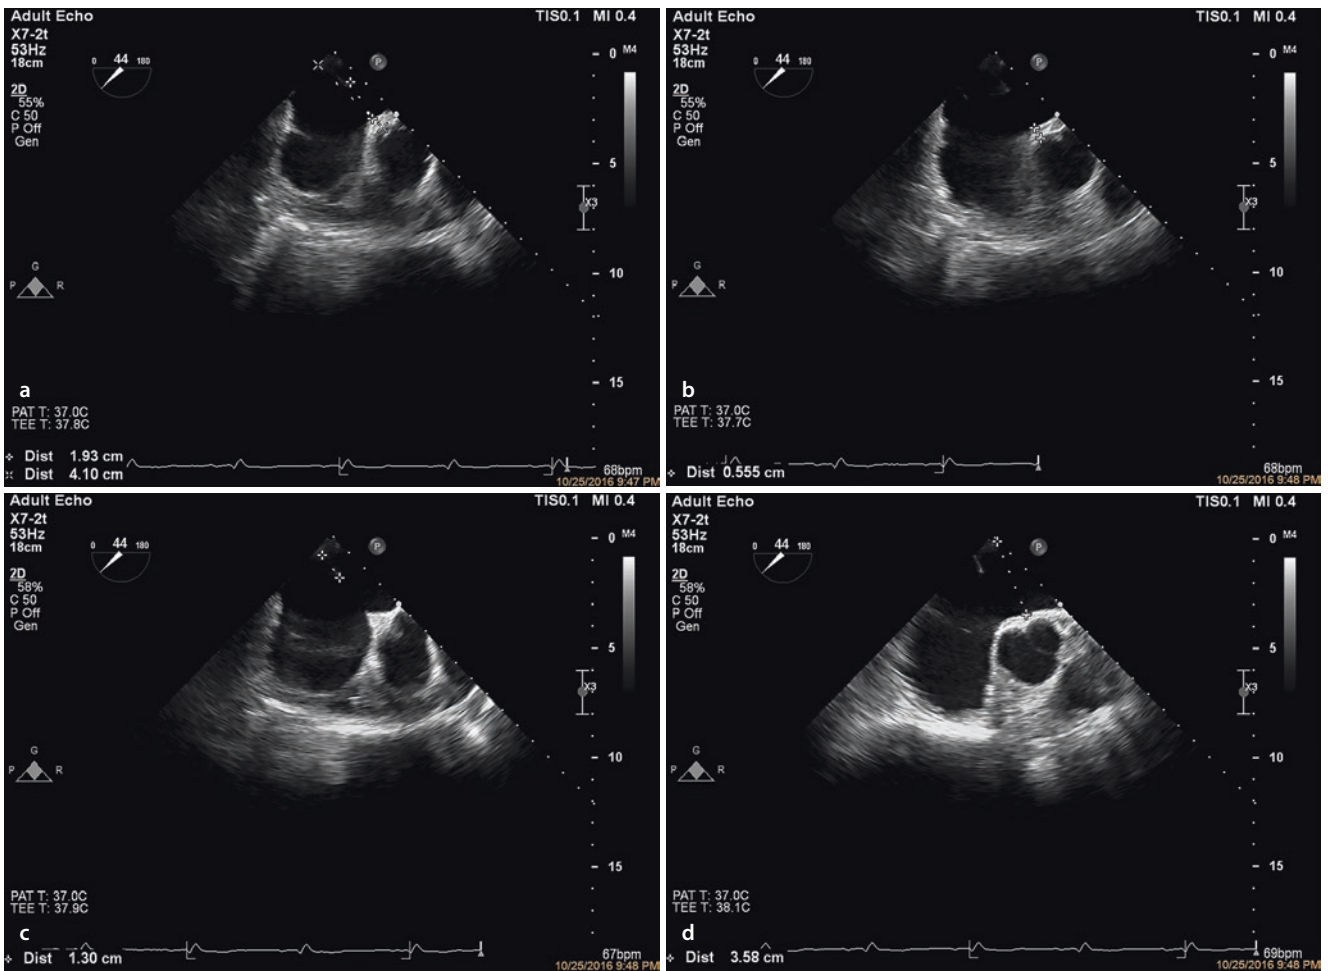
Fig. 12.5 The ratio of ASD/IAS measures 19/41 mm in TEE short-axis view a, the rim to aortic valve measures 5.5 mm b and the opposite rim measures 13 mm c in this view, atrial depth measures 36 mm d
