# HIGHWAY BRIDGE MAINTENANCE PLANNING AND SCHEDULING

**MARK HURT**

**STEVEN D. SCHROCK**

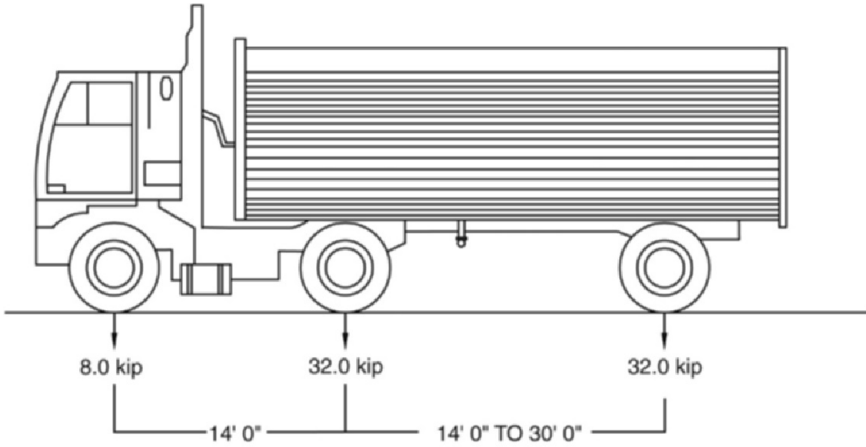
**Figure 1.4 HL-93 Design Truck.** (Adapted from AASHTO LRFD [10]).

The current AASHTO LRFD design truck is the HL-93, a 72,000 pound truck with a maximum axle load of 32,000 pounds. Its load effects are combined concurrently with those of a uniform load of 640 pounds per ft. per lane. It was not until 1944 that the design specifications of the predecessor to AASHTO, the American Association of State Highway Officials (AASHO), recommended a minimum design truck load for highways with heavy truck traffic, the H15-S12. The H15-S12 loading consisted of checking for the effects of either a 54,000 pound truck or a 480 pound per ft. lane load with a 13,500 pound concentrated load. This was still considerably heavier than the first weight limits for trucks on public roads in the United States. These were enacted by four states in 1913: 18,000 pounds gross vehicular weight (GVW) in Maine; 24,000 pounds GVW in Pennsylvania and Washington; and 28,000 pounds GVW in Massachusetts [8] (Figures 1.4 and 1.5).

All bridges on the NBI are required by the NBIS to be load rated for the HL-93 truck configuration, note that the concurrent lane loading is not used [9]. The HL-93 truck configuration is known as HS20-44 truck configuration in previous design specifications. Two load ratings are reported to the FHWA: operating and inventory ratings. The operating rating is the maximum permissible weight of truck in the chosen load configuration to which the bridge may be subjected. The inventory rating is the maximum permissible weight of truck in the chosen load configuration, which may safely utilize the bridge for an indefinite period of time. For example, an inventory rating of 39 tons for the HL-93 truck configuration would imply that a truck weighing 39 tons with axles spaced and apportioned similar to the HL-93 should be able to use the bridge indefinitely without

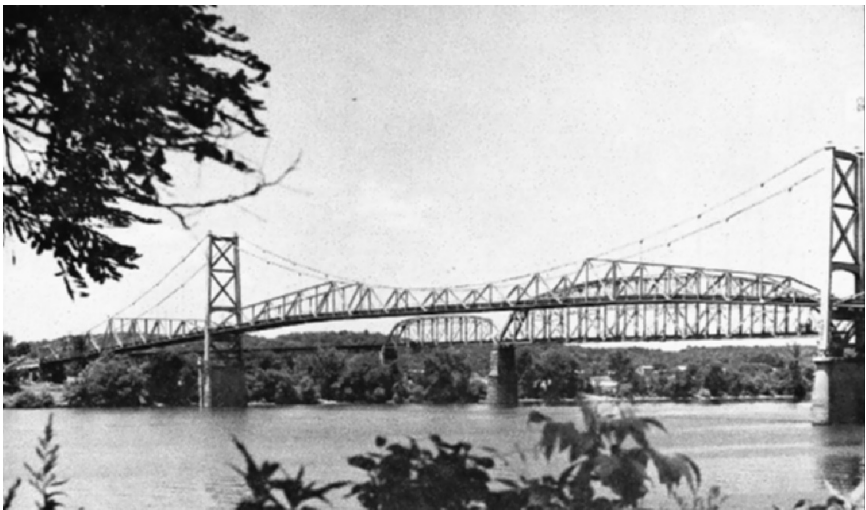
Figure 1.8 *The Silver Bridge (in Foreground)*. (From 1968 NSTB Report [14]).

The Silver Bridge was constructed in 1928 over the Ohio River between Point Pleasant, West Virginia and Gallipolis, Ohio. The main superstructure was a 1760-ft.-long eyebar chain suspension bridge, with a center span of 700 ft. and anchor spans of 380 ft. on either side. At about 5:00 in the evening of December 15, 1967, an eyebar just west of the tower on the west side of the center span suddenly fractured resulting in the immediate collapse of the structure and the loss of 46 people and serious injury to 9 others. The fracture of the eyebar was the result of the growth of a minute imperfection, present from the initial casting of the eyebar, due to stress corrosion cracking [14] (Figure 1.9).

The Silver Bridge had been regularly inspected and maintained prior to the collapse. It had originally been constructed as a private toll facility,

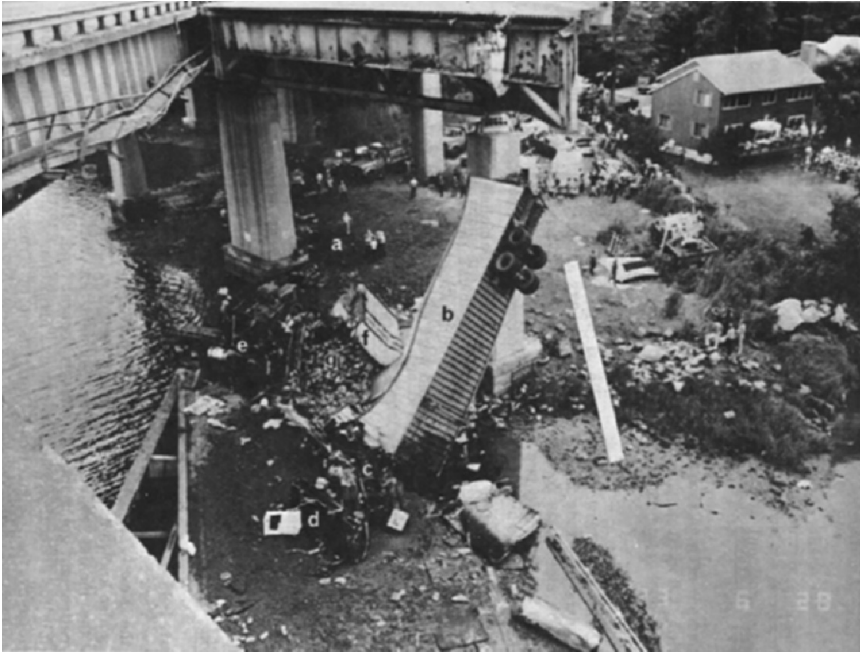
**Figure 1.11** *Collapsed Section of Mianus River Bridge.* (From 1983 NTSB Report [16]).

The impetus for fracture critical inspections came from the collapse of the Mianus River Bridge in Greenwich, Connecticut in 1983. The Mianus River Bridge was a 2656 ft. long welded steel plate girder bridge built in 1958, which carried Interstate 95. At about 1:30 in the morning on June 28,

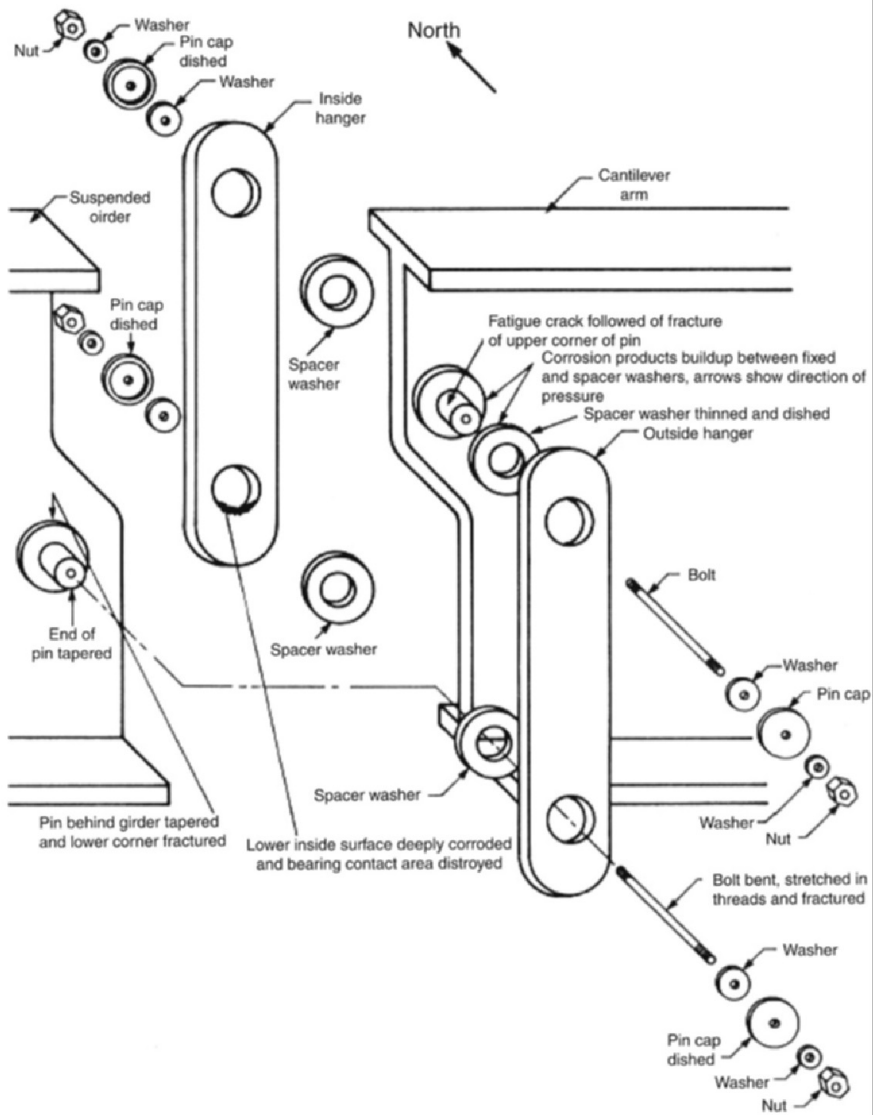
**Figure 1.12** *Sequence of Failure in Pin and Hanger Assembly per NTSB.* (From 1983 NSTB Report [15]).

In its report, the NTSB cited deficiencies in the bridge maintenance and inspection policies of the Connecticut Department of Transportation as the probable cause of the collapse. Deck drains provided in the original construction had been paved over during maintenance work on the bridge. Runoff from the deck, contaminated in the winter with salts used to melt snow and ice, ran onto the pin and hanger assemblies causing corrosion, which induced distortions in the assembly. Subsequent bridge inspections failed to discover the condition of the pin and hanger assemblies. Current standards for the inspection of fracture critical structures require an inspection of the fracture critical members at no more than arm's length away by

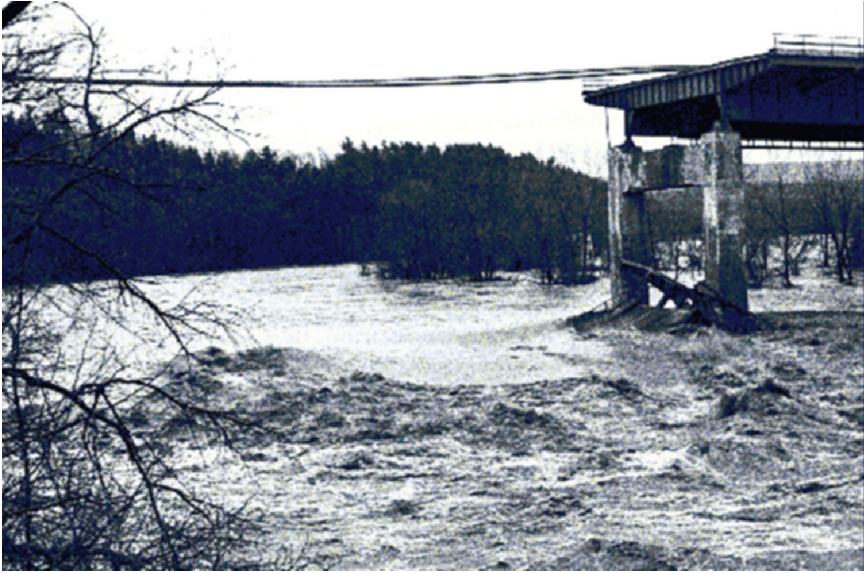
**Figure 1.13** *Collapse of NY State Thruway Over Schoharie.* (From FHWA Underwater Inspection Manual [16]).

Requirements for the inspection of the underwater foundation elements of bridges were developed as a result of the failure of the bridge carrying the New York State Thruway over Schoharie Creek in 1987 [16]. After a

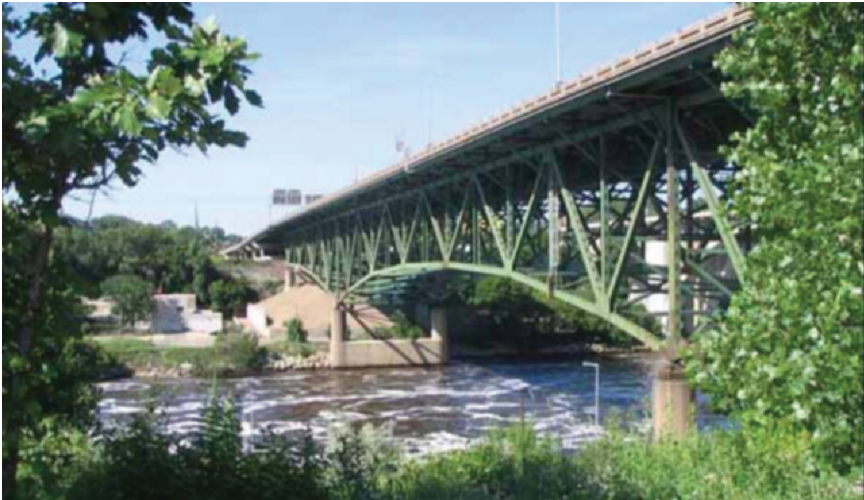
**Figure 1.15** *Center Span of I-35W Before Collapse. (From 2008 NSTB Report [17]).*

deck truss. The adjacent superstructure type was welded steel girder. The average daily traffic, as of traffic information dated 2004, for this section of Interstate 35W was 141,000 automobiles, 5,640 of which were heavy commercial vehicles (Figure 1.15).

The deck of the bridge sat atop 27-in.-deep wide flange rolled steel stringers, running longitudinally at 8 ft. 1 in. on center, attached to transverse

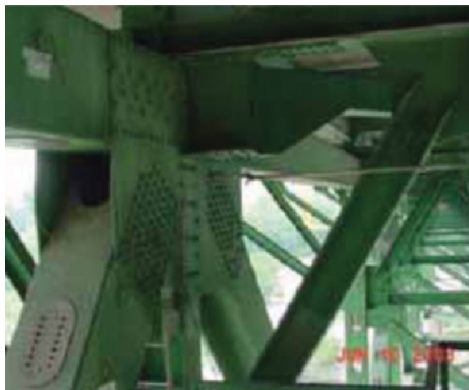
**Figure 1.18** Connections at Node U10 West. (From 2008 NTSB Report [17]).

plates. On the I-35W Bridge, each of the main deck trusses was found to have undersized gusset plates at 8 of their 112 nodes (Figure 1.18).

The NTSB reported in its final report that, according to the design methodology and procedures current at the time of the design of the I-35W Bridge, 24 gusset plates should have been 1 in. thick, as opposed to the 0.5-in. thickness specified by the designer. The collapse was initiated by the fracture of the gusset plates at the U10 nodes, a location which according

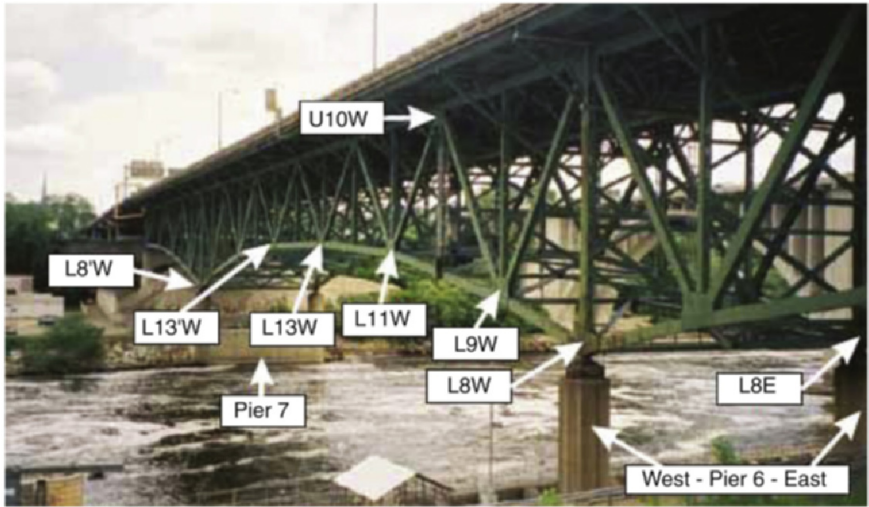
Figure 1.19 Location of Node U10. (From 2008 NSTB Report [17]).

to postincident finite element analysis by the FHWA, was beyond yield stress in the originally constructed dead load only condition (Figure 1.19).

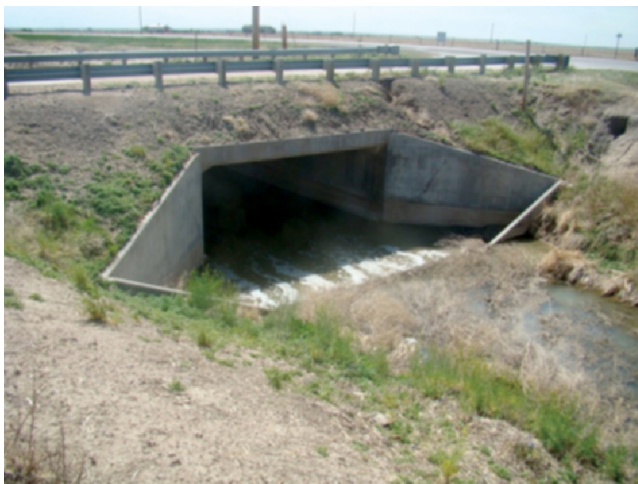
**Figure 2.1** *Typical Single Cell Culvert Structure.*

A typical reinforced concrete box culvert is shown in [Figure 2.1](#). The primary components for a buried structure such as this are the conduit for conveyance through the roadway berm and the retaining structures at each end of the conduit. The body of the conduit may consist of one cell or several adjacent cells. In typical practice, for highway loading and with contemporary construction materials, cells are rarely wider than 20 ft. and usually no more than 14 ft. The import of this is that the top element of the conduit (for a box culvert this is the ceiling slab) is relatively lightly loaded compared to structures with longer spans and may have considerable capacity to distribute the effects of loading perpendicular to the span. This is true even for such structures, which although still buried or embedded in

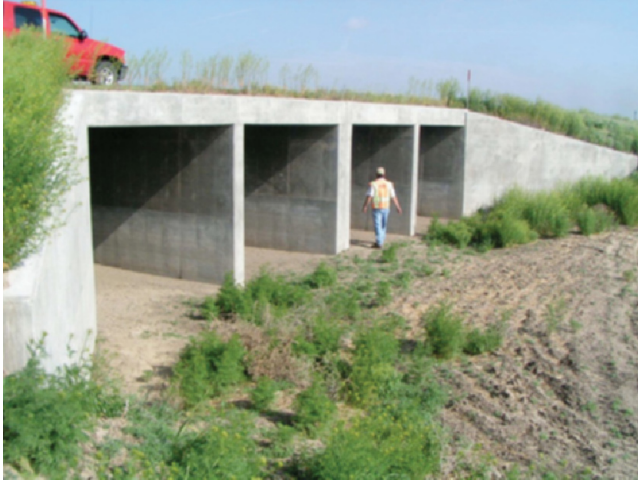
**Figure 2.2 Multiple Cell At-Grade Box Bridge.**

fill, may have a total opening bigger than 20 ft. or may have the top of the structure exposed directly to traffic as shown in [Figure 2.2](#).

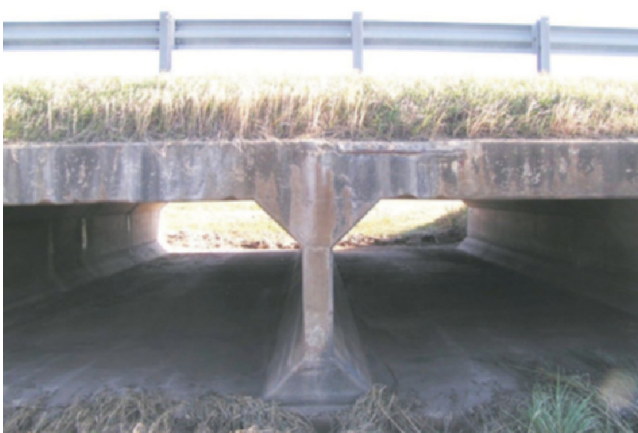
**Figure 2.3 Fillet on Reinforced Concrete Box Culvert.**

The box shape, constructed with reinforced concrete, is common for contemporary buried structures. It may or may not be constructed with a fillet between the horizontal and vertical elements to provide rigidity. Pipes are another common structure and may be formed from reinforced concrete, corrugated steel or aluminum, fiberglass, or plastic ([Figures 2.3 and 2.4](#)).

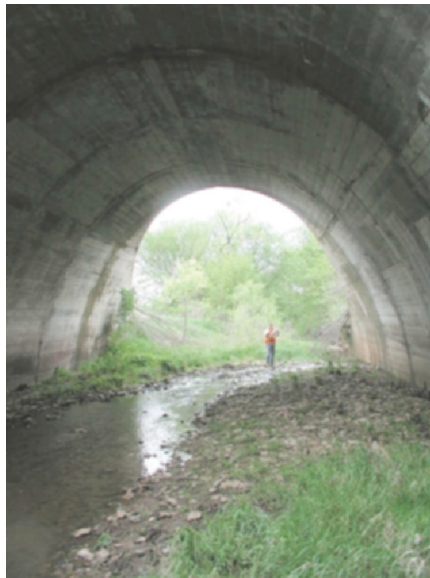
**Figure 2.5** *Inside of Reinforced Concrete Arch.*

Less common are arch shapes, constructed from reinforced concrete or corrugated steel. This structure requires the construction of a footing for each wall, but the open bottom allows for a more natural stream passage, which may be of use to meet environmental permitting requirements (Figure 2.5).

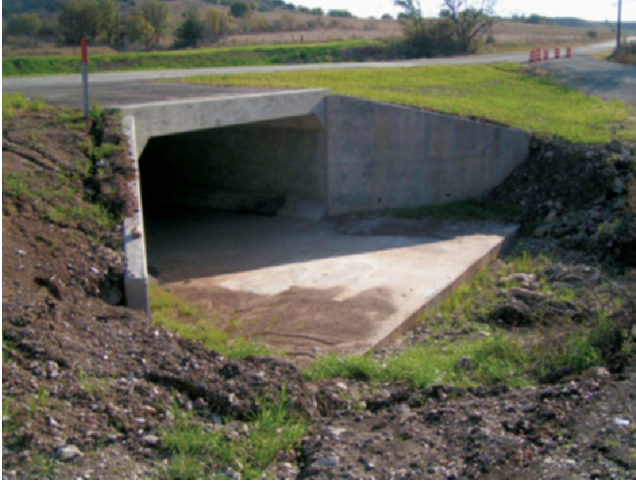
**Figure 2.6** Reinforced Concrete Box With Concrete Apron.

due to undermining of the support mantle due to the flow of water at either the entrance or the exit of the conduit. To protect the supporting soil mantle, a concrete apron may be placed at either the entrance or exit end of the conduit, depending on the need. A similar effect may be achieved with an apron of large rock (Figure 2.6).

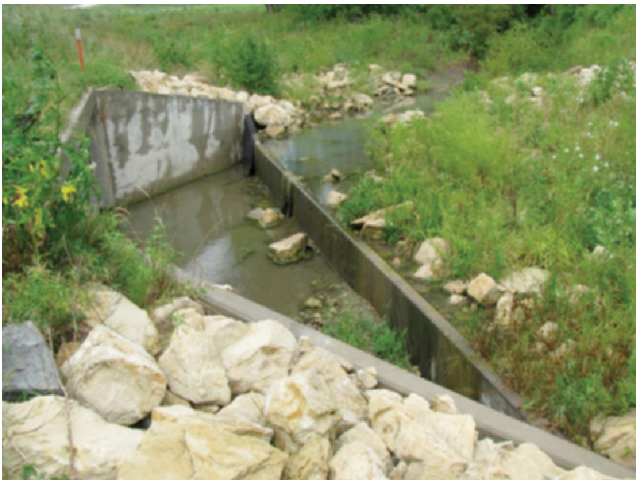
**Figure 2.7** Inlet End of Reinforced Concrete Box With Soil Saver.

If there is a need to prevent degradation of the streambed of the channel approaching the structure, a soil saver may be constructed. This is a small wall to retain the fill beneath the channel and maintain its elevation. This reduces the slope of the channel approaching the conduit and reduces the velocity of the water (Figure 2.7).

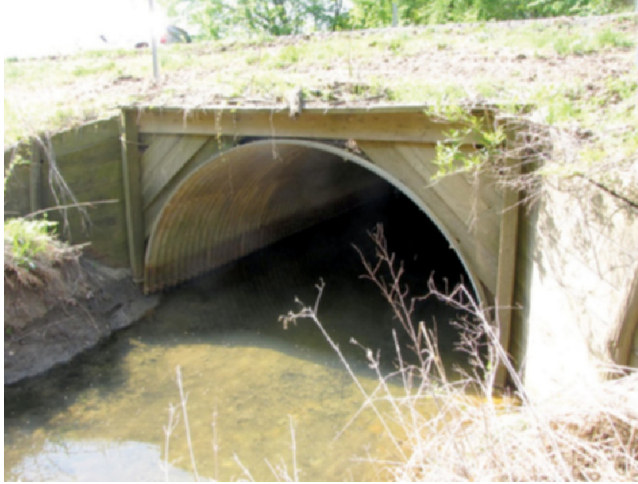
**Figure 2.8** *Timber Headwall on Corrugated Metal Pipe.*

For pipe structures, the structure retaining and protecting the fill around the conduit is a headwall. The headwall may also serve the purpose of directing the flow into the pipe, resulting in a more orderly flow and minimizing turbulence. This improves the capacity of the conduit for conveyance of water (Figure 2.8).

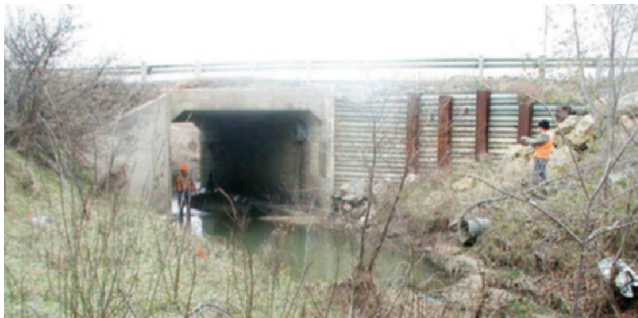
**Figure 2.9** *Concrete Wingwall and Temporary Wingwall.*

Box structures, arches, and large-opening pipes will have retaining walls at each end to retain fill. Typically these are constructed of reinforced concrete; however, particularly for structures, which have been repaired on an expedient basis, they may be formed in a number of manners. They may be formed by piles and lagging or even by blocks massive enough to resist earth pressure by weight alone (Figure 2.9).

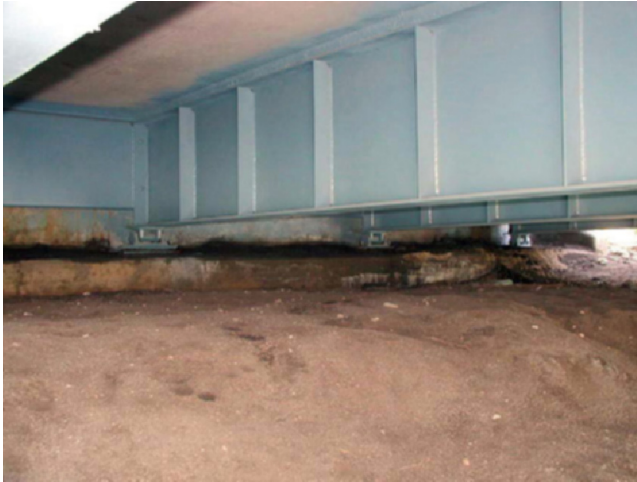
**Figure 2.13** *Bearing Seat on Abutment Backwall.*

is the abutment backwall. In the configuration shown in [Figure 2.13](#), the superstructure may move horizontally independently (up to the gap distance) of the abutment. This allows for thermal expansion and contraction of the superstructure, which depends on the length and material of the superstructure. For long steel structures, the range may be well over 4 in.

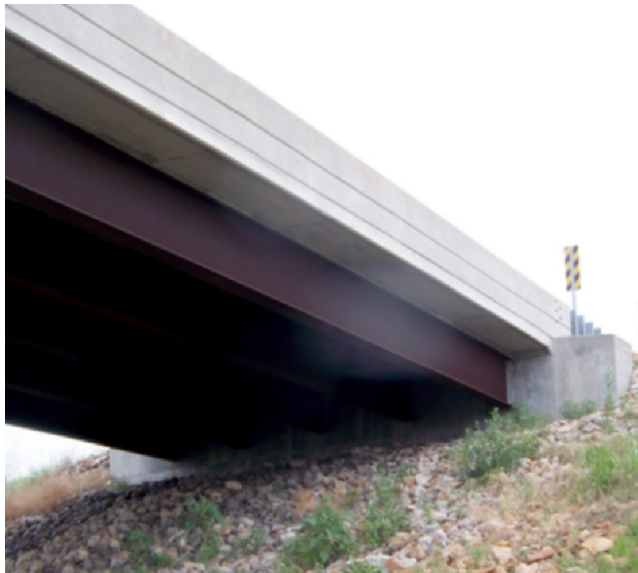
**Figure 2.15** *Integral Abutment With Straight Wings on Girder Bridge.*

An abutment may also be classified by its relation to the embankment fill ([Figure 2.15](#)). An abutment which sits atop and in the embankment fill is referred to as either a stub, perched, or shelf-type abutment (in [Figure 2.16A](#)). An abutment in which a wall bears the weight of the superstructure down to the foundation and retains the full height of the embankment fill is a full height, cantilever, or closed abutment. Abutments with structural elements separating the beam near the top of the embankment and a footing under the embankment are spill-through or open abutments. Although the

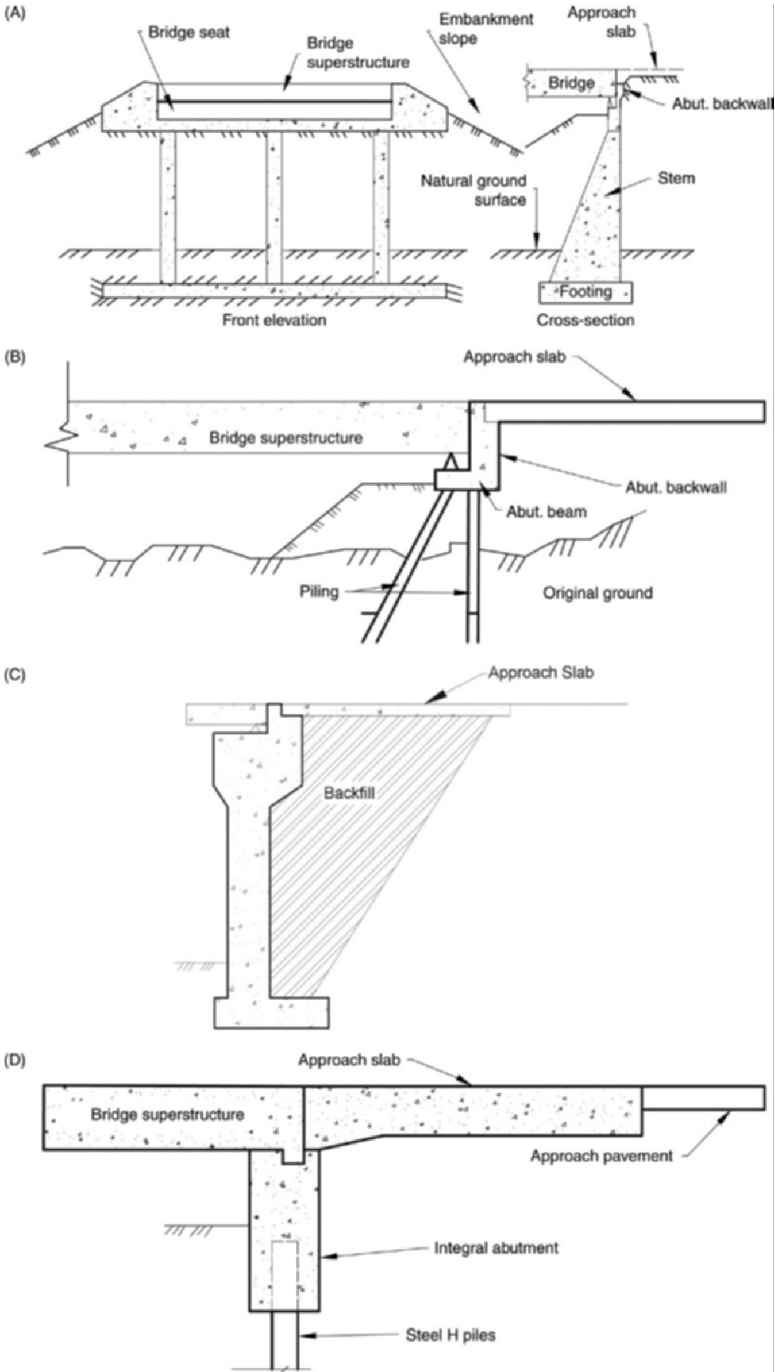
Figure 2.16 *Abutment Types*. (A) Typical spill through abutment. (B) Typical stub or perched abutment. (C) Typical full-height closed or tall abutment. (D) Typical integral abutment. (Adapted from NCHRP Synthesis 234 [3]).

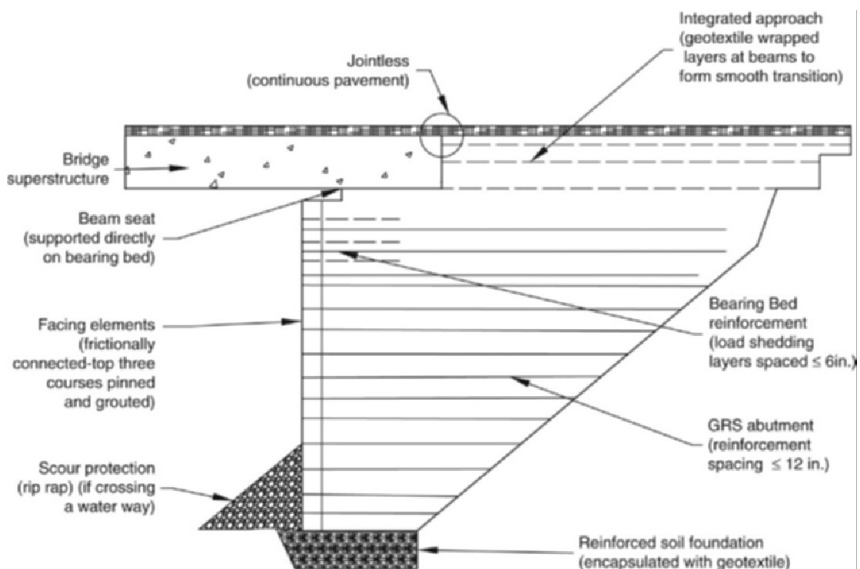
Figure 2.17 Typical Plan of GRS Abutment. (Adapted from FHWA-HRT-11-027 [4]).

Although abutments are typically founded on deep foundation elements, discussed in Section 2.3.1.3, to provide the vertical stability that is paramount to minimizing differential settlement, in recent years some highway bridge abutments have been built atop embankment fill that has been mechanically stabilized. In this layout, a stub abutment is constructed atop a mass of stabilized fill, which is over the *in situ* material. The concept rests on the premise that any difference in settlement between the bridge and the approaching roadway will be spread across a long enough section of roadway above the fill to minimize the impact on vehicle operation (Figure 2.17).

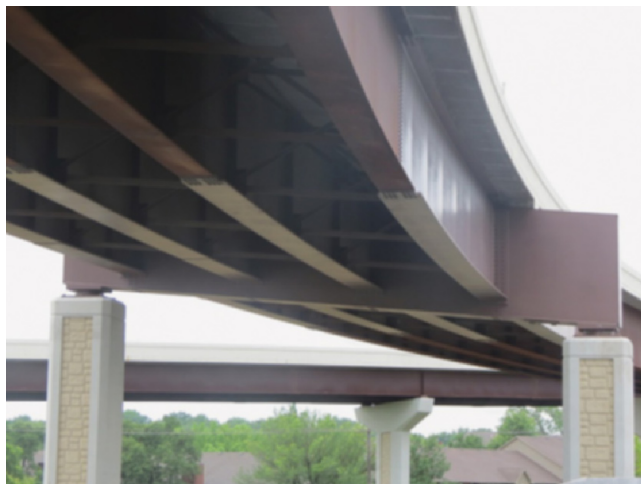
**Figure 2.19** *Steel Pier Beam on Straddle Bent.*

bridges constructed in the first decades of the last century or earlier. In contemporary designs, where highway geometrics result in constraints on pier beam depths, steel may be used to allow for shallower members than may be formed from reinforced concrete (Figure 2.19).

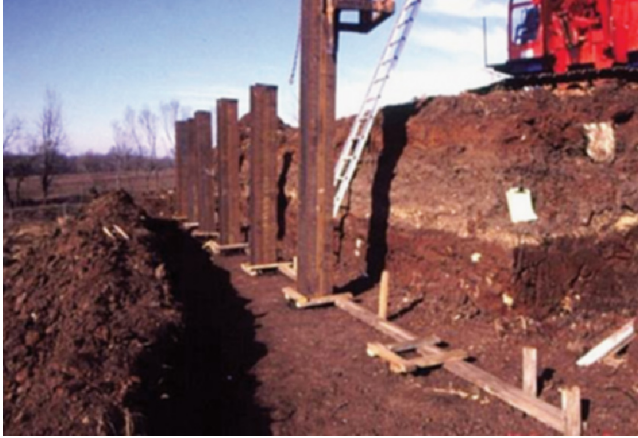
Figure 2.20 *Steel H-Piles.*

If rock is unavailable near the surface, pilings may be used. Pilings are typically steel (Figure 2.20), prestressed concrete (Figure 2.21), or timber members, driven through the soil mantle into underlying geological

members where they reach capacity by either point bearing on rock, by friction against the member driven into, or by a combination of both.

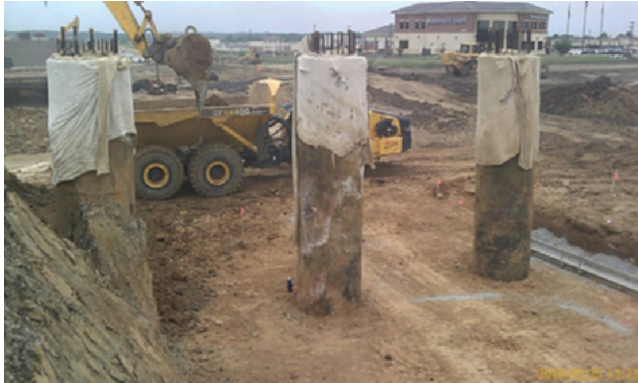
**Figure 2.22** *Drilled Shafts.*

Another common deep foundation element is the drilled shaft or caisson (Figure 2.22). Individual shafts vary from 2 ft. to 10 ft. in diameter. Shafts are formed by auguring out geological material down into the supporting layer. Reinforced concrete is then cast in place. Either a permanent or temporary steel casing may be used to prevent collapse of surrounding geologic material prior to concrete placement and/or the infiltration of water into concrete as it is placed. Similar to piling, the shaft may develop load-carrying capacity by bearing on bedrock, by friction against the rock around the perimeter near the base of the shaft, or a combination of both.

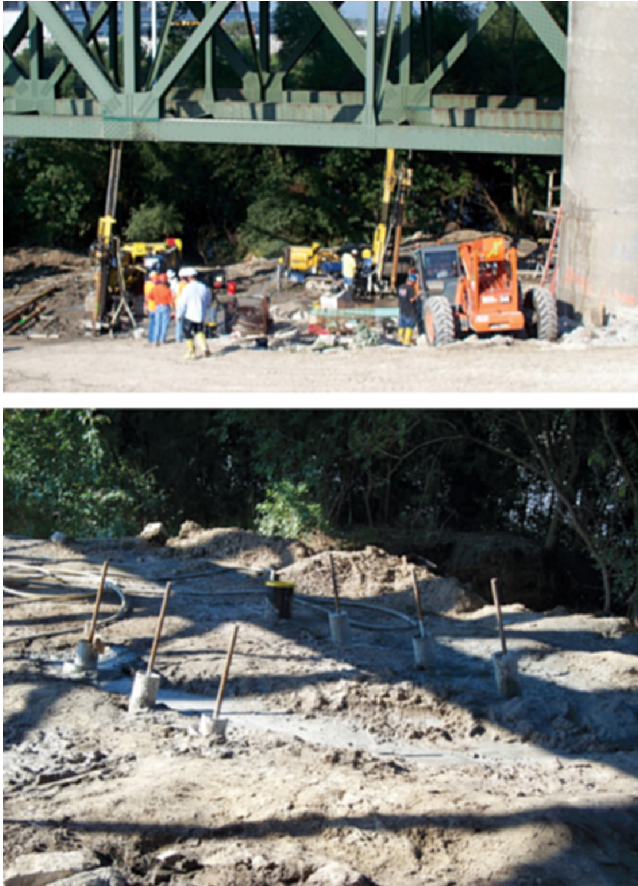
Figure 2.23 *Installation of Micropile.*

On contemporary highway bridge structures, smaller diameter reinforced concrete shafts may also be found. These will have been placed by either augercast (typically 12–24 in., but can be up to 42 in. in diameter) or micropile (3–12 in. in diameter) methods. For augercast piles, once the auger reaches its desired depth grout or concrete is pumped through the stem of the auger as it is pulled from the hole. Reinforcing steel is placed afterward. For micropiles, a casing is drilled to a desired depth, then reinforcing is placed to that depth or farther as required to develop capacity, and then the casing is filled with concrete or grout (Figure 2.23).

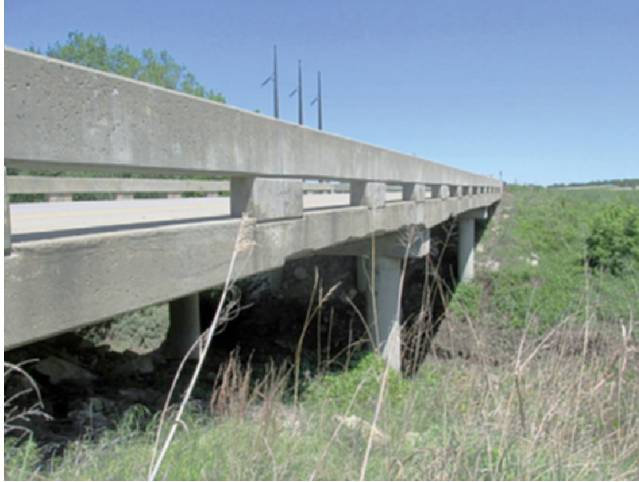
**Figure 2.25** *Corral Rail.*

There are various shapes and configurations of bridge rails and the common materials are reinforced concrete, steel, and aluminum (Figures 2.25 and 2.26). Contemporary bridge rail configurations are crash tested for vehicular impacts and are of significantly more substantial construction than rails from only a few decades ago (Figure 2.27). Newer rails may require

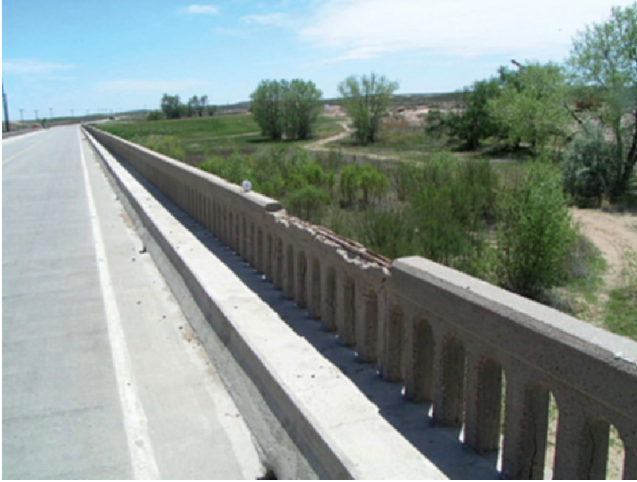
**Figure 2.27** *Damaged Type A Rail.*

attention due to damage from impacts, but older rails may also require attention due to deterioration abetted by their lighter construction.

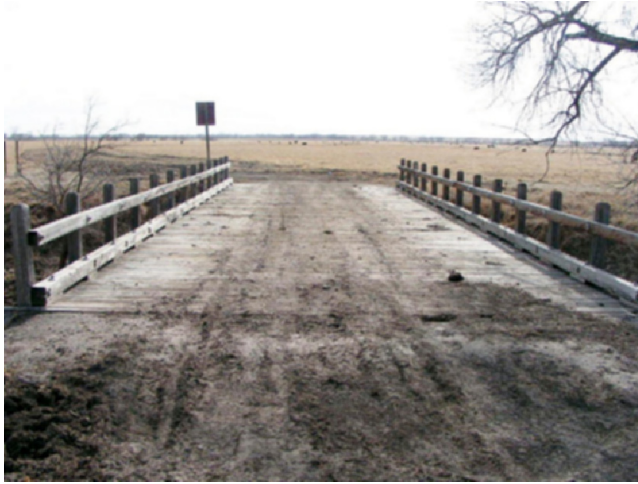
**Figure 2.29** *Timber Deck.*

Although reinforced concrete decks are by far the most common type of construction, other deck materials may be encountered in an inventory of highway bridges. On bridges carrying a very low volume of traffic, timber decks may be found (Figure 2.29). On long span bridges, where the weight of the deck may be a significant concern in the structure design, steel grates have been used (Figure 2.30). On newer structures, deck constructed from

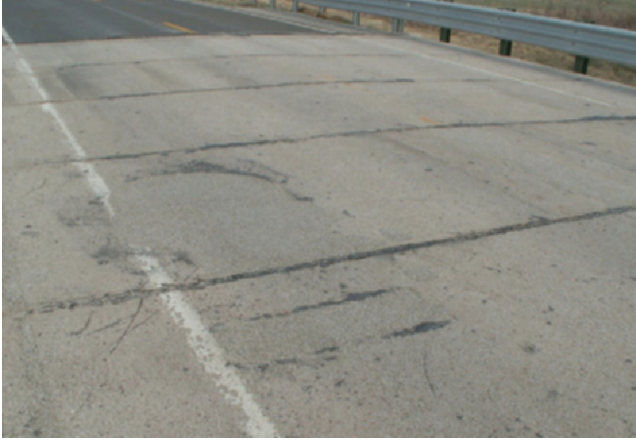
**Figure 2.31** *Wearing Surface of Extruded FRP Deck Panels.*

fiber resin polymers (FRP) have been used in an attempt to address corrosion and weight; however, to date there is not a long history to judge FRP performance (Figure 2.31).

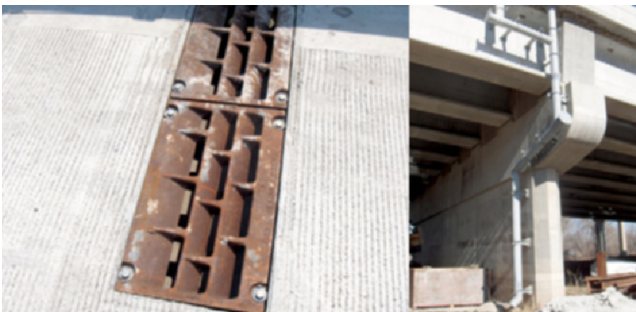
**Figure 2.32** *Deck Drain.*

An item of particular interest to those who deal with bridge maintenance is deck drainage (Figure 2.32). Provisions must be made to convey precipitation away from driving lanes and off the deck. If a bridge is relatively short, curb or barrier rail may direct drainage down the curb line of the deck and off of the approach at the downhill end of the bridge. Alternately, open railing may allow runoff over the side of the deck. However, if a bridge is long enough and open rail cannot be used in order to prevent the spread from runoff into driving lanes; drains through the deck must be provided. Deck drains and associated piping come in a myriad of forms. Common to most drains is a steel grate over the top surface to prevent wheels from dropping into the drain pan. Maintaining deck drains is a key issue in preventative maintenance.

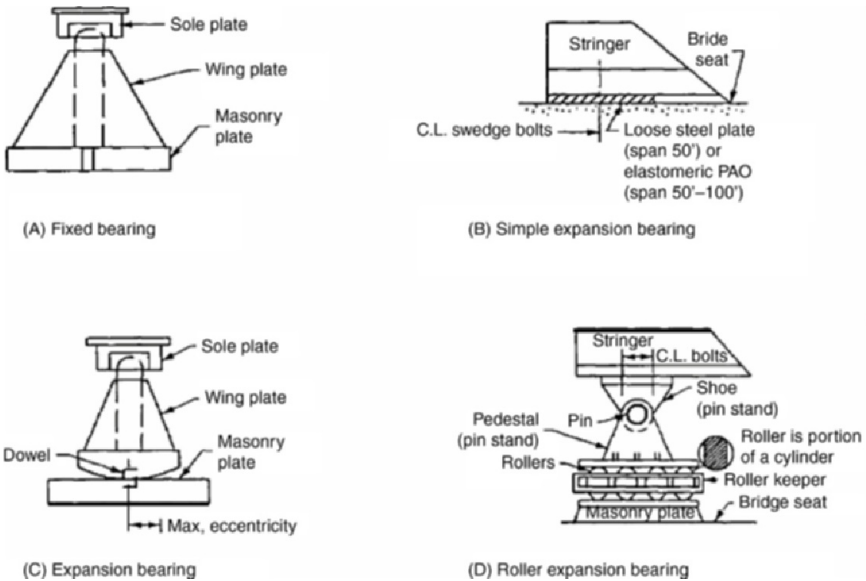
**Figure 2.33 Steel-Bearing Types.** (A) Fixed bearing. (B) Simple expansion bearing. (C) Expansion bearing. (D) Roller expansion bearing. (Adapted from FHWA Bridge Maintenance Manual [5]).

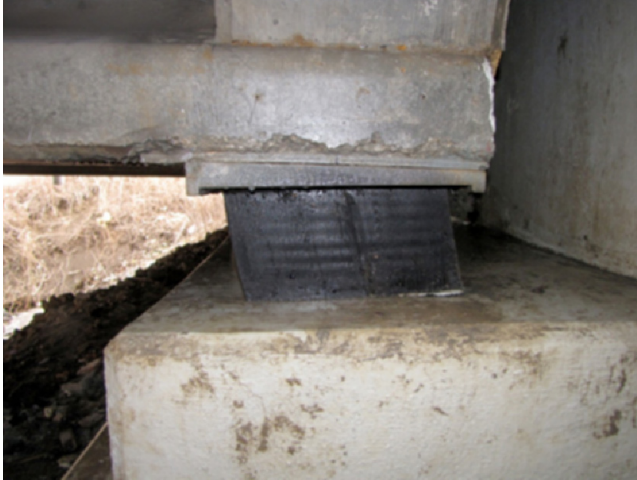
**Figure 2.35 Reinforced Elastomeric Bearing.**

after load is removed. The most common elastomers used for bridge bearings are neoprene and natural rubber, with neoprene being the more commonly used in the United States. To resist higher stresses the elastomeric material may be reinforced with layers of steel (Figures 2.34 and 2.35). Whether used as fixed or as expansion bearings, elastomeric bearings may be thought of as deformable bearings. Rotational movement is accommodated by deformation of the elastomer under load. Translation may be accommodated solely by deformation of the elastomer for small movements, or by use of a polytetrafluoroethylene (commonly known as PTFE or Teflon<sup>TM</sup>) sheet to permit sliding.

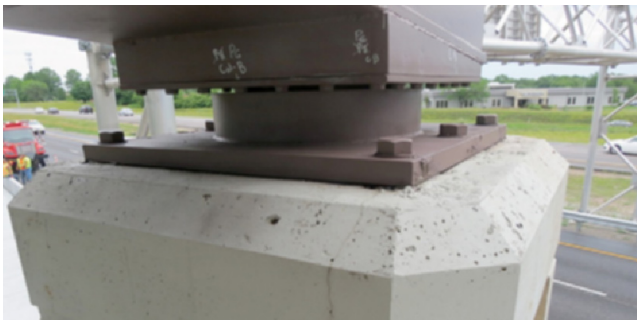
**Figure 2.36 Pot Bearing.**

To provide for the capacity to carry high-bearing loads and for rotational capacity in multiple orientations, pot bearings and disc bearings are used. In the pot bearing, the elastomer is confined within a pot – a steel ring – with the load transmitted through a piston attached to the sole plate

(Figure 2.36). Disc bearings are similar save that a hard plastic disc is used in place of the confined polymer.

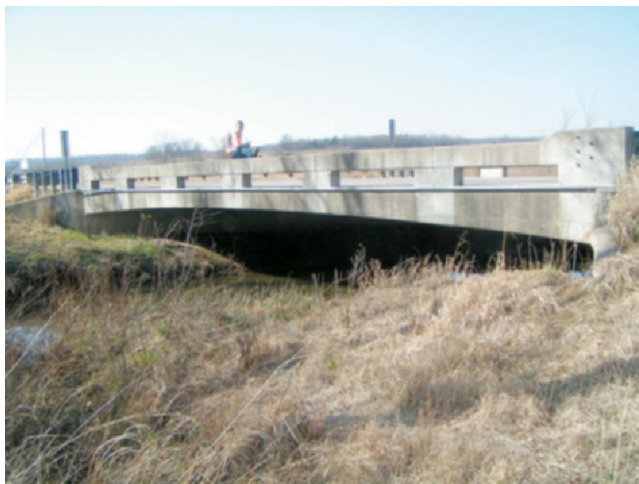
Figure 2.37 *Single Span Reinforced Concrete Haunched Slab Bridge.*

The simplest and cleanest type of superstructure is the structural slab. The span of a structural slab is formed by a deck with any intermediate framing between it and the substructure. Since the entire width of the slab is available to provide a load path to support vehicular loads, this structure type is highly robust. They are limited in application to shorter spans, less than 40 ft. for individual simple spans and less than 70 ft. as part of a series of continuous spans (Figure 2.37). See discussion in Section 2.4 for definition of simple versus continuous spans.

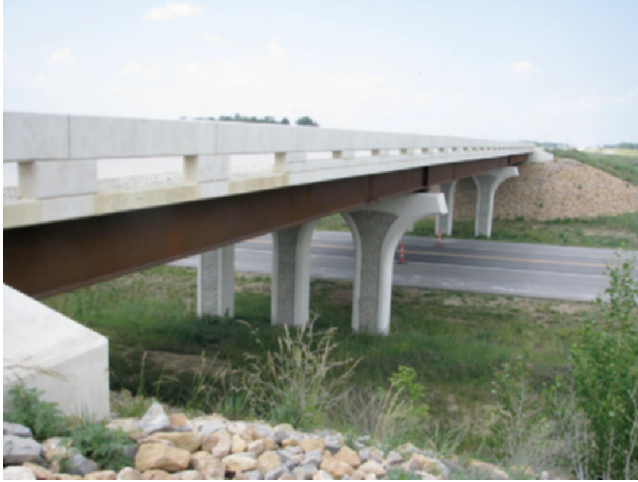
**Figure 2.38** *Steel Girder Bridge.*

The structural form most commonly used in highway bridges to span short- to medium-length spans (spans less than 400 ft.) are beams or girders (Figure 2.38). Both terms refer to members that act as beams in terms of their structural mechanics, that is, they are primarily loaded transversely to their long axis, which induces flexure, or bending, in the member. In the

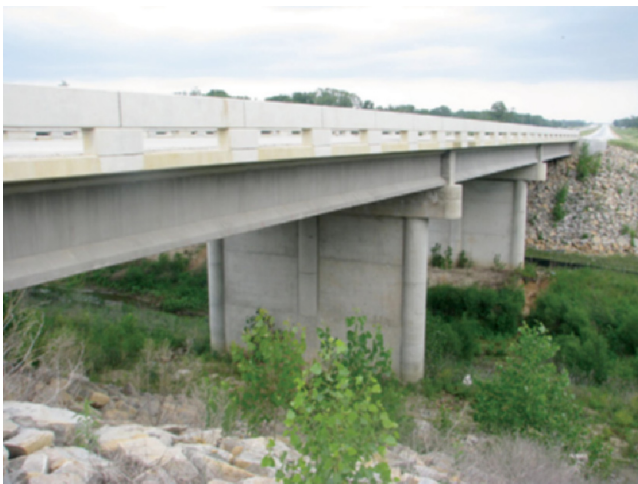
**Figure 2.39** *Prestressed Concrete Beam Bridge.*

Beams may be fabricated (off-site) or formed (at the bridge site) from rolled steel sections, cast in place concrete, timber, or prestressed concrete (Figure 2.39). Girders may be fabricated from plate steel, formed from cast in place concrete (typically for concrete box girder bridges) or erected from prestressed concrete sections posttensioned together at the bridge site. Beam

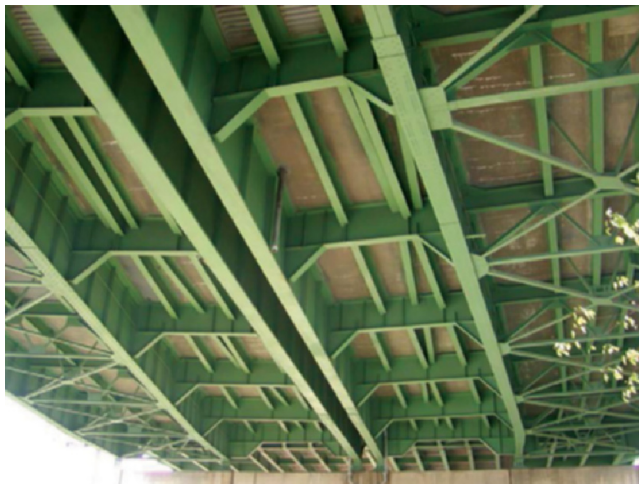
Figure 2.41 *Stringer and Floorbeam System.*

Steel girder spans may have secondary framing consisting of stringers and floorbeams to carry the load from the deck to the girders (Figure 2.41). Almost all beam or girder bridges have diaphragms or cross-frames between beam lines

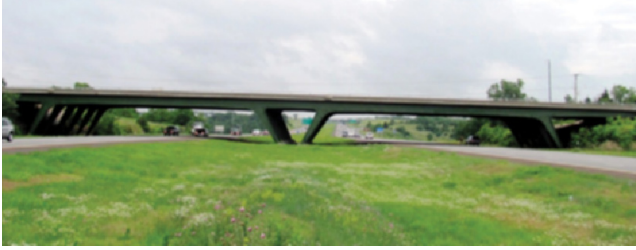
**Figure 2.42** *Welded Steel Rigid Frame Bridge.*

If the structure of the span is integral and rigidly connected with the supporting substructure elements, and the span and the substructure element are of similar stiffness, then a rigid frame is formed (Figure 2.42). For a steel structure this most commonly takes the form of plate girders fabricated to be monolithic with legs at pier locations. For concrete structures this most commonly takes the form of a structural slab cast integrally atop walls at the abutment locations.

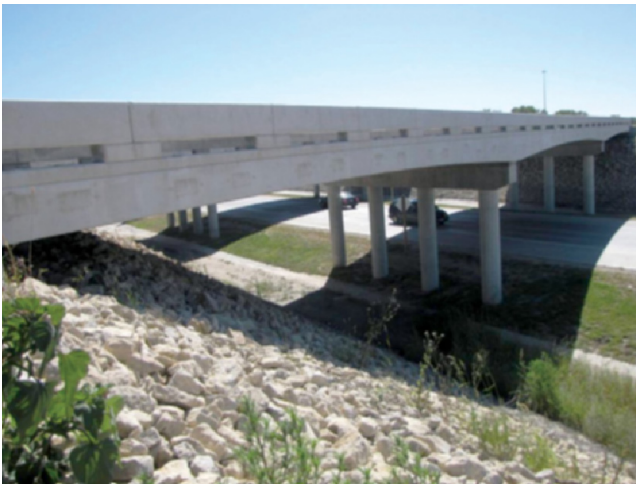
**Figure 2.43** *Reinforced Concrete Haunched Slab on Columns.*

If the superstructure is significantly stiffer than the substructure elements, then even if both elements are formed integral they are not considered a frame. The structural slab of the reinforced concrete haunched slab shown in Figure 2.43 is integral with the pier beam and columns; however,

the stiffness of the columns does not significantly affect the behavior of the slab above; therefore it is not considered a frame-type structure.

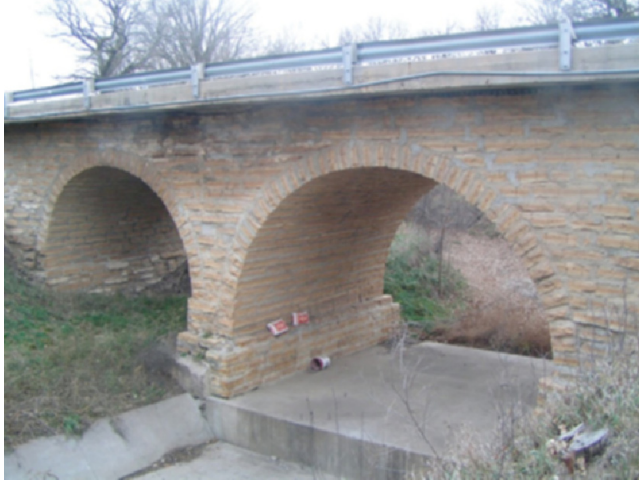
**Figure 2.46** *Stone Arch Bridge.*

The arch is a classic structural form, which resolves the vertical loading of a span into compression in its rib. The arch may be constructed from stone, masonry, concrete, or steel. Stone and masonry arches may be found on inventories with older bridges as culvert-sized structures (Figure 2.46). The roadway is typically supported on earthen fill above the arch contained between walls, which close the spandrels. The spandrel is the area between the roadway and the arch.

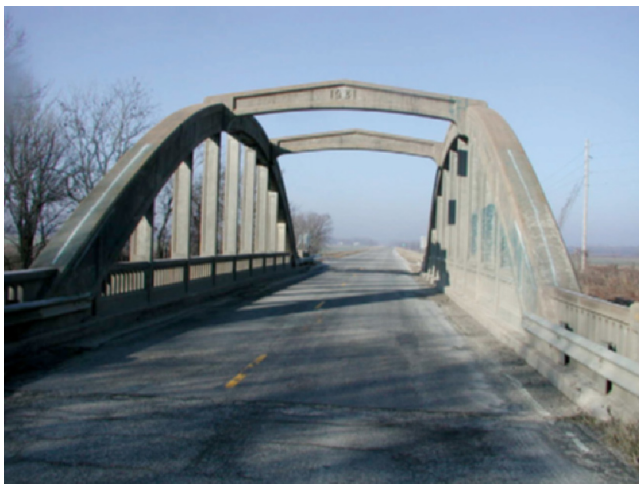
**Figure 2.47** *Reinforced Concrete Arch Bridge.*

deck to the arch. The use of reinforced concrete and steel also allows for the arch to be constructed above the roadway, making for through arches (Figure 2.47).

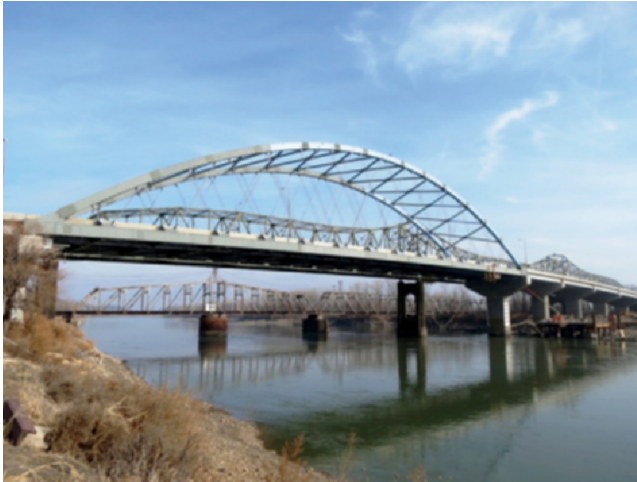
**Figure 2.48** *Network Tied Arch Bridge.*

The compressive force in an arch rib must be resisted to maintain the shape and stability of the arch. In a true arch structure this is done at the footing of the arch. Alternately, with reinforced concrete or with steel construction, a horizontal tie may be used, resulting in a tied arch (Figure 2.48).

For new steel construction, a tied arch is economical in spans ranging from 450 ft. to 900 ft. True arches may be used for spans up to 1800 ft., as with the Lupu Bridge in China for example.

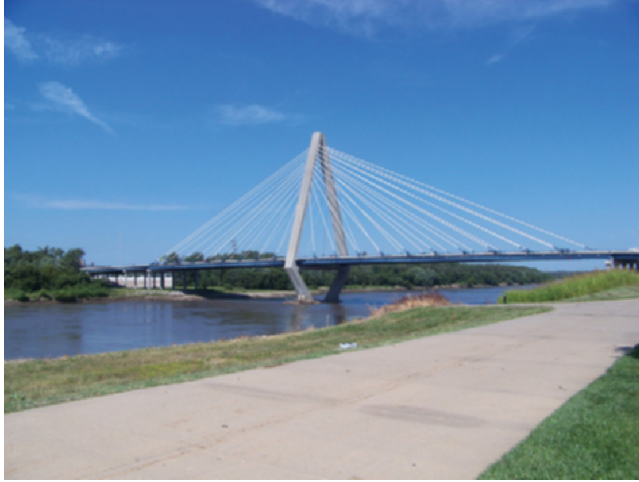
**Figure 2.49** *Christopher Bond Bridge – Cable Stayed.*

Bridges for which the main span is supported from cables made up less than 0.05% of the total number of bridges in the FHWA National Bridge Inventory of 2013. There were 96 suspension bridges, from which the span is supported from vertical cables, which attach to the main suspension cables spanning between pylons. There were also 48 cable-stayed bridges, where the supporting cables run from the girders directly back to the pylons (Figure 2.49).

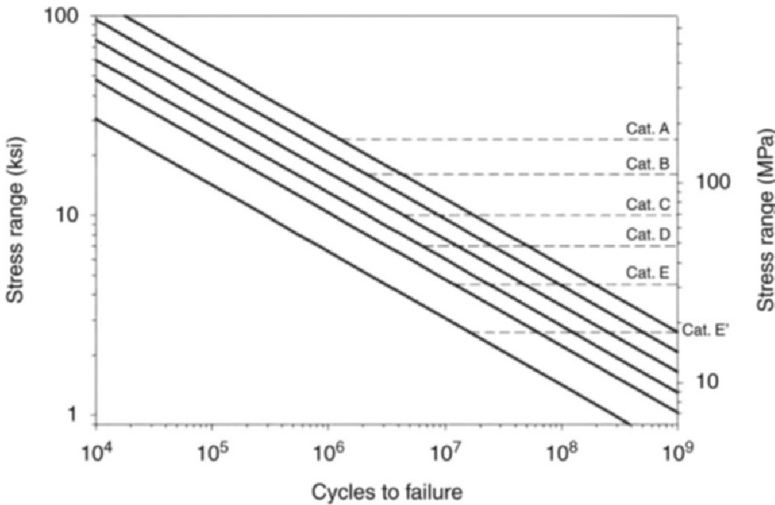
Figure 2.62 S-N Curves Used in AASHTO Specifications.

The constant,  $m$ , equals 3 for carbon steels. Since 1974, the AASHTO bridge design specification has organized specific connection and welding details on steel bridges into categories. Large-scale testing of these details has been used to develop stress range versus cycle to failure ( $S-N$ ) curves. The number of loading cycles can be related to the traffic counts for a particular bridge providing a predicted fatigue for details (Figure 2.62).

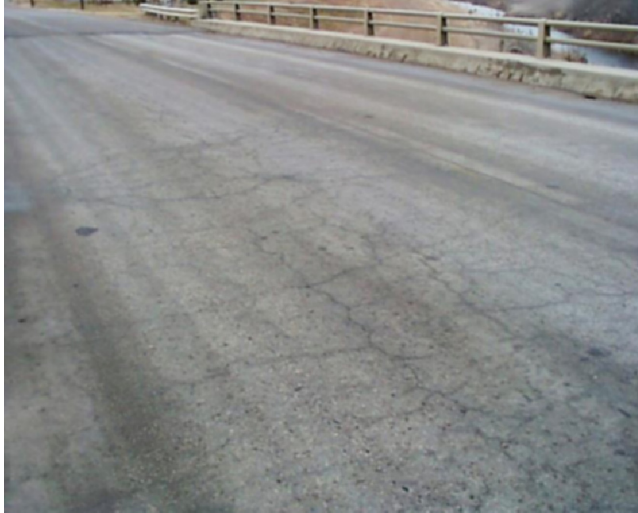
**Figure 2.63** *Map Cracking.*

individual cracks. Pattern cracking extends across the surface of a concrete member in two dimensions, appearing as a web of interconnected cracks. Alternately, it may be described as similar in appearance to the lines on a road map, hence the term map cracking (Figure 2.63). Pattern cracks occur due to restraint in the surface layer of the material relative to either shrinkage of the surface, or expansion of the volume of material underneath.

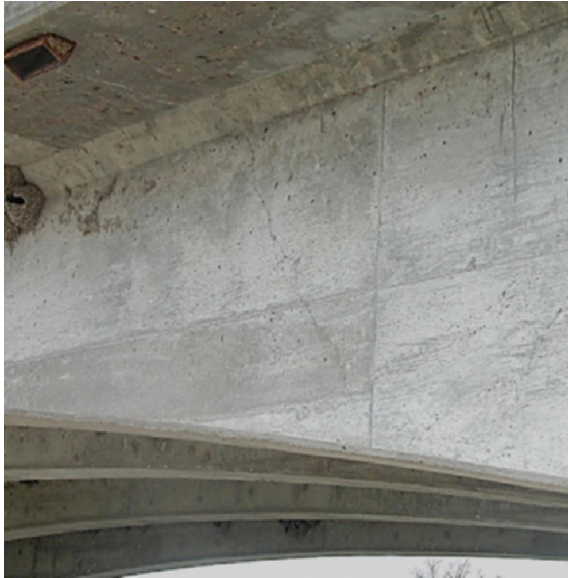
**Figure 2.64** *Typical 45° Shear Crack in Concrete Girder.*

Cracks may result from structural issues or nonstructural issues. Structural cracks occur when a concrete member has been loaded past its elastic capacity (Figure 2.64). Such a loading may be one greater than anticipated in the original design, or the capacity of a member may have been reduced by wear, deterioration, or prior damage. Specific issues of structural cracking will be discussed with applicable remediation in Chapter 5.
