# HIGHWAY BRIDGE MAINTENANCE PLANNING AND SCHEDULING

**MARK HURT**

**STEVEN D. SCHROCK**

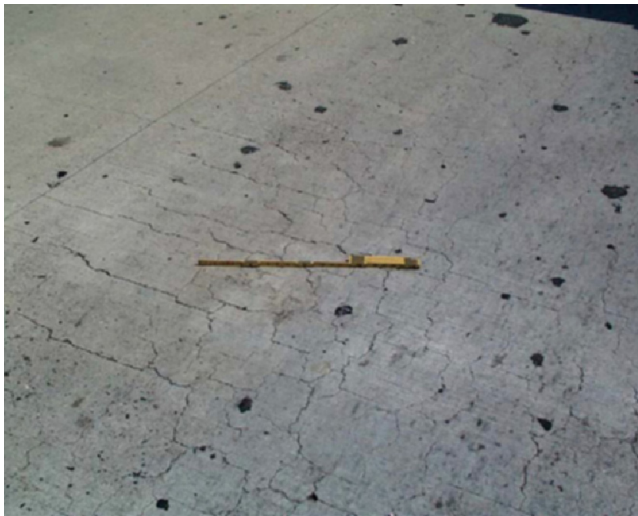
Figure 2.66 *Shrinkage Cracks.* (Adapted from FHWA Bridge Inspectors Reference Manual [7]).

Shrinkage cracking occurs when concrete loses water due to evaporation (Figure 2.66). Shrinkage that occurs prior to the set of the concrete is plastic shrinkage cracking. These cracks typically appear within 24 h of placement and are parallel and spaced 1–3 ft. apart. This cracking is why it is important to maintain a wet cure in the hours and days after initial placement of concrete.

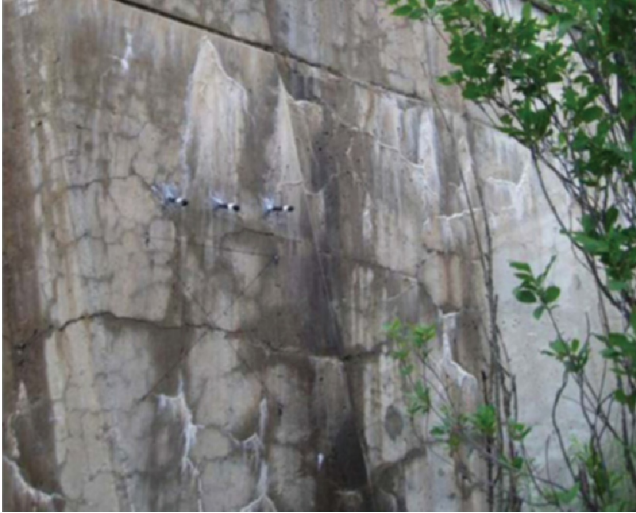
**Figure 2.67 Alkali-Silica Reaction.** (Adapted from FHWA Bridge Inspectors Reference Manual [7]).

has already set due to heat and an excess availability of water for continued hydration. All three of these reactions result in the development of expansive products within the already hardened concrete matrix (Figure 2.67).

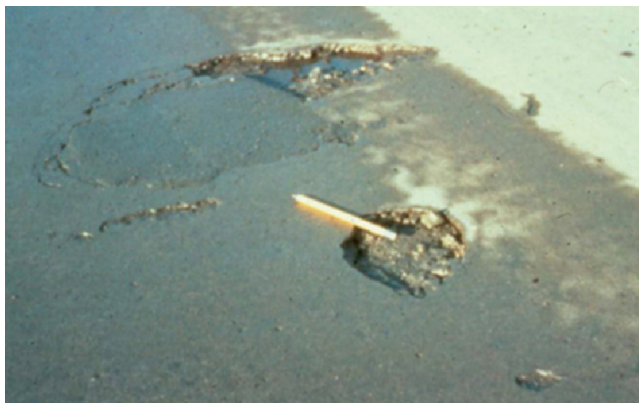
**Figure 2.69 Concrete Spall.** (Adapted from FHWA Bridge Inspectors Reference Manual [7]).

Spalling is the loss of sections of the surface of a concrete member. Unlike scaling, where the surface is disintegrating, spalling is when a section falls off as an intact fragment. Spalls may result as heavily cracked surfaces lose their integrity or due to an overstress at the surface of the member. Most often this overstress is due to corrosion, and resulting expansion, of reinforcing steel in the member. It may also be due to restrained thermal movement, such as at a nonfunctioning expansion joint, or to an overload due to externally applied loads (Figure 2.69).

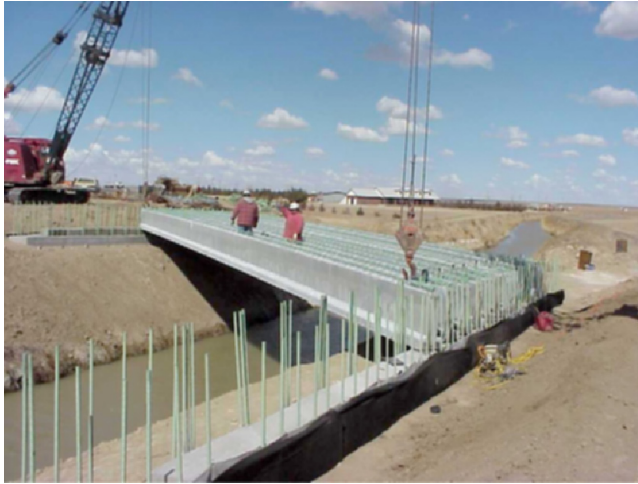
**Figure 2.71** *Construction of Prestressed Concrete Inverted-T Beam Bridge.*

The prestressing tension may be applied either before or after concrete member is formed and cast. Pretensioning is used for members that are precast by fabricators. Deck panels, piles, and beams are examples of pretensioned members. Typically beams are shaped like a capital I for efficiency, but shapes like an inverted capital T and planks are also available. The latter shapes have advantages in speed of construction (Figure 2.71).

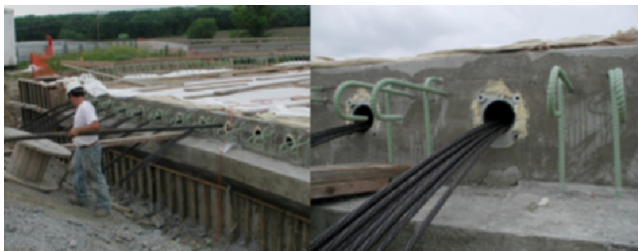
**Figure 2.72** *Posttension Ducts in Haunched Slab.*

Tension applied in the field is posttensioning (Figure 2.72). It may be done to a member that has been cast and set, such as a structural slab or a

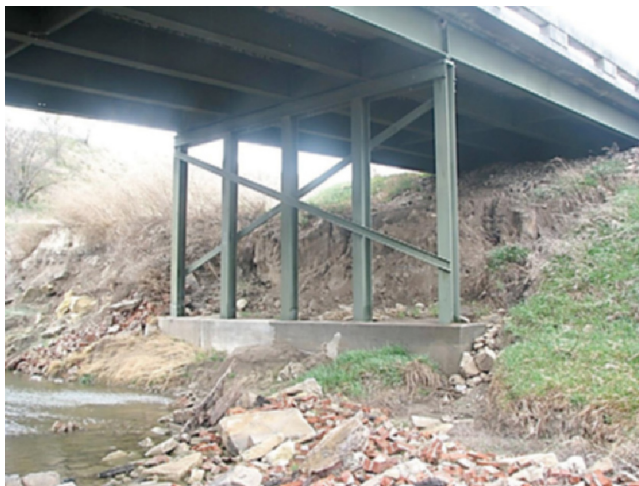
Figure 2.73 *Steel Pile Bent.*

Steel piling is commonly used as the foundation element to support bridge substructures (Figure 2.73). On some bridges, the piles extend above the ground line up to the pier cap to form the vertical supporting element of the pier.

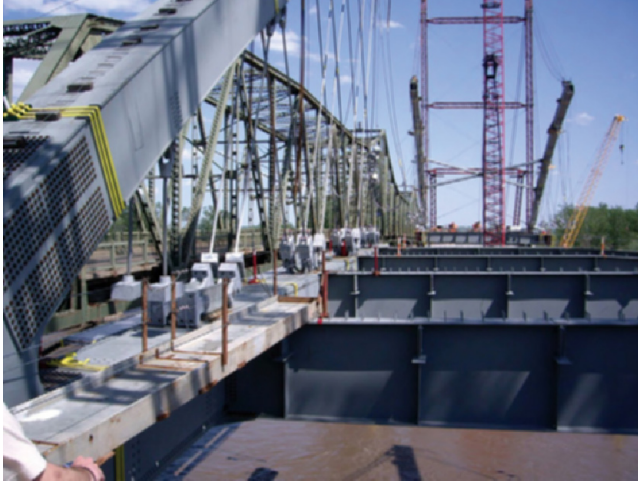
**Figure 2.74** *Steel Cables for Network Arch.*

In multiple, miscellaneous applications where higher-strength material is required: cables, tension rods, bearing devices, expansion joints, etc. steel has been the material used (Figure 2.74).

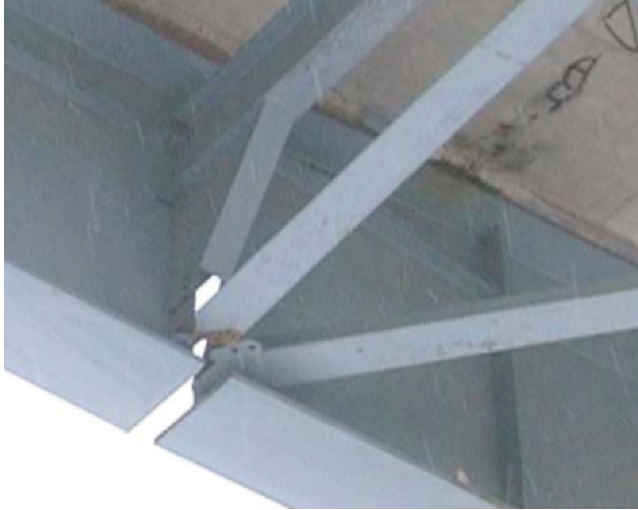
**Figure 2.75** *Triaxial Constraint Condition on Hoan Bridge. (FHWA Inspection Manual [7]).*

The fracture toughness of steel is affected by its temperature. The lower the temperature, the lower the toughness. This, combined with stresses induced by the thermal contraction of a bridge in cold weather, can lead to cracking at locations that are overly restrained, even without prior visible fatigue cracking. This is what occurred on the Hoan Bridge on the morning of December 13, 2000, in Milwaukee, Wisconsin. Three 10-ft. deep girders fractured, two completely through, where the webs were highly constrained by the connection to the lateral bracing (Figure 2.75).

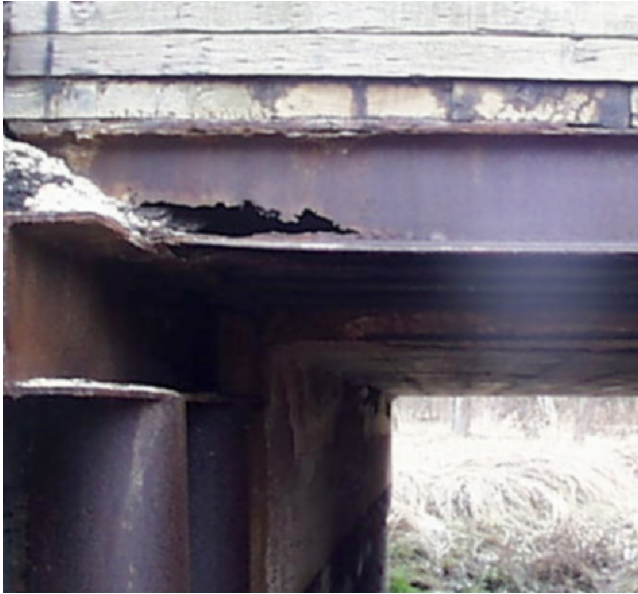
Rust initially appears as a discoloration, but the corrosion products are several times the volume of steel. As the corrosion expands, the surface will begin to pit, then form flakes, which stratify into layers of scale as the corrosion penetrates into the member (Figure 2.76). It may result in complete loss of section if allowed to continue.

**Figure 2.76** *Corrosion Through Web of Steel Beam.*

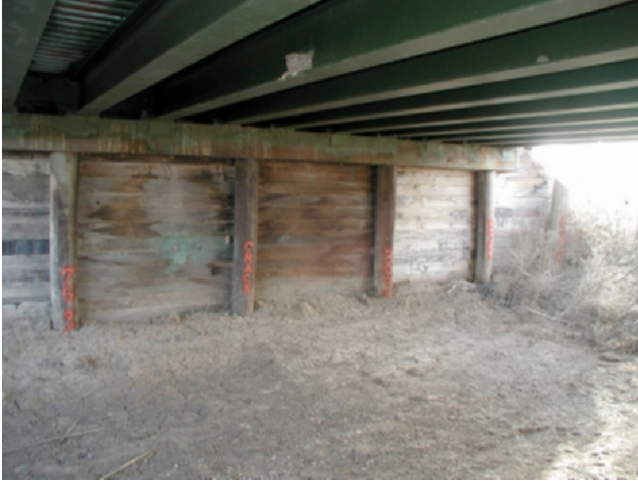
Timber bents are an element common to timber bridges, and to bridges using steel beams on timber substructures. The bents may be used as piers or, with lagging to retain fill, as timber abutments. Timber bents with steel beam spans allowed for relatively quick construction of small span bridges without requiring heavy equipment (Figure 2.78).

**Figure 2.78** *Timber Abutment Bent.*

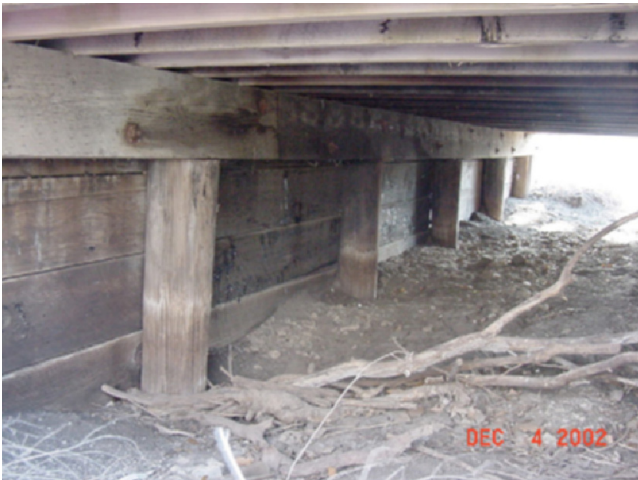
Spans of 25 ft. or less may be framed with timber beams (Figure 2.79). Decks may be formed with lumber planks.

**Figure 2.79** *Short Span Timber Bridge.*

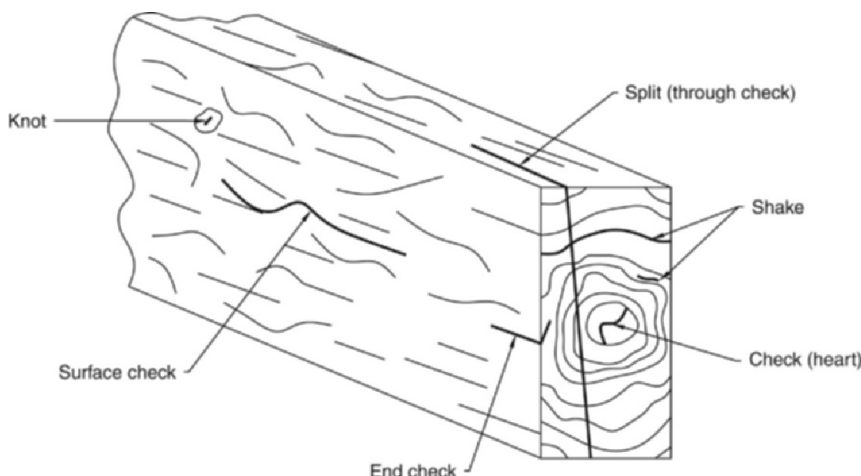
**Figure 2.80** Defects in Timber.

In wood, the analog to cracks are checks, splits, and shakes (Figure 2.80). Checks are separations of the wood fibers parallel to the grain. Splitting is

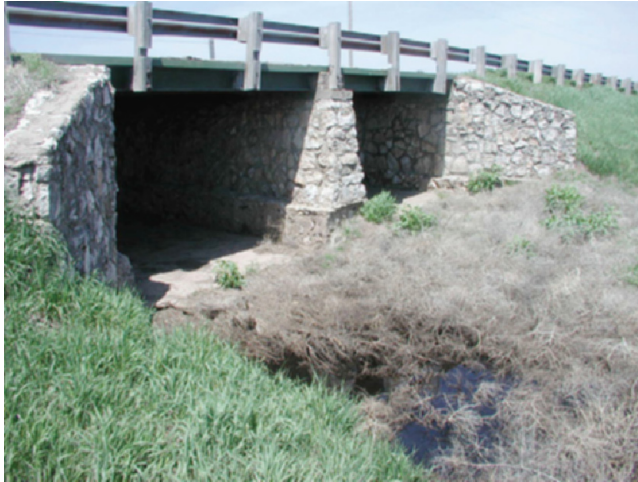
There are fewer stone masonry bridges on the 2013 NBI than timber bridges, with less than 1700 reported making up less than 0.3% of inventory. The majority of these were built before 1940 with less than ten new masonry bridges constructed annually in every year after 1950. As with timber bridges, the NBI does not count structures with an opening of less than 20 ft., nor does it count the number of span bridges with a stone substructure element (Figure 2.81).

**Figure 2.81** *Stone Masonry Substructure.*

Stone masonry deteriorates by weathering (breaking into small particles), spalling (small sections of rock popping out), or splitting (separations occurring either at seams in the rock or along mortar joints). Possible causes include: chemical reactions, thermal expansion and contraction, freeze-thaw, plant growth in the seams, and movement of the soil mass behind stone masonry walls.

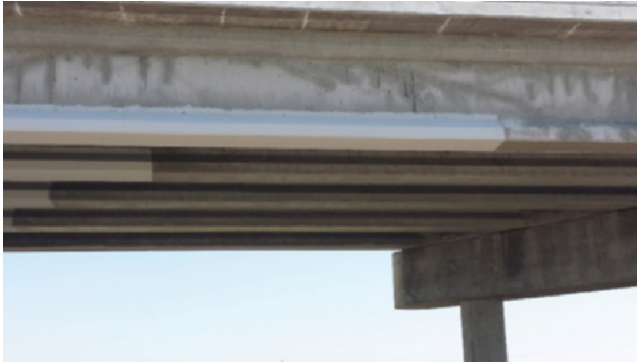
FRP fabric and strips are used for repairs and retrofits of damaged or deficient members to provide tensile capacity. The technology was an extension of the prior technique of externally bonding steel plates to deficient concrete members. FRP retrofits came into use in the United States in the 1990s. The first AASHTO Guide Specification for the Design of Bonded FRP Systems for Repair and Strengthening of Concrete Bridge Elements was published in 2012 (Figure 2.82).

**Figure 2.82** *Repair of Prestressed Concrete Beam With FRP.*

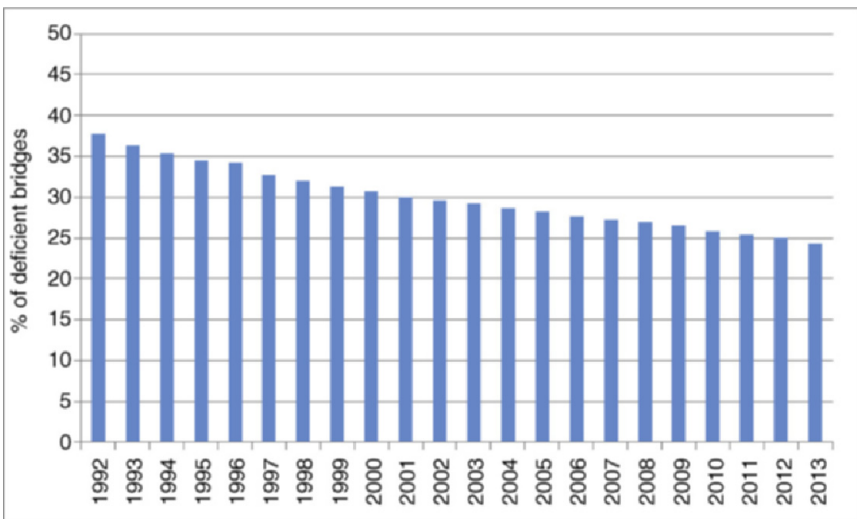
Figure 3.3 Percentage of Deficient Bridges 1992–2013.

The NBIS has been successful in the goal of improving the safety of highway bridges in the United States for the traveling public. The number of deficient bridges on public roads in the United States is being steadily reduced. For the years for which bridge inspection data have been collected following the 1992 NBI coding guide (1992–2013) the percentage of deficient bridges has been reduced from 37.8% to 24.3% (Figure 3.3). The

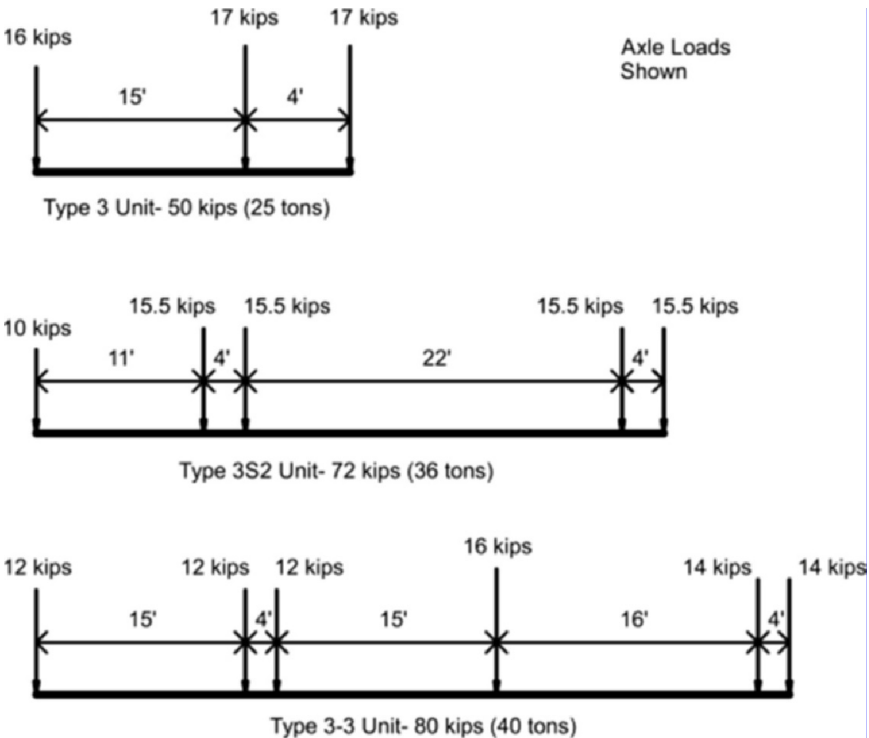
Figure 3.6 AASHTO Type 3 Legal Load Trucks.

The type 3 truck loadings were developed to produce worst-case demands by legal trucks. The smallest truck usually produced the most demand on shorter span bridges while the medium length and the longest trucks governed for medium and longer spans, respectively. However, the trucking industry has developed other legal axle configurations, particularly for specialized hauling vehicles (SHV), which produce more severe loading on some bridge span arrangements. The single-unit, short wheelbase, multiple-axle trucks are used in construction, waste management, and bulk commodity hauling. NCHRP Project 12-63 studied contemporary truck configurations and found the need to develop a series of single unit SHV legal trucks, SU4 to SU7 (Figure 3.7).

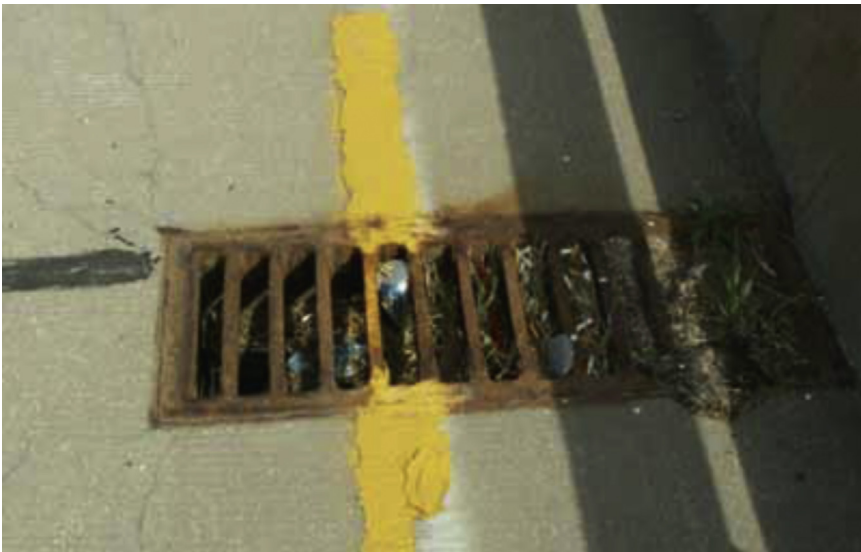
Figure 4.2 *Plugged Deck Drain.*

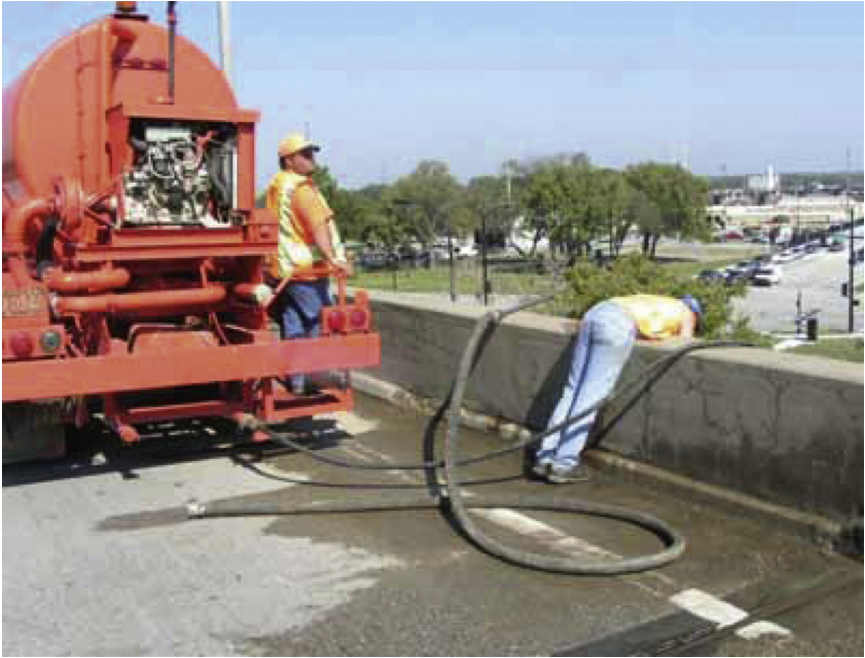
As the component which both directly bears traffic loads and conveys runoff from precipitation, bridge decks require the most attention from preventative maintenance efforts. Intact bridge decks and expansion joints also serve to shield the structural elements beneath from runoff which may be laden with salts and debris (Figure 4.2). The first priority in maintaining the deck is to provide positive drainage by maintaining open drains and scuppers. Drains can become clogged with sand and other debris from the roadside. Maintenance crews can clean out smaller debris by pushing it through the system with water under high pressure. Larger items, such as cans and bottles, may have to be snaked out from above, or from turnouts in the drainpipe if so provided (Figure 4.3).

Figure 4.3 Flush Truck in Operation.

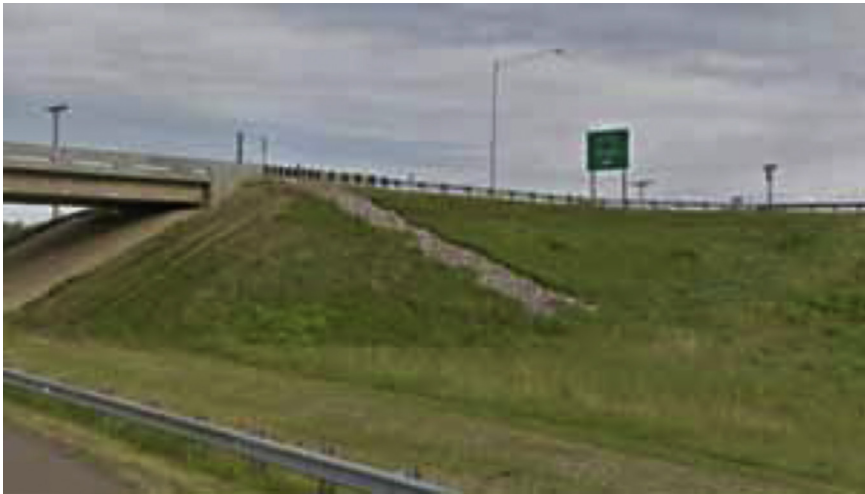
Bridge decks which have drainage over the side through openings in the bridge rail and shorter decks which convey all of their drainage to the end of the bridge still require attention in maintaining gutter lines free from obstructions. Once past the end of the deck, a positive path should be provided from drainage down the gutterline of the approach and down the roadside berm. Off of the bridge this may require clearing vegetation and maintaining flumes constructed from either concrete or rock (Figure 4.4).

Figure 4.4 Rock Flume-Off of Bridge Approach.

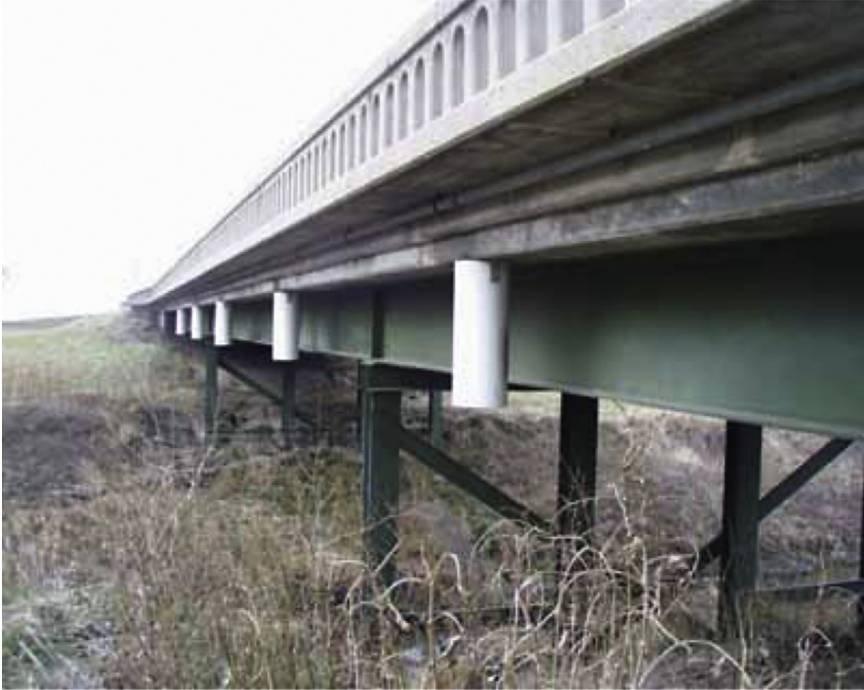
Whether off of the deck or through the deck, drainage should be directed to designated locations to ensure that it contributes to neither erosion at the berm nor to deterioration at the bearings and substructure. Drainage

**Figure 4.5** *Drain Extension Retrofit.*

through the deck should be conveyed below the top of the bearing seats (Figure 4.5).

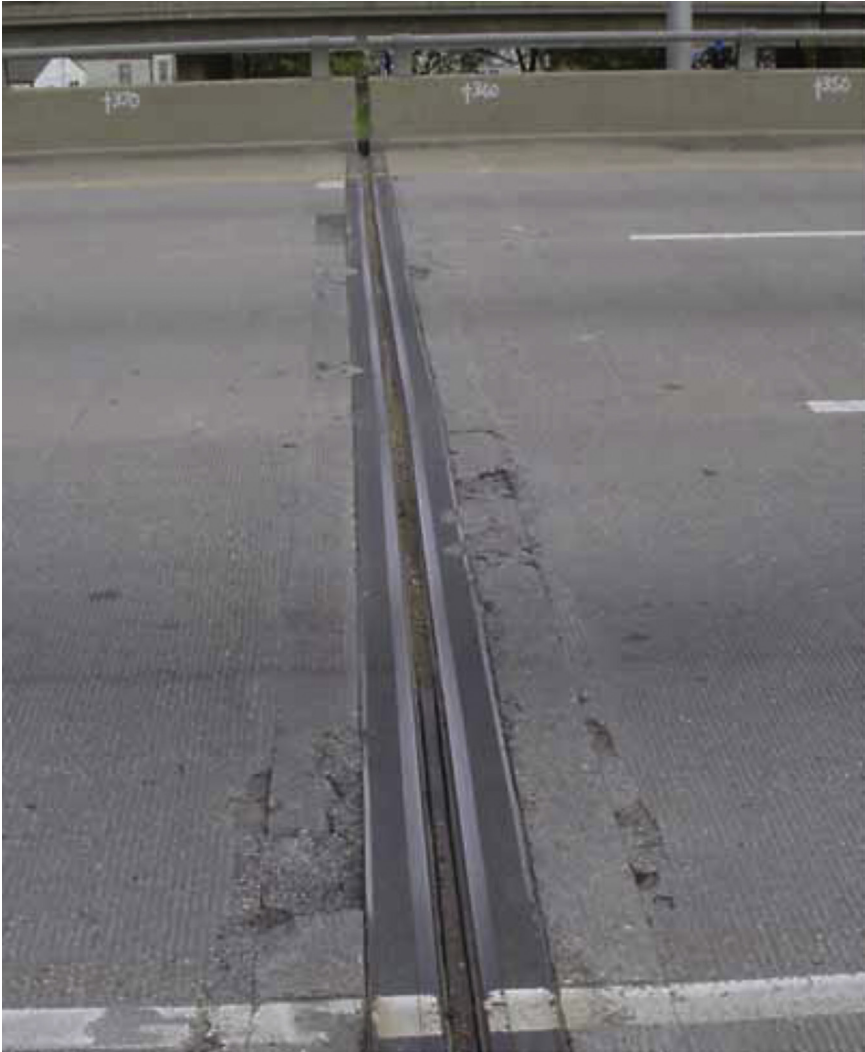
The second priority in deck maintenance is maintaining a relatively smooth wearing surface. For concrete decks, spalling may occur at the edges around expansion joints and drains, or anywhere that corrosion of the underlying reinforcing steel occurs. The spall results in edges that unravel further under subsequent traffic and with freeze/thaw cycles, resulting in growth of the deteriorated area. The best course of action is to address this by patching the area – removing slightly past the damaged area and replacing with new concrete or other patching material. Although maintenance crews often carry out small patching operations of a few square yards, large patching operations are typically handled through substantial maintenance projects. Concrete patching is discussed in Chapter 5 (Figures 4.6 and 4.7).

**Figure 4.6** *Deck Deterioration at Expansion Joint.*

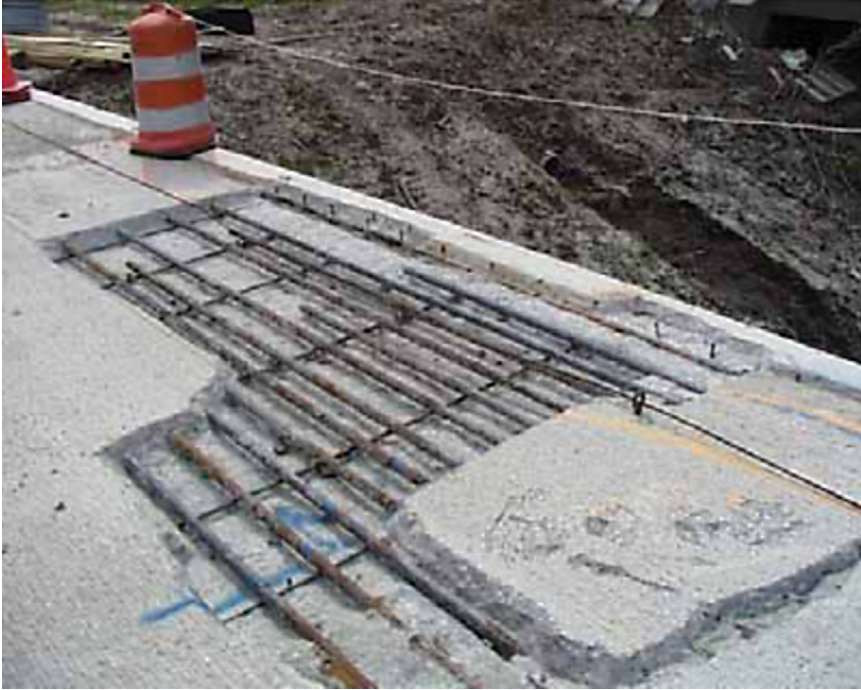
**Figure 4.7** Area Prepared for Partial Depth Patching.

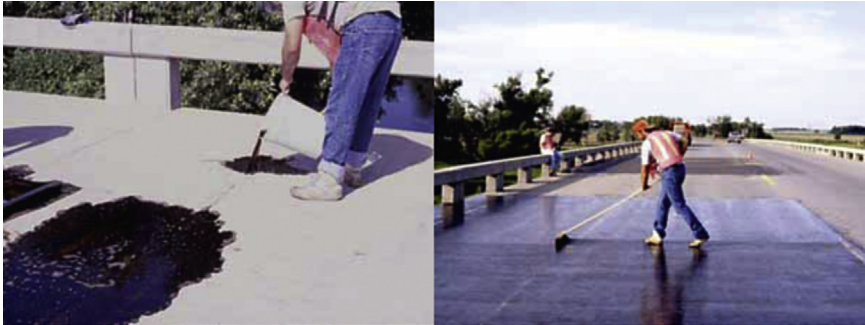
the cement paste inside of the pours. Epoxies and linseed oil form a film at the surface of the pours to prevent penetration (Figure 4.10).

**Figure 4.10** *Deck Sealing Operation.*

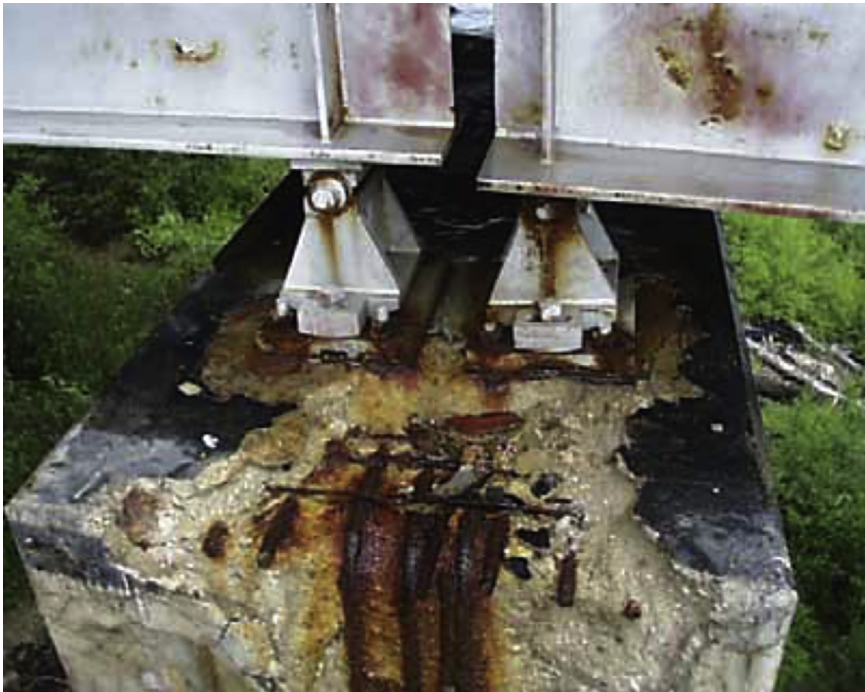
Washing of the bearing seats is an activity that would typically be performed in conjunction with washing the deck and cleaning out expansion joints, as previously discussed. Similar to concrete decks, the concrete surfaces at the bearing seat, including adjacent concrete backwalls and girder ends, may be sealed to prevent water intrusion. A number of the same products are applicable here, as on the deck. At the bearing seat, though, wear from traffic is not a concern. What should be avoided at these locations is applying a membrane-type sealant that does not penetrate into the concrete substrate. A membrane-type sealant forms a relatively thick intact barrier to water. A membrane material which does not seep into the pours of the underlying concrete may also act to trap water at the interface between the material if holidays (i.e., tears) appear in the membrane (Figure 4.11).

Figure 4.11 *Failed Waterproofing Member and Bearing Area Deterioration.*

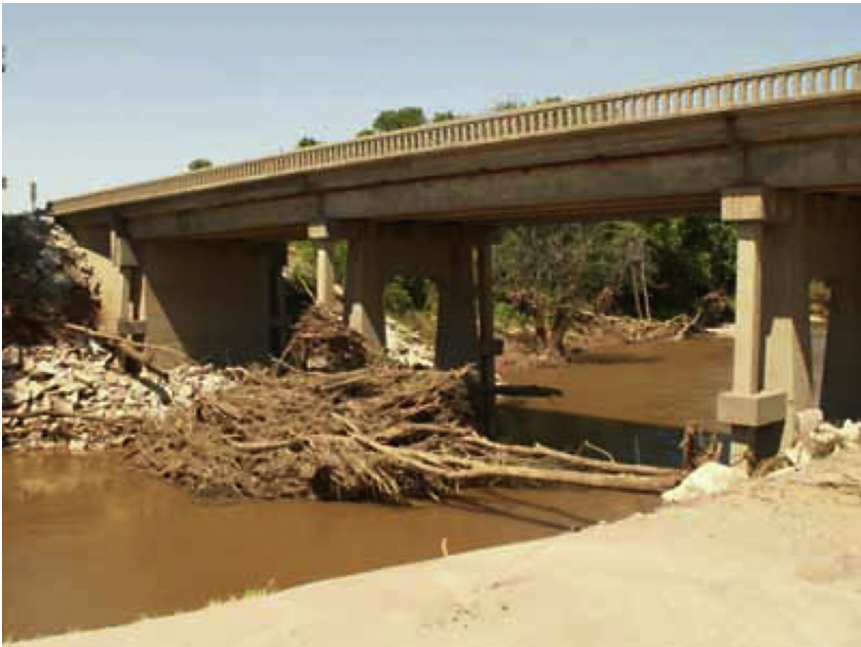
Piers adjacent to waterway channels face a different set of challenges. After high water flows, maintenance crew may find debris in the form of drift wedged between column, or even up into the superstructure. It is essential to remove this in that remaining drift may serve to catch more debris in subsequent high water flows. This serves not only to increase the hydraulic force on the piers, but by narrowing the available waterway opening, back-water elevations are increased as is the velocity of the flow under the bridge. Even after the water levels go down, drift presents a possibility for fires to start under the structure (Figure 4.12).

Figure 4.12 *Example of Drift Accumulation.*

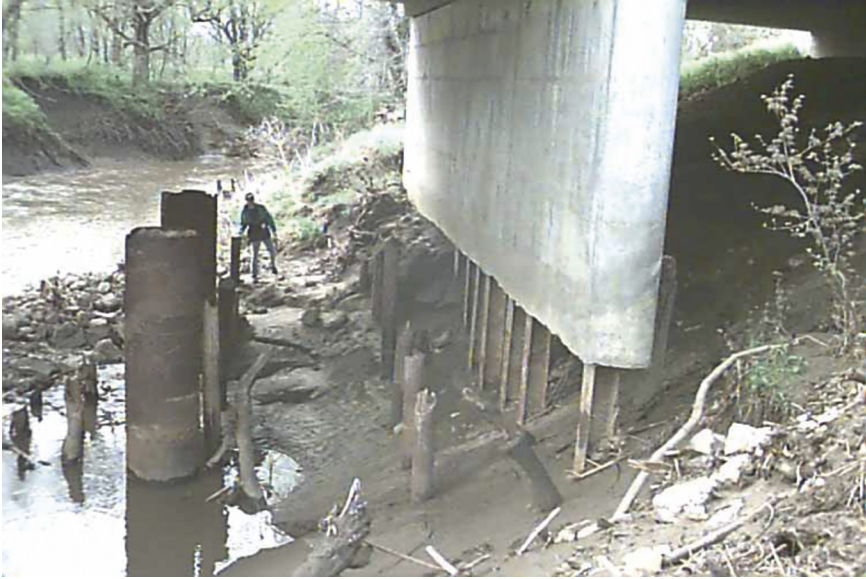
**Figure 4.13** Scour at Pier Wall.

High-water velocities can result in scouring away of the streambed material from foundation elements. Even if the foundation elements are founded deep enough into the geological strata to provide safe capacity, the exposure of an element such as a steel pile to cycles of wet and dry

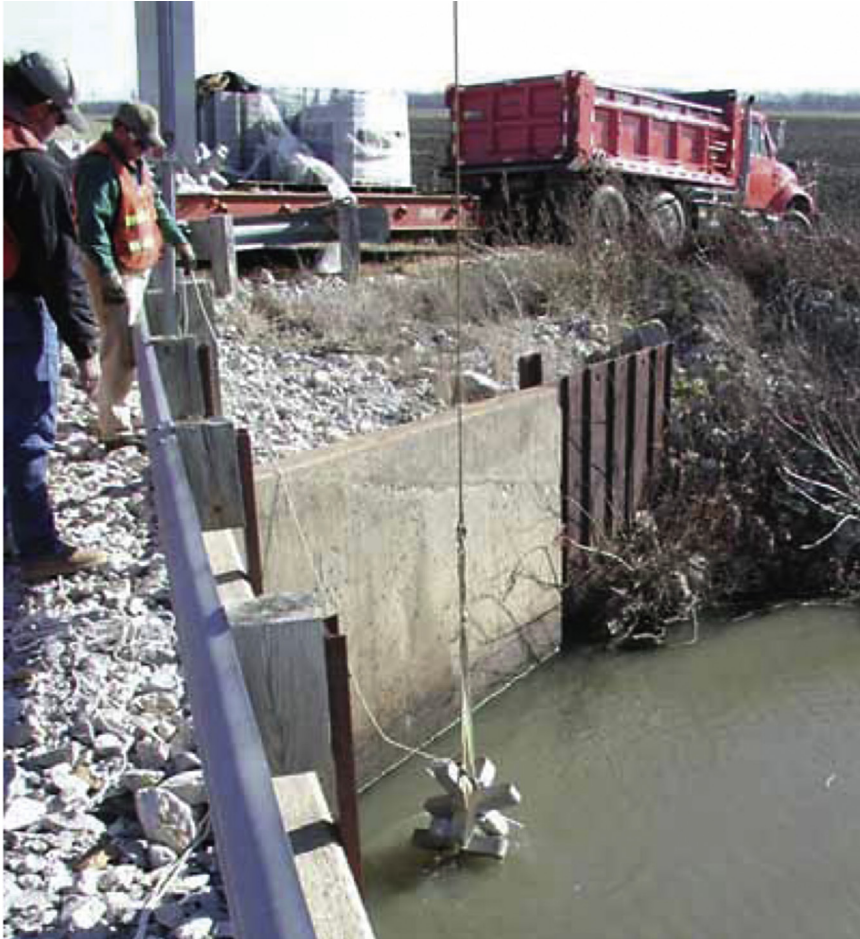
**Figure 4.14** *Maintenance Forces Placing “A-Jacks.”*

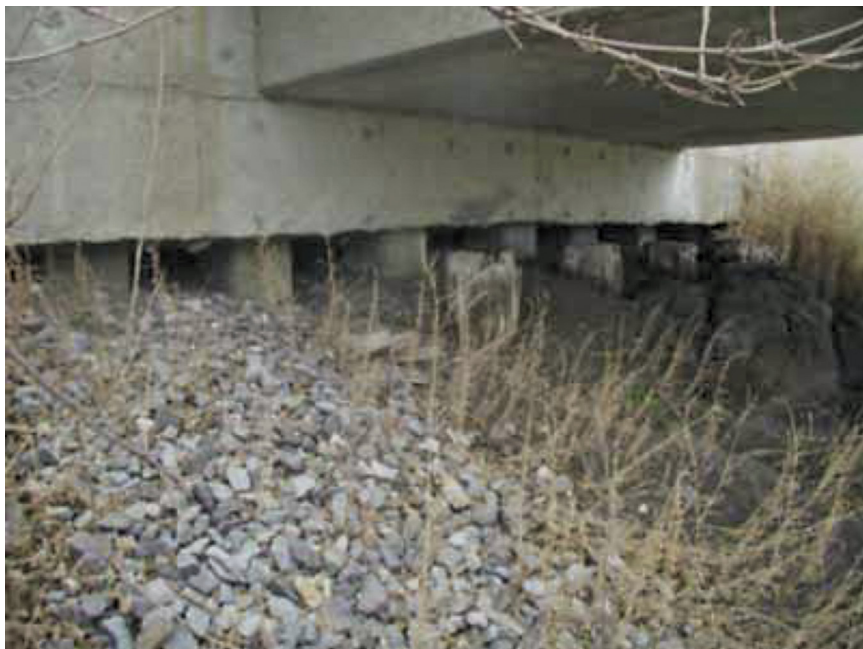
Erosion due to drainage from the roadway can also be addressed with proper grading and the placement of rock. Rock or concrete placed to protect a berm is also known as revetment. Left unchecked, improper drainage at the berms can find its way back to the abutment and expose the foundation elements under the abutment beam (Figures 4.15 and 4.16).

**Figure 4.15** *Erosion Under Abutment.*

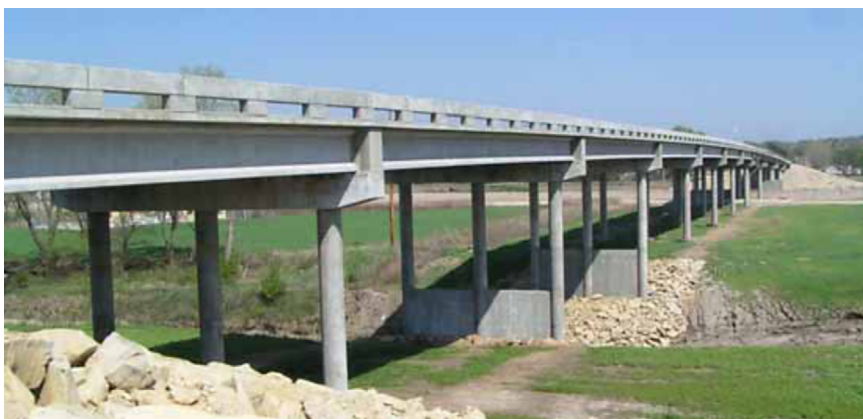
**Figure 4.16** *Use of Stone as Revetment at Berms and Scour Protection at Piers.*

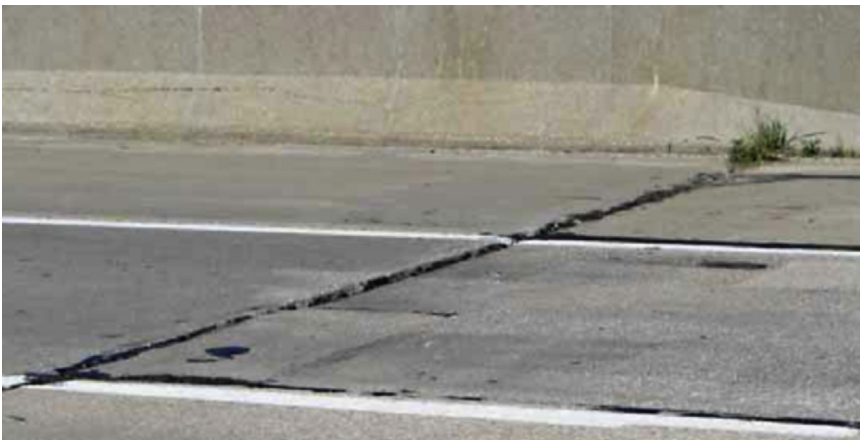
Figure 4.17 *Settlement of Approach Slab.*

The most ubiquitous problem concerning approaches and bridge maintenance is the “bump at the end of the bridge”, typically resulting from settlement of the approach relative to the bridge. Bridges are usually founded on deep foundations to ensure that they will not settle, while approach roadways are treated as pavement structures founded on the soil mantle at the site. Proper drainage away from the roadbed will do much to prevent settlement of the approach. Settlement is often caused as the fine material in the underlying soil matrix is washed out, leaving a void underneath the approach (Figure 4.17).

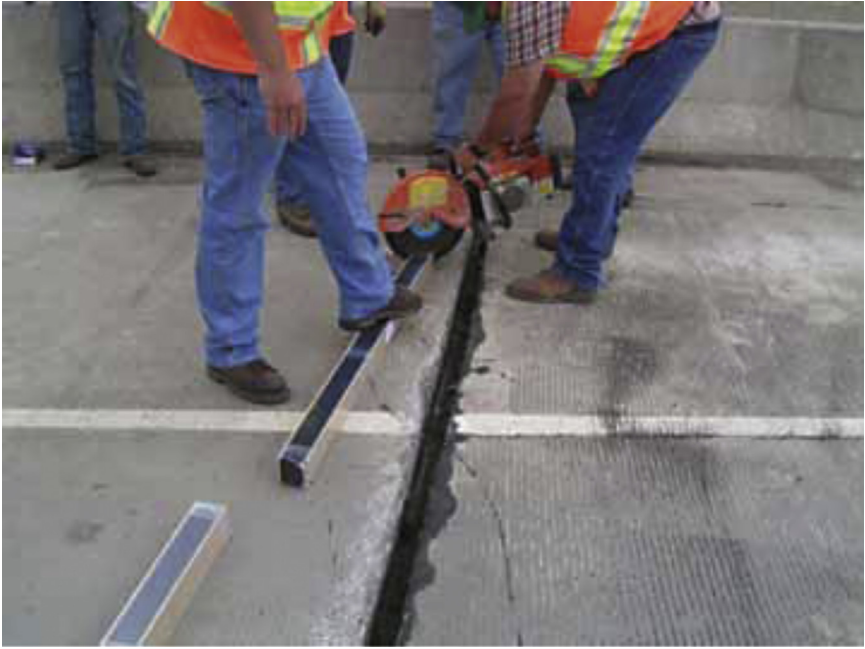
Approaches can also suffer distress from the growth of adjacent concrete pavement. Concrete pavement grows in length as sand or other incompressible particles penetrate into the saw cut contraction joints in concrete pavement over cycles of cold weather contraction and placement of salt and sand during the winter. To compensate, maintenance forces can cut relief joints at the road-end of the approach and install a compressible watertight joint. An opening, no more than 4 in. in width is cut. A number of joint systems are available, but a polymer impregnated polyurethane foam system appears to be the easiest for maintenance crews to install and maintain (Figure 4.20).

**Figure 4.20** *Installation of Pressure Relief Joint.*

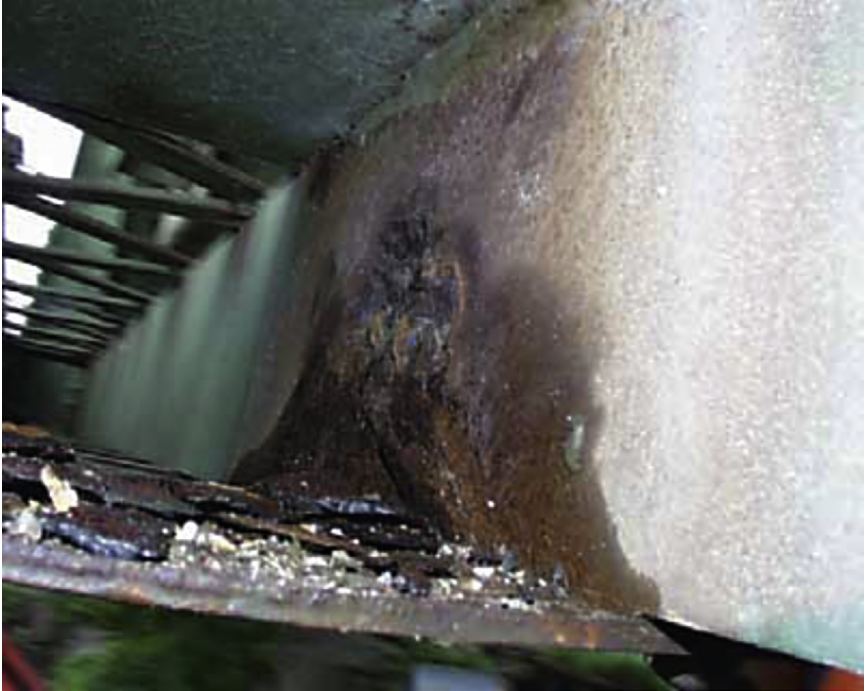
The initial effort to repair the effects of corrosion is to stop its growth, and therefore prevent any further loss of capacity. This entails removing existing corrosion products and protecting the area with a paint system, and addressing any contributing deficiencies in immediately environment, such as leaking expansion joints. Painting may be done as part of repainting the entire superstructure or by spot painting, as discussed in Chapter 4. If the loss of section is not great enough to significantly impact the capacity of the member, this may be the limit of the scope of the repair (Figure 5.19).

**Figure 5.19** *Section Loss Inside of Truss Chord.*

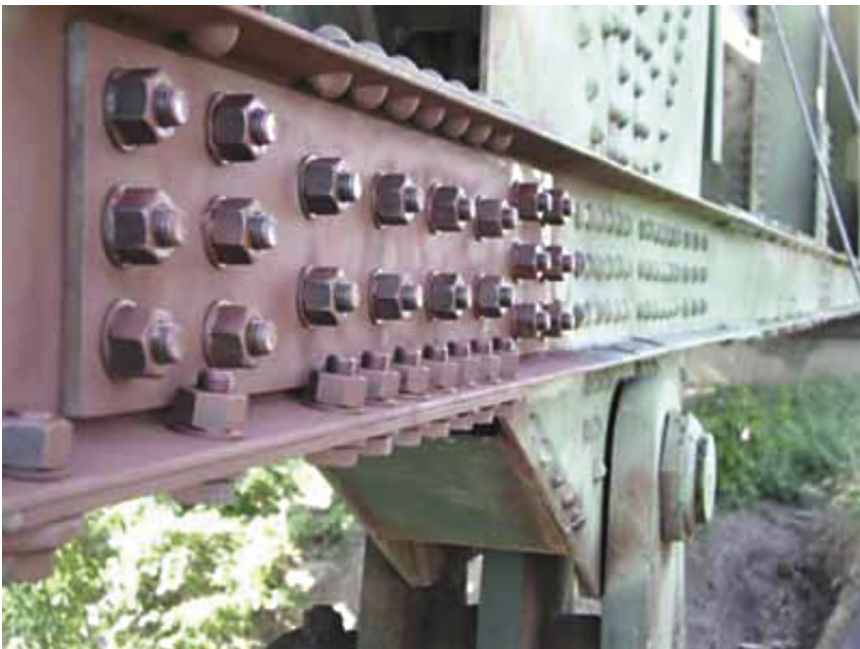
rotation. Additionally, welding may be significantly more costly do to than bolting since a certified welder and subsequent material inspection of the welding is required. For these reasons, in maintenance work, the preference is to use bolted connections if it is possible to develop the required capacity at the location of the repair (Figure 5.20).

Figure 5.20 *Repair Splice in Truss Chord.*

When designing a bolted splice connection, consideration must be given to the degree of surface preparation possible at the site of the repair. The default bolted connection type for the design of a modern steel highway bridge is slip critical. In a slip critical connection, adjoining plates are pulled into contact with sufficient force by the tension in high strength bolts to develop sufficient friction that the plates will not slip from each other when the member deflects. The alternative to a slip critical connection is a bearing connection. In a bearing connection the adjoining plates slip relative to each other when the member deflects until the bolts contact the edges of the bolt hole. A slip critical connection precludes fatiguing of the bolts or unwanted rotation between plates under normal service loads. However, to develop the necessary friction, the contacting surfaces must meet a certain surface profile. If it is not possible to achieve the required surface preparation, a bearing connection must be used.

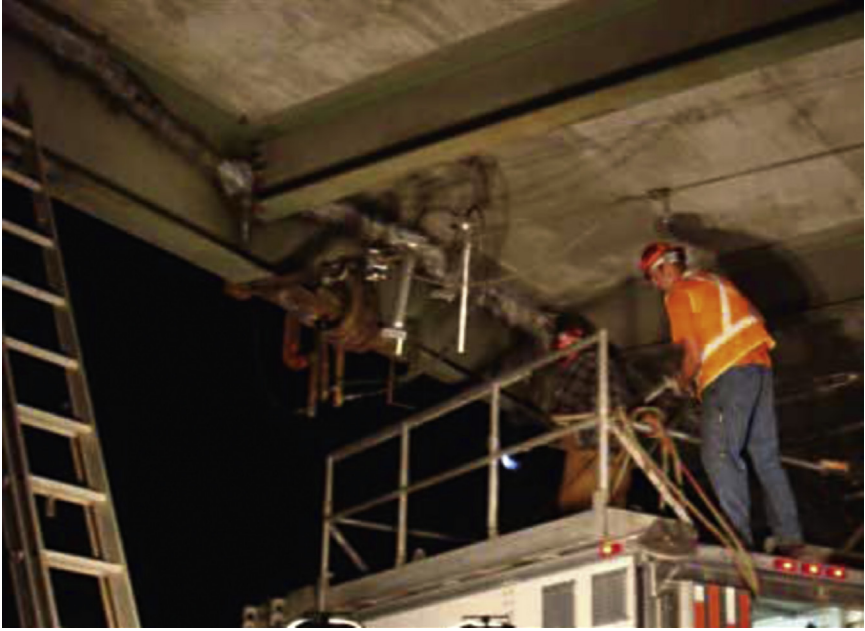
**Figure 5.24** *Restraint Applied to Girder Being Heat Straightened.*

force during heat straightening is only to restrain, not to cause movement (Figure 5.24). To that end, the FHWA guide provides procedures for calculating the maximum allowable force. The moments produced by restraint jacks on the member should be less than half of the plastic moment capacity of the section less any residual moments from the impact as determined by a plastic analysis. In lieu of calculating residual moments, a limit of one-quarter of the plastic moment capacity of the section may be used.

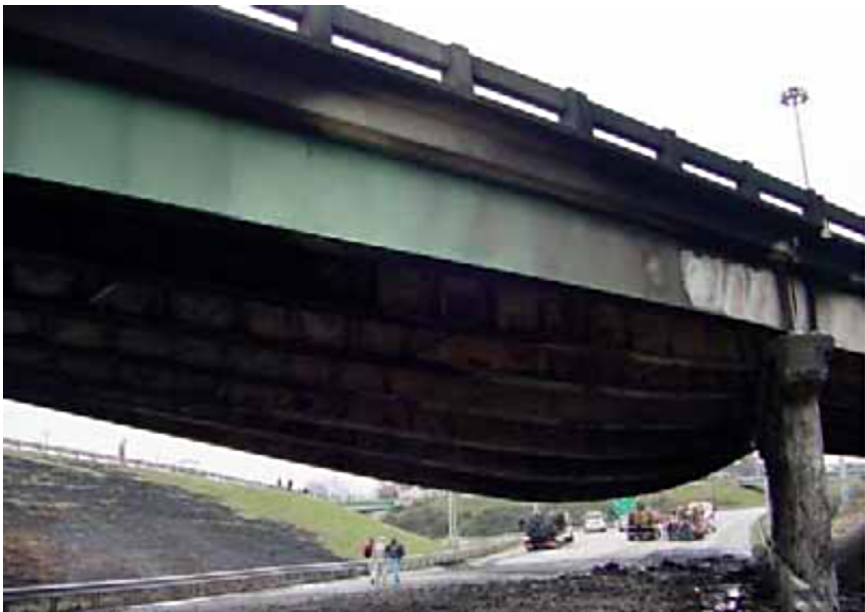
**Figure 5.25** *Fire Damaged Steel Girders.* (Adapted from Federal Highway Administration. *Bridge Inspector's Reference Manual*. FHWA-NHI 12-049. Washington, DC; US Department of Transportation; 2012).

The primary damage to steel members from fire is plastic deformation. However, heat straightening is typically not an option to repair members deformed from fire. At temperatures over 1300°F, steel undergoes a phase transition and potential changes in material properties. Even if the temperature of the steel remained below this, if water was sprayed on the steel while the fire was being suppressed, the rapid cooling will have a delirious effect on member properties. For substantially deformed members, the only repair option is replacement.

International Standard E1529, *Standard Test Methods for Determining Effects of Large Hydrocarbon Pool Fires on Structural Members and Assemblies*, climbs to 2000°F within 5 min (Figure 5.25).

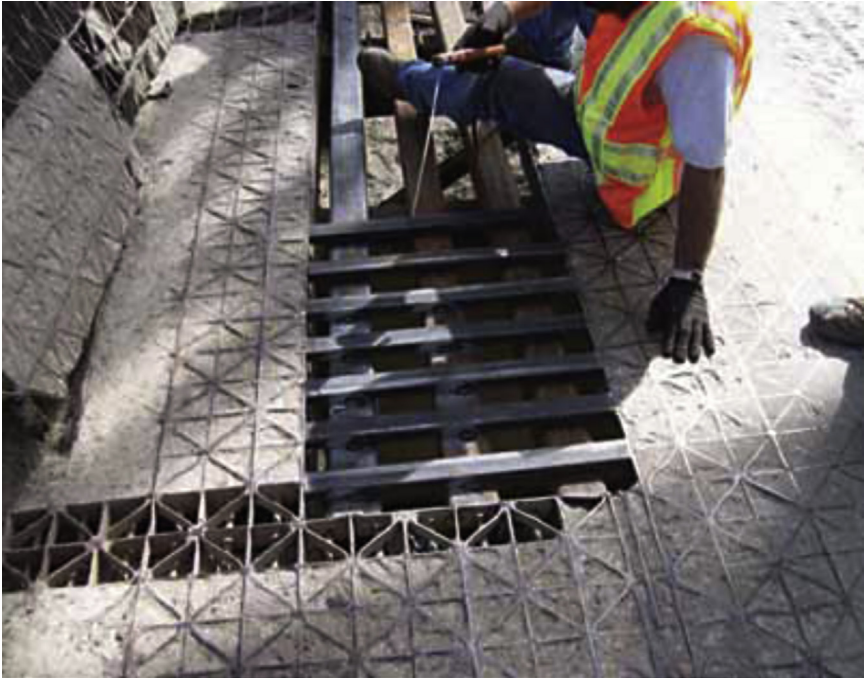
**Figure 5.32** *Repair of Steel Grid Deck.*

exposure to water and deicing salts is expected. Continuous exposure to moisture will drive corrosion in weathering steel past the formation of its characteristic protective patina. For a weathering steel grid deck, the result is not only loss of section to corrosion, but growth of the deck itself. As a result, the deck will bow upward requiring repair by cutting the deck, realigning it and reattaching (Figure 5.32).

The other types of deck construction on highway bridges are steel grid, timber, and FRP. Steel grid decks are used primarily on long span structures where the savings in material weight result in less loading on the span structure. The main substantial maintenance issue with these decks is repairing broken grids and steel supports underneath. The steel will fracture due to corrosion and loading from traffic and from thermal expansion and contraction. It should be noted that there was a period in the early 1980s when grid deck panels made from weathering steel were available. Weathering steel is not suited for use in this application, or for expansion joints or any other use where continuous

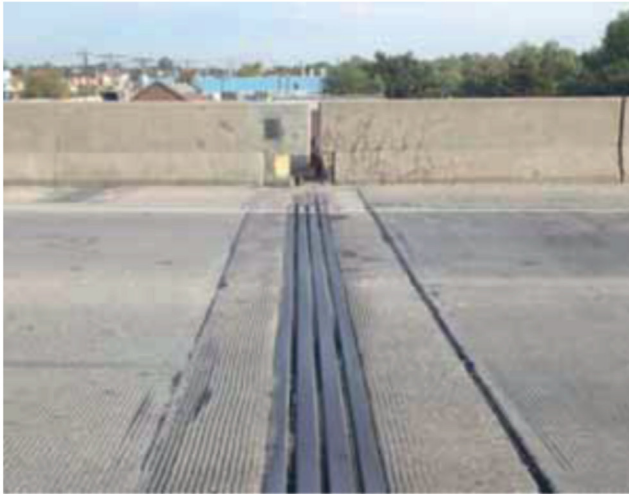
**Figure 5.38** *Modular Joint Expansion Joint.*

Sealed joints use a gland or membrane to prevent water from traveling through. Instead, water is conveyed down the gland, following the cross-slope of the road, to the curb line. If sealed joints are not kept clean of debris, they can tear and allow water onto the substructure (Figures 5.37 and 5.38).

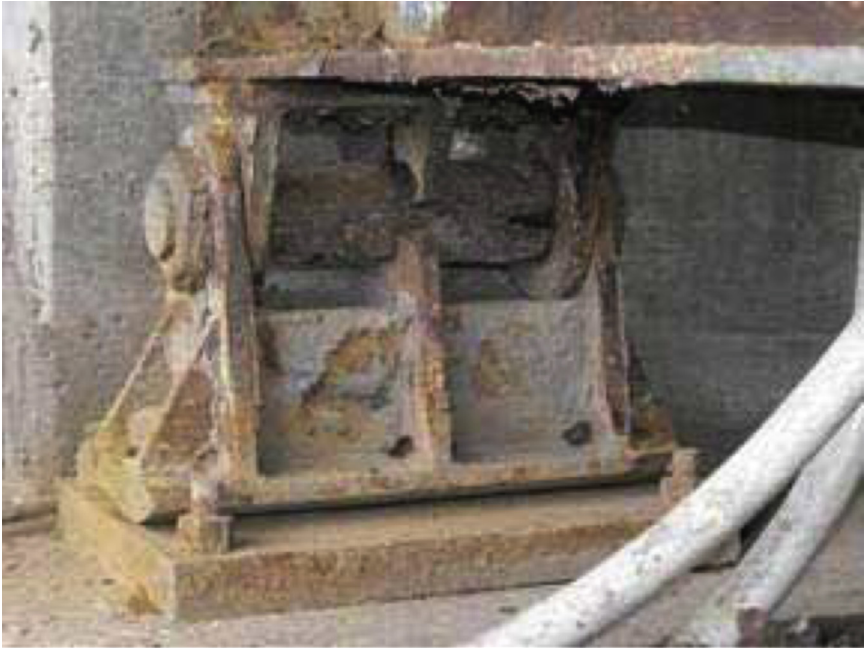
Figure 5.44 *Deteriorated Steel Rocker Bearing.*

The minimal substantial maintenance for corroded steel bearings is to clean and paint them. If there has been loss of section, or if mating surfaces are simply too heavily pitted, components of the bearing device replaced. Severely corroded bearings may be replaced, entirely (Figure 5.44).
