# HIGHWAY BRIDGE MAINTENANCE PLANNING AND SCHEDULING

**MARK HURT**

**STEVEN D. SCHROCK**

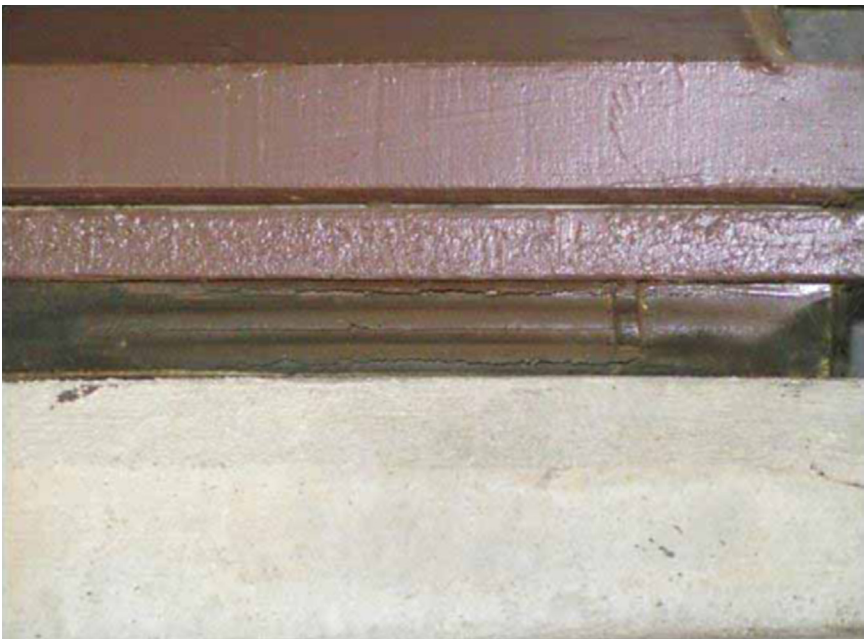
Figure 5.45 *Splitting of Reinforced Elastomeric Bearing.*

Elastomeric bearings do not rust, but the material can deteriorate, particularly if loads encountered in service are greater than those assumed in design or if the fabrication of the bearing did not meet specifications. Bearings with reinforced elastomeric pads may be replaced if the material is split or severely cracked (Figure 5.45).

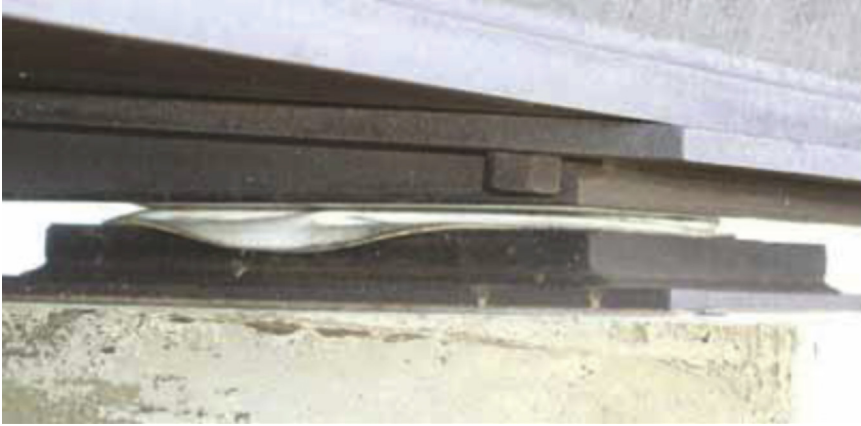
**Figure 5.46** *Teflon Sliding From PTFE Bearing.*

by the brand name Teflon™). This sheet may “walk out” if not properly set. Maintenance actions may be needed to reset the PTFE sheet (Figure 5.46).

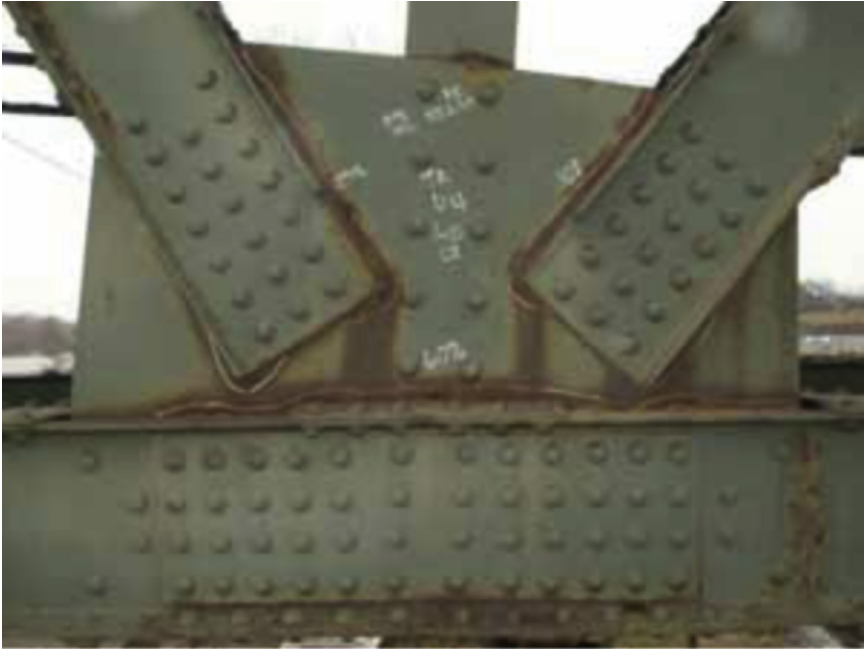
Figure 5.48 Deteriorated Gusset Plate on Steel Truss Bridge.

Gusset plates, particularly on the lower chords, receive a great deal of exposure to moisture and road salts, which may sit in the corners and crevices of the connection. The moisture and salt will continue to drive corrosion after the rest of the superstructure has dried. Any loss of section identified in bridge inspections should be evaluated by the methods discussed in the FHWA publication, *Load Rating Guidance and Examples for Bolted and Riveted Gusset Plates in Truss Bridges* [11]; and the AASHTO *Manual for Bridge Evaluation* [12]. If repair is required, it will typically consist of adding steel section across the predicted failure plane and replacing rivet with high-strength bolts (Figures 5.48 and 5.49).

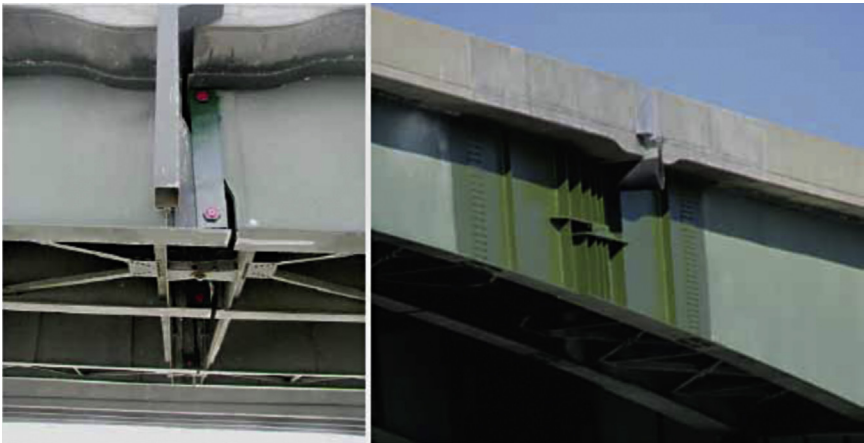
**Figure 5.52** *Replacement of Pin and Hanger Joint With Shelf.*

A third option is to replace the pin and hanger with a more robust joint configuration, such as a shelf (Figure 5.52). In this configuration, the suspended span rests on an elastomeric bearing device on a shelf protruding from the cantilever span. This does not change the configuration of the girder for moment distribution, but provides a joint that has better access for inspection and is less vulnerable to corrosion.

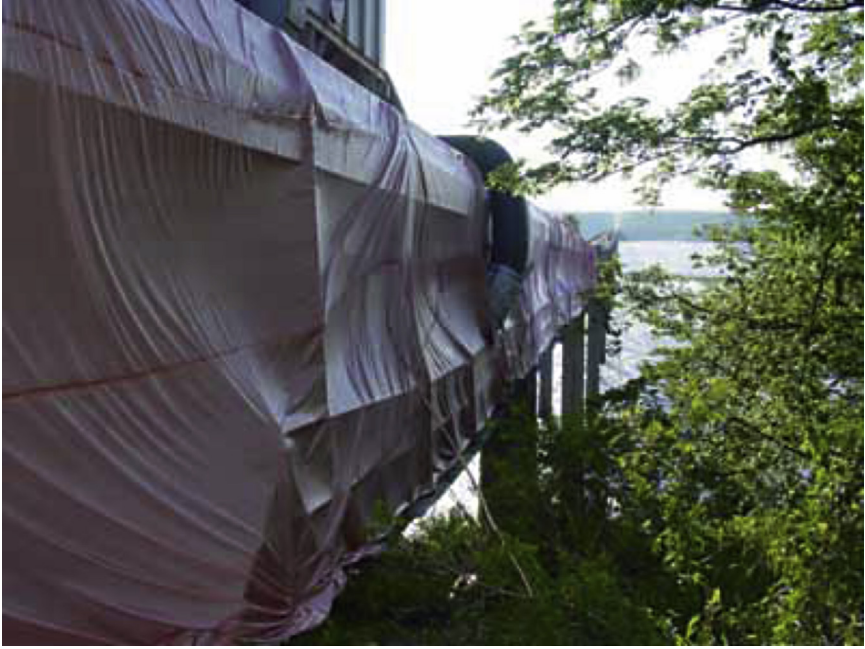
**Figure 5.53** *Containment for Paint Removal on Steel Girder Bridge.*

Much of the cost of repainting is attributable to the cost of removing existing paint systems and properly preparing the surface. Most paint systems require the preparation of the surface to be completely free of any oil, mill scale, corrosion products of other contaminants in any  $3 \times 3$  in. area over 95% of the surface. This is referred to as near-white, as that the prepared surface should shine, and must remain free of contaminants until the new paint is applied. Some more tolerant paint systems utilizing organic primers may only require a commercial-blast quality of preparation, which requires 66.7% of surface in any  $3 \times 3$  in. area to be completely free from contamination (Figure 5.53).

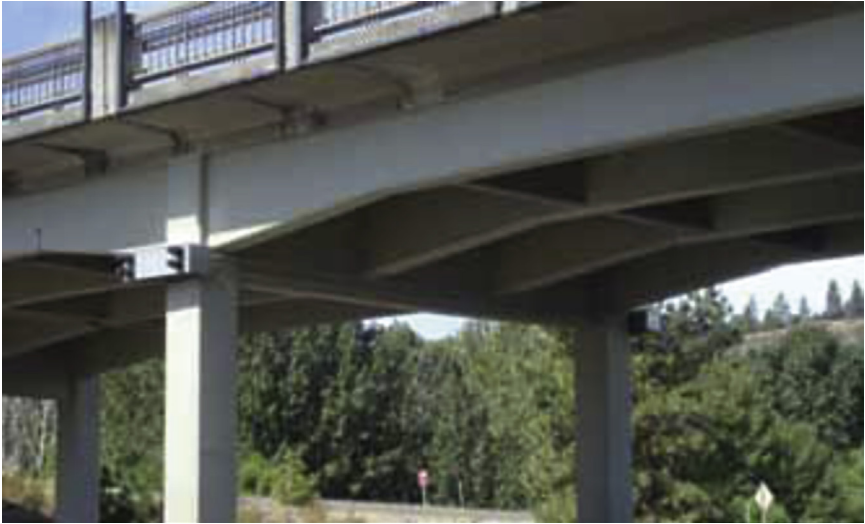
Figure 5.55 *Posttension Retrofit of Pier Cap.*

Similar to its use as a retrofit for steel superstructures, post-tensioning can be used to introduce compressive stresses, counter deflections, and increase flexural capacity of reinforced concrete members (Figure 5.55).

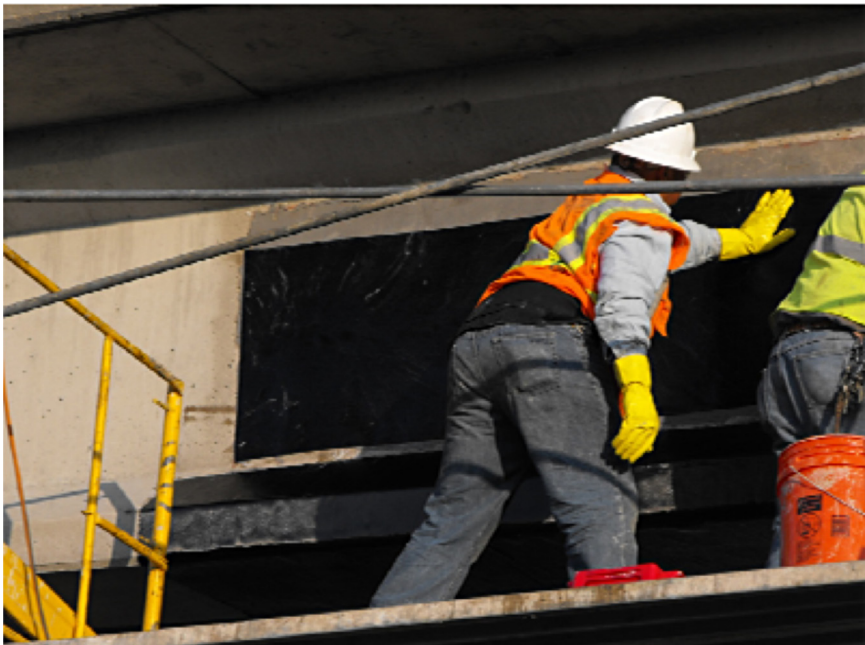
Figure 5.56 *Installation of FRP Repair on Prestress Concrete Beam.*

The method that has come to be preferred for adding shear and/or flexural capacity to reinforced concrete members is the use of FRP reinforcing (Figure 5.56). Note, that most bridge owners prefer carbon fiber material,

rather than glass fibers, for structural uses due to its superior strength. Using externally bonded FRP reinforcing strips provides for a significant increase in strength without the need for heavy construction equipment or prolonged construction times. Work in the field to apply FRP consists of concrete surface repair of any damaged concrete at the location of attachment for the FRP to provide a sound substrate, followed by a final cleaning, applying the reinforcing strips, and then the application of any protective coat to seal out ultraviolet light from FRP material.

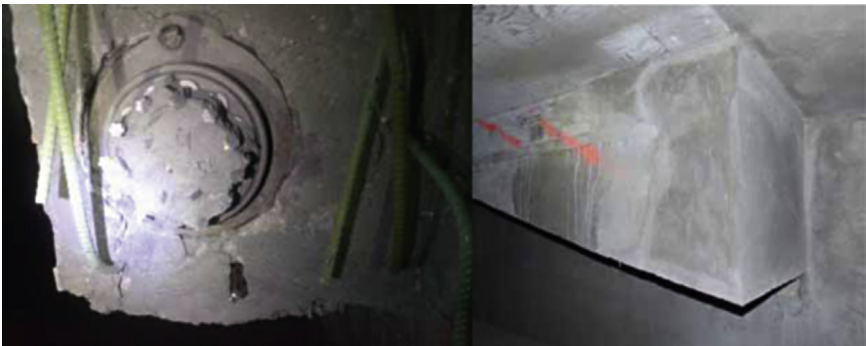
Figure 5.59 *Repair of Posttensioning Anchorage.*

In 2013, the FHWA issued the publication, *Guidelines for Sampling, Assessing, and Restoring Defective Grout in Prestressed Concrete Bridge Post-Tensioning Ducts* [18]. It provides direction on how to conduct a physical investigation of post-tensioning ducts, and on the sampling of in place grout and subsequent material investigation. Using Non-Destructive Testing (NDT) methods such as ultrasound and ground-penetrating radar, post-tensioning ducts are located. A small area of the concrete cover is removed and the top of the duct is drilled into. The interior is inspected for voids and grout samples are taken. If a void is present, the hole may be capped to retain access for subsequent regrouting (Figure 5.59).

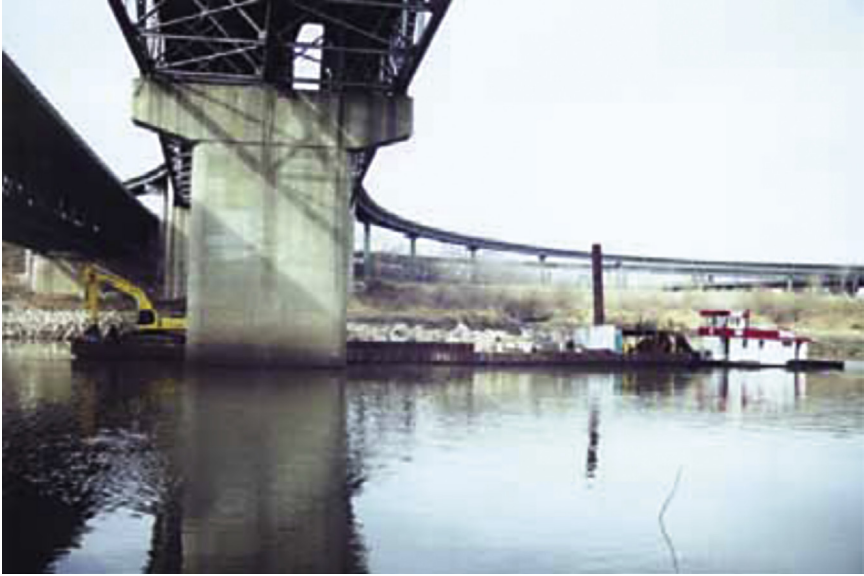
Figure 5.61 *Placing Rock Around Pier in Missouri River.*

Hydraulic Engineering Circular #23 (HEC-23), *Bridge Scour and Stream Instability Countermeasures Experience, Selection and Design Guidance* by the FHWA discusses the selection and design of various hydraulic countermeasures for river training and for armoring to protect bridge piers and abutments [19]. River training countermeasures are intended to alter the flow and velocity of water to mitigate adverse erosion or deposition of streambed material along a reach of the channel. Armoring protects the streambed from hydraulic stresses, and therefore, erosion. Other than rock riprap, there are other options for armoring at piers. They are typically shaped concrete products (like A-Jacks™) with greater capacity for interlocking than does rock, or bags of cement or grout which may be more convenient to locate and handle than large diameter rock. The majority of armoring used, though, is rock riprap (Figure 5.61).

The width of the mat of riprap should extend upstream and downstream a minimum of twice the pier width parallel to the direction of flow. The top of the mat should be the same elevation as the streambed in normal flow. Burying the mat may hide it from bridge inspectors, while protruding

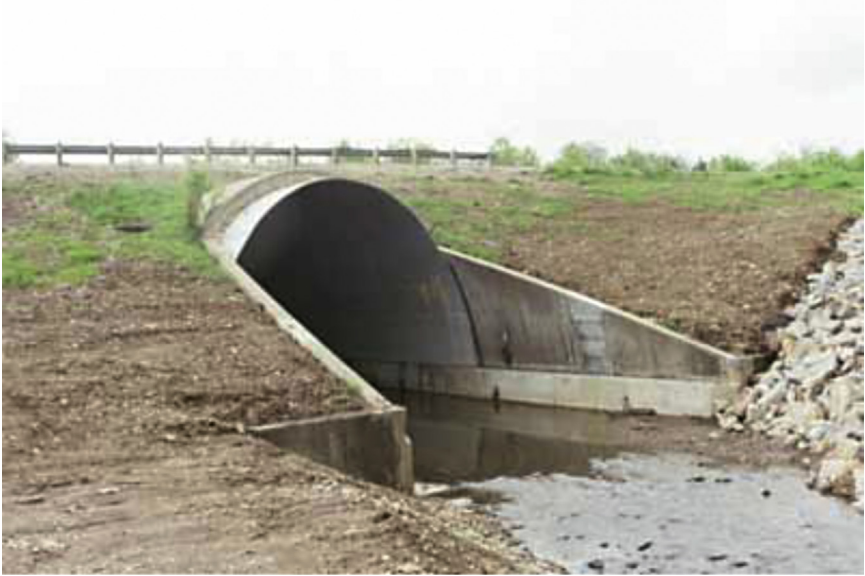
**Figure 5.66** Reinforced Concrete Arch Culvert Lined With Corrugated Steel.

For reinforced concrete culverts, repair of the deteriorated concrete by patching is problematic if the deterioration extends completely through the section (Figure 5.66). In this case, lining is done by construction of a corrugated metal arch inside the opening and the annular void is filled with grout.

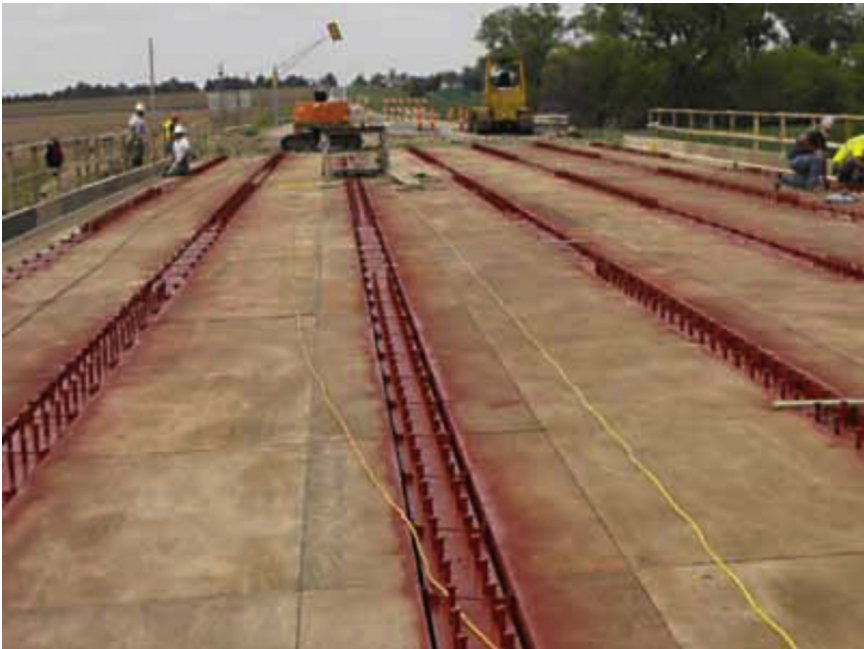
Figure 5.67 Deck Forming for Redeck Project.

It is common to make replacement deck acts compositely with existing steel girders with the addition of headed steel studs to the top flange. This also reduces live load deflections in the rehabilitated structure (Figure 5.67).

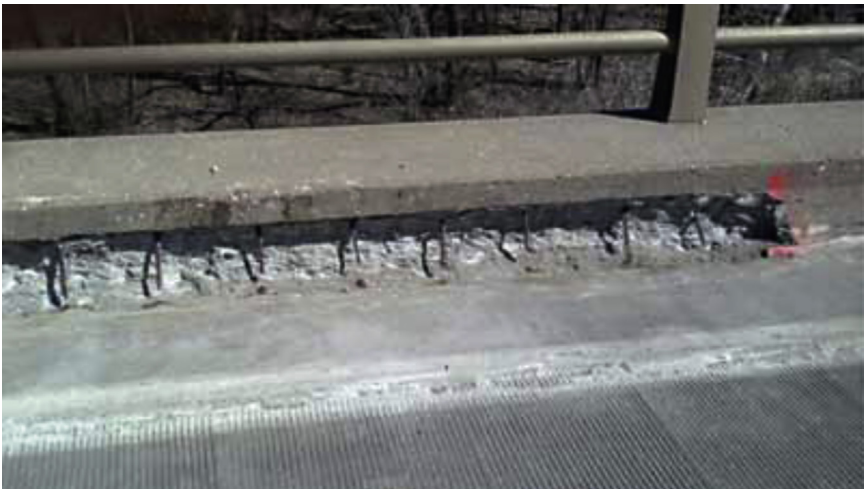
Figure 6.10 *Deteriorated Reinforcing Steel in Parapet (KDOT).*

The first use may be best illustrated by means of a real life example. During contracted deck repairs to a reinforced concrete deck girder bridge carrying K-177 over Munker's Creek near Council Grove, Kansas, the deterioration to the existing parapet and deck at the curb line was found to be significant enough so as to require removal of the parapet with the bridge railing (Figure 6.10). The reinforcing steel had corroded to the point where the parapet was liable to separate from bridge with a vehicular impact. Almost all the reinforcing steel between the deck and the parapet would have

to be replaced. The most economical repair alternative would be to remove and replace the entire length of bridge rail and parapet on each side of the bridge. This added work would cost more than the bridge work in the original contract bid.
