The 2016 Mw 7.1 Kumamoto Earthquake

A Photographic Atlas of Coseismic Surface Ruptures
Related to the Aso Volcano, Japan

Aiming Lin
Department of Geophysics
Kyoto University
Kyoto, Japan

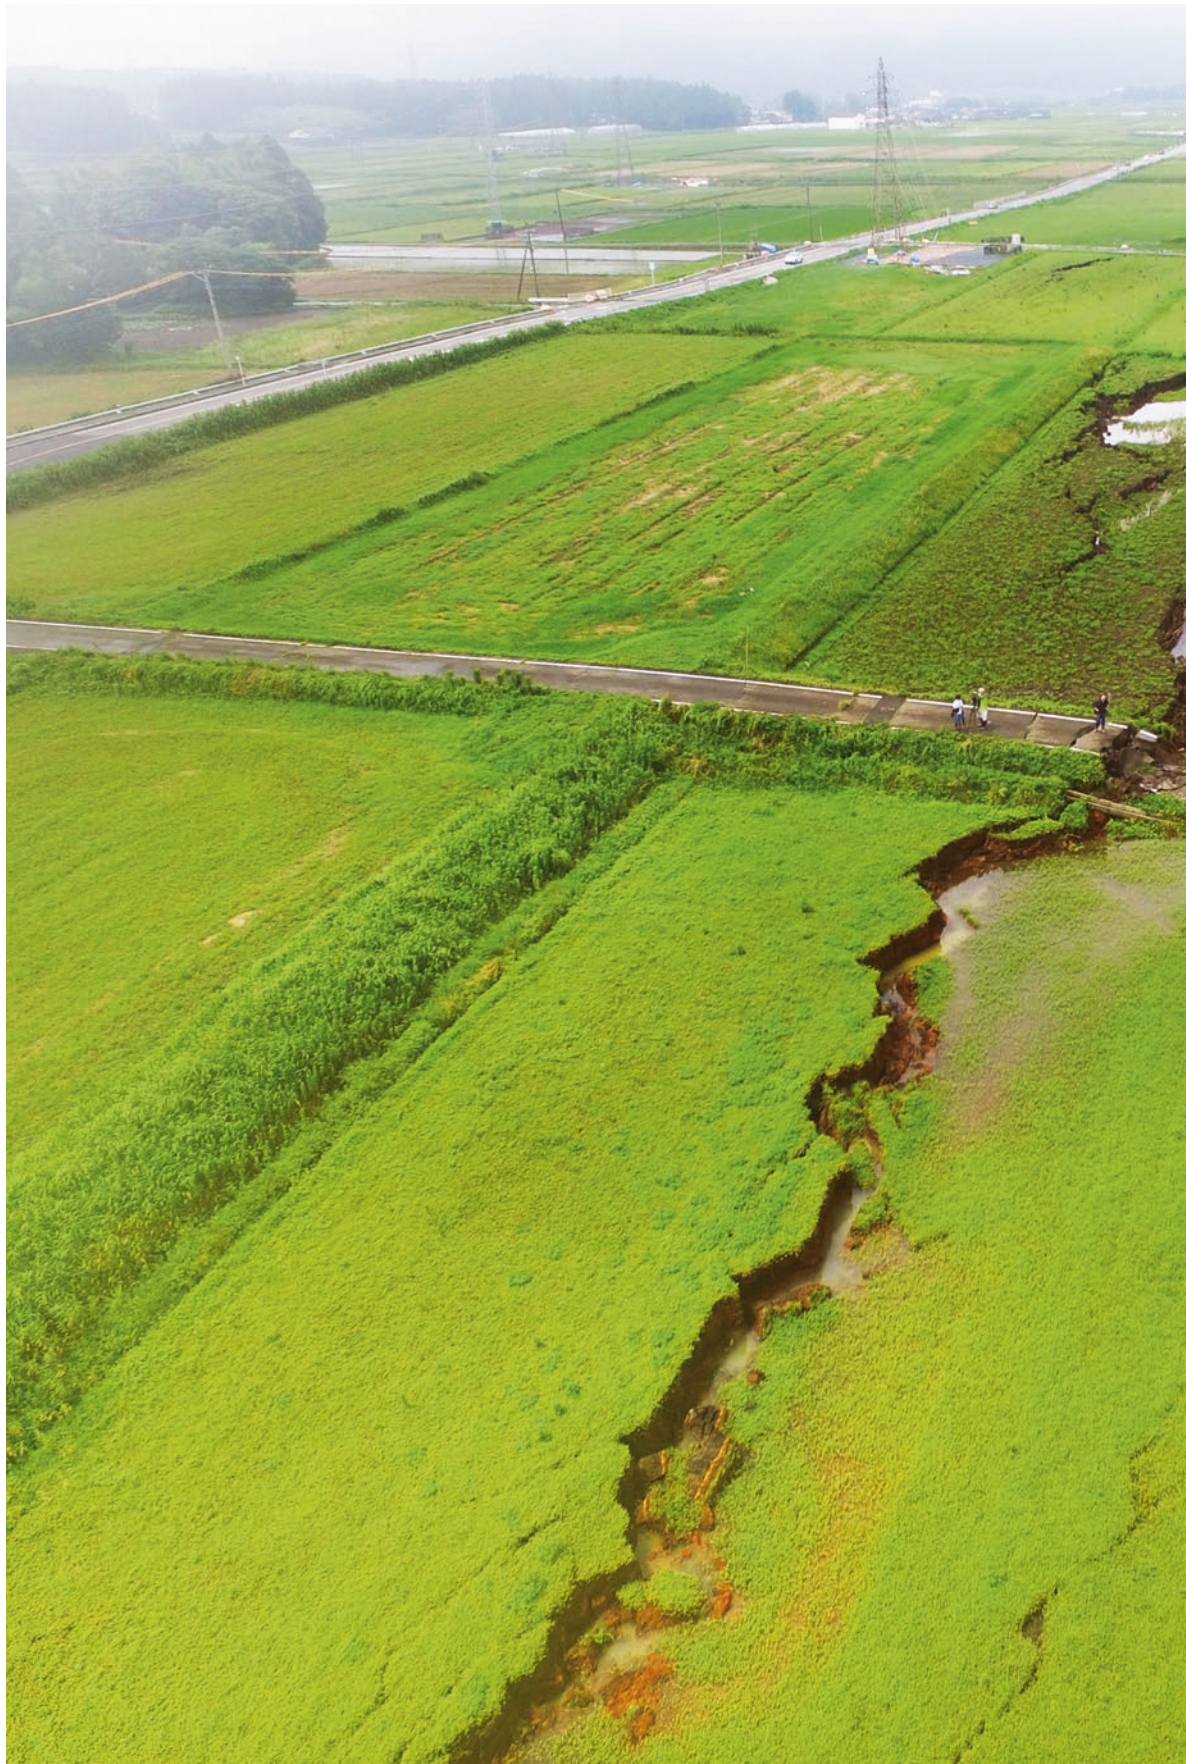
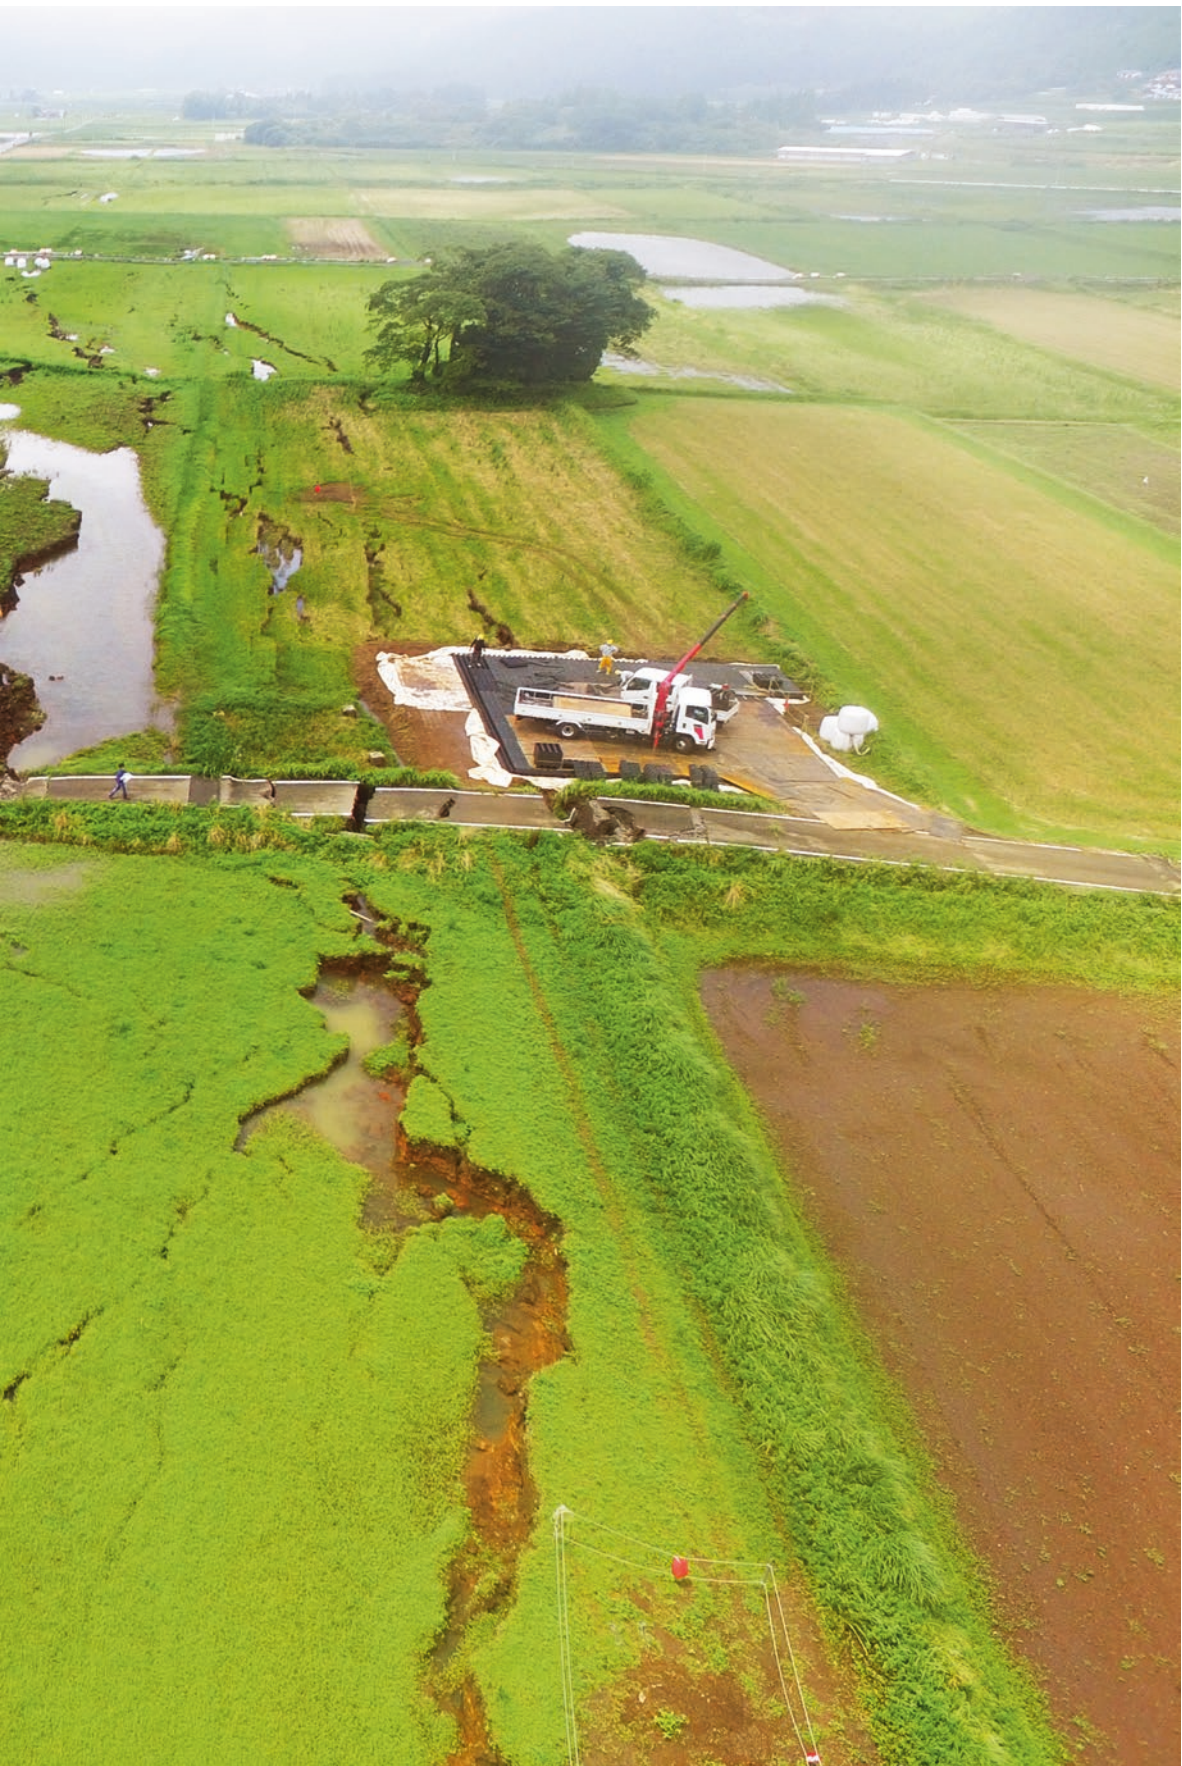
Figure Plate 2 Drone image showing a coseismic graben structure on the western side of the Aso caldera

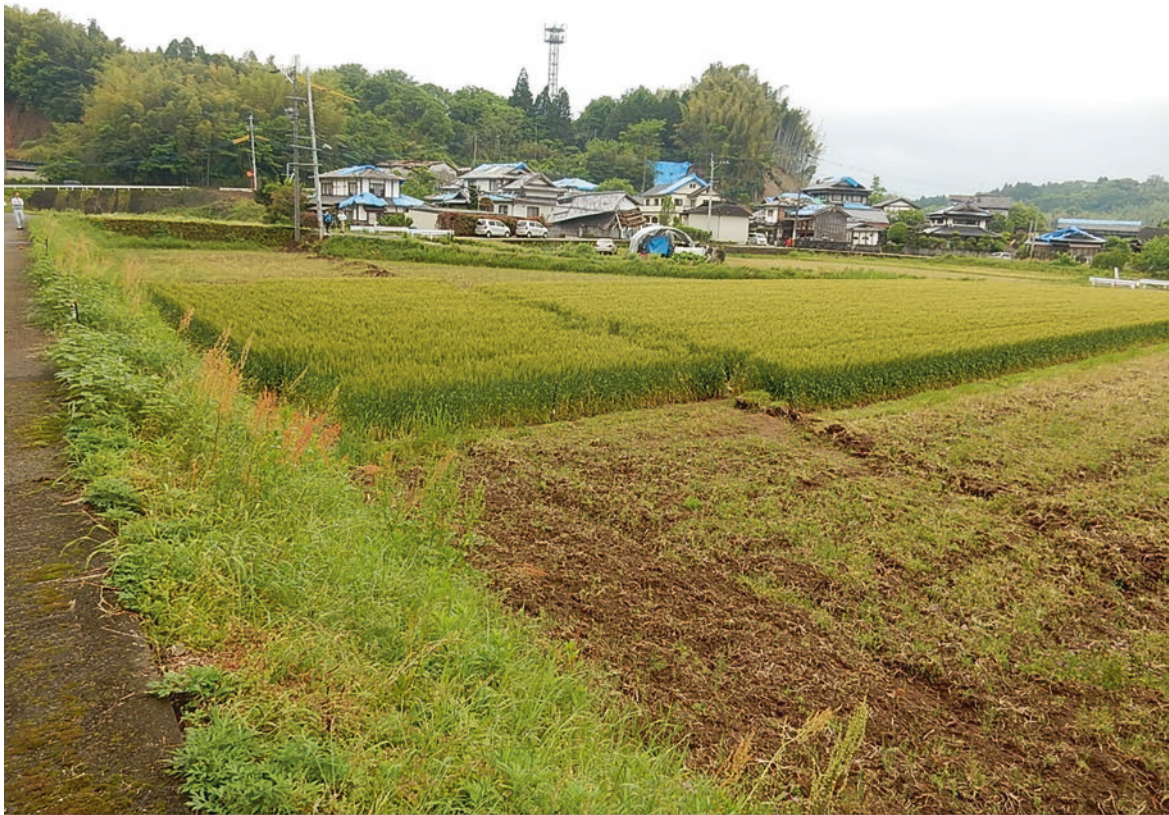
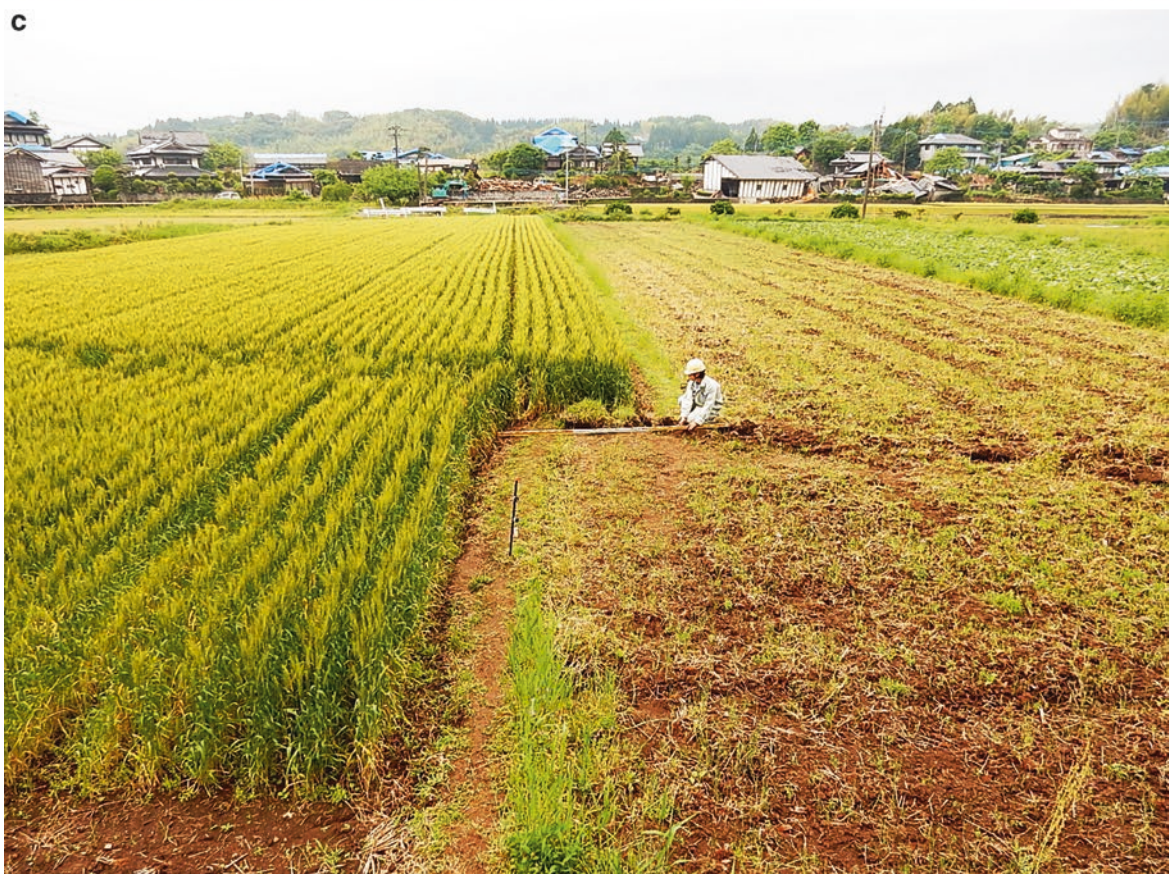
Figure Plate 3 Right-lateral strike-slip offset of wheat fields in the coseismic surface rupture zone. (a) Aerial photograph (with permission from The Mainichi Newspapers). (b, c) Strike-slip offset of field paths,

measuring ~2.5 m, which was the maximum displacement in the 2016 coseismic surface rupture zone

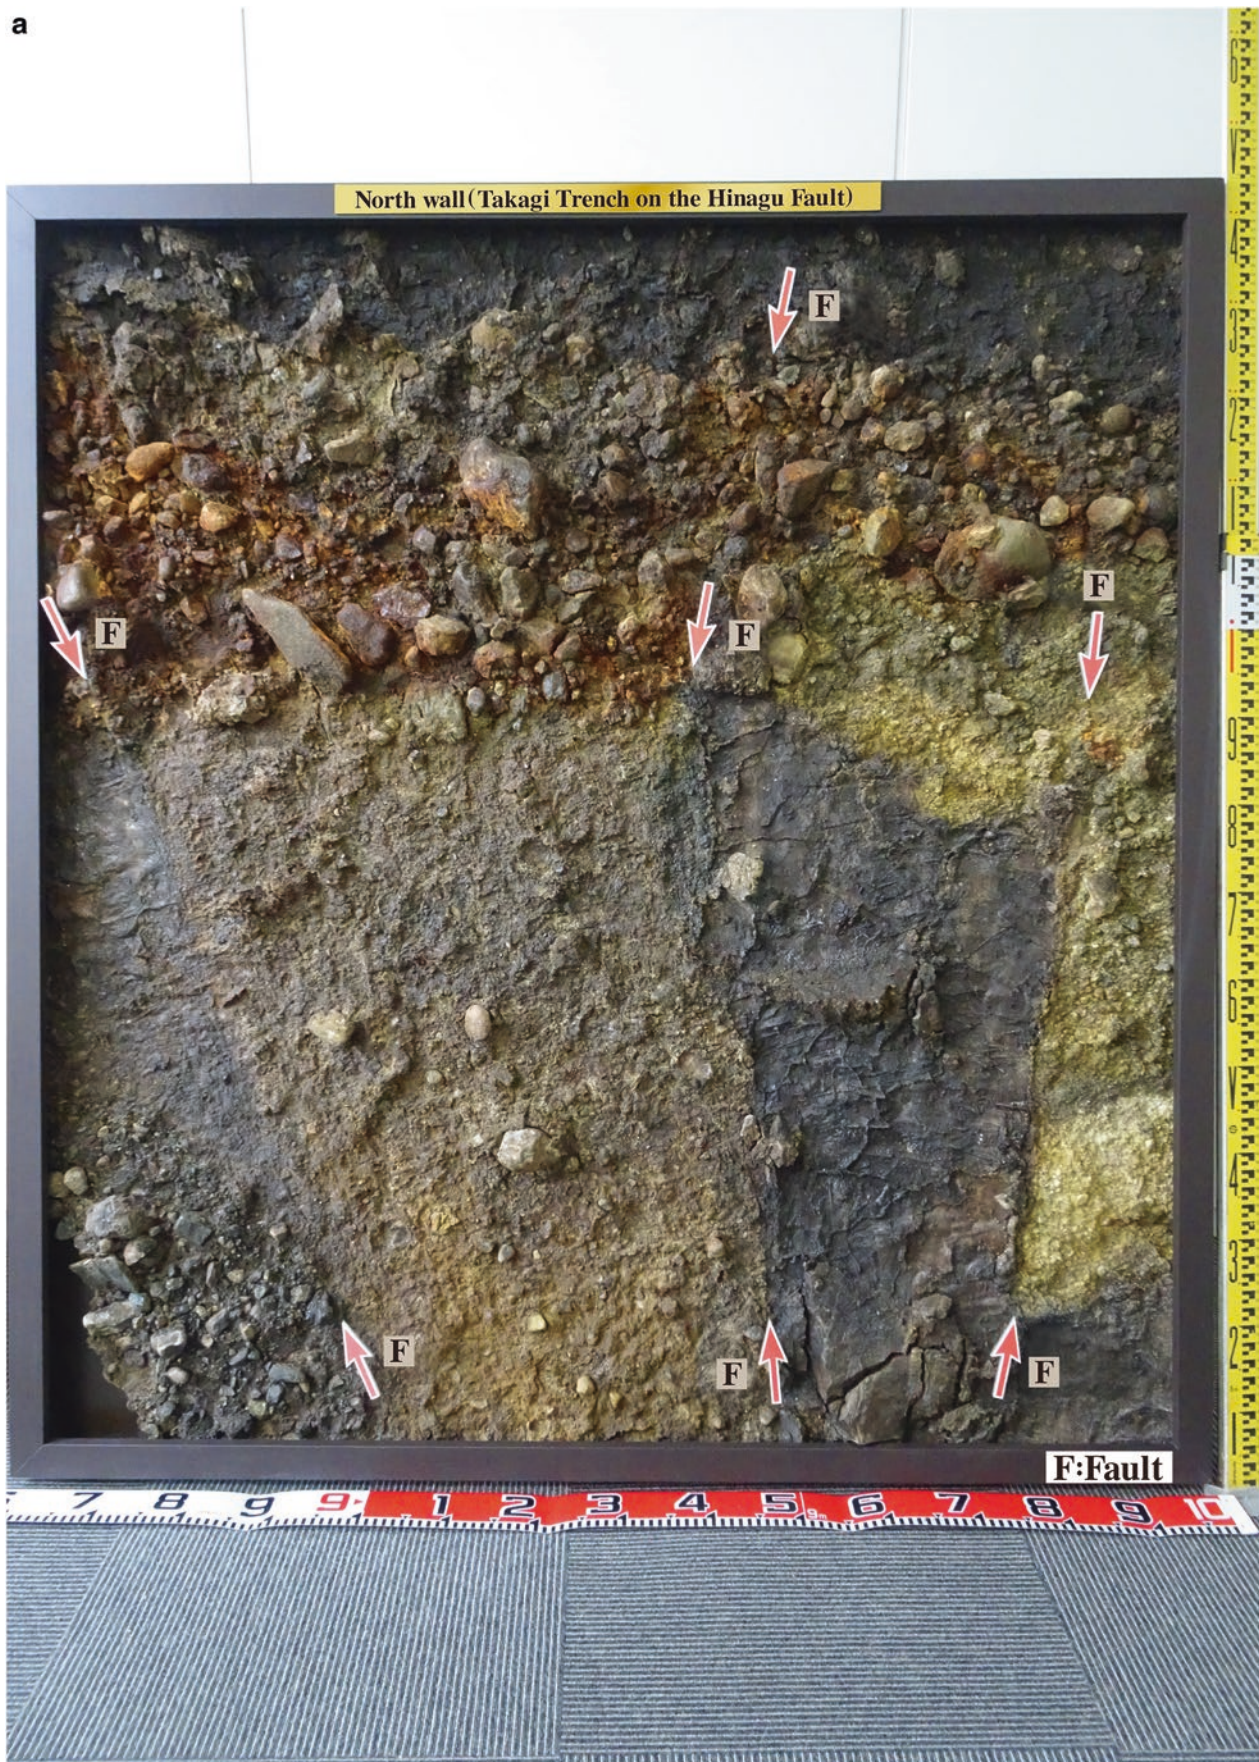
Figure Plate 8 Drone images showing (a) the phreatic explosion of the Aso volcano after the 2016 Kumamoto earthquake, and (b) a close-up view of the explosion (taken on November 16, 2016)

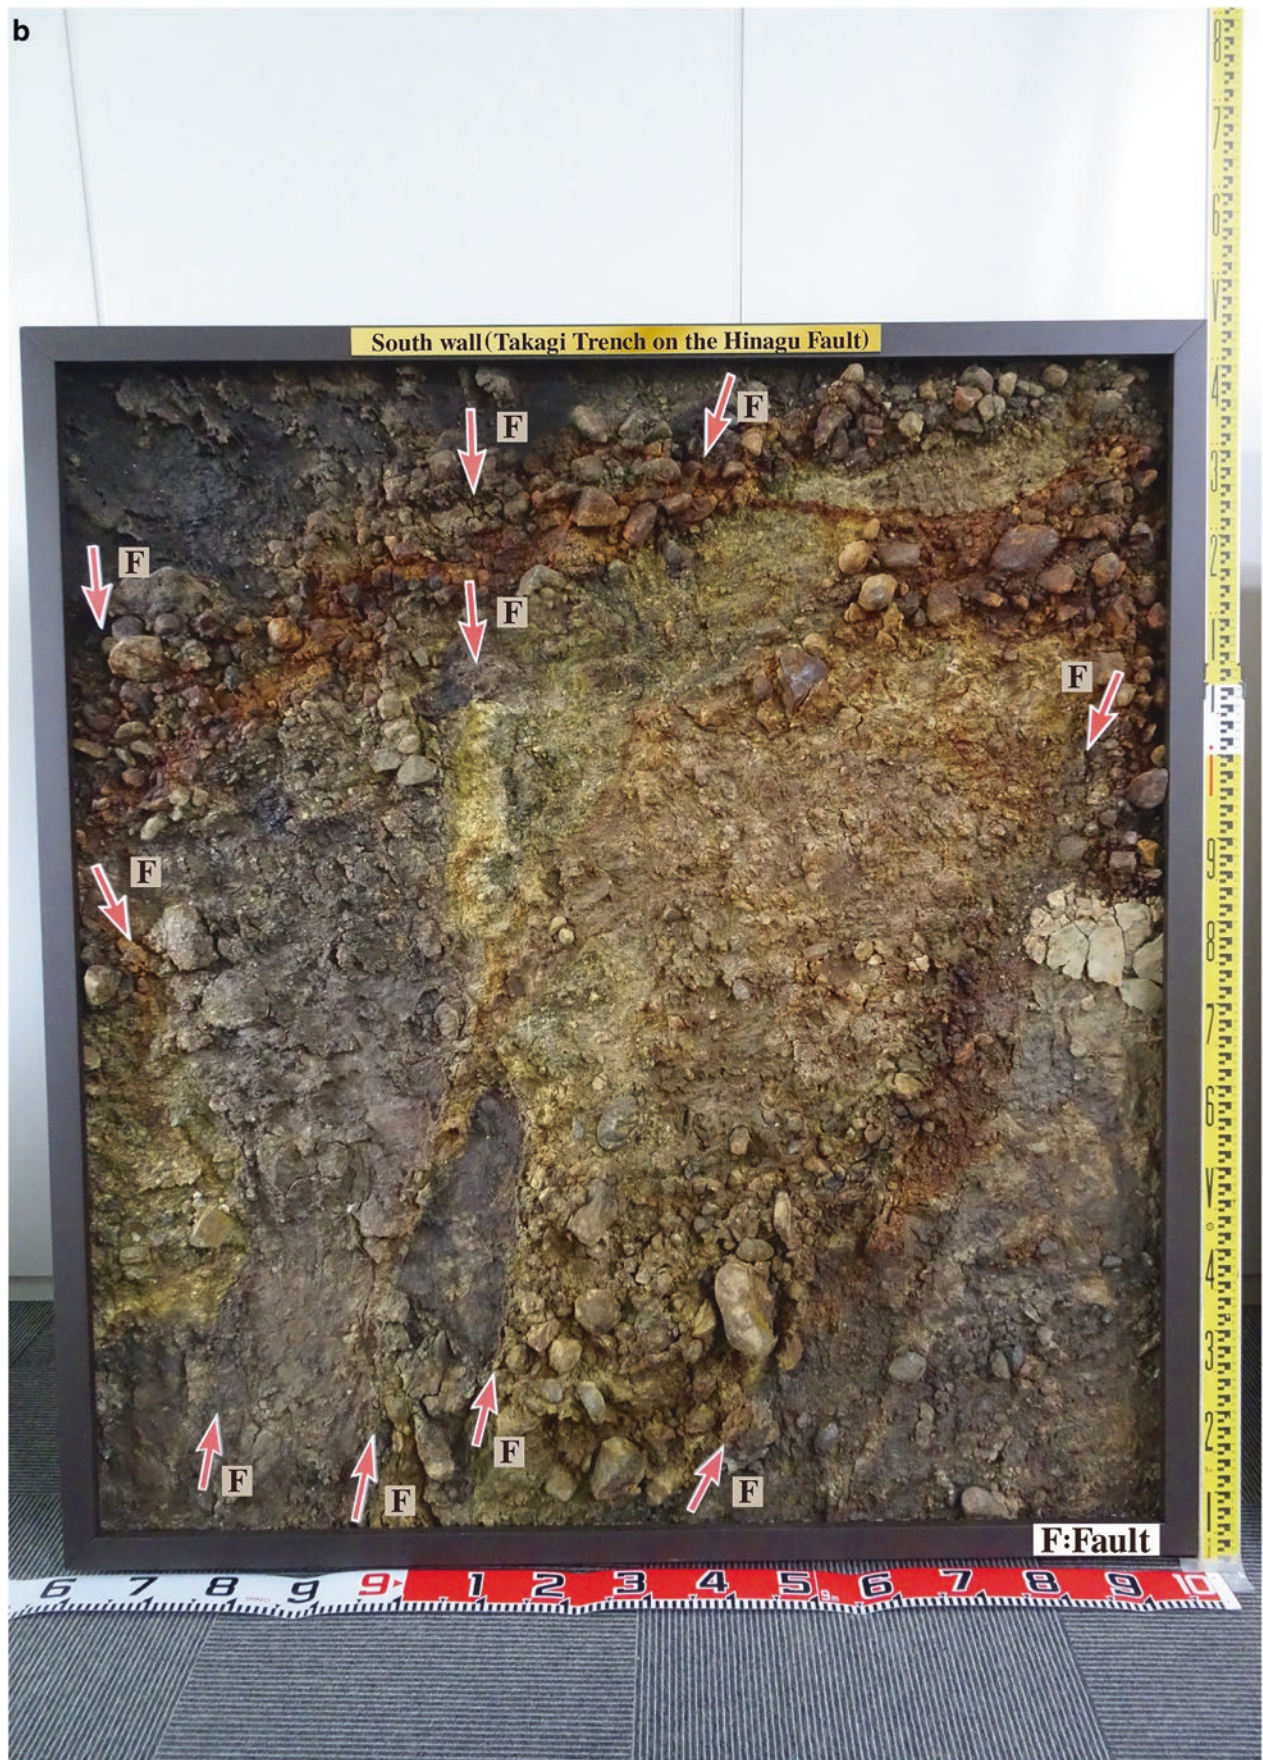
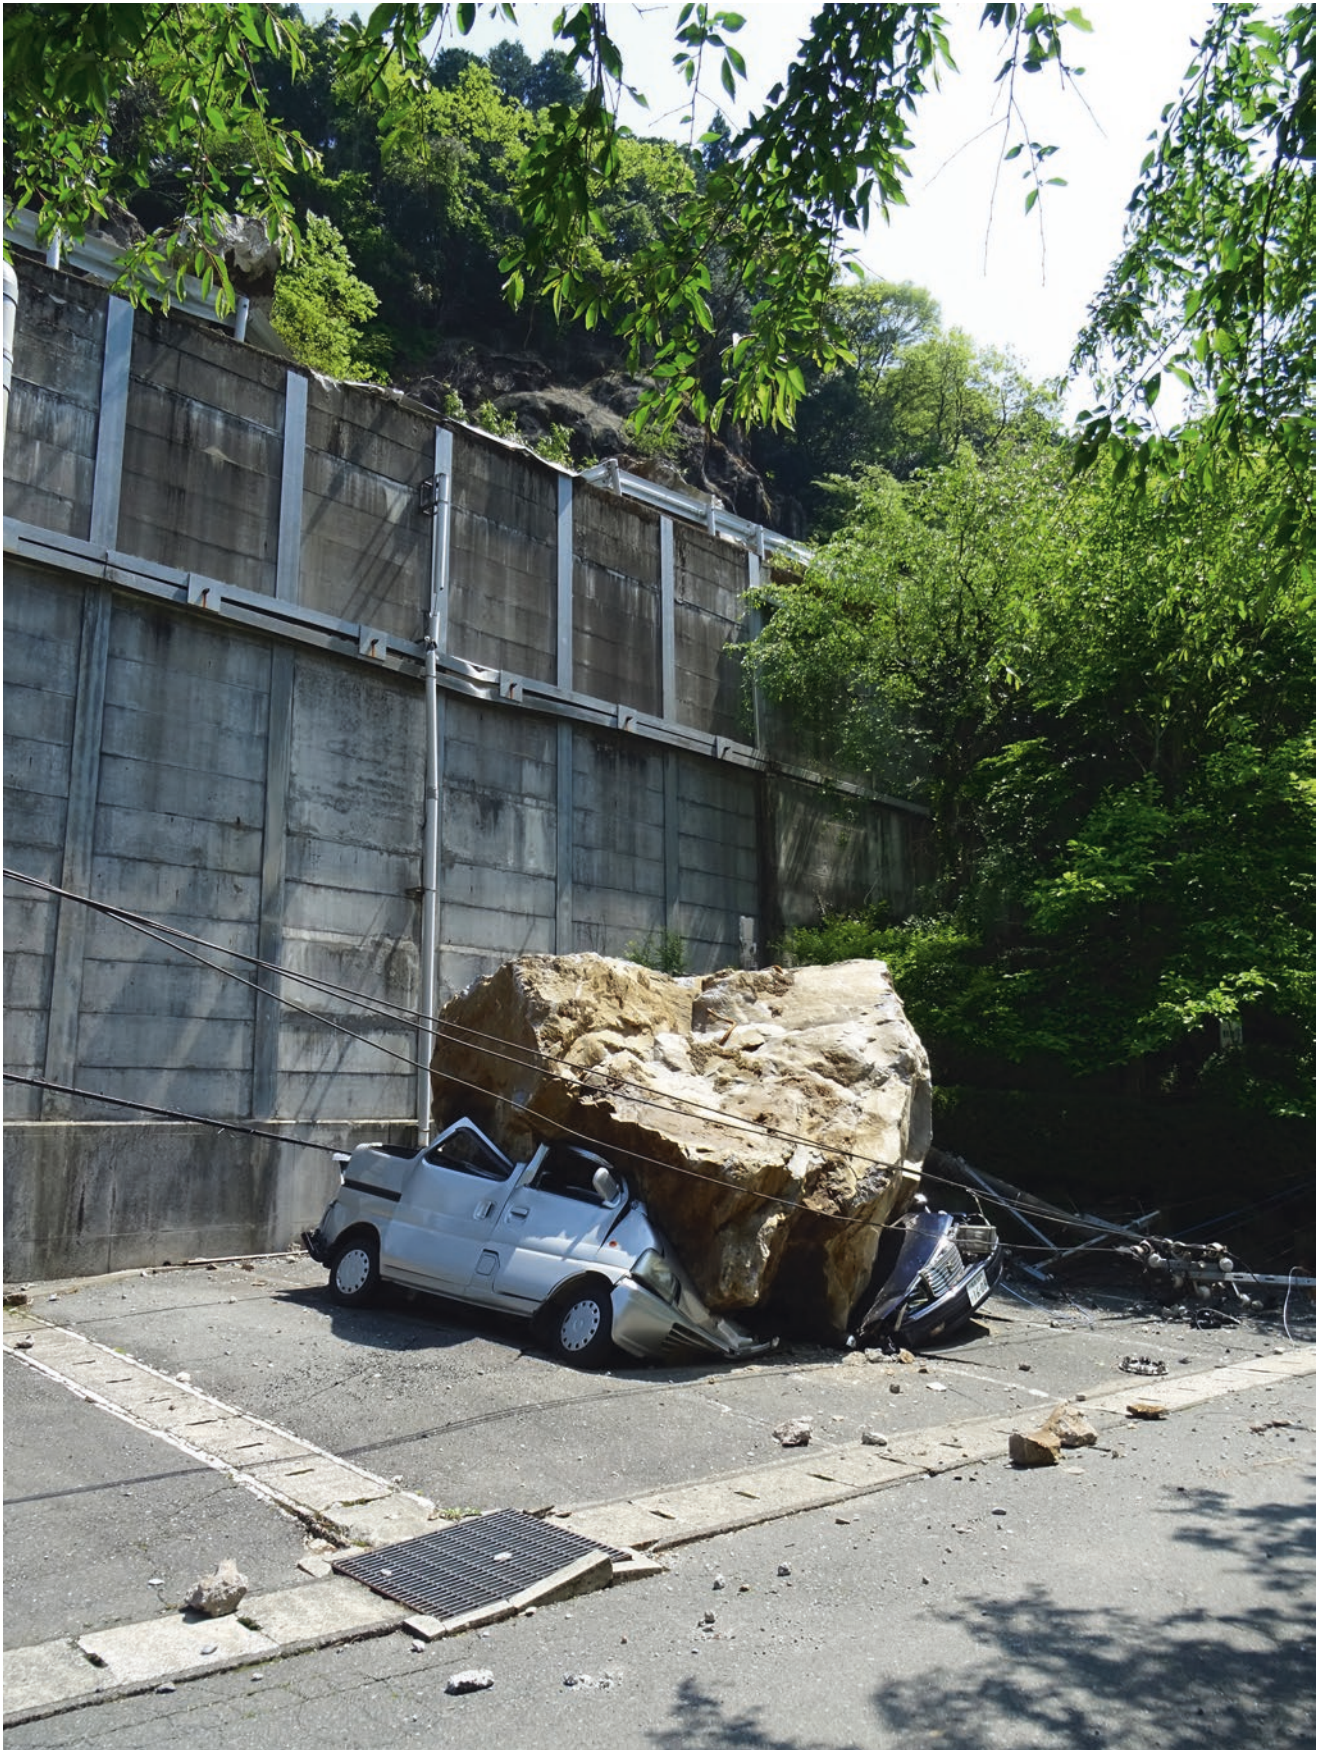
Figure Plate 9 Stripped sections of exposure walls from the Takagi trench. The trench was dug across the coseismic surface rupture along the Hinagu Fault at the Takagi site, Mihune town. (a) North wall. (b) South wall

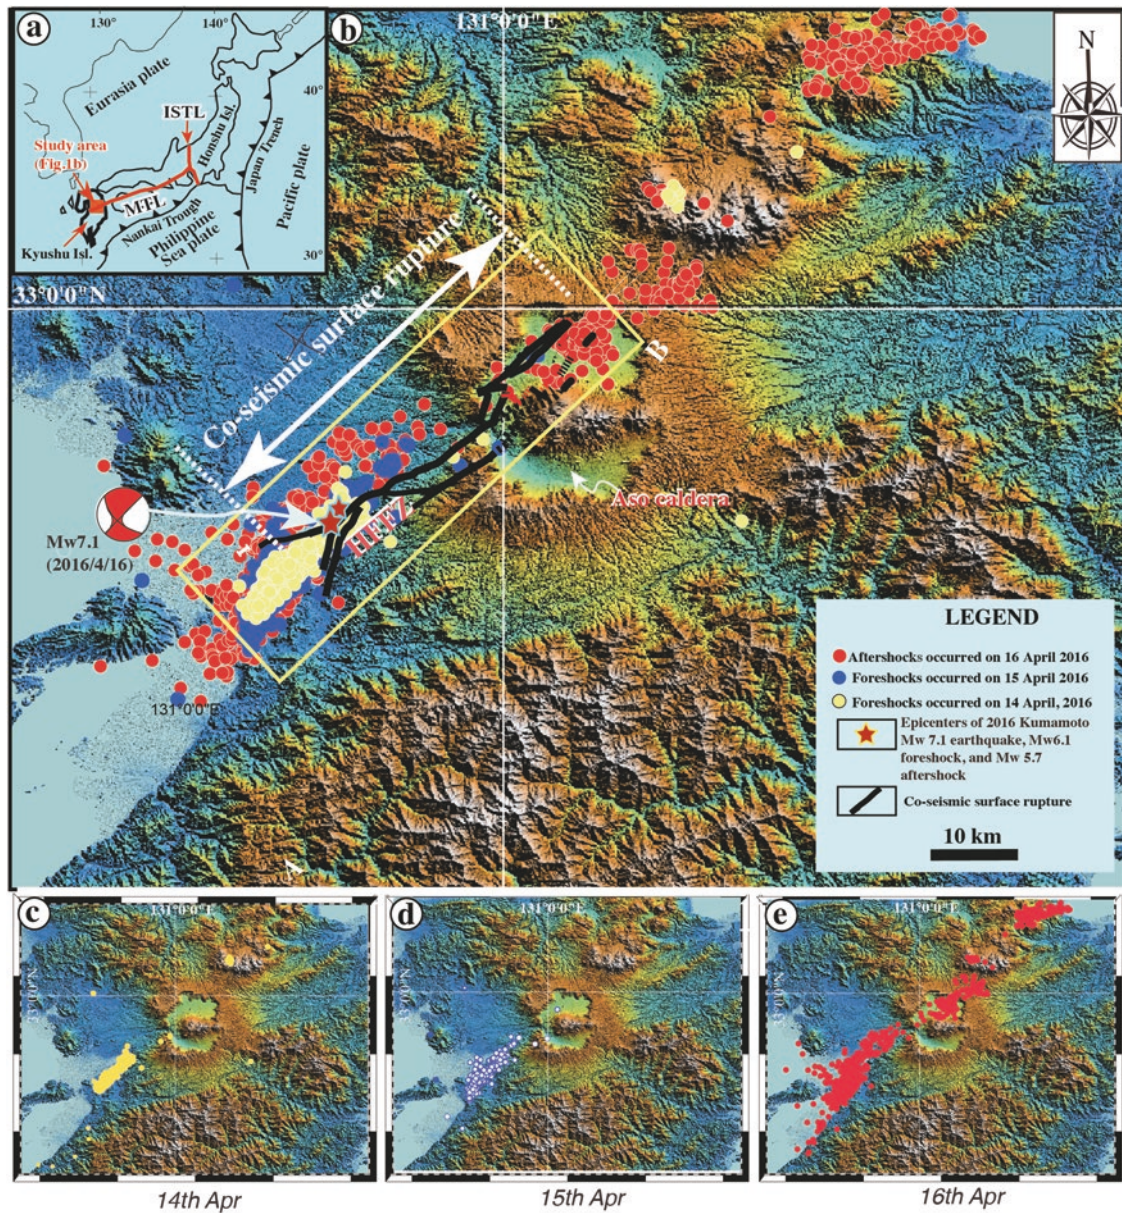
Fig. 1 Index map showing the distribution of the 2016 Kumamoto coseismic surface ruptures [modified from Lin et al. (2016) and Lin (2017)]. (a) Tectonic setting map. (b) Color-shaded relief map showing the distribution of the coseismic surface ruptures, foreshocks, and aftershocks that occurred in the period during 14 and 16 May 2016 and (c)-(e) the epicentral distribution of earthquakes that occurred on 14,

15, and 16 April 2016, respectively (epicentral data cited from the National Research Institute for Earth Science and Disaster Resilience, 2016). Profile A–B is shown in Fig. 4c. MTL, Median Tectonic Line; ISTL, Itoigawa-Shizuoka Tectonic Line; Honshu Isl., Honshu Island; Kyushu Isl., Kyushu Island; HFFZ, Hinagu-Futagawa fault zone

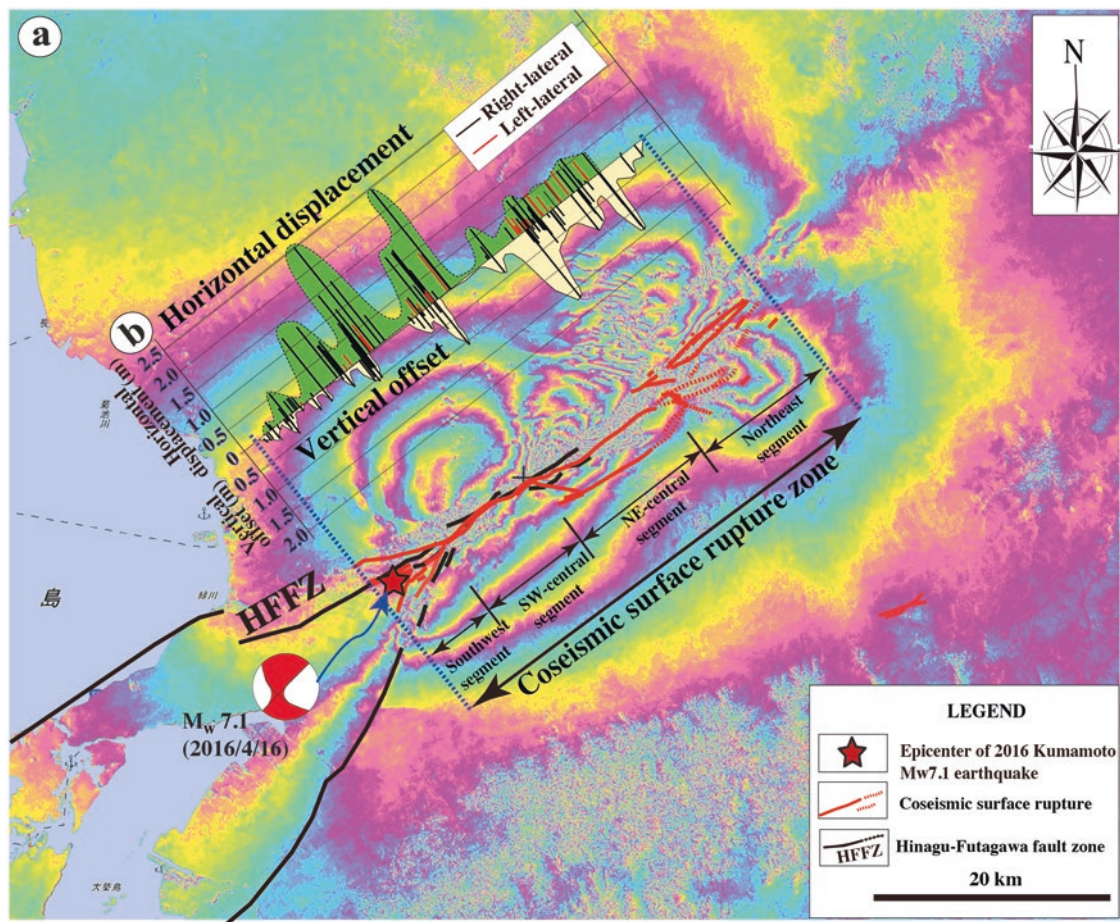
Fig. 2 InSAR image and distribution map showing the ground deformation features and distribution pattern of coseismic displacements (modified from Lin 2017). (a) InSAR image generated from PALSAR-2 data (acquired on 16 January 2016 and 20 April 2016) showing the deformation features of ground surface caused by the 2016 Kumamoto earthquake [modified from the Geospatial Information Authority of

Japan (2016)]. The coseismic surface displacement zone is up to ~40 km in length. Active faults cited from the Geographical Survey Institute (2001) and Headquarters for Earthquake Research Promotion (2016). (b) The field-measured offset distribution along the coseismic surface rupture zone is shown for comparison. SW segment, southwest segment; NE segment, northeast segment

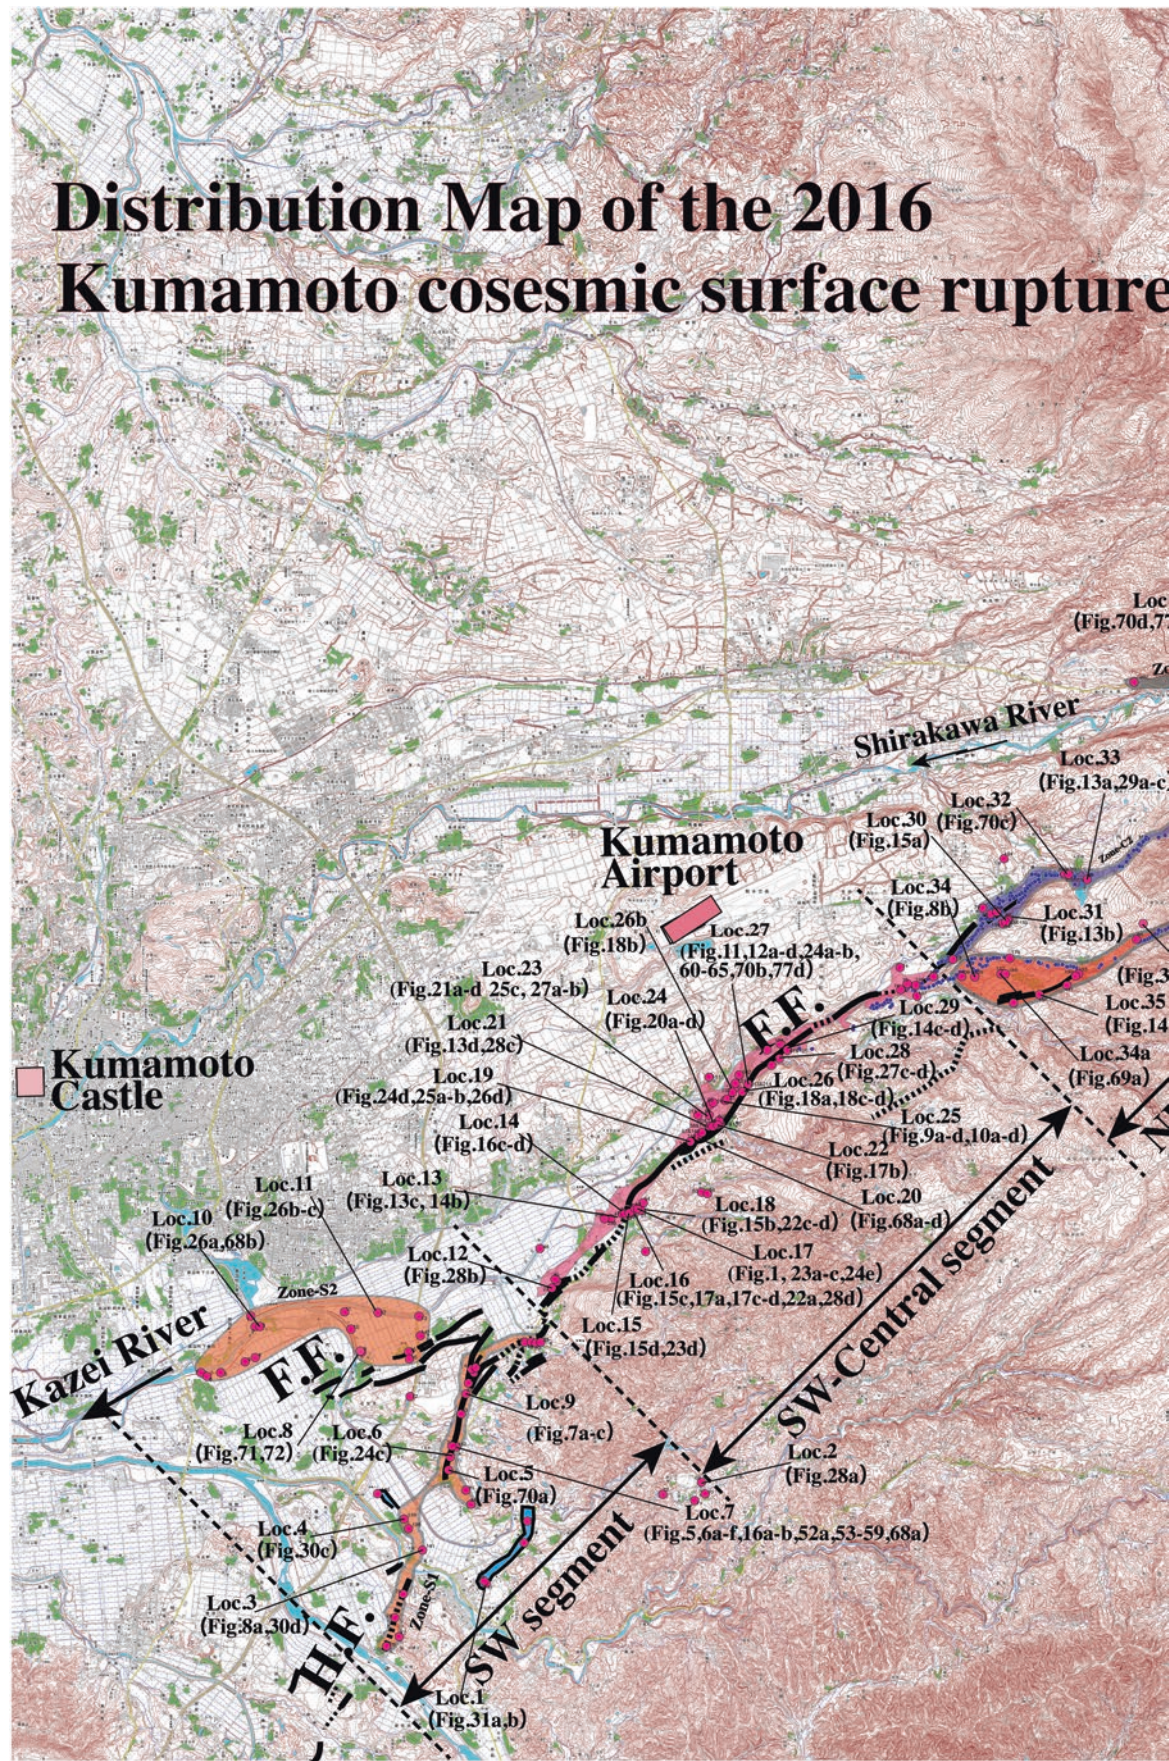
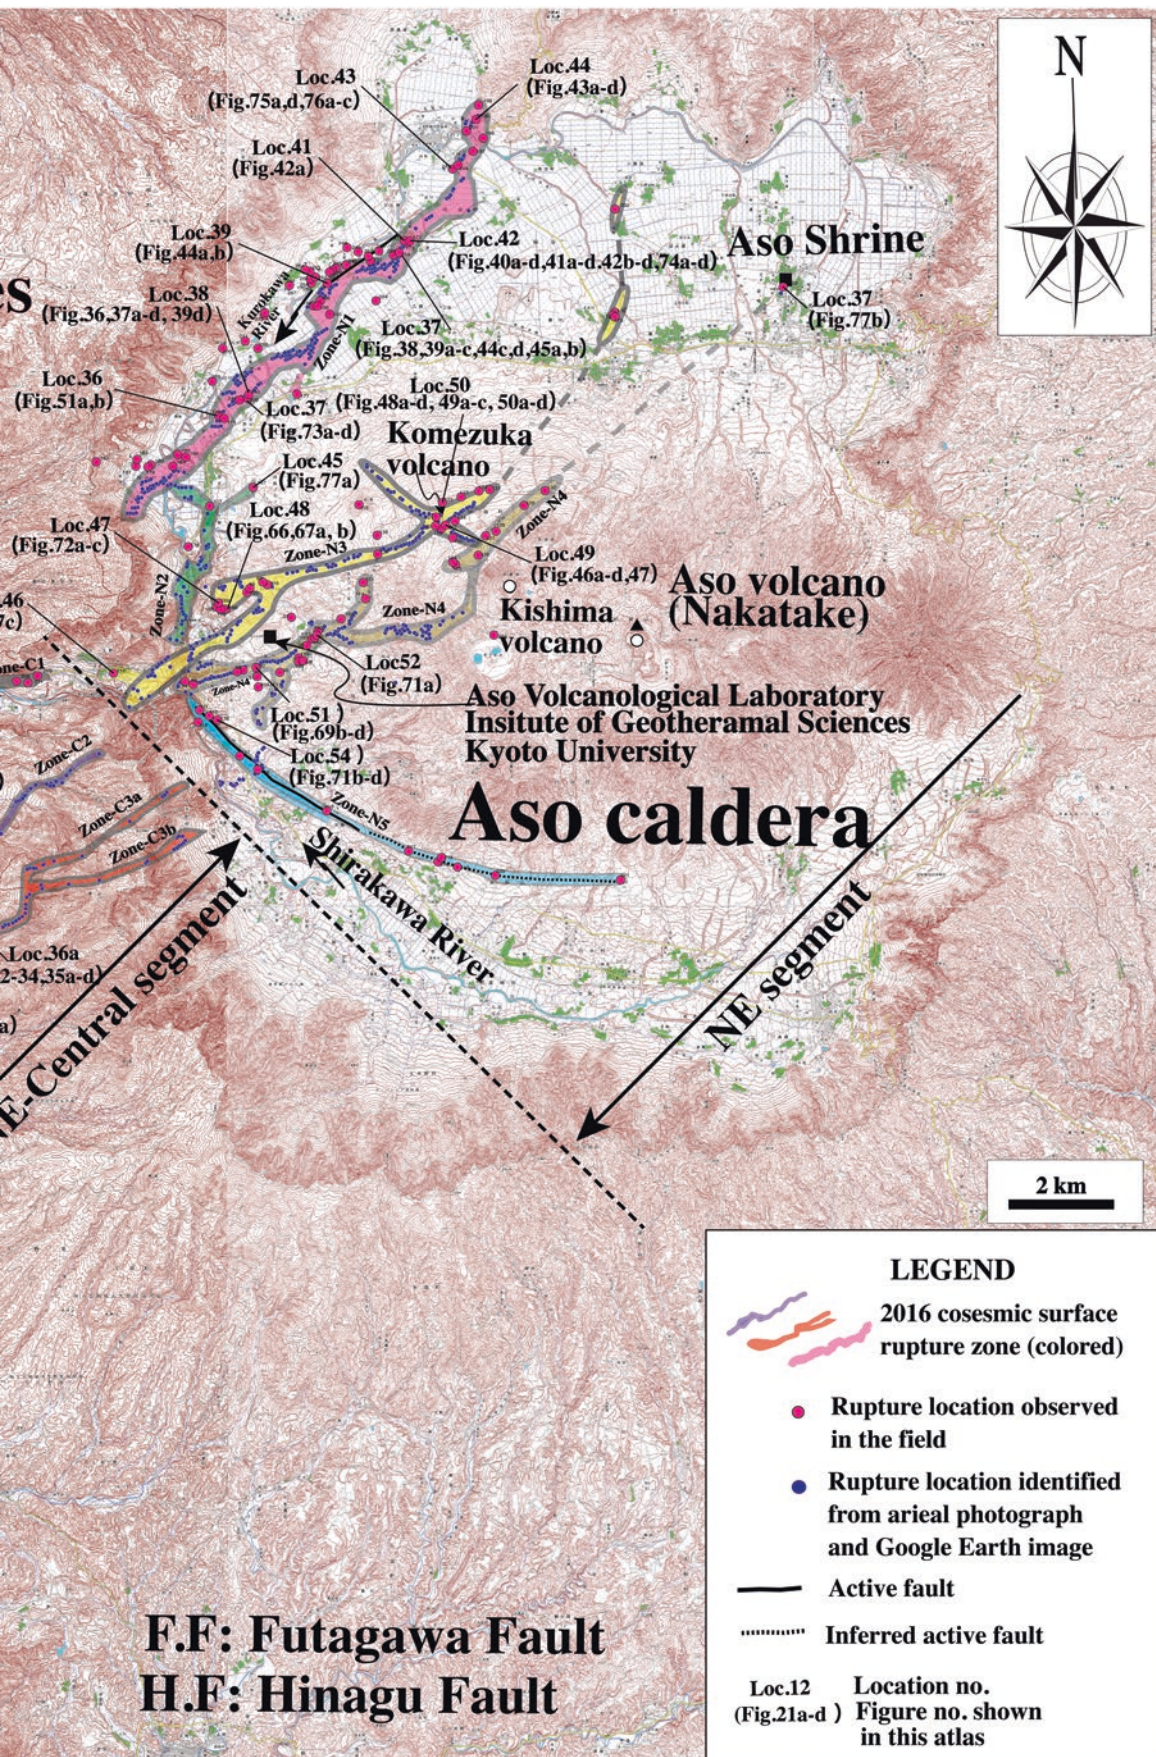
Fig. 3 Index map showing the distribution of 2016 coseismic surface ruptures (modified from Lin 2017). Active faults are cited from the Geospatial Information Authority of Japan (2016) and Headquarters for Earthquake Research Promotion

(2016) Evaluation of Heisei 28 (2016) Kumamoto earthquake (http://www.mext.go.jp/component/a_menu/science/detail/_icsFiles/afieldfile/2016/04/15/1285728_001_1.pdf). Detail locations of figures with latitude and longitude are listed in Table 1

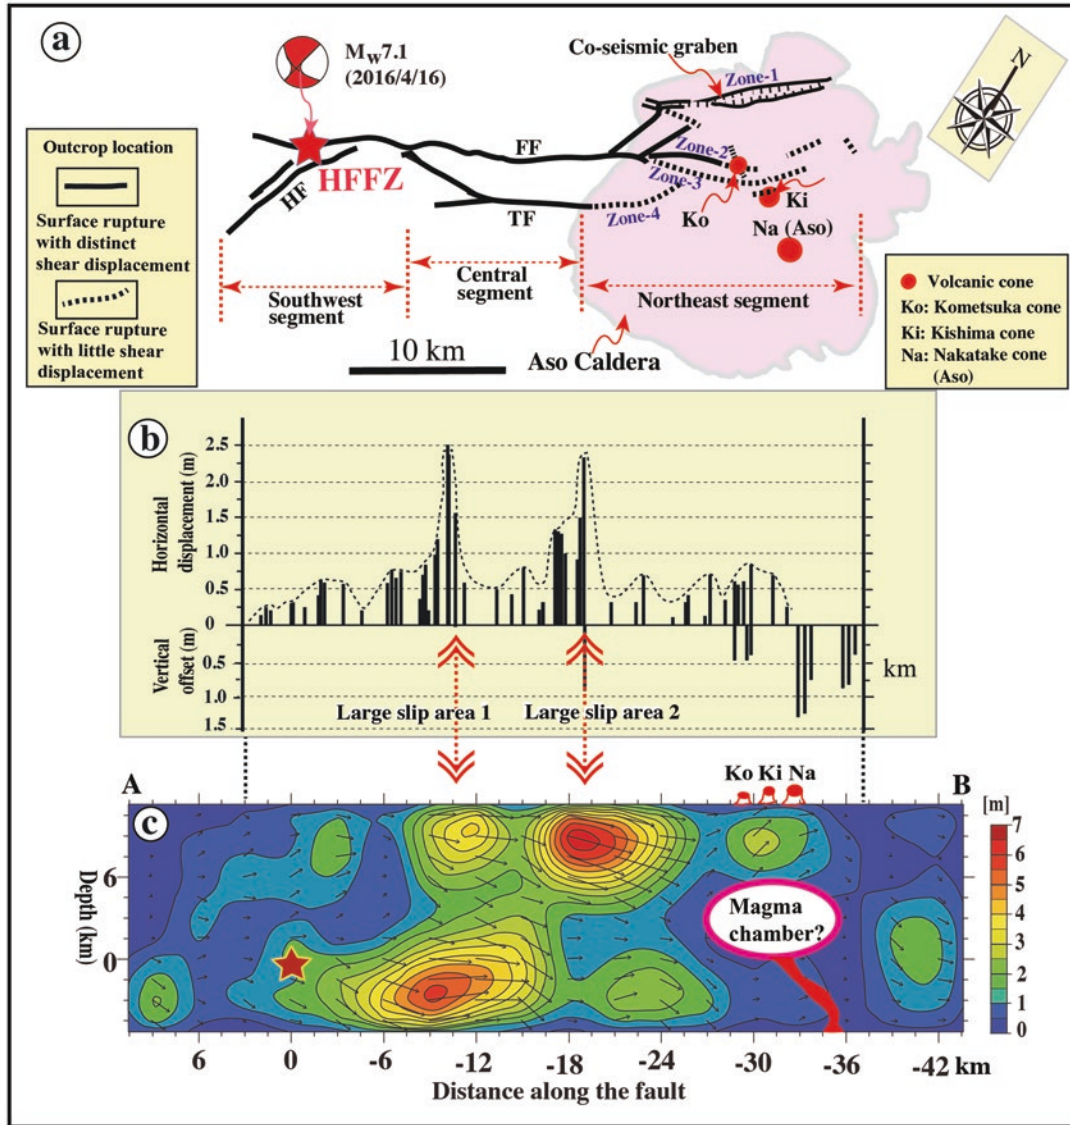
Field measurements of coseismic displacements are plotted in Fig. 4, representing samples taken at 148 sites (Lin 2017). The maximum right-lateral displacements in the SW– and NE–central segments, respective are up to 2.45–2.50 m (Fig. 4). The deformation features of surface ruptures and slickenside striations observed in a wheat field (where the

Fig. 4 Displacements and distribution and rupture traces of coseismic surface rupture zone (modified from Lin et al. 2016). (a) Distribution of coseismic displacements measured in-site. (b) Map showing the distribution of the coseismic surface rupture zone. (c) Seismic inversion

results for seismic slip (in meters) on the seismogenic fault plane (modified from Koketsu et al. 2016) (see Fig. 1b for the surface location of profile A–B)
