The 2016 Mw 7.1 Kumamoto Earthquake

A Photographic Atlas of Coseismic Surface Ruptures
Related to the Aso Volcano, Japan

Aiming Lin
Department of Geophysics
Kyoto University
Kyoto, Japan

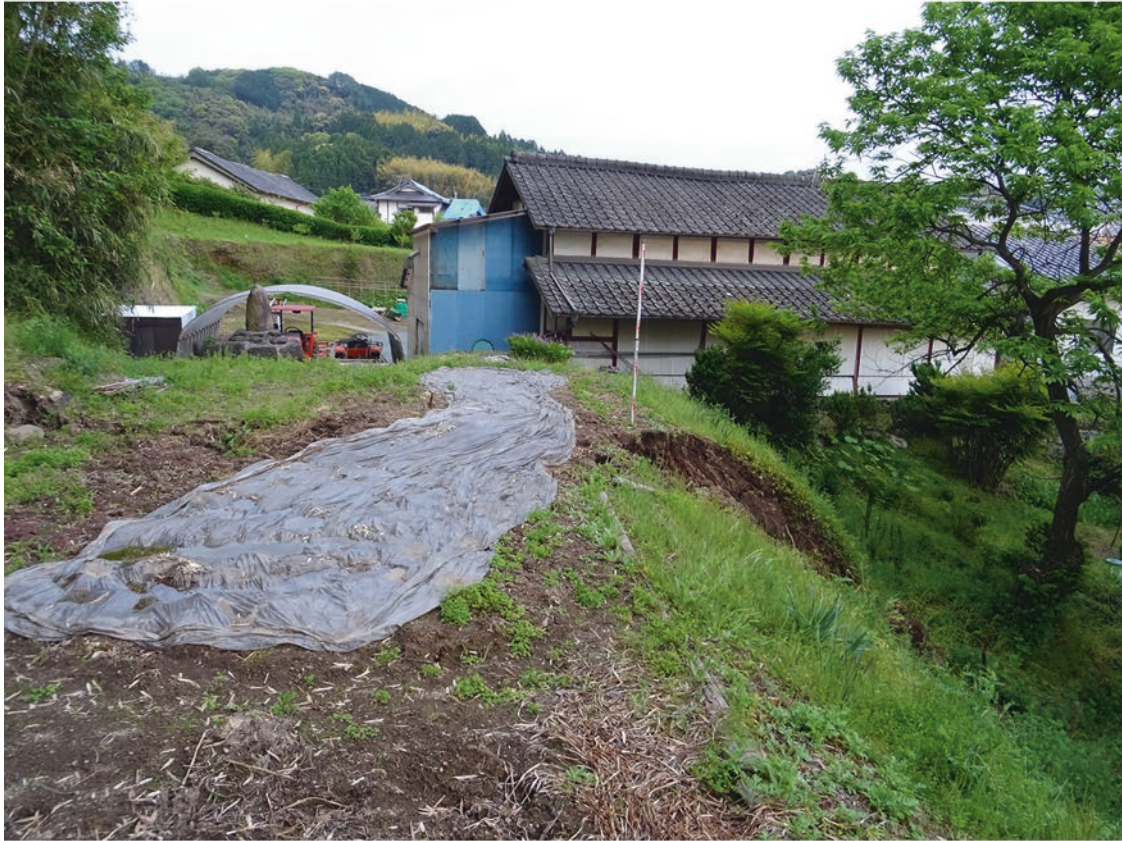
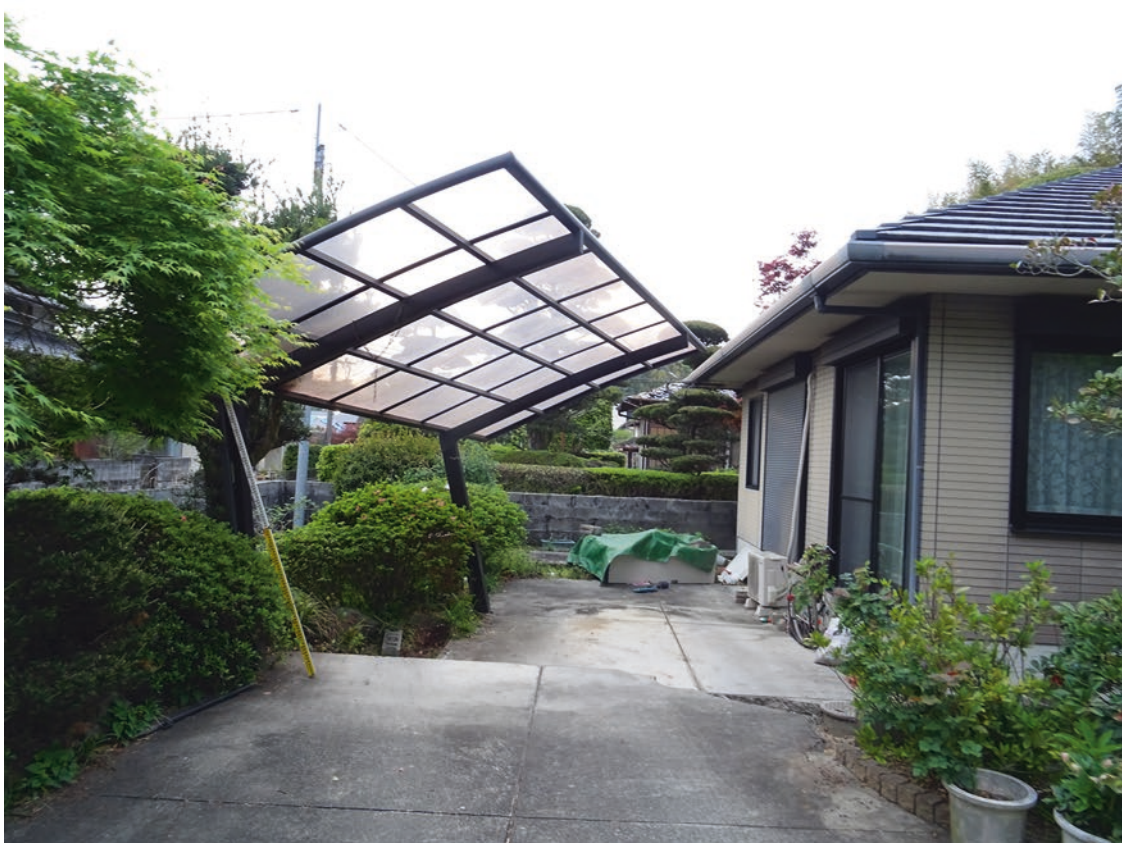
Fig. 9 Right-lateral offset of ditch slope and damaged parking area in a house garden. **(a, b)** Dextral offset ~ 1.3 m with a vertical component of ~ 0.30 m. **(c)** Right-lateral offset of ditch slope (offset ~ 0.9 m). **(d)** Right-lateral offset of parking area (offset ~ 1.1 m)

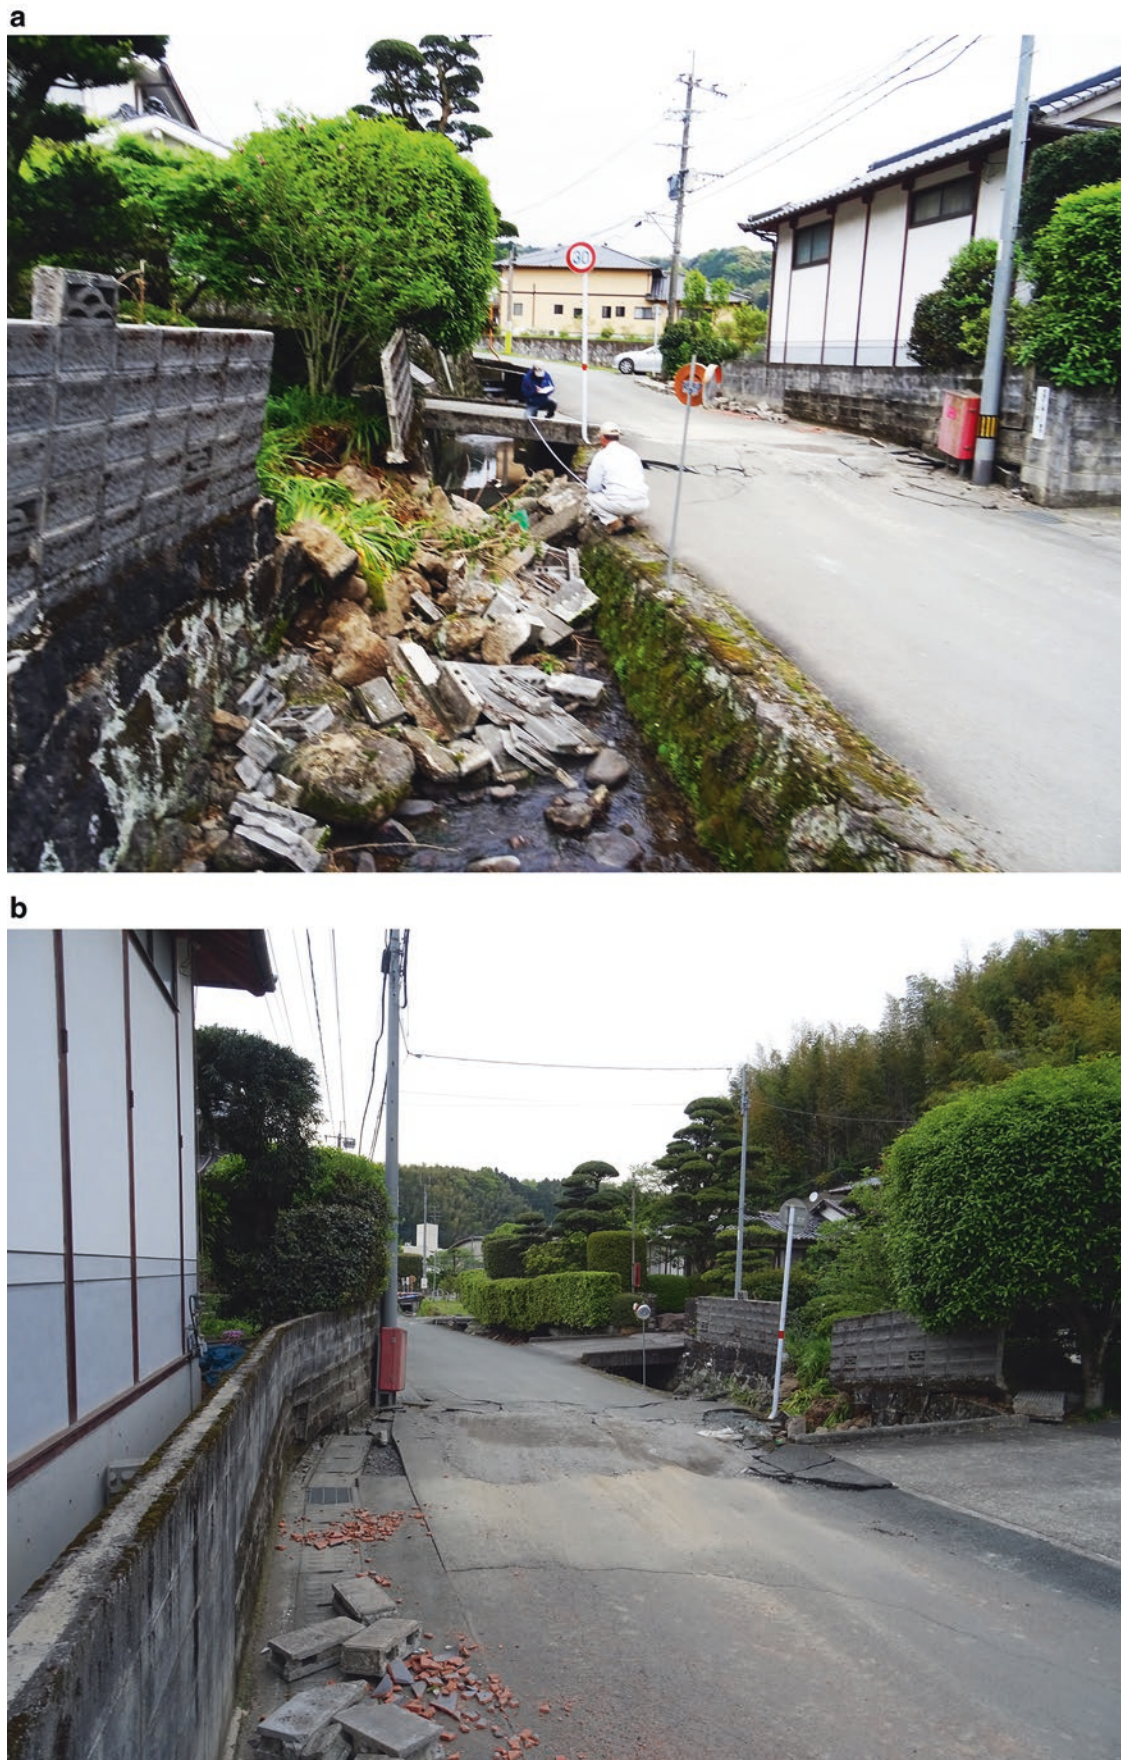
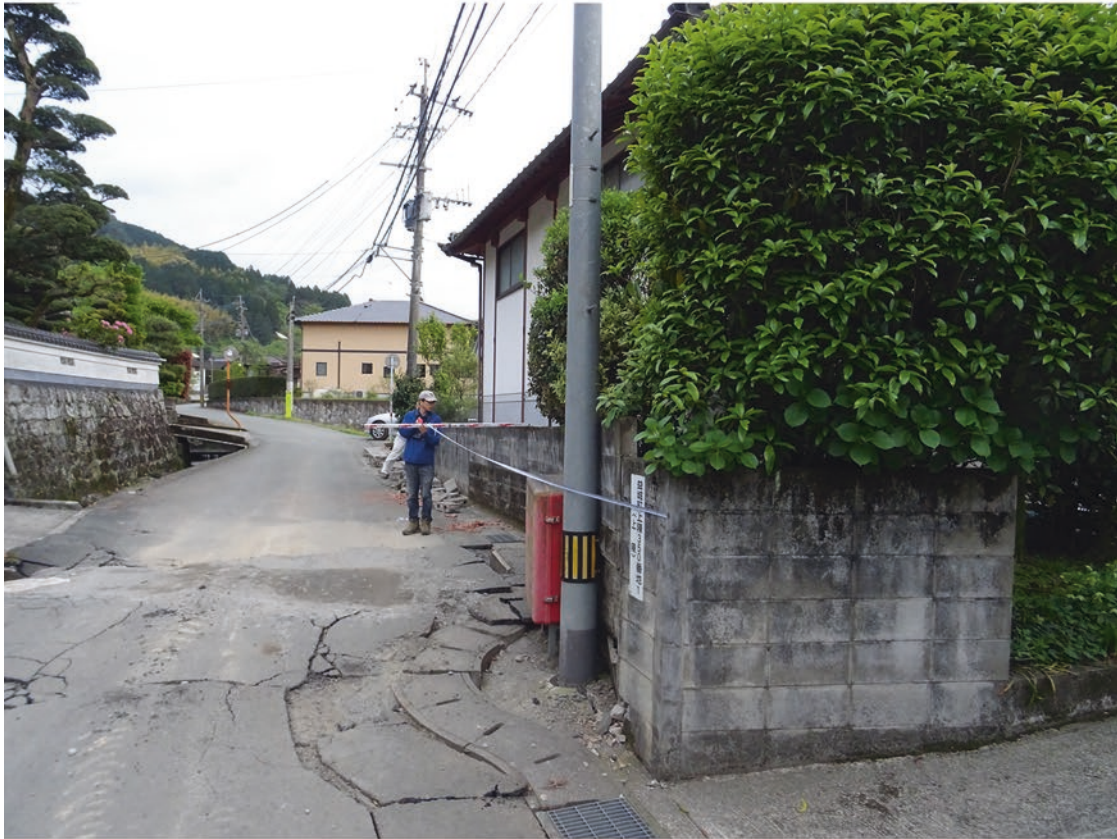
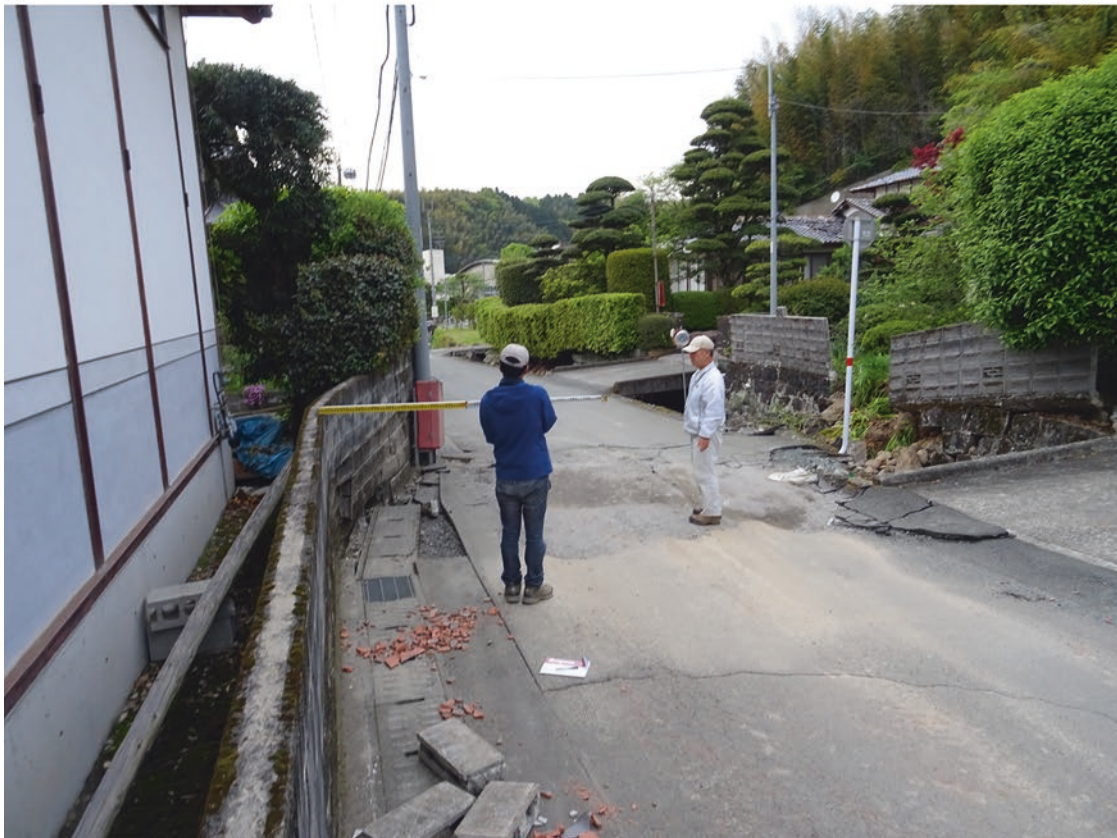
Fig. 10 Right-lateral offsets of a road, ditch, and fence wall. (a–c) Dextral offset ~1.3 m of the ditch (a), road (b), and wall fence (c–d)

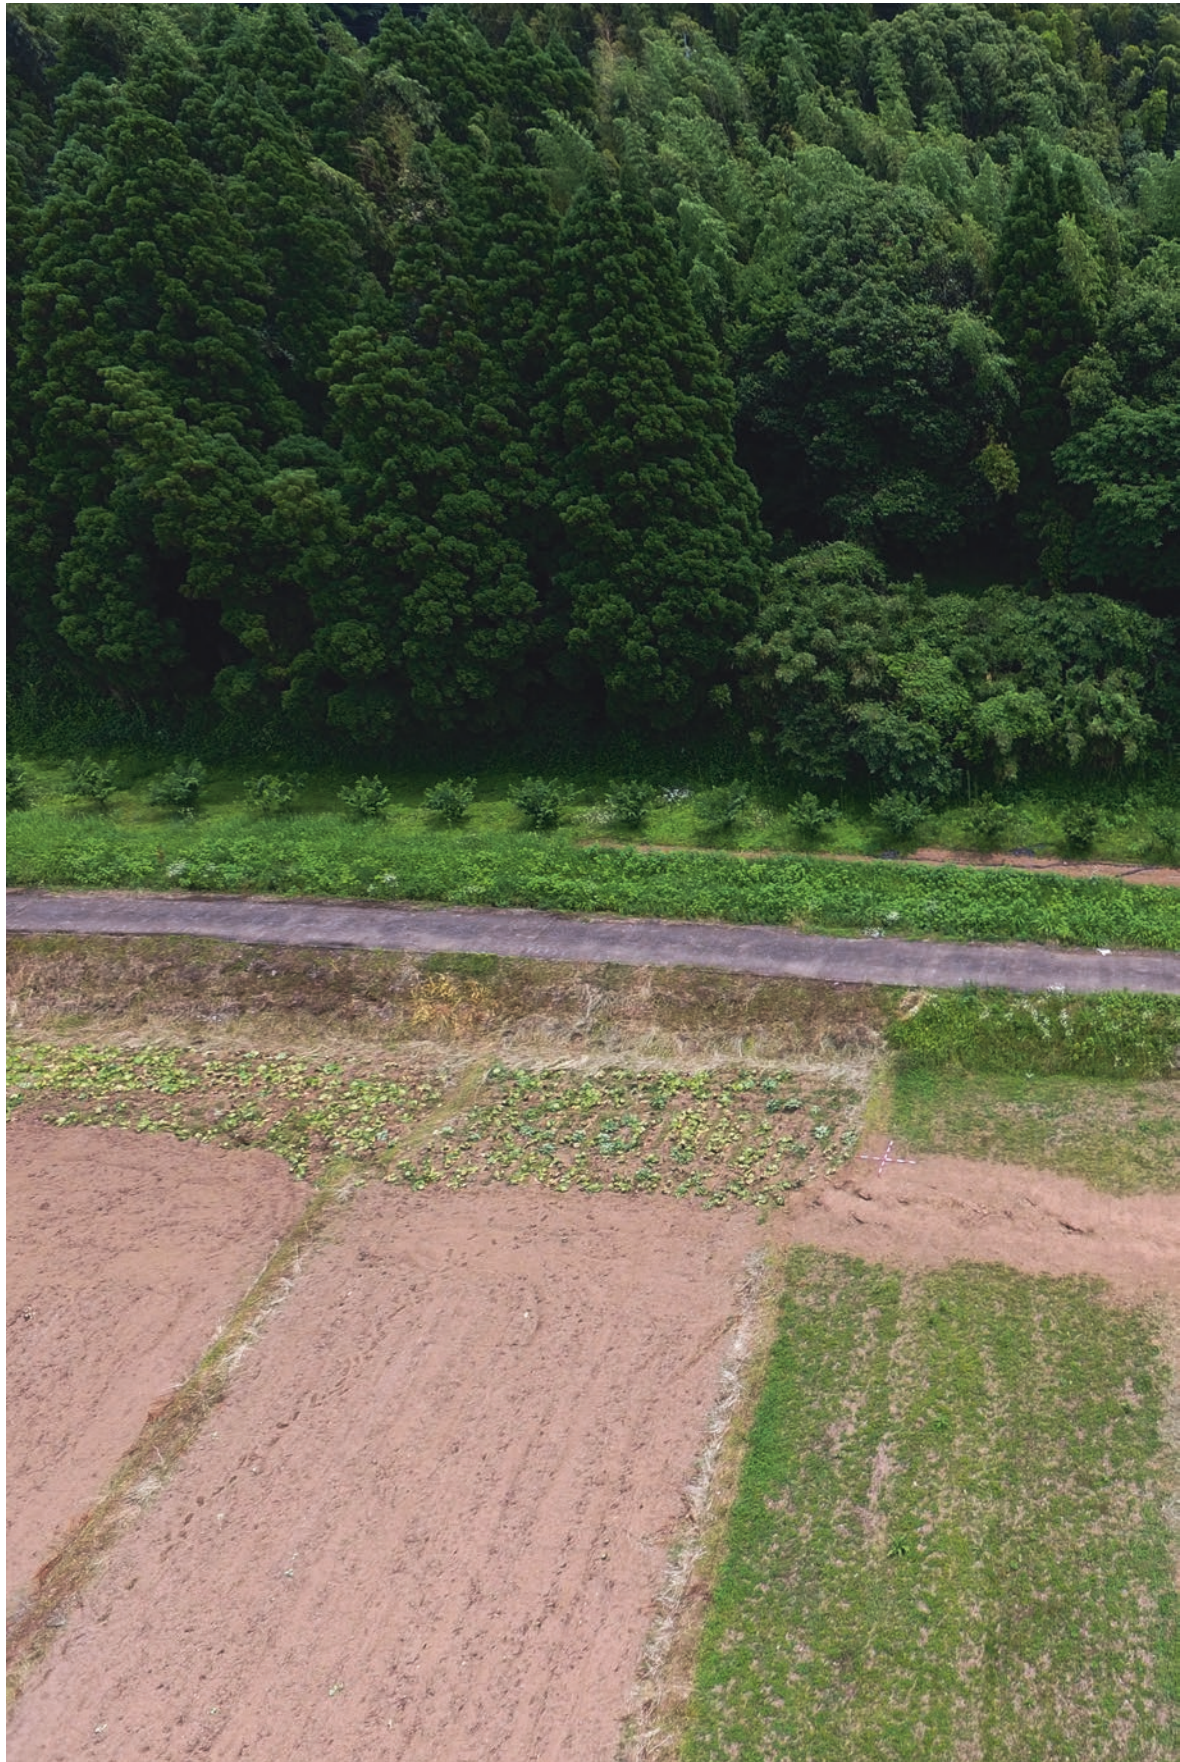
Fig. 11 Drone image showing the right-lateral offset of fields at Masiki town

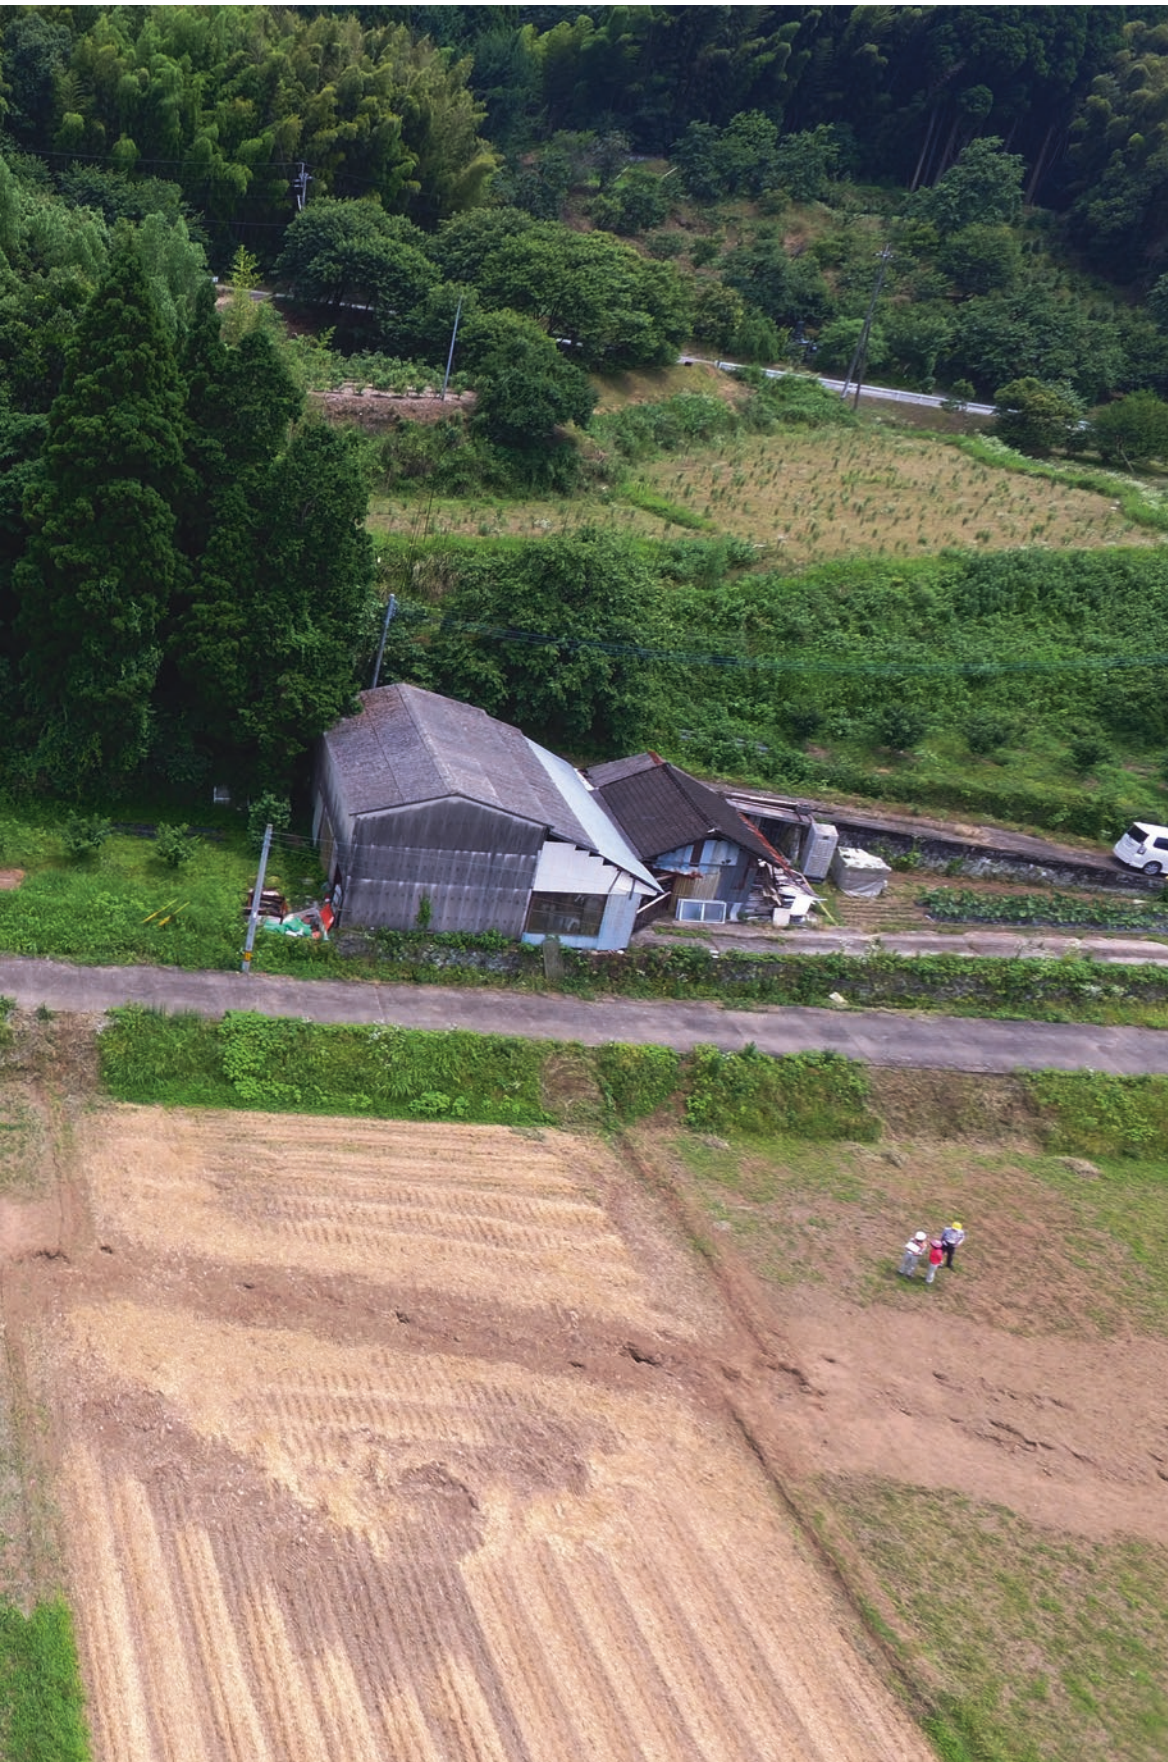
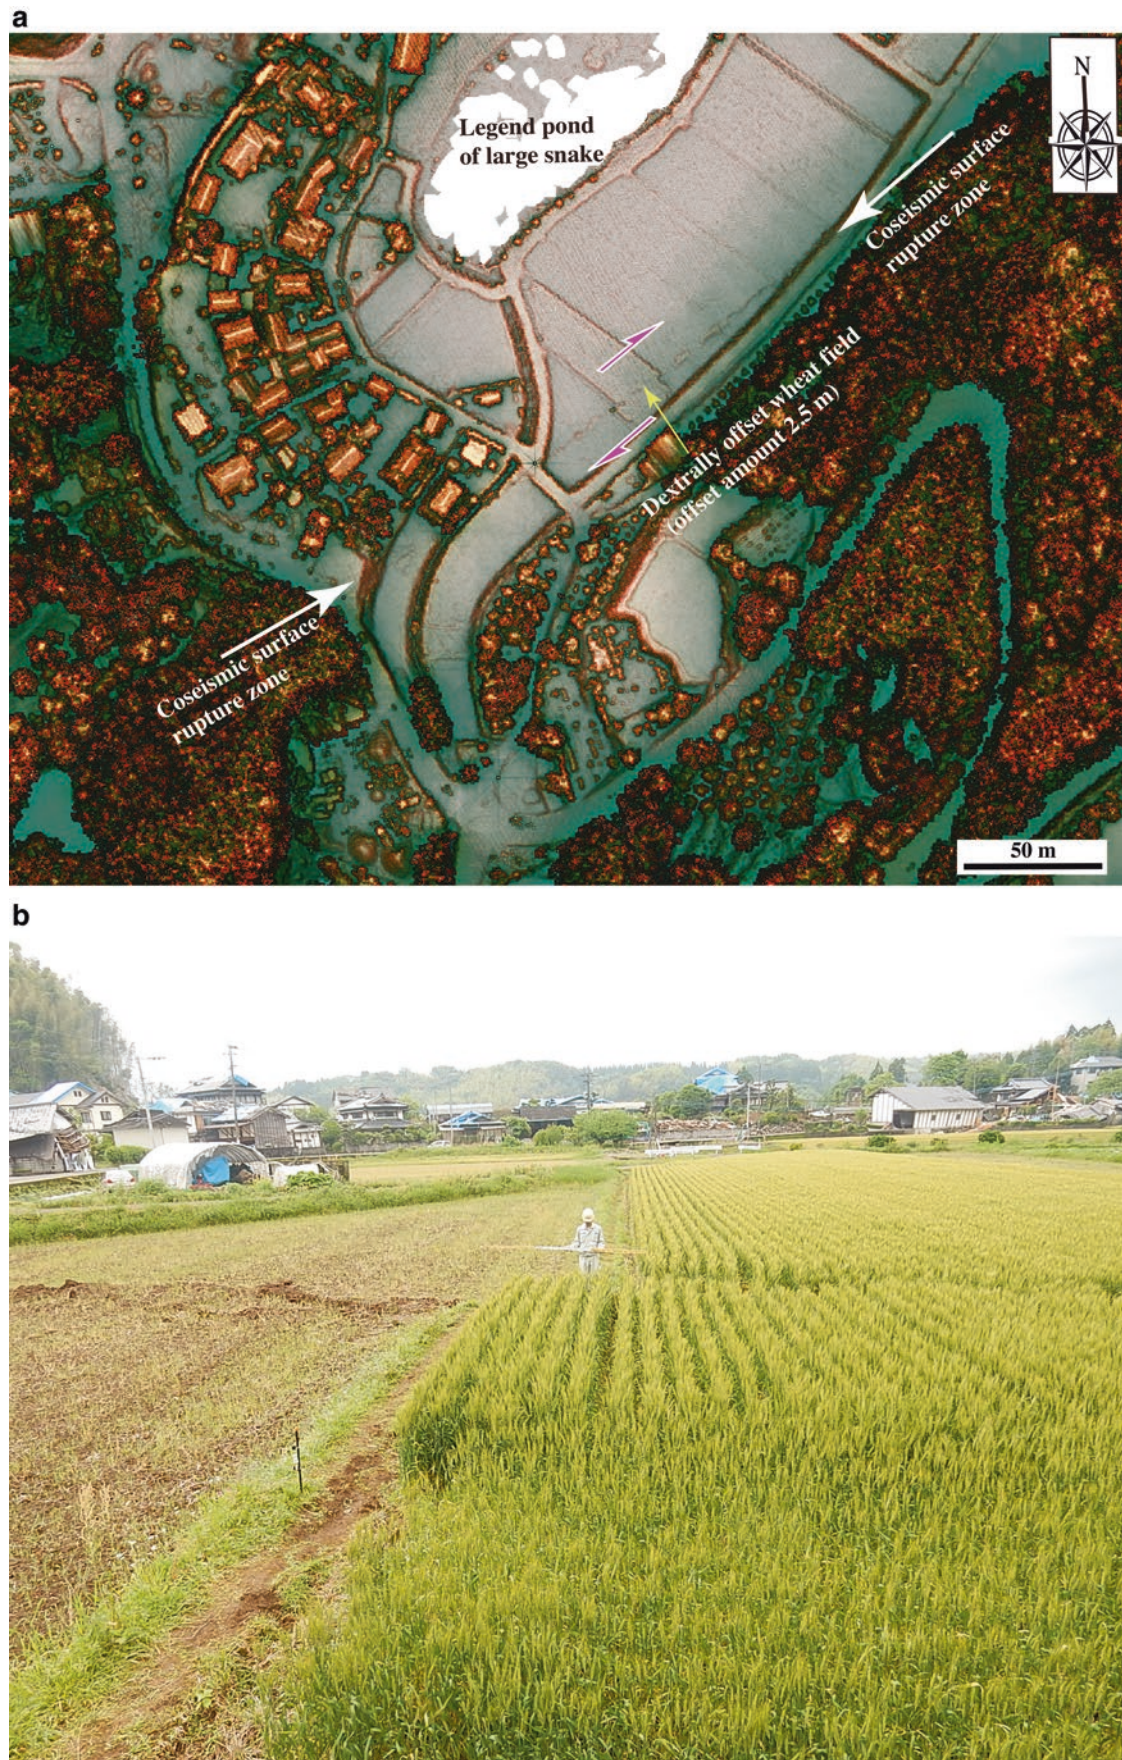
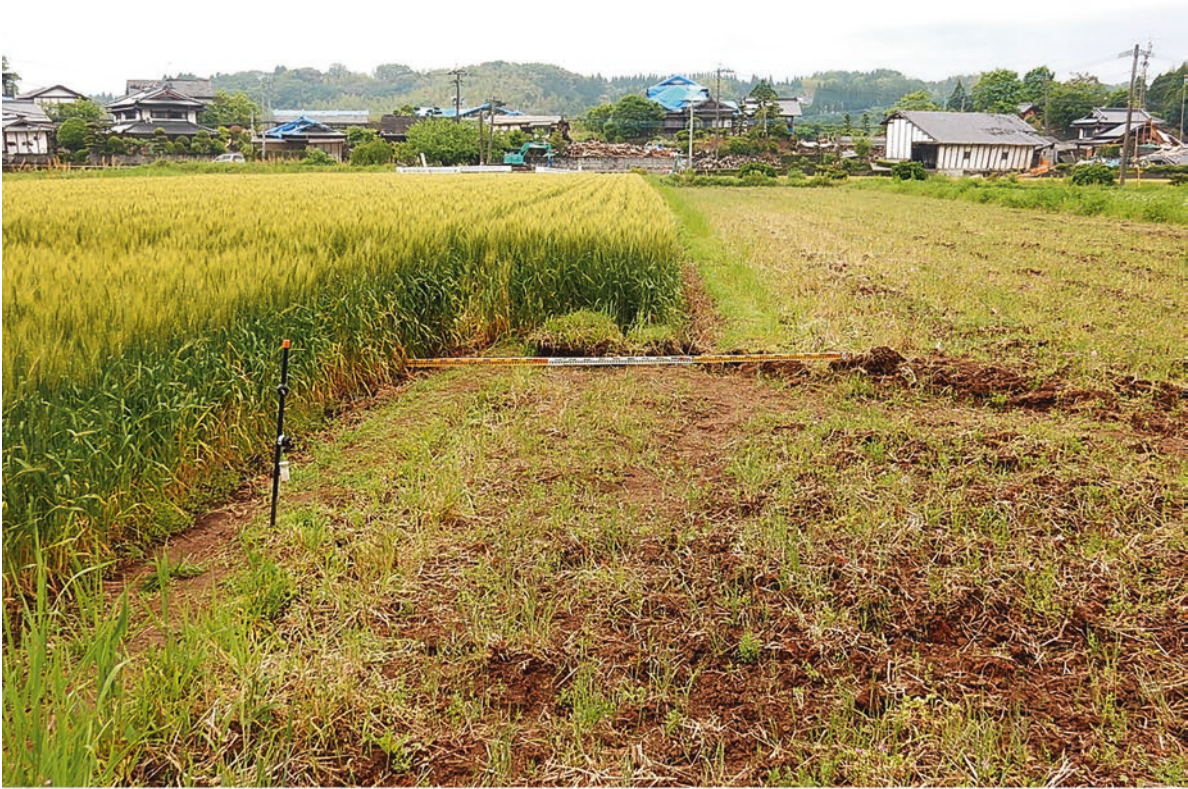
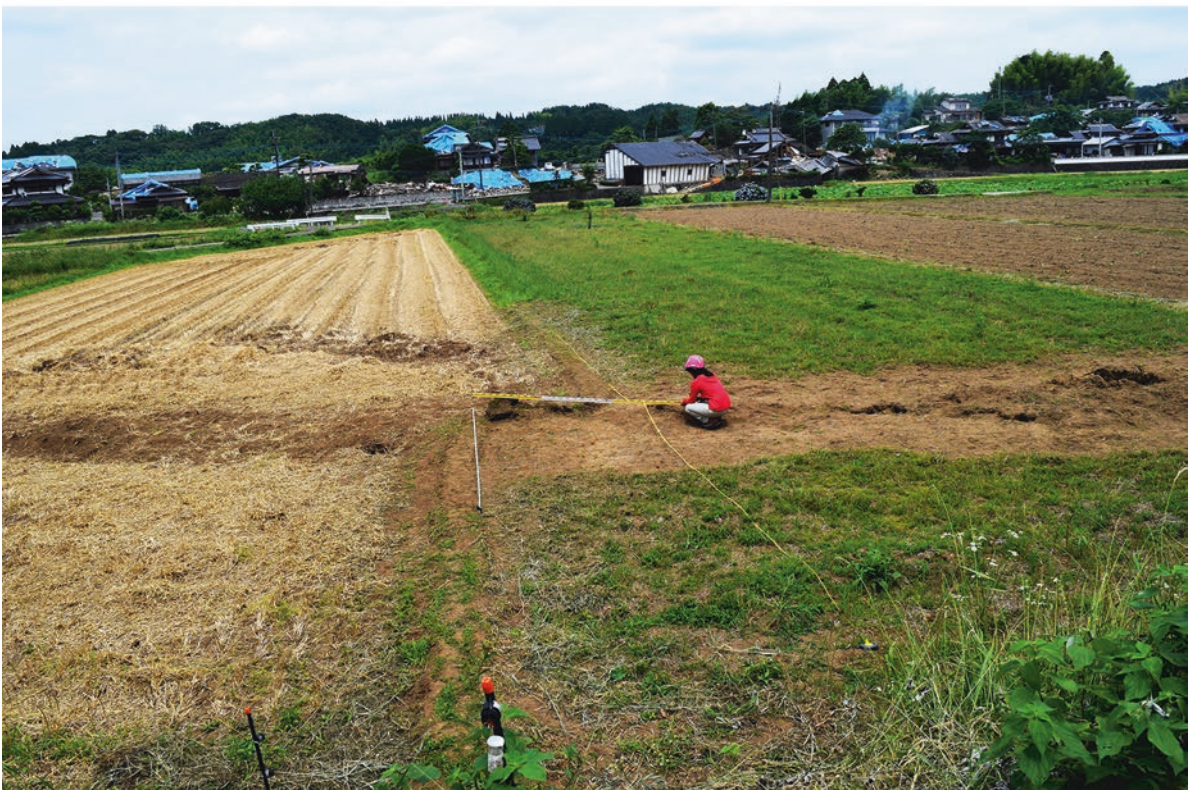
Fig. 12 Red relief image and photographs showing the right-lateral offset of fields. (a) Red relief image (image courtesy T. Chiba). (b, c) Right-lateral offset of wheat field. Photograph taken on 1 May 2016 (d) Photograph taken on 20 June 2016 after the wheat crops

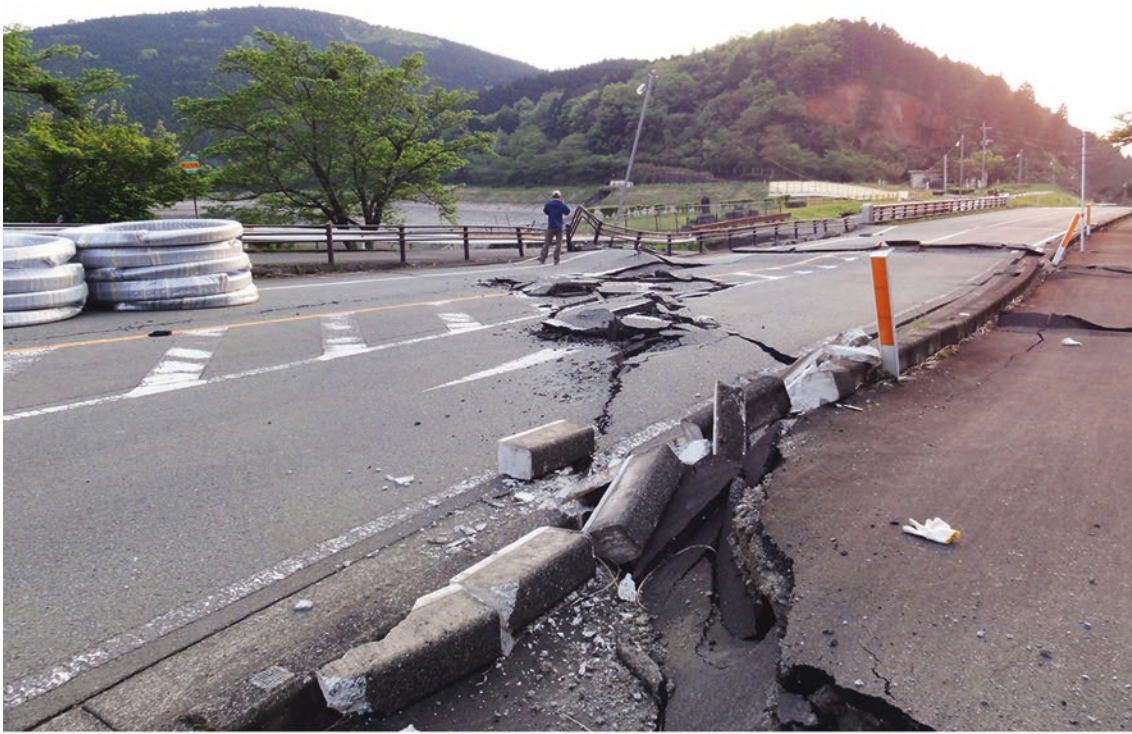
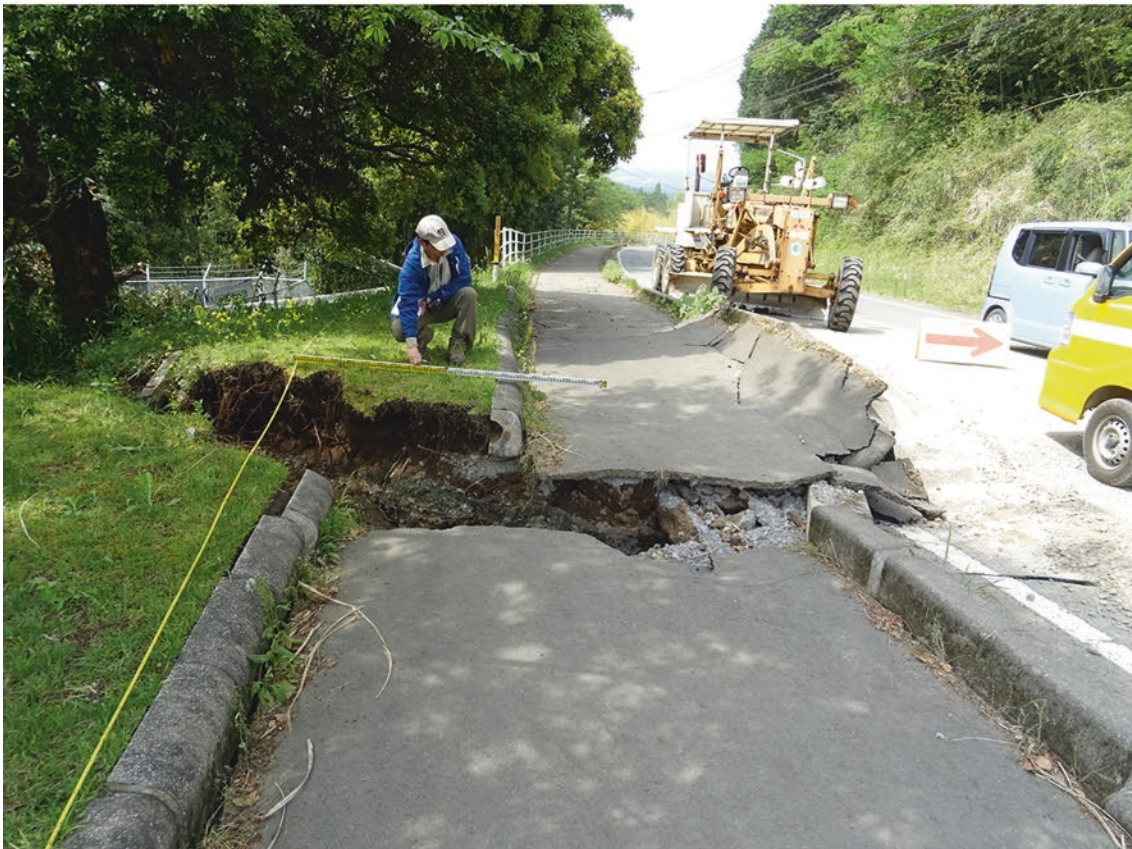
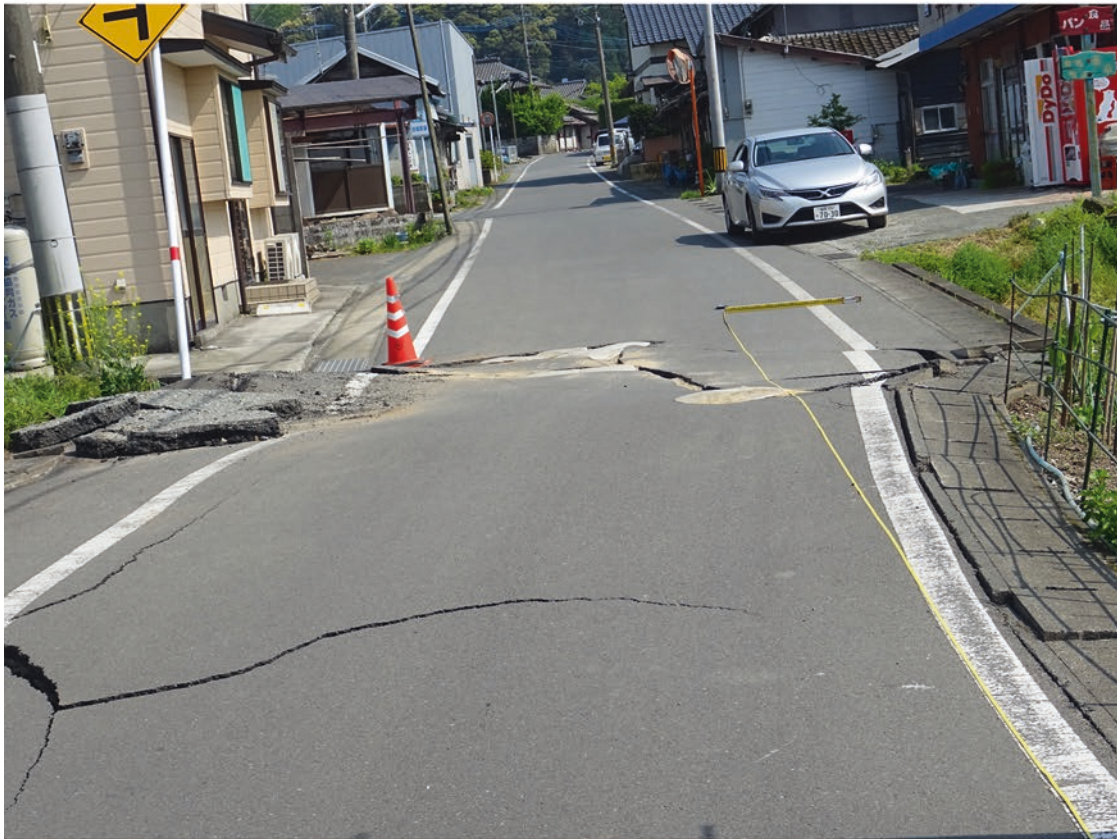
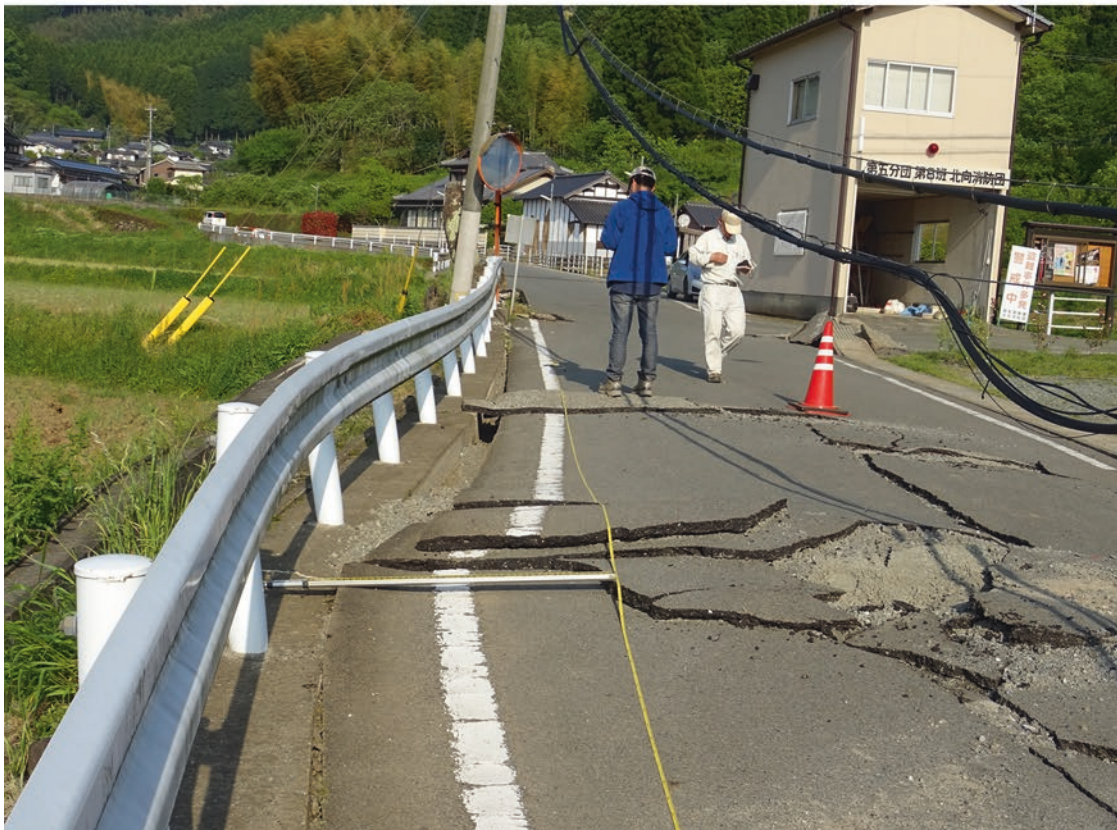
Fig. 13 Right-lateral offset of roads. (a) Coseismic surface ruptures cut a road at Okirihata dam site. Dextral offset ~1.3 m (b), ~0.8 m (c) and 0.5 m (d)

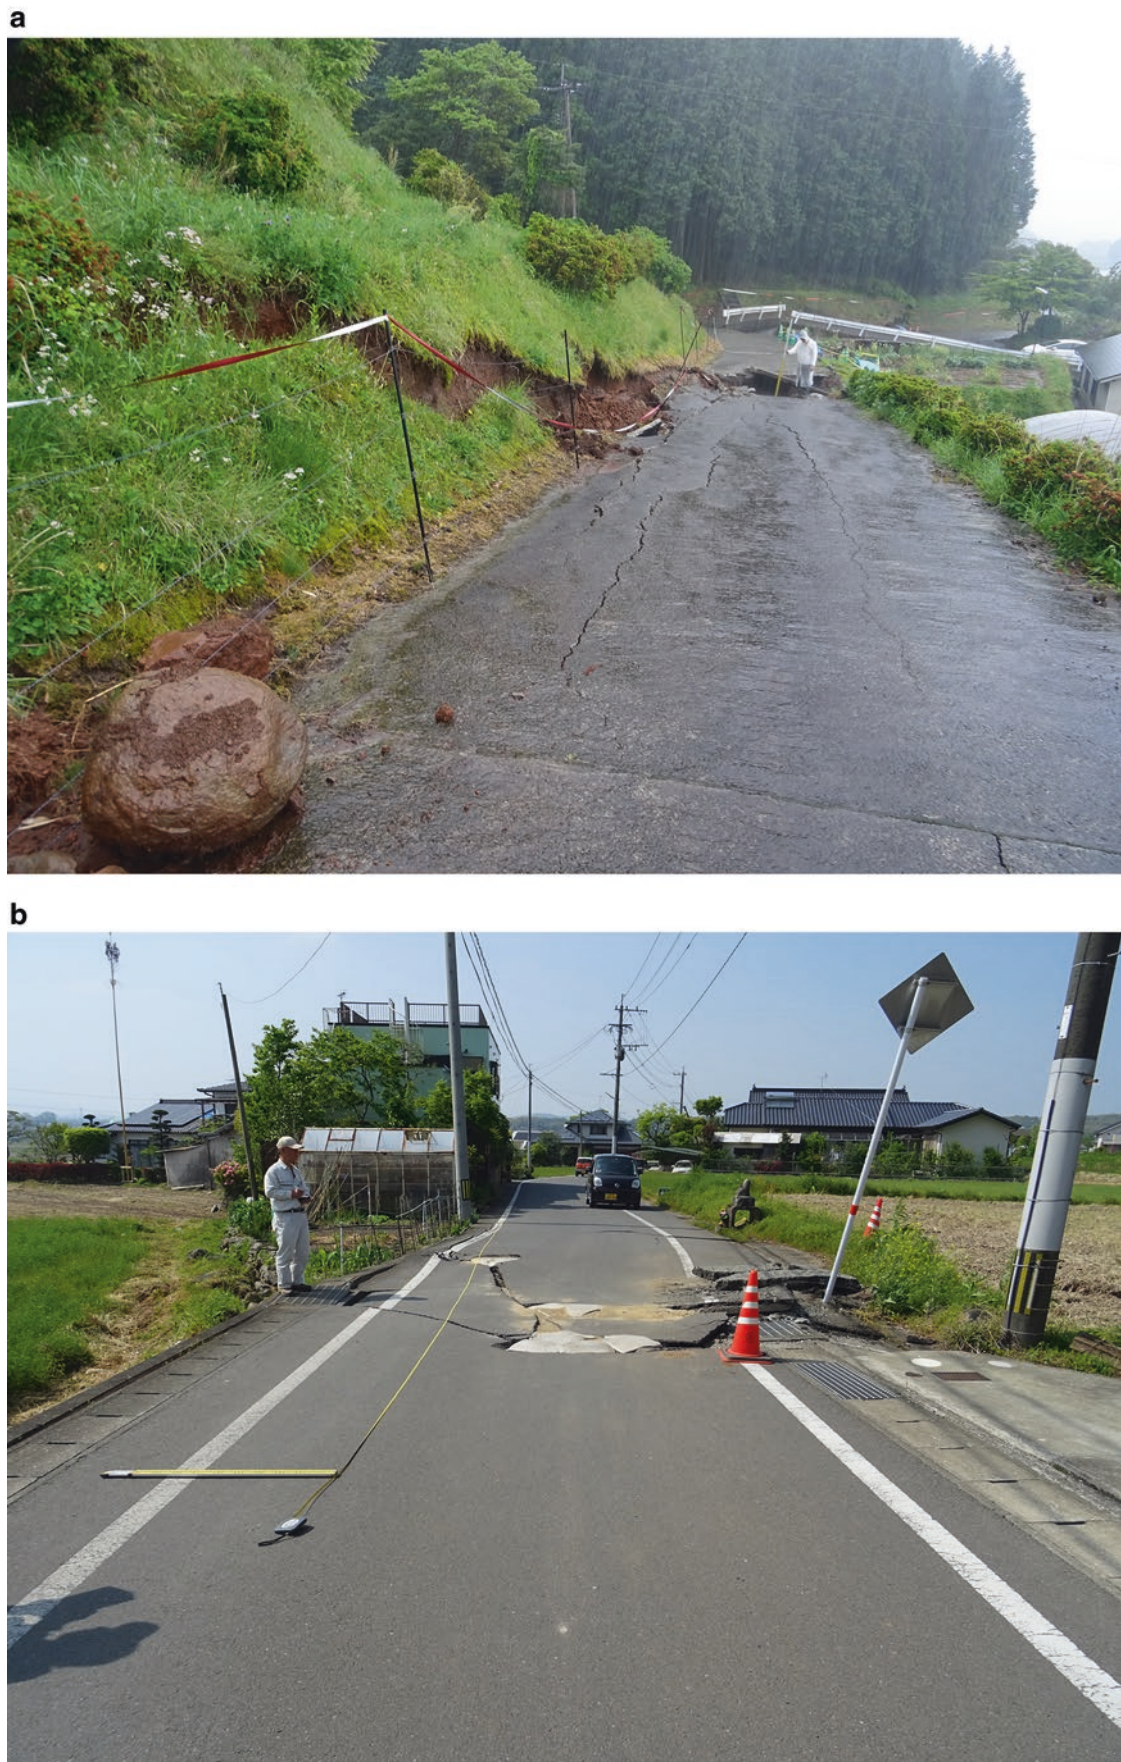
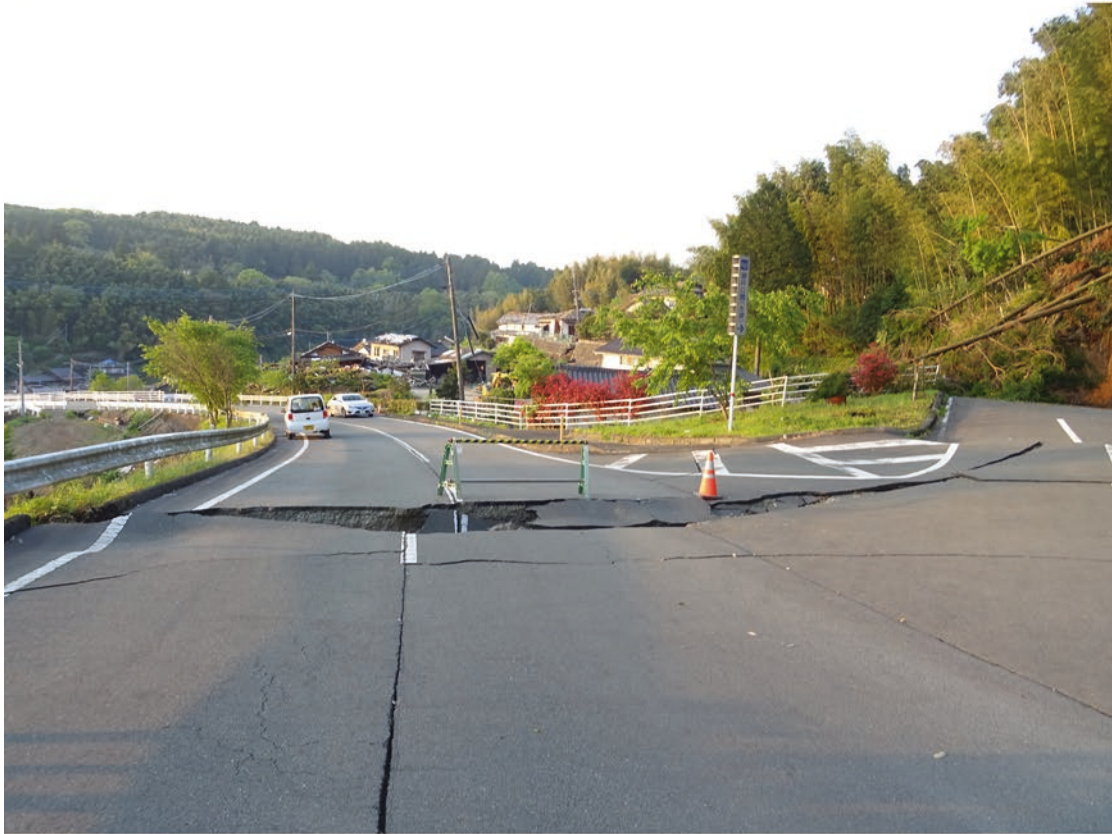
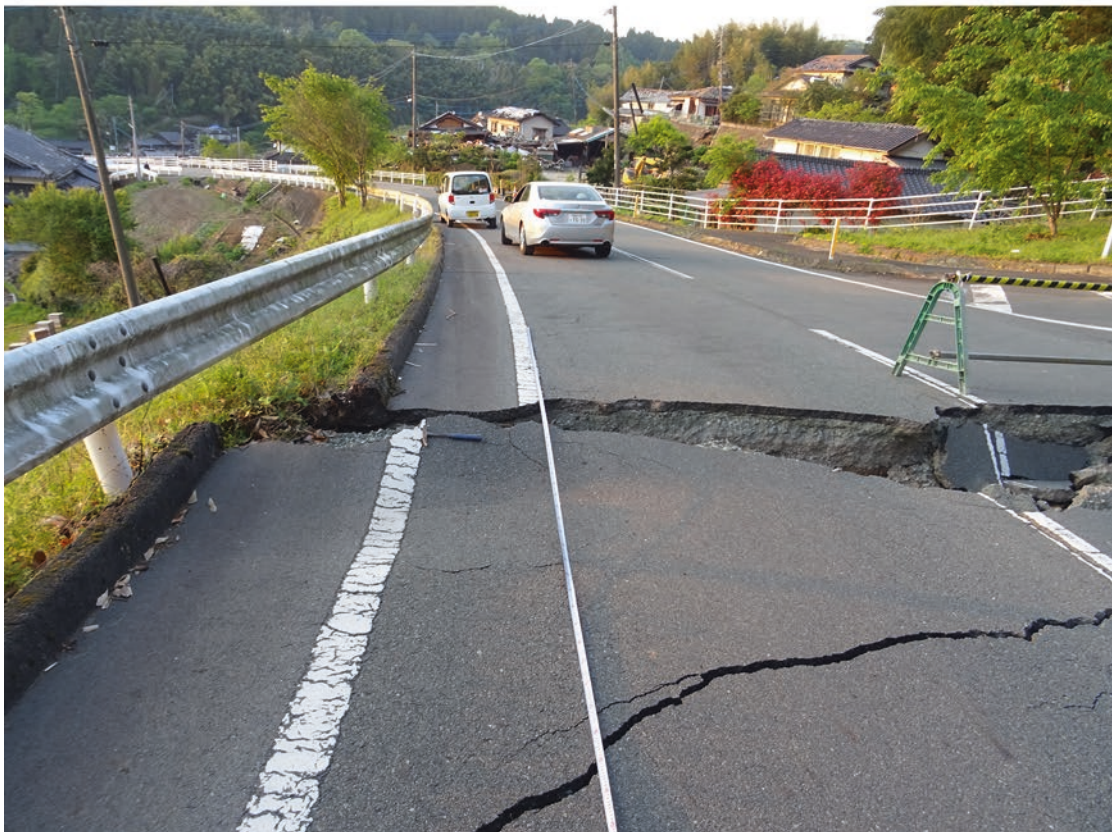
Fig. 14 Right-lateral offset of roads and slope. (a) Offset ~0.5 m, (b) 0.8.m, (c, d) 0.7.m
