The 2016 Mw 7.1 Kumamoto Earthquake

A Photographic Atlas of Coseismic Surface Ruptures
Related to the Aso Volcano, Japan

Aiming Lin
Department of Geophysics
Kyoto University
Kyoto, Japan

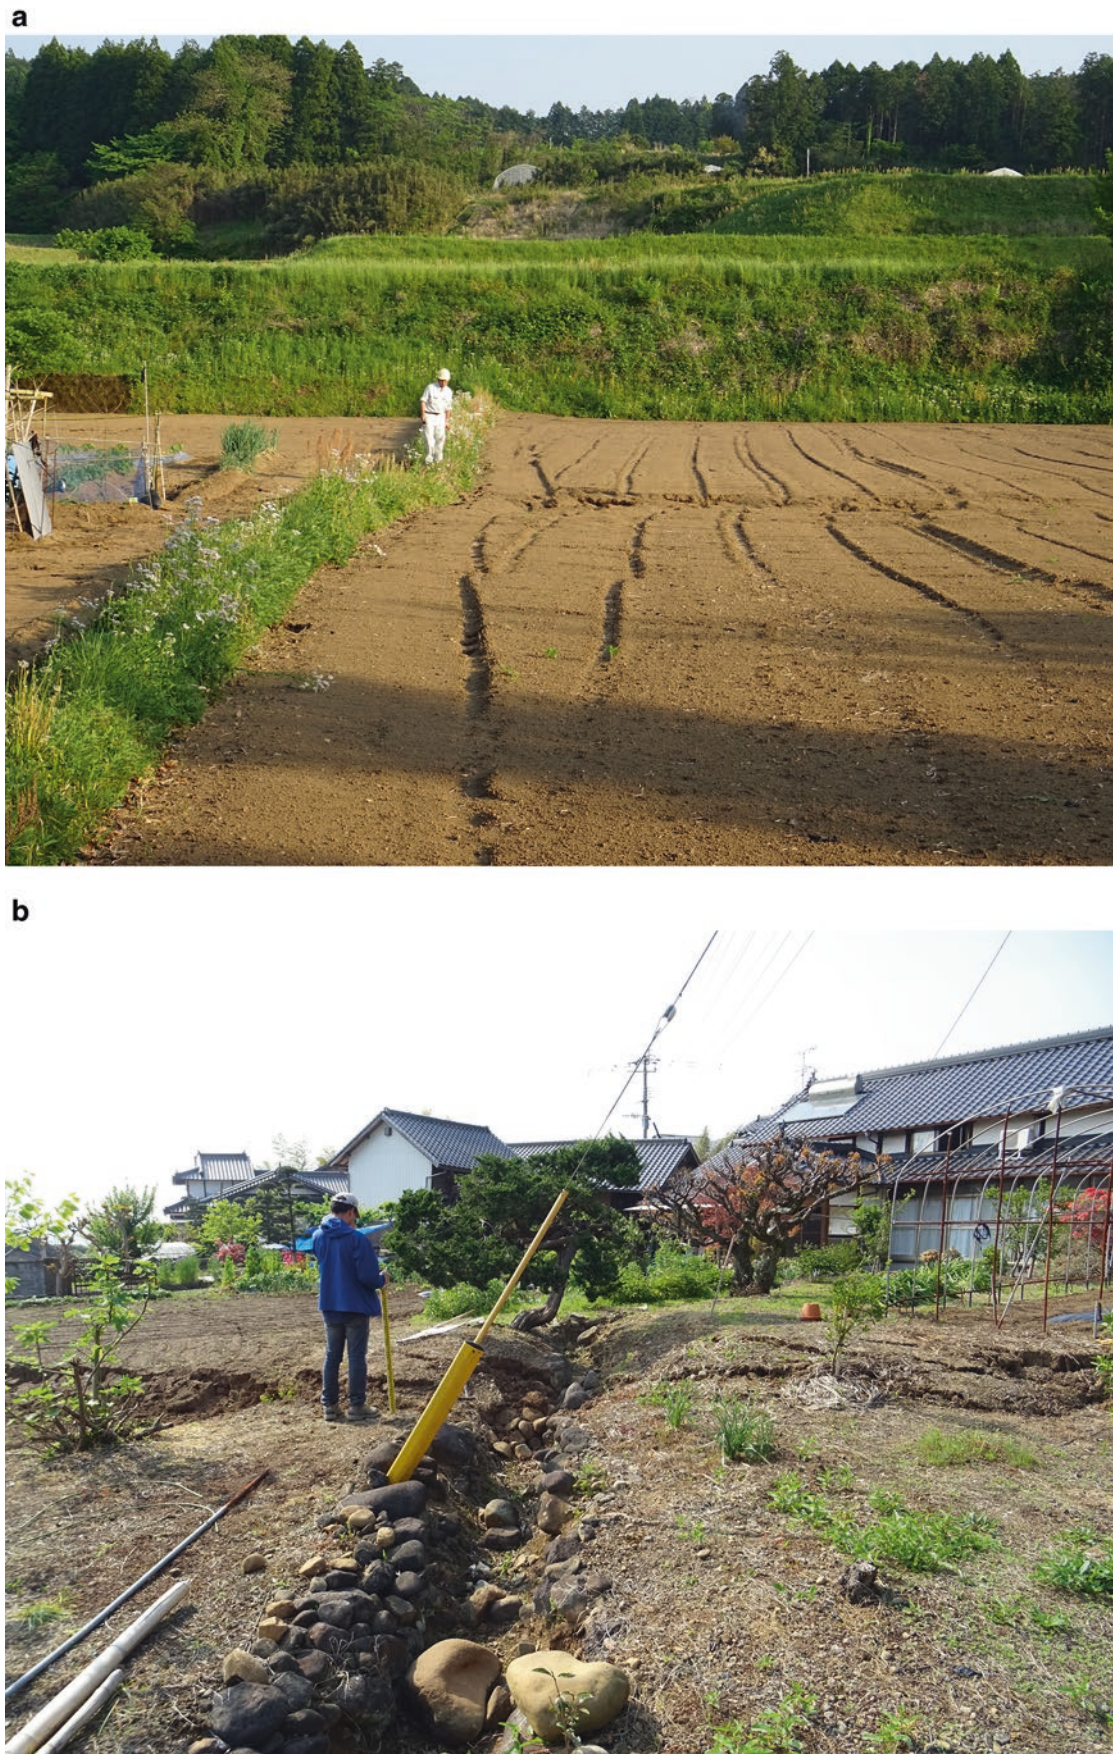
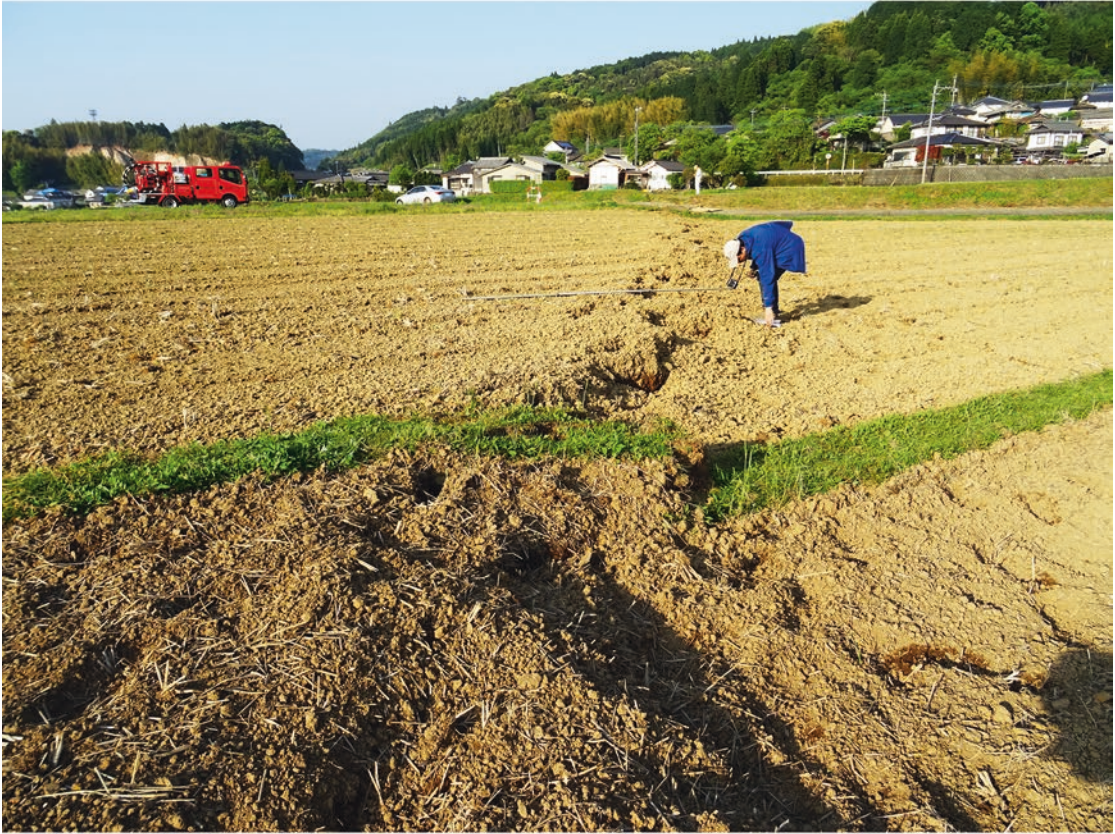
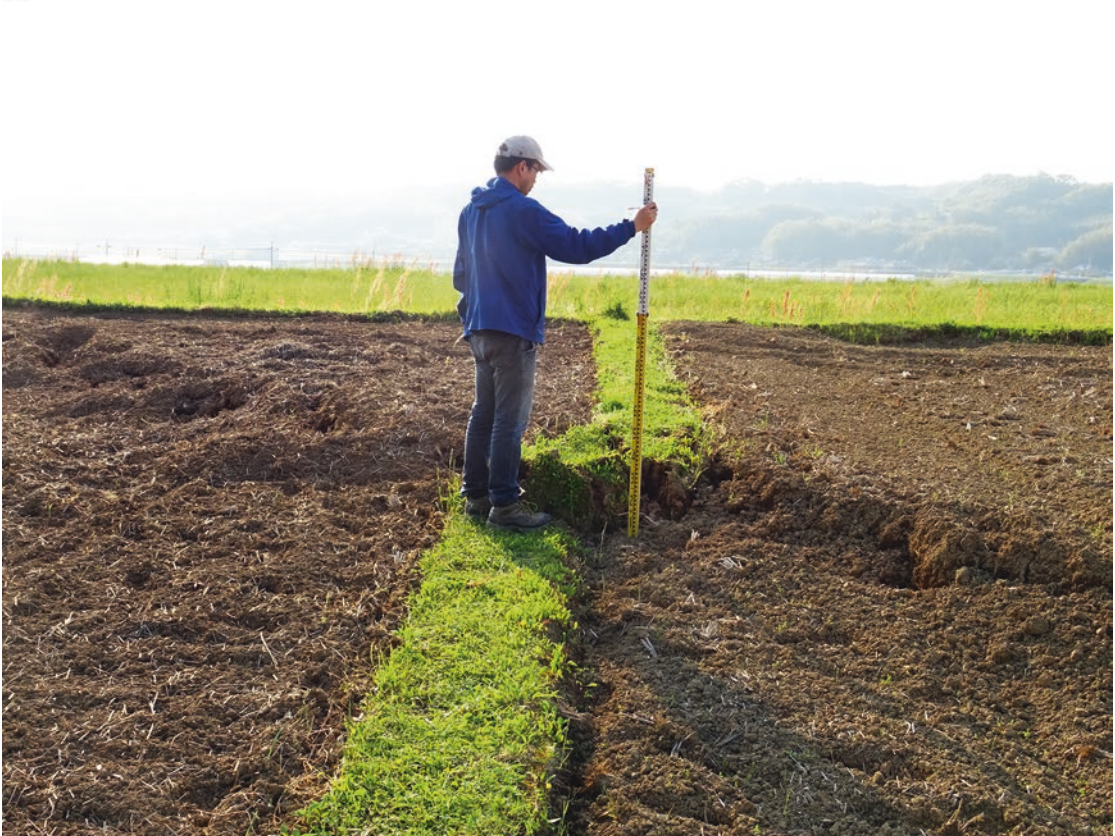
Fig. 15 Right-lateral offset of fields, paths, and ditch. (a) Offset ~0.6 m, (b) 0.8 m, (c, d) 0.3 ~ 0.4 m

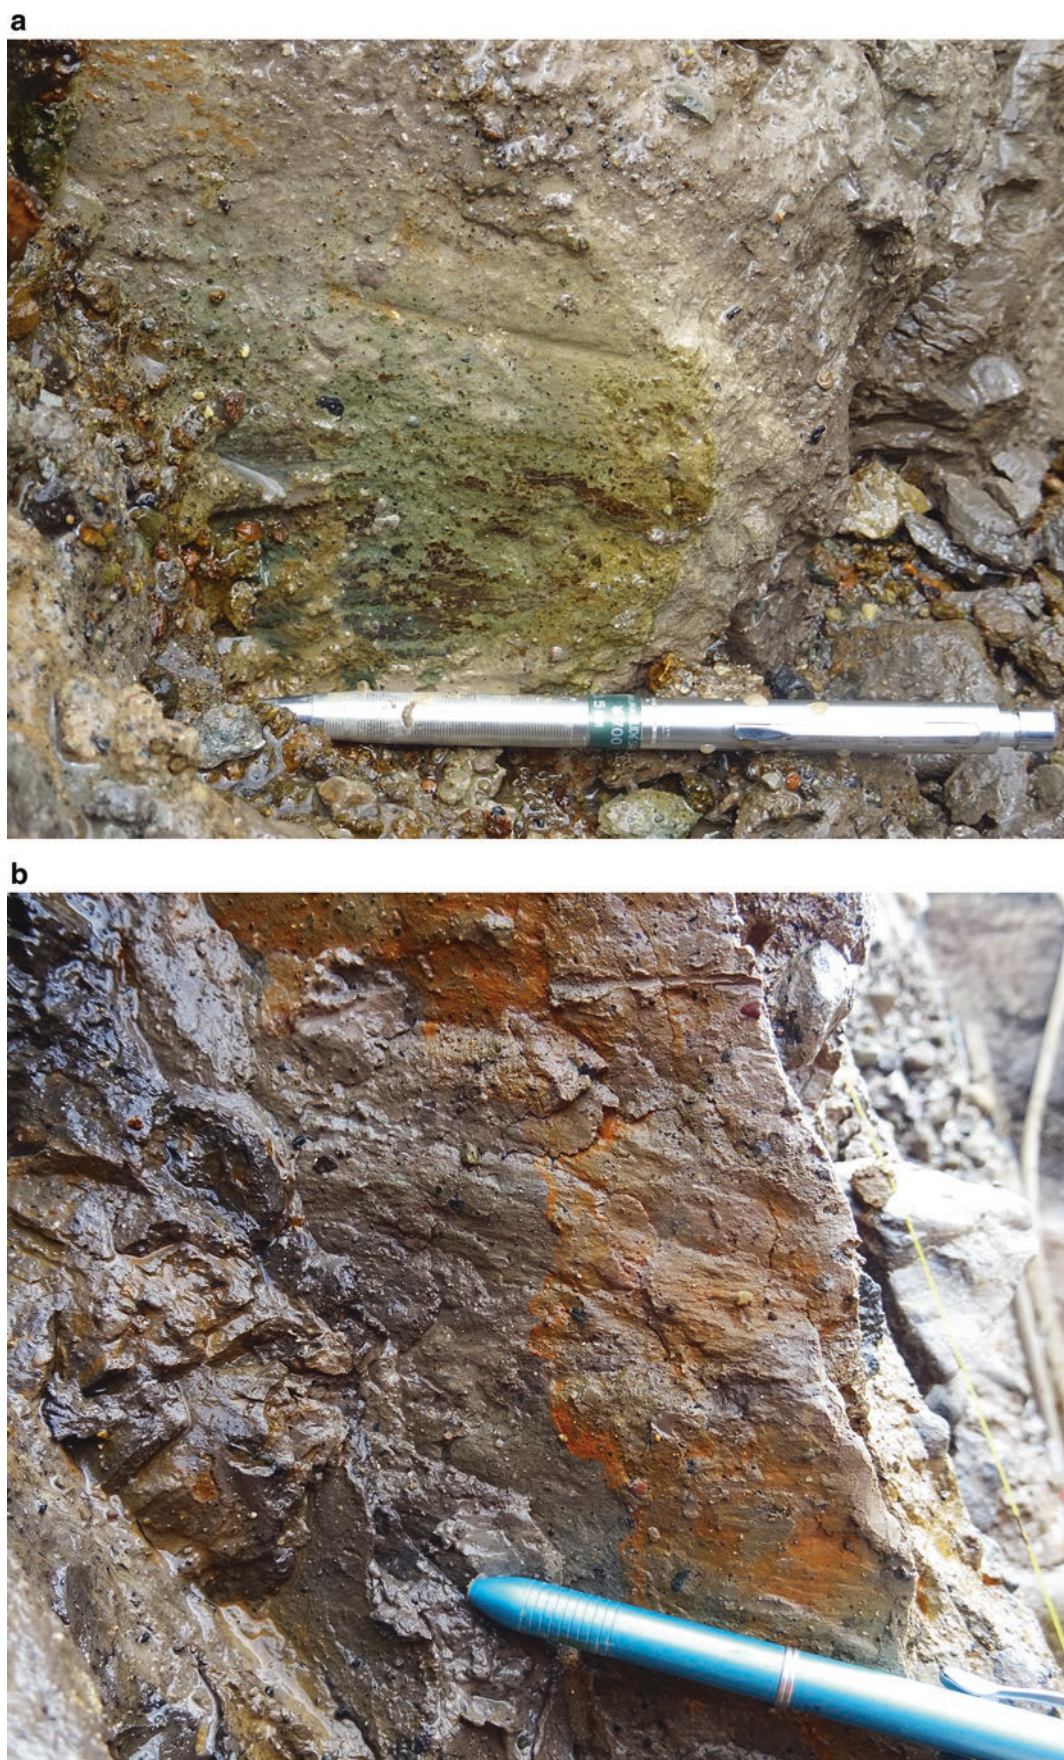
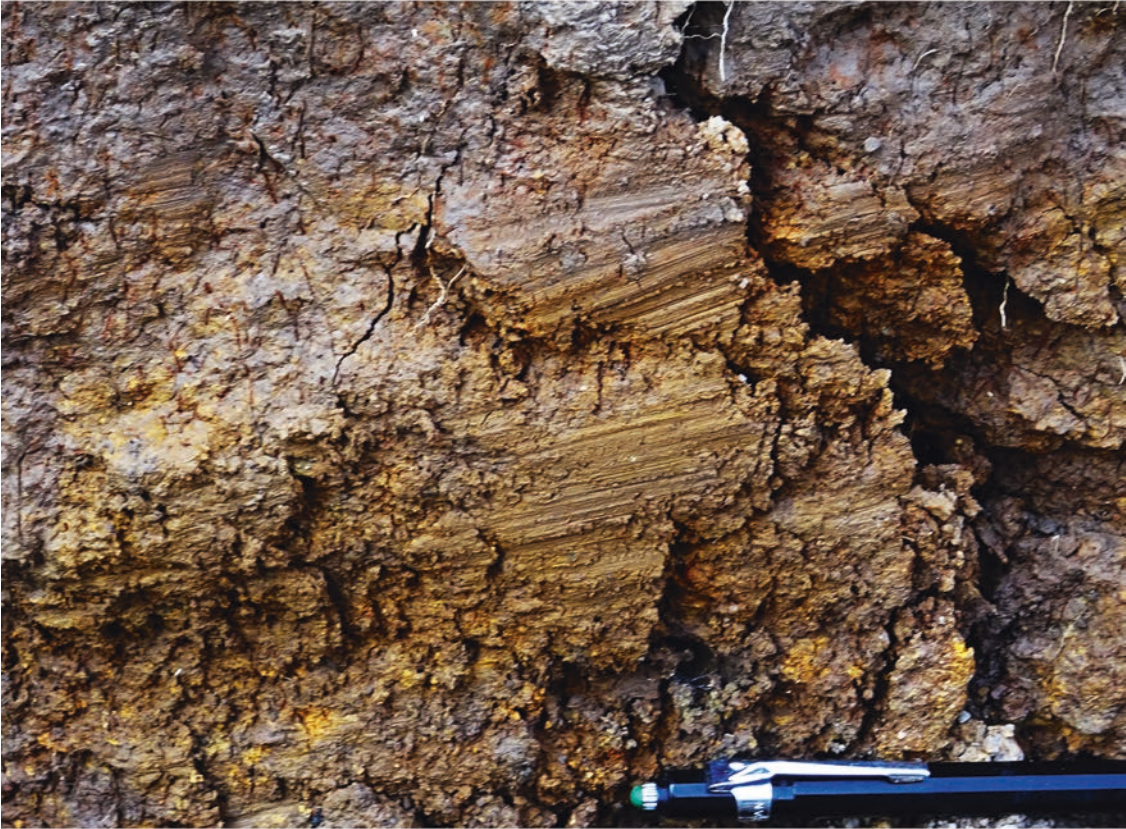
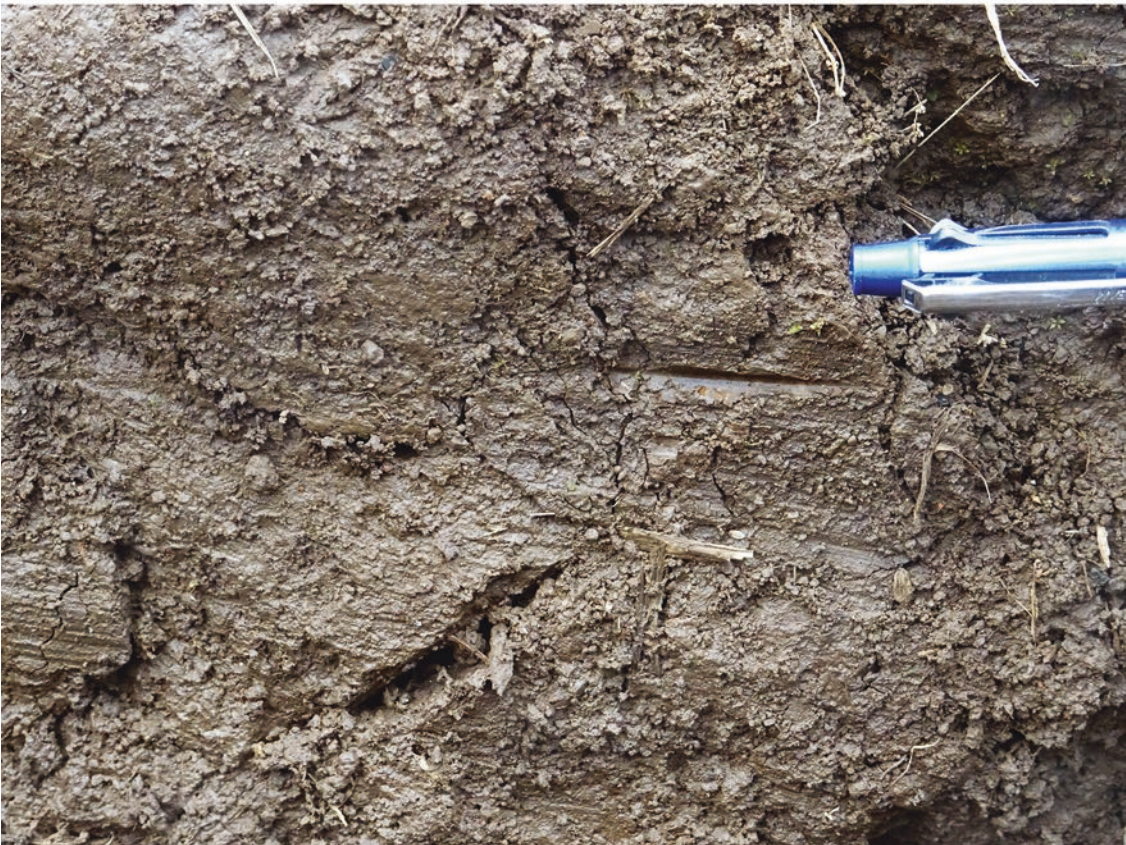
Fig. 16 Slickensides upon coseismic fault planes. (a, b) Coseismic fault plane developed within basement rocks (*sandstone*) and (c, d) unconsolidated surface soil layer. Striations developed on main fault planes indicate a strike-slip-dominated movement sense

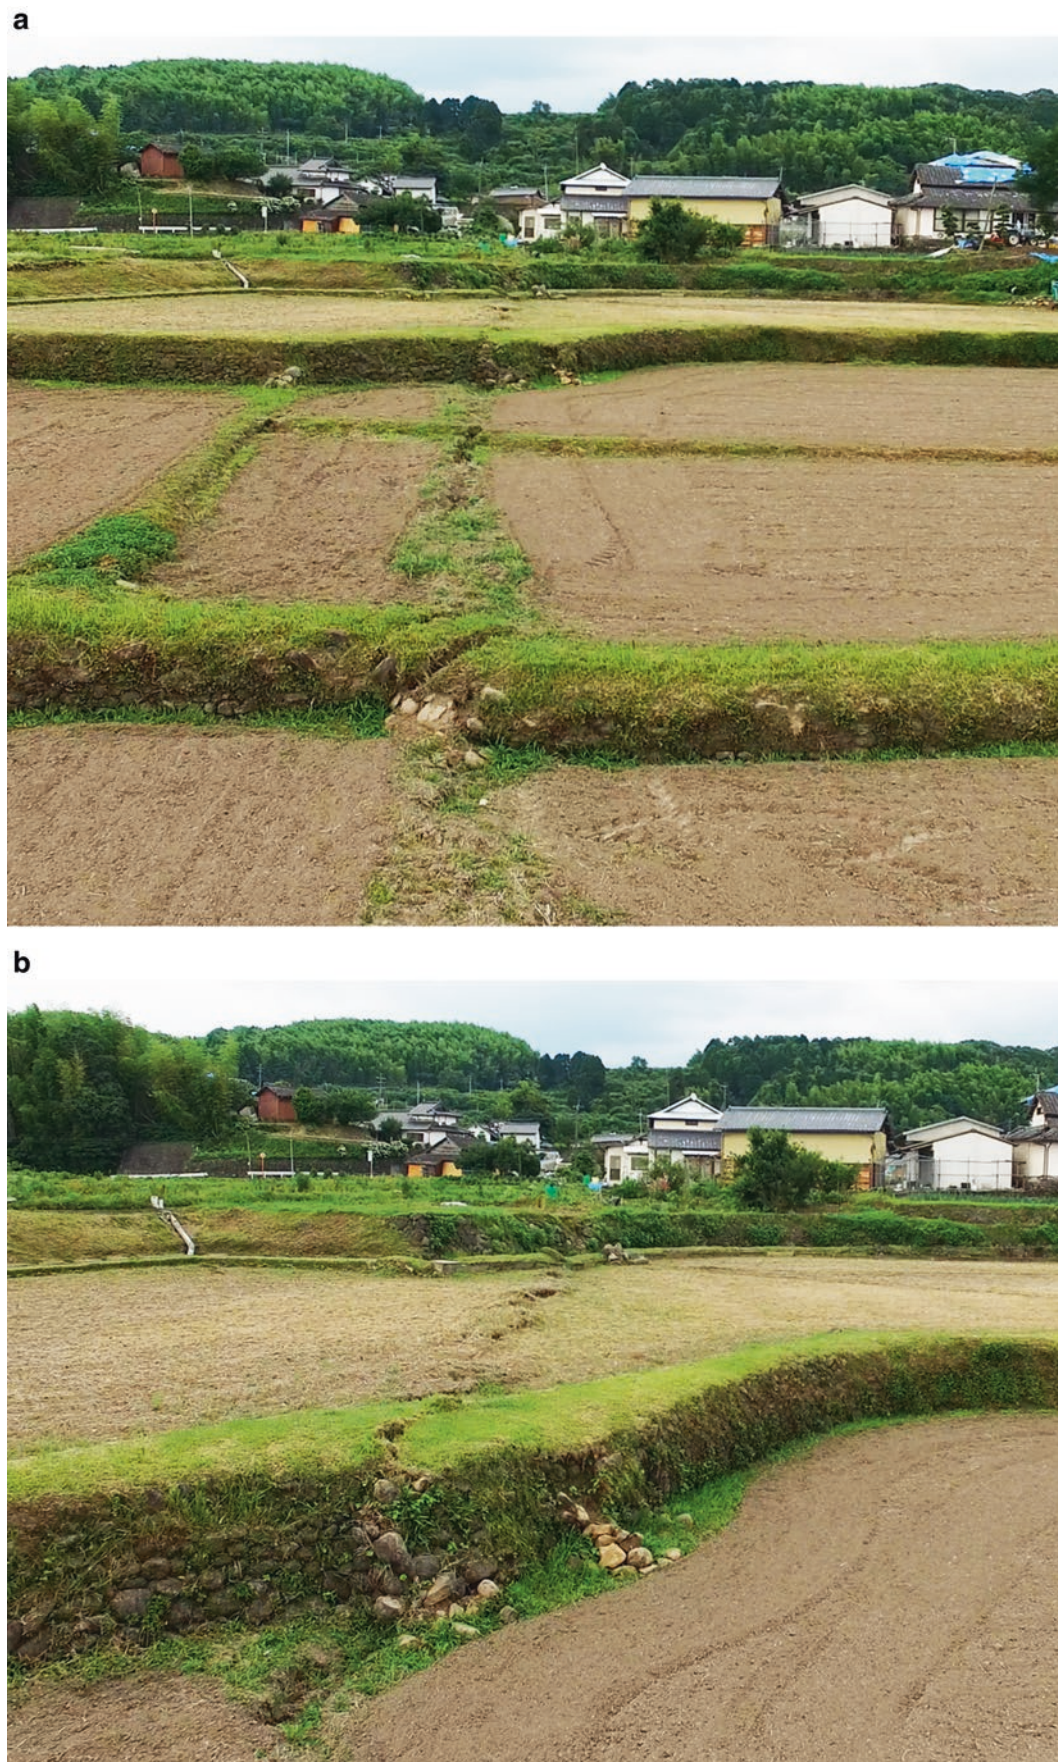
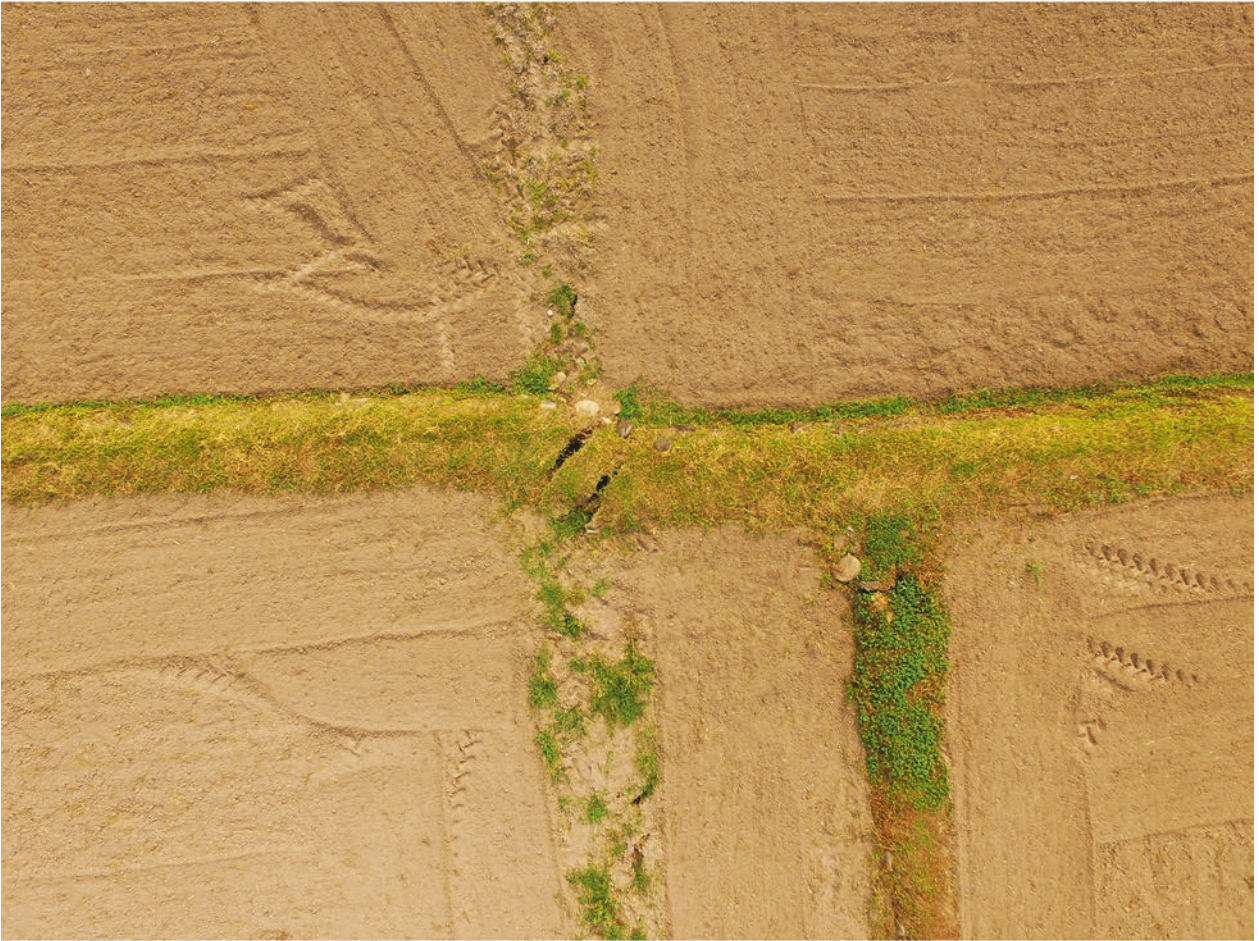
Fig. 17 Right-lateral offset of fields. Drone images (a–c) and photograph (d) showing the right-lateral offset of fields. Coseismic surface ruptures preserved inside fields (a–c)

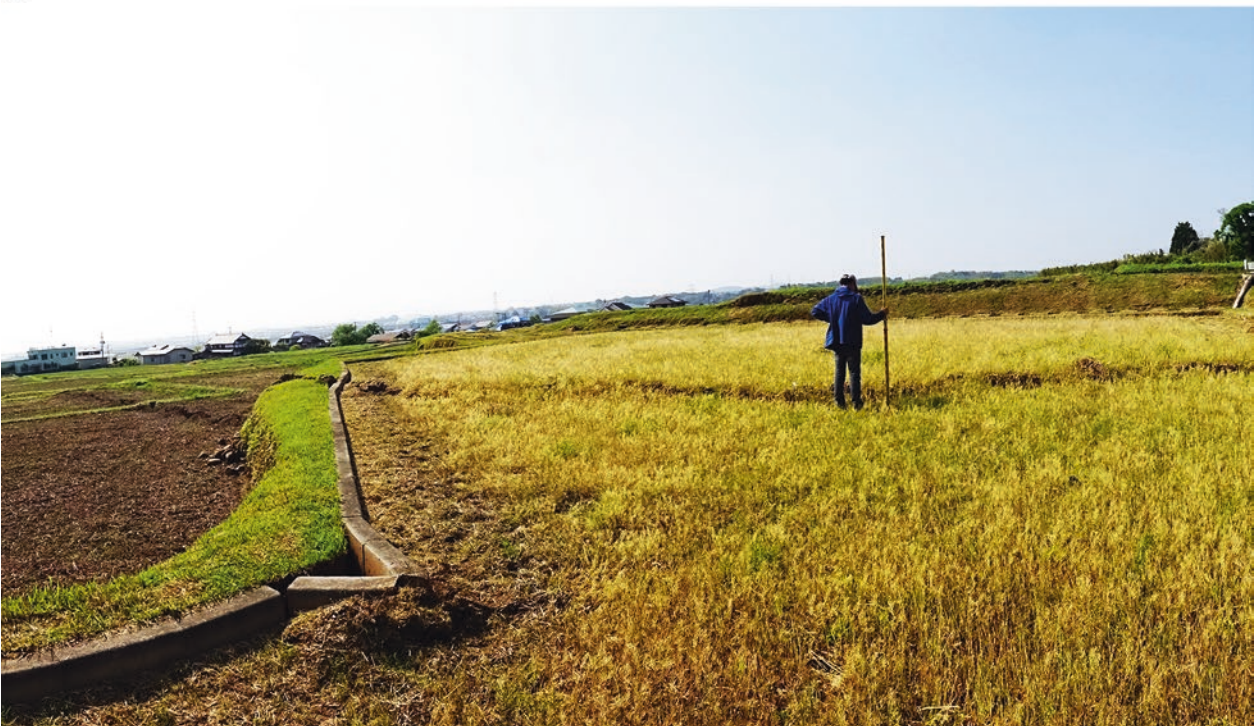
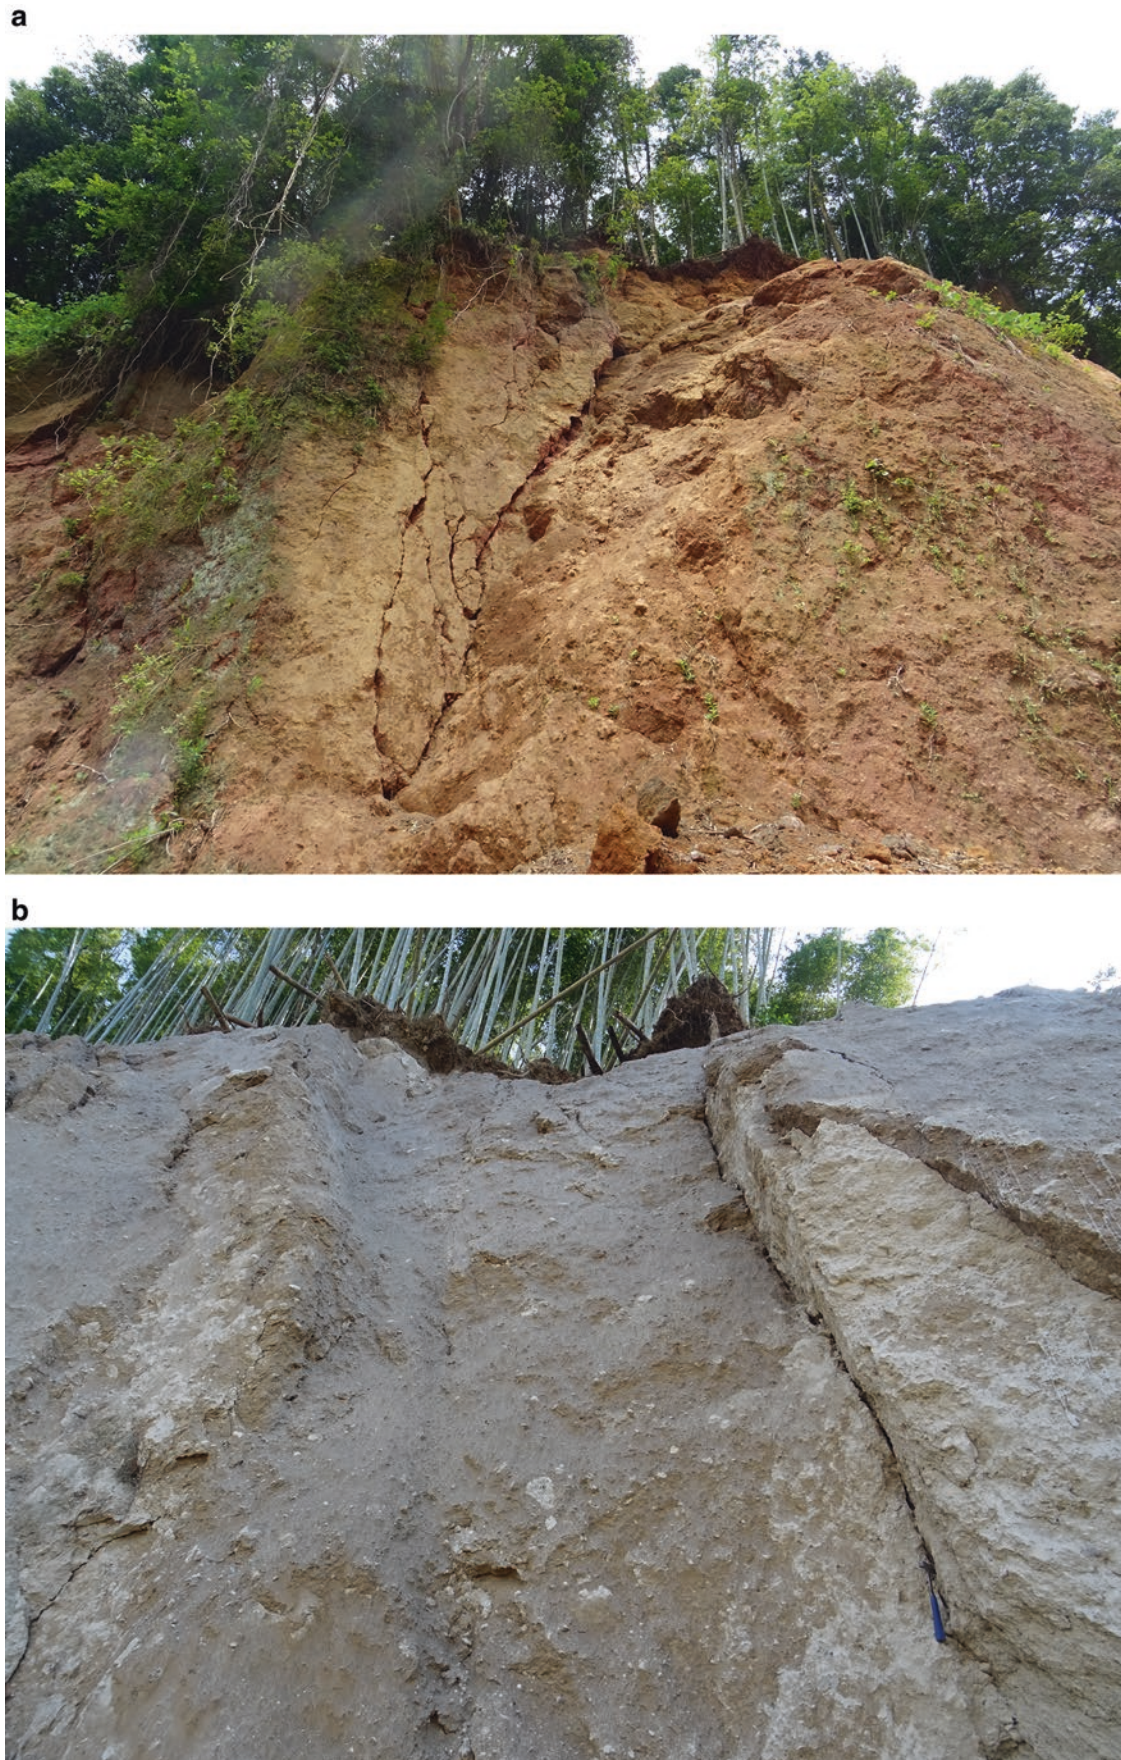
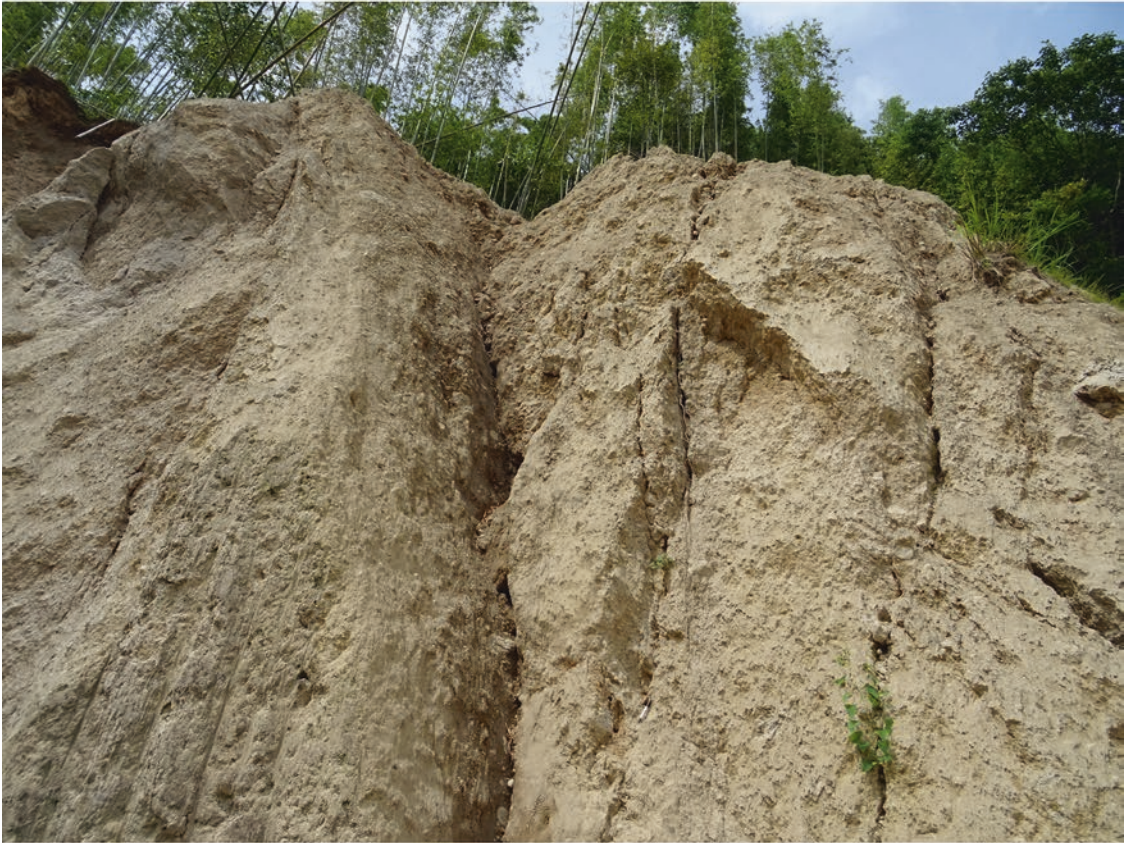
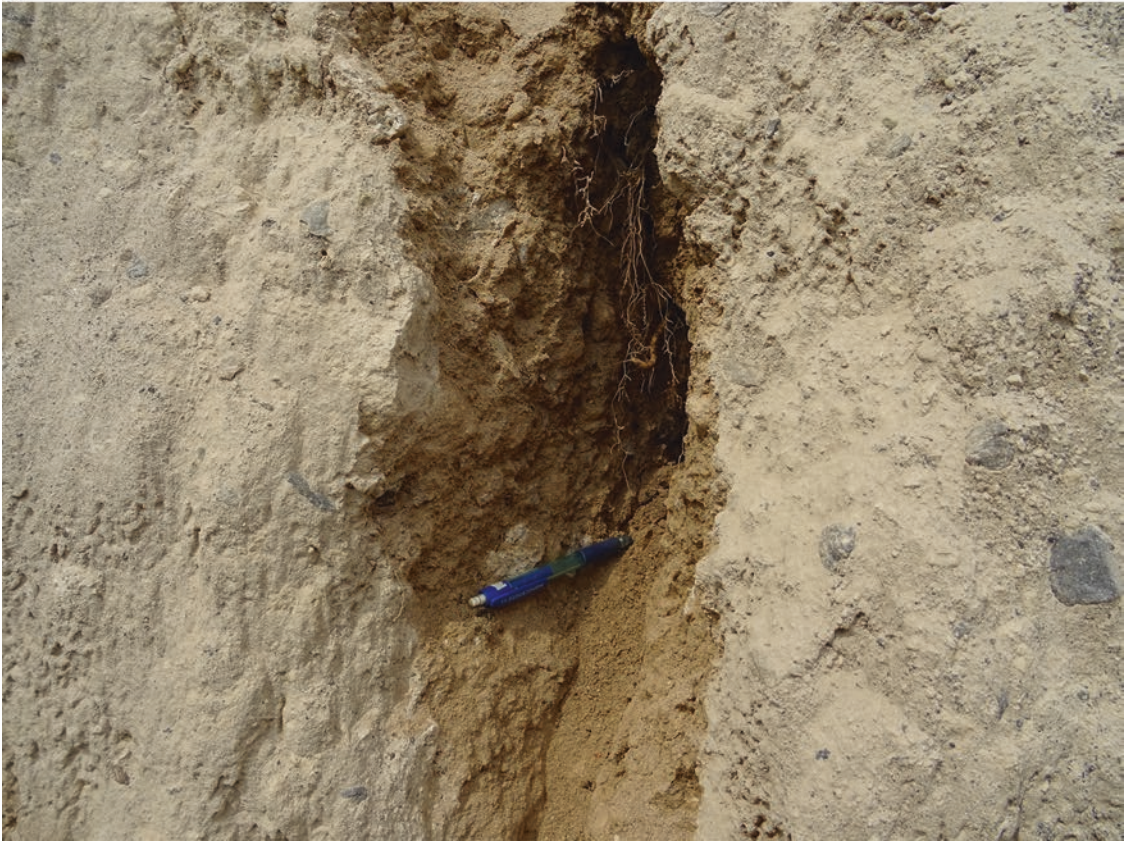
Fig. 18 Coseismic surface rupture occurred in weakly consolidated deposits. (a) Coseismic fault plane developed within volcanic deposits. (b) Coseismic surface rupture occurred in alluvial deposits. (c)

Coseismic fault plane and slickensides developed upon a fault plane in alluvial deposits. (d) Close-up view of (c)

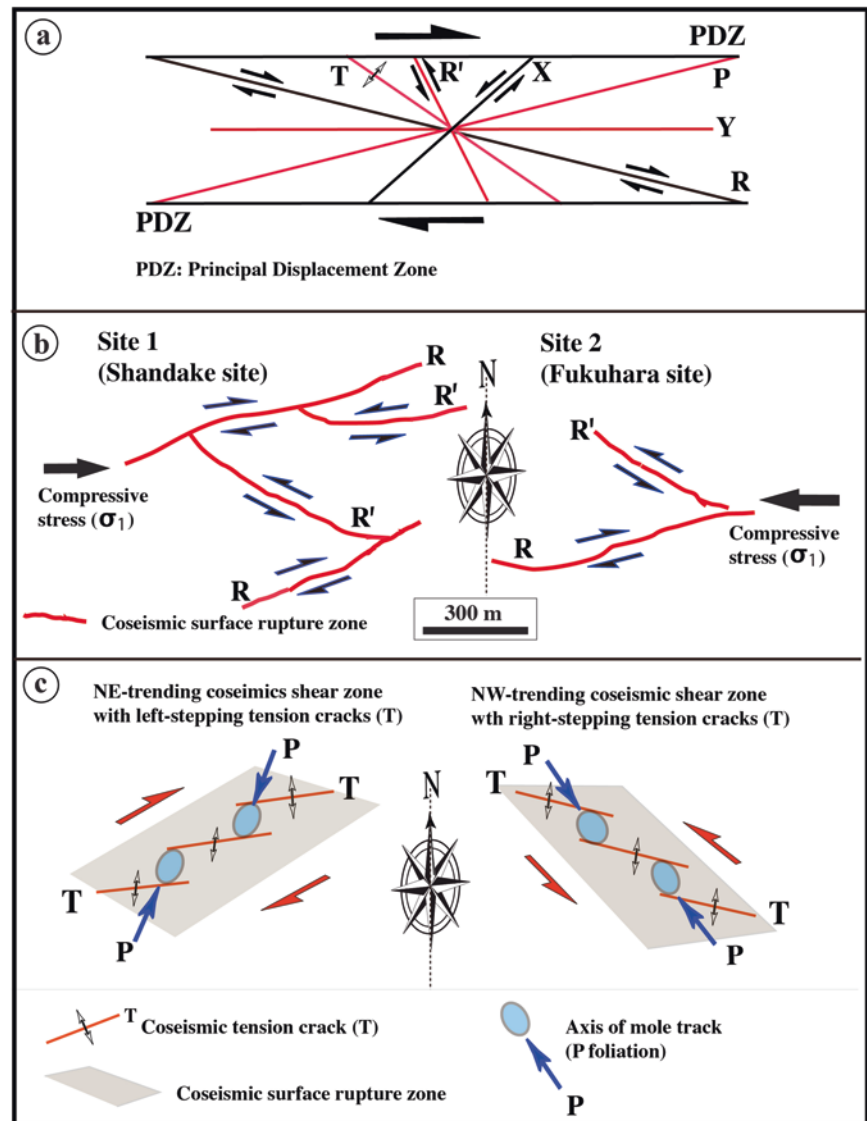
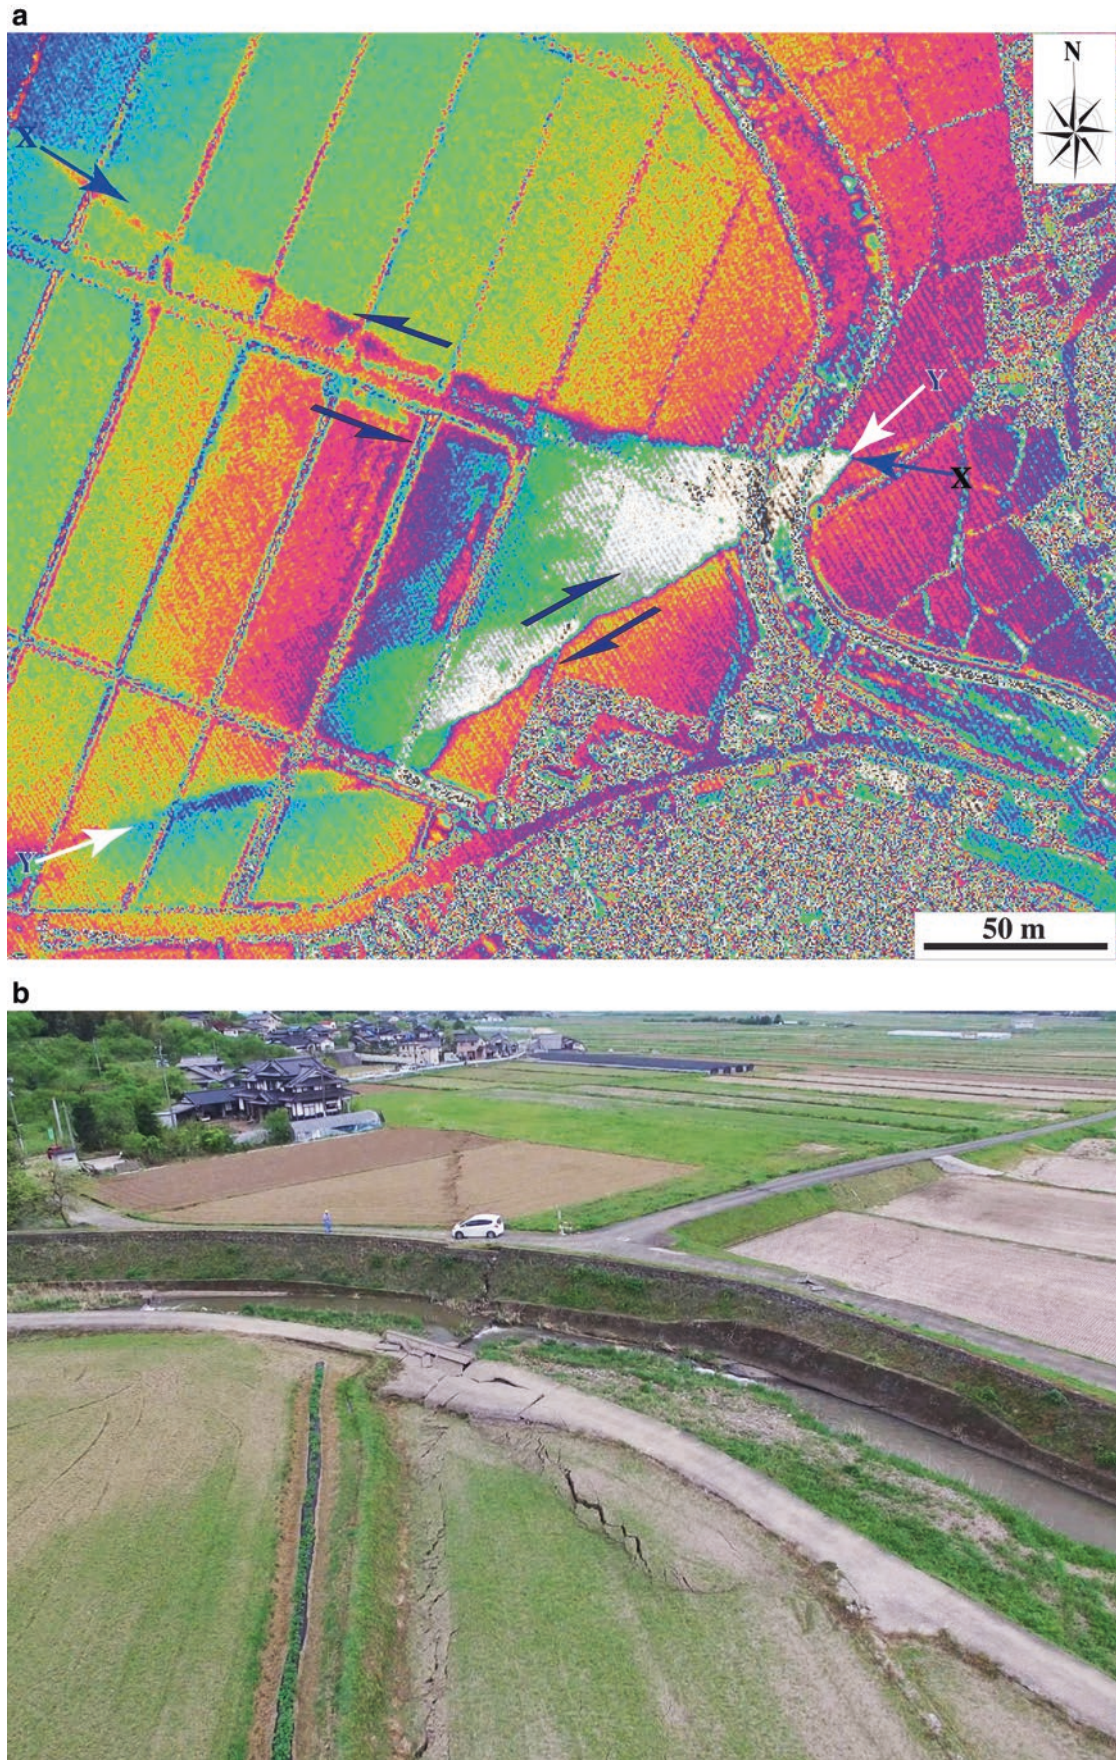
Fig. 19 Diagrams showing Riedel shear structural features (modified from Lin and Chiba [2017]). (a) The geometric features of an idealized Riedel shear zone. (b) The structural features of coseismic surface rupture zones mapped in typical areas. (c) Tension cracks (T) and mole tracks (P) are developed within the ENE-trending and WNW-trending coseismic Riedel shear zones

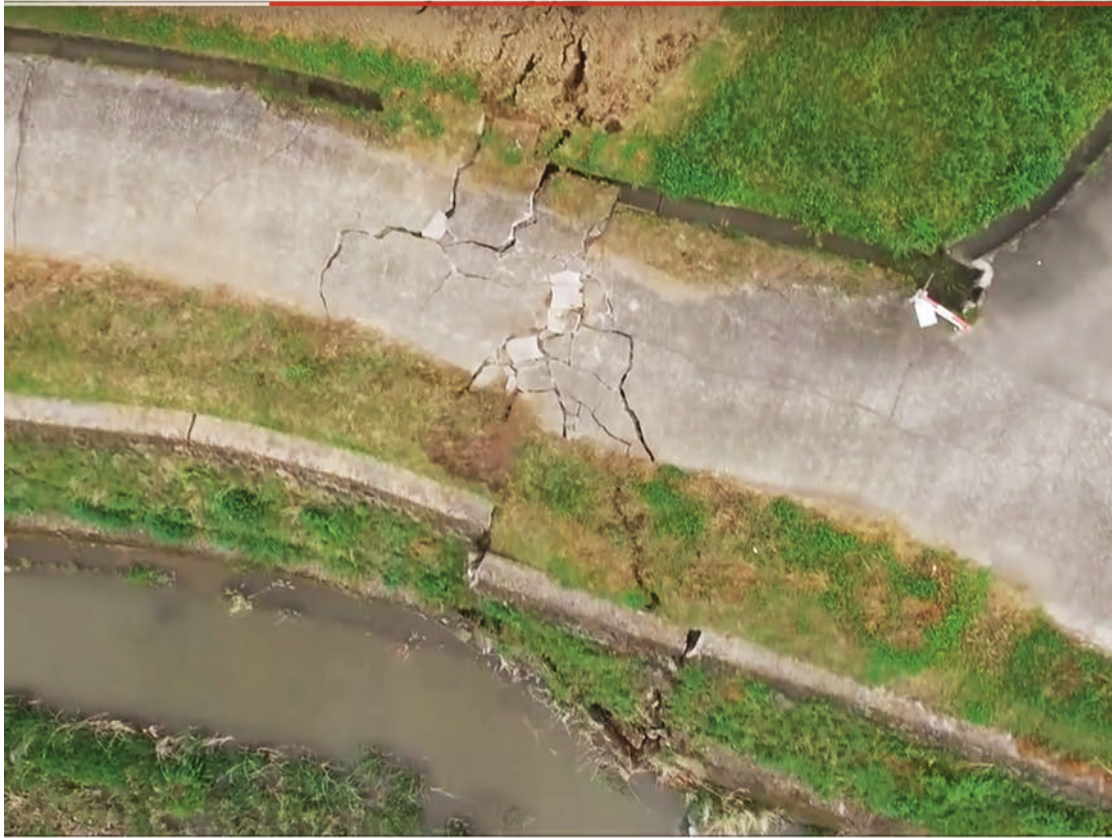
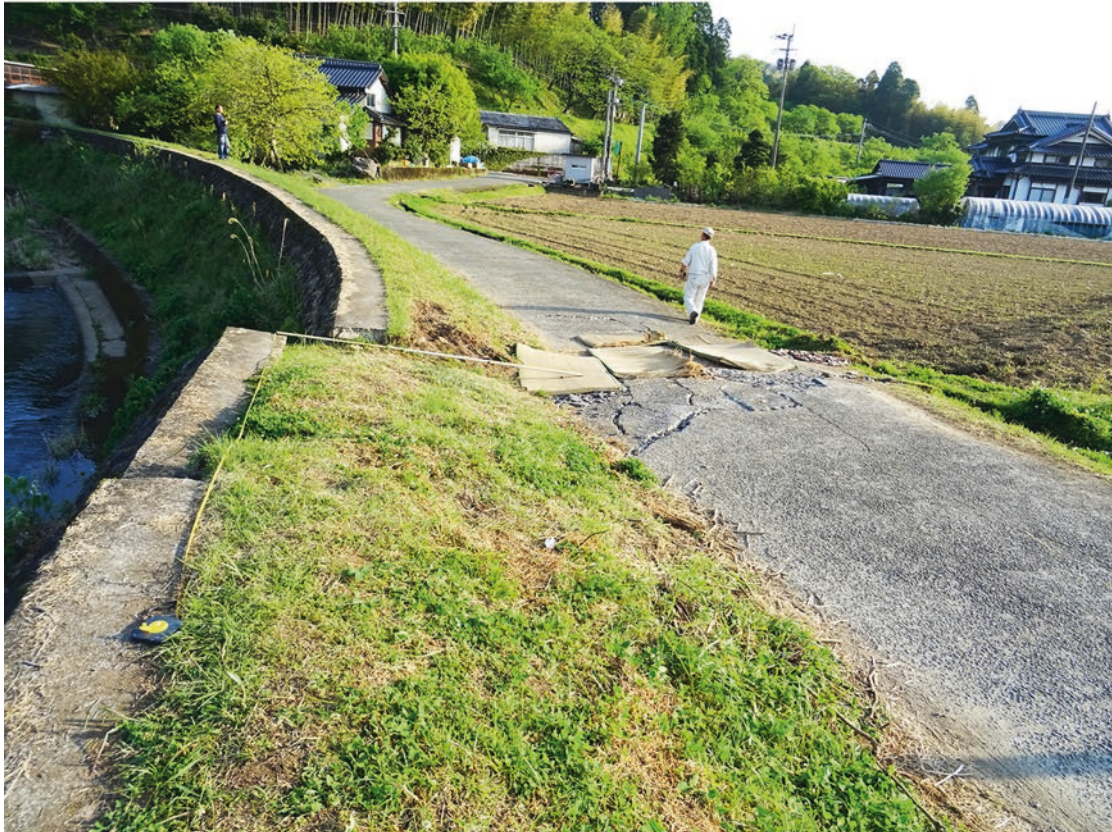
Fig. 20 LiDAR and drone images showing structural features of coseismic conjugate faults at Shantake village. (a) Right-lateral strike-slip displacements occurred along Y fault striking northeast-southwest, while

left-lateral strike-slip displacements occurred along X fault striking northwest-southeast. (b, c) Drone images and (d) photograph showing right-lateral offset of river channel and the fields (offset ~0.9 m)
