The 2016 Mw 7.1 Kumamoto Earthquake

A Photographic Atlas of Coseismic Surface Ruptures
Related to the Aso Volcano, Japan

Aiming Lin
Department of Geophysics
Kyoto University
Kyoto, Japan

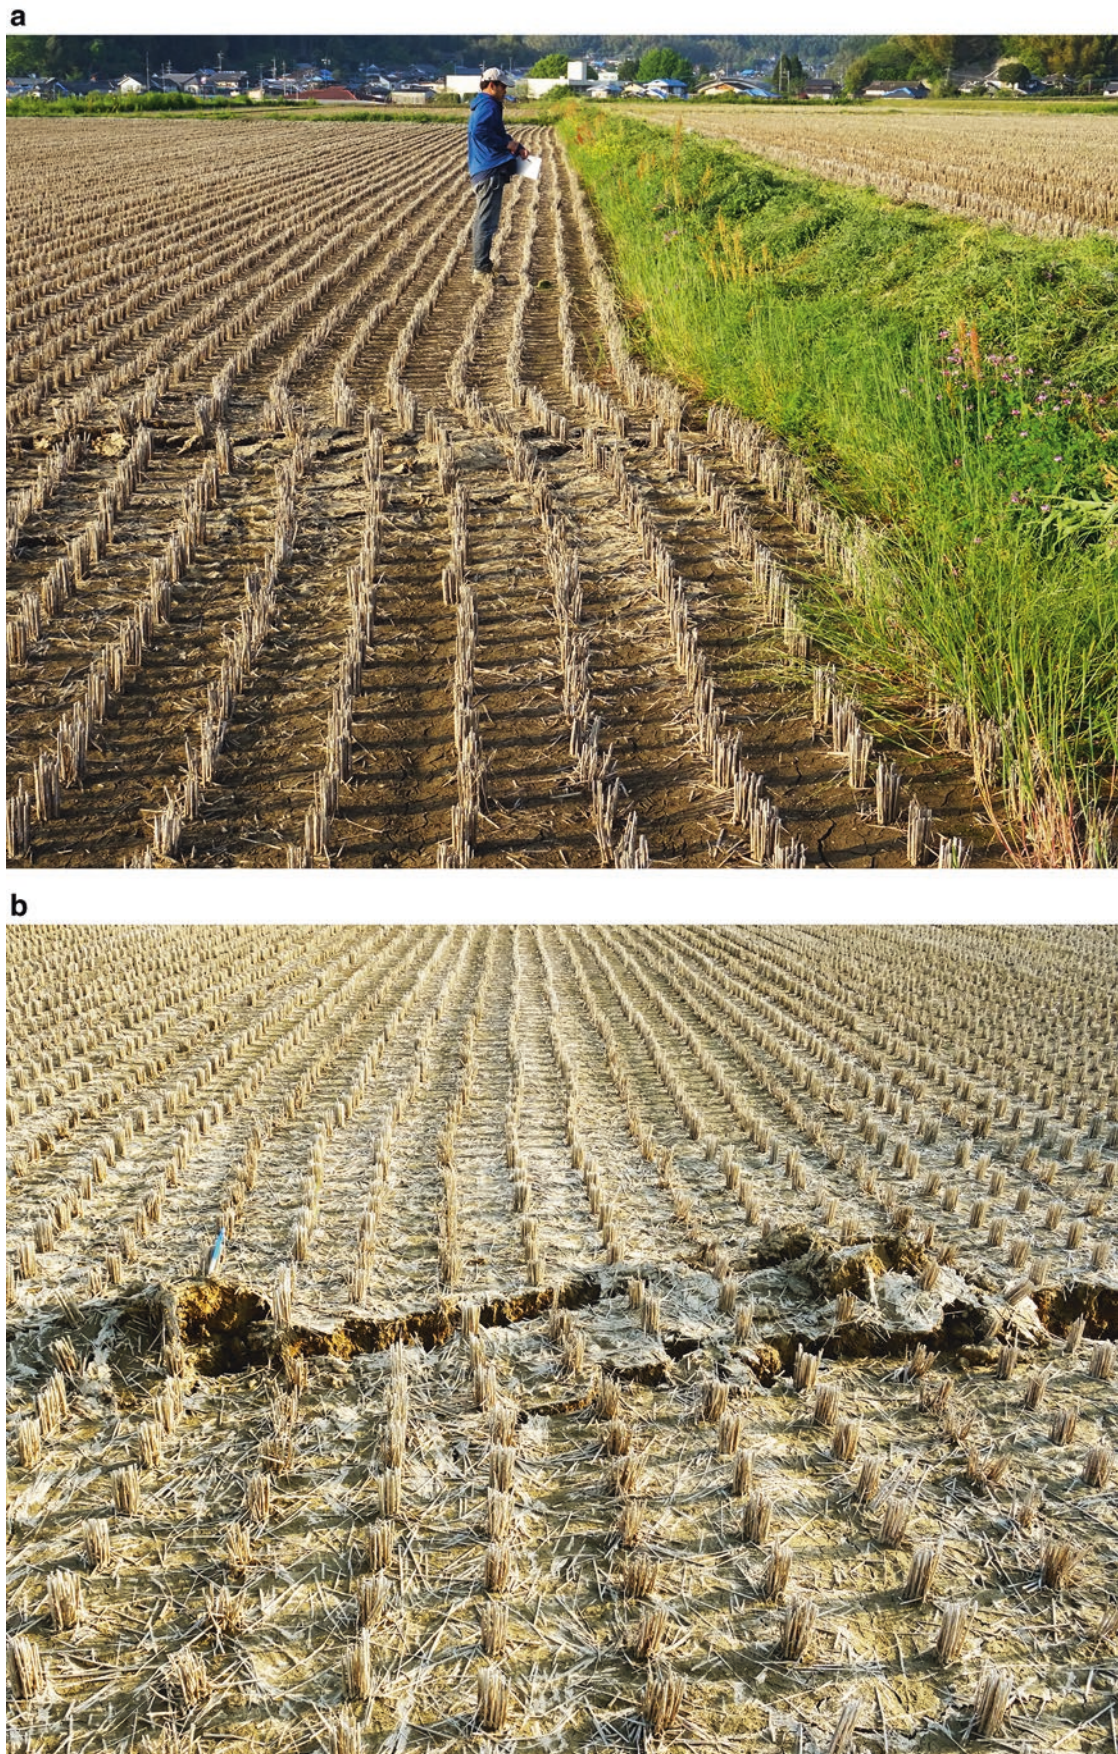
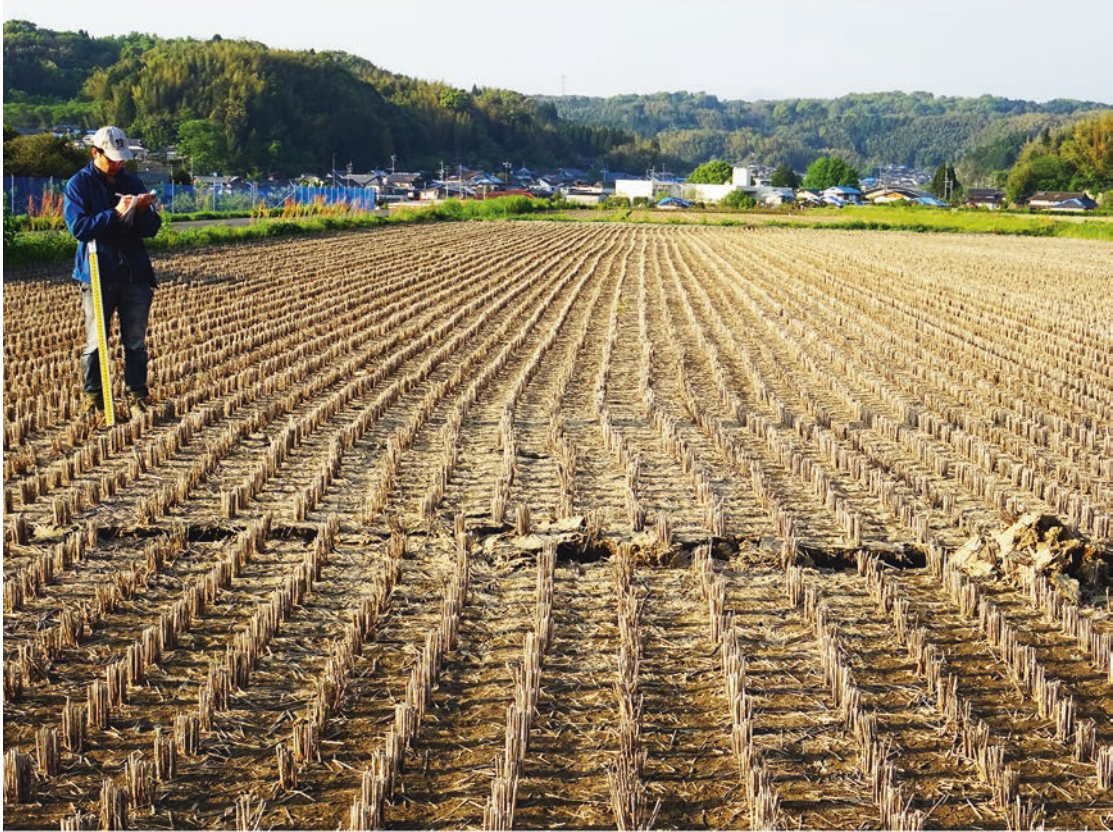
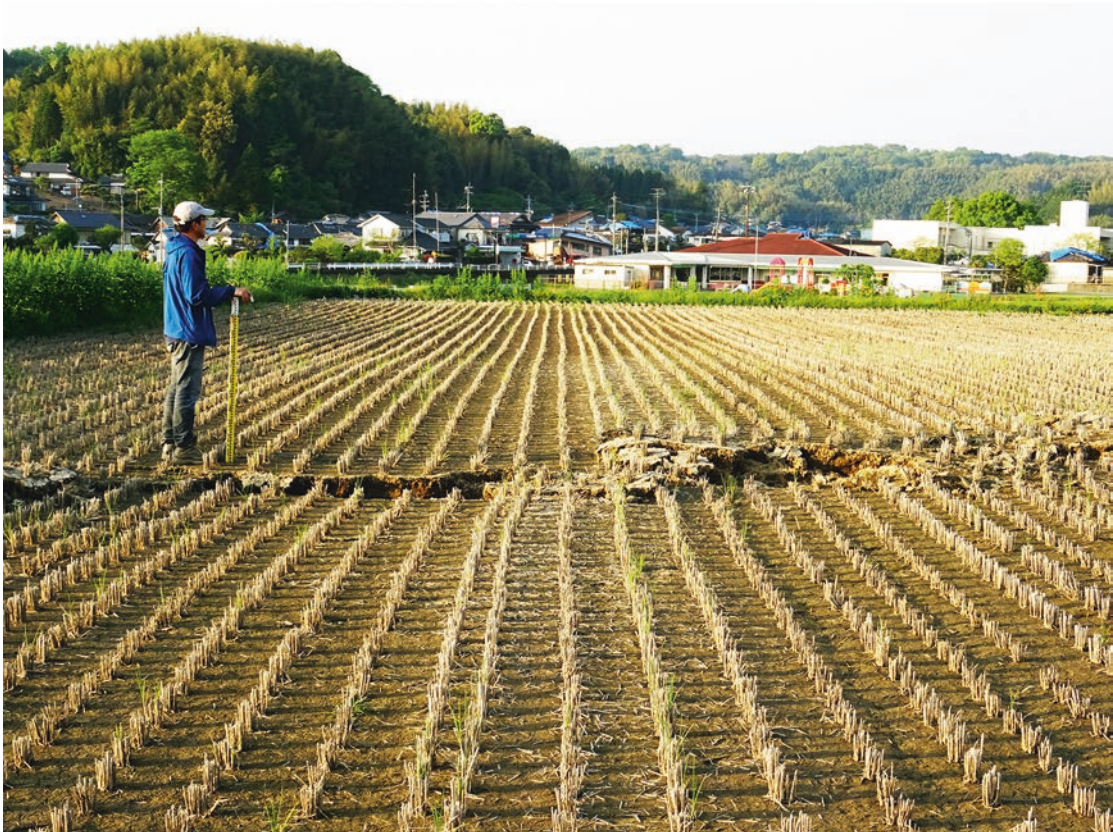
Fig.21 Strike-slip offset of rice field rows. (a–c) Left-lateral offset of rice field rows along WNW-ESE striking rupture zone (offset amount ~0.3 m). (d) Right-lateral offset of rice field rows (offset ~0.6 m)

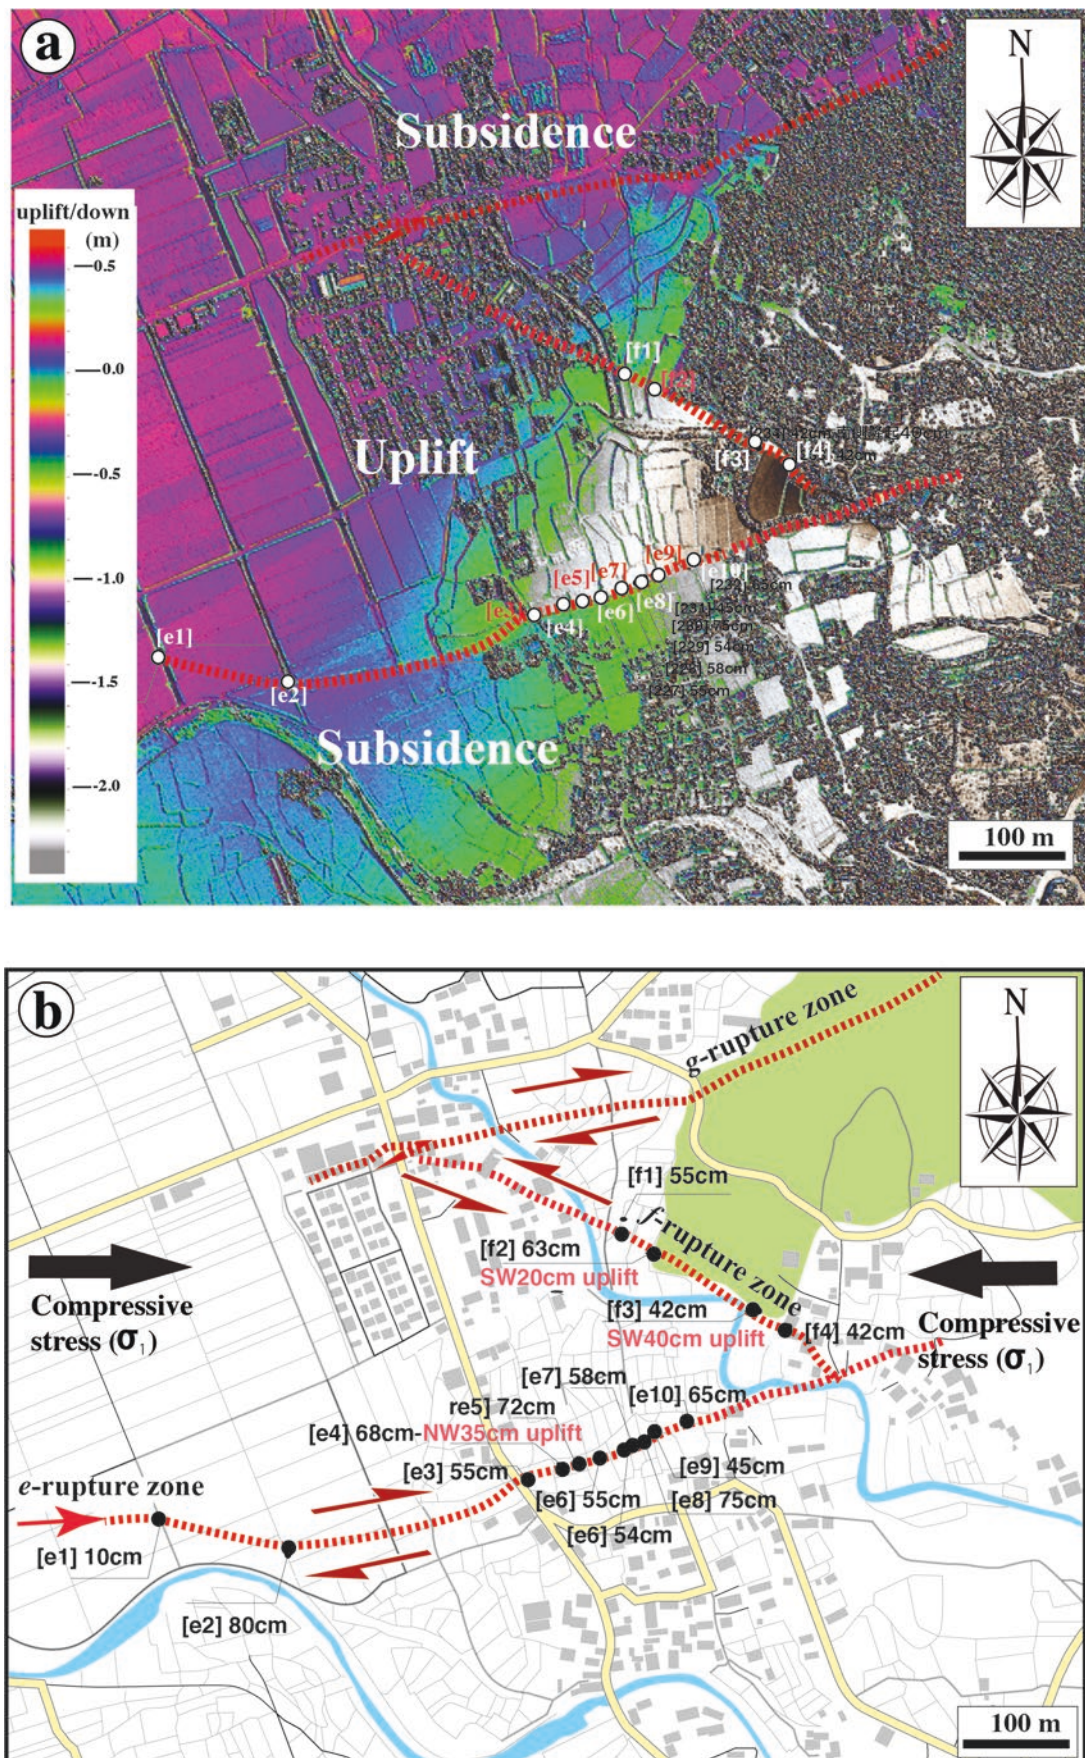
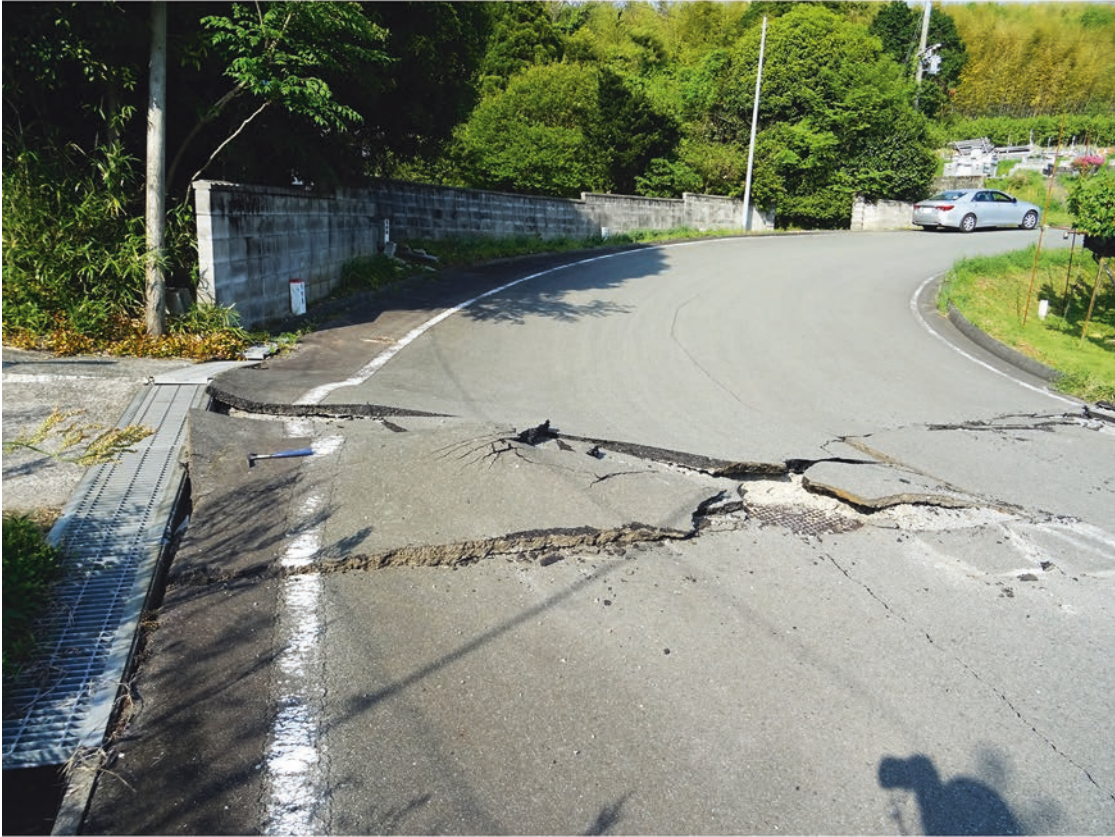
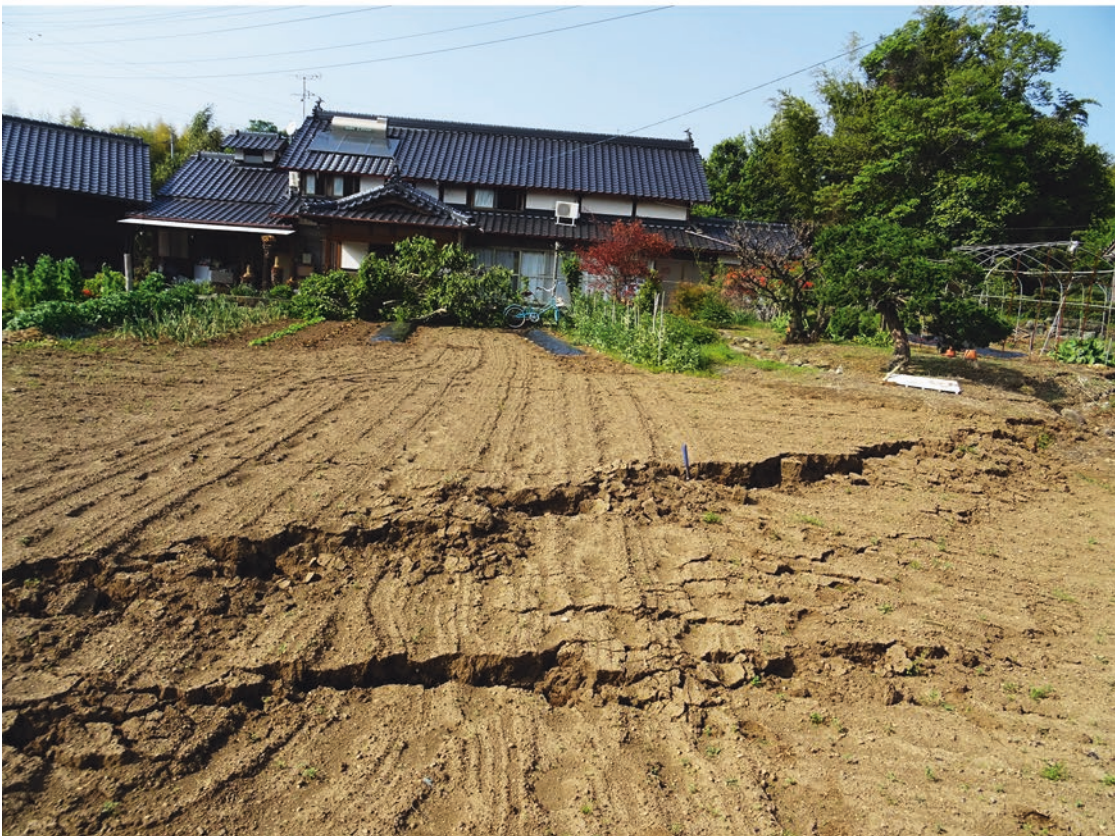
Fig. 22 LiDAR image and photographs showing structural features of coseismic conjugate faults at Fukuhara village (modified from Lin and Chiba [2017]). (a, b) Right-lateral strike-slip displacements occurred

along R fault striking northeast–southwest, while left-lateral strike-slip displacements occurred along R' fault striking northwest–southeast. Conjugate ruptures occurred on a road (c) and vegetable field (d)

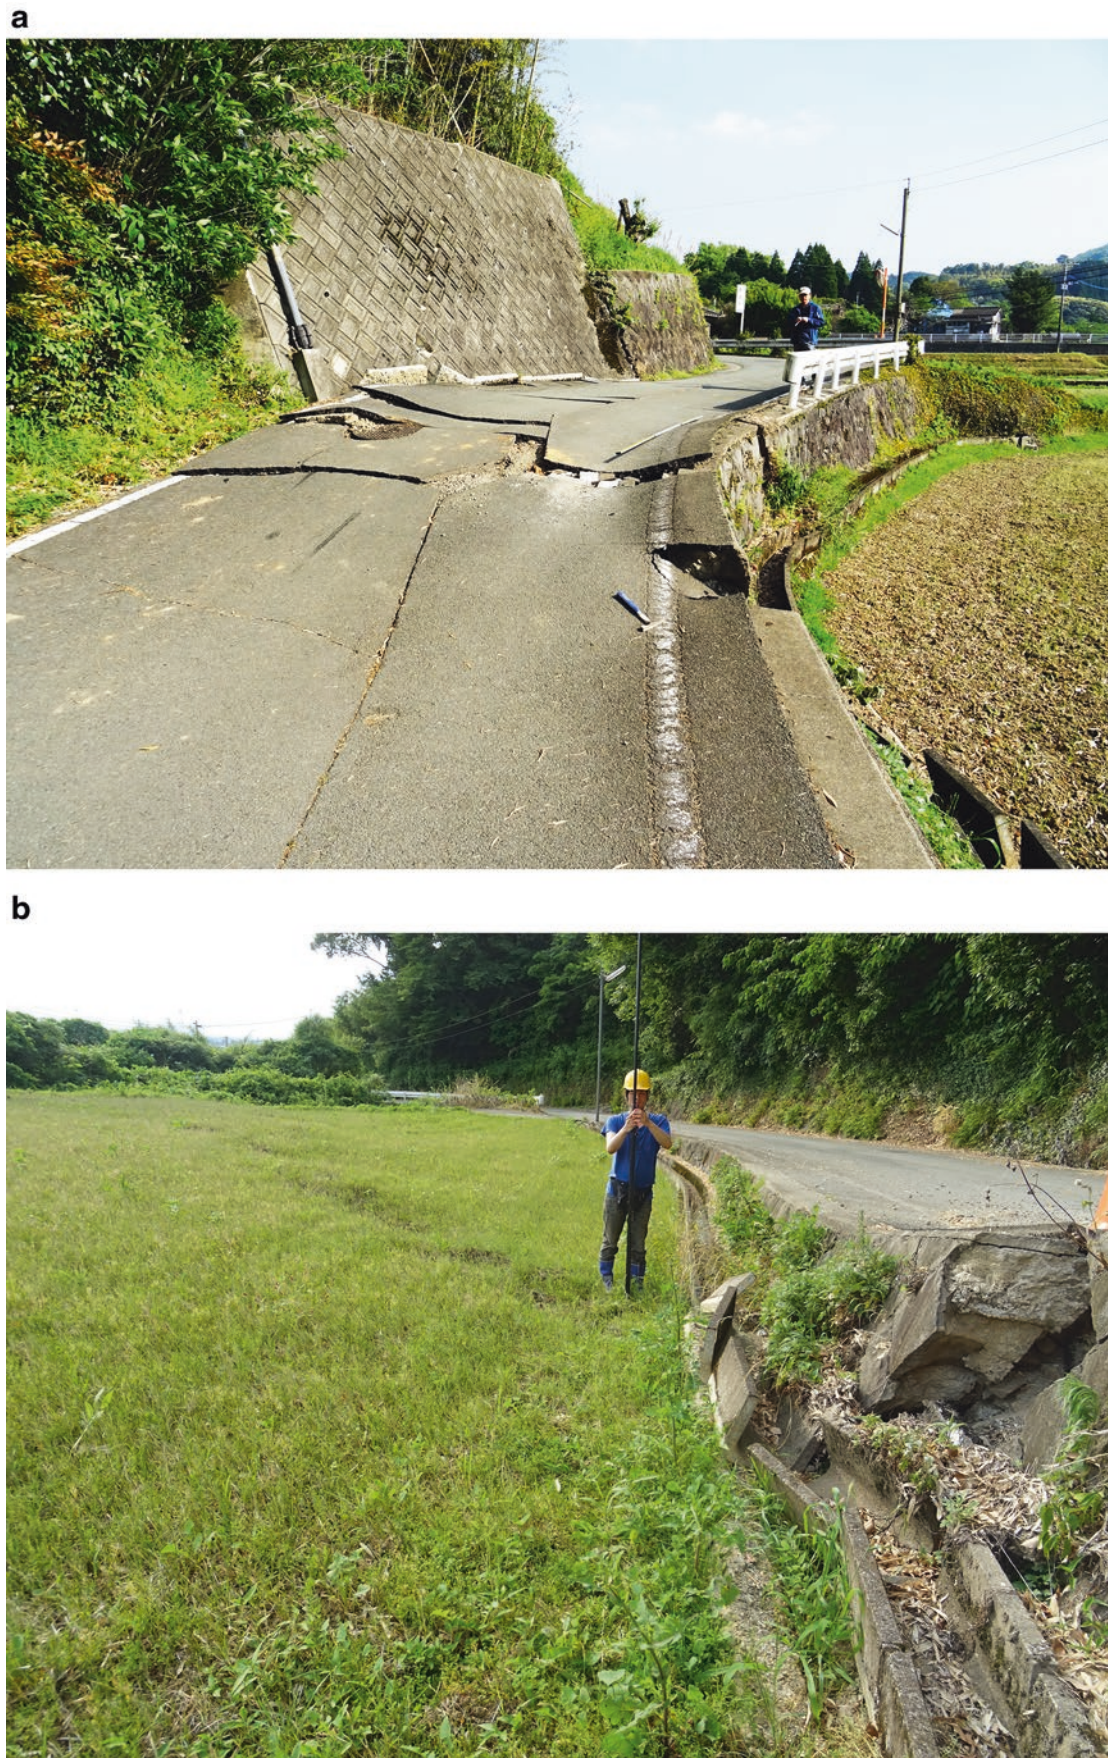
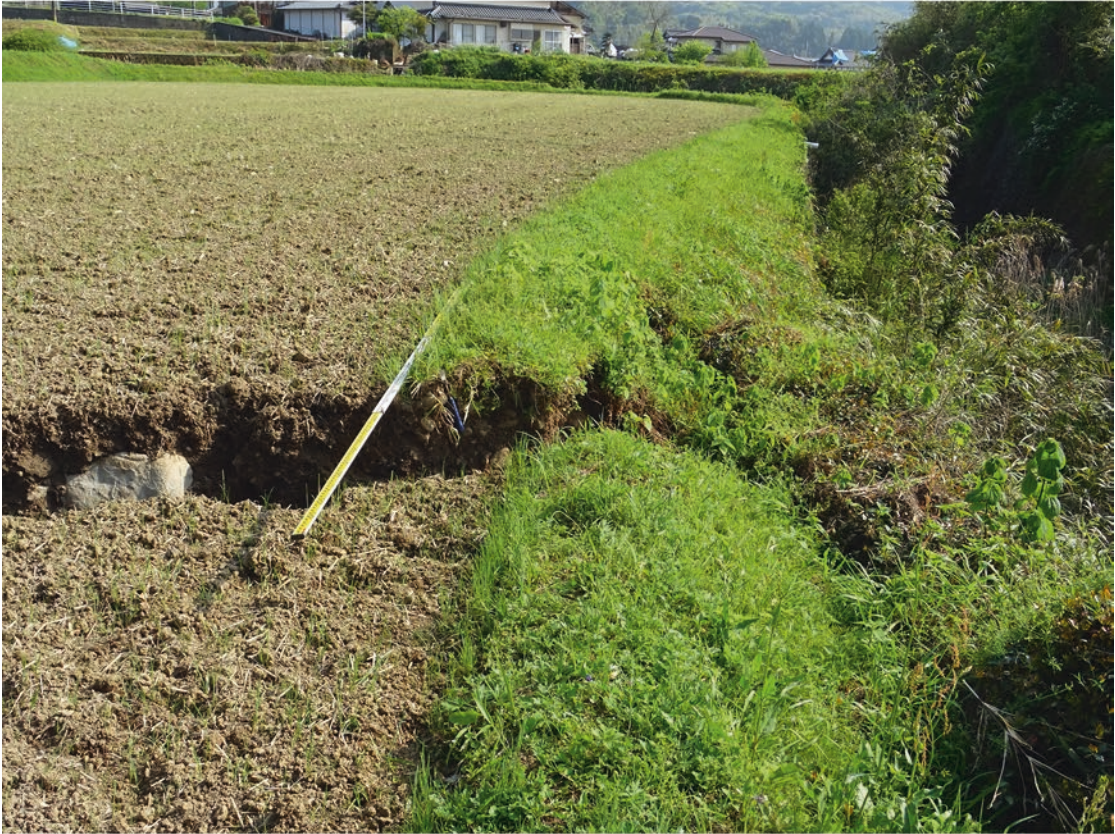
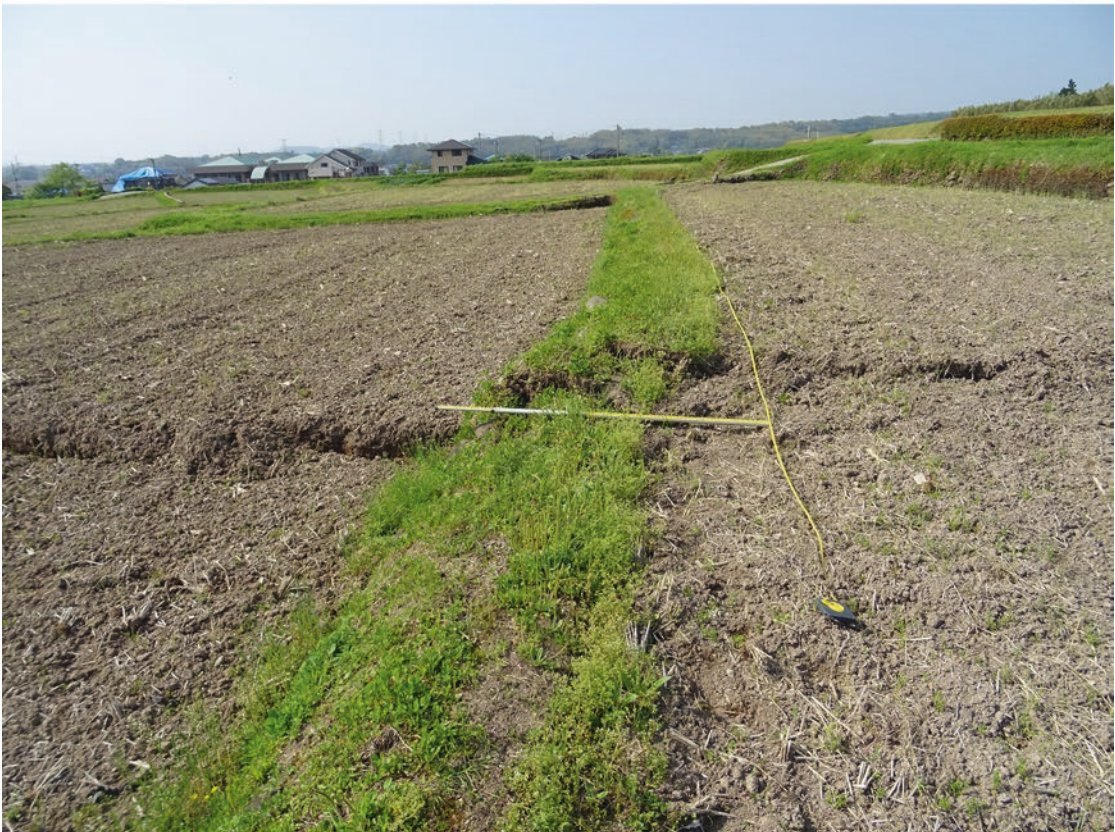
Fig. 23 Strike-slip offset of a road and field paths. (a, b) Left-lateral offset of a road and field. (c) Left-lateral offset of a field path (offset ~ 0.3 m). (d) Right-lateral offset of a field path (offset ~ 0.4 m)

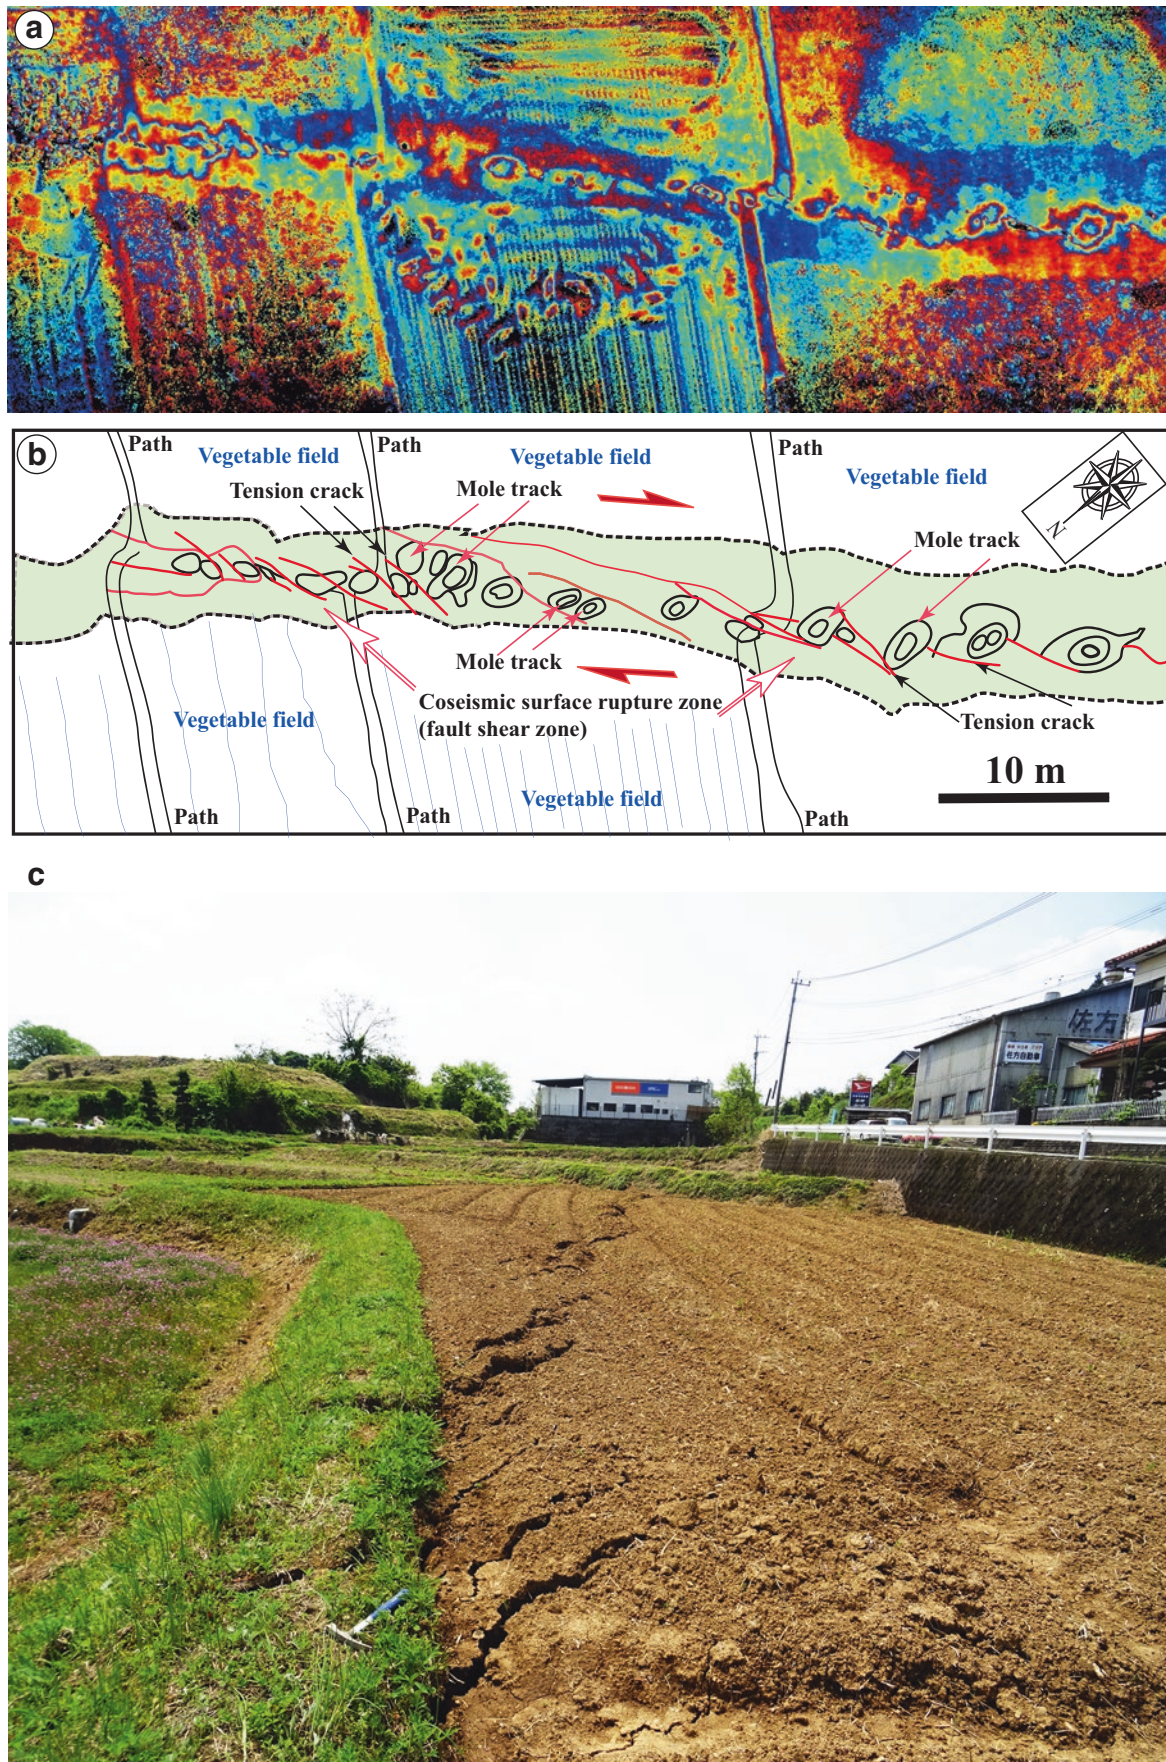
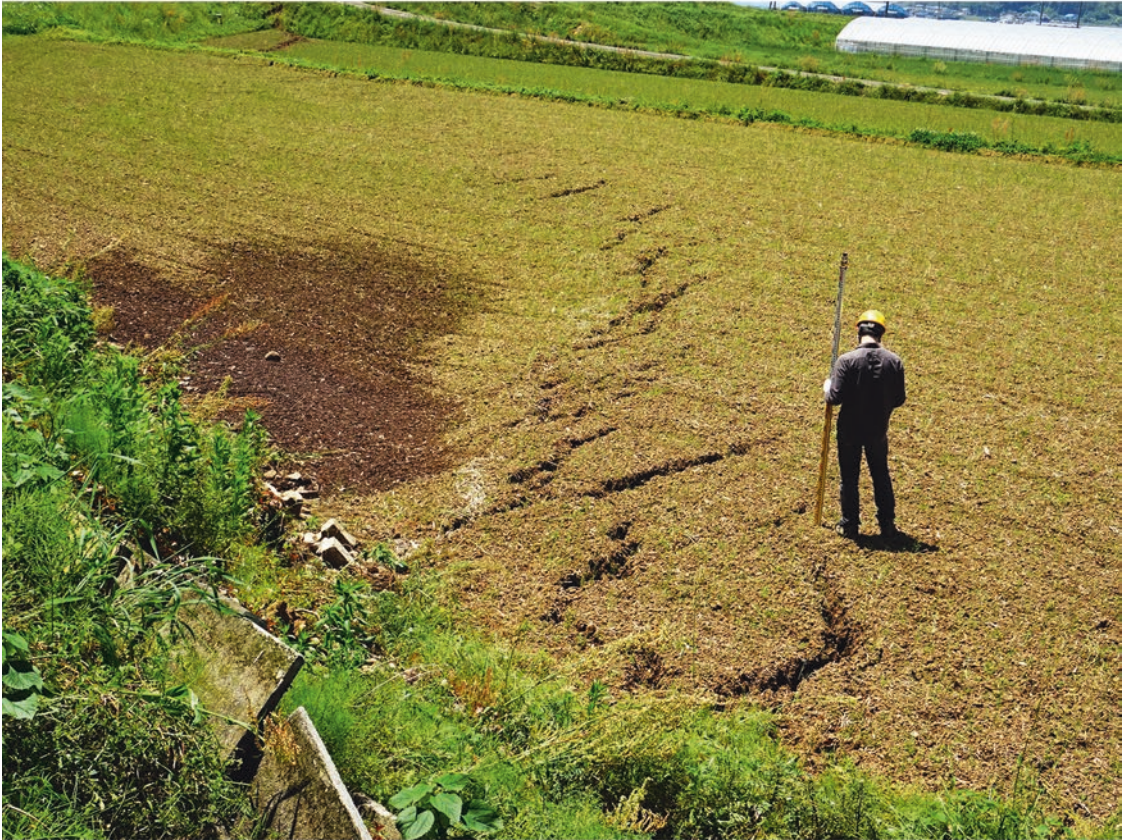
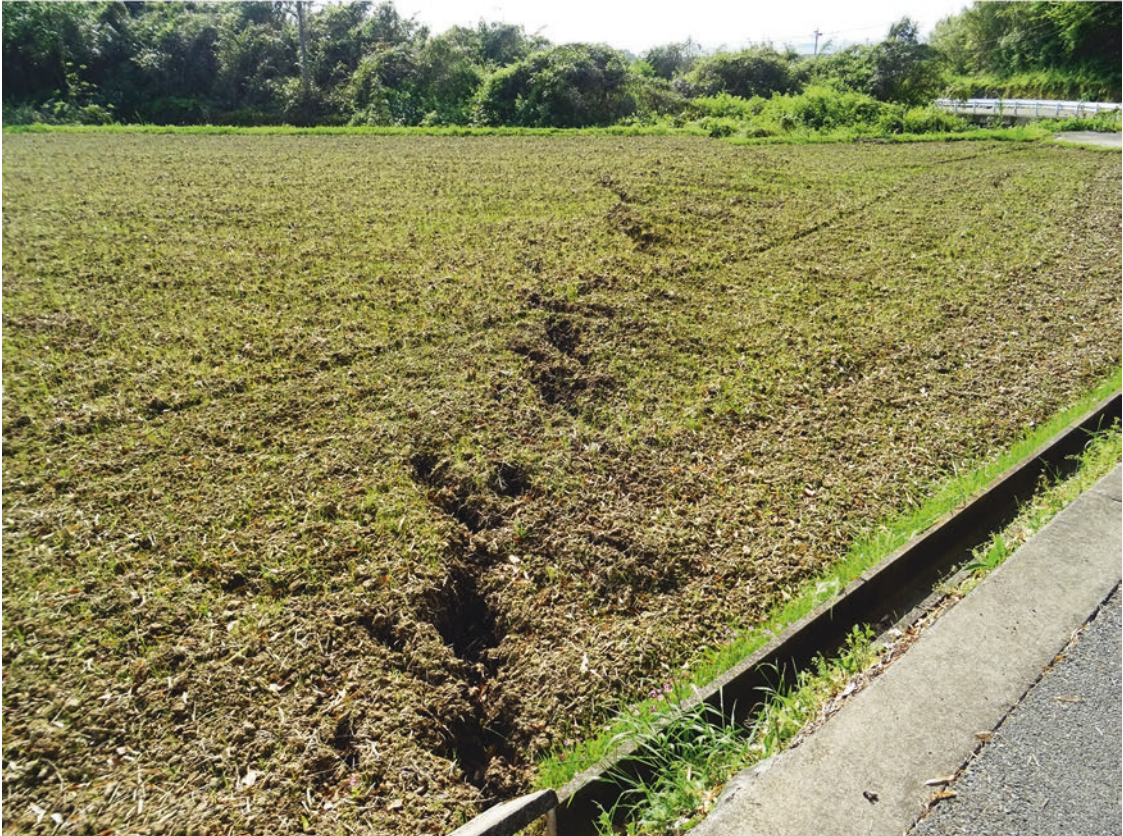
Fig. 24 3D color shaded relief image and photographs showing Riedel shear structures of the coseismic surface rupture zone (modified from Lin and Chiba [2017]). (a) Color shaded relief image acquired by

Trimble TX5 3D laser scanner. (b) Sketch of (a). (c–e) Left-stepping en echelon tension cracks occurred along the NE–SW-striking coseismic surface rupture zone

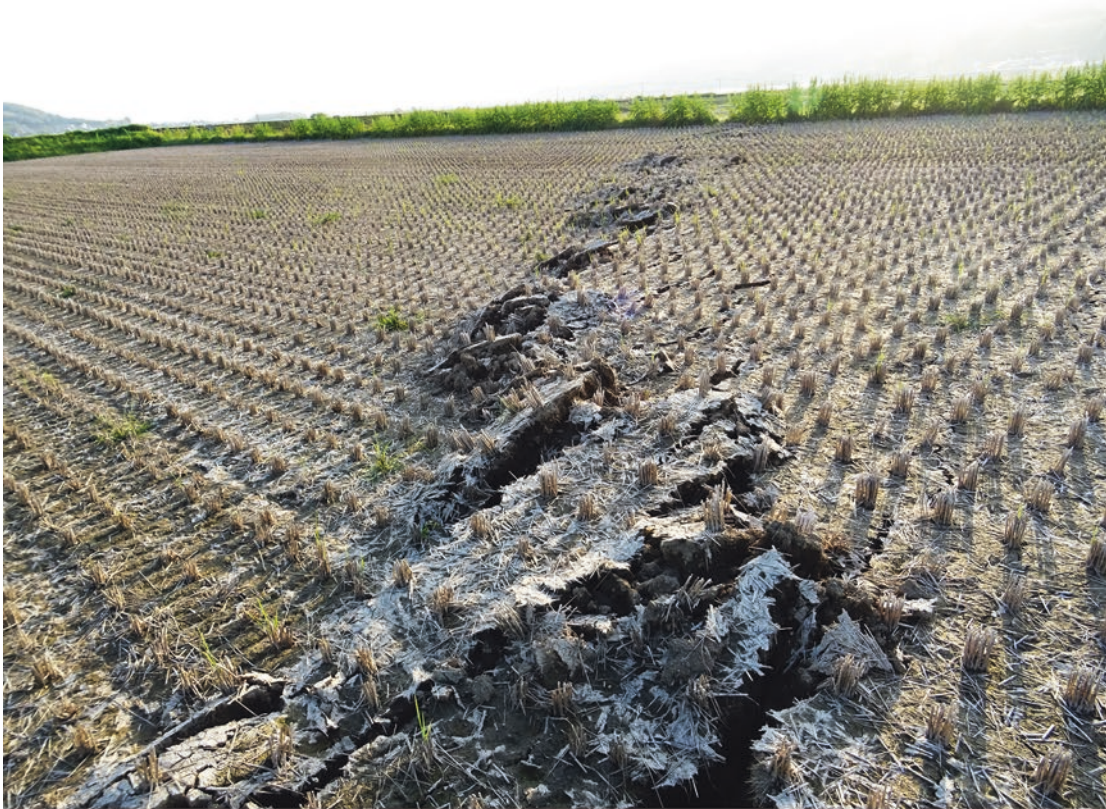
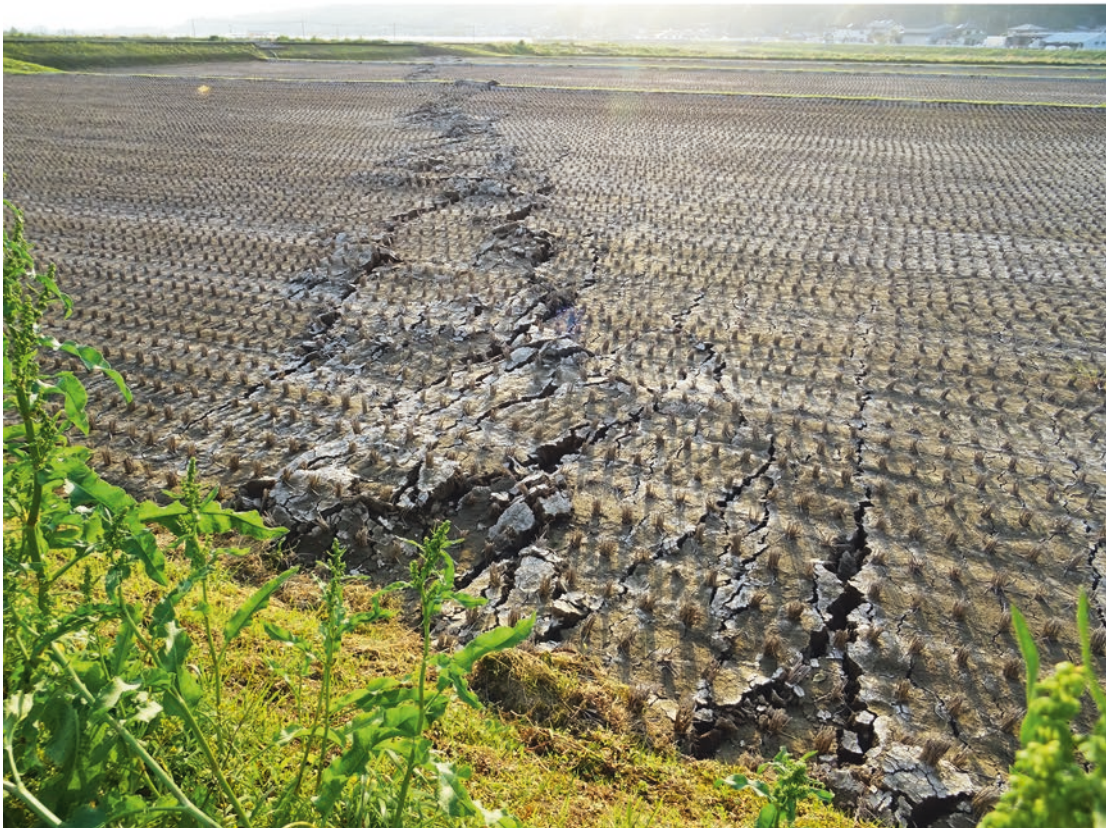
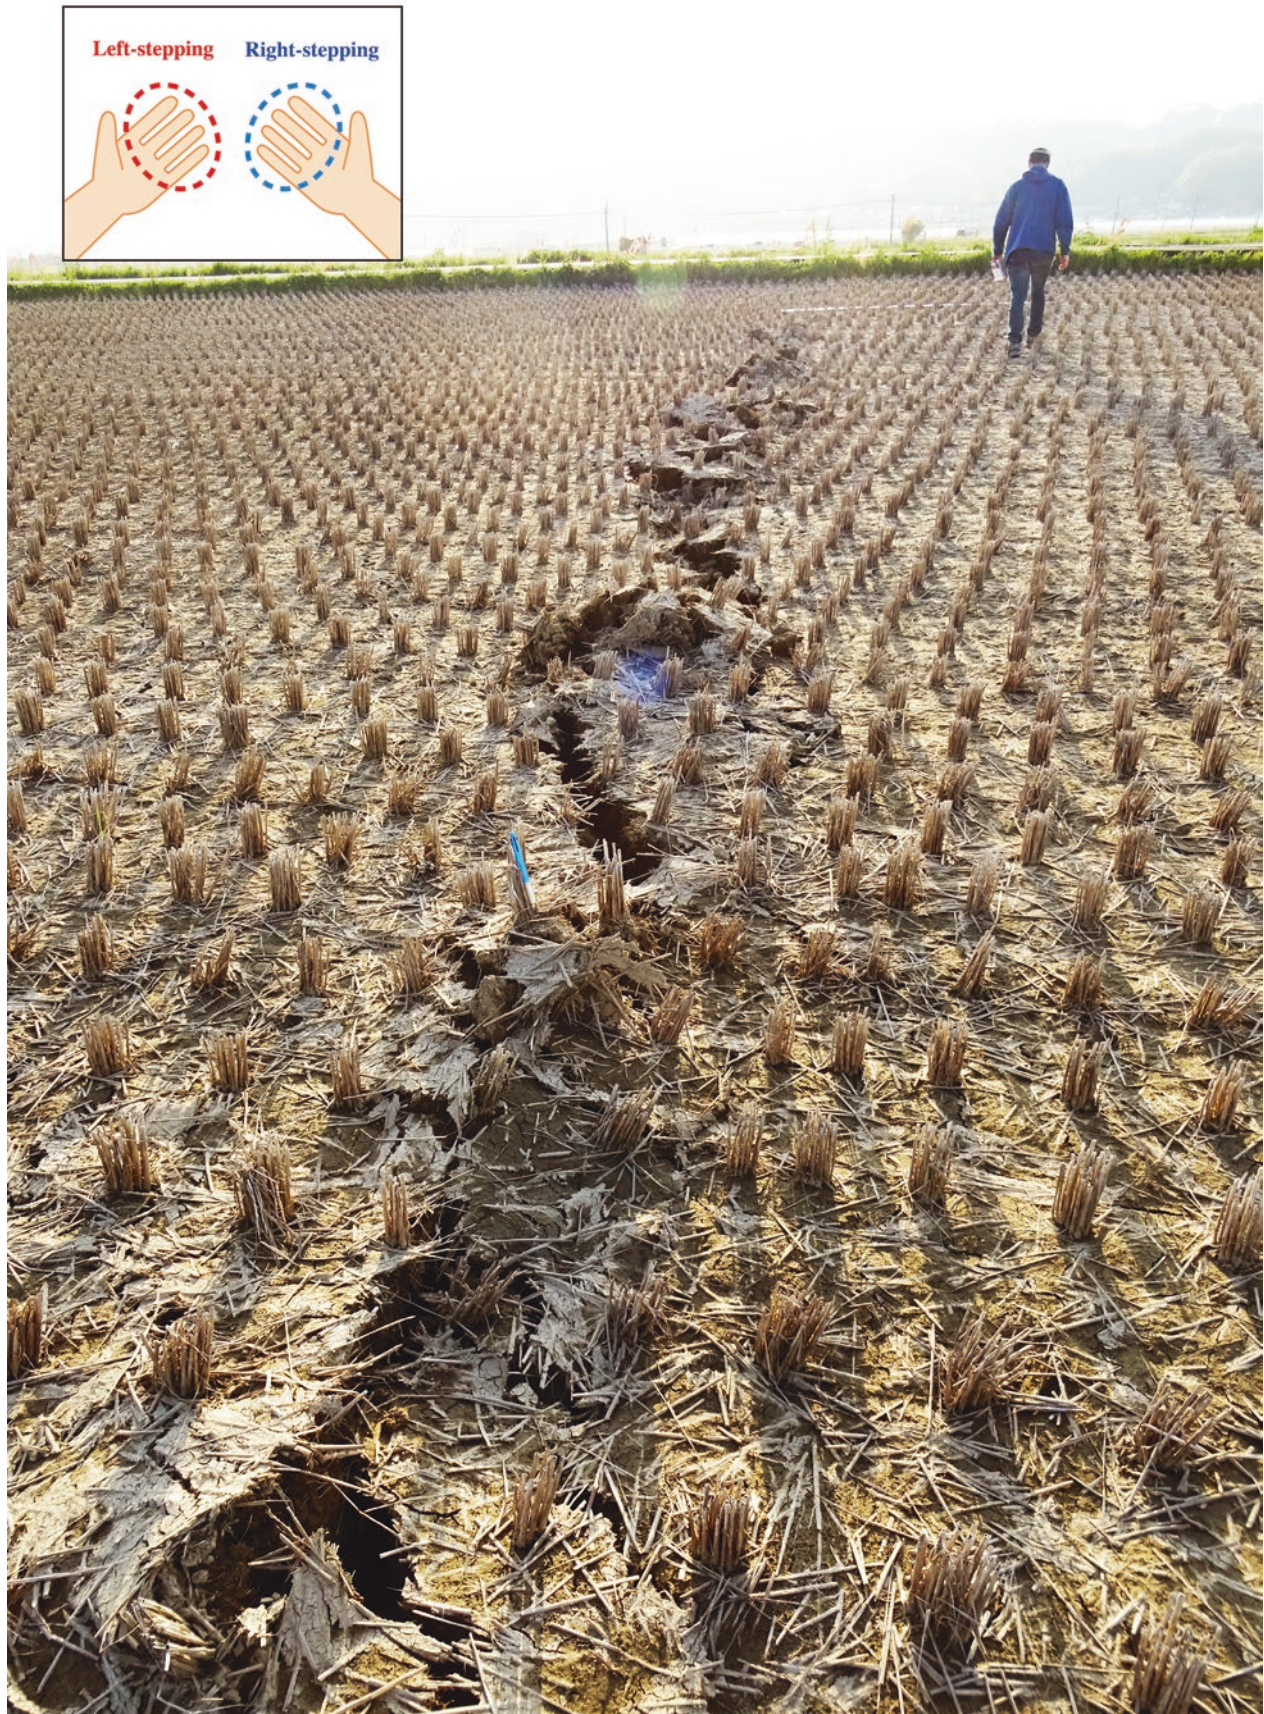
Fig. 25 Coseismic en echelon tension cracks. (a) Left-stepping tension cracks occurred along the NE–SW-striking coseismic surface rupture zone. (b, c) Right-stepping tension cracks along the WNW–ESE-striking rupture zone
