The 2016 Mw 7.1 Kumamoto Earthquake

A Photographic Atlas of Coseismic Surface Ruptures
Related to the Aso Volcano, Japan

Aiming Lin
Department of Geophysics
Kyoto University
Kyoto, Japan

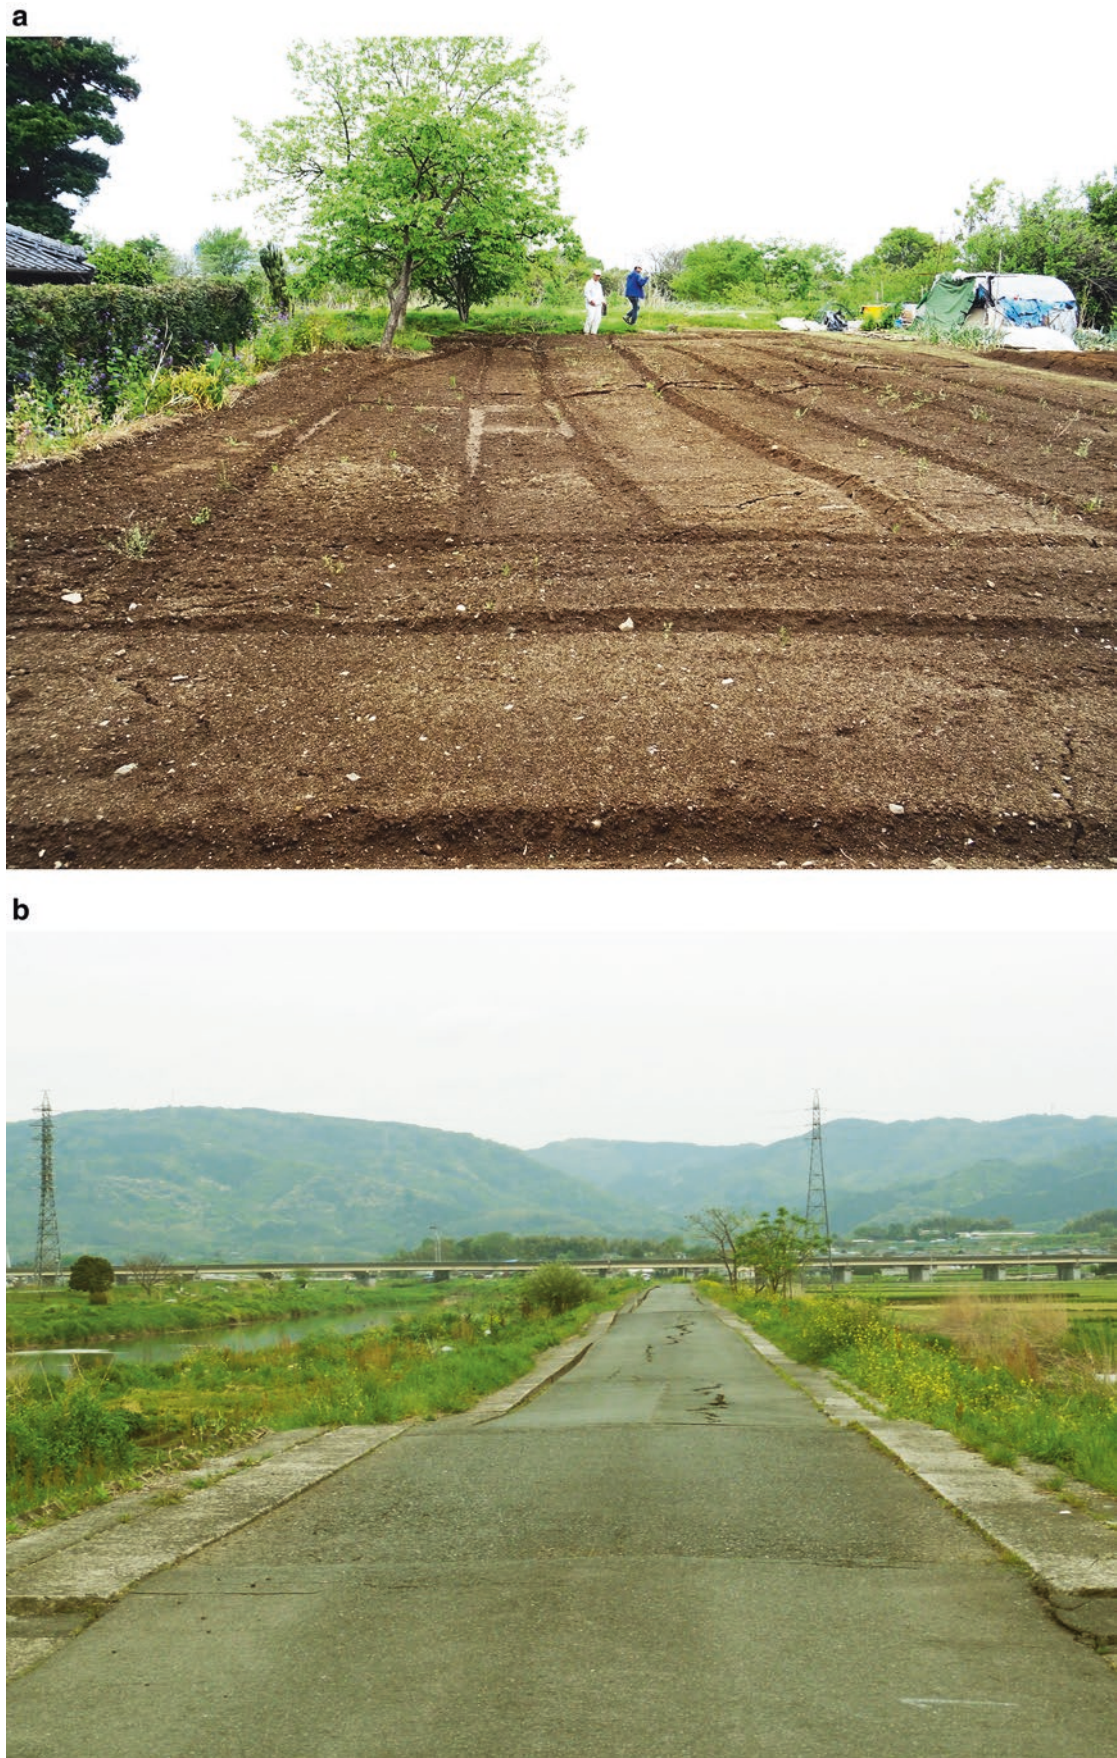
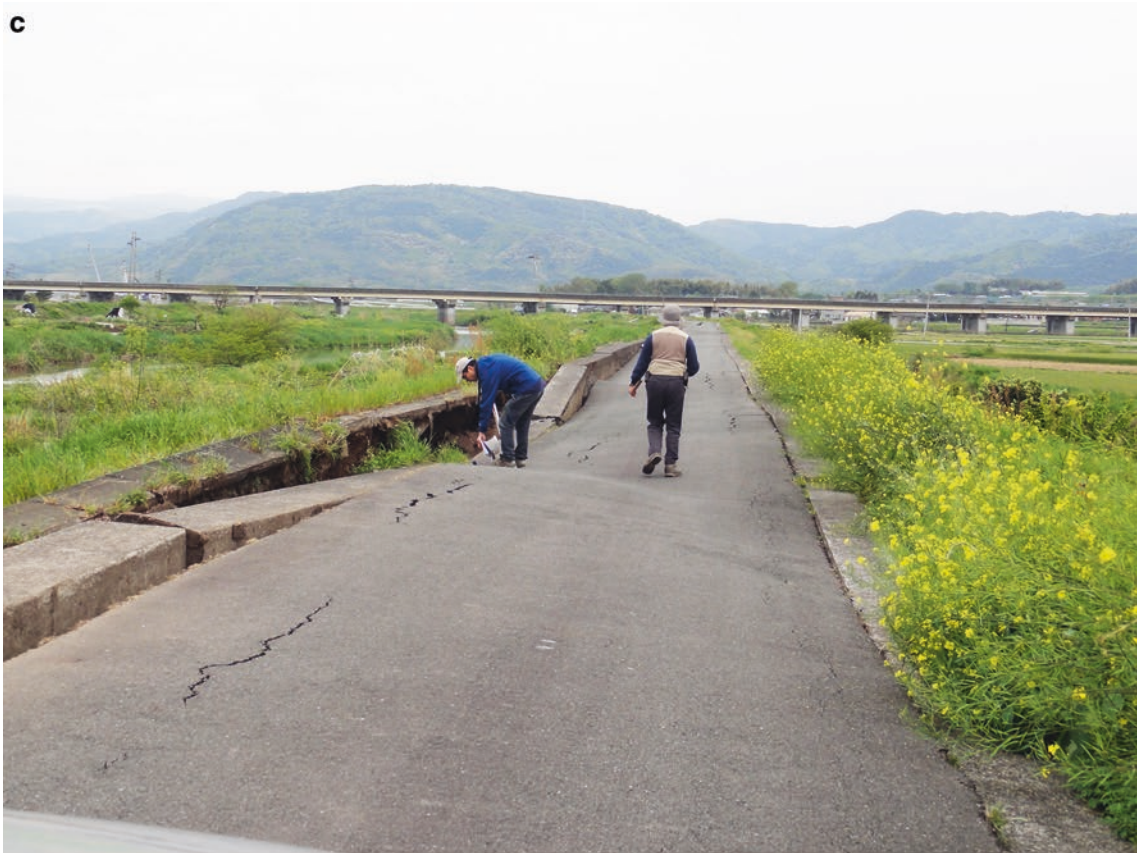
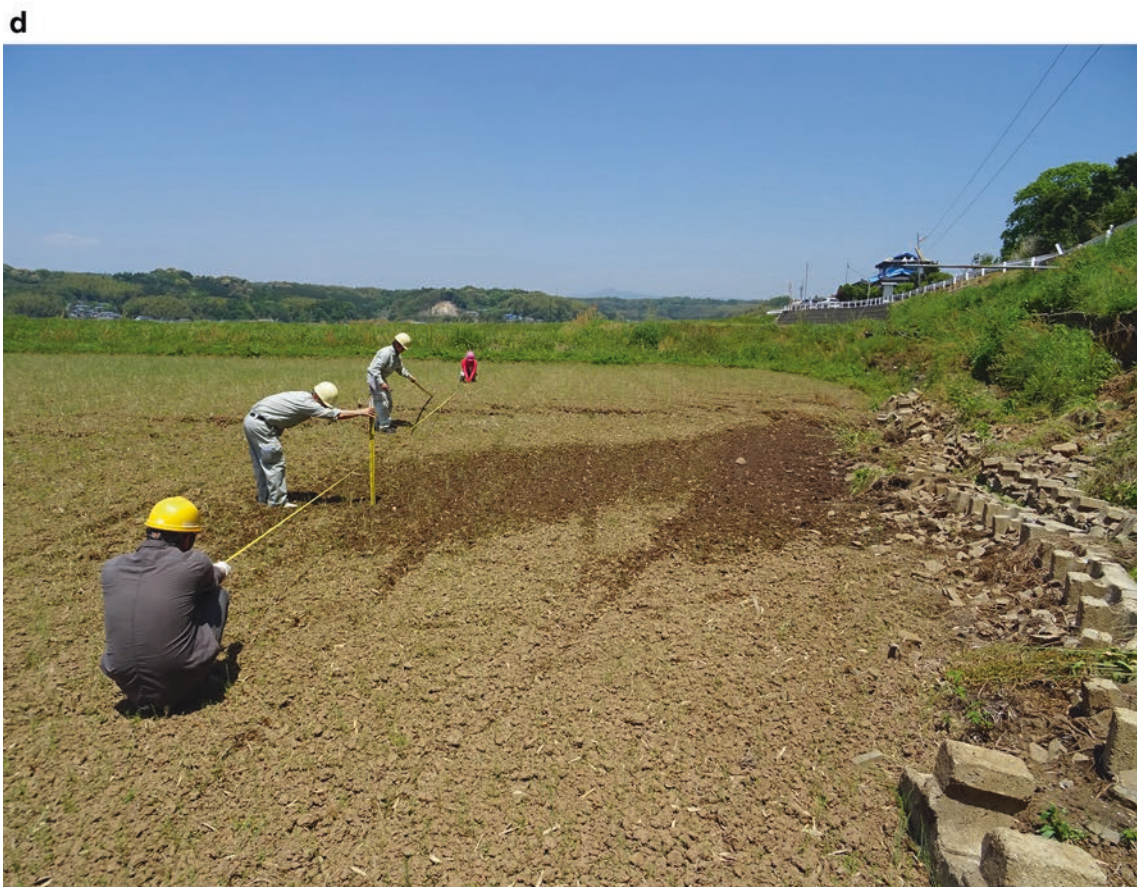
Fig. 26 Flexural structures occurred along the coseismic surface rupture zone. (a) Flexure structure occurred at a vegetable field. (b, c) A road folded as a waveform. (d) Flexural structure occurred at a rice field

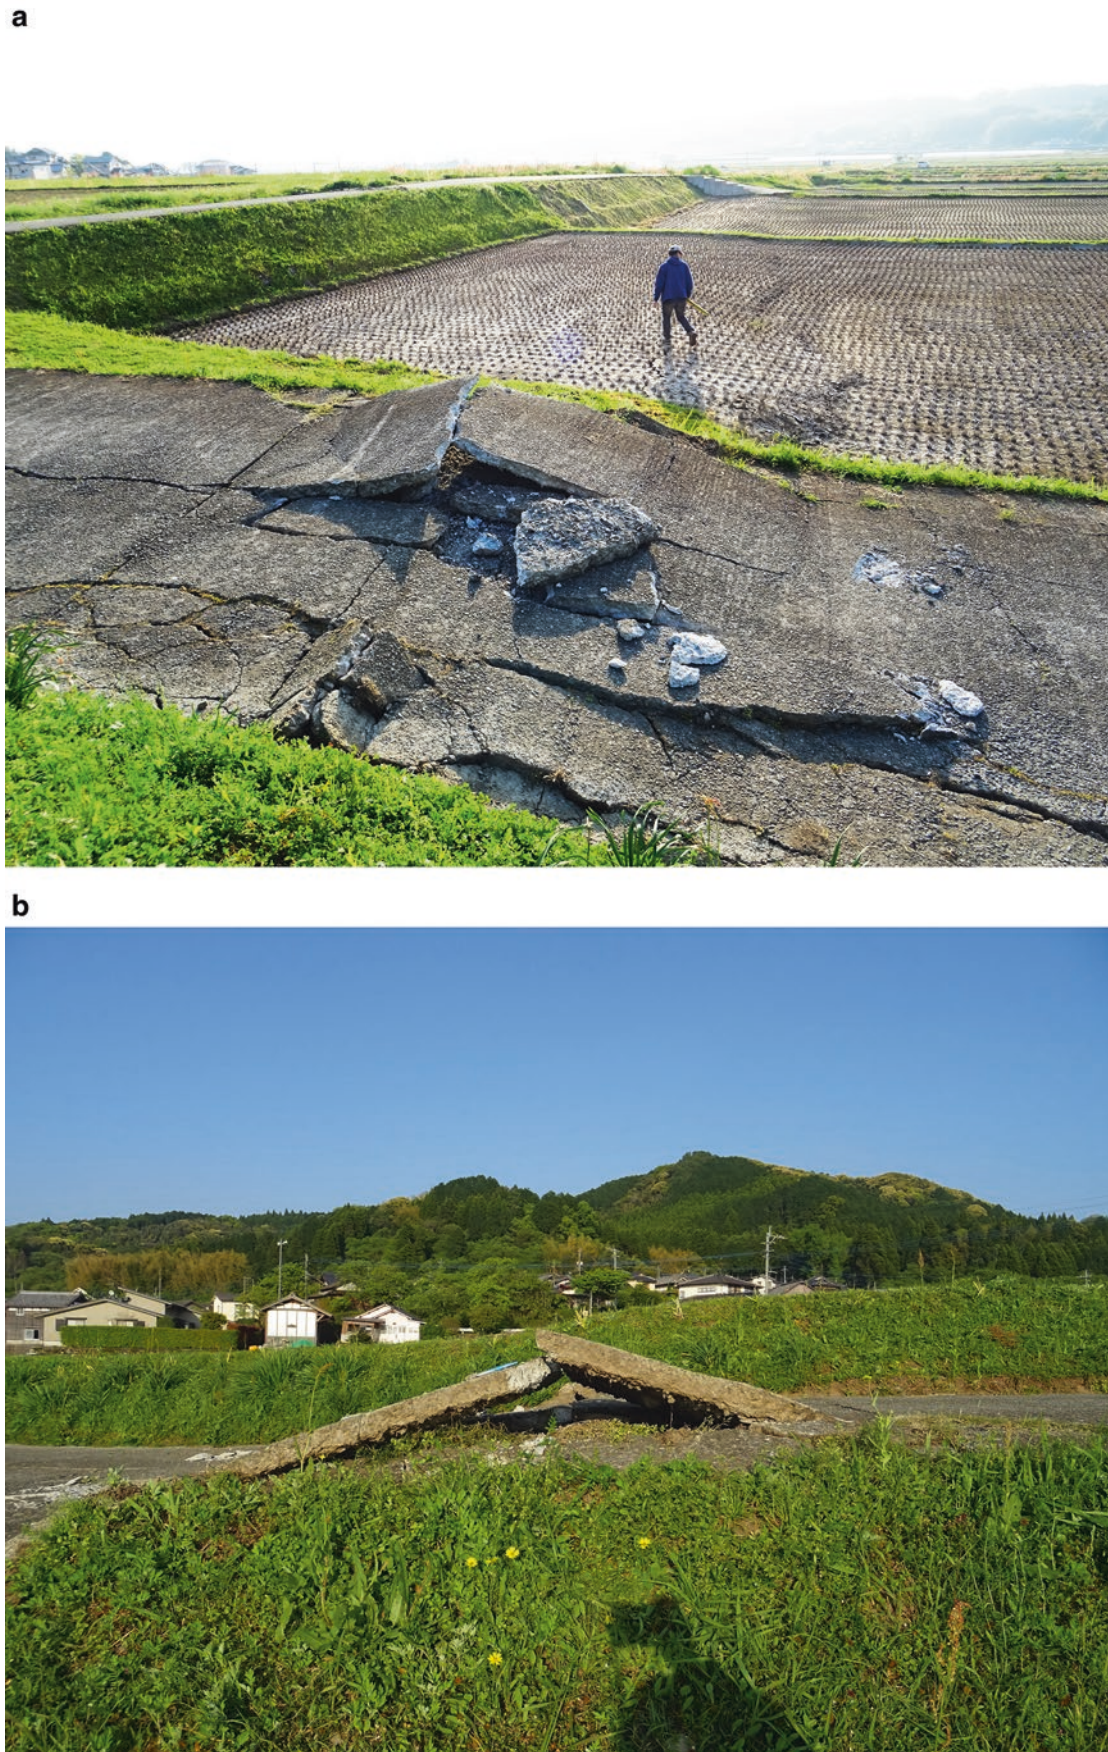
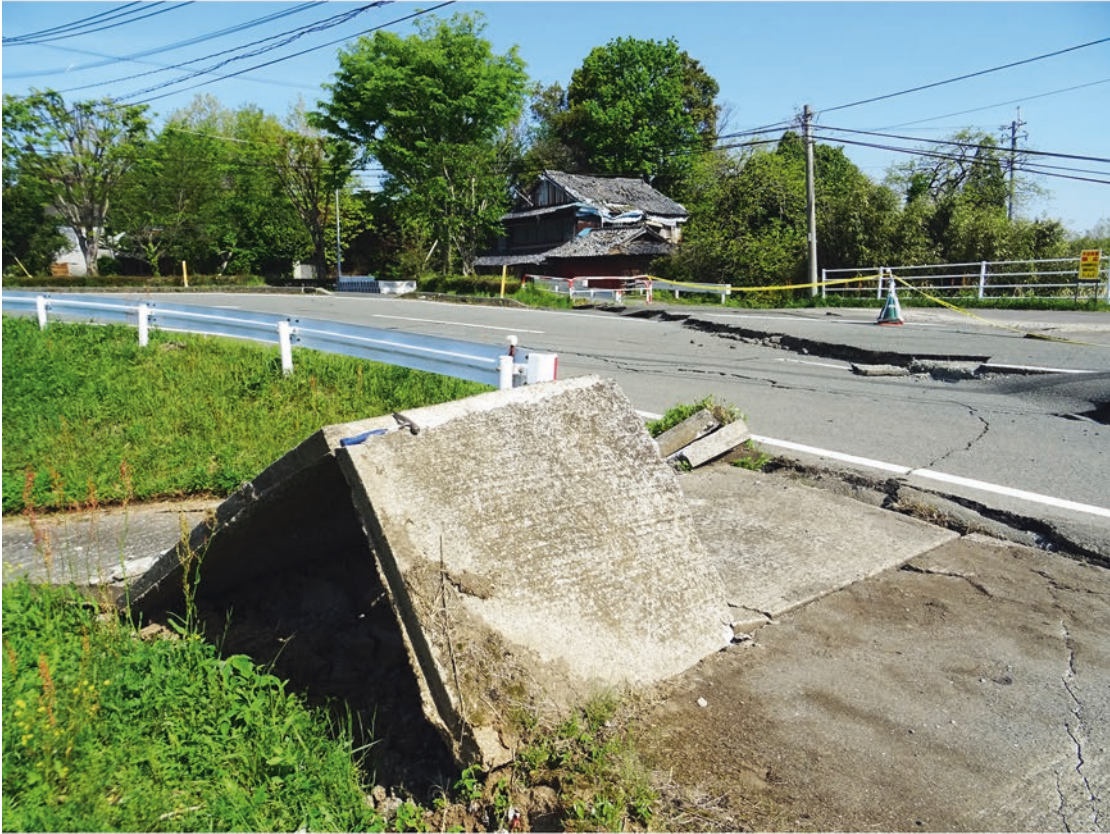
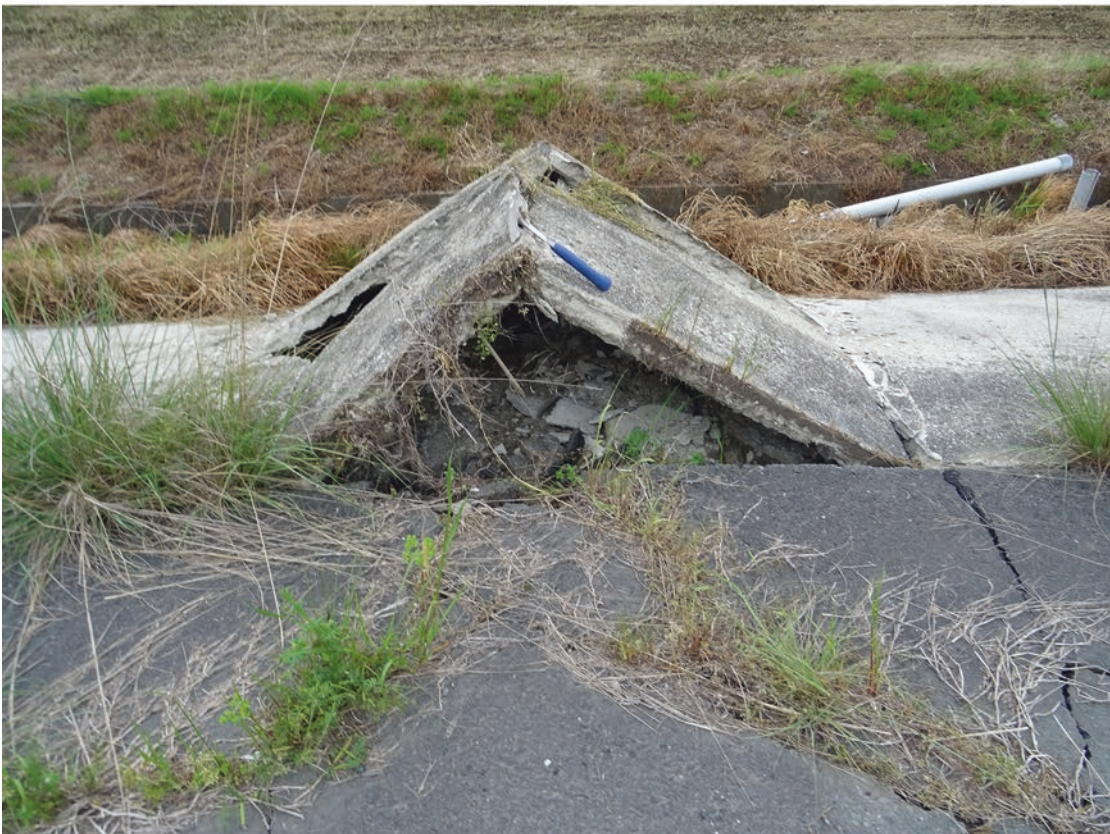
Fig. 27 Mole track structures occurred at roads. **(a, b)** Mole track along the WNW–ESE-striking coseismic surface rupture zone. **(c, d)** Mole track occurred on a road along the ENE–WSW-striking coseismic surface rupture zone

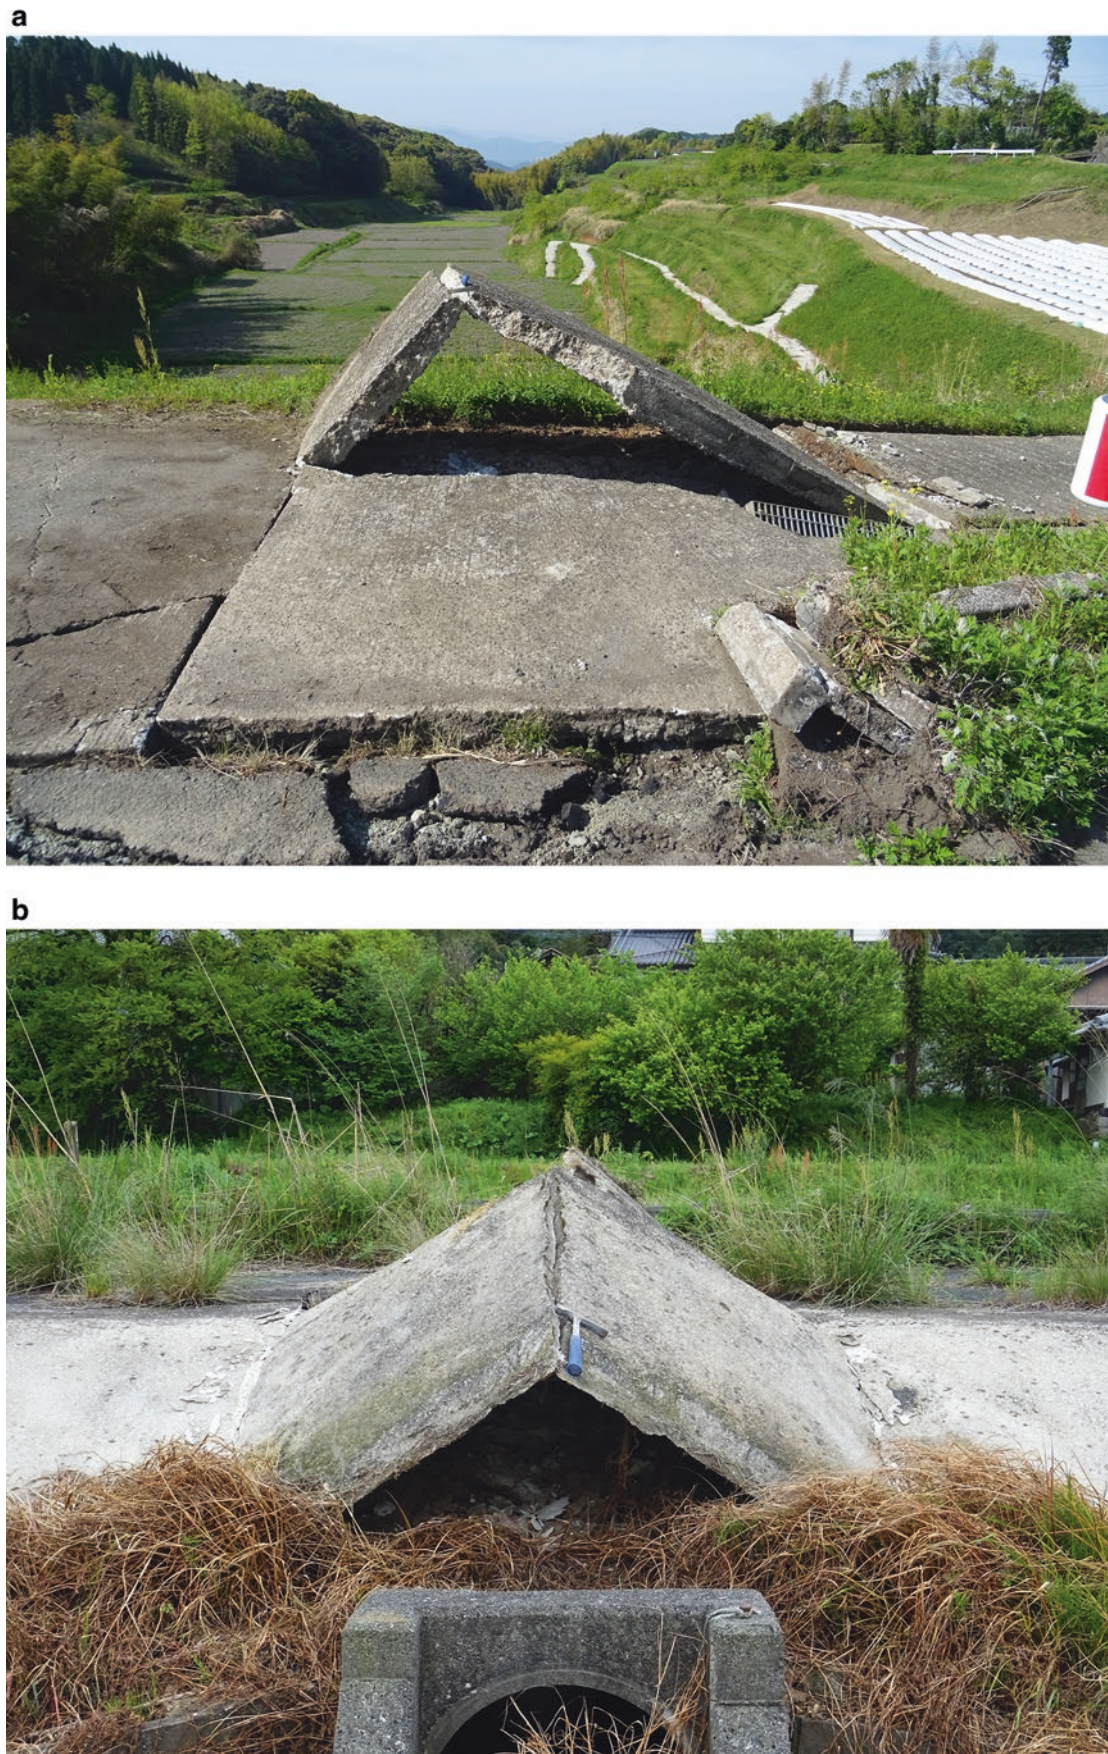
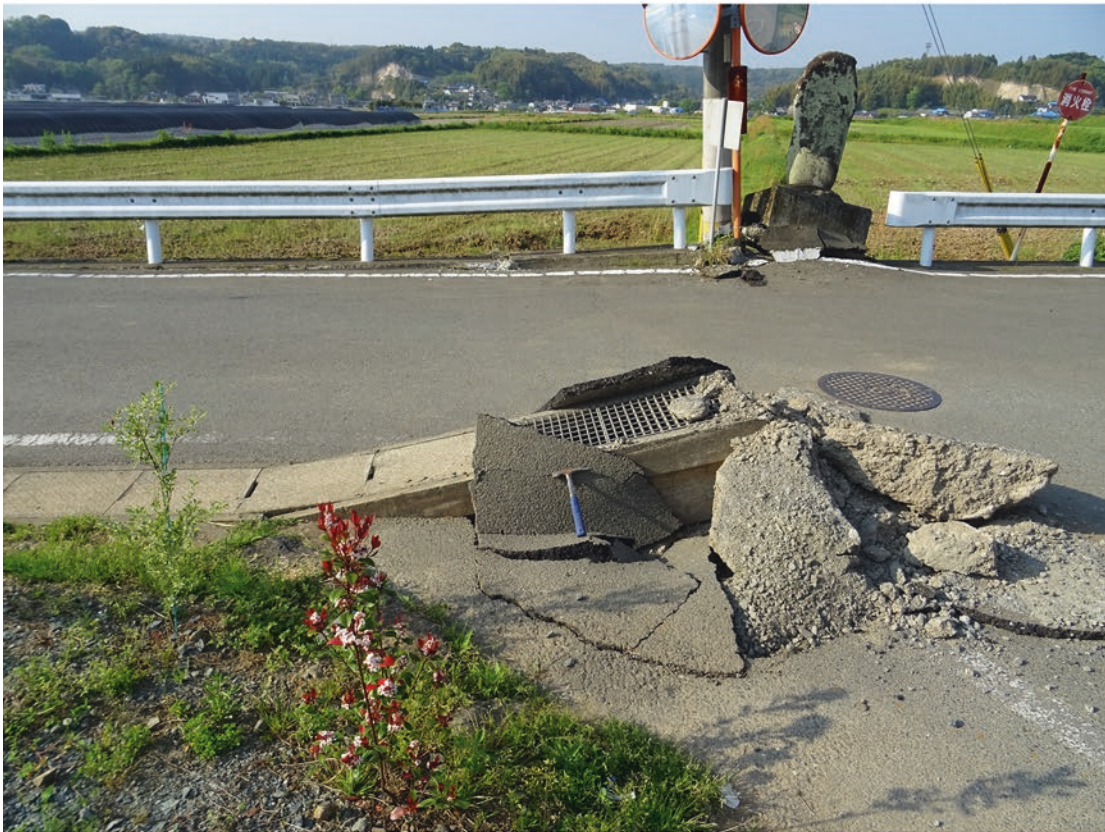
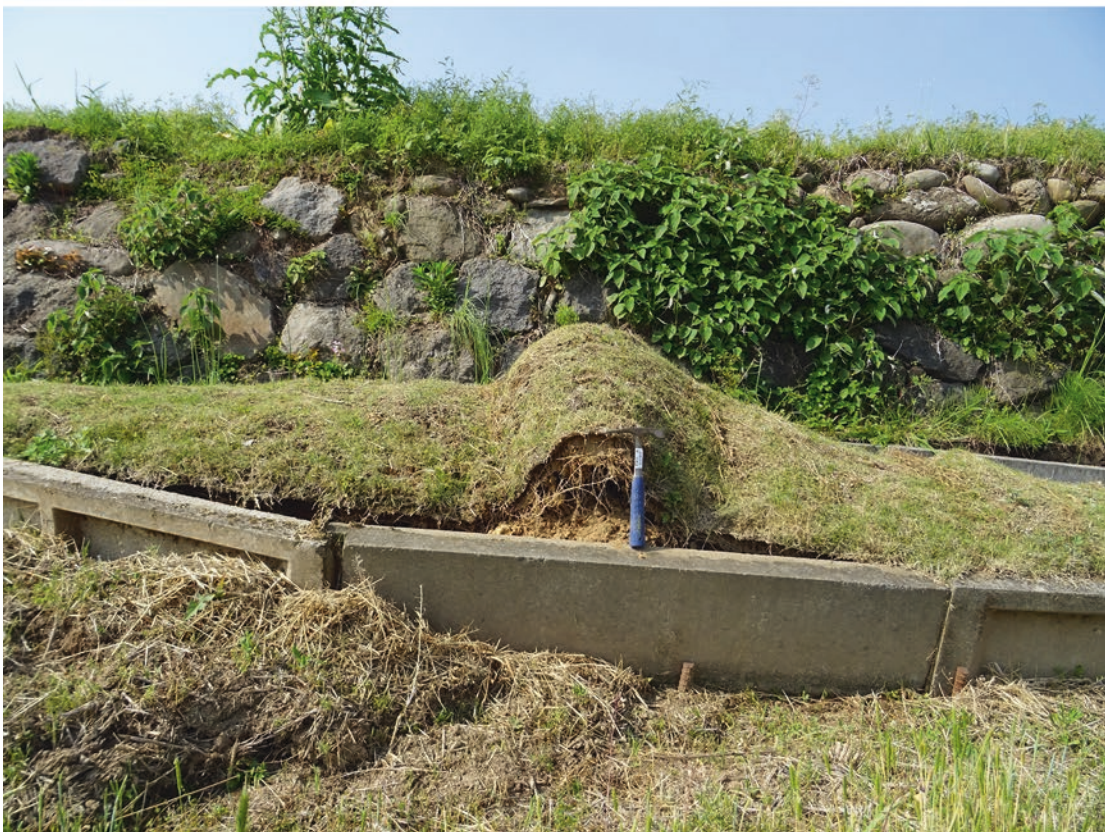
Fig. 28 Mole track structures occurred at a road and field path. (a–c) Mole track structure occurred at a road. (d) Mole track structure occurred at a field path along the ENE–WSW-striking coseismic surface rupture zone

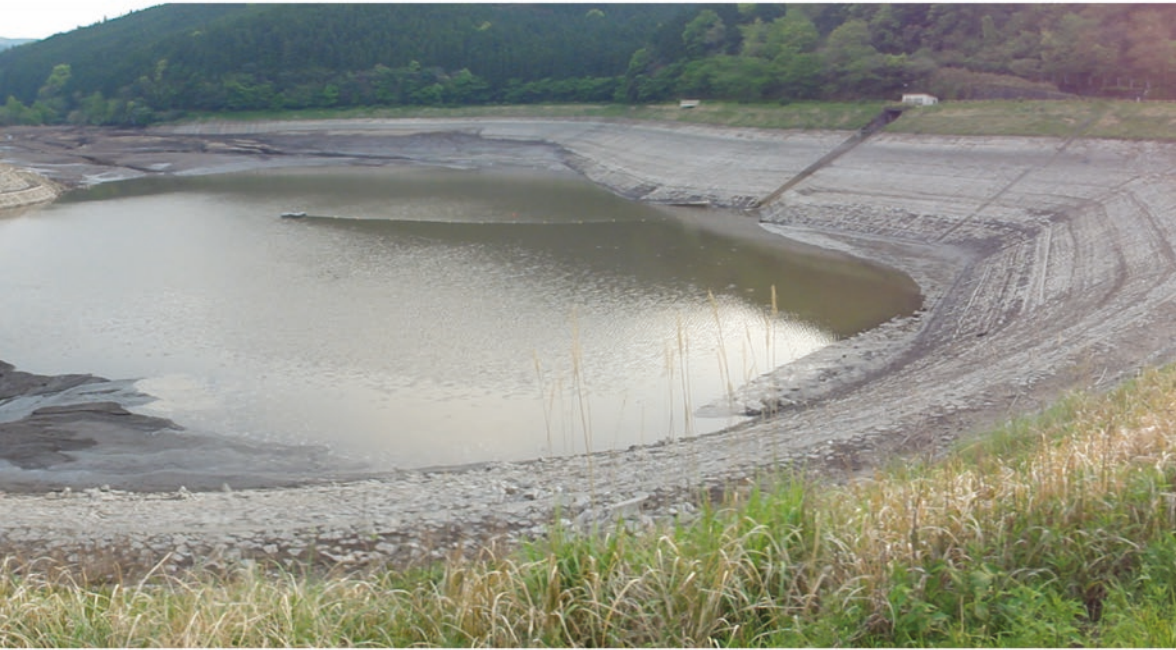
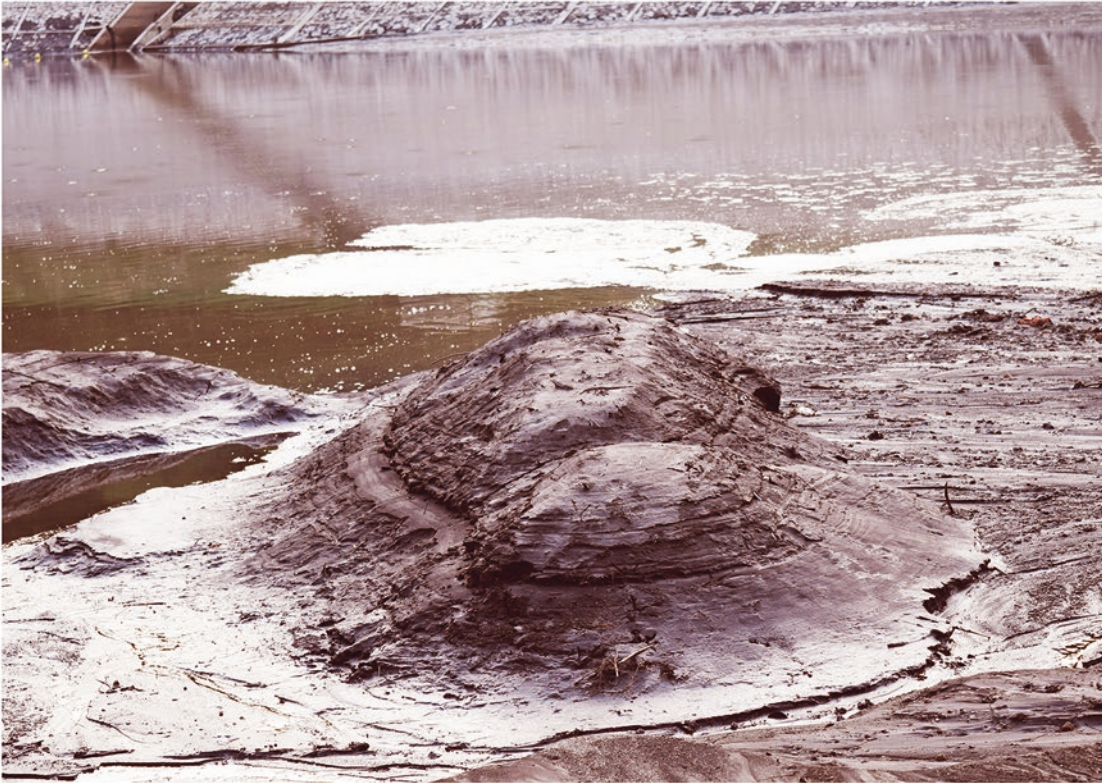
Fig. 29 Earthquake-induced liquefaction that occurred inside a dam. (a) Overview of the Okirihata dam that was damaged by the coseismic surface rupture zone. (b, c) Sand boils occurred inside the dam

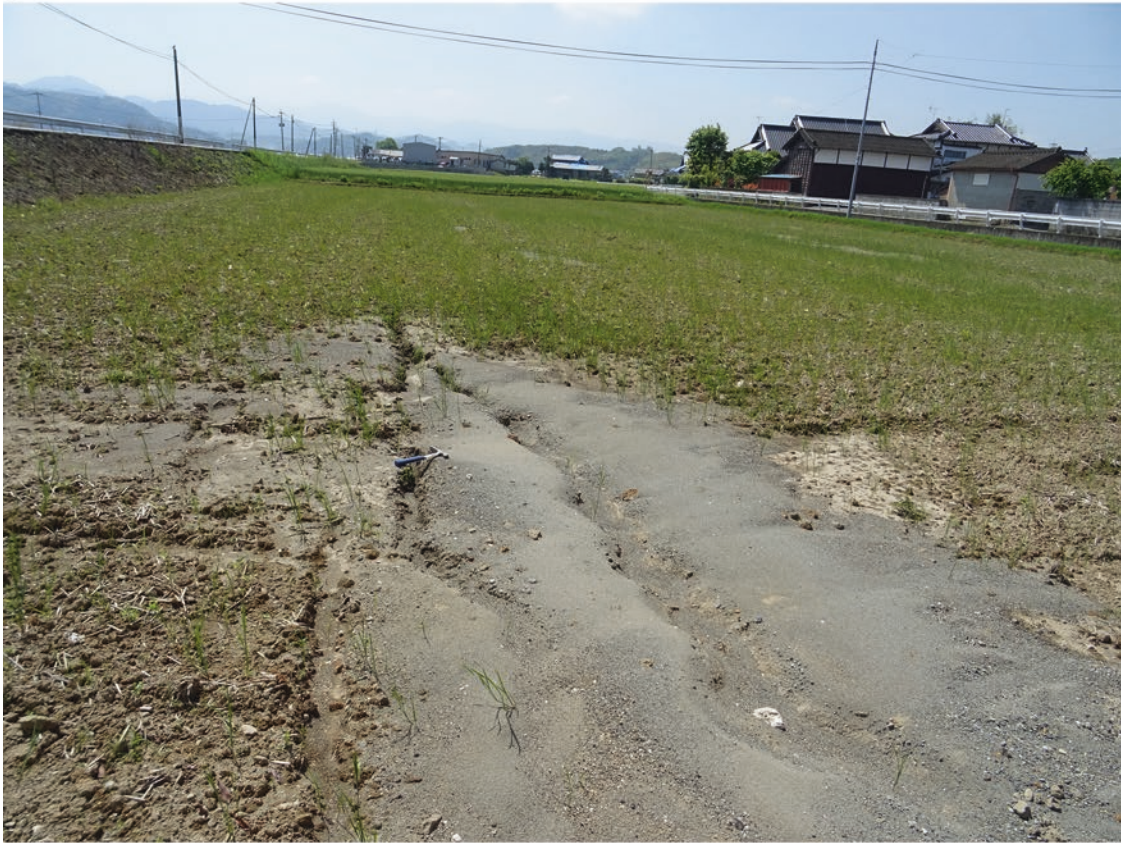
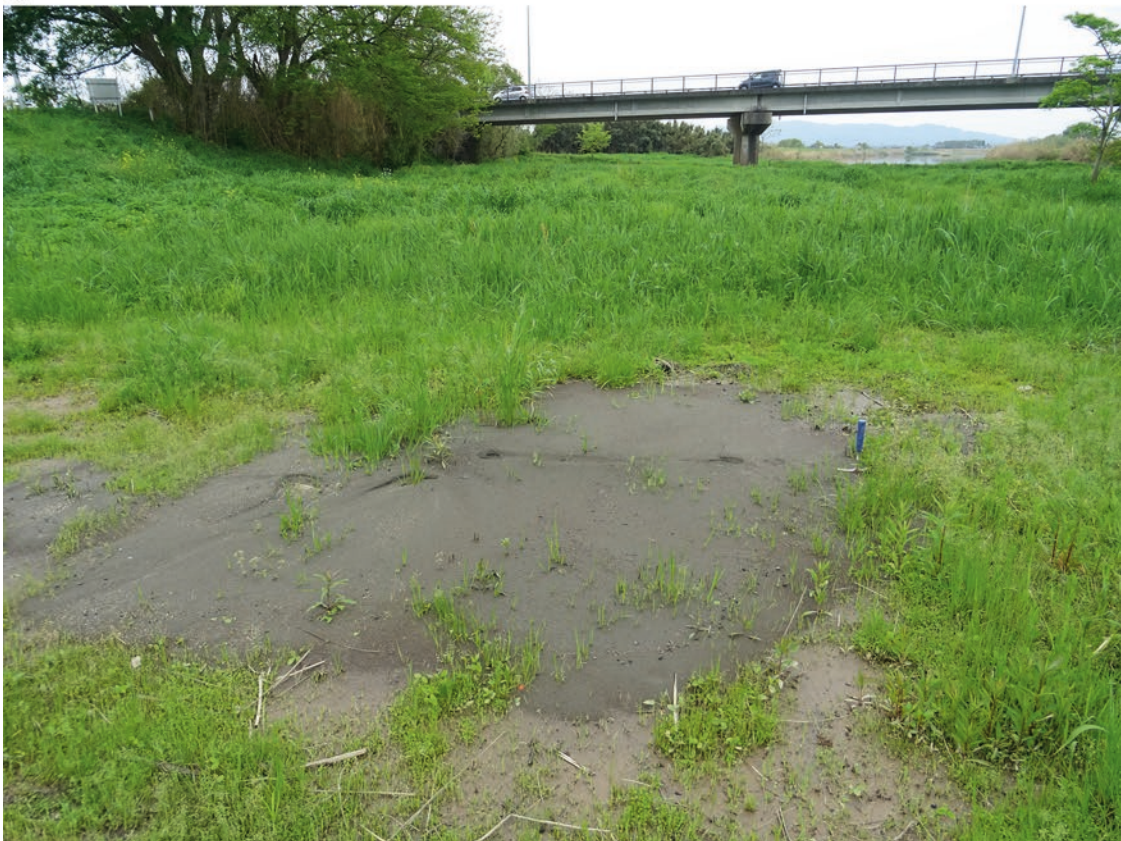
Fig.30 Earthquake-induced sand boils. (a–c) Sand boils occurred in association with earthquake-induced liquefaction that occurred within extensional cracks in vegetable fields. (d) Sand boils occurred in a lowland of river bank

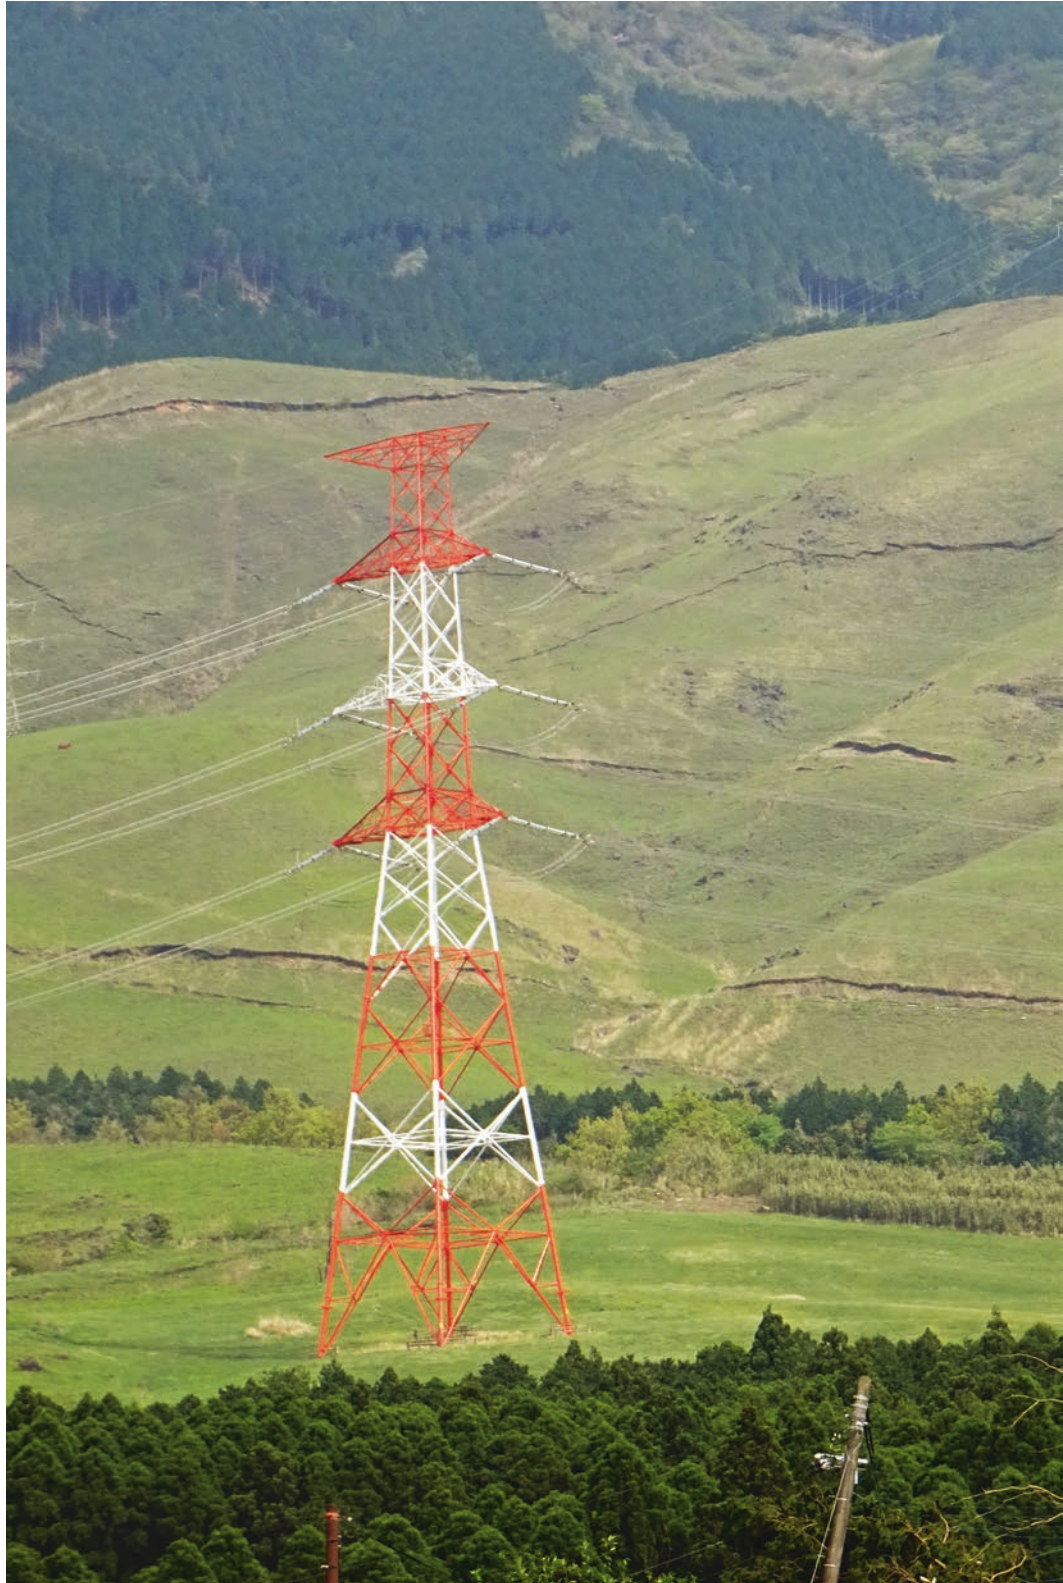
Fig. 32 All view of coseismic surface ruptures occurred on the slope of Tawarayama Mt

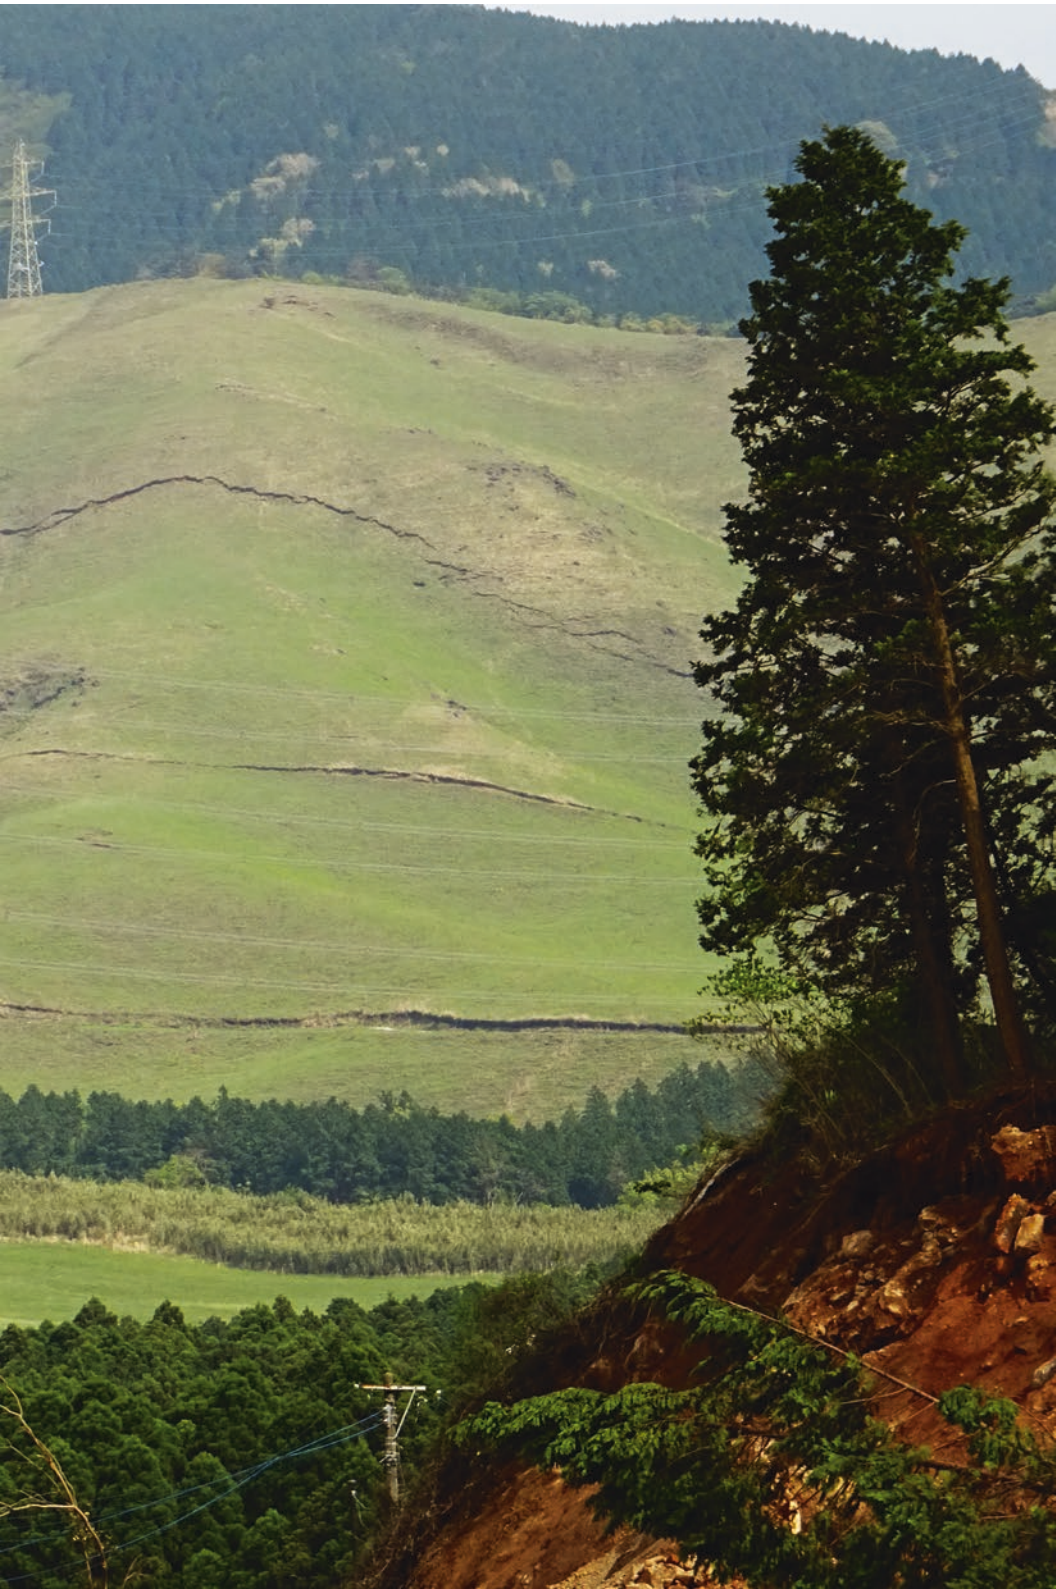
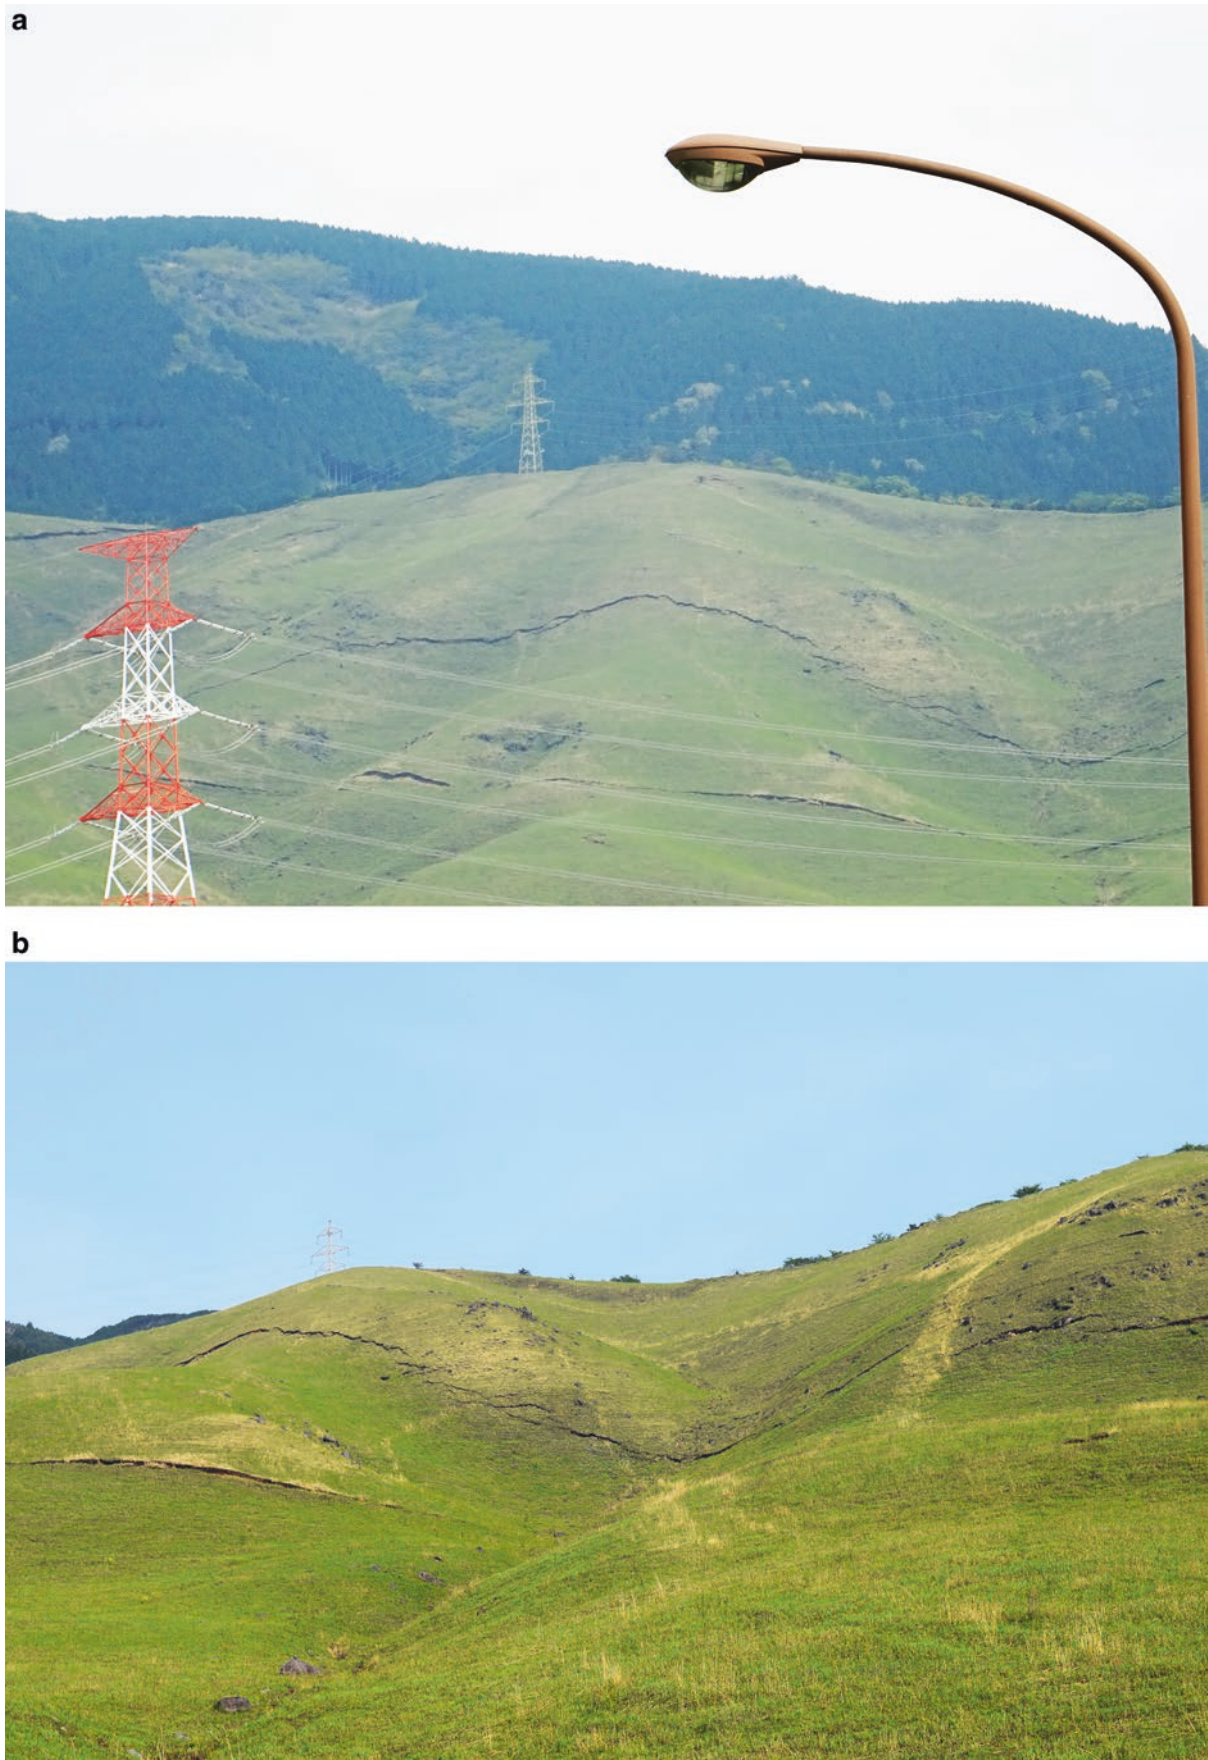
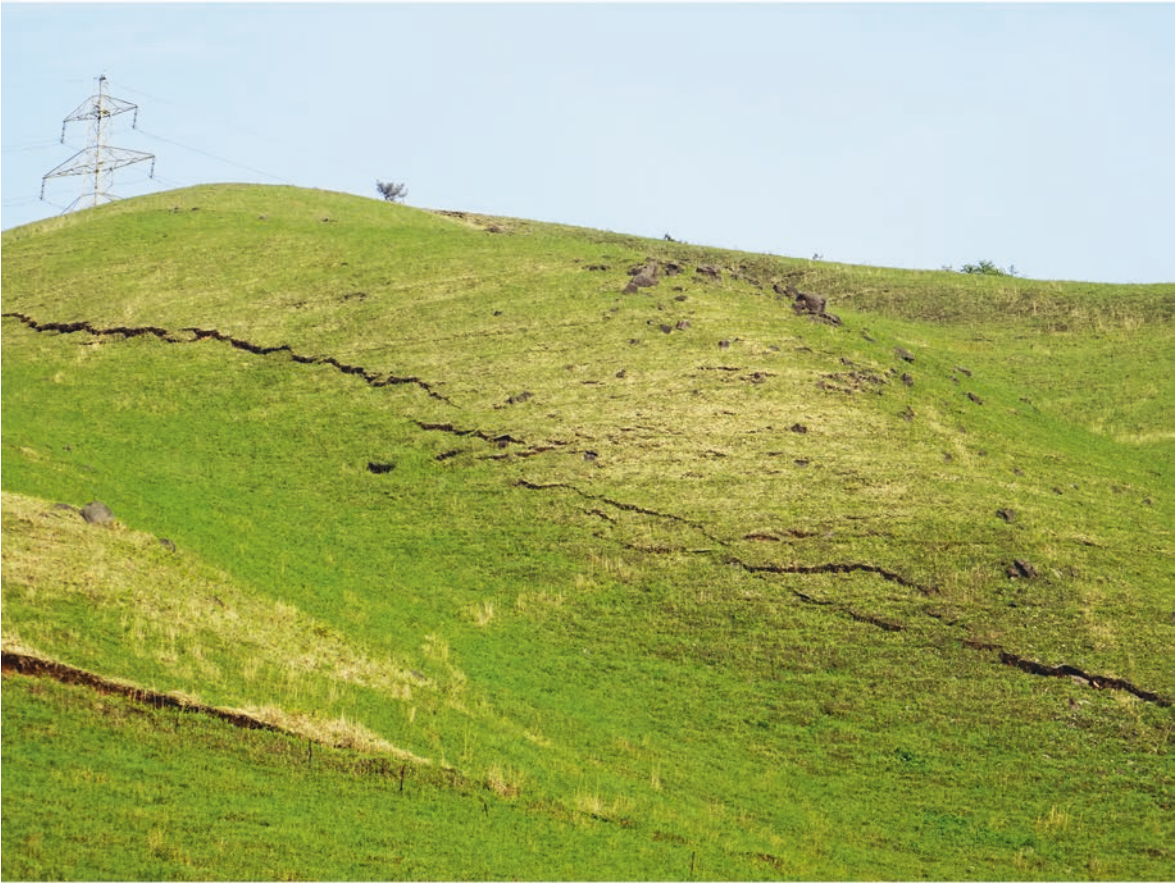
Fig. 33 Coseismic surface ruptures occurred on a slope of the Tawarayama Mt. (b) Close-up view of (a). (c, d) Close-up view of en echelon coseismic surface ruptures shown in (a) and (b)
