The 2016 Mw 7.1 Kumamoto Earthquake

A Photographic Atlas of Coseismic Surface Ruptures
Related to the Aso Volcano, Japan

Aiming Lin
Department of Geophysics
Kyoto University
Kyoto, Japan

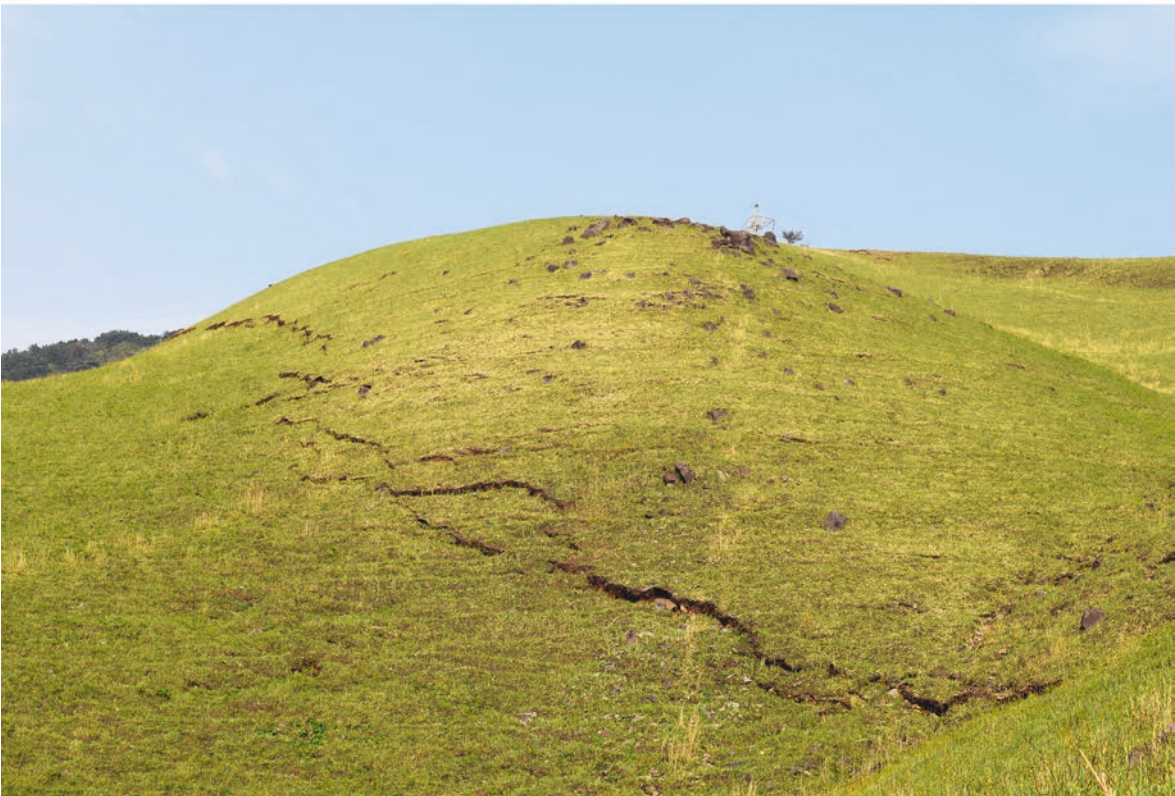
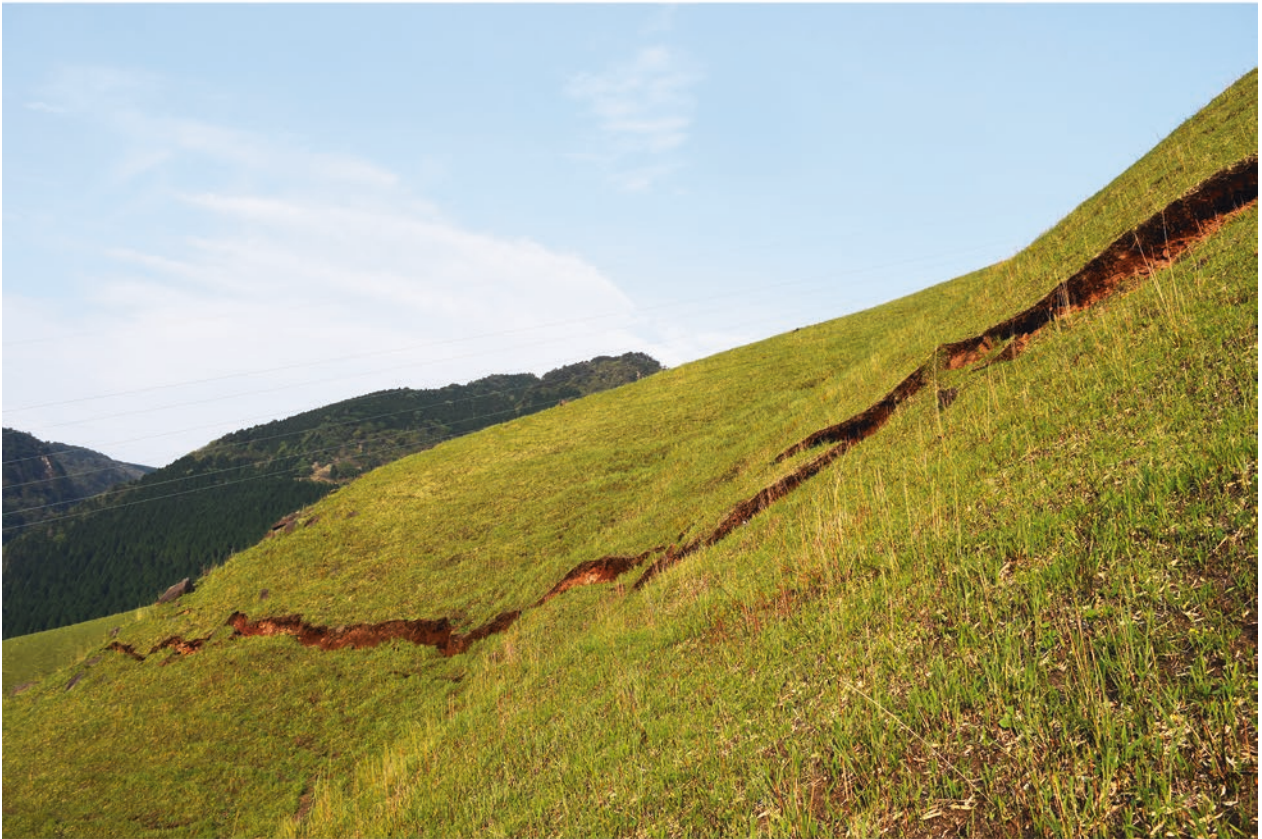
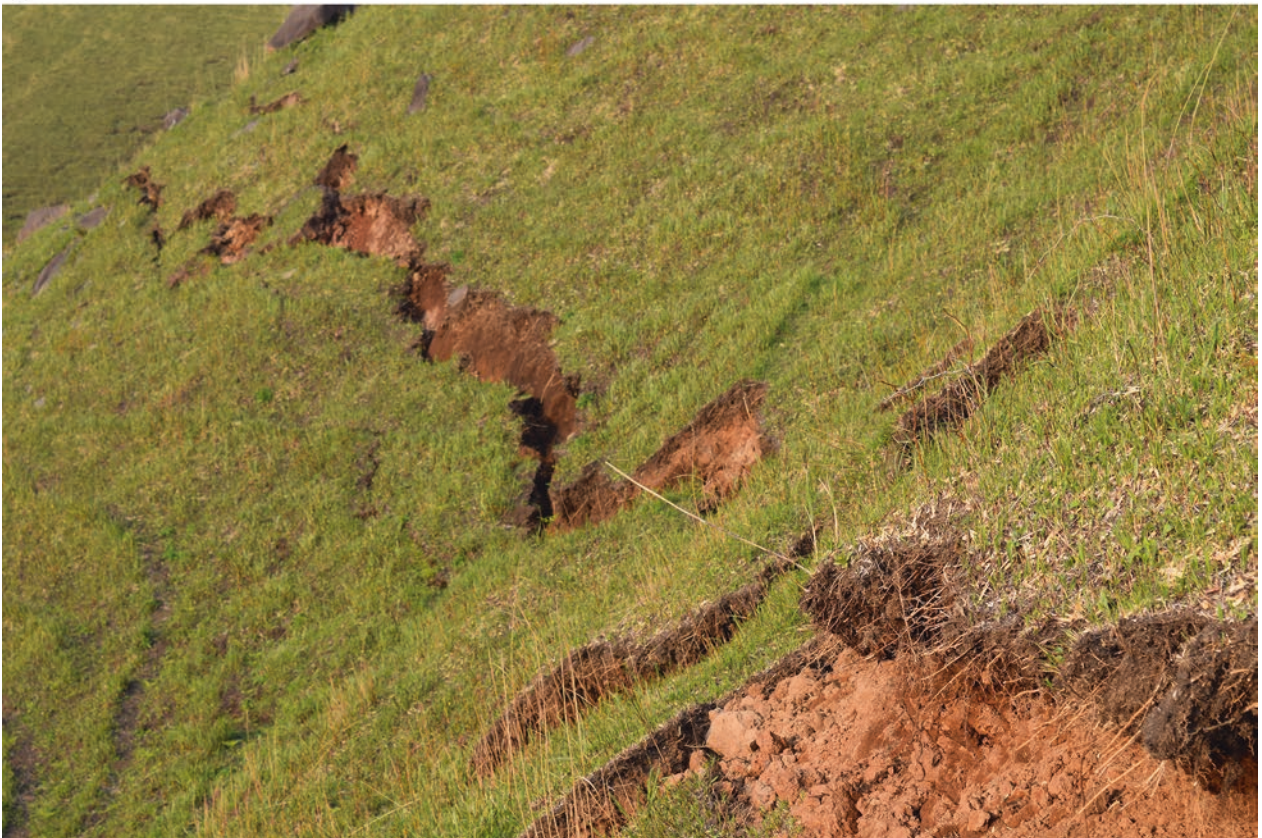
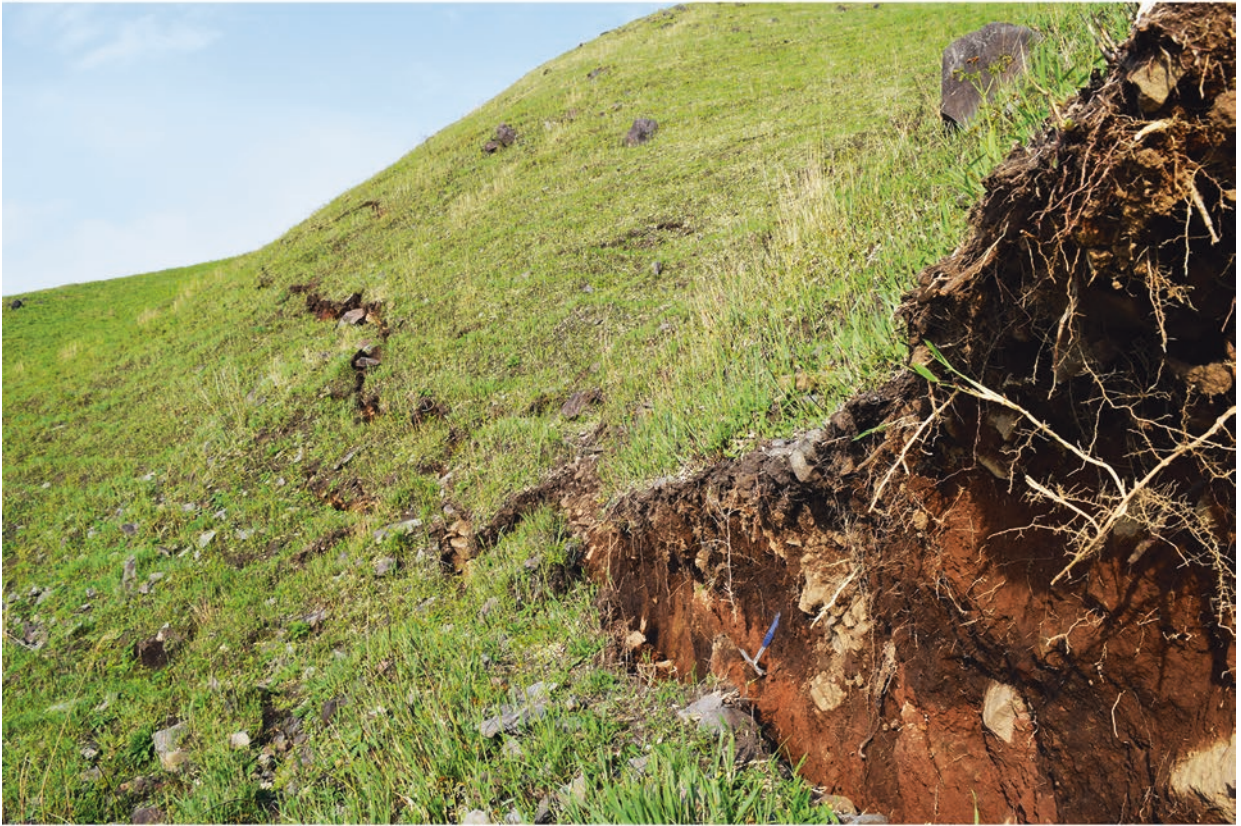
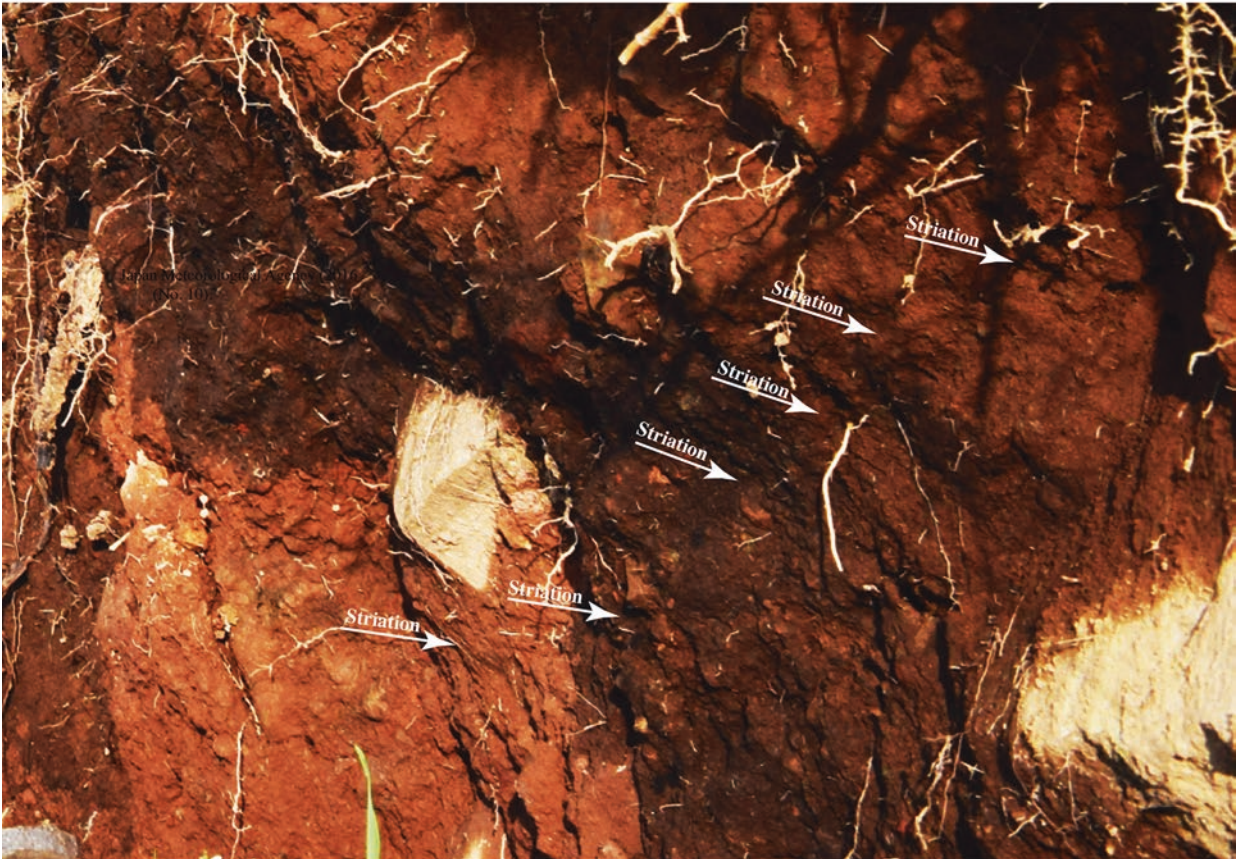
Fig. 34 Coseismic shear faults. (a–c) Continuous coseismic shear faults occurred on the Tawarayama Mt. slope. (d) Coseismic shear fault plane exposed in pyroclastic flow deposits on a mountain slope

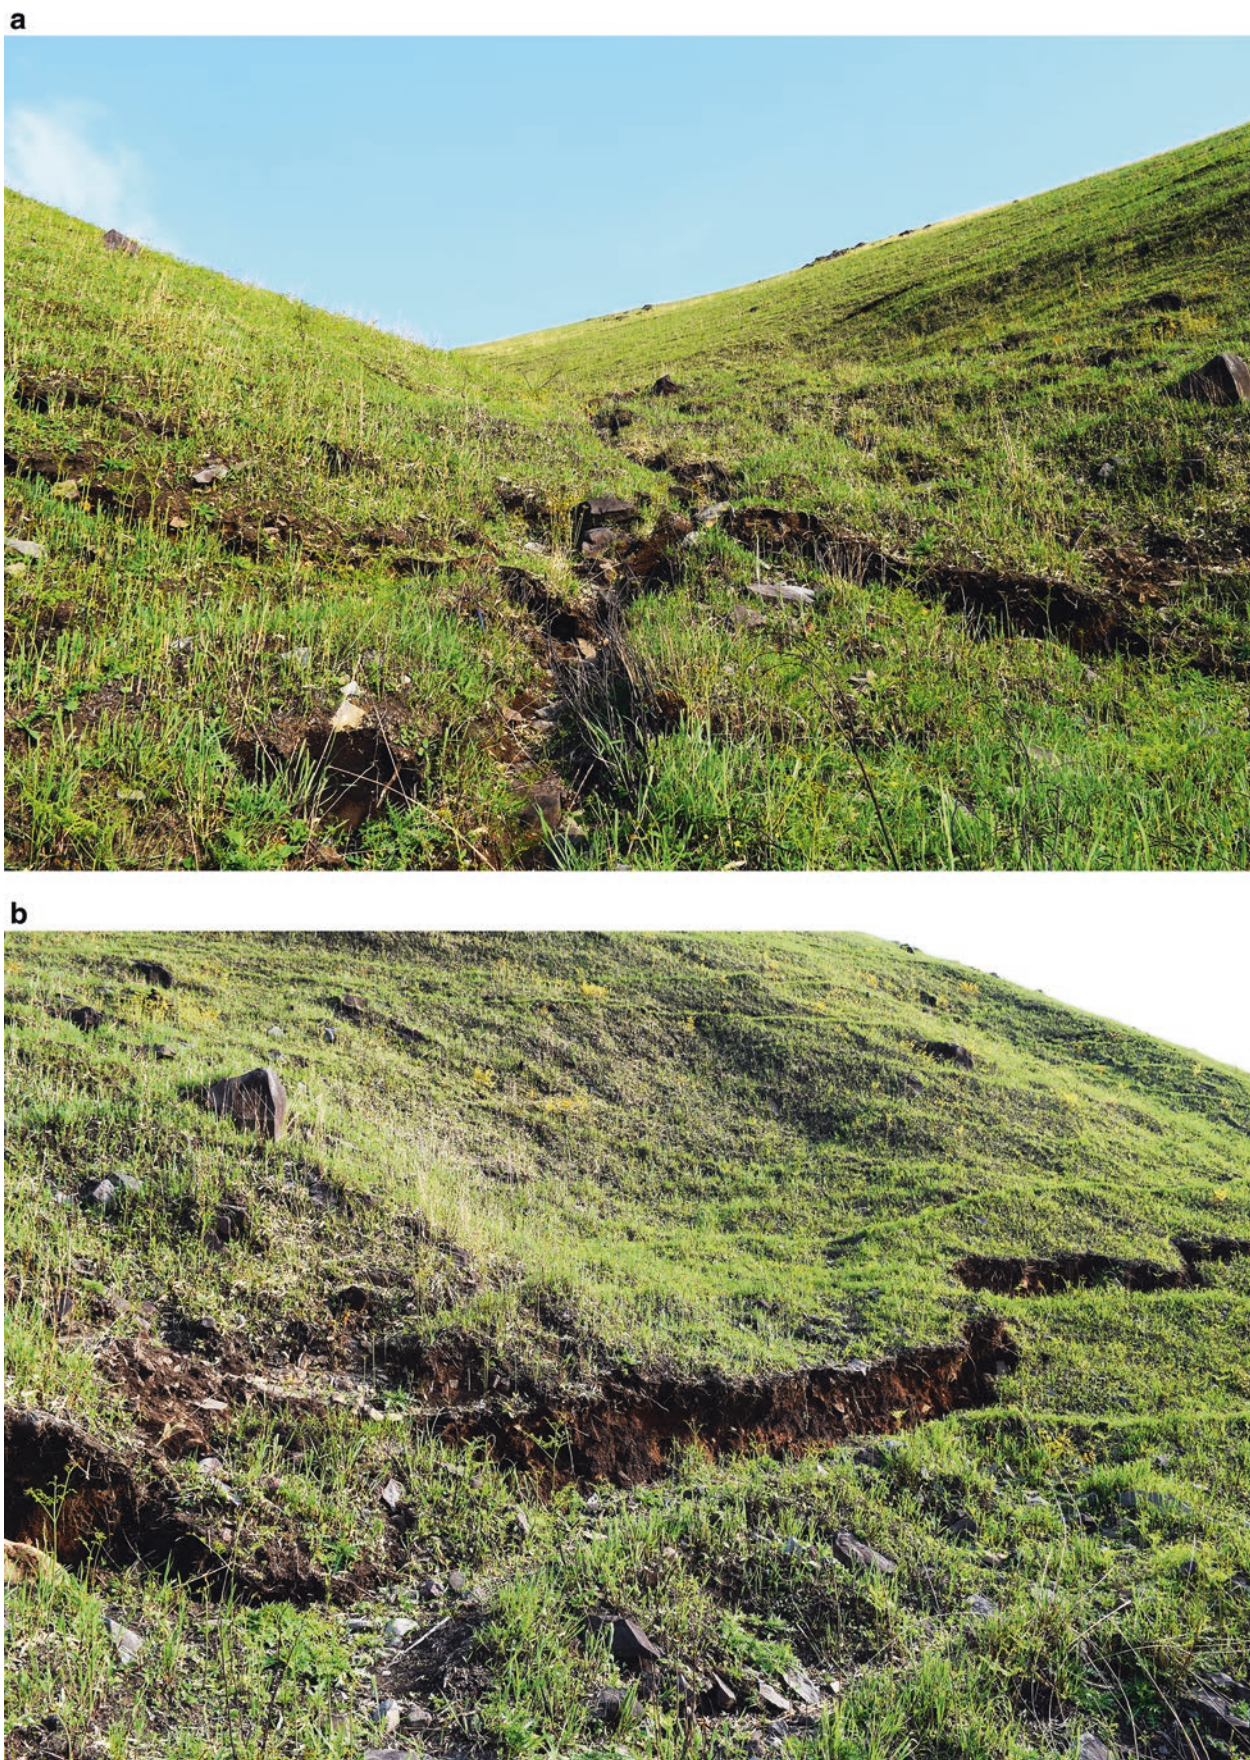
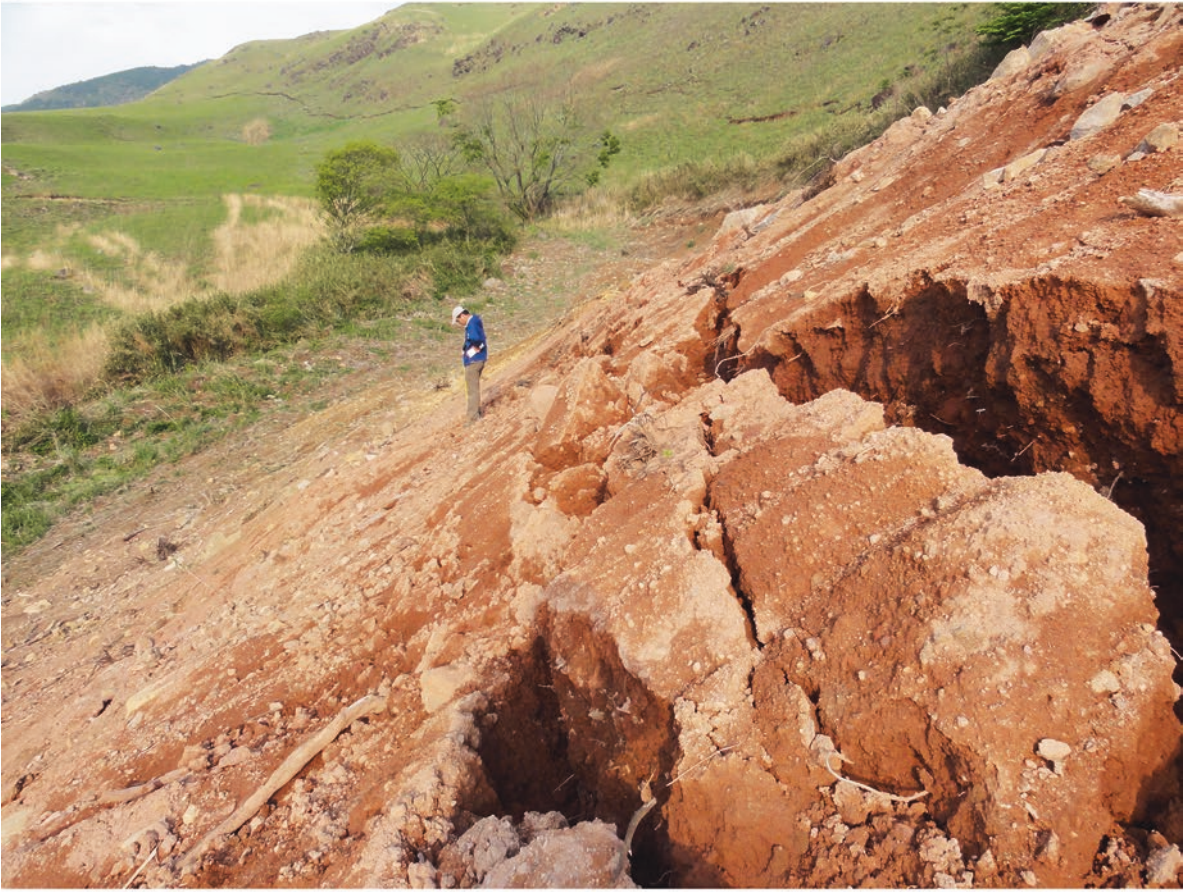
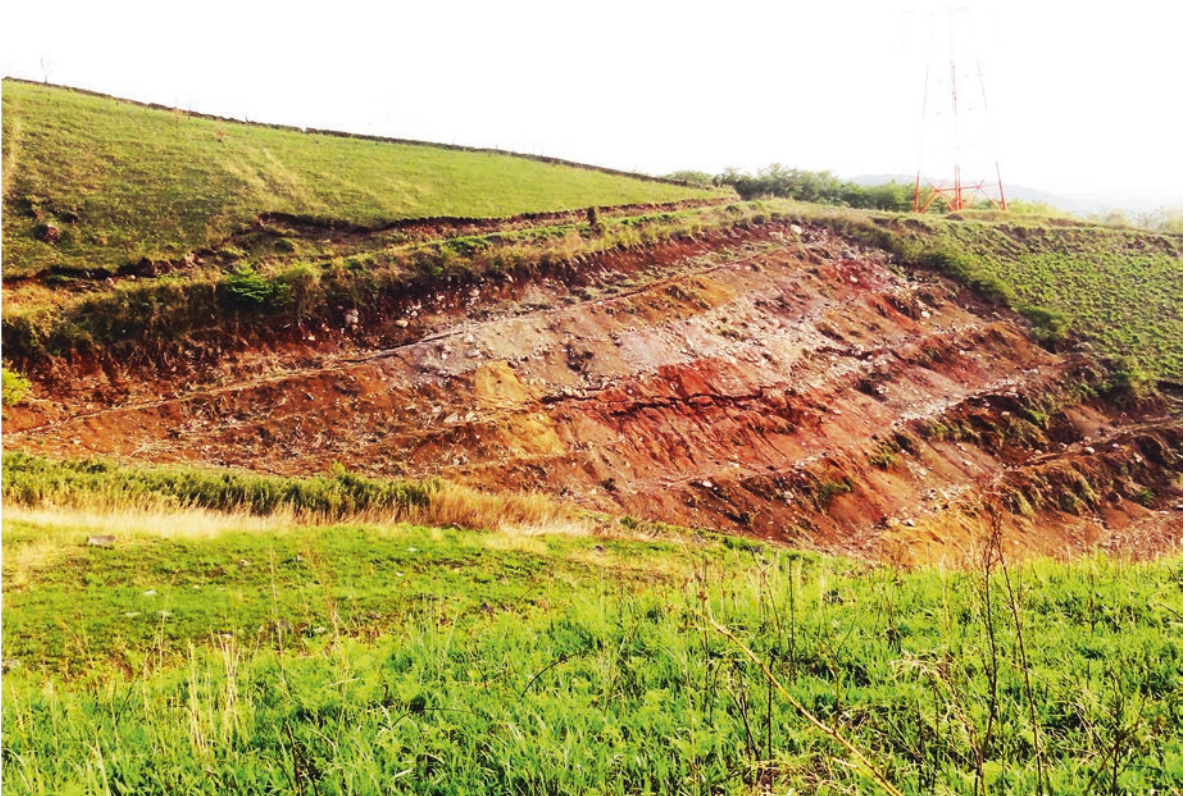
Fig. 35 Right-lateral strike-slip displacement of a gully and path on Tawarayama Mt. (a) Gully offset ~2.4 m. (b) Path offset ~1.7 m. (c, d) Coseismic surface ruptures without distinct vertical offset developed in pyroclastic flow deposits

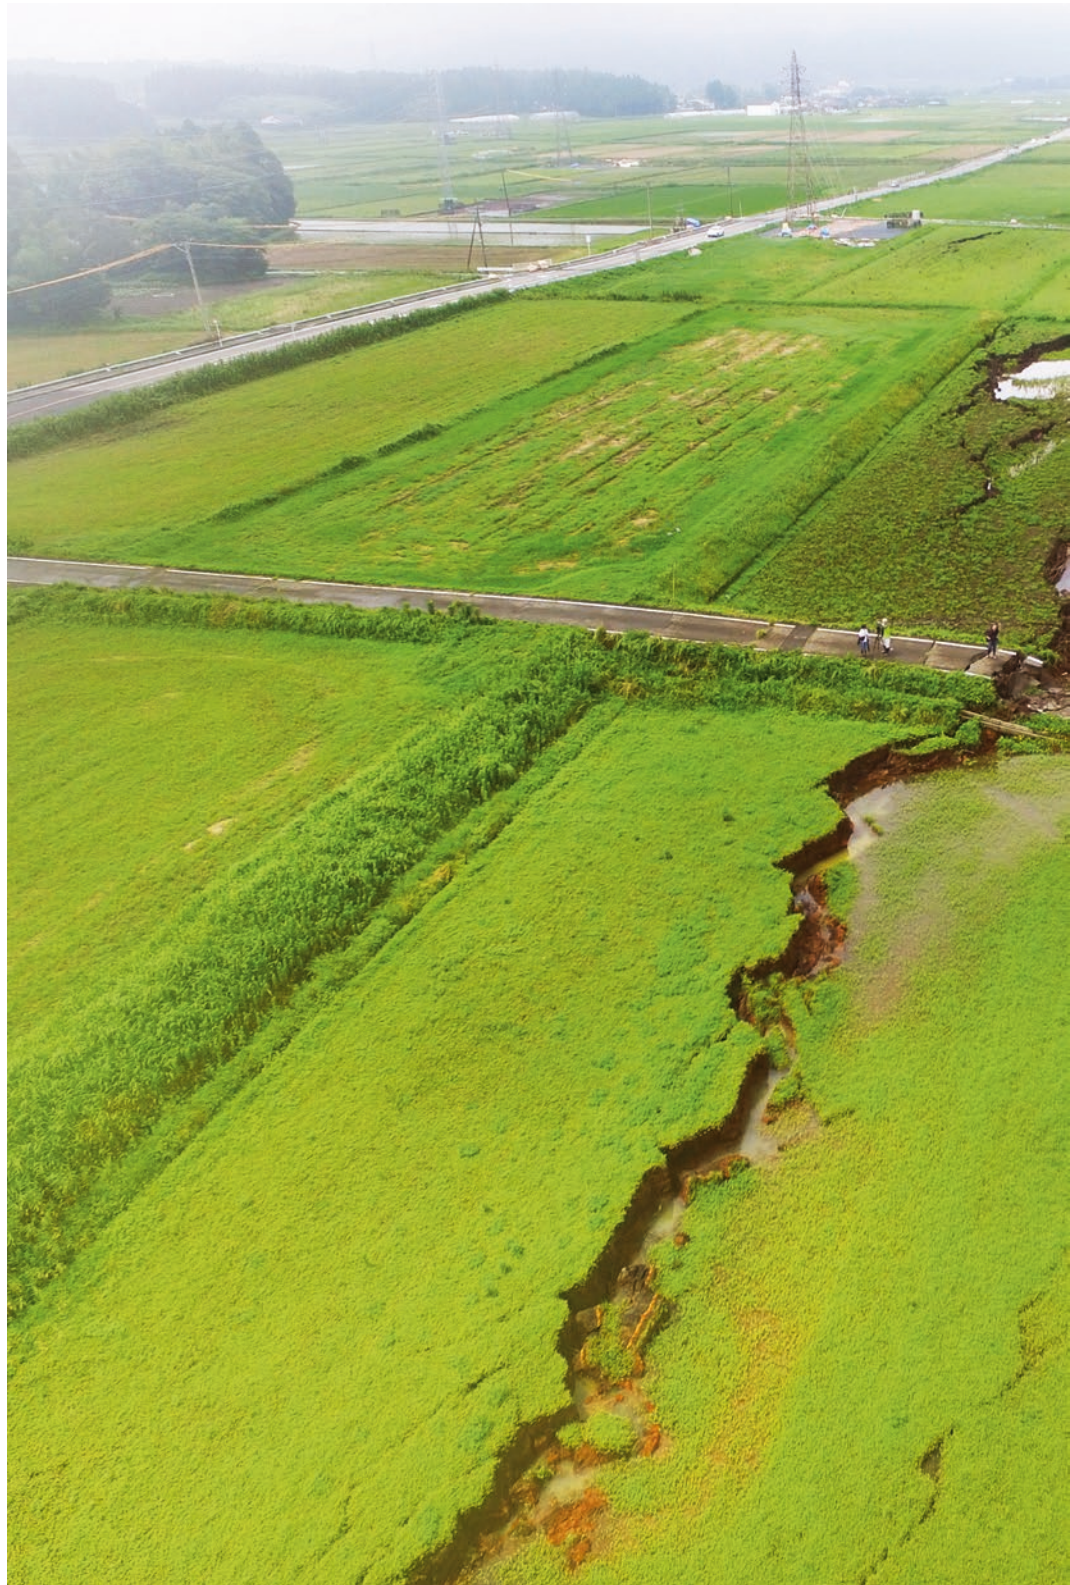
Fig. 36 Drone image showing a coseismic graben structure developed inside Aso caldera

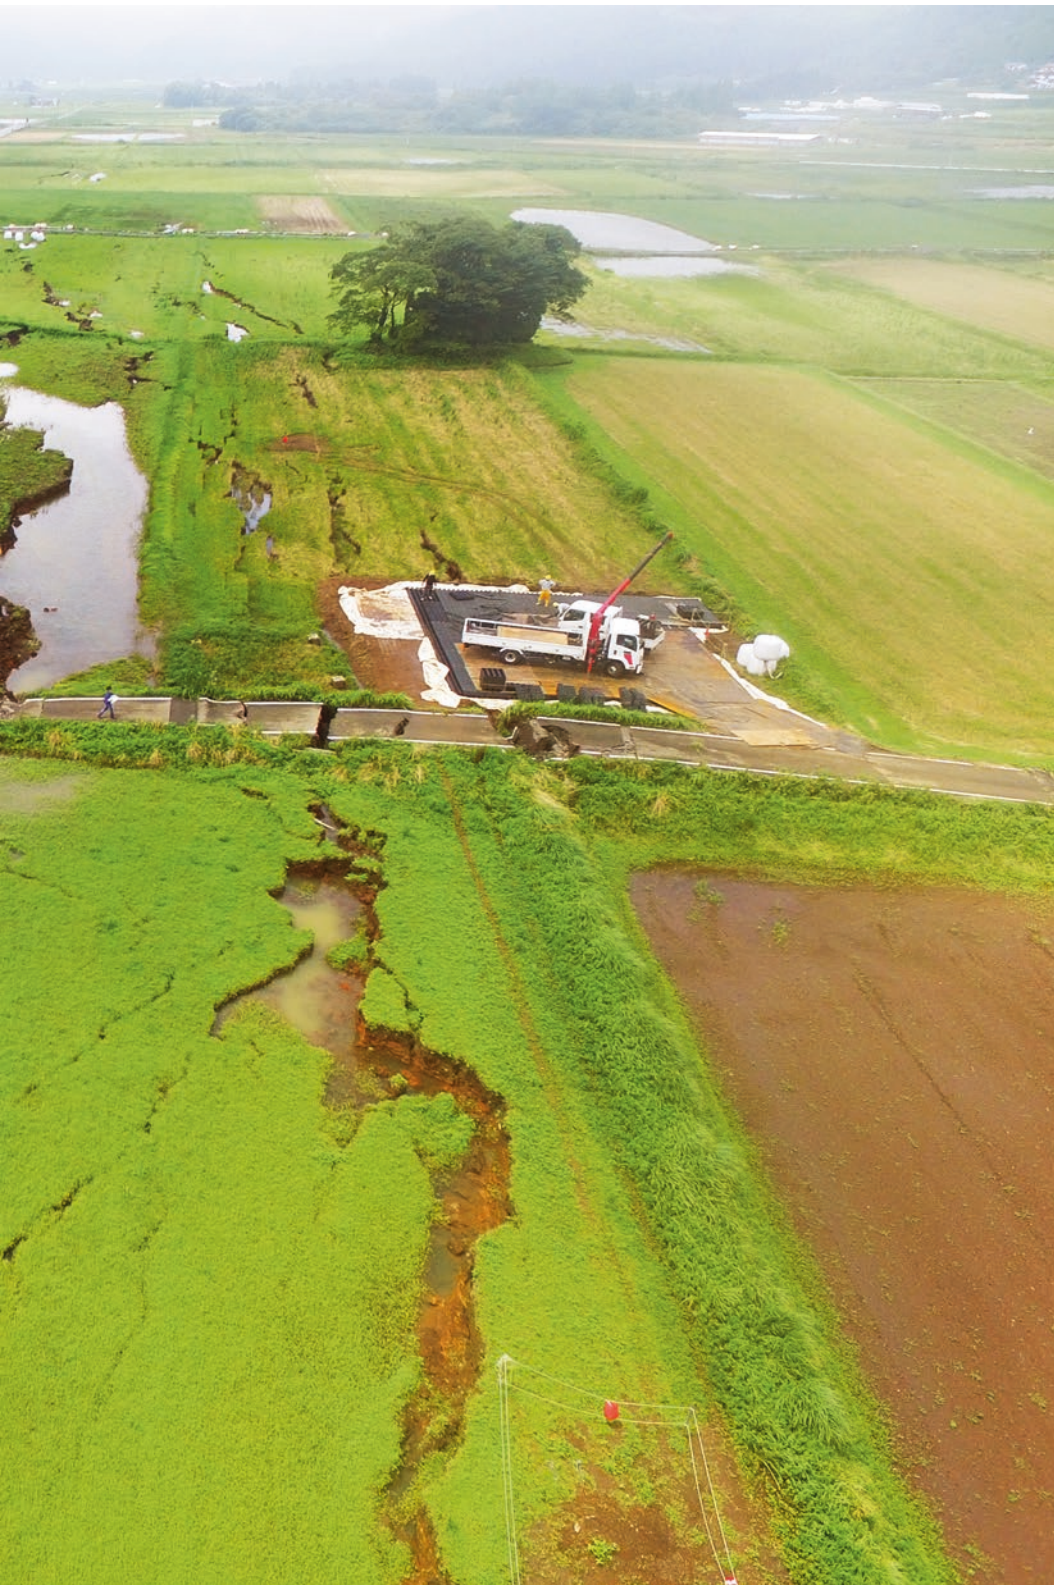
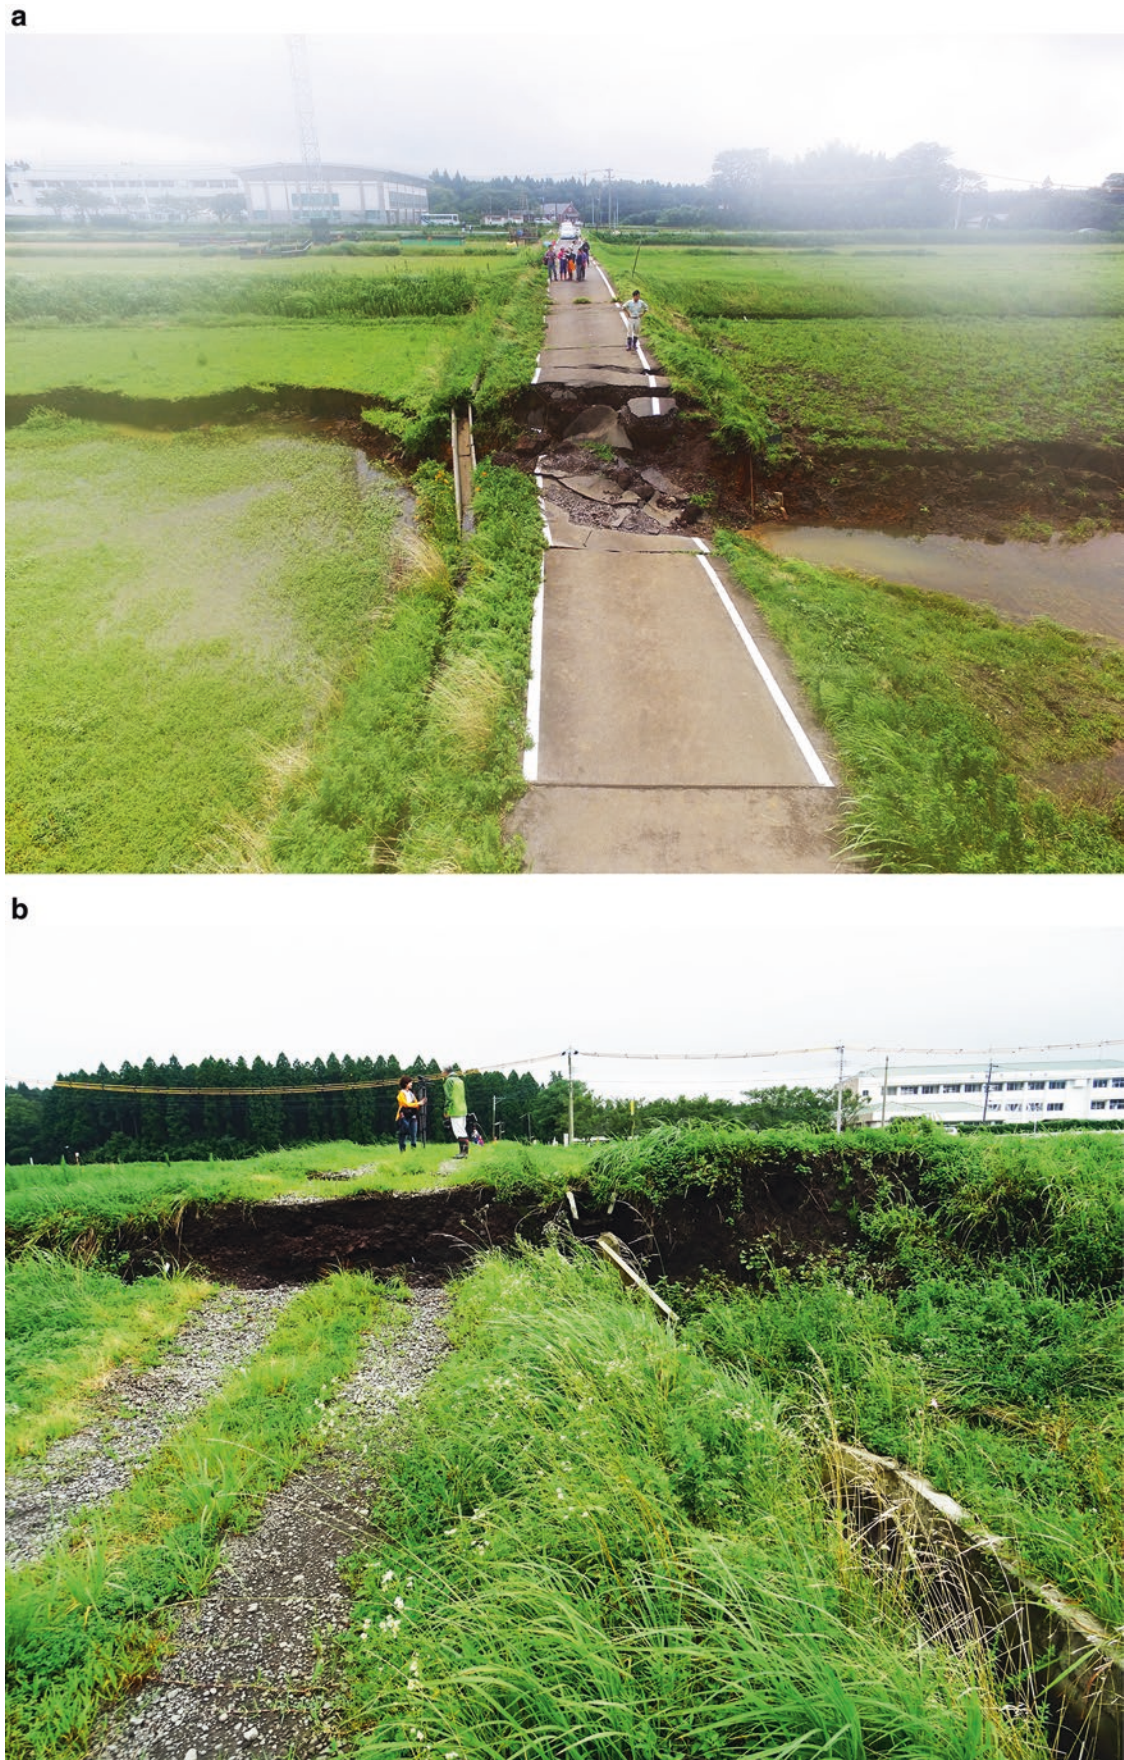
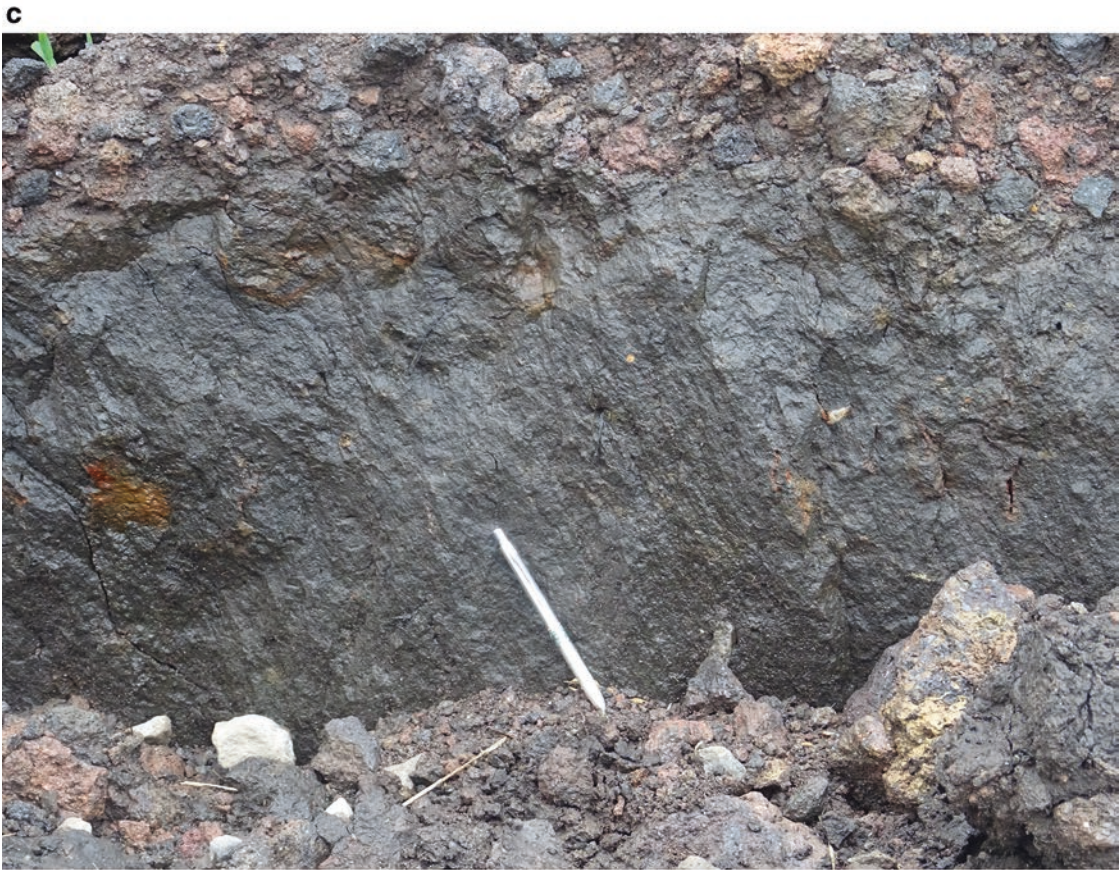
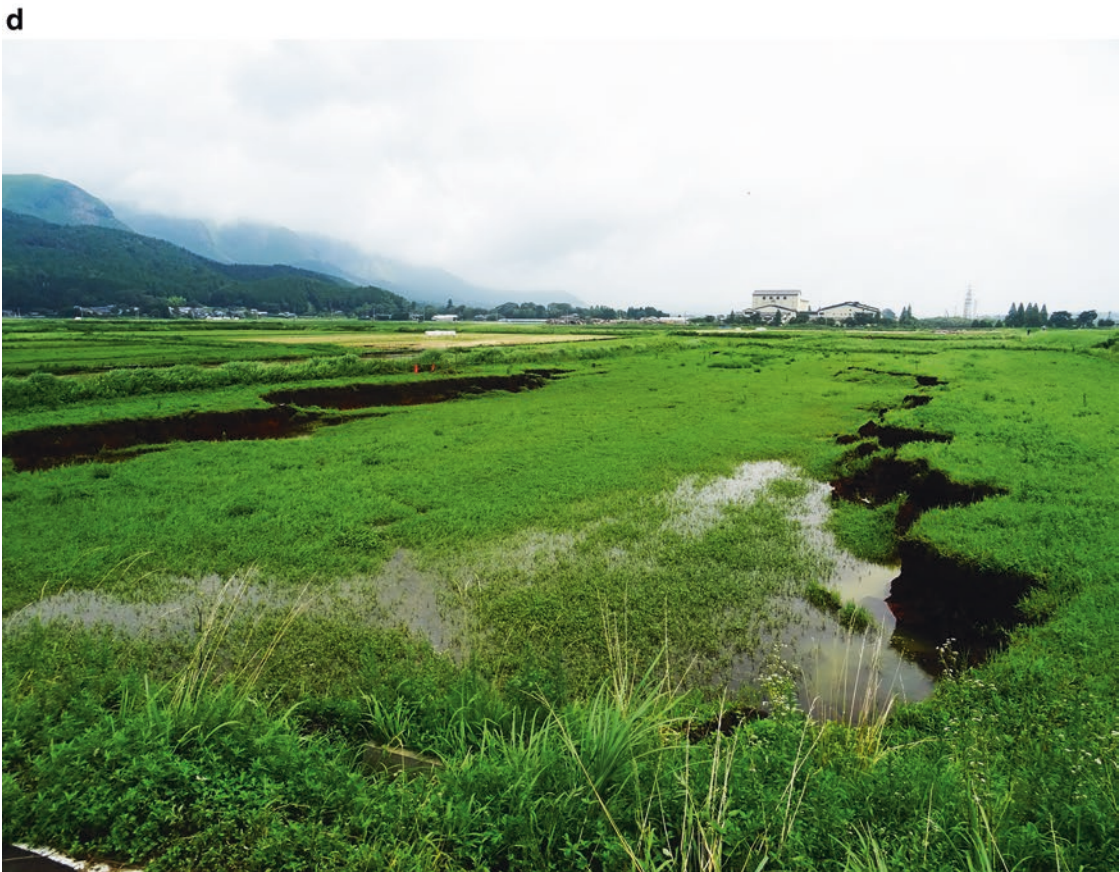
Fig. 37 Coseismic fault scarps of a graben structure and slickenside. (a, b) Coseismic fault scarp developed along one side of a graben structure (vertical offset up to ~1.7 m). (c) Slickenside on a fault plane of (b). (d) Drone image showing a graben structure where a pond formed

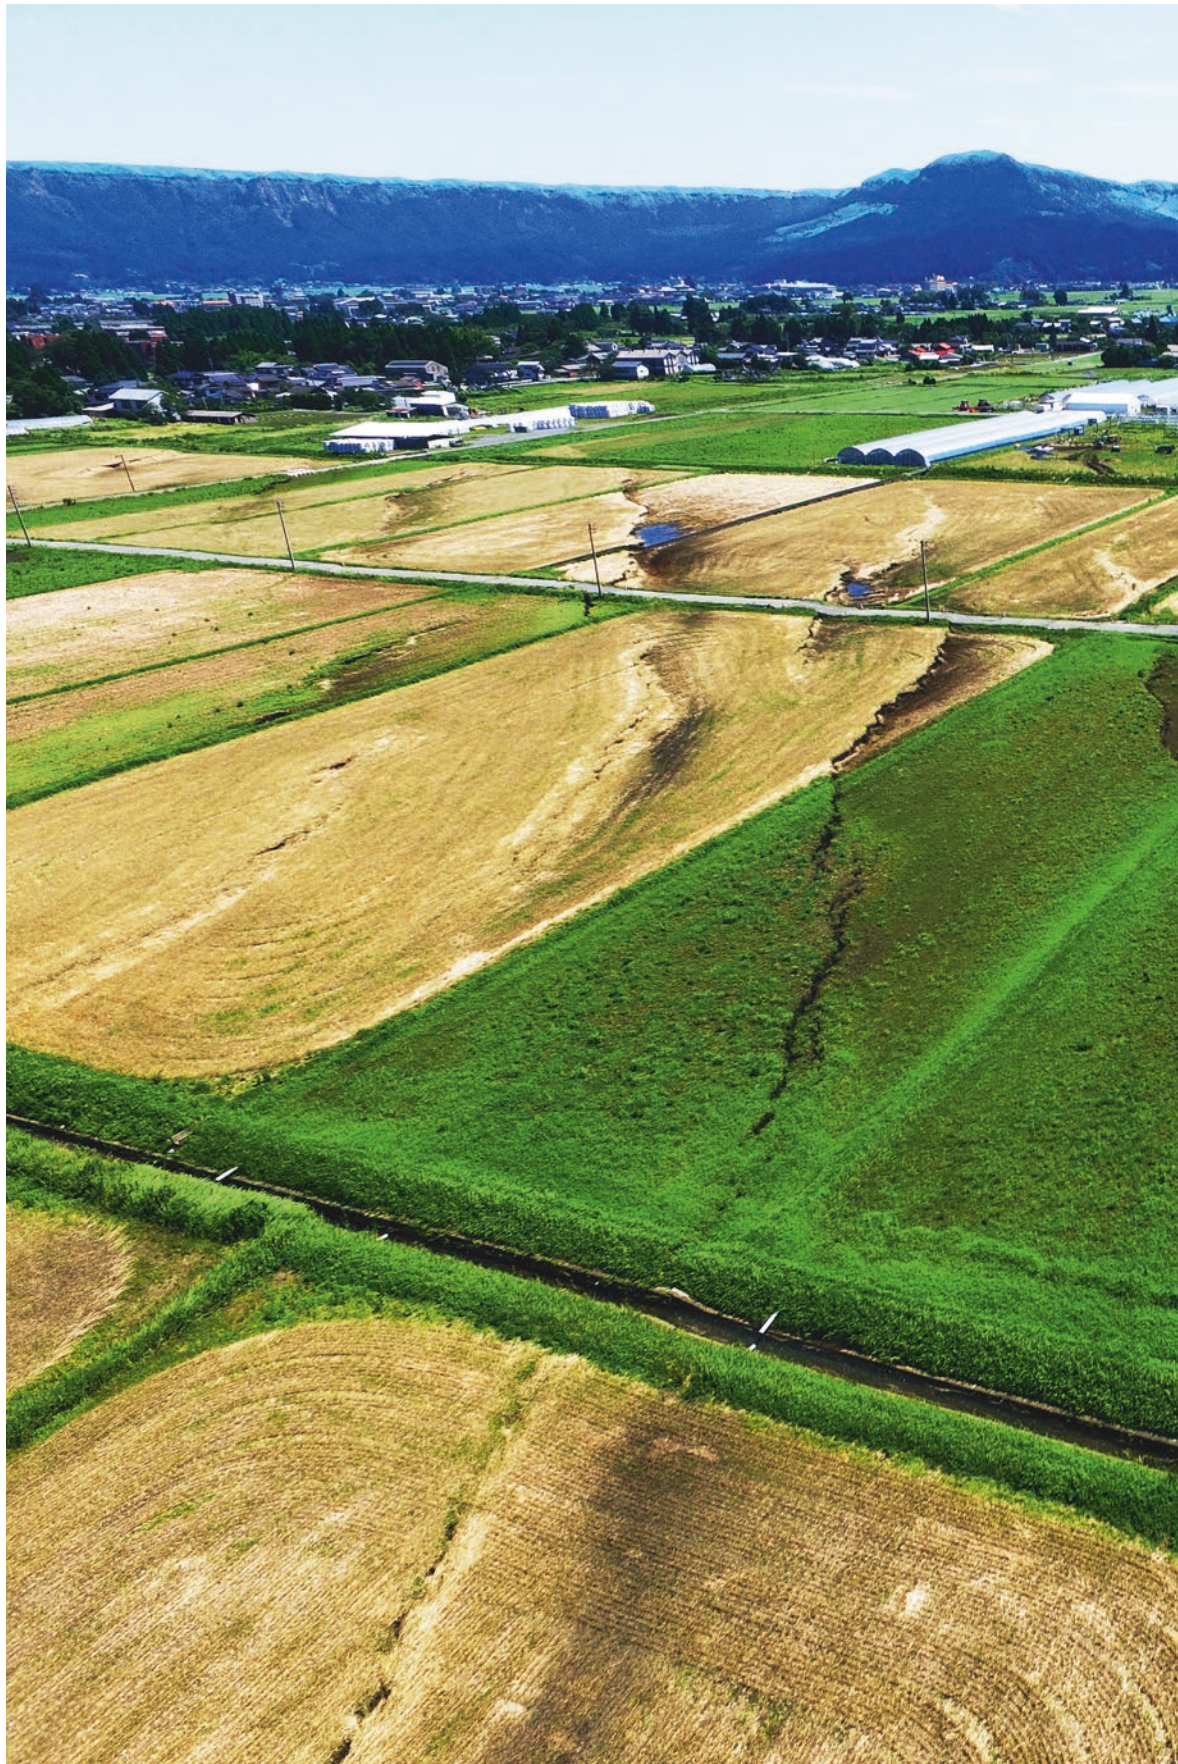
Fig. 38 Coseismic flexure structures formed in rice fields. Drone image showing a flexure feature of coseismic surface ruptures occurred in rice fields that are folded as waveform
