The 2016 Mw 7.1 Kumamoto Earthquake

A Photographic Atlas of Coseismic Surface Ruptures
Related to the Aso Volcano, Japan

Aiming Lin
Department of Geophysics
Kyoto University
Kyoto, Japan

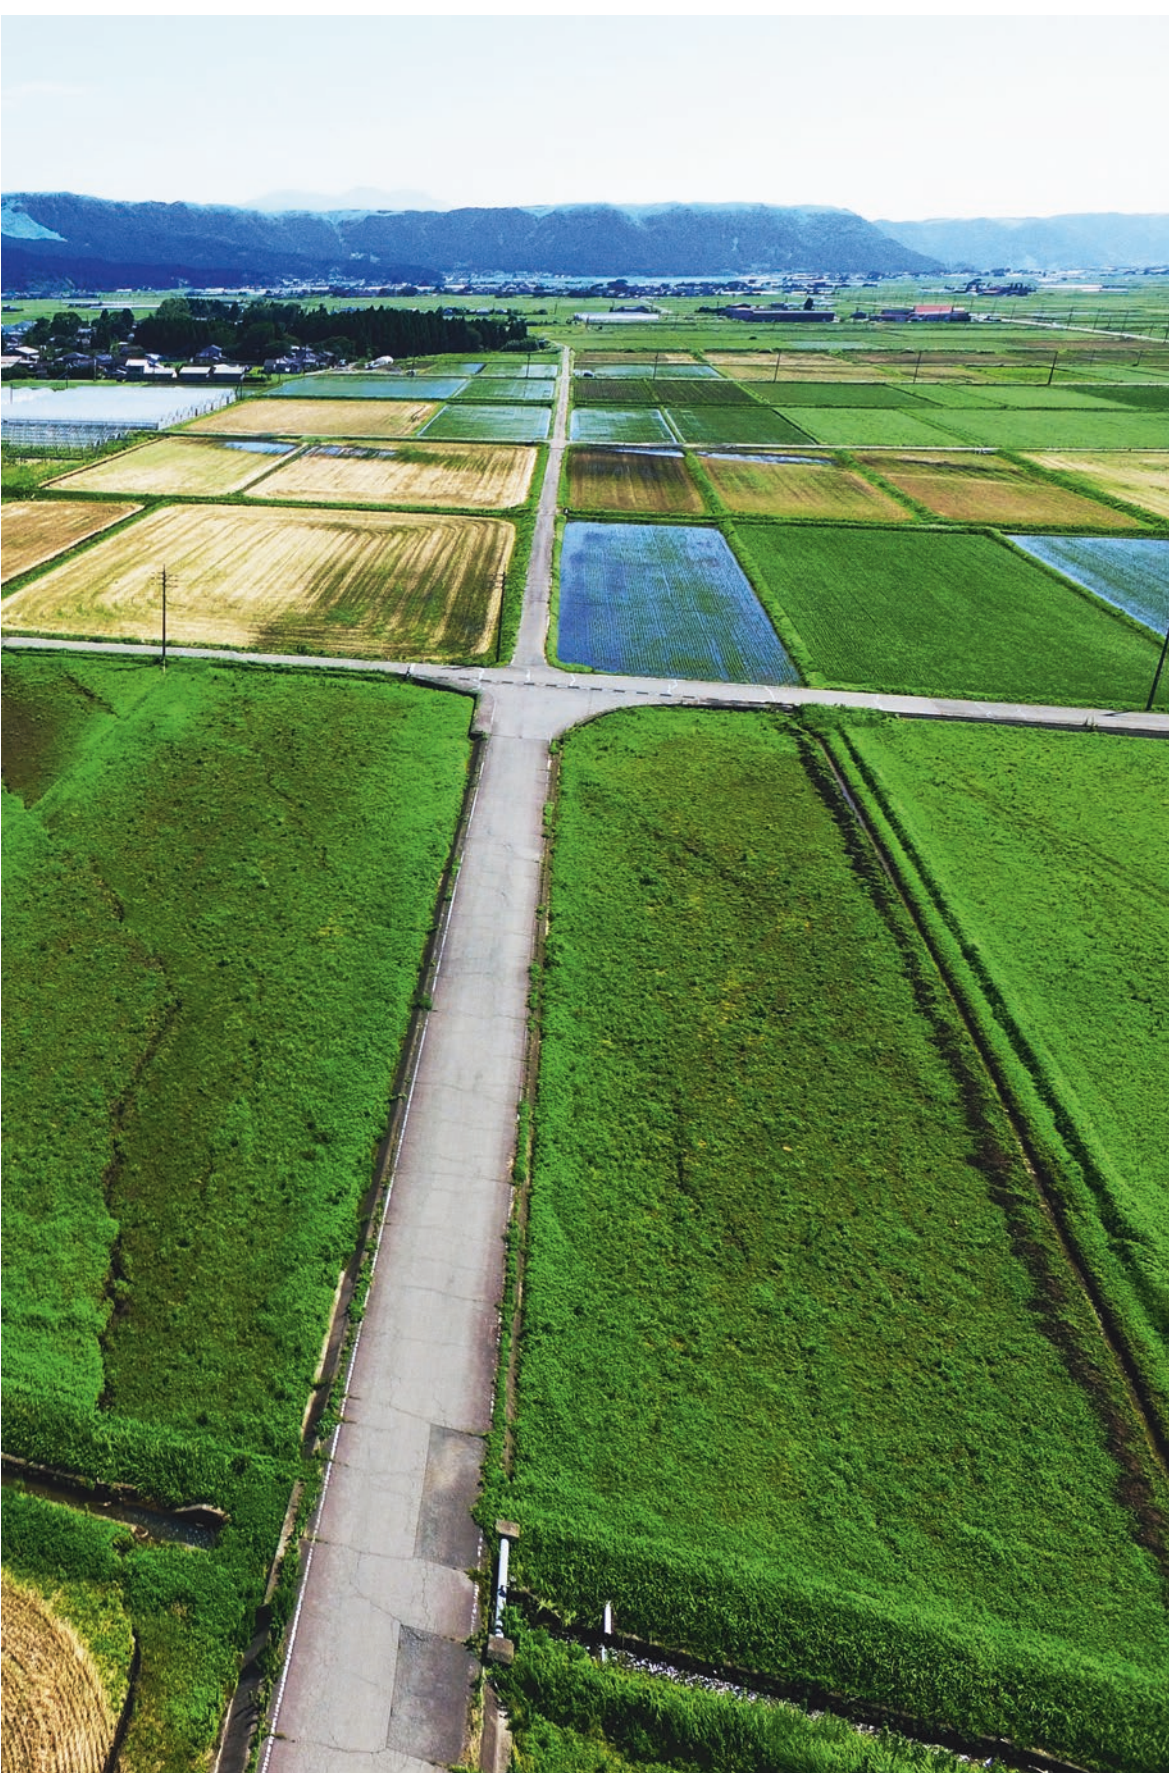
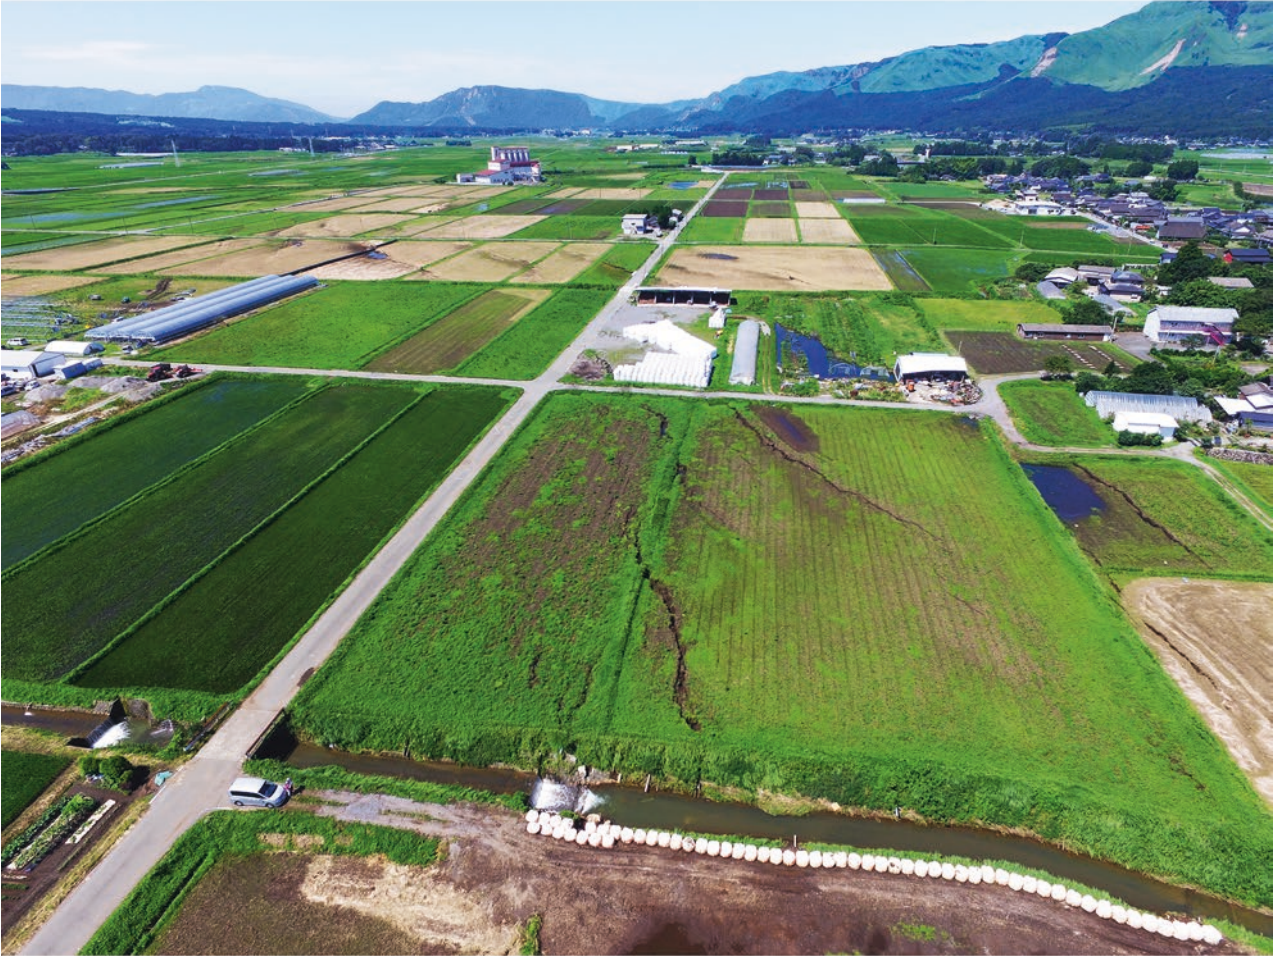
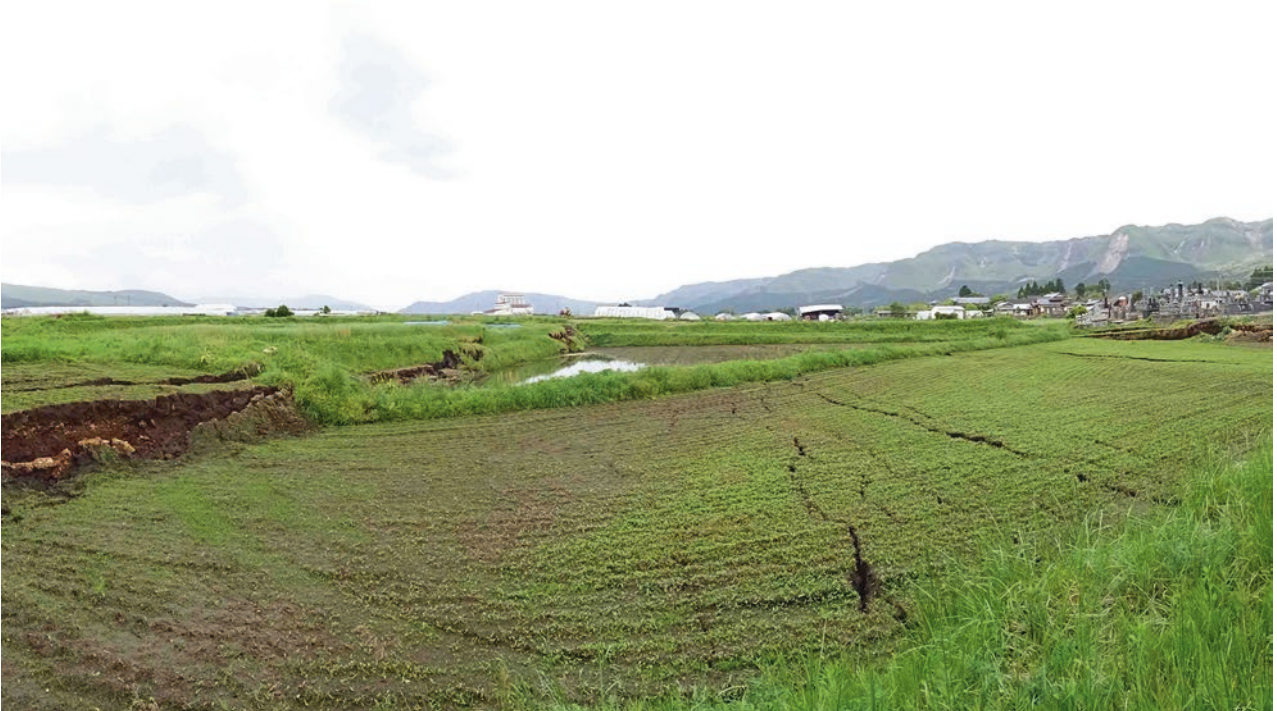
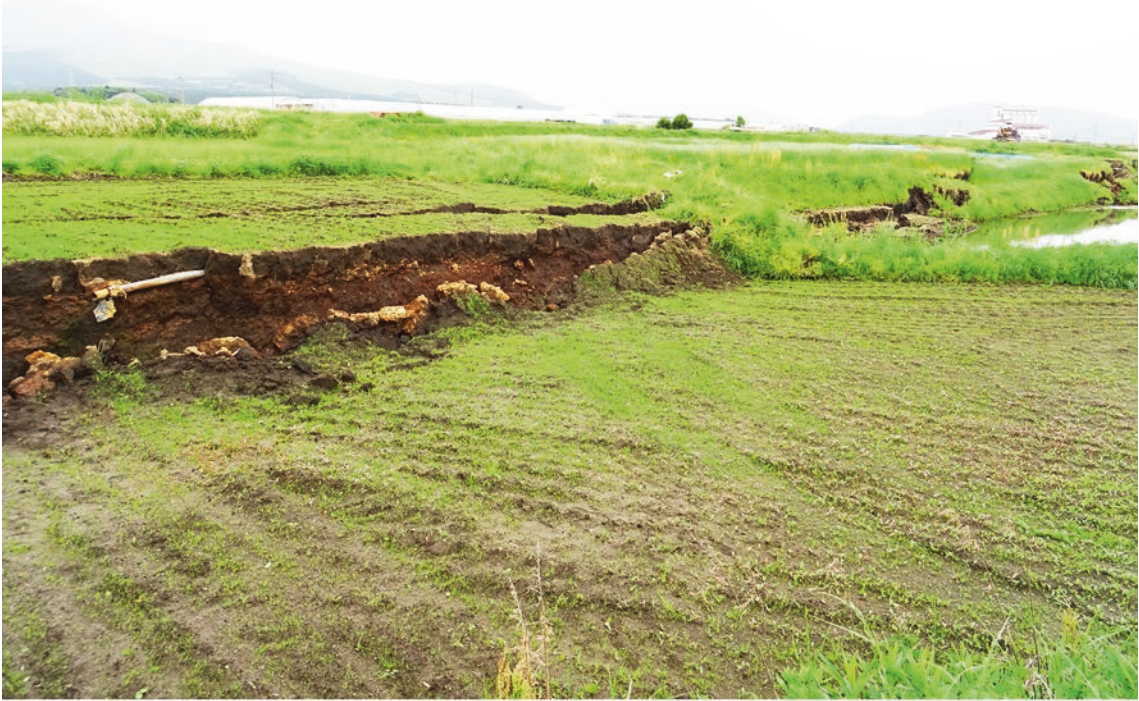
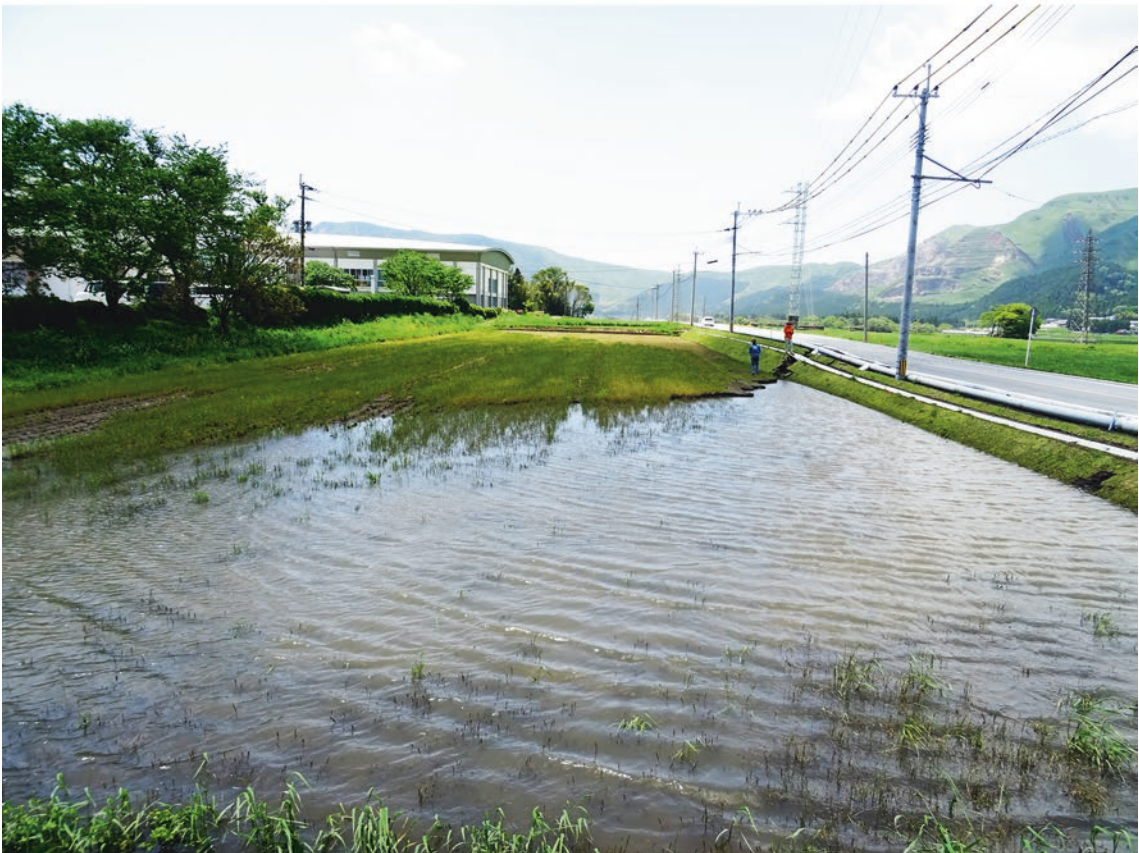
Fig. 39 Drone images showing a coseismic graben structure formed in rice fields. **(a)** Rice fields folded as waveforms. **(b)** A graben structure formed in rice fields where a temporary pond formed. **(c)** Close-up view

of **(b)**. **(d)** Ground subsidence of up to ~ 0.4 m occurred in a rice field where a temporary pond formed

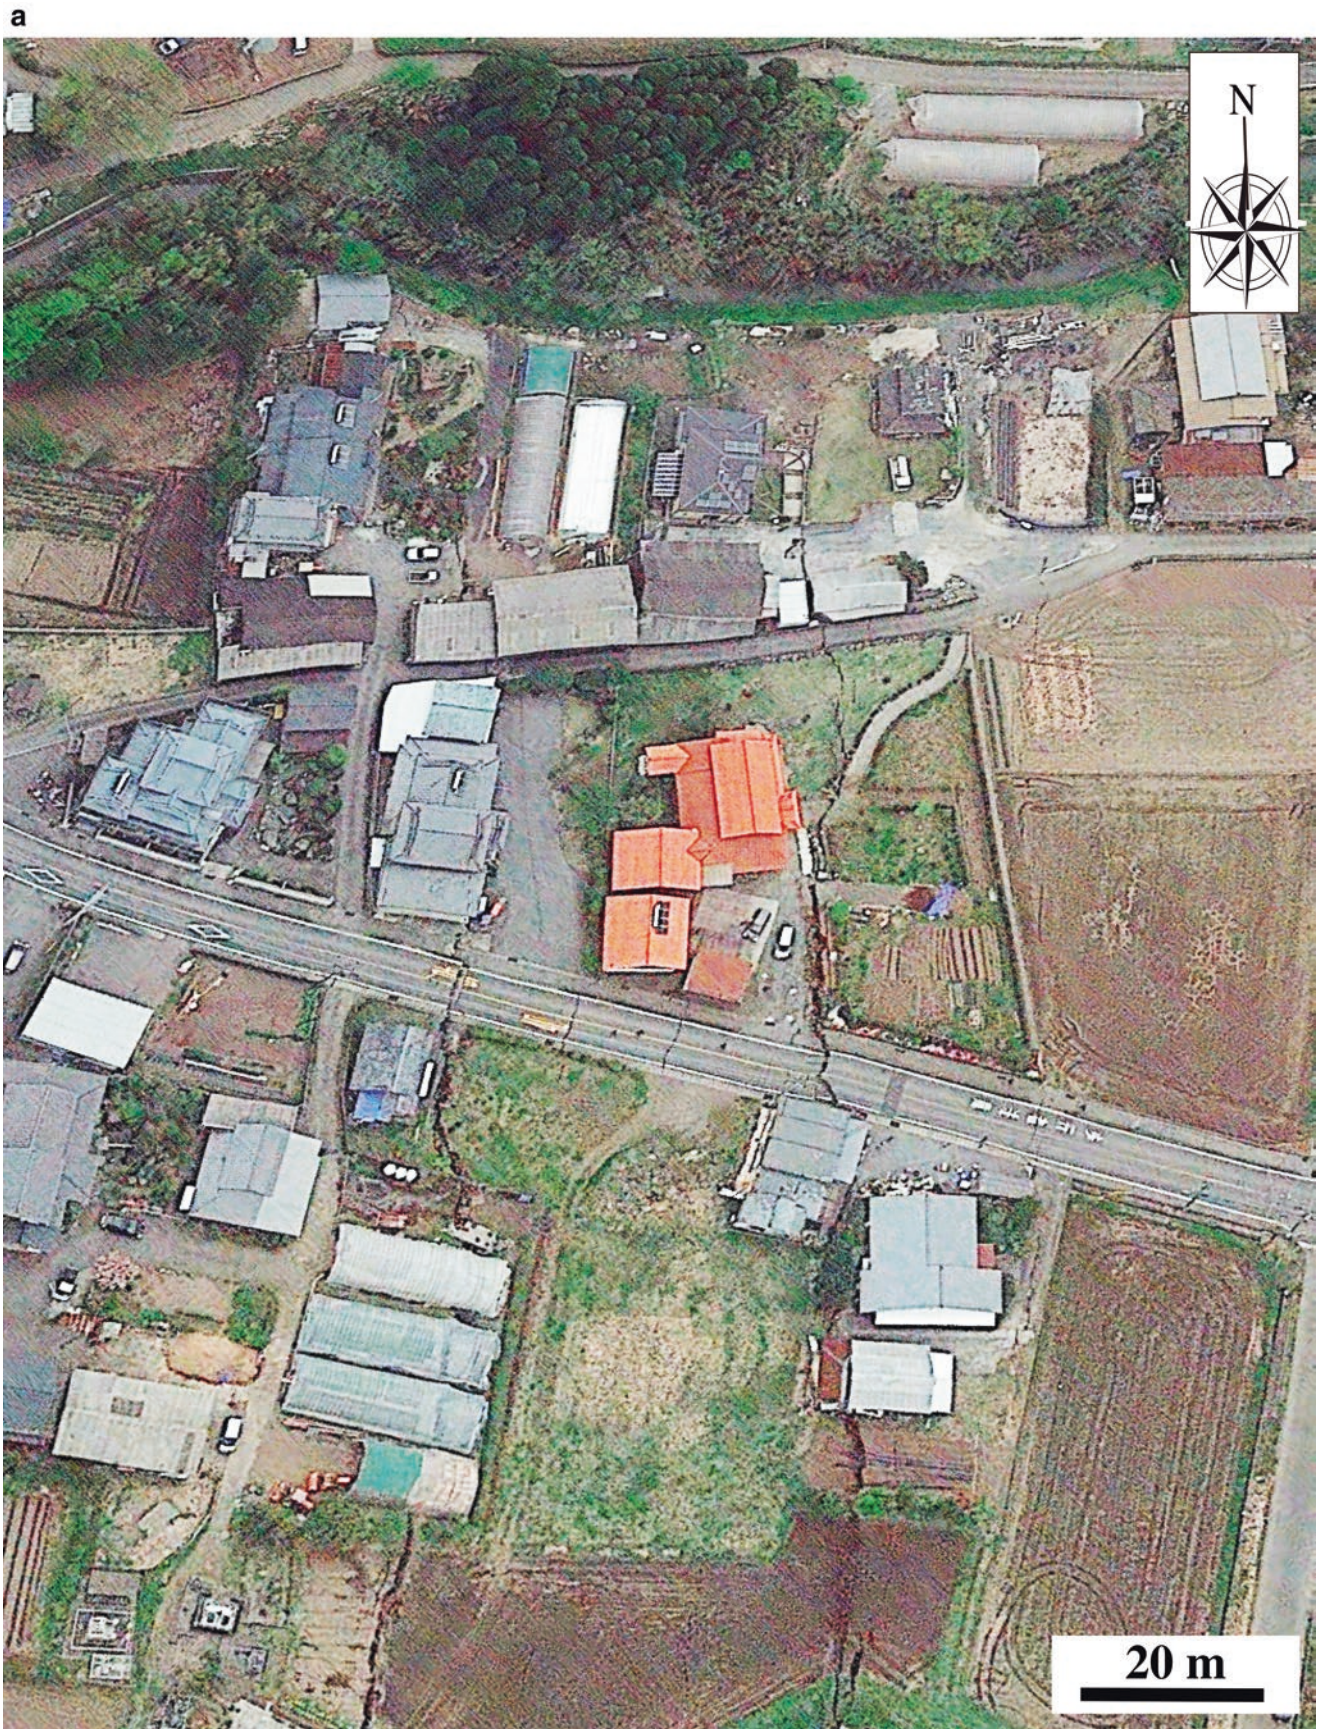
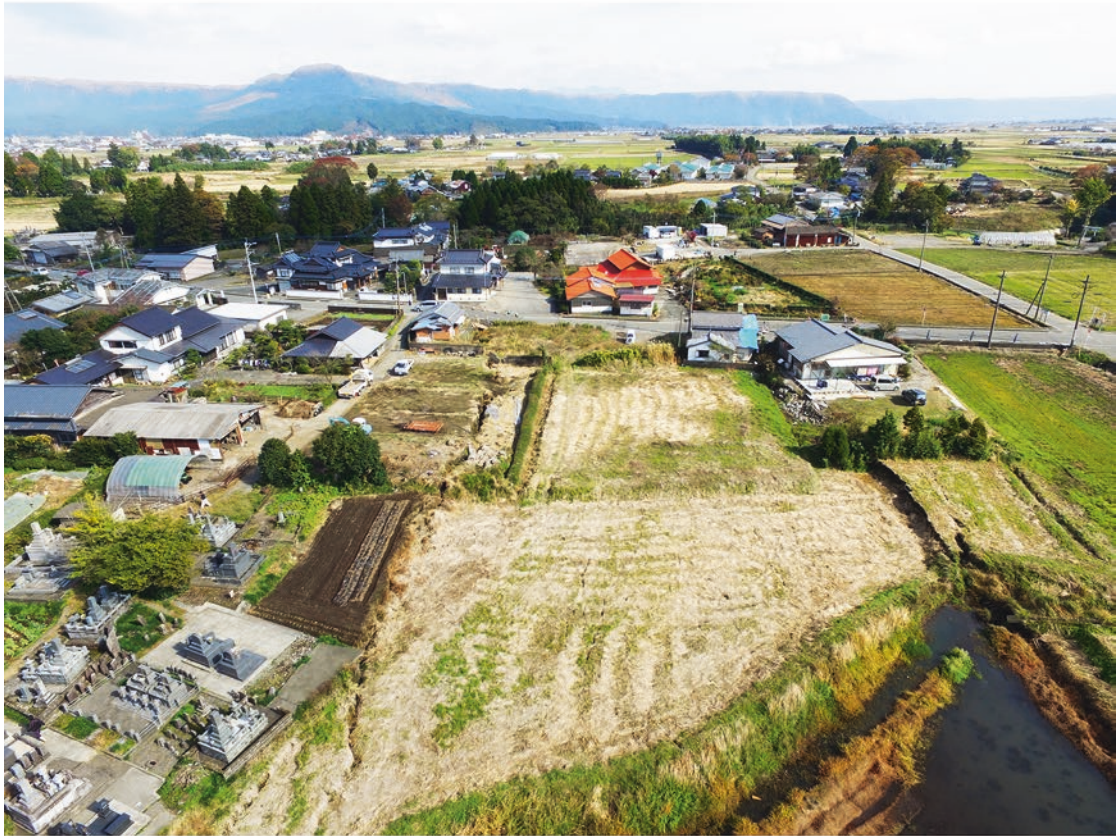
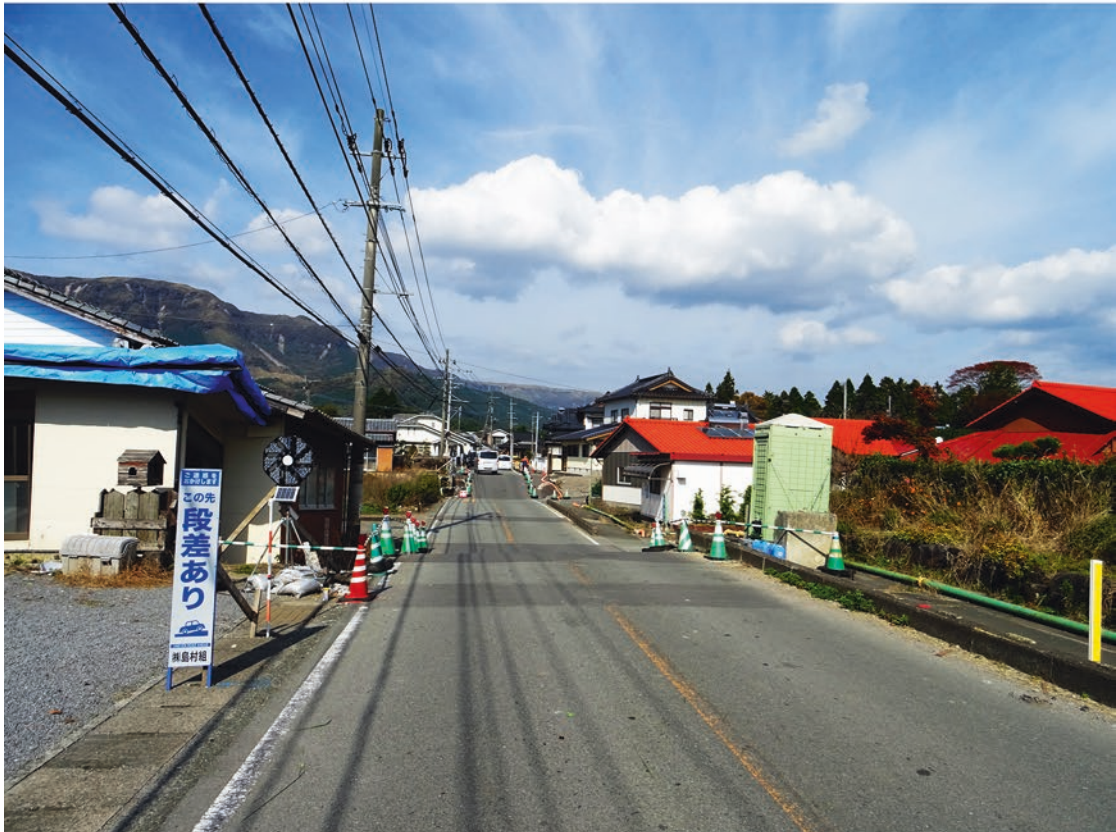
Fig. 40 A coseismic graben structure formed in a residential area. (a) Google Earth image showing a coseismic graben structure. (b) Drone image showing the coseismic surface ruptures formed a graben struc-

ture. (c) A graben structure formed on a road that was repaired immediately after the earthquake. Red roof houses located inside the graben, which are the same as that shown in (a) and (b)

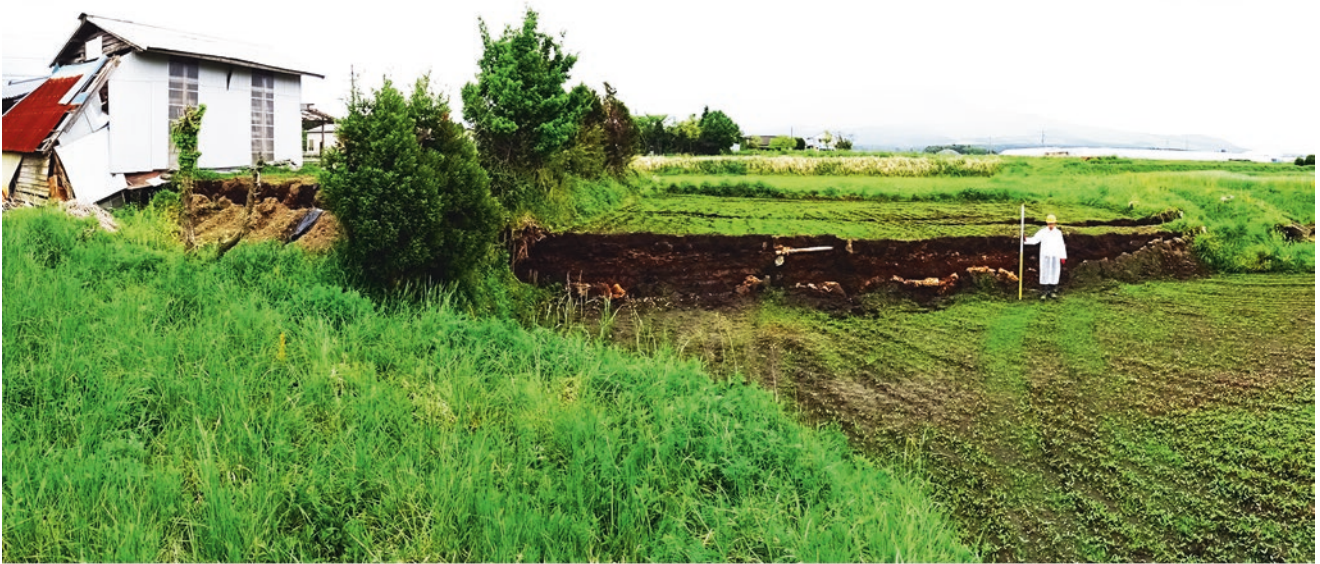
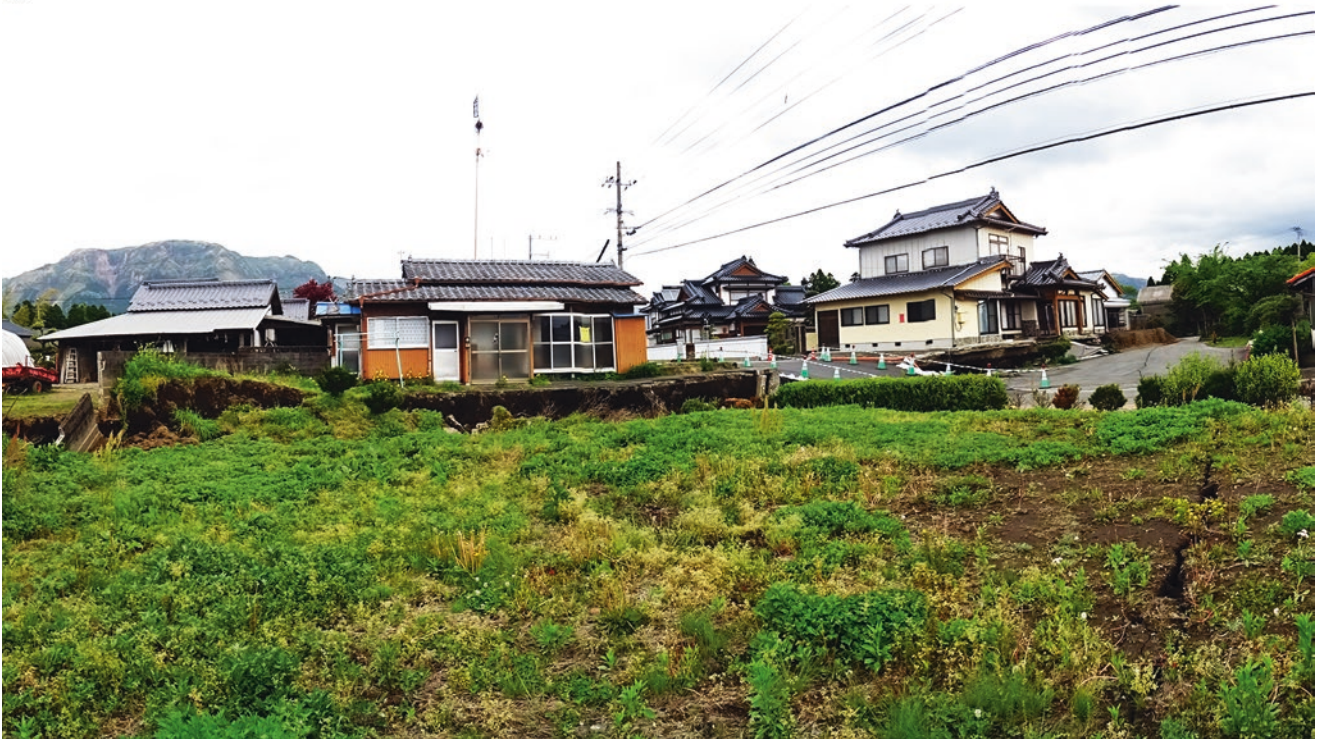
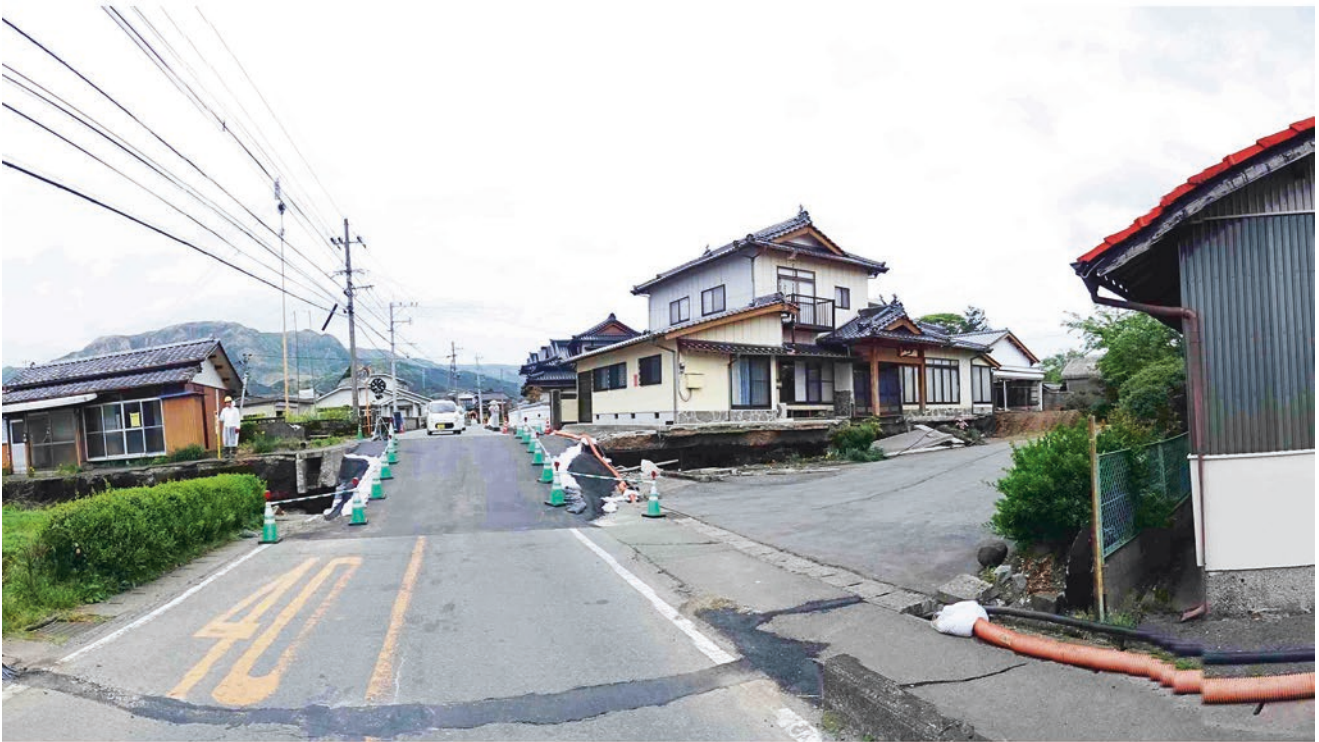
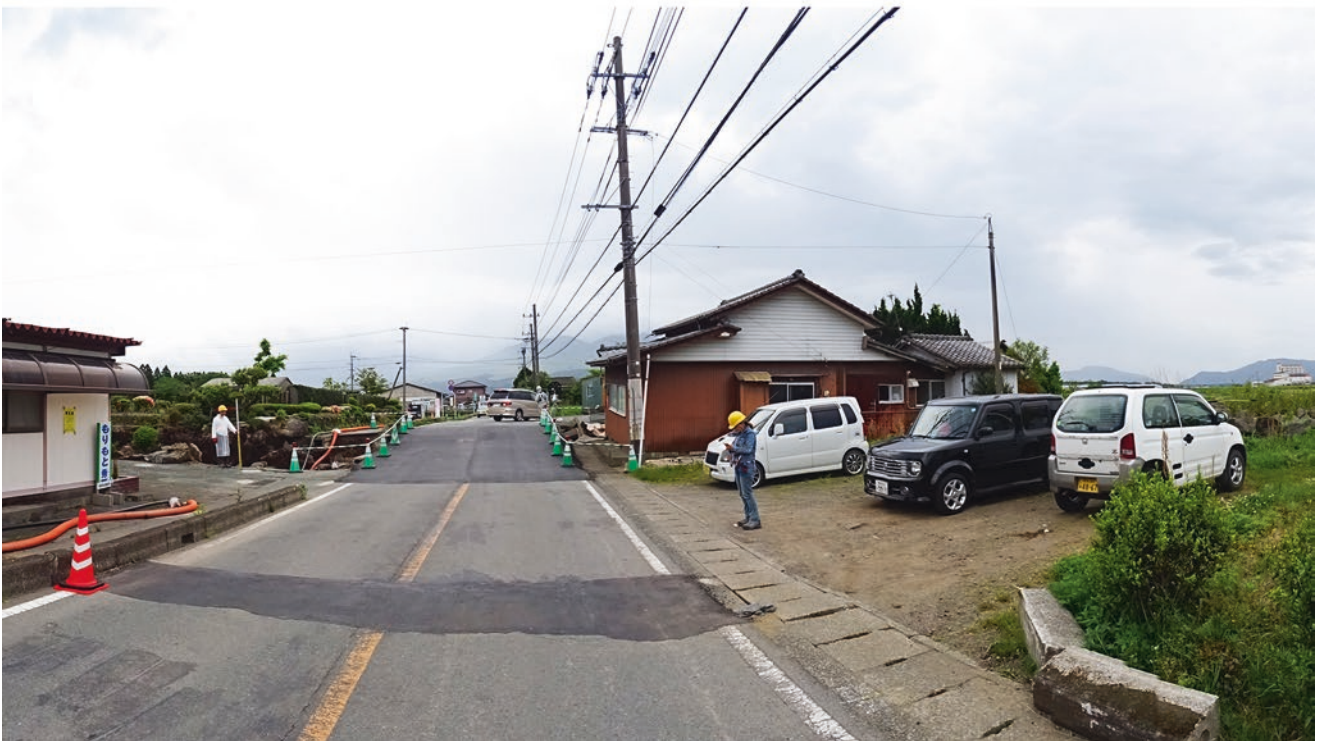
Fig. 41 Coseismic normal fault scarps. (**a**, **b**) A normal fault scarp developed along one side of a graben structure (vertical offset ~1.3 m). (**c**, **d**) Vertically offset road (offset ~1.3 m)

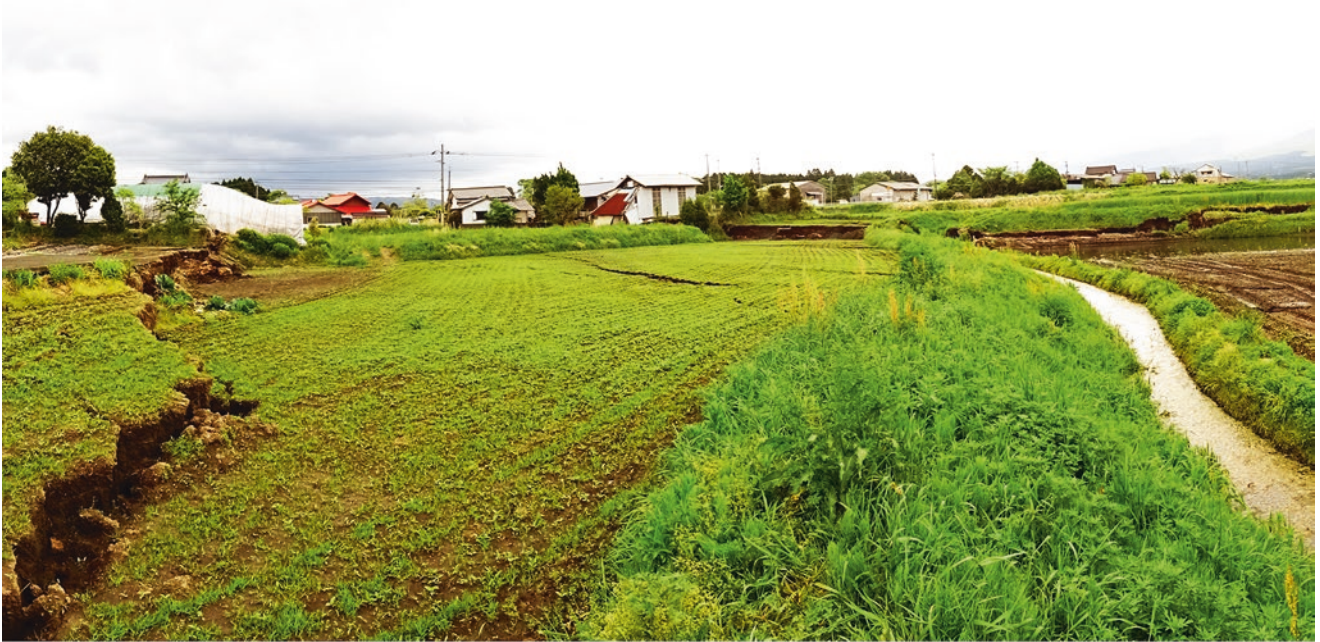
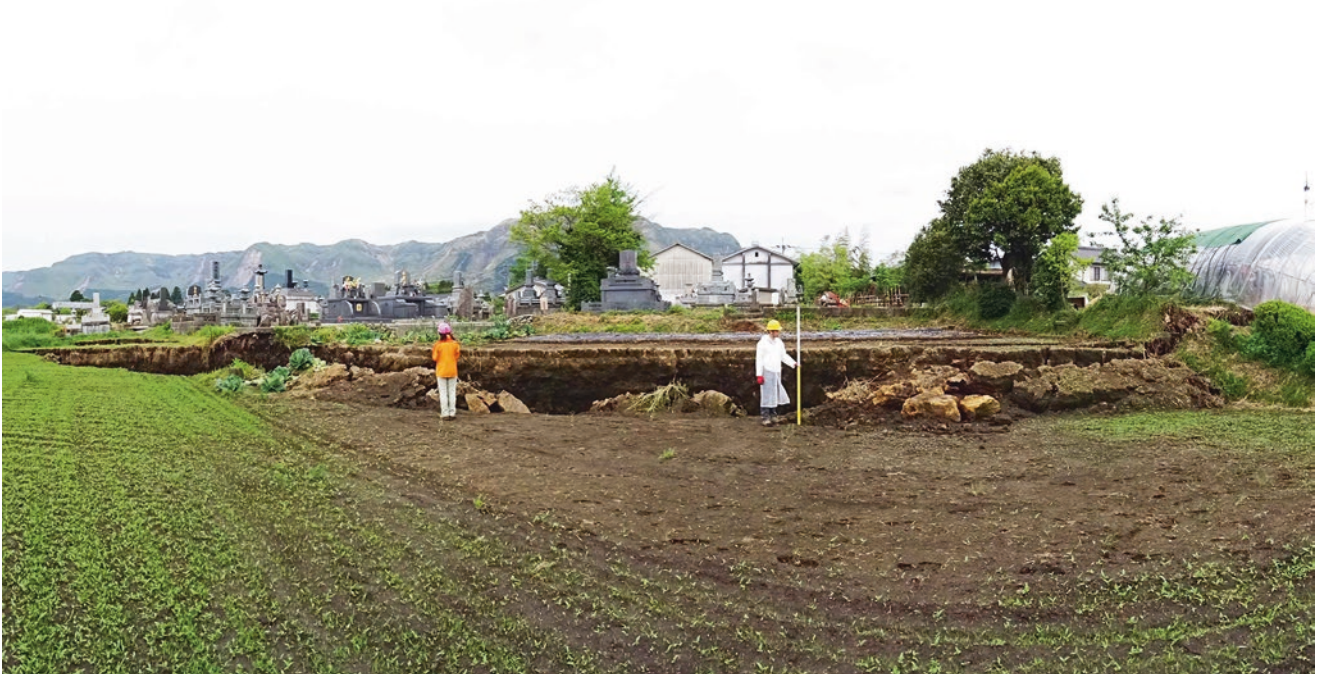
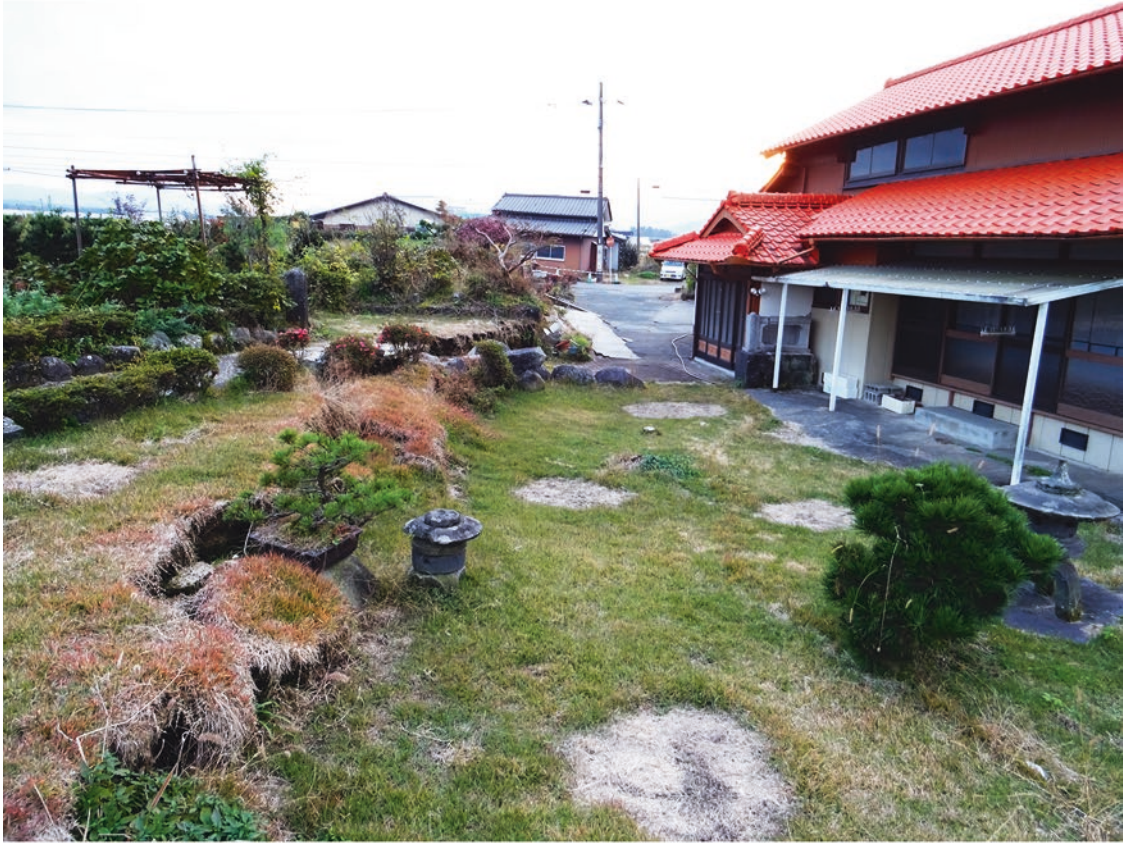
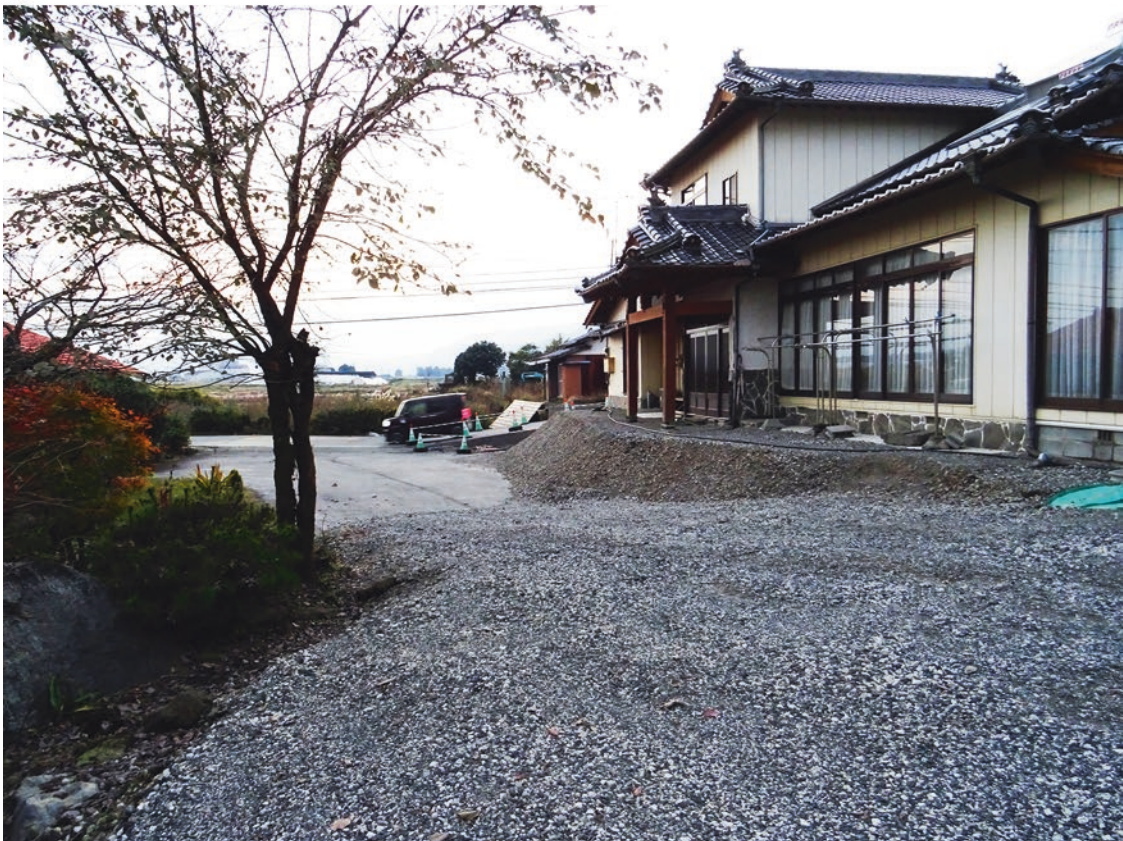
Fig. 42 Coseismic graben structure and normal fault scarps. **(a)** Drone images showing a graben structure formed in rice fields. **(b)** A normal fault scarp developed along one side of a graben structure. **(c, d)** A normal fault scarp developed in a house garden (vertical offset ~1.2 m)

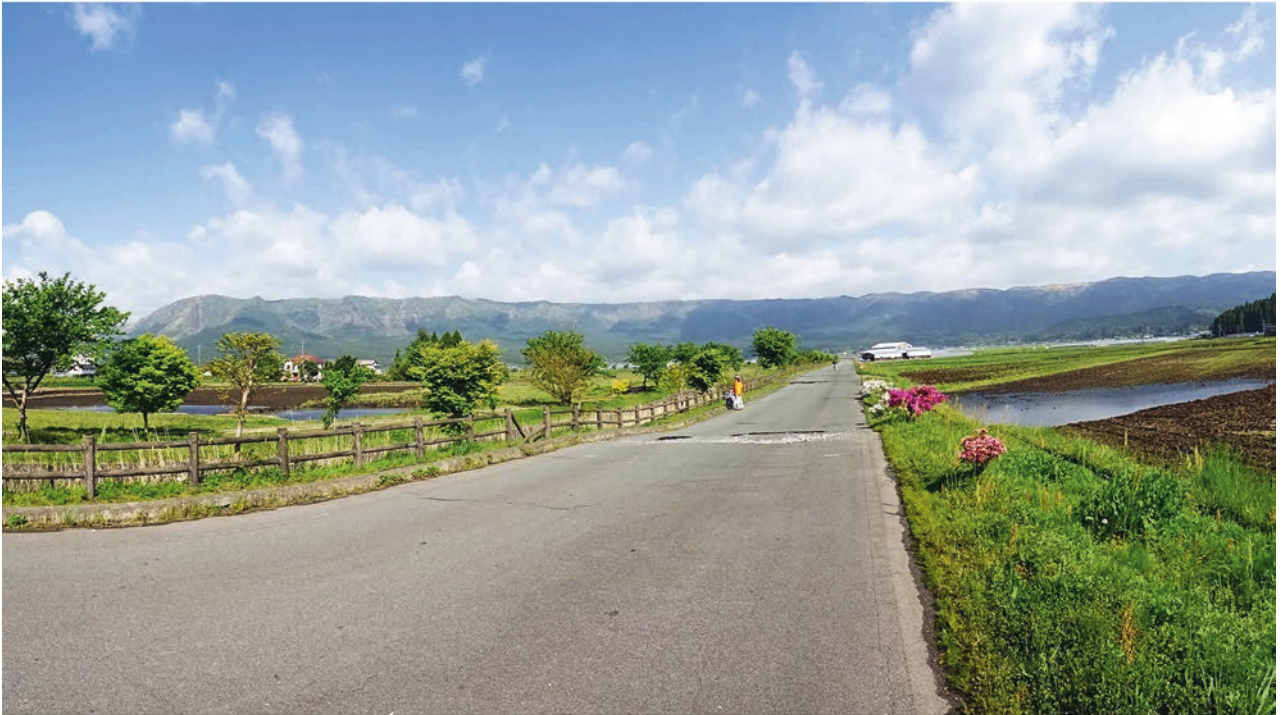
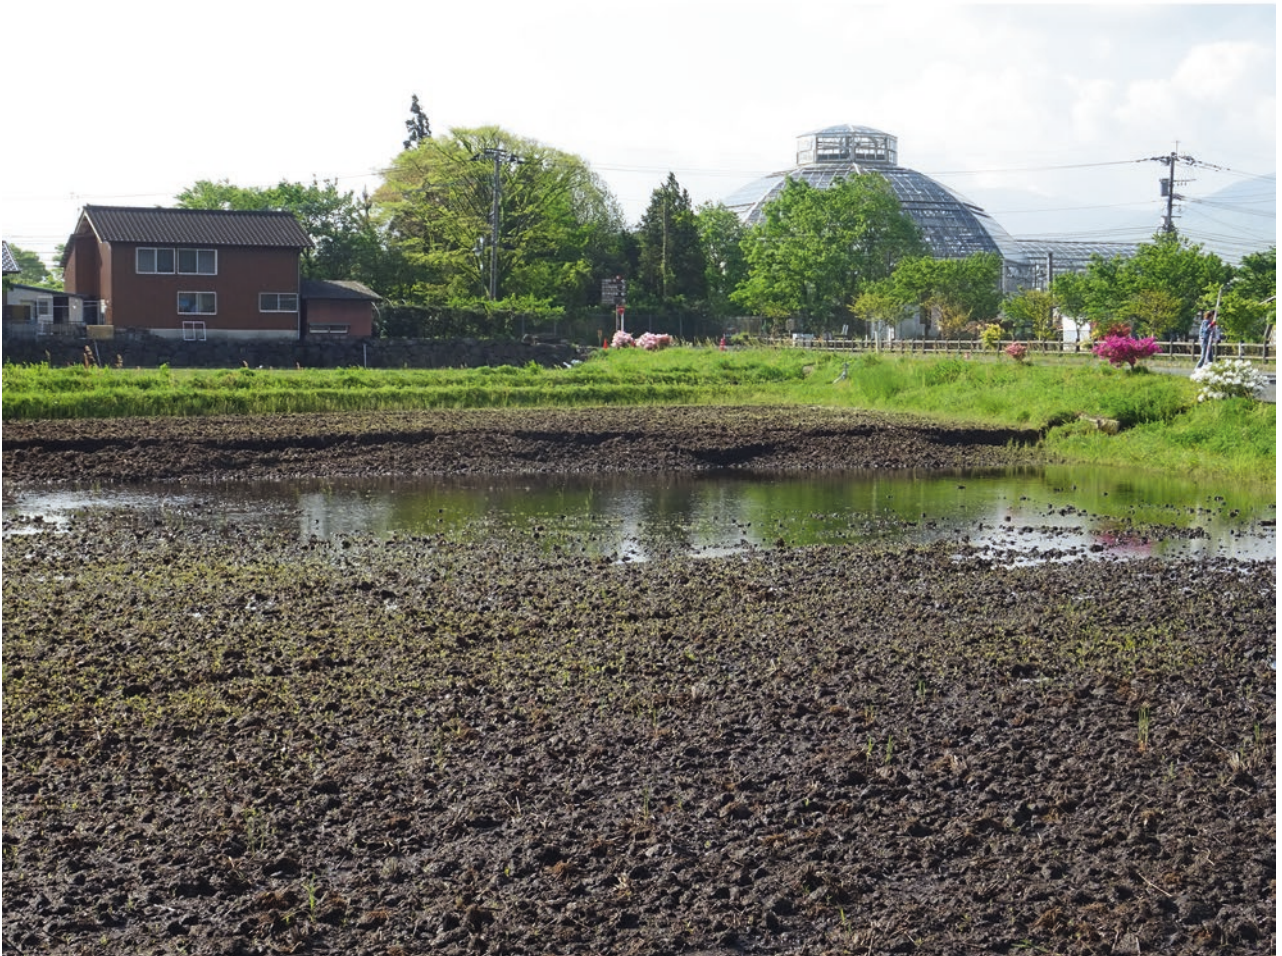
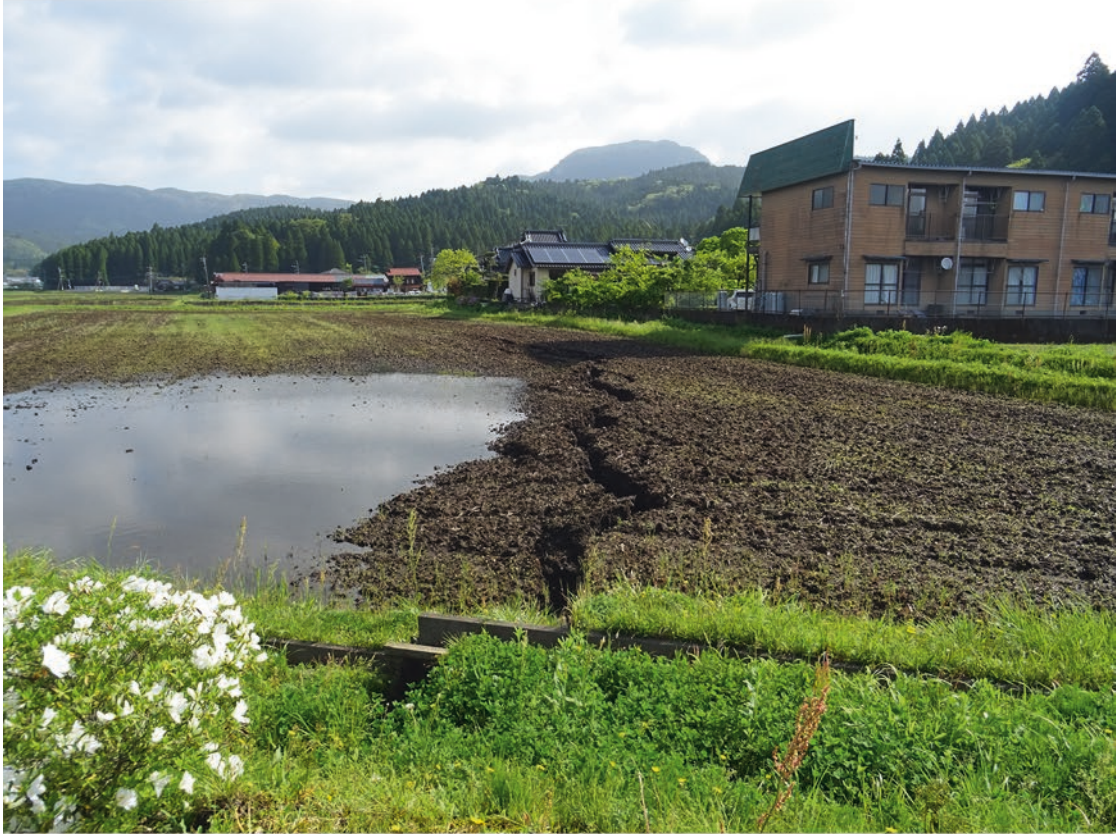
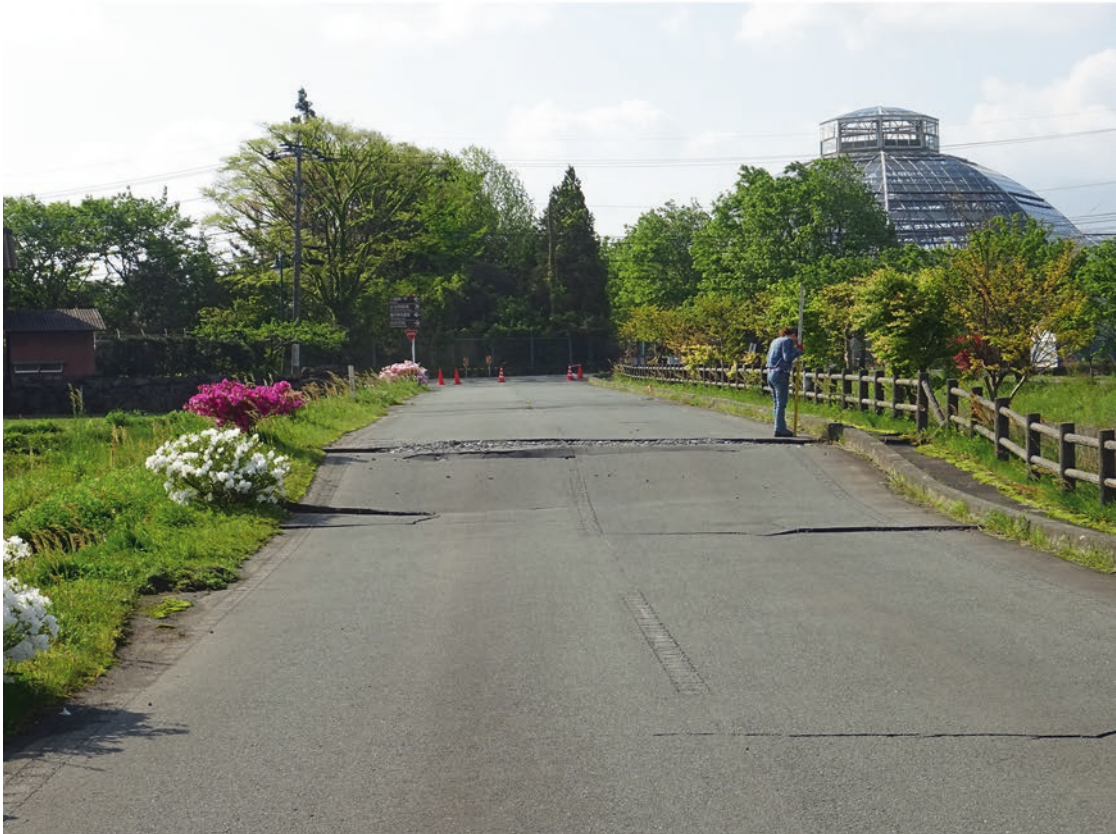
Fig. 43 Coseismic surface ruptures formed on roads and fields. (a) A coseismic graben structure formed in fields and roads. (b) A flexure structure formed in a rice field that was folded. (c) A temporary pond formed inside a coseismic graben structure. (d) Vertical offset of a road (offset ~0.4 m)
