The 2016 Mw 7.1 Kumamoto Earthquake

A Photographic Atlas of Coseismic Surface Ruptures
Related to the Aso Volcano, Japan

Aiming Lin
Department of Geophysics
Kyoto University
Kyoto, Japan

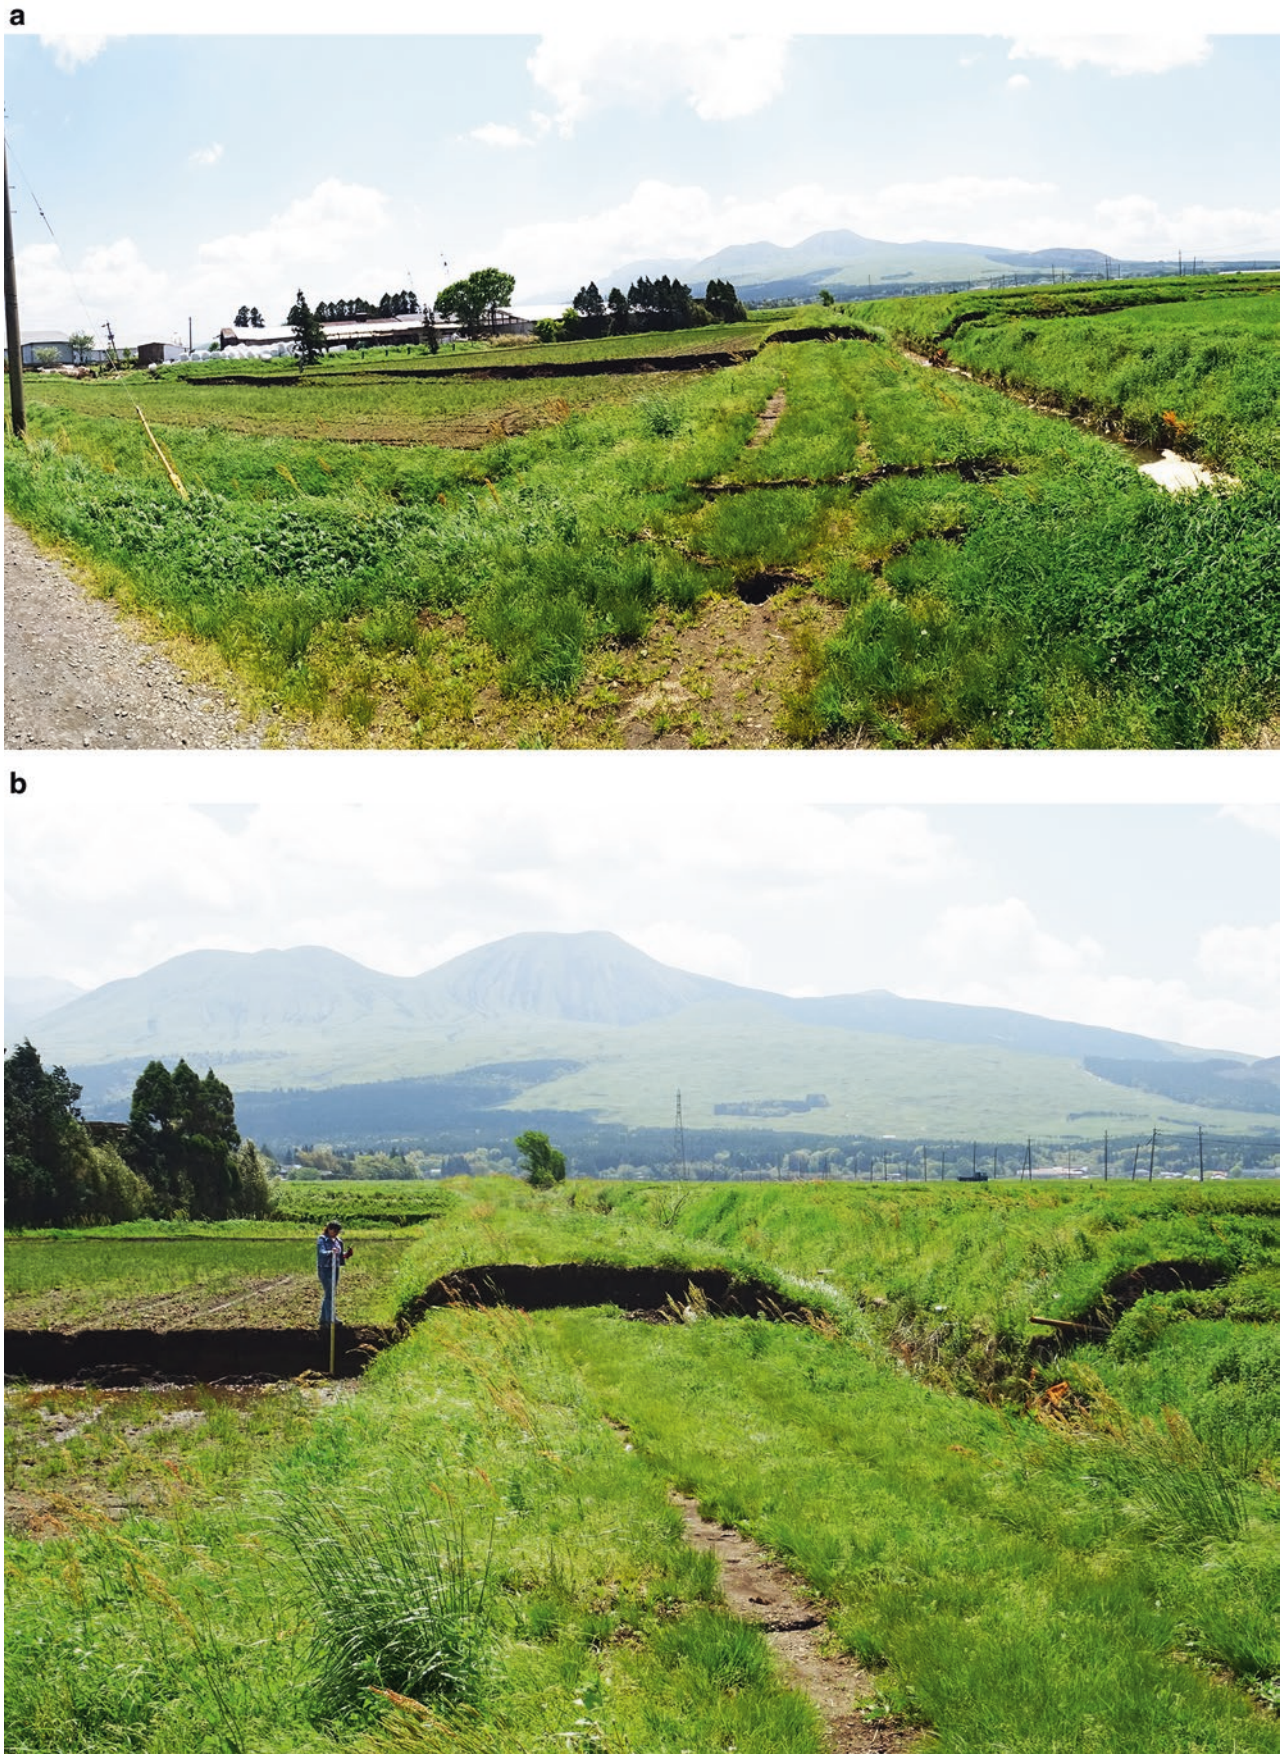
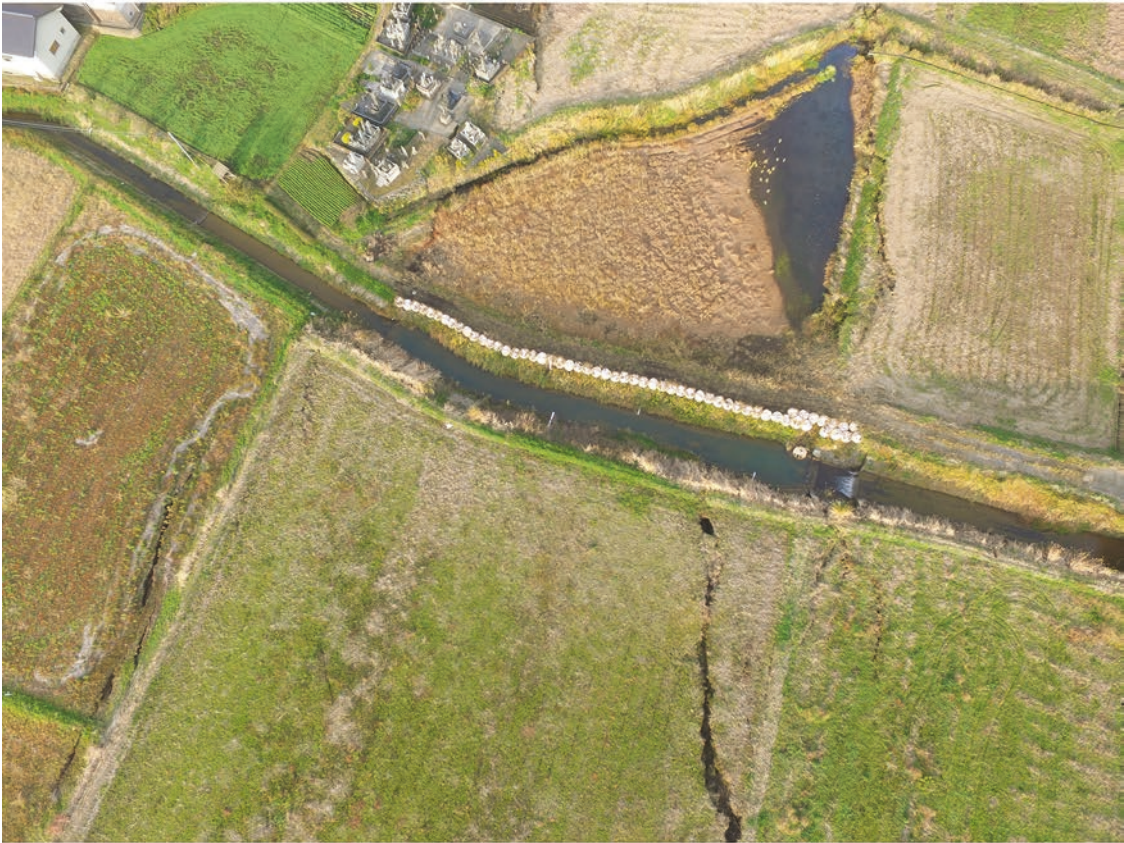
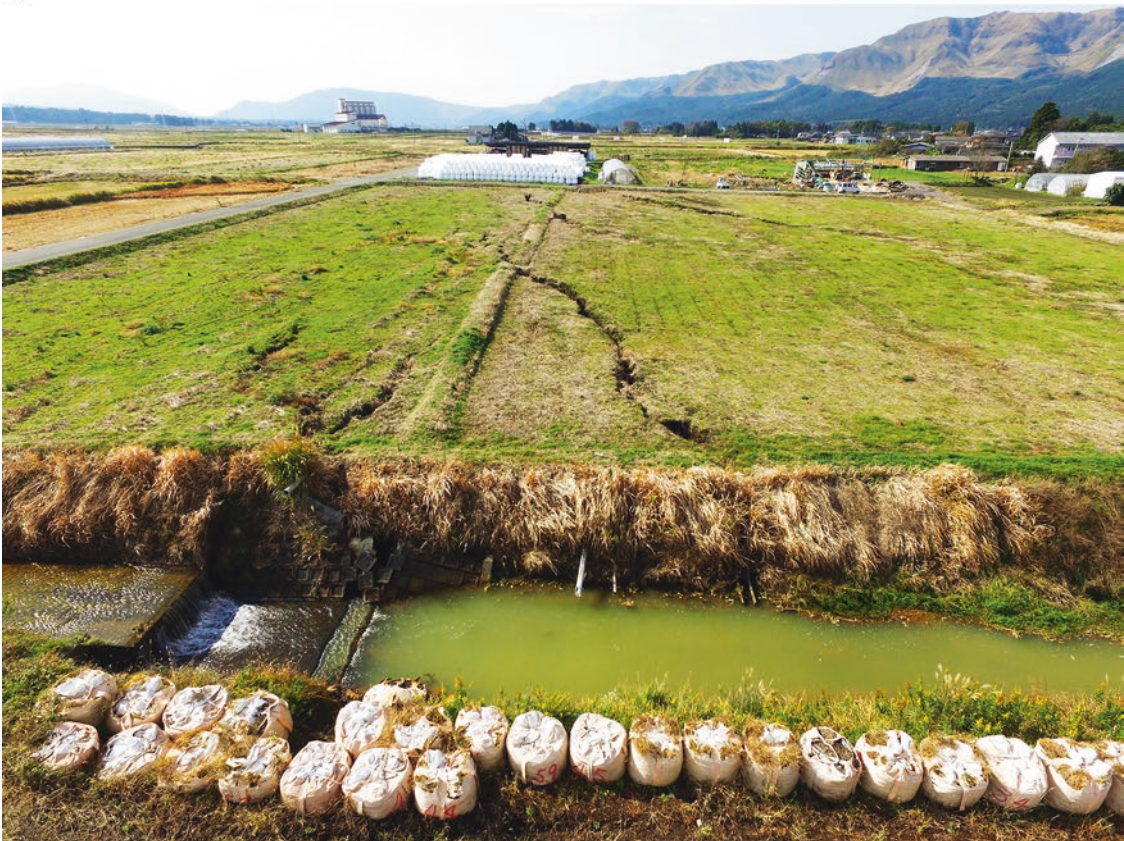
Fig. 44 Coseismic normal fault scarp along a graben structure. (a) A coseismic normal fault scarp cut a road and fields. (b) Close-up view of (a). (c) Drone image showing a coseismic graben structure formed in vegetable fields where a temporary pond formed. (d) Close-up of (c)

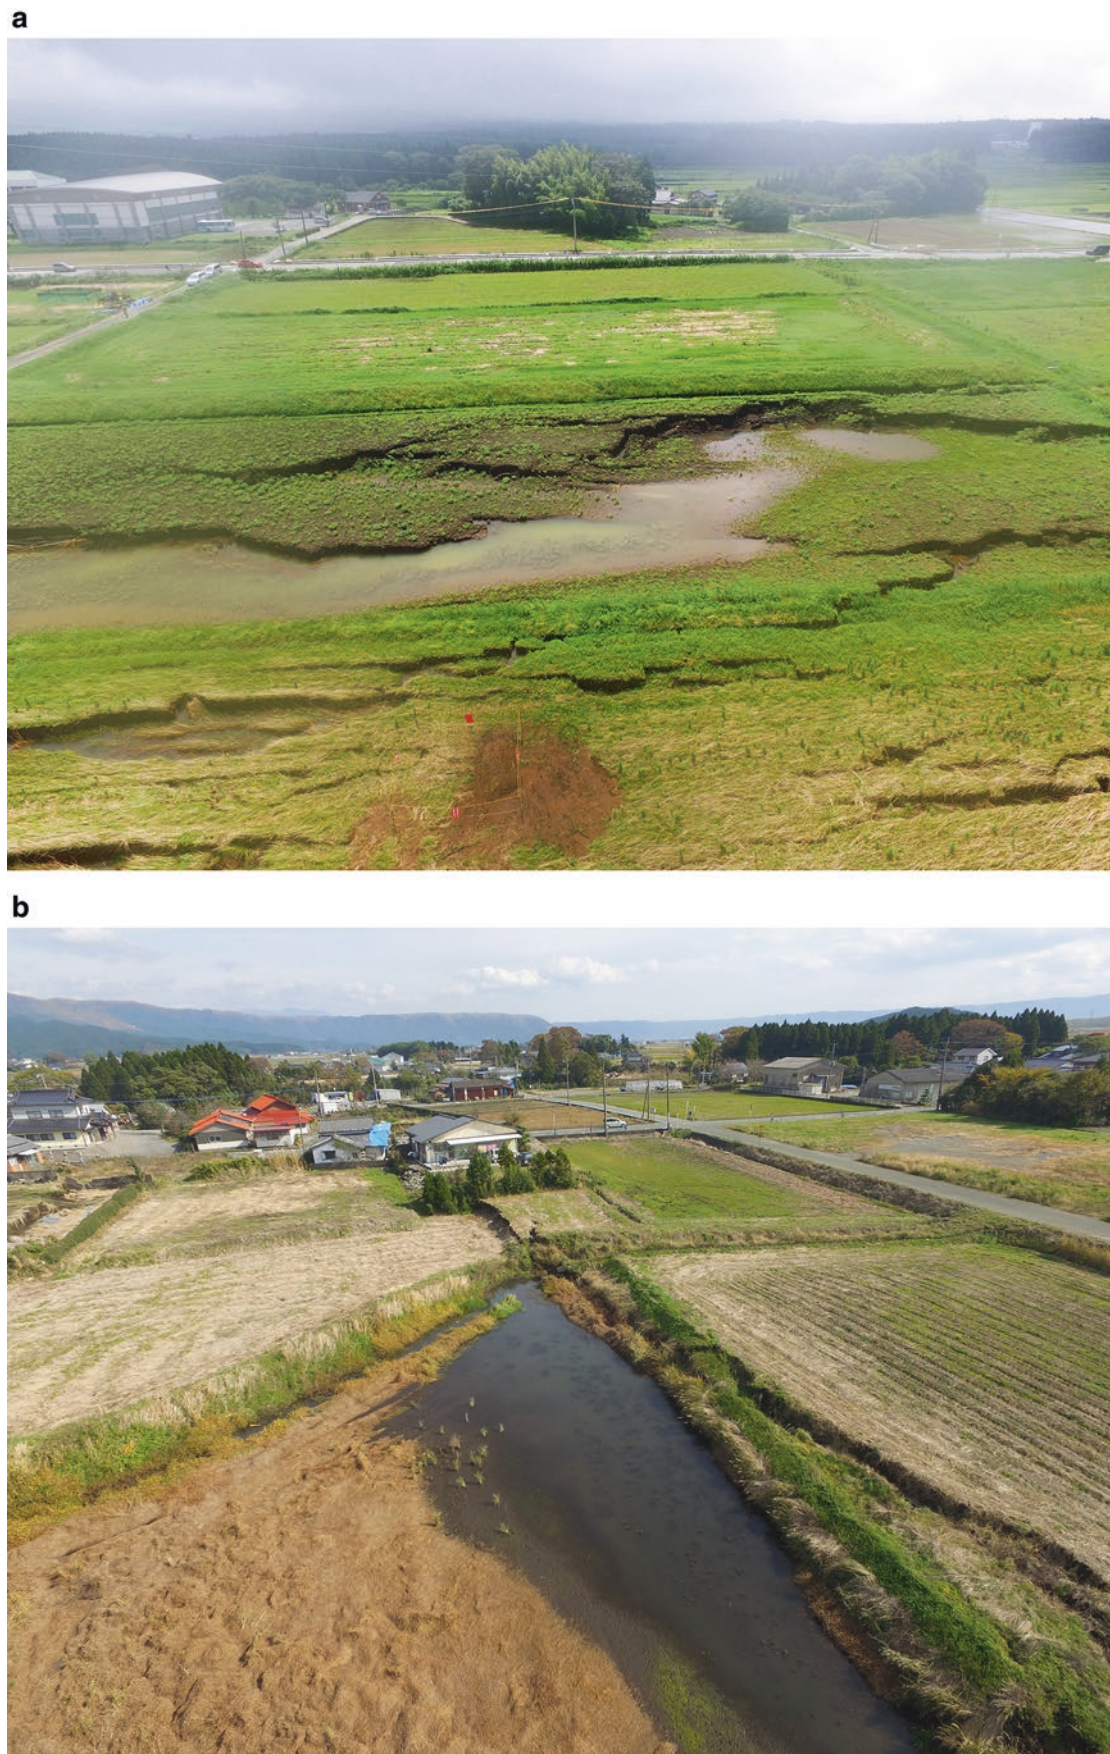
Fig. 45 Drone image showing en echelon coseismic surface ruptures developed in fields. (b) Close-up view of (a)

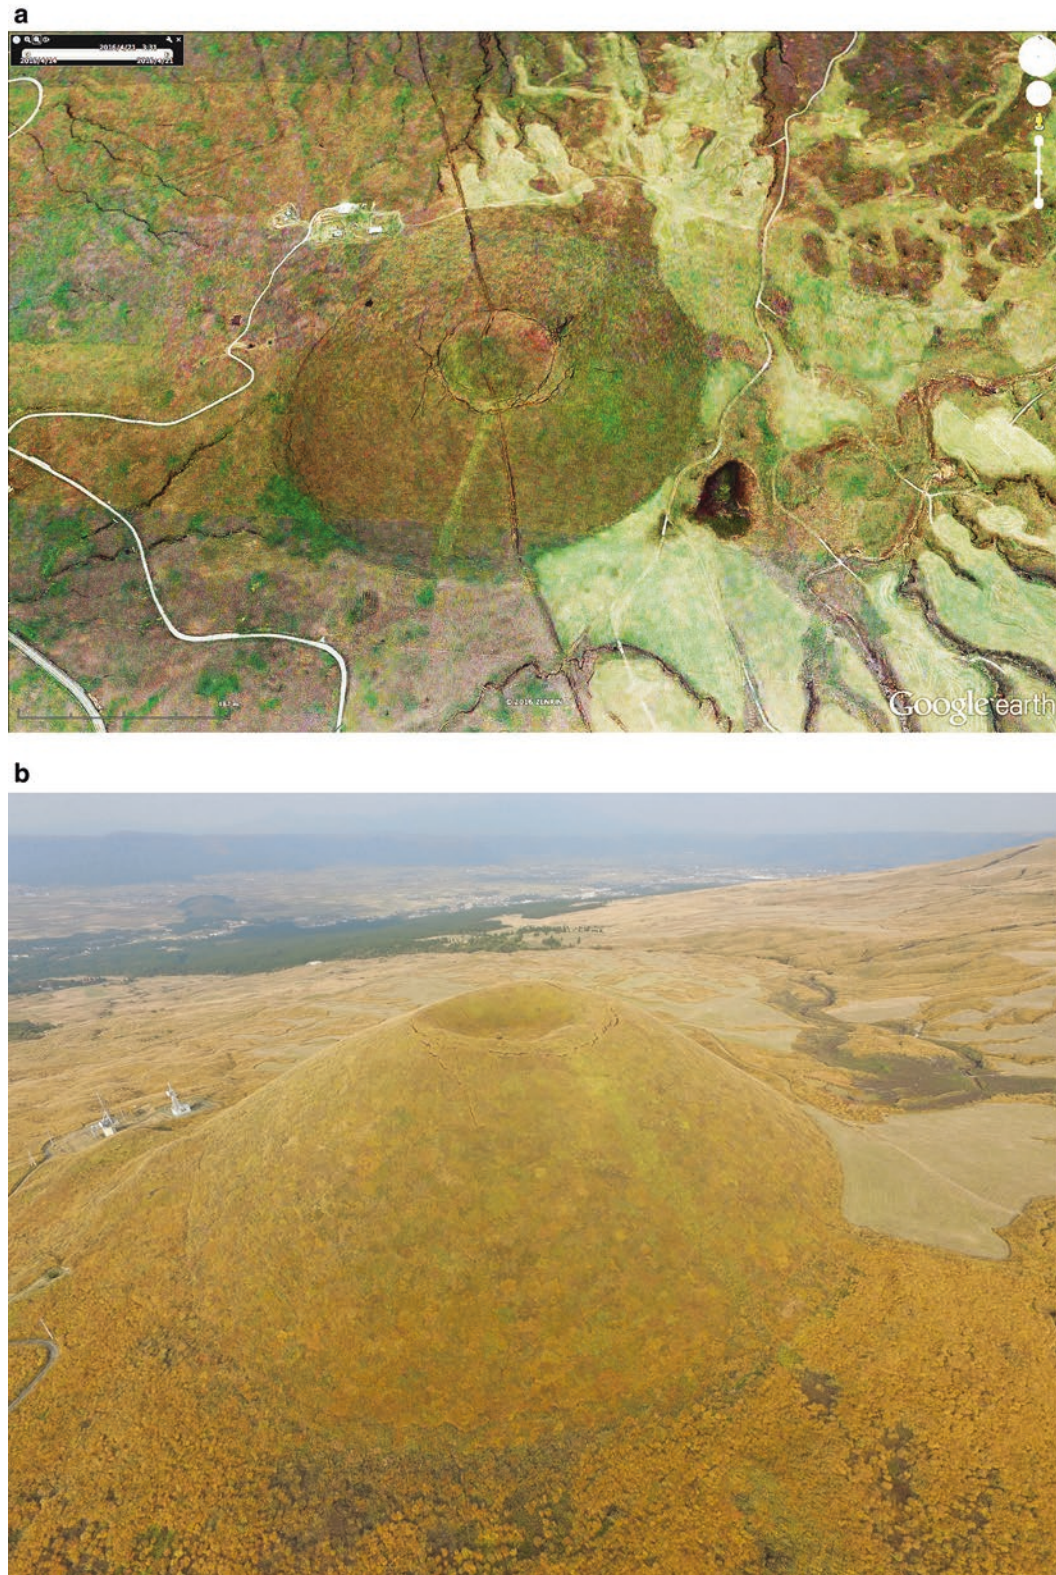
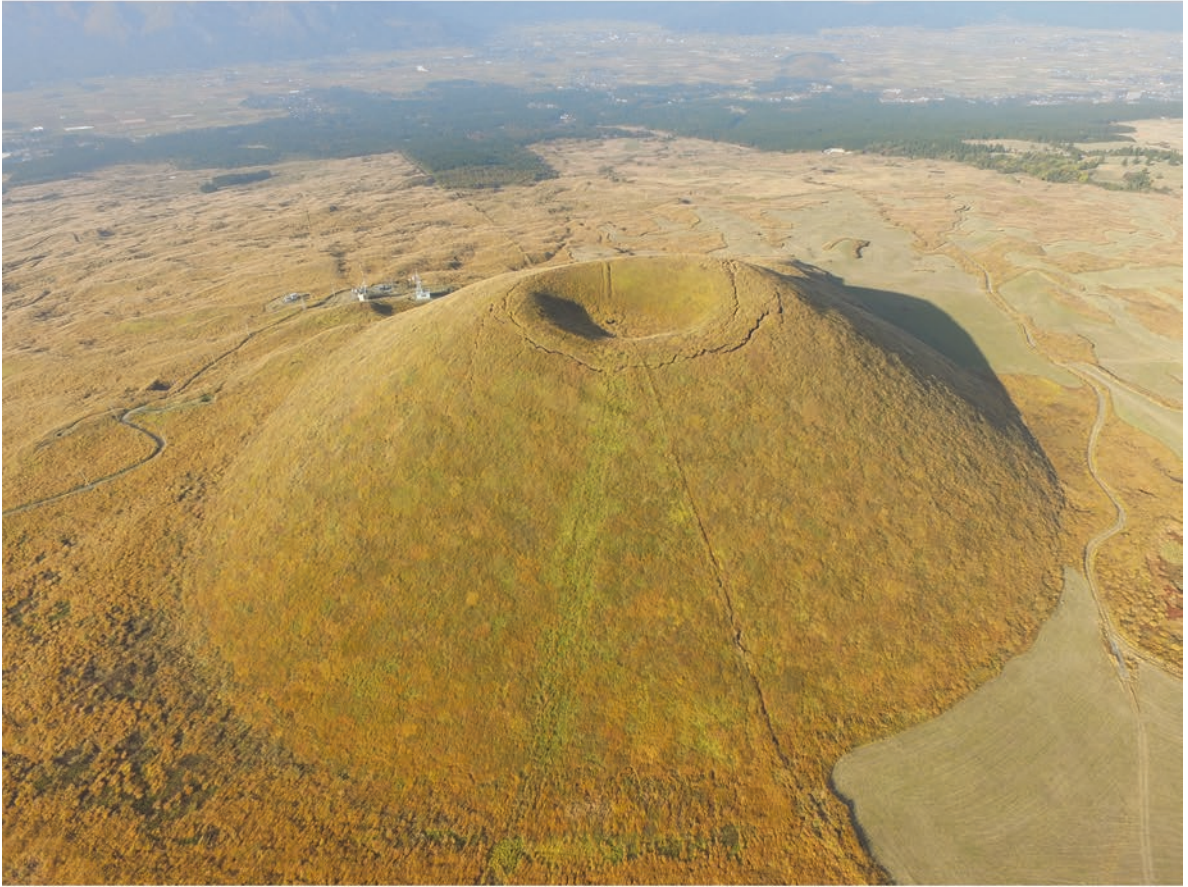
Fig. 46 Coseismic surface ruptures crosscut the Komezuka cone. (a) Google Earth image acquired on 16 April 2016 showing coseismic surface ruptures occurred in the area around the Komezuka volcano. (b) Drone image showing an overview of coseismic surface ruptures

occurred on the *top* and *foot* of the Komezuka cone (acquired on 16 Nov. 2016). (c) Close-up view of (b). (d) Aerial photograph acquired on 18 April 2016 (copyright permission from Mainichi Newspapers)

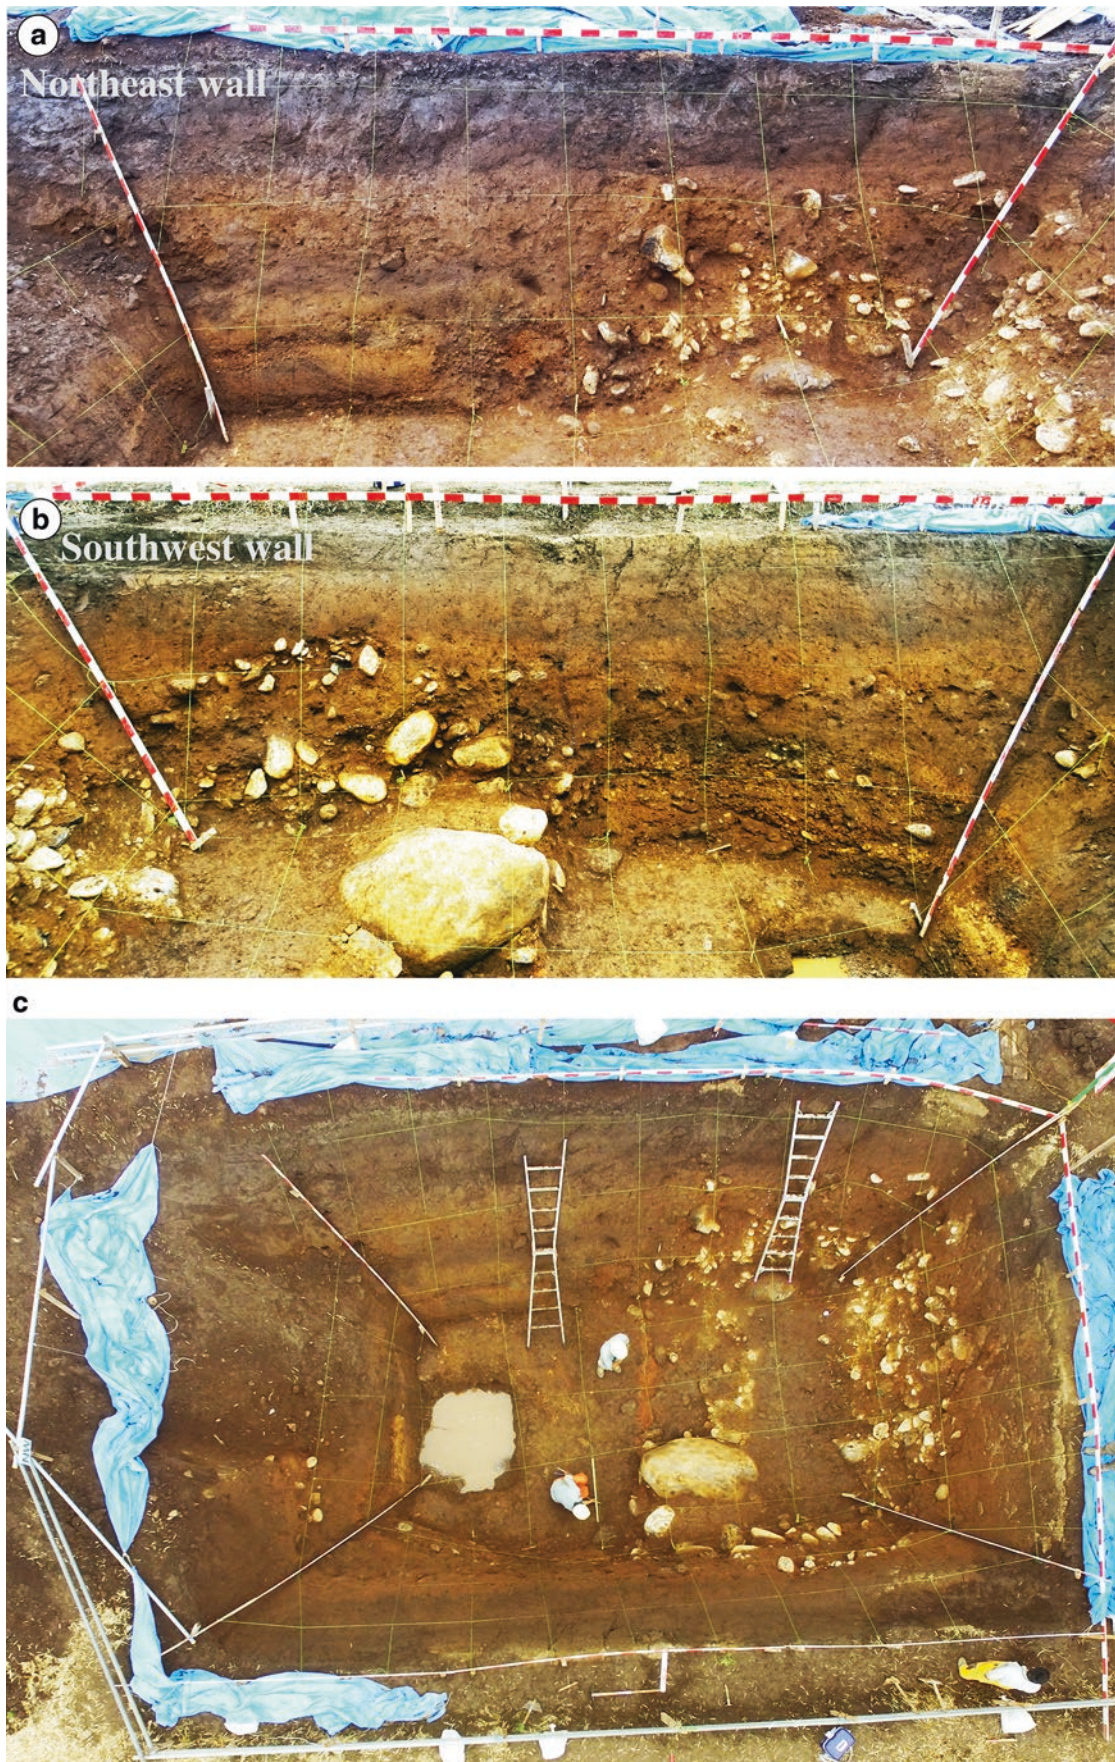
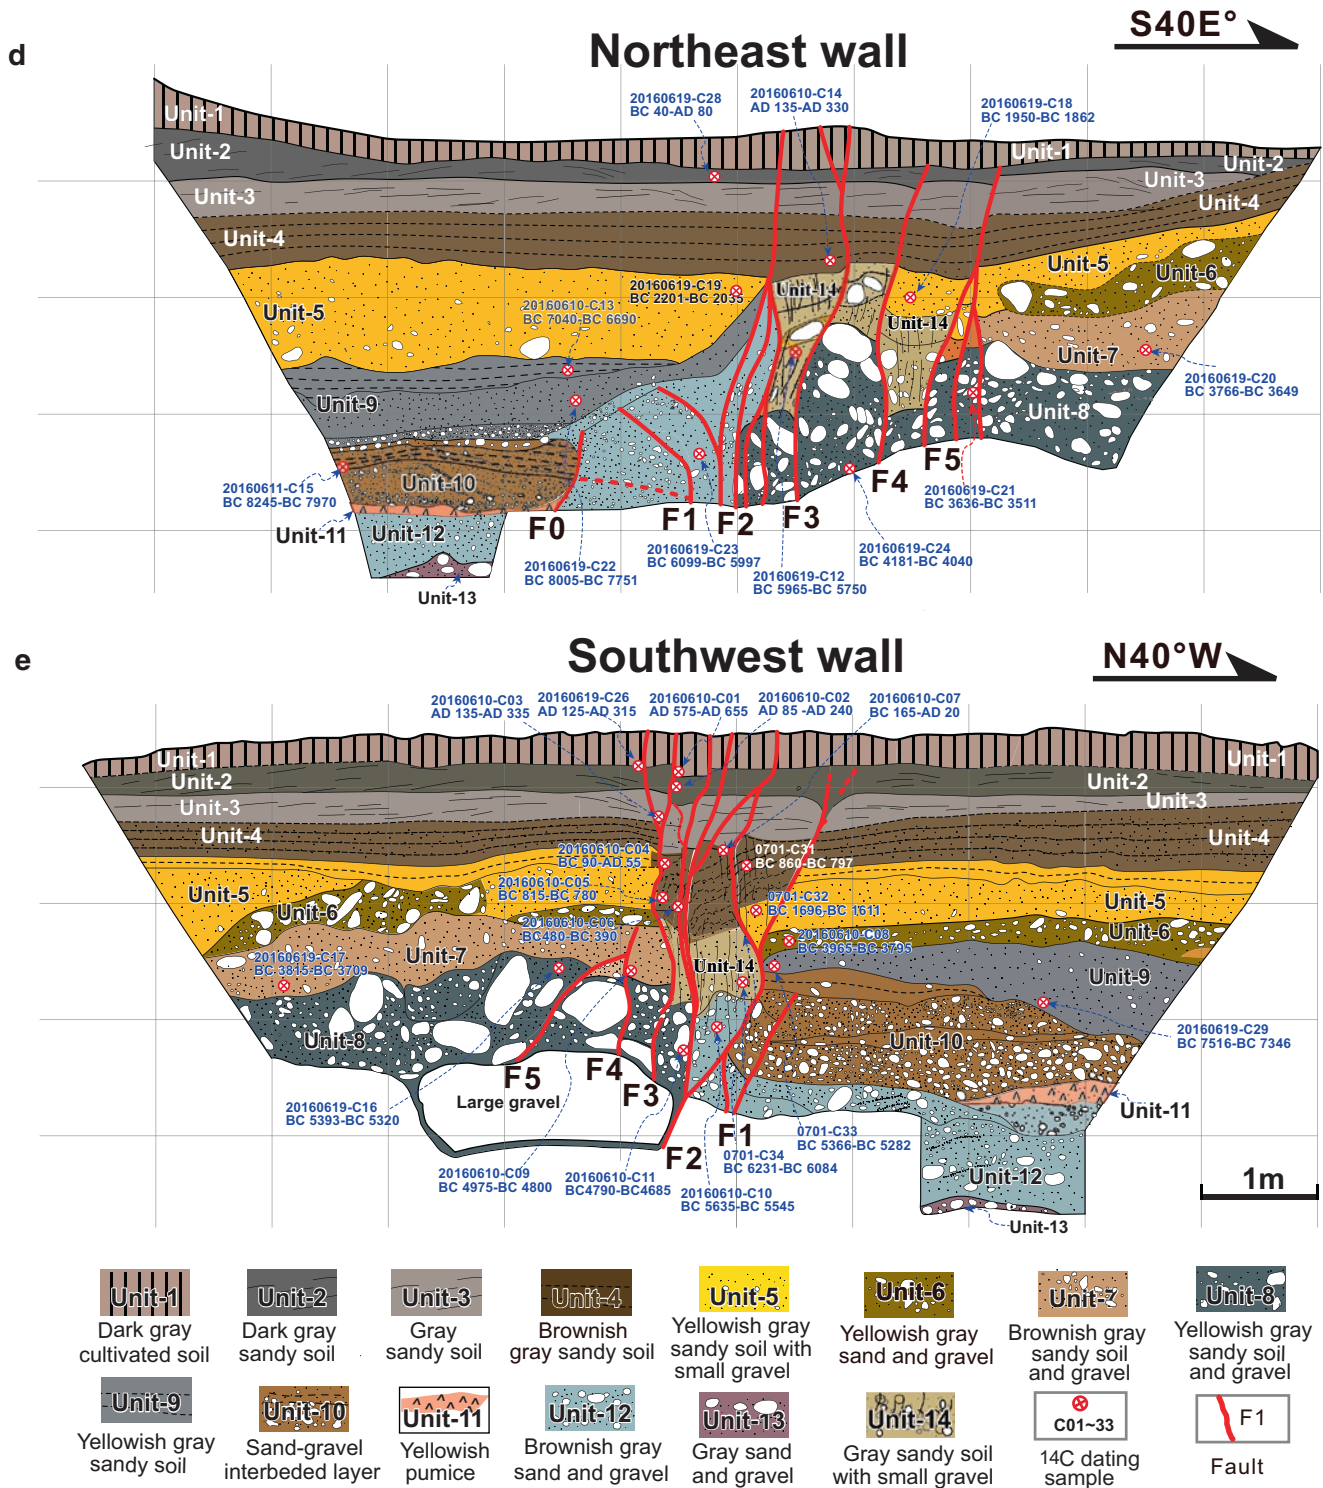
Fig. 65 Exposure walls of the Kamijin trench. (a) Northeast wall. (b) Southwest wall. (c) Base wall. (d, e). Sketches of exposure walls shown in (a) and (b)

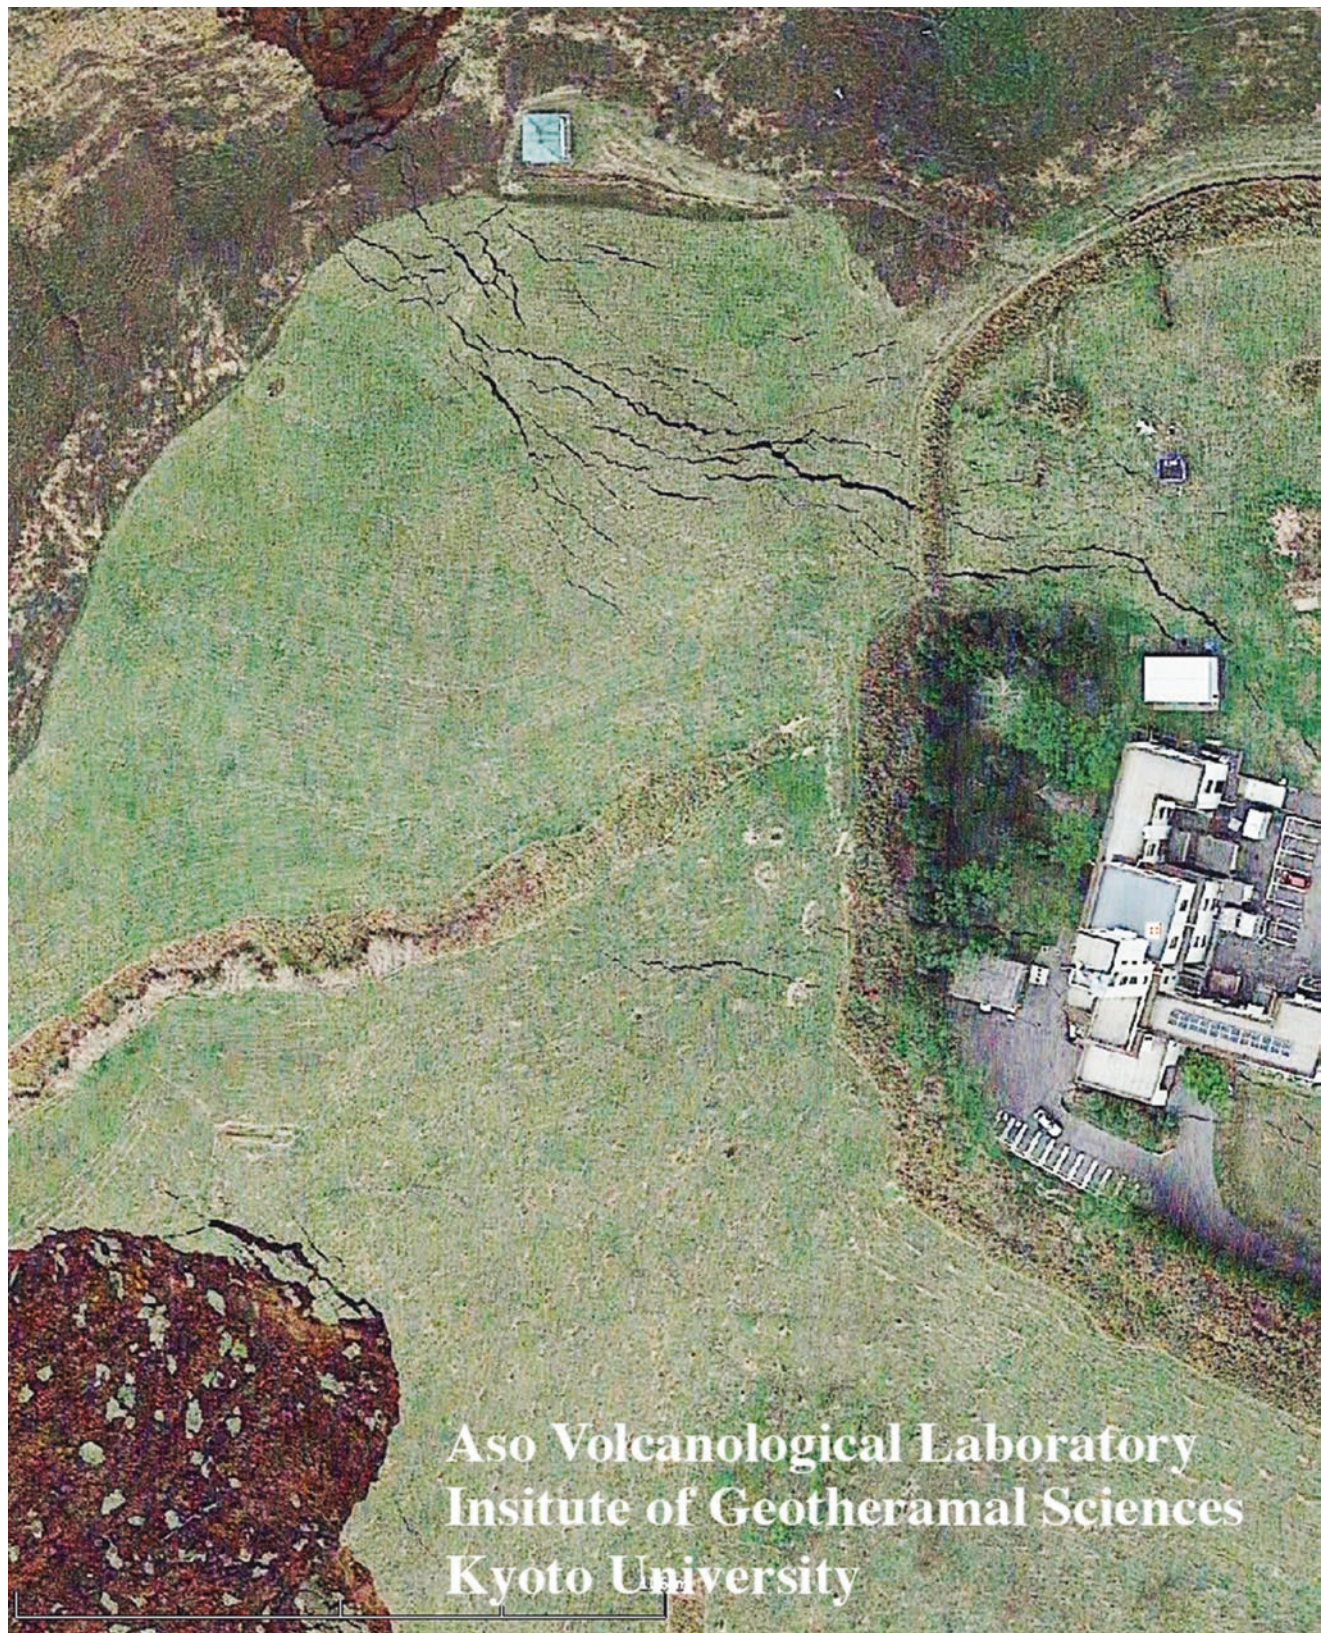
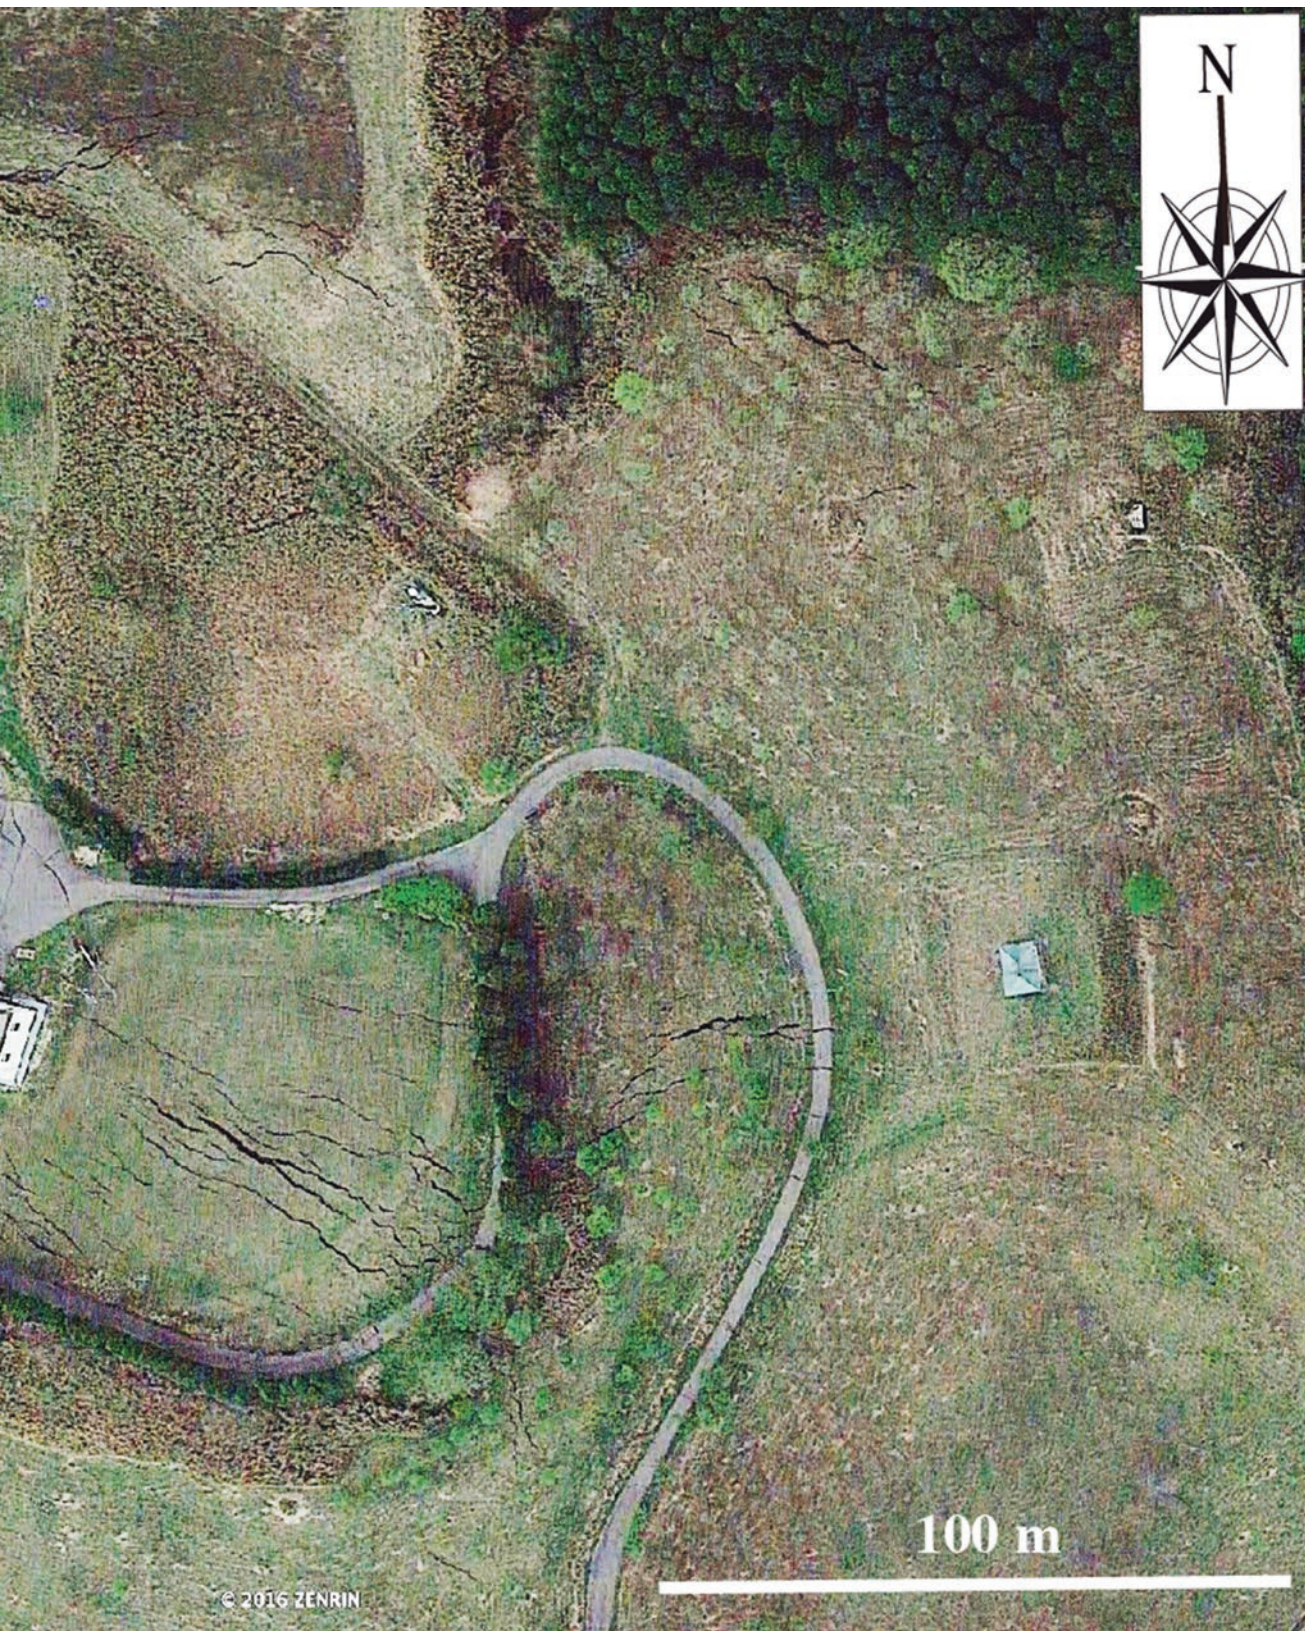
Fig. 66 Coseismic tension cracks developed throughout the house yard of the Volcanological Laboratory, Institute of Geothermal Sciences, Kyoto University (modified from Google Earth image acquired on 16 April 2016)

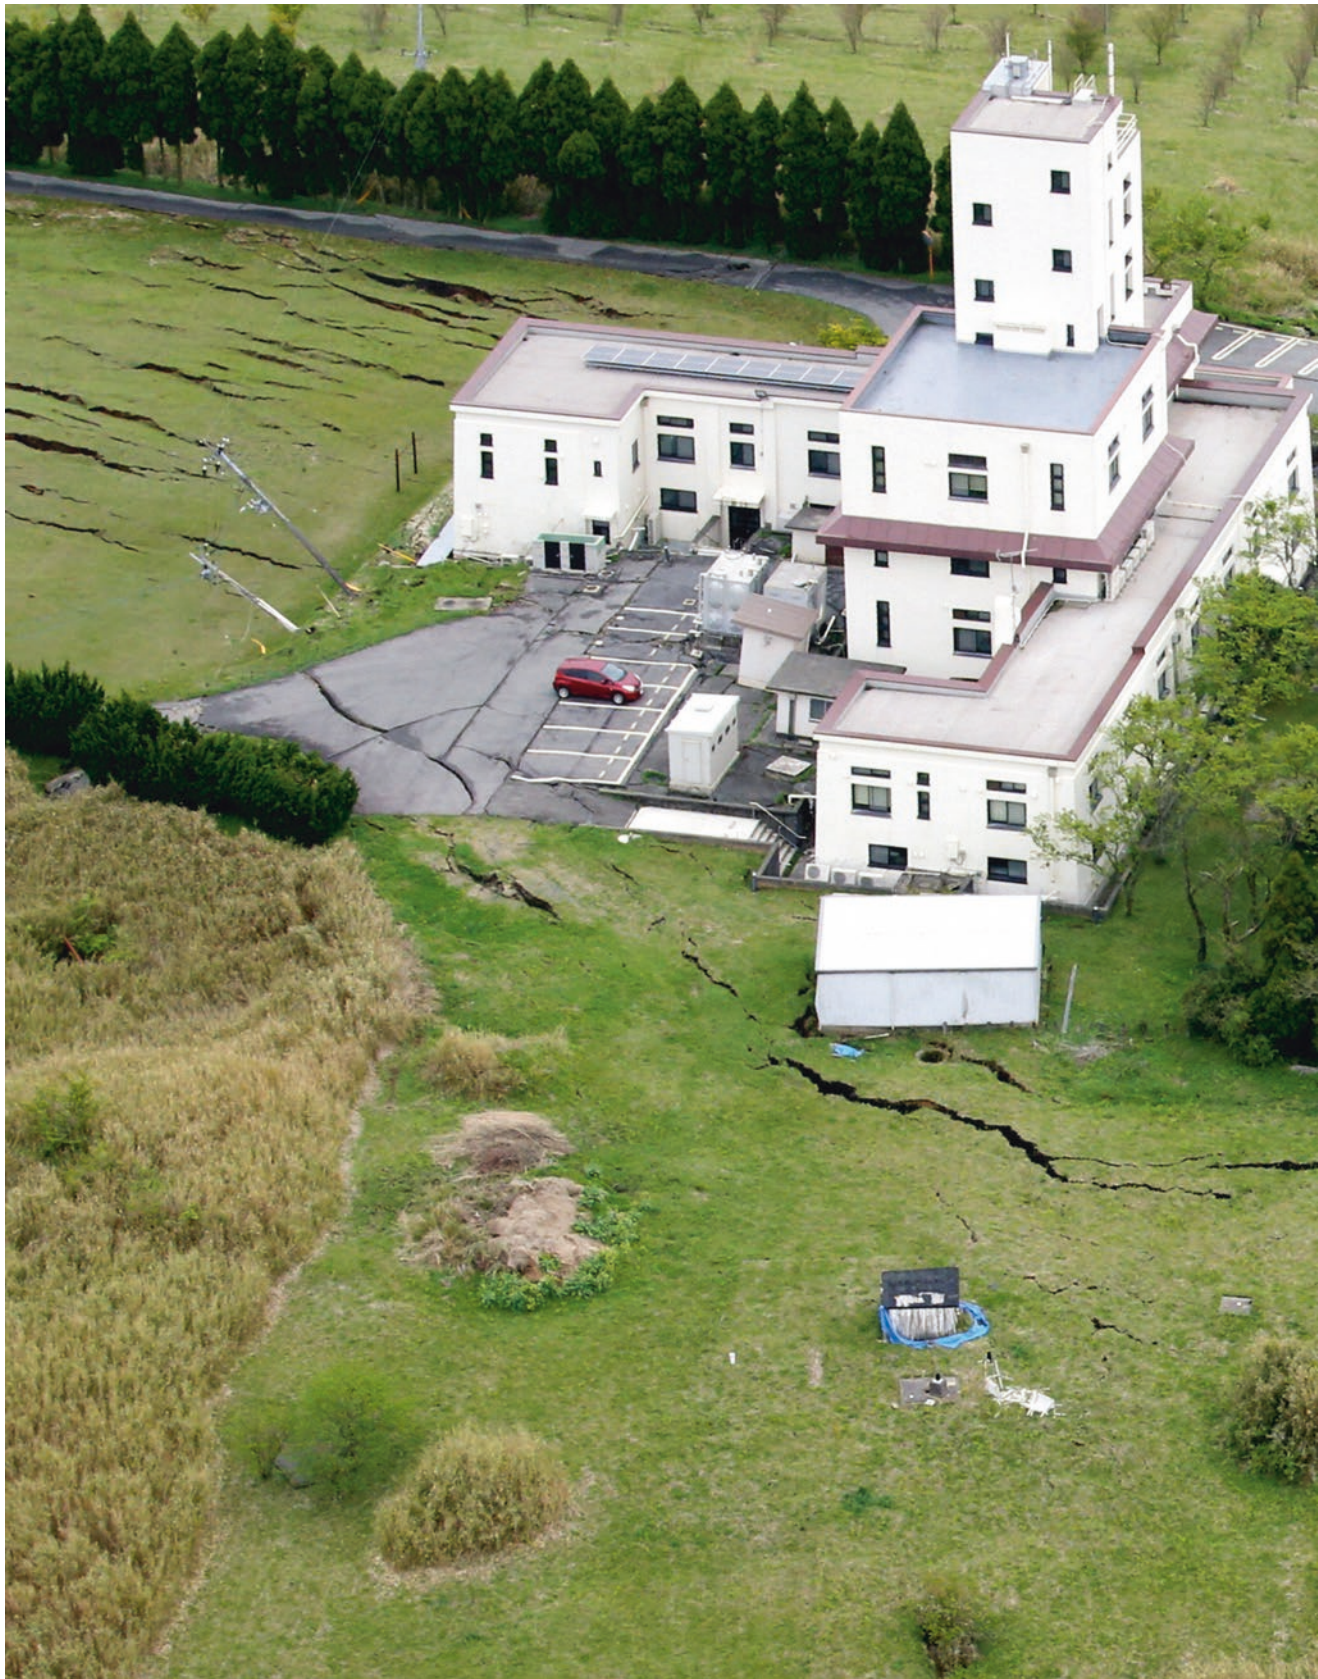
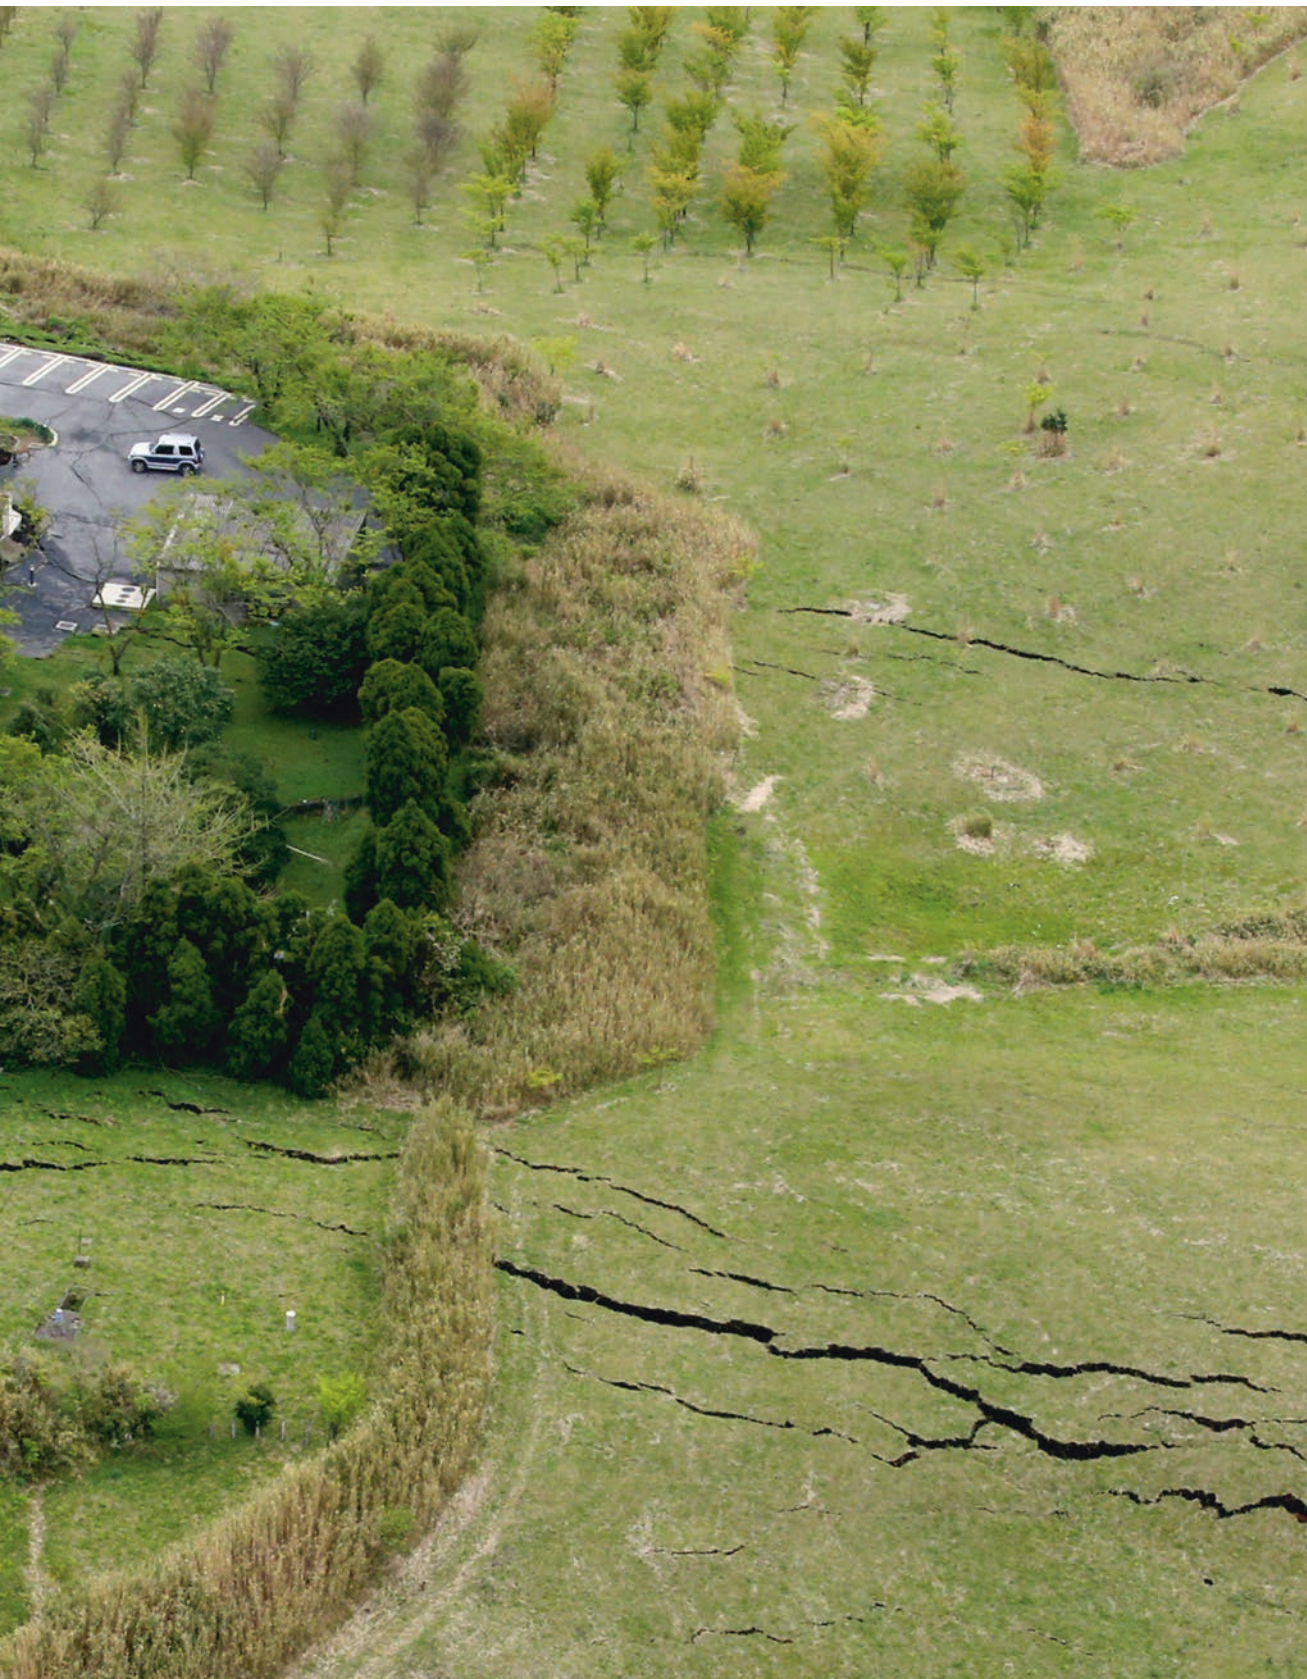
Fig. 67 Aerial photograph showing a close-up view of coseismic tension cracks shown in Fig. 66. Parallel-subparallel coseismic tension cracks developed in the house yard of the Volcanological Laboratory,

Institute of Geothermal Sciences, Kyoto University (copyright permission by Asahi Shimbun)
