The 2016 Mw 7.1 Kumamoto Earthquake

A Photographic Atlas of Coseismic Surface Ruptures
Related to the Aso Volcano, Japan

Aiming Lin
Department of Geophysics
Kyoto University
Kyoto, Japan

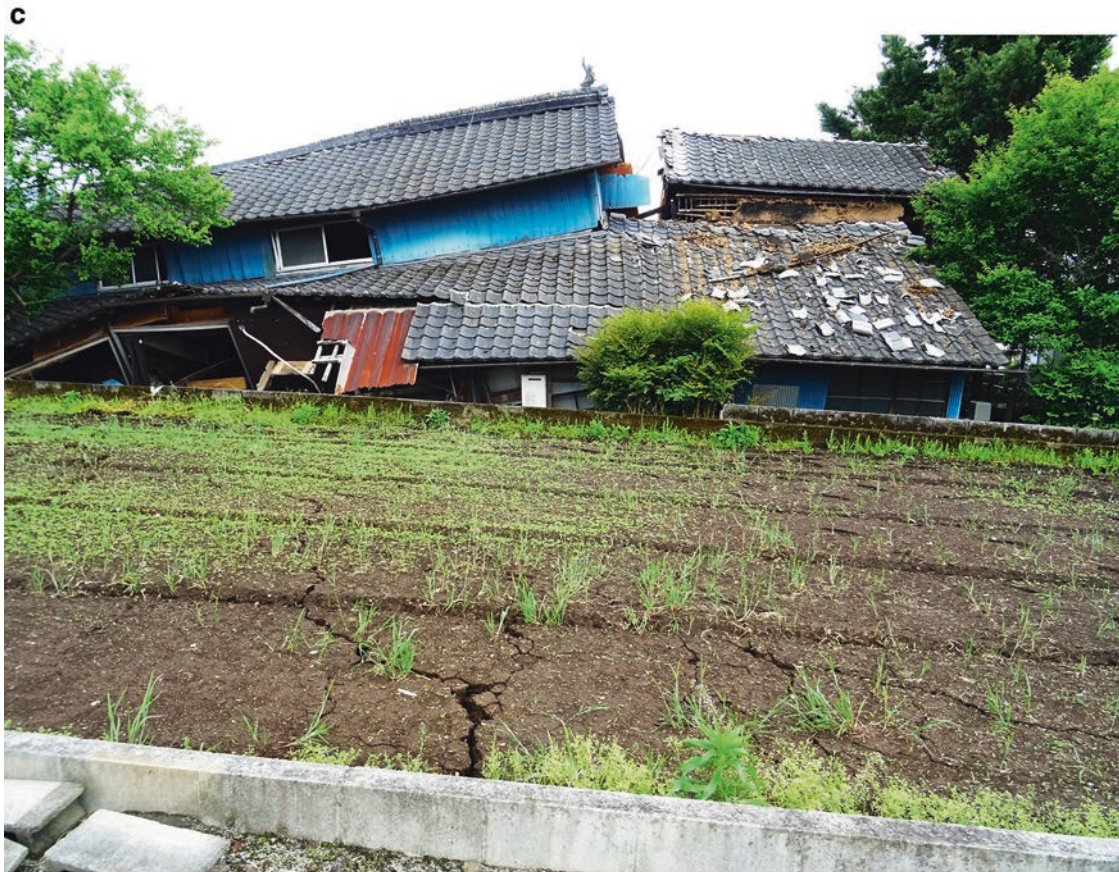
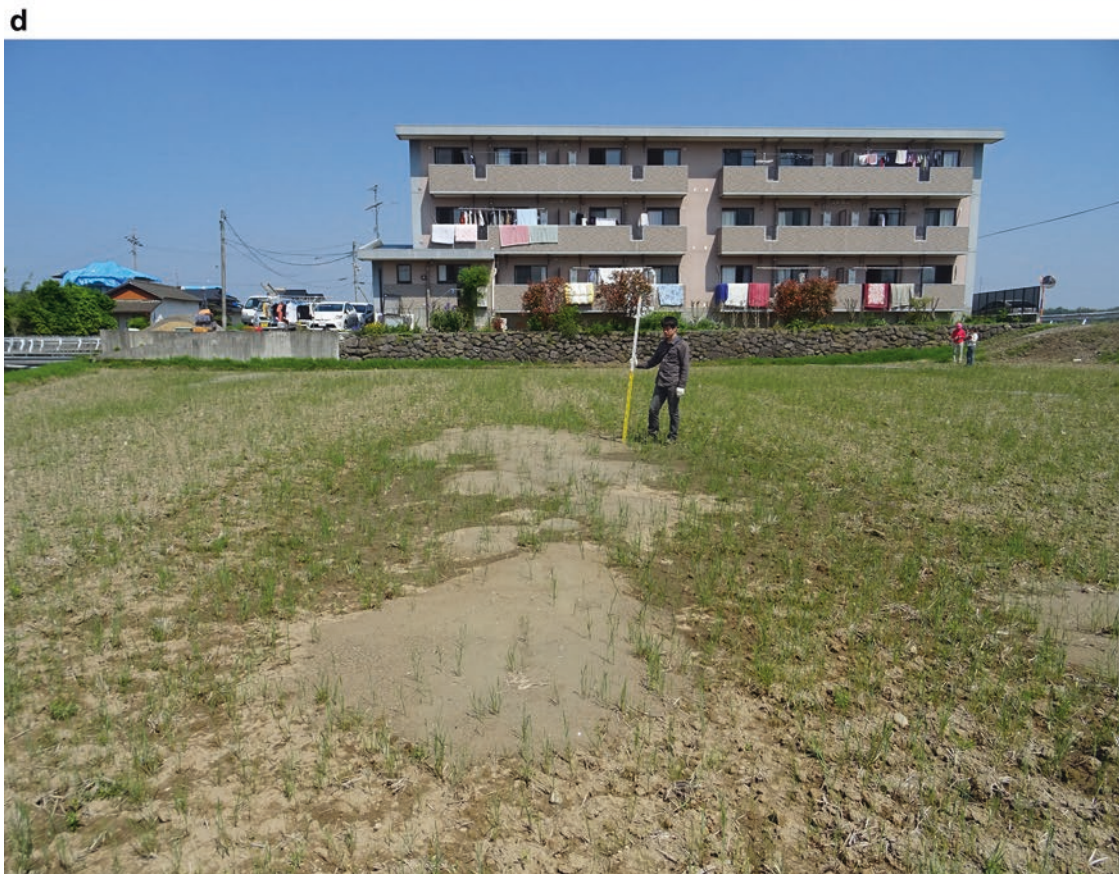
Fig. 68 Houses and buildings damaged along coseismic cracks. (a, b) Eastward view of the damaged buildings of the Volcanological Laboratory, Institute of Geothermal Sciences, Kyoto University, where numerous of

cracks and a large-scale landslide occurred on the slope. (c) Collapsed house on the preexisting fault scarp. (d) Earthquake-induced sand boil occurred along the coseismic crack extended to the base of a building

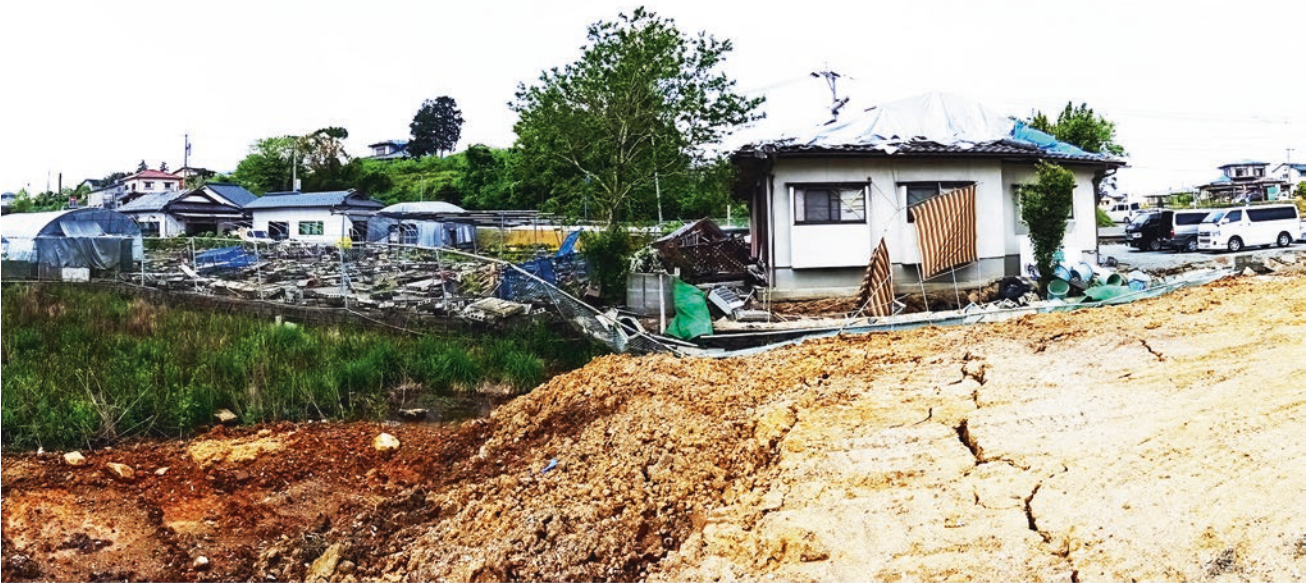
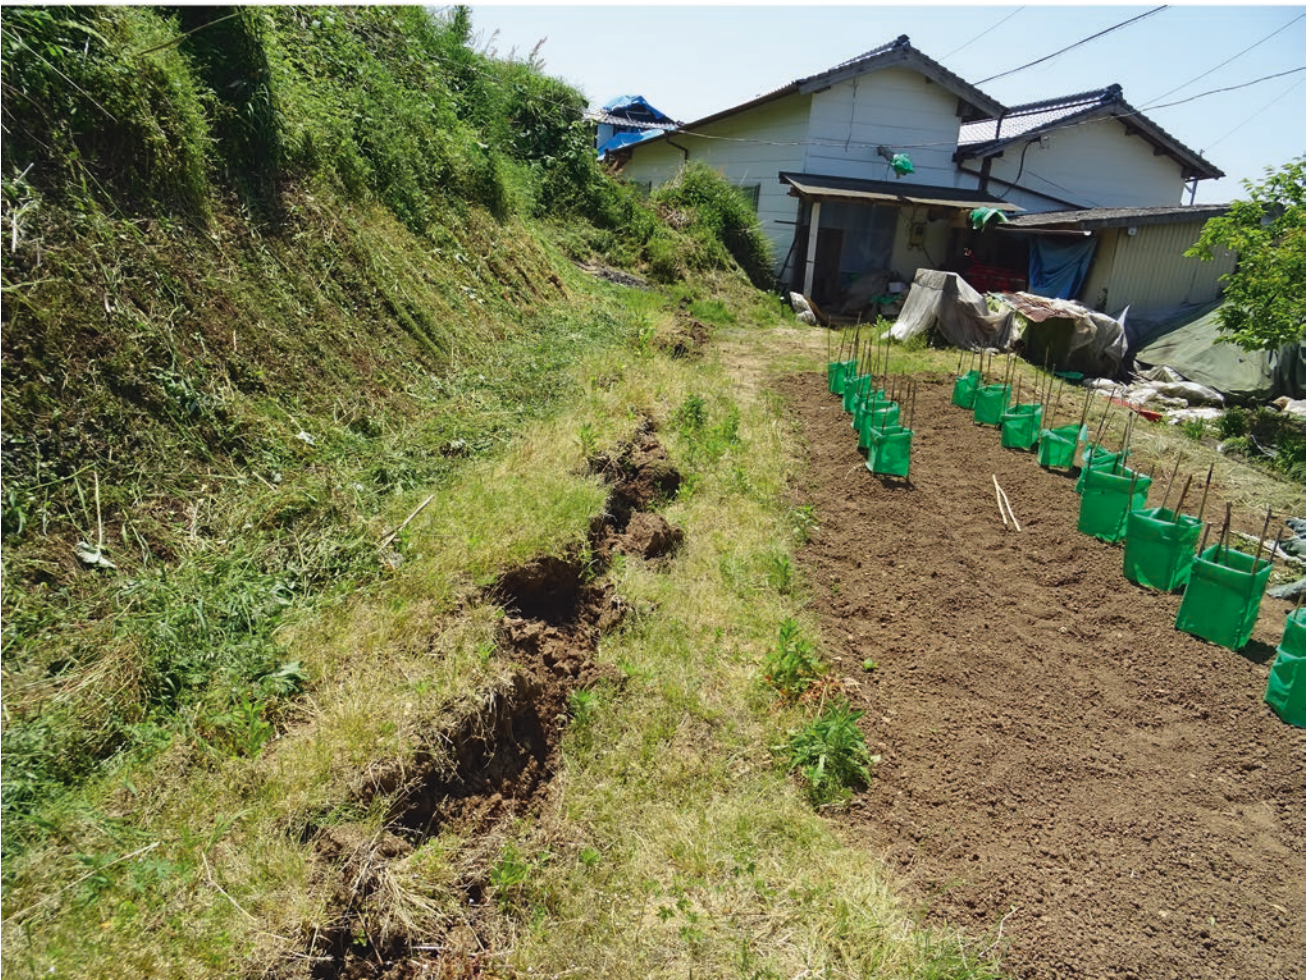
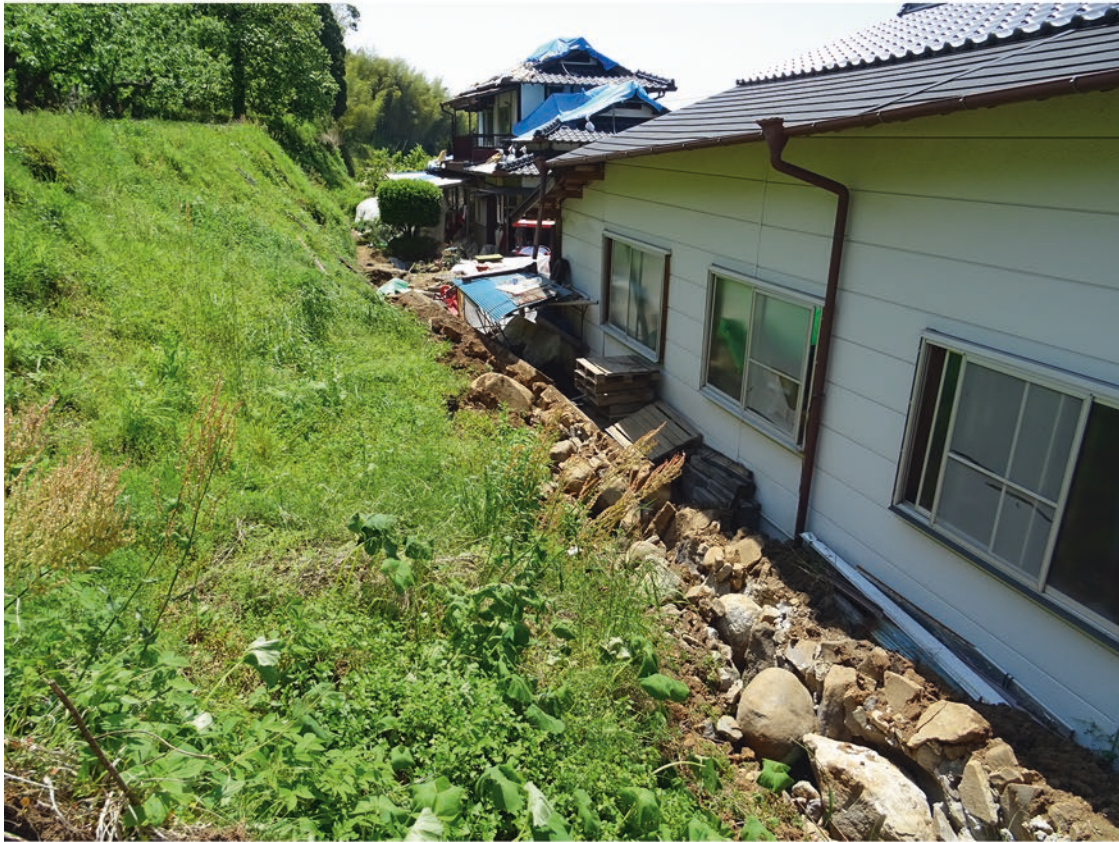
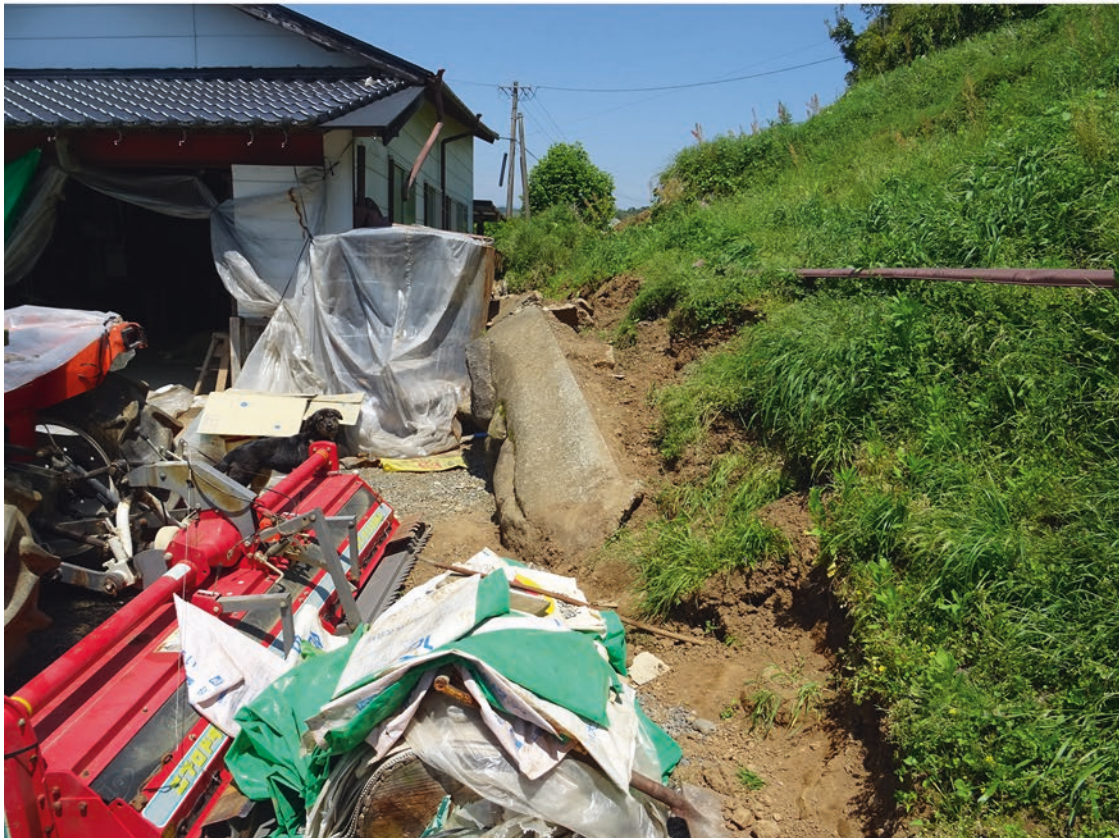
Fig. 69 Houses collapsed along a coseismic fault scarp. (a) Houses collapsed along a coseismic fault scarp of the Hinagu fault at the southern location of Takagi trench site. (b–d) Houses collapsed along the

coseismic surface rupture zone developed along a preexisting fault scarp of the Futagawa Fault

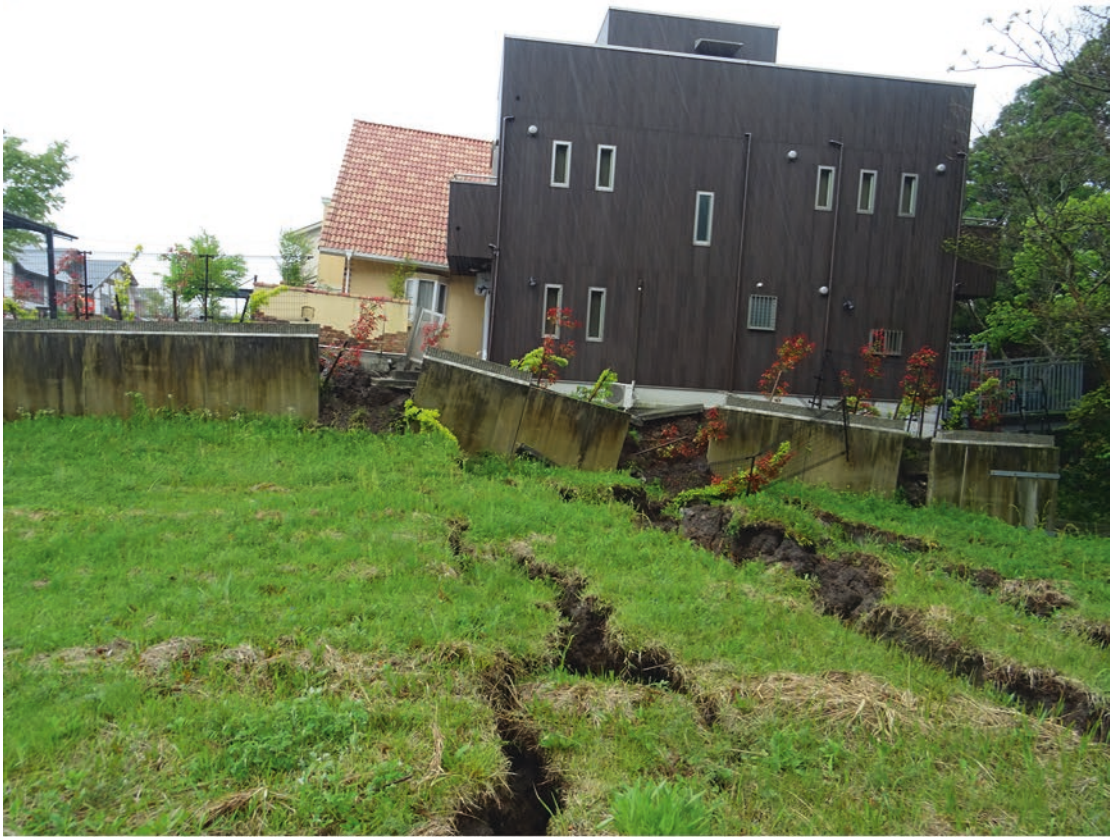
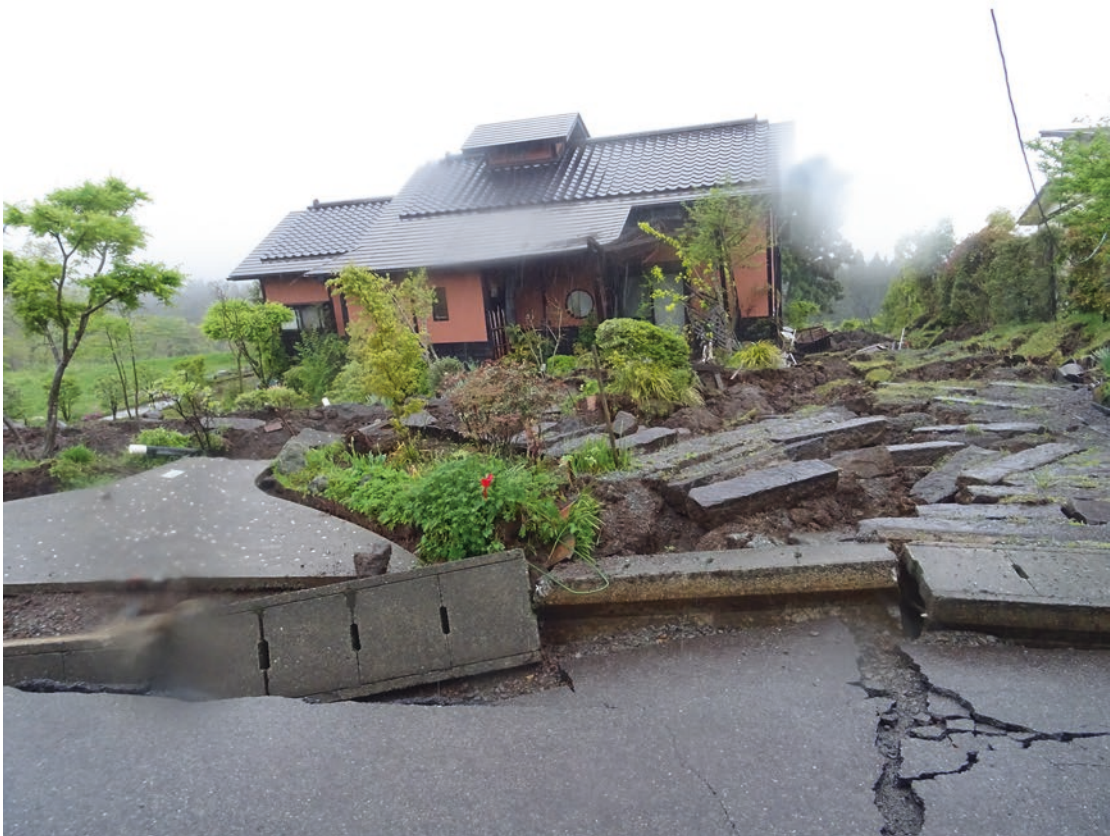
Fig. 70 Houses collapsed along a coseismic surface rupture zone. (a) Houses collapsed along the coseismic surface ruptures along a preexisting fault scarp of the Futagawa fault. (b–d) Houses collapsed and slanted along the coseismic surface ruptures

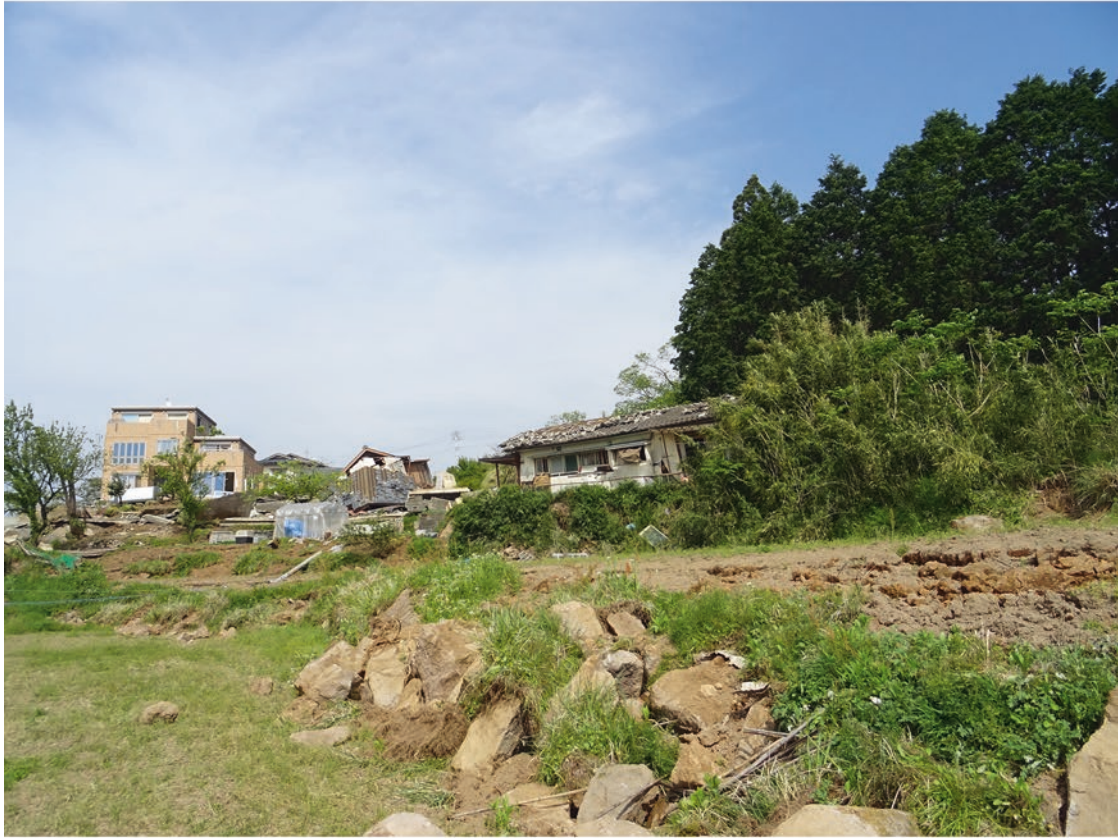
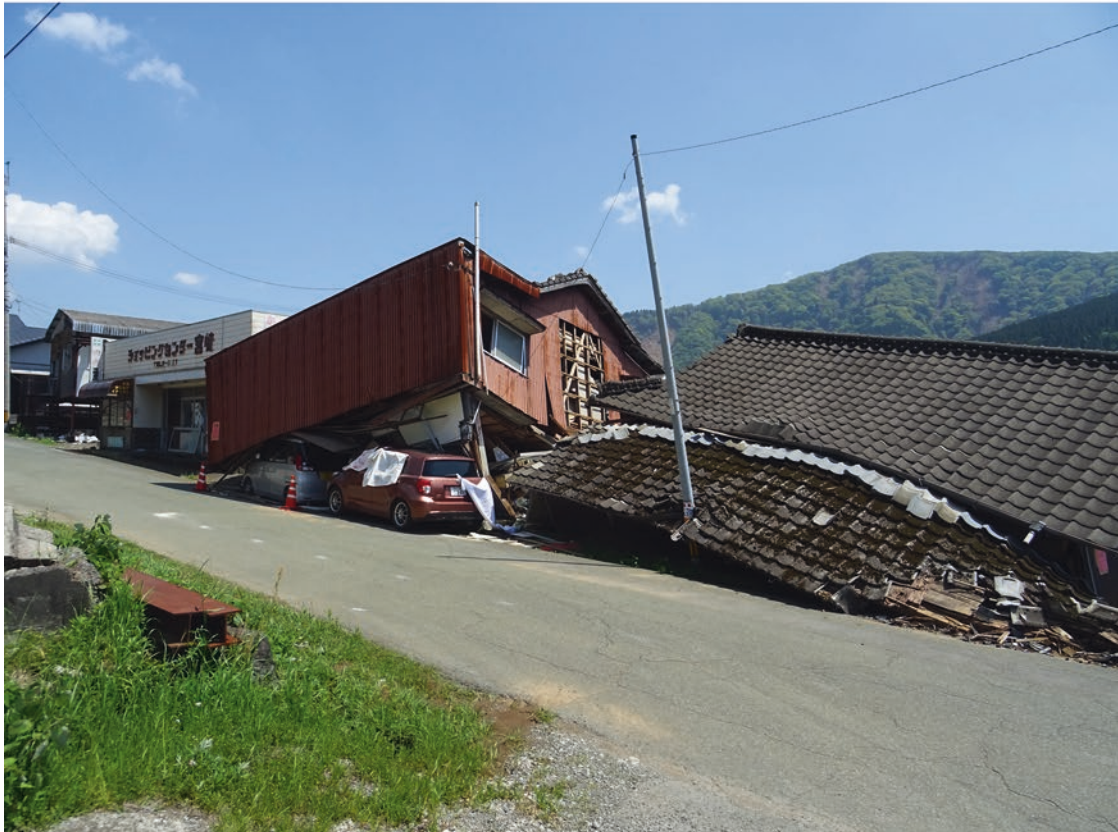
Fig. 71 Houses damaged and collapsed along the coseismic surface ruptures. (a, b) House damaged on the coseismic surface ruptures. (c)

Houses collapsed along the coseismic surface ruptures developed along a preexisting fault scarp. (d) House collapsed on a preexisting fault scarp

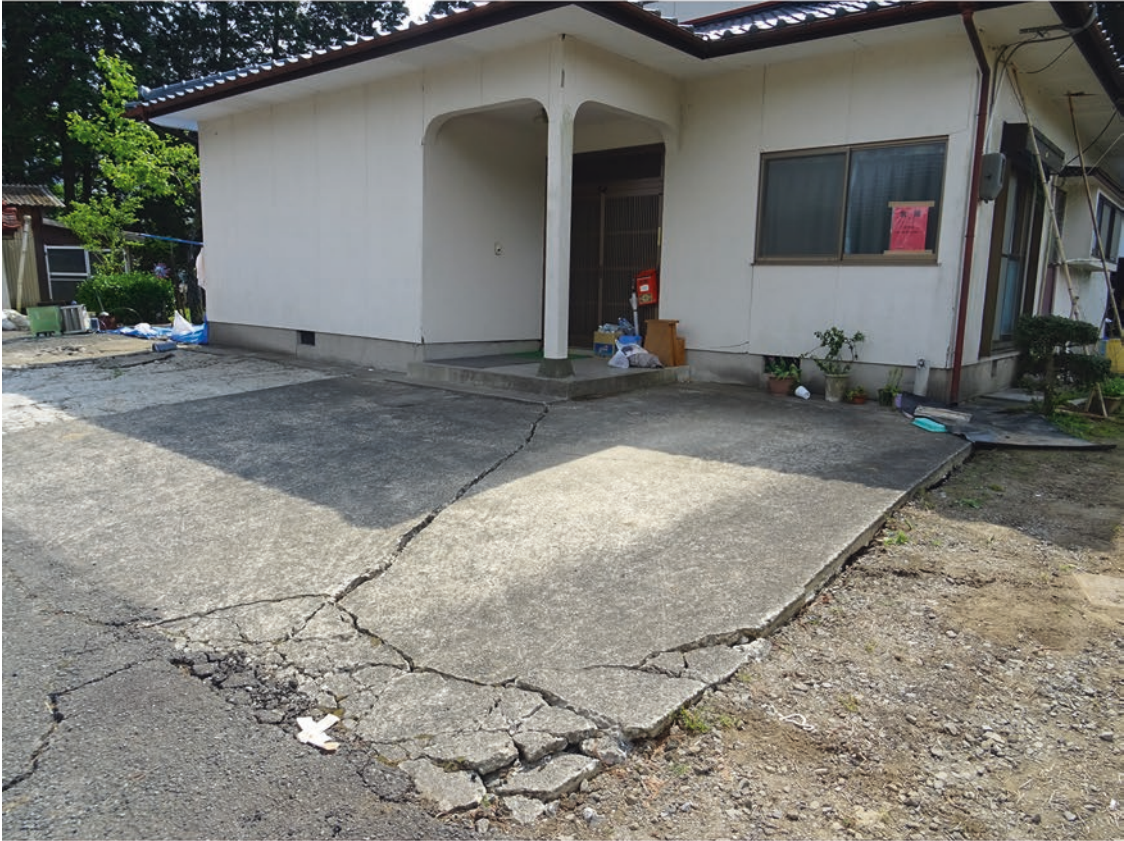
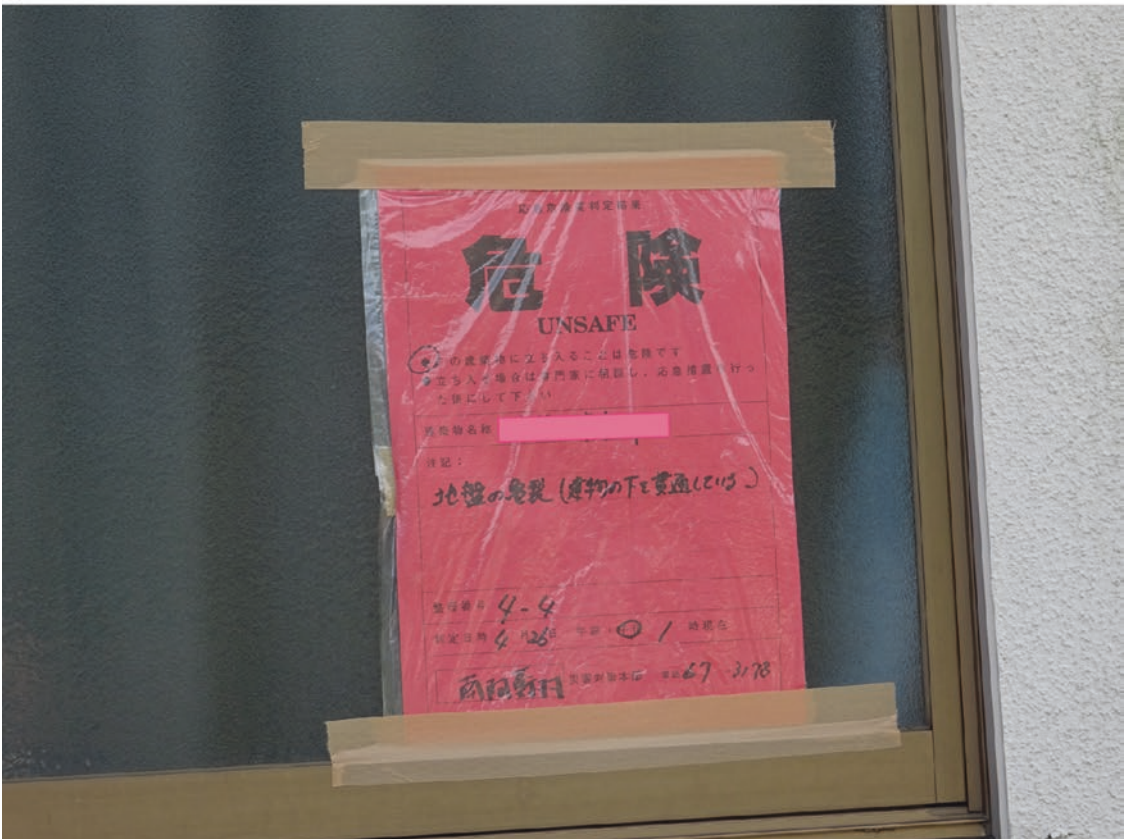
Fig. 72 Houses damaged on the coseismic surface ruptures. (a–c) Houses damaged on the coseismic surface ruptures. (d) Judgment card of dangerous house that cannot be inhabited again

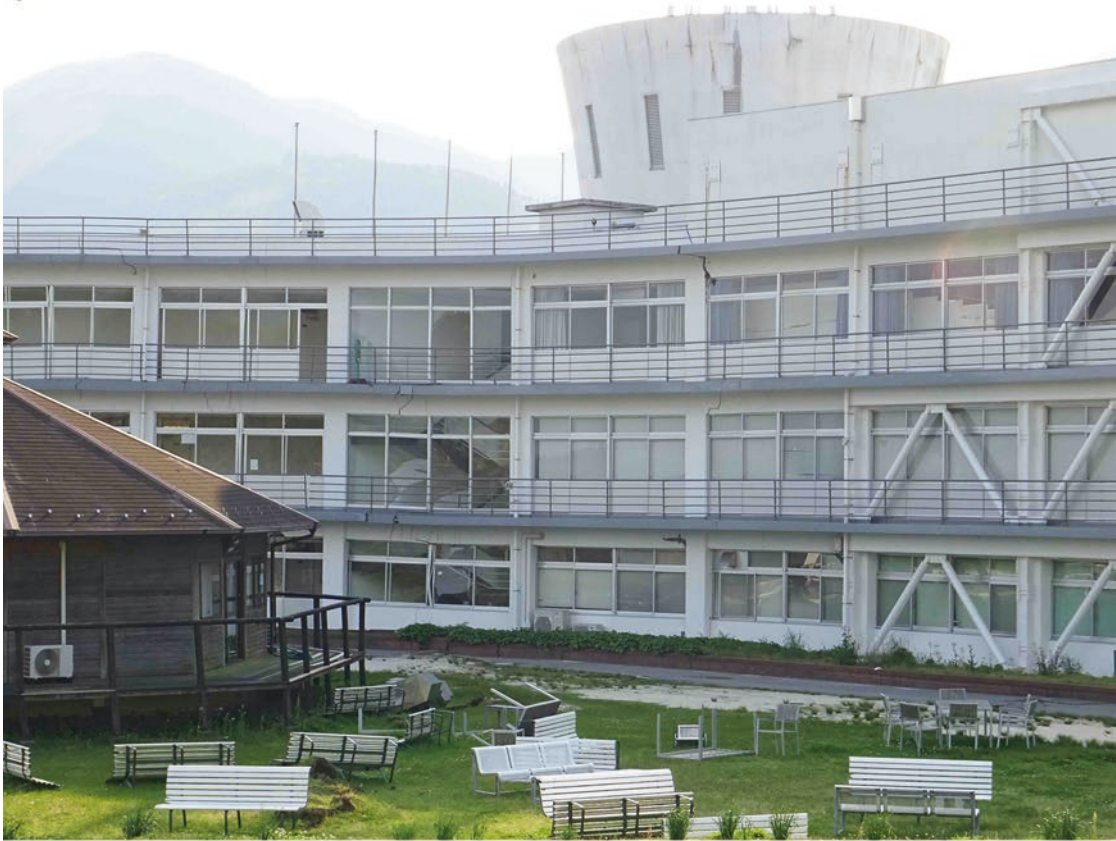
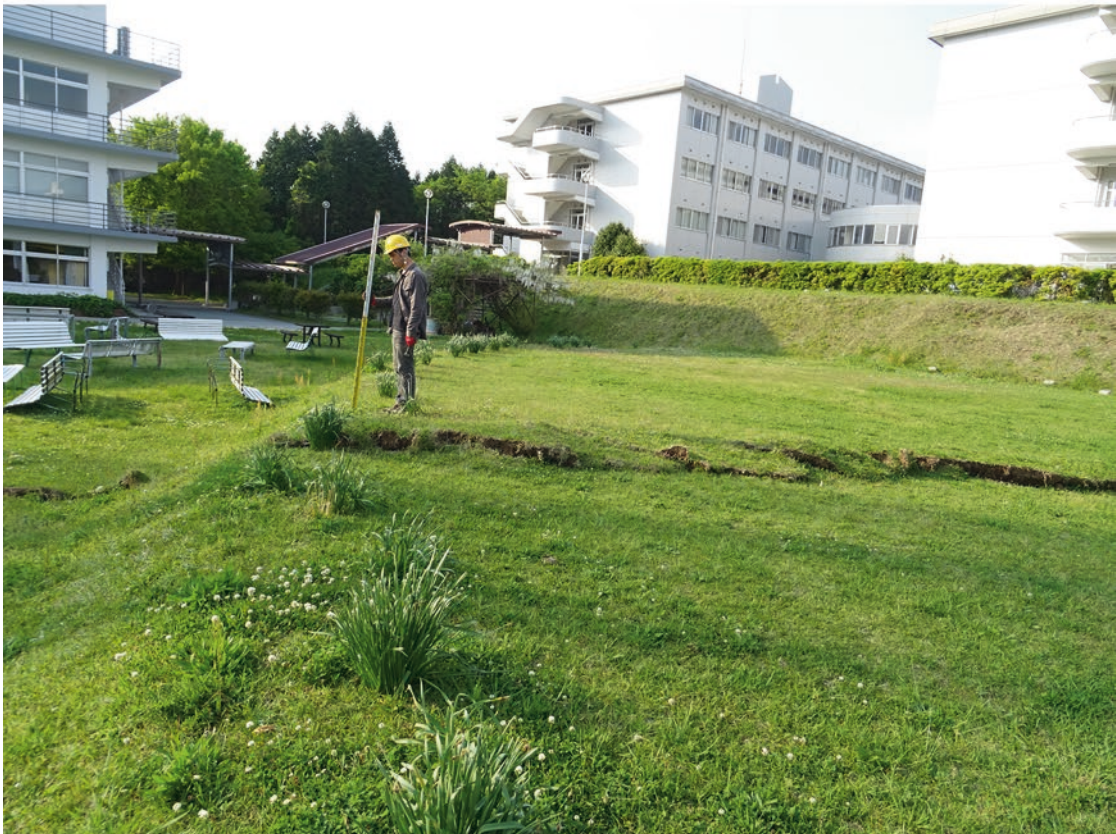
Fig. 73 Coseismic surface ruptures and damaged building of Tokai University at the Kumamoto Aso campus. **(a)** Coseismic surface ruptures occurred in a schoolyard throughout the base of the building. **(b)**

Building damaged with coseismic cracks. **(c)** Coseismic surface ruptures occurred in a schoolyard

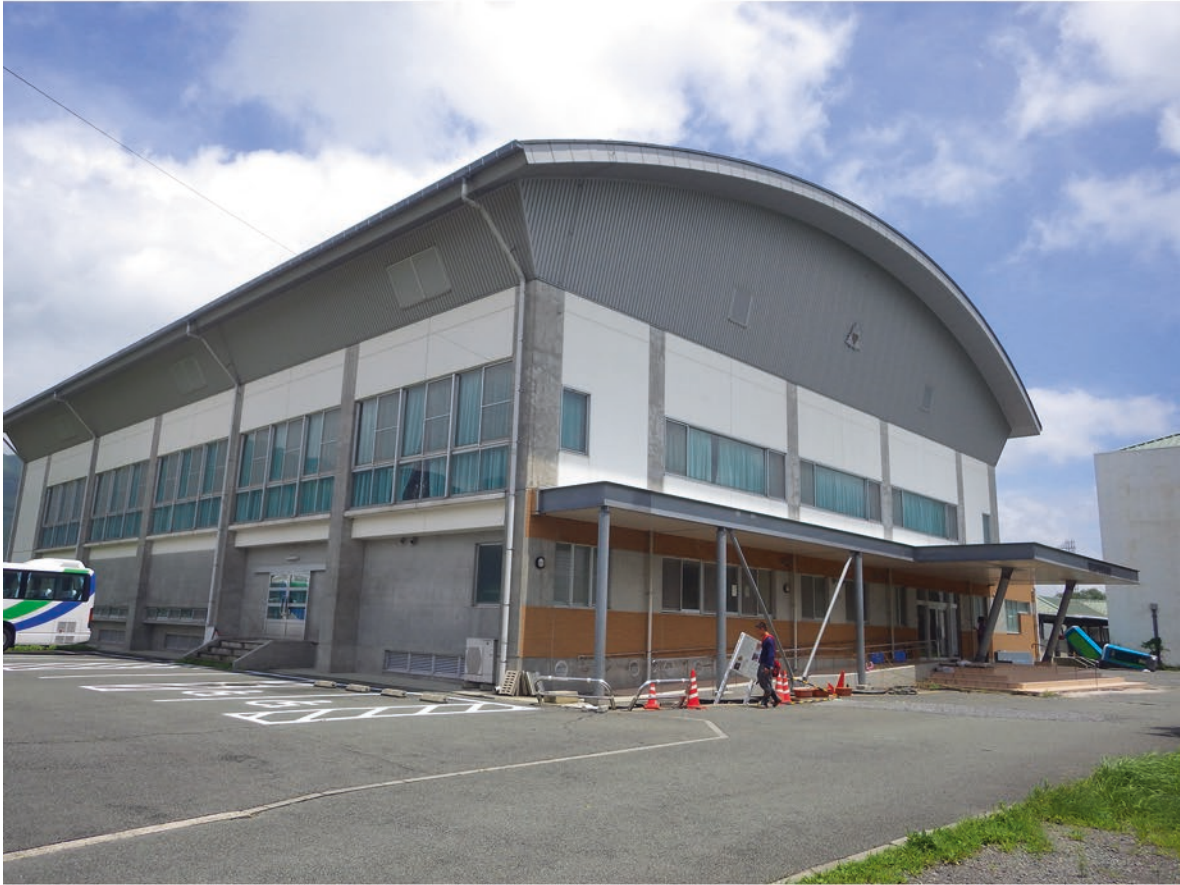
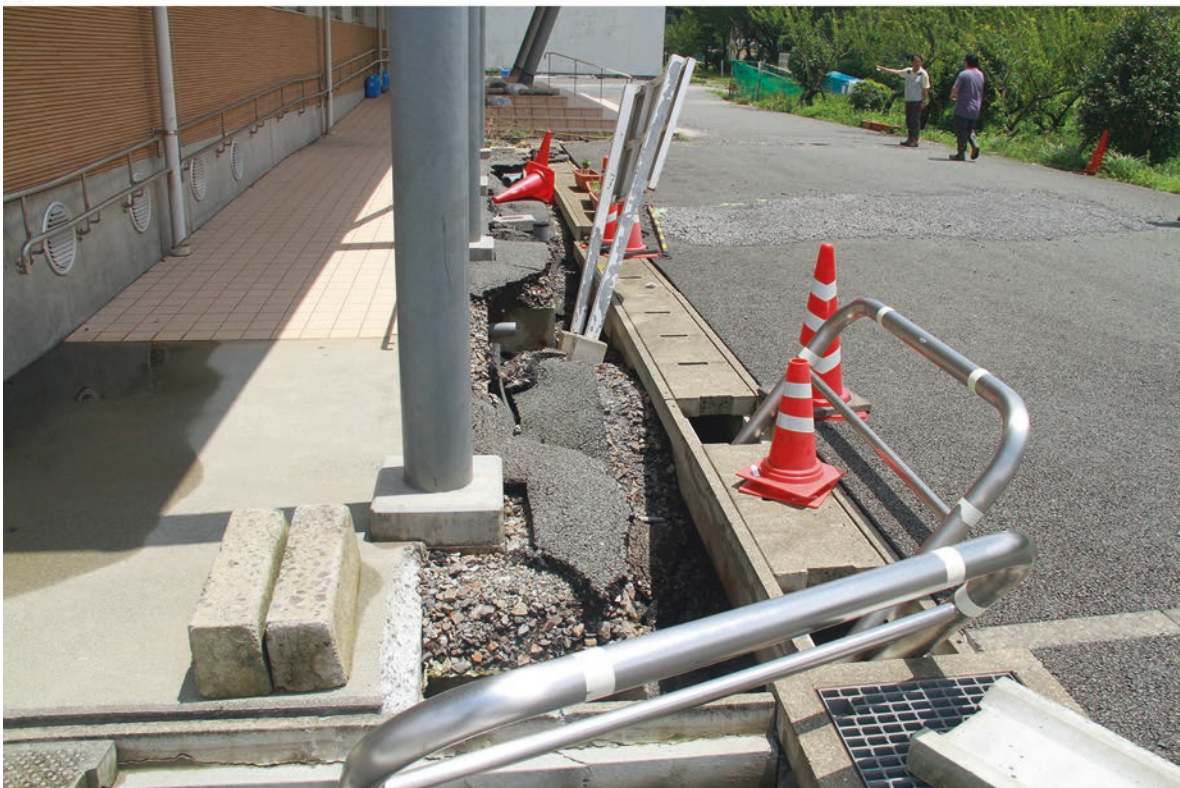
Fig. 74 Coseismic surface ruptures and damaged school house in a site near the Aso Nishi primary school. (a) Coseismic surface ruptures crosscut a road and fields (right side uplift ~50 cm). (b) A continuous

coseismic fault scarp occurred in fields and crosscut a road (vertical offset ~1.7 m). (c) The building of the Aso Nishi primary school damaged on the coseismic surface rupture zone. (d) Close-up view of (c)

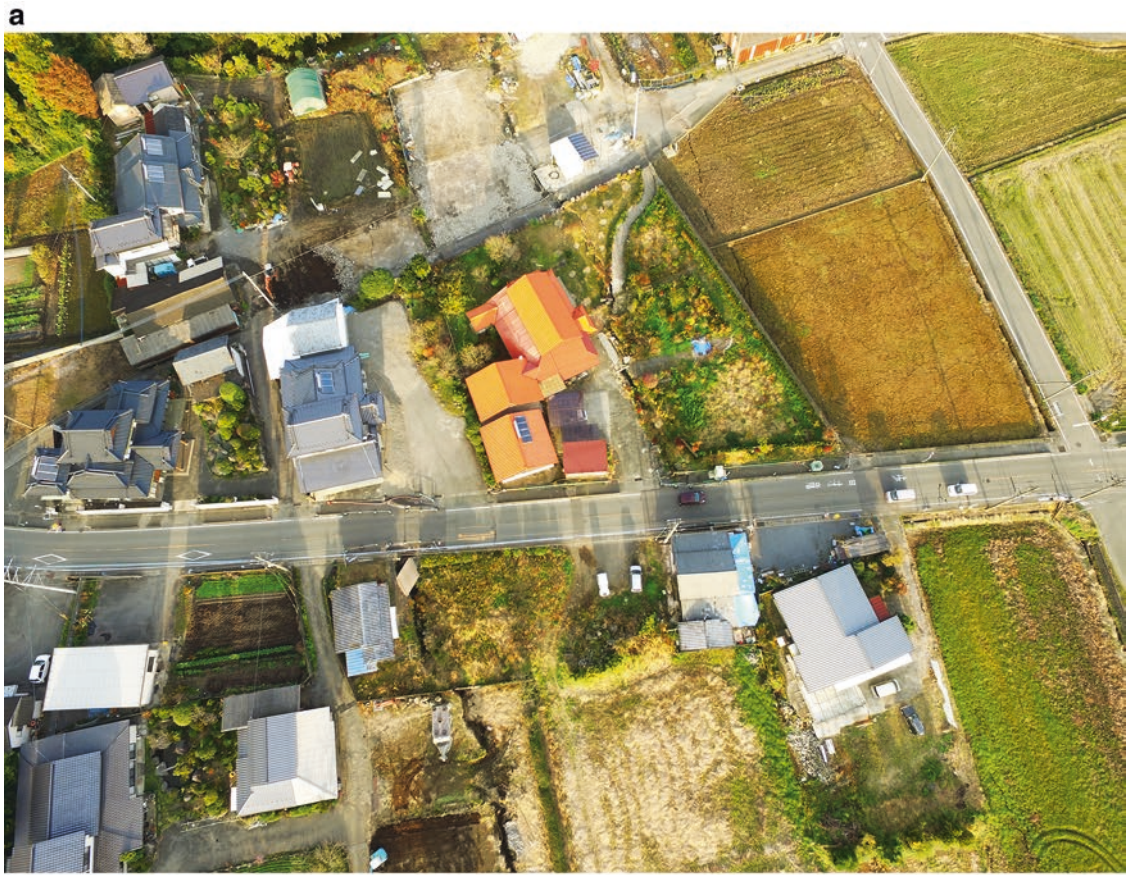
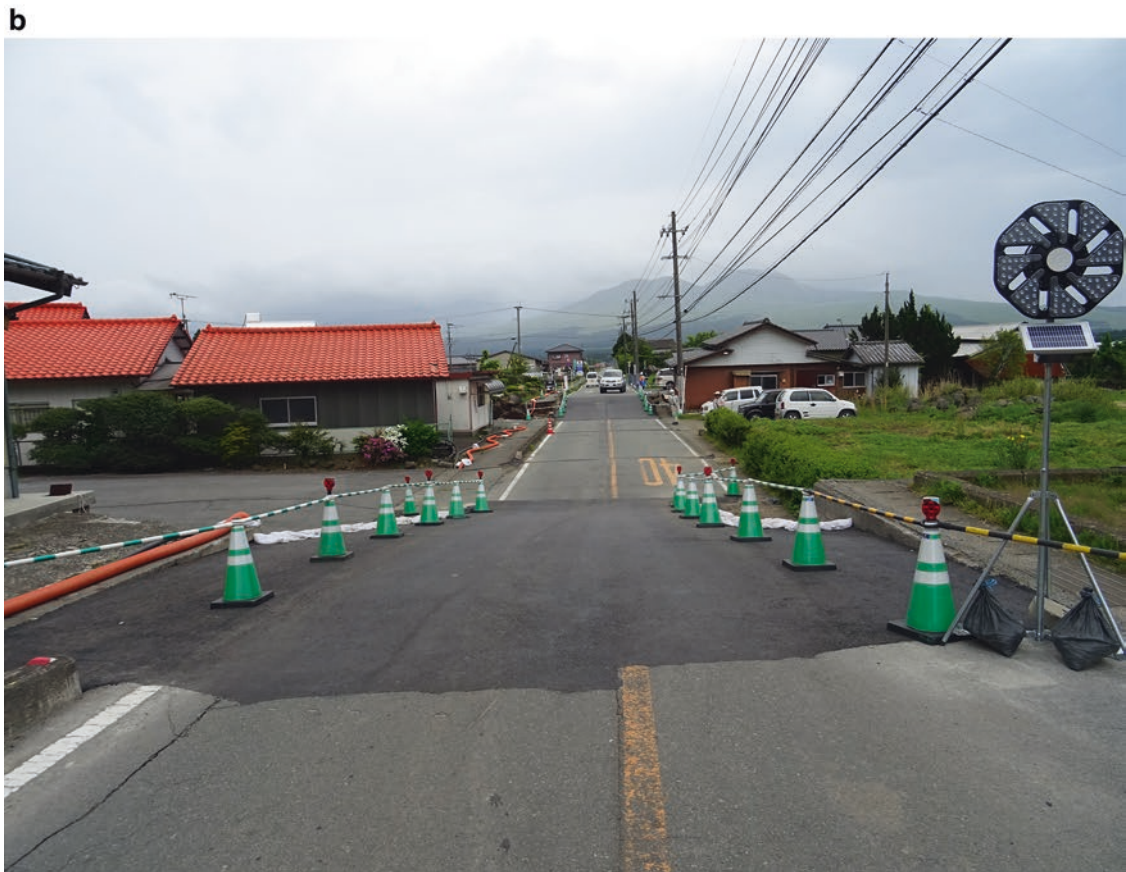
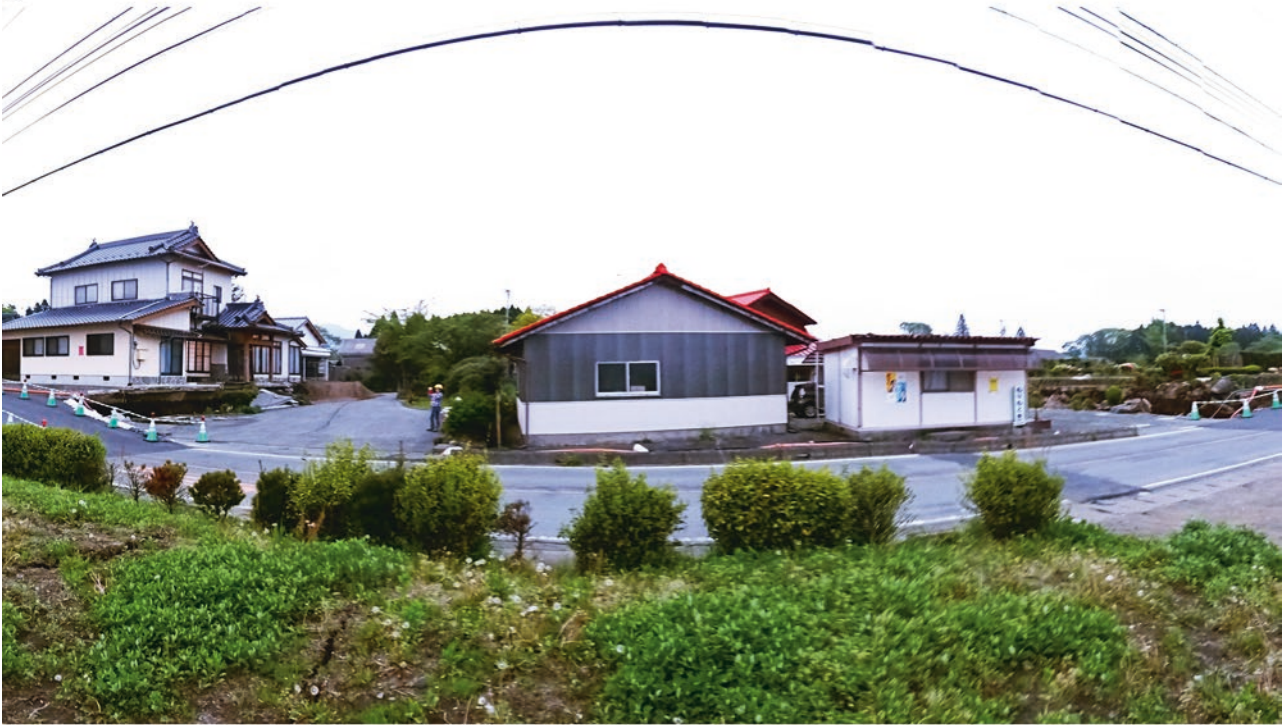
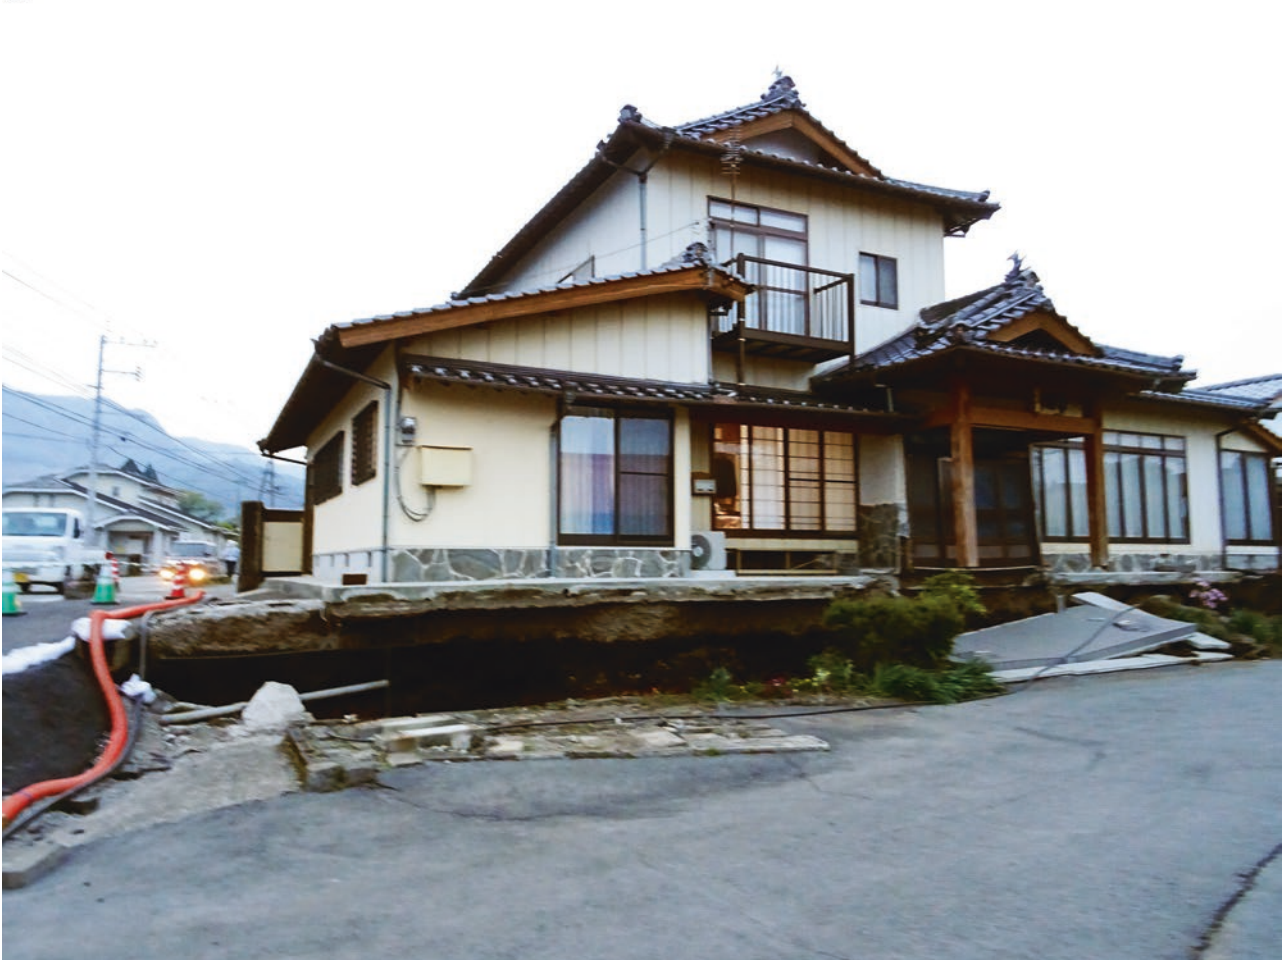
Fig. 75 Houses damaged along a coseismic graben. (a) Google image (acquired on 16 April 2016) showing a coseismic graben structure in which the houses and roads were damaged. (b, c) Ground subsidence inside a graben structure (the road was repaired immediately after the

earthquake). The red roof houses shown in (b–c) are the same as that in (a), which are located inside a coseismic graben structure. (d) Damaged house on the hanging wall of a coseismic normal fault scarp located in the uplift side of graben

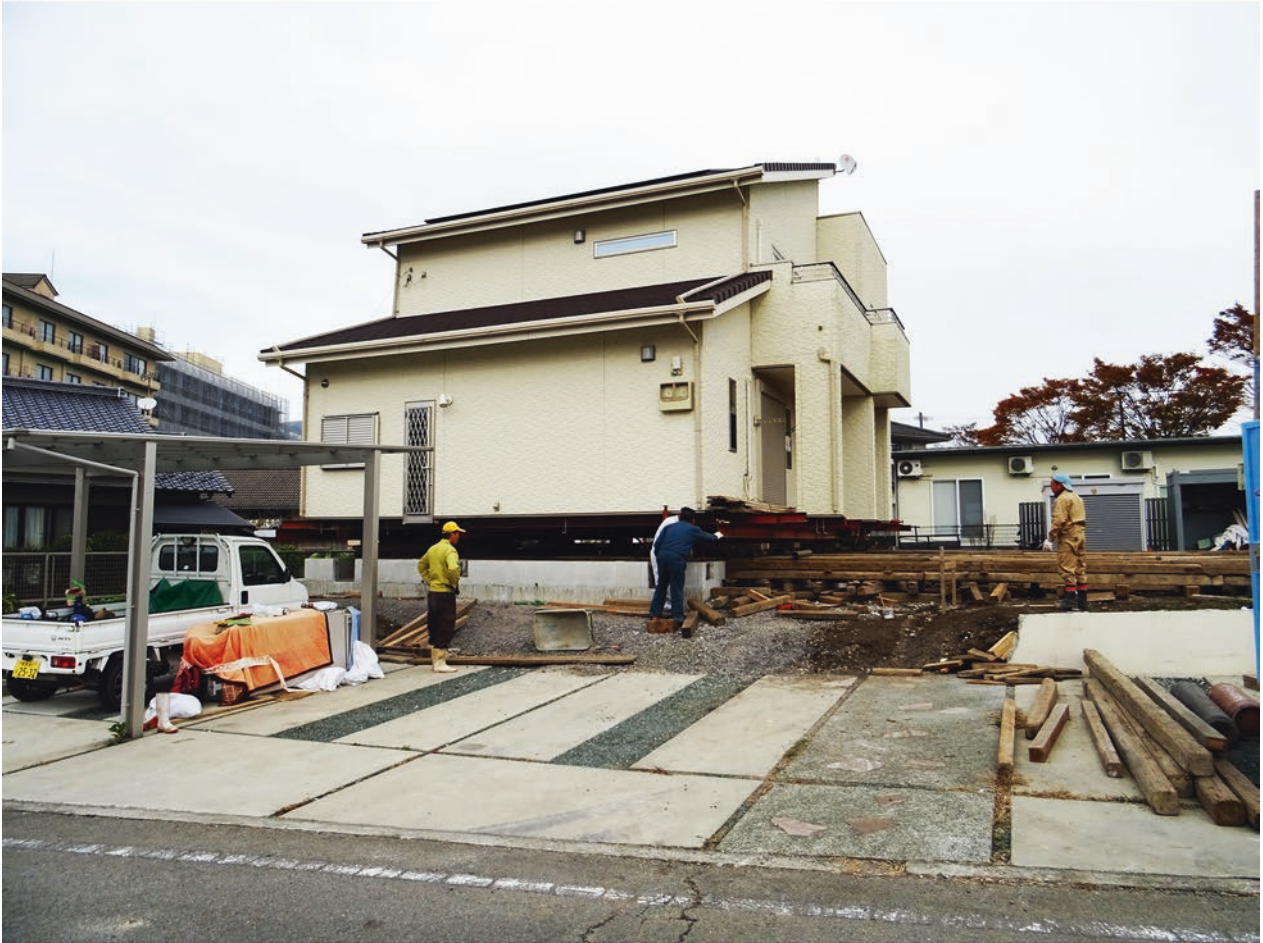
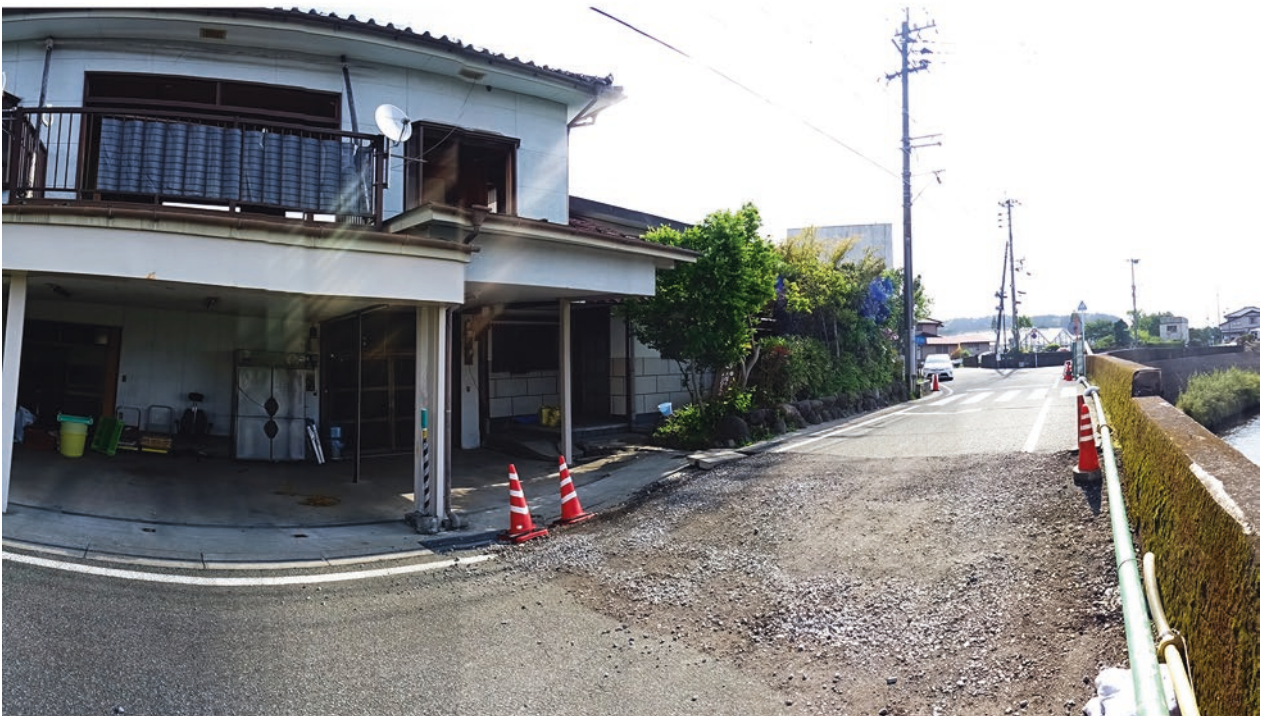
Fig. 76 Damaged houses on a coseismic normal fault scarp. (a) A damaged house located on a coseismic normal fault scarp. (b) Close-up view of (a). (c) A house inclined to a coseismic normal fault scarp,

which was uplifted ~ 0.5 m by jacking. (d) House damaged on a coseismic normal fault scarp throughout a road
