The 2016 Mw 7.1 Kumamoto Earthquake

A Photographic Atlas of Coseismic Surface Ruptures
Related to the Aso Volcano, Japan

Aiming Lin
Department of Geophysics
Kyoto University
Kyoto, Japan

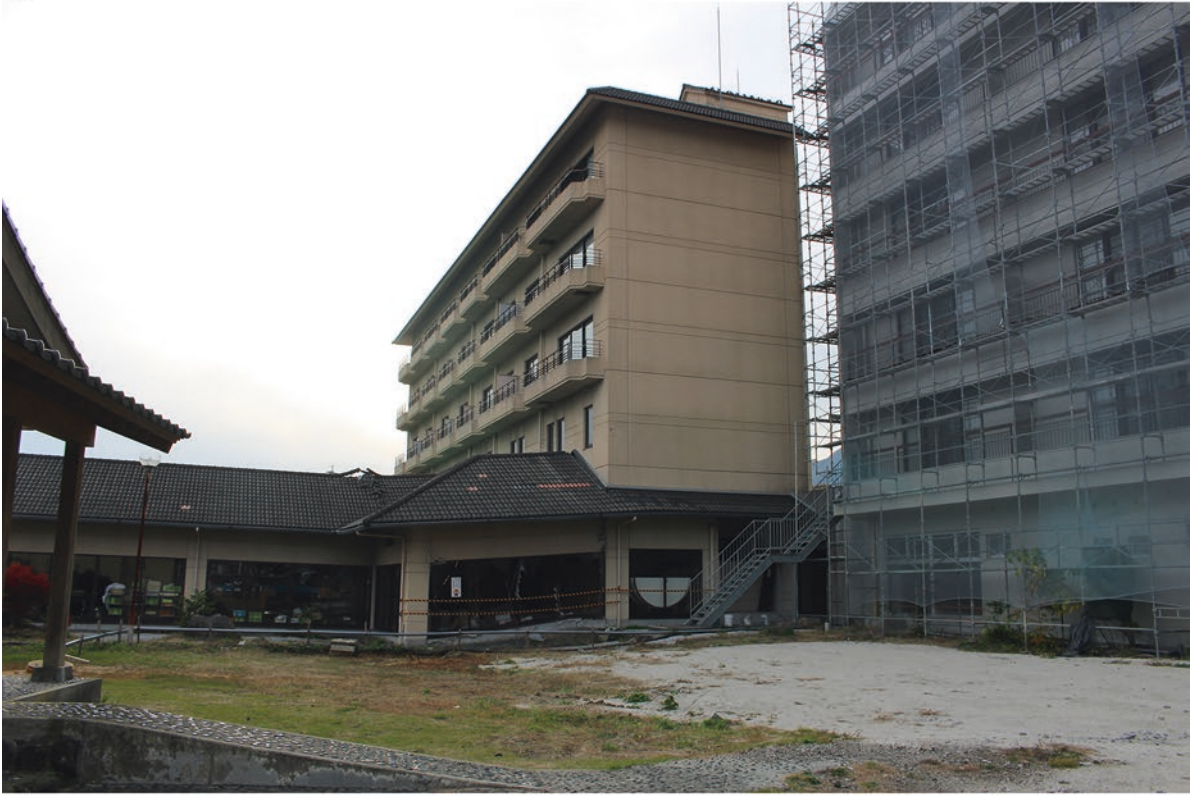
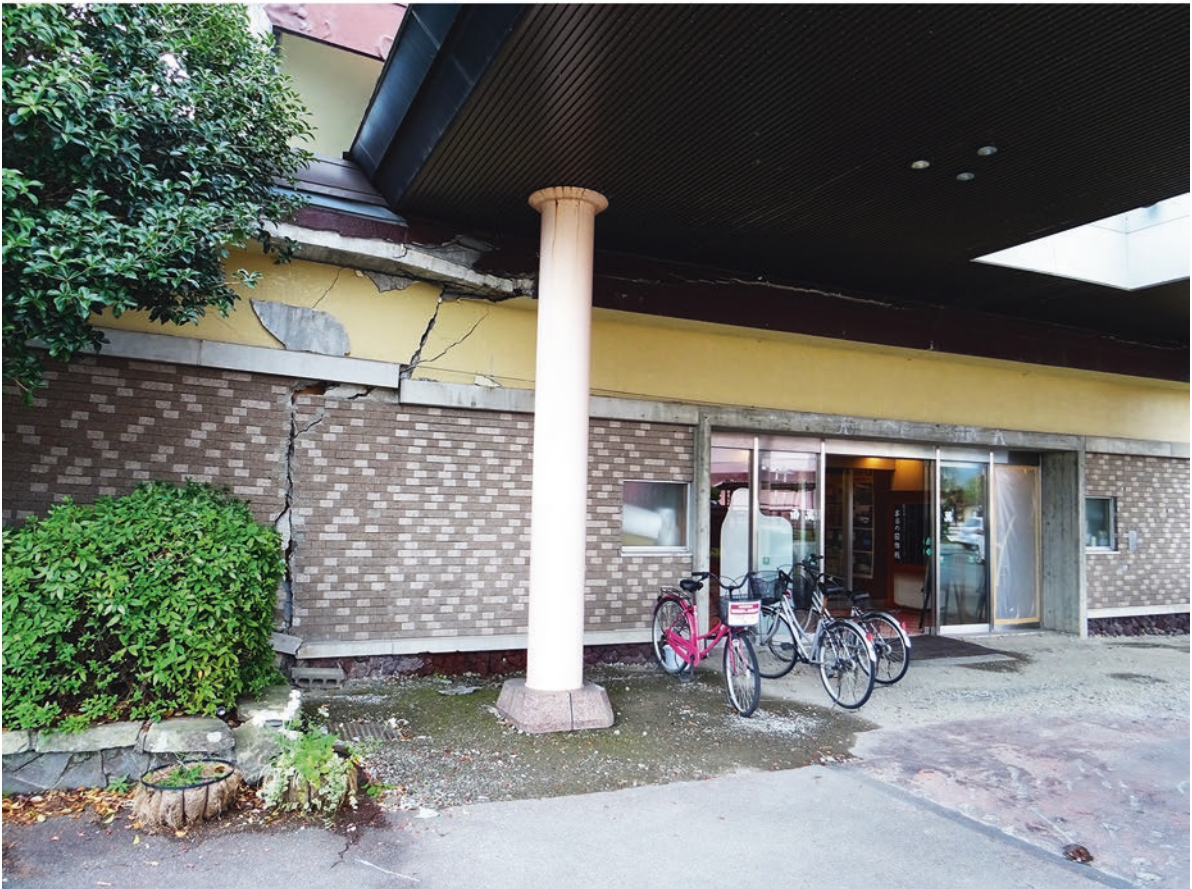
Fig. 77 Damaged building on a coseismic normal fault scarp. (a) A building on a coseismic normal fault scarp. (b) The building shown in (a) was uplifted $\sim 0.5 \sim 0.7$ m on a coseismic normal fault scarp (right side uplift). (c) Coseismic cracks occurred on a wall of building shown in (a, b)

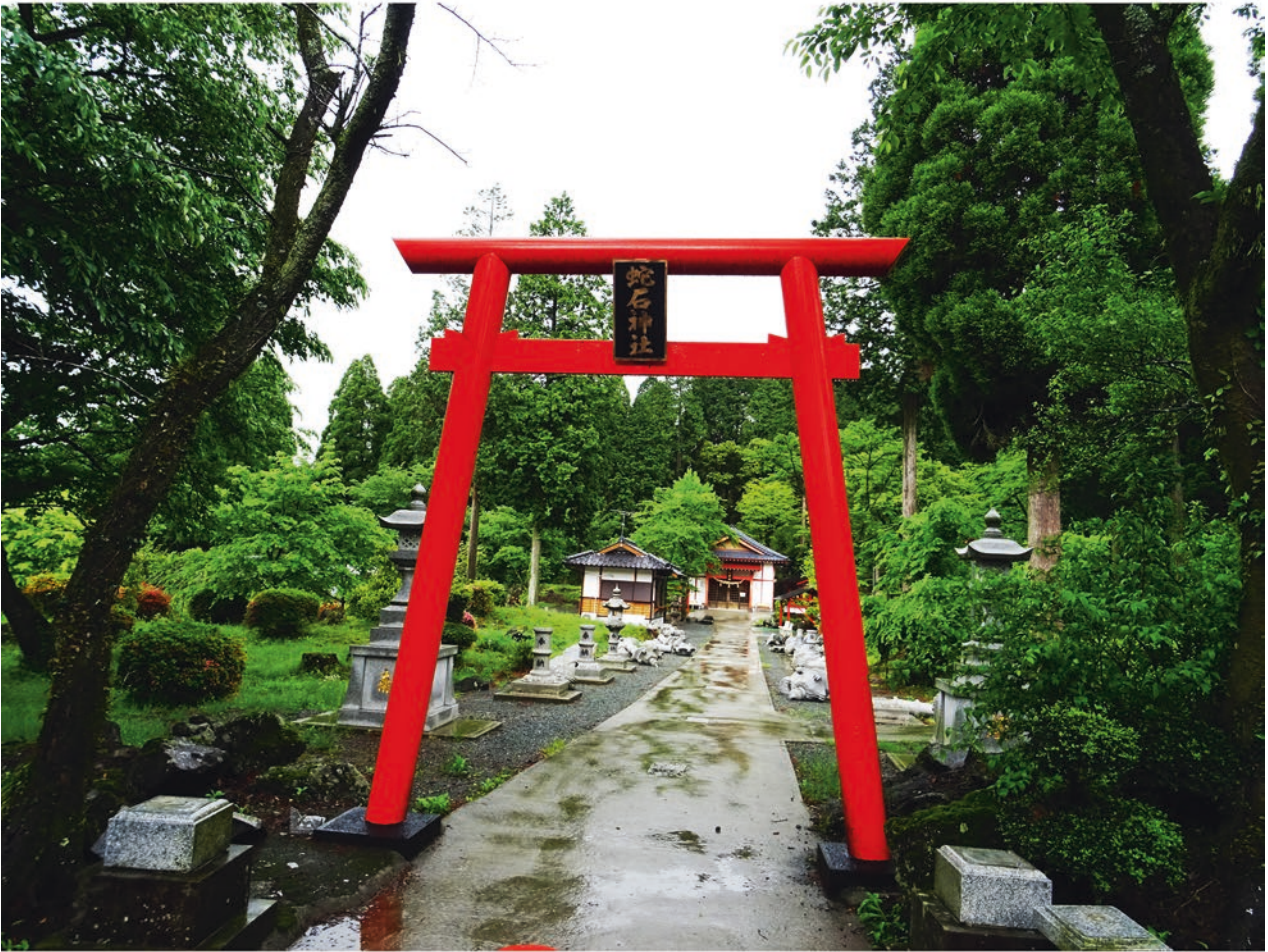
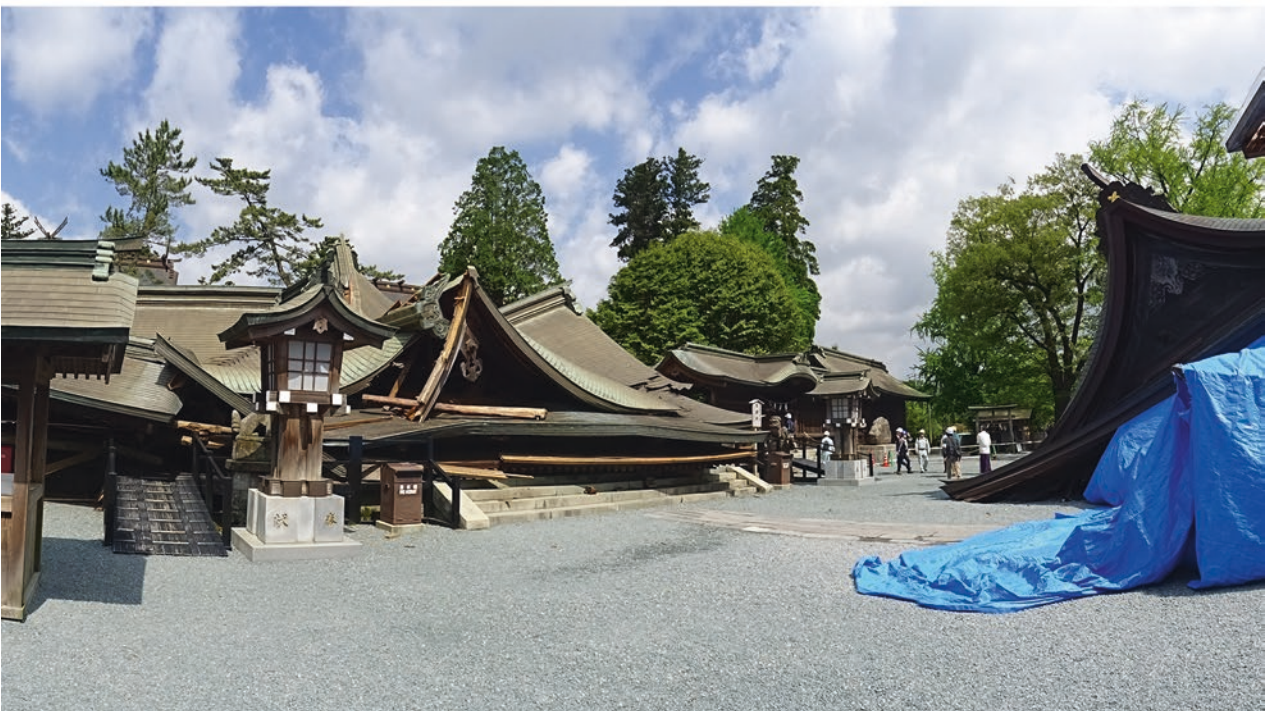
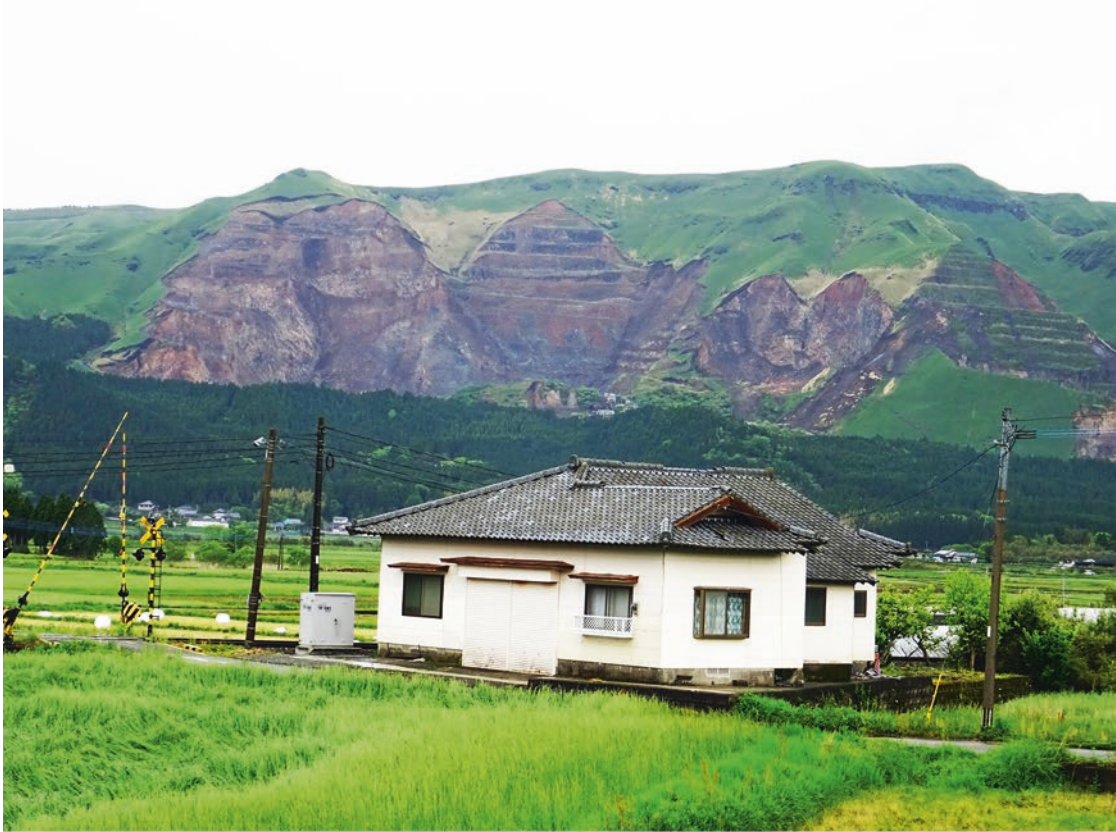
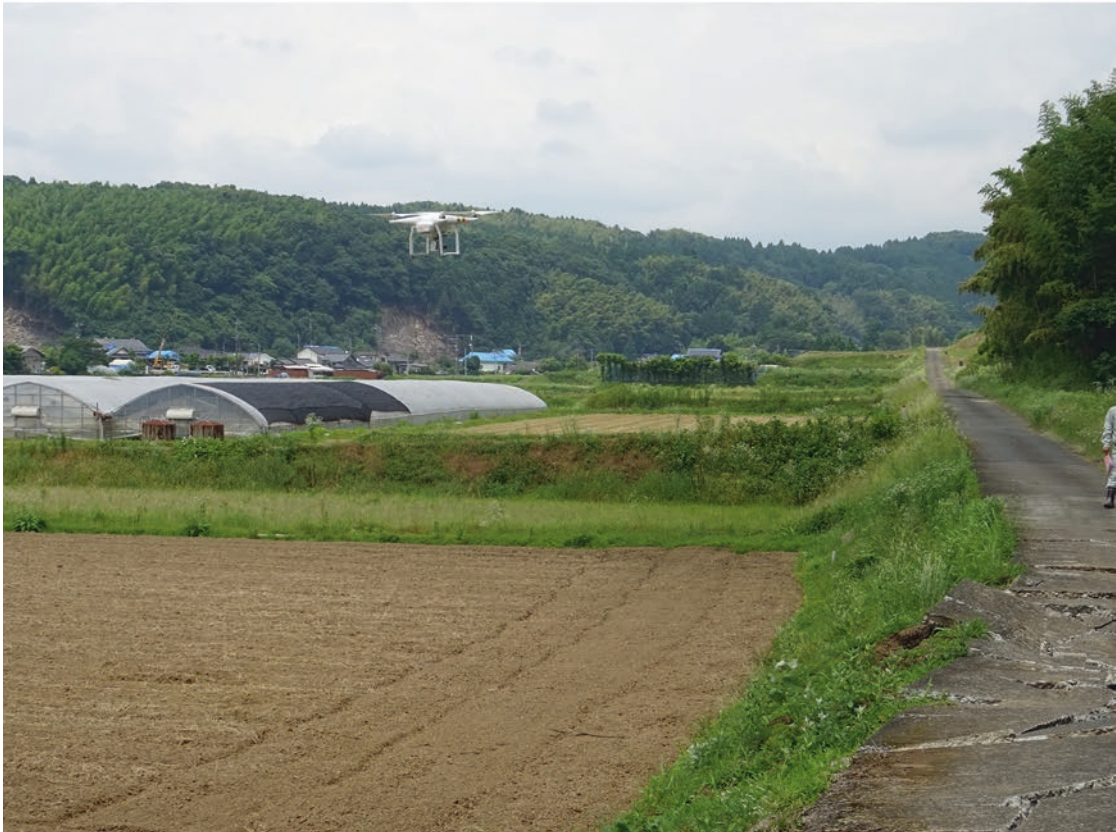
Fig. 78 Damaged shrines and landslides. (a) Collapsed stone lanterns in the Hebi-ishi (*means* slake stone) shrine. (b) Collapsed Aso Shrine located in the northeastern end area of the coseismic surface rupture

zone. (c) Landslides occurred in a slope of Aso caldera. (d) An overview of field investigation using drone to take photographs of coseismic surface ruptures
